INTERSTATE COMMERCE COMMISSION

REPORT OF THE CHIEF OF THE BUREAU OF SAFETY IN RE INVESTIGATION OF AN ACCIDENT WHICH OCCURRED ON THE ATLANTIC CITY RAILROAD AT WINSLOW JUNCTION, N J, ON JULY 2, 1922

JULY 26, 1922

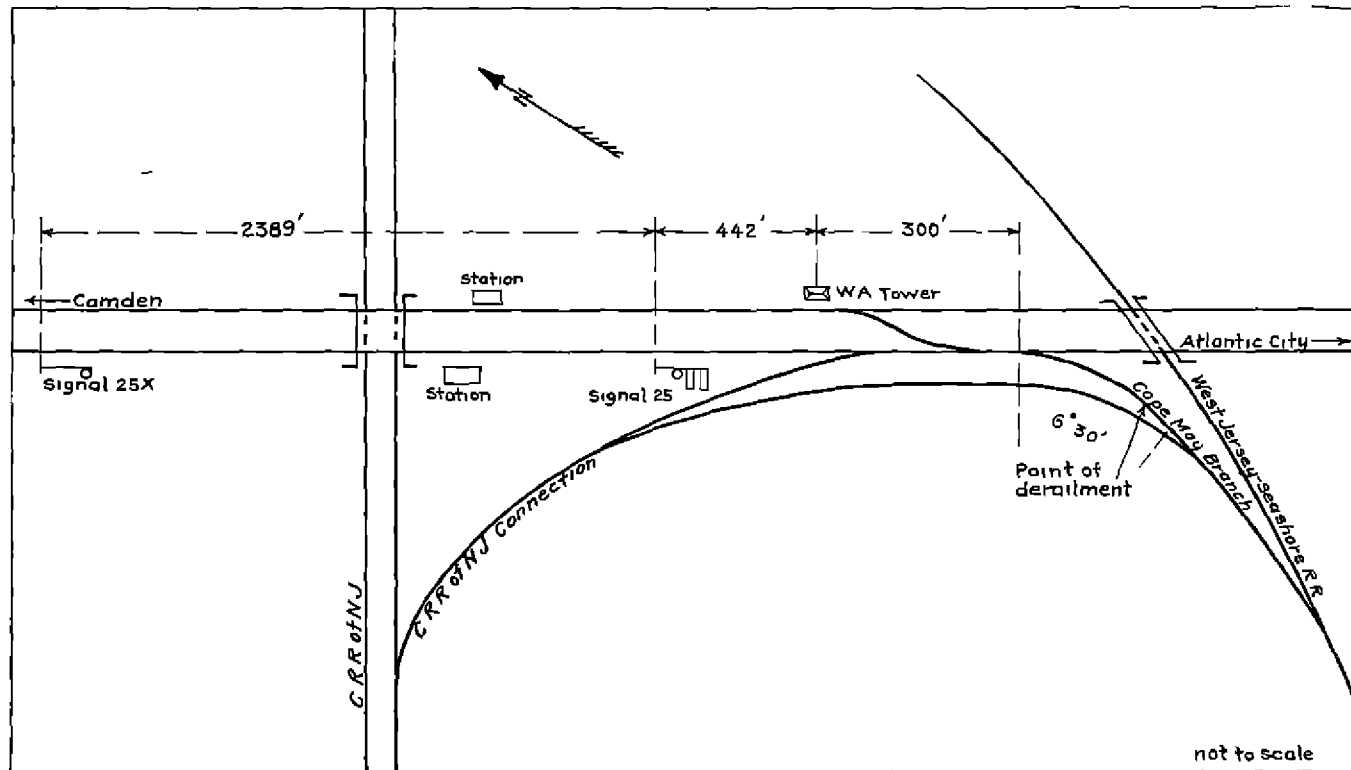
DIAGRAM SHOWING RELATIVE LOCATION OF TRACKS AND SIGNALS INVOLVED

Approaching Winslow Junction from the north, the first signal involved is distant signal 25-X, 3,131 feet from the Cape May switch. This signal is an automatic signal of the disk type, displaying a distant indication for signal 25. Home signal 25 is located 742 feet north of the switch, and is also of the disk type, it is mounted on the same mast with and under the two interlocking signals. The top arm of the interlocking signals, signal 48, governs the high-speed route to Atlantic City, and the bottom arm, signal 47, the diverging route to Cape May. When the high-speed route is set up and the block is clear, signal 48 displays a green indication, signal 47 red, and the automatic signal green, while the distant signal also displays a green indication, when the diverging route is set up and the block on the diverging route is clear, as was the case just prior to this accident, signal 48 displays a red indication, signal 47 and the automatic signal display green indications, and the distant signal a yellow, or caution, indication.

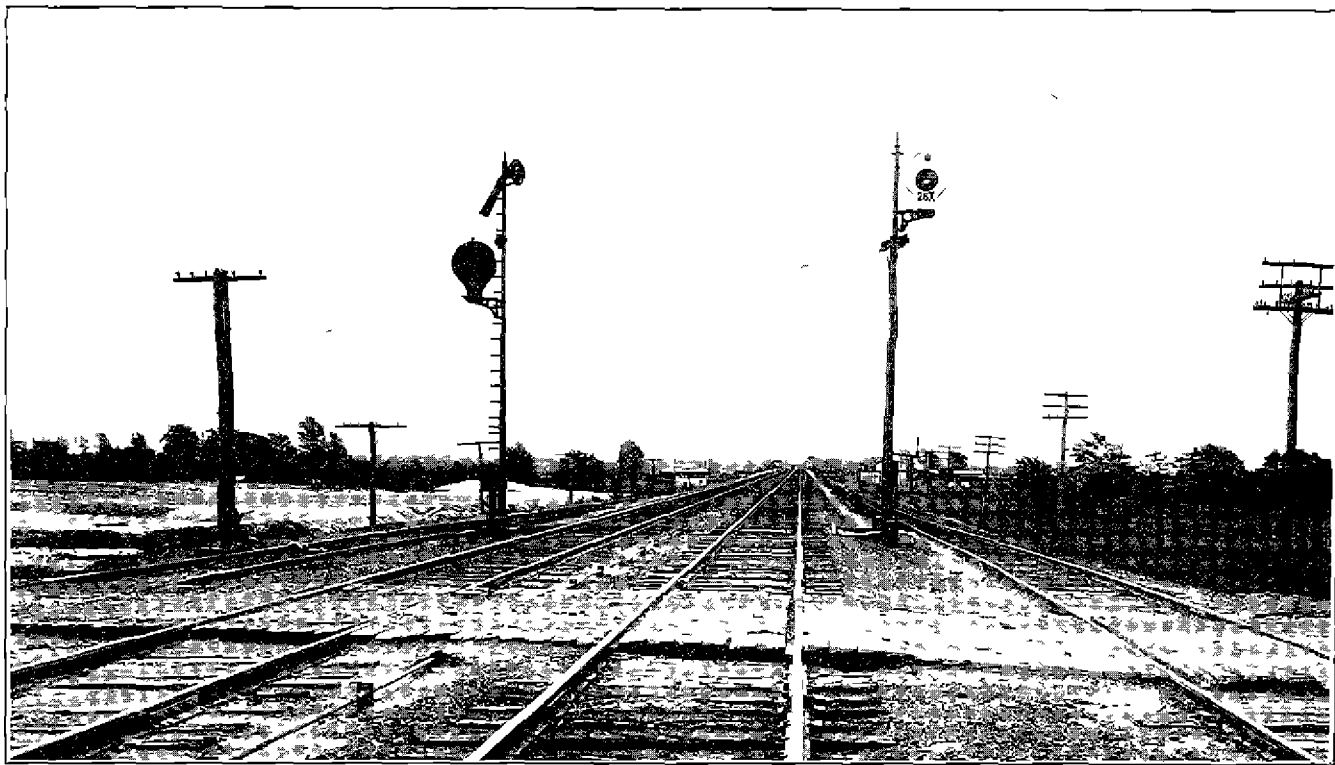
FIG NO 1—VIEW APPROACHING WINSLOW JUNCTION DISTANT SIGNAL 25X IN FOREGROUND

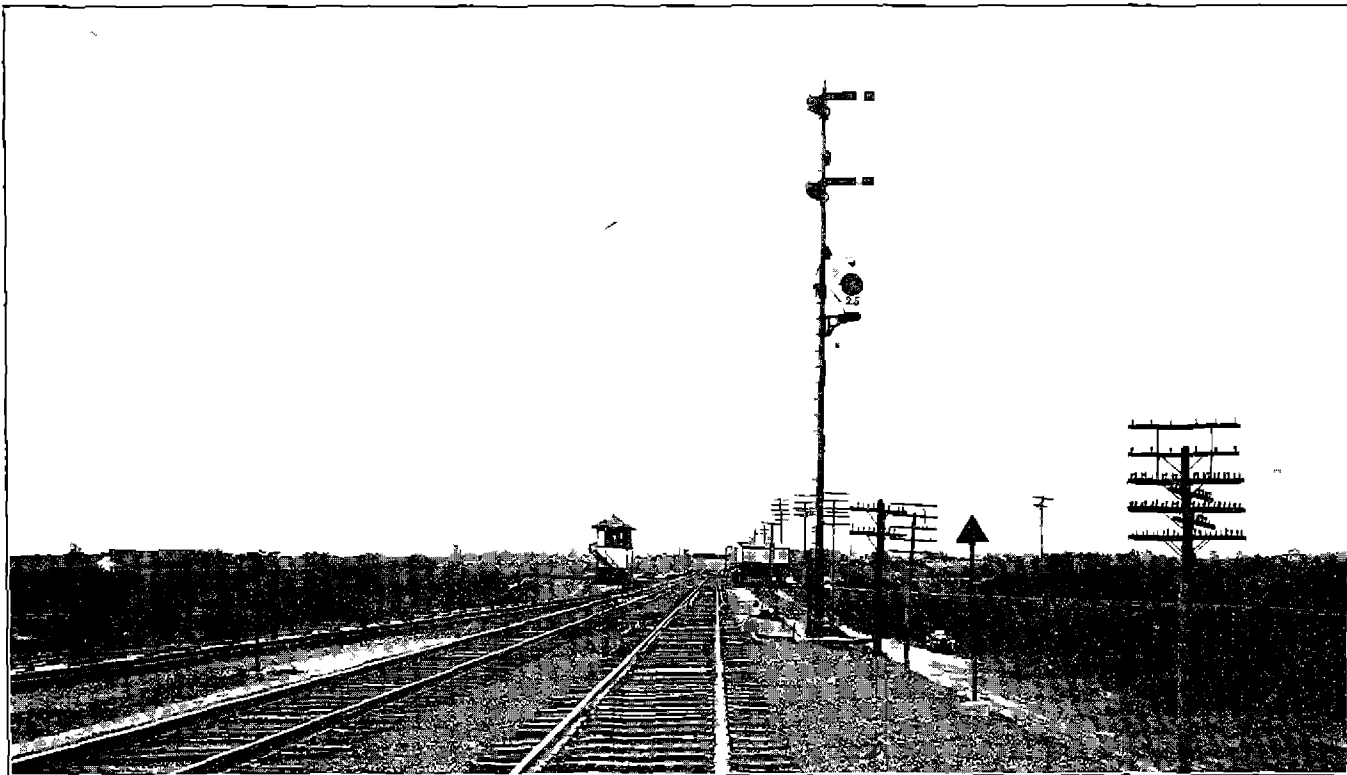
FIG NO 2—SOUTHBOUND INTERLOCKING AND HOME AUTOMATIC SIGNALS WA TOWER ON LEFT

The signals involved in this accident had been in use for many years, and the interlocking plant was not fully equipped with modern appliances While the approach locking was not complete and the arrangement was such that it was possible for the towerman to change the route through the plant after the approaching train has passed the distant signal, there was no evidence whatever that this was done, and the towerman was very positive in his statements that he did not move any of the operating levers after setting up the route to the Cape May branch several minutes before the accident occurred

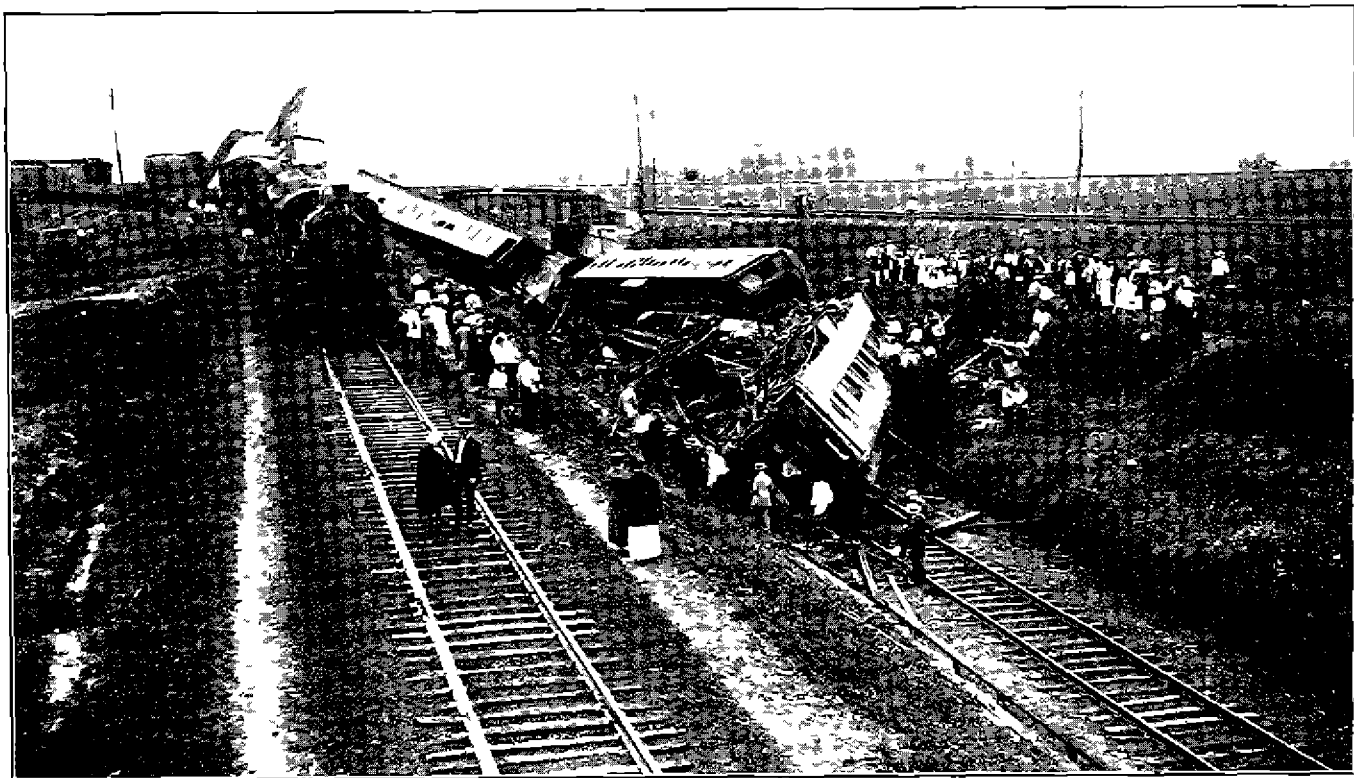
The entire train was derailed, the engine and the first four cars going down the embankment on the outside of the curve and coming to rest on the track of the West Jersey & Sea Shore Railroad, which

FIG NO 3.—GENERAL VIEW OF WRECKAGE

runs nearly parallel with the Cape May branch at this point. The engine, tender, and first car remained coupled together and came to rest on their left sides in a badly damaged condition. The parlor car came to rest nearly bottom up, on top of the engine, and was very badly damaged. The third car was on its left side on top of the first car, and the fourth car nearly on its left side directly behind the first and third cars. The two remaining cars went part way down the embankment, but did not turn over and were not seriously damaged. The employees killed were the engineman, fireman, and conductor.

Examination of the track showed that the point of derailment was on the left side of the Cape May track at the fifth rail south of the frog of the switch leading to this track, the rail having been torn out and the angle-bar bolts at the receiving end broken, as well as all but one of the bolts in the delivering end of the fourth rail, this latter rail remained in place, with the spikes showing evidence of the outward strain which had been placed on them as the train rounded the curve.

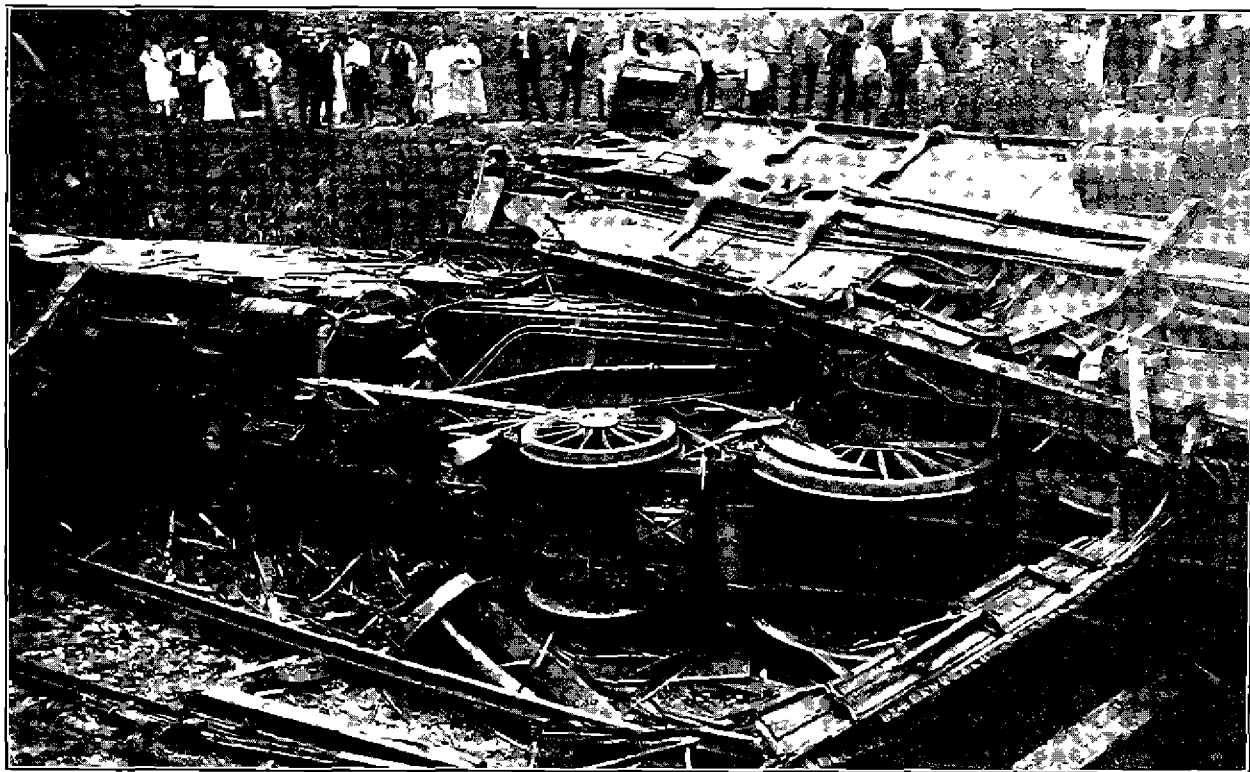
FIG NO 4—ENGINE 349 WITH TENDER, PULLMAN PARLOR CAR ON TOP OF ENGINE

Master Mechanic Stohlberger said that on examining engine 349 at the scene of the accident he found the throttle and reverse lever had been considerably damaged, but the link block was set for a one-eighth or one-fourth inch cut-off, the proper position for high speed.
