INTERSTATE COMMERCE COMMISSION

REPORT OF THE CHIEF OF THE BUREAU OF SAFETY COVERING THE INVESTIGATION OF AN ACCIDENT WHICH OCCURRED ON THE CANADIAN PACIFIC RAIL- WAY, NEAR ONAWA, ME, DECEMBER 20, 1919

JANUARY 17, 1920

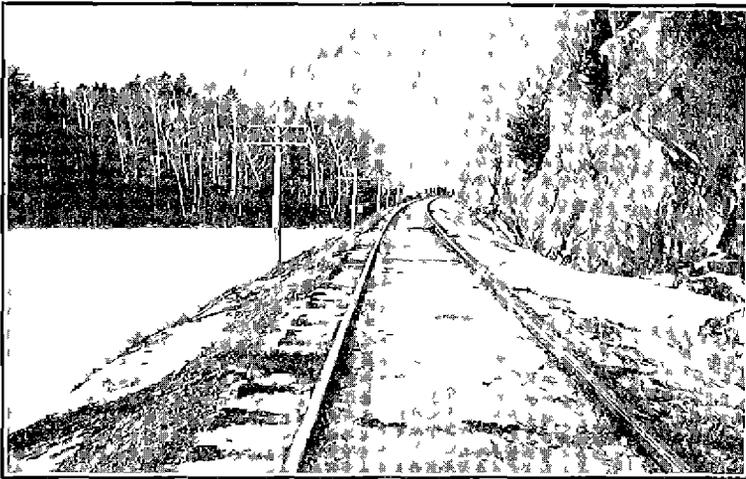
dent on an eastbound train and that of a fireman approaching on a westbound train is limited to about 750 feet, while an engineman approaching on a westbound train can see little farther than the front of his engine. Illustrations Nos 1 and 2, both of which are views approaching the point of accident from the east, show how the vision of engine crews is obscured. For more than a mile on each side of the point of accident the grade is descending for eastbound trains, varying from 1.2 per cent to 0.33 per cent. At the point of accident it is 0.9 per cent. The accident occurred in the morning shortly after daylight, and the weather at the time was clear.

FIG 1.—View approaching point of collision from the east

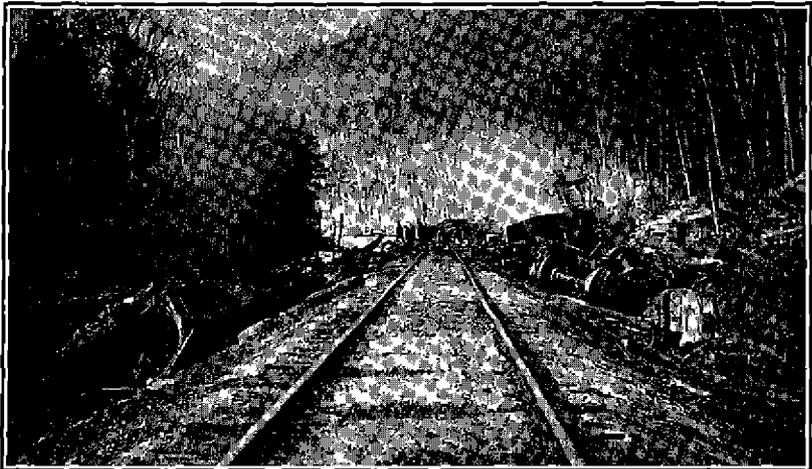
FIG 2—View from east showing wreckage after it had been cleared from track

The force of the collision interlocked the engines of both trains and the tender of the passenger train was forced upon its front end and jammed up against the boiler head of the engine. The baggage car of train third No 39 was entirely demolished, while the coach telescoped the colonist car directly behind it for about two-thirds of its length. Both of these cars, however, remained upright on the track. Illustration No 3 is a view of the damaged colonist car after it had been thrown down the bank to clear the track. The second colonist car remained on the rails and was but slightly damaged, while the remaining cars in the train sustained practically no dam-

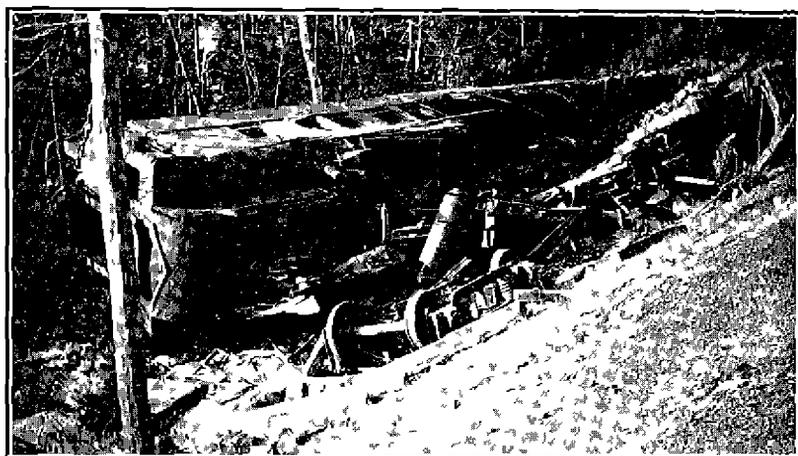
FIG 3—Wreckage of third car in train 3d No 39 after it had been cleared from the track
