INTERSTATE COMMERCE COMMISSION.

REPORT OF THE CHIEF OF THE BUREAU OF SAFETY COVERING THE INVESTIGATION OF AN ACCIDENT WHICH OCCURRED ON THE LOUISVILLE & NASHVILLE RAILROAD AT SHEPHERDS- VILLE, KY., ON DECEMBER 20, 1917

JANUARY 28, 1918.

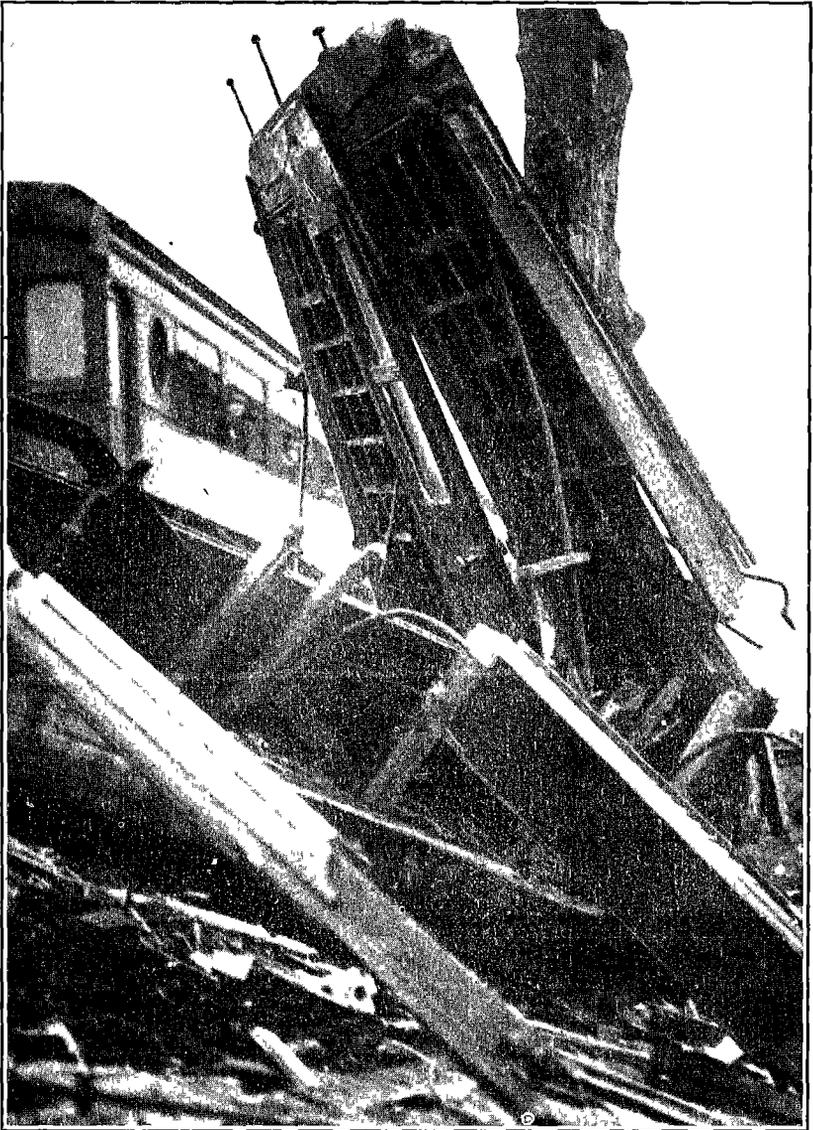
The force of the collision drove train No 41 forward a distance of 800 feet, completely telescoping the rear coach and crushing the rear compartment of the compartment car next to the rear coach. Figures Nos 1 and 2 are views of the rear coach and compartment coach, respectively, of train No 41 after the accident. All of the wreckage was shoved ahead with train No 7 until it came to a stop. The engine and baggage car of train No 41 remained coupled together and were driven ahead about 150 feet beyond where the

FIG 2 --Showing wreckage of compartment coach of train No 41

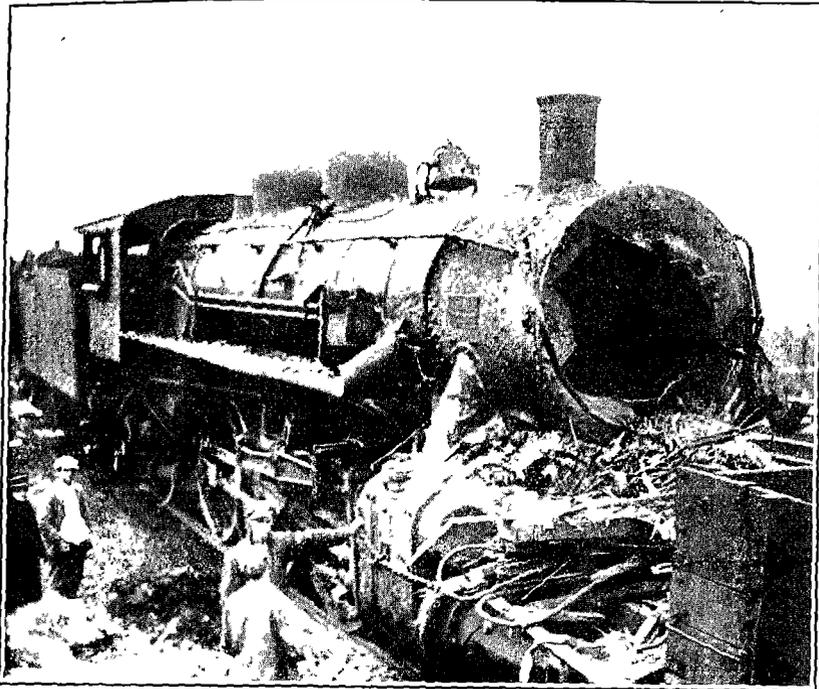
On train No. 7 the express car next to the engine was crushed for 8 or 10 feet and the sides of the car were bulged. The baggage car was not damaged with the exception of a broken steam pipe and no other cars in the train were damaged. The engine of train No. 7 had its front end crushed and some other parts broken, as shown by figure No. 3, but was not derailed. Five of the cars on this train

FIG. 3.—Showing locomotive No. 230 of train No. 7 after the accident.
