INTERSTATE COMMERCE COMMISSION

REPORT OF THE CHIEF OF THE BUREAU OF SAFETY IN RE INVESTIGATION OF AN ACCIDENT WHICH OCCURRED ON THE MISSOURI PACIFIC RAILROAD AT SULPHUR SPRINGS, MO , ON AUGUST 5, 1922

OCTOBER 10, 1922

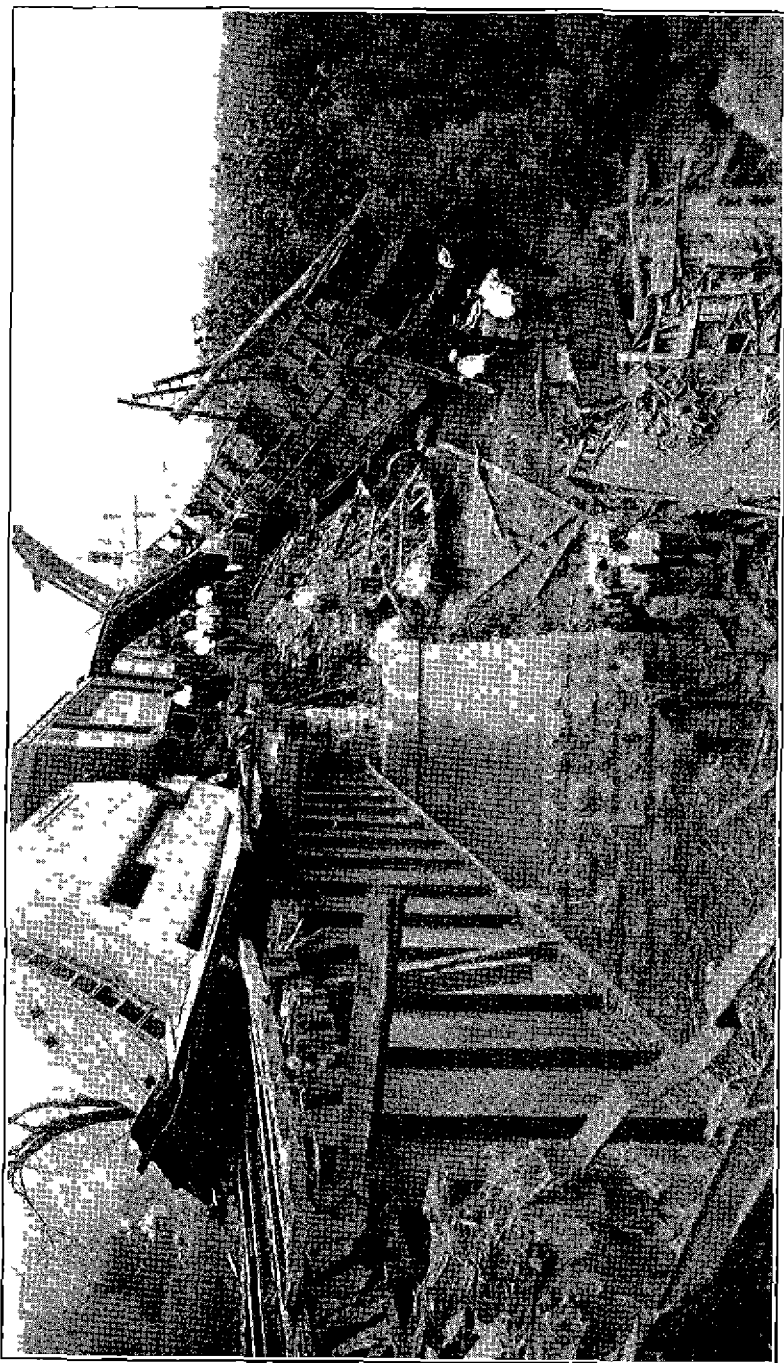
FIG. 2.—View looking north from south end of bridge wreckage of cars of train No. 42 on right equipment of train No. 4 on and north of bridge

The last two cars in train No. 32 were demolished, the debris being thrown to the bed of the creek, while the seventh and eighth cars were derailed to the right and came to rest down the embankment, badly damaged. Although the rest of the equipment in this train was moved forward a distance of between two and three car lengths by the force of the impact, it was not derailed or materially damaged. One pair of driving wheels on engine 5312 was derailed and the second car in train No. 4 was demolished, none of the other equipment in this train was either derailed or materially damaged. The employee killed was the engineman of train No. 4.
