# SEISMIC PROTECTION DEVICES STUDY – MARQUAM BRIDGE

## SEISMIC PROTECTION DEVICES STUDY FOR THE W. MARQUAM INTERCHANGE – MARQUAM BRIDGE SECTION

**Experimental Features Project 93-03**

April 2000

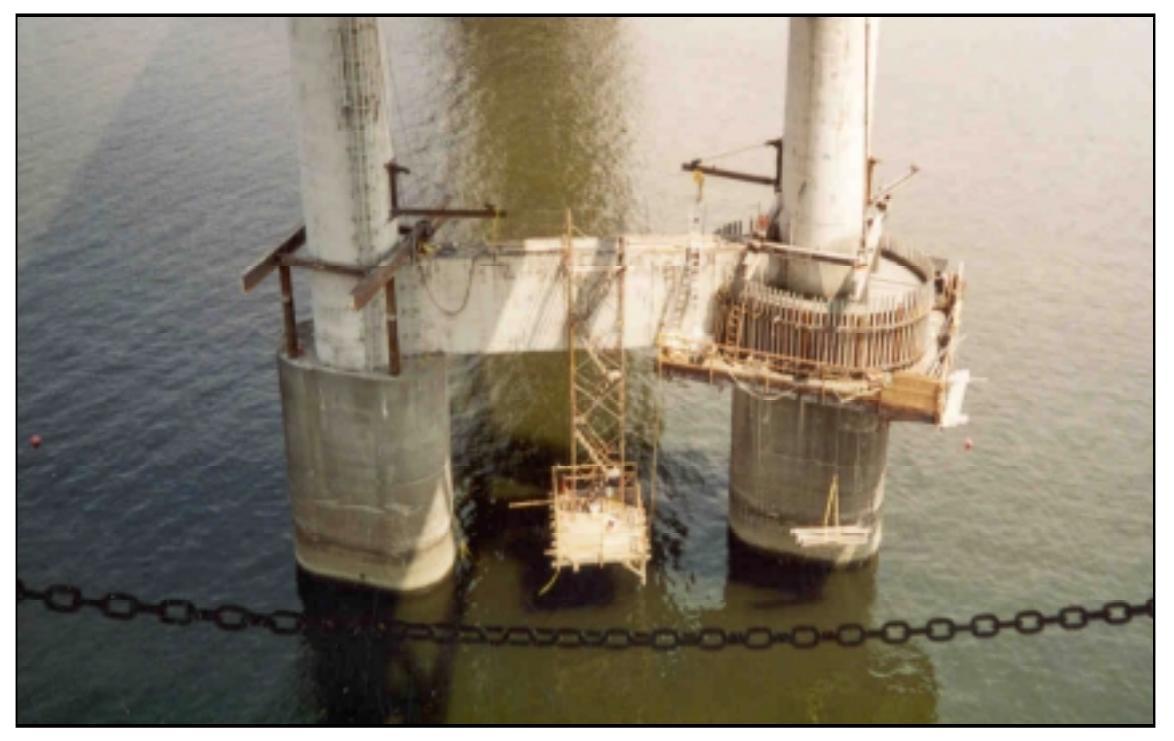
Figure 3.1: Collars Being Constructed Around Pier Columns

Installation of the VEP 1400/280-ST bearing/restraint devices at Piers #2 (left and right) and #5 (left and right) required that the existing base of the pier columns be modified to accommodate placement of the jacking columns. At the pier base, concrete support collars were constructed to carry the jacking pipe supports (Figure 3.1).

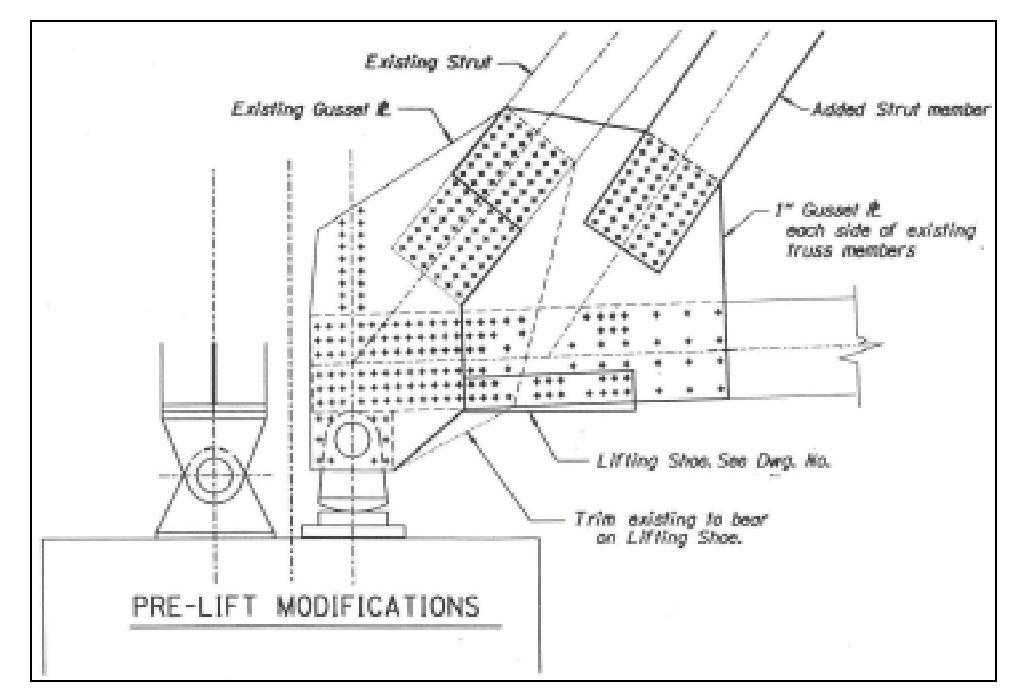
Figure 3.2: Additional Strut and Lifting Shoe Assembly at Piers #2 and #5

A lifting shoe for jacking the structure was constructed and bolted to the bottom of the bridge truss chord. An additional strut was attached to strengthen the structure to accommodate the jacking at the bearing connection (Figure 3.2).

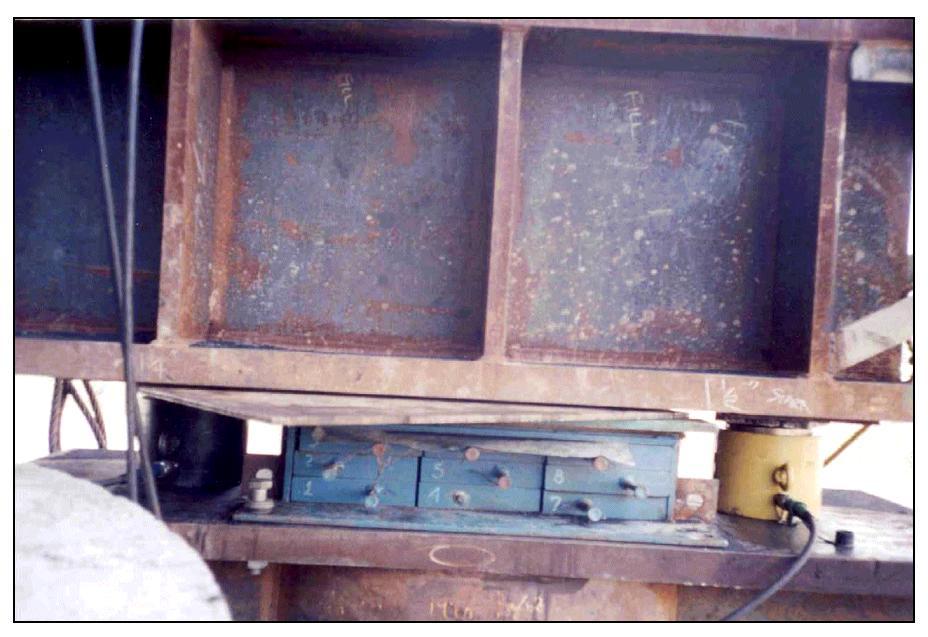
Figure 3.3: The Lifting Assembly for Piers #2 and #5

Once the concrete support collars were built, the lifting assembly for each bearing/restraint device was constructed alongside the pier column. The lifting assembly consisted of two pipe columns (outside diameter - 863.6 mm (34.0 in)), one lifting beam, temporary bearings and four jacking devices (Figure 3.3 and Figure 3.4).

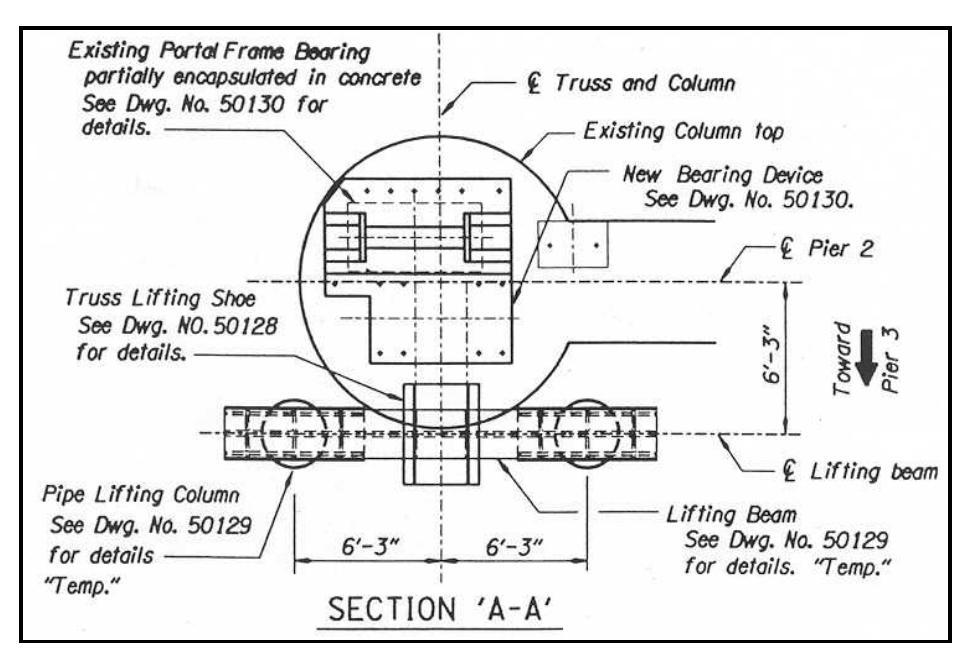
Figure 3.4: Section View Showing the Two Lifting Columns and Beam for Piers #2 and #5

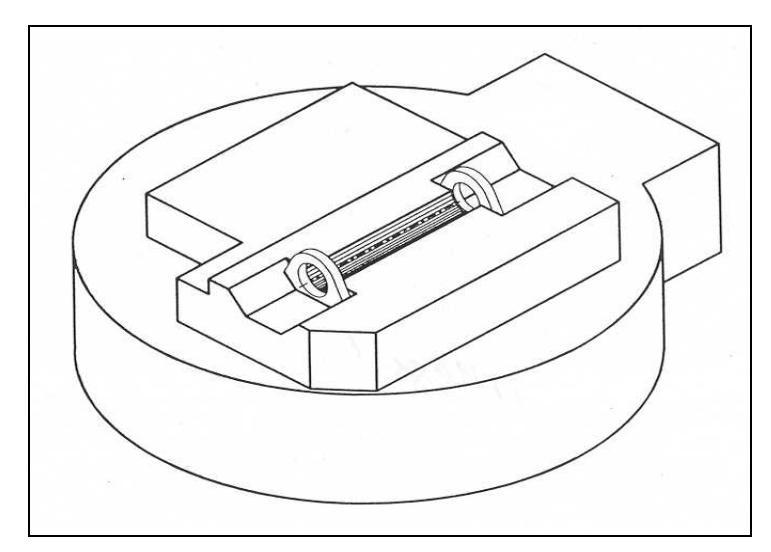
Figure 3.5: New Concrete Bearing Pedestal and Encapsulated Approach Bearing Device

A hydraulic crane lowered a new bearing shoe assembly from the top deck of the bridge. It was placed and bolted to the bottom of the truss chord. Fifteen 31.6 mm (1.25 in) threaded anchor rods, with two hex nuts and a 25.4 mm (1.0 in) x 150 mm (6 in) square plate at the top end of each rod, were drilled and bonded into the existing concrete. The bearing anchor plate was placed so that it was level and supported by the square plates on the anchor rods. The anchor plate was positioned with the transverse axis in line with the centerline of the bearing and the longitudinal axis aligned with the centerline of the bottom truss chord. The adjacent approach bearing device was not removed, but encapsulated in concrete as the concrete pedestal for the new bearing was constructed (Figure 3.5).

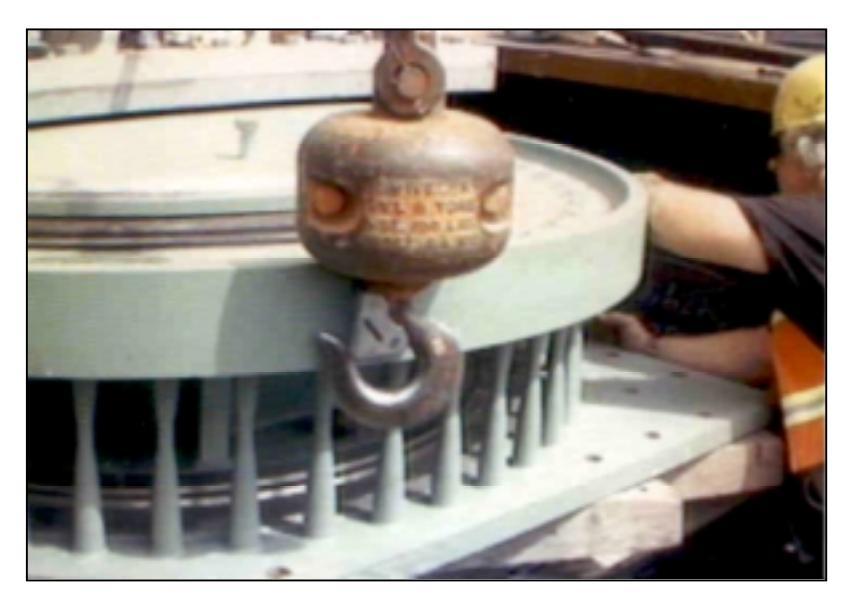
Figure 3.6: Bearing is Positioned between Masonry Plate and Top Sole Plate

The crane positioned on the top deck of the bridge lifted the new bearings from the bridge deck down the side of the bridge. The bearings were maneuvered onto the pier (Figure 3.6) and connected to the masonry plate and the sole plate of the bearing shoe assembly. Once the jacks were lowered, the bearing was operational, and carrying the live and dead loads of the structure.

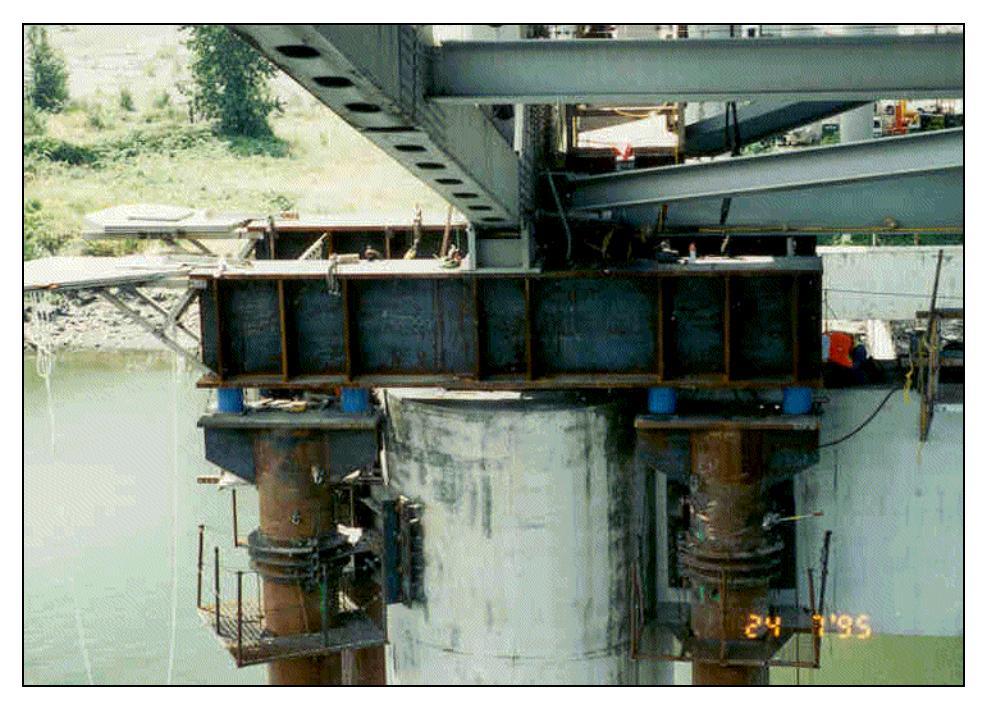
Figure 3.7: The Lifting Assembly for Piers #3 and #4

The installation work sequence at Piers #3 (left and right) and #4 (left and right) for the VEP 5200 bearing and restraint devices was similar to the VEP 1400/280-ST bearing/restraint device installation on Piers #2 and #5. Concrete support collars were constructed at the base of the pier columns to support the jacking pipe supports. For each bearing replacement, the lifting assembly consisted of four pipe columns (863.4 mm (34.0 in) outside diameter), two lifting beams and cross braces, four temporary bearings, and eight, 726 Mg (800 ton) jacking devices (Figure 3.7 and Figure 3.8). For this installation, no additional struts were needed on the truss to support the lifting operations. Two lifting shoes were connected to the bottom of the bridge truss chord by replacing existing rivets with high-strength bolts. The lifting beams were turn bolted to the lifting shoes.

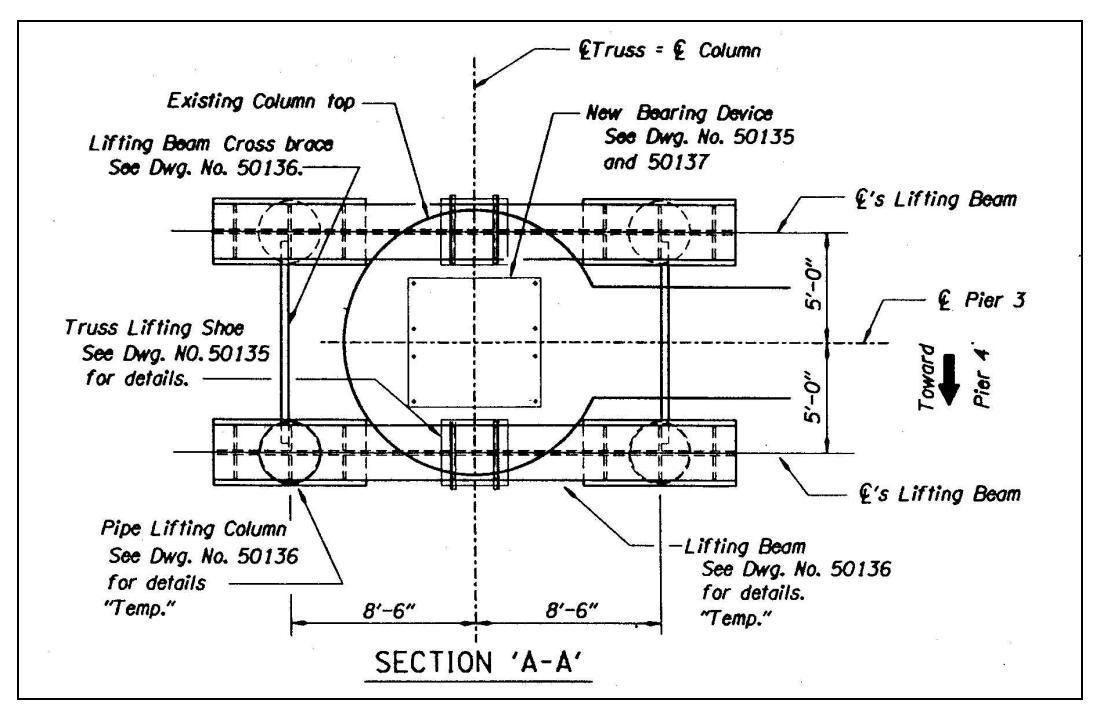
Figure 3.8: Section View Showing the Four Lifting Columns and Beam for Piers #3 and #4

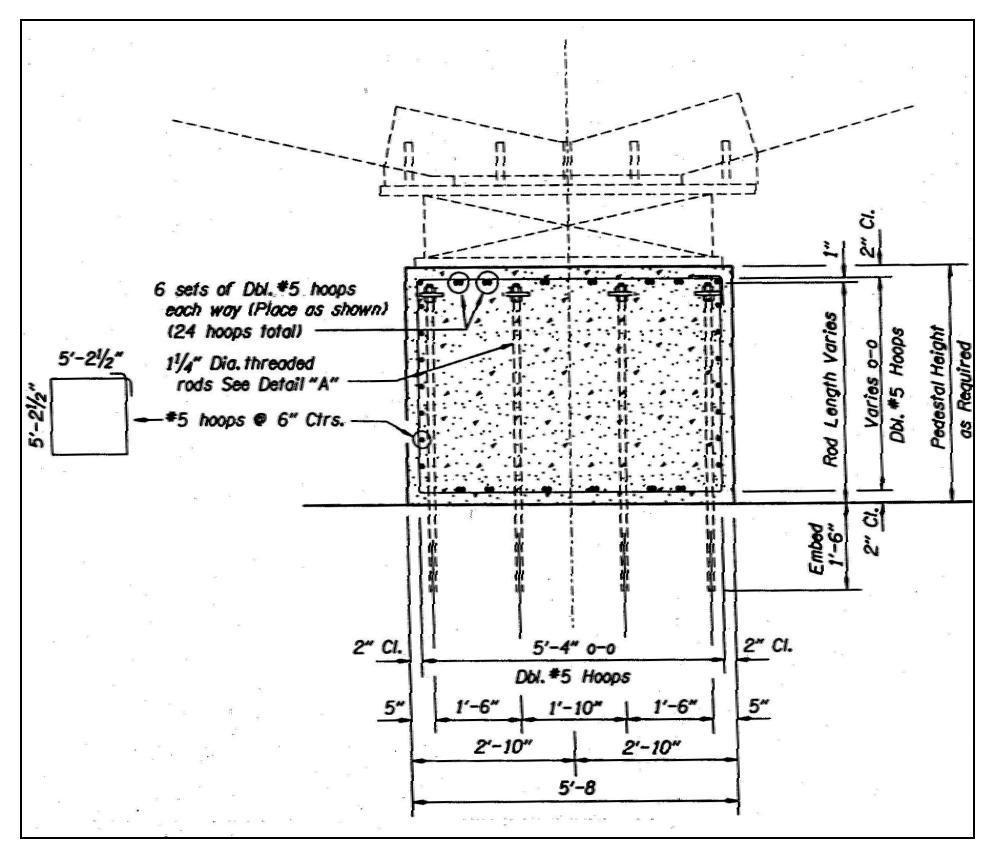
Figure 3.9: Bearing Pedestal Detail at Piers #3 and #4

Subsequently, the bearing masonry plate was set and a concrete pedestal was constructed. The masonry plate was supported by the  $25 \text{ mm} (1 \text{ in}) \times 150 \text{ mm} (6 \text{ in})$  square plates at the top end of the anchor rods. As before, the masonry plate was positioned on the leveling nuts so the transverse axis would be in line with the centerline of the new bearing and the longitudinal axis would align with the centerline of the bottom truss chord. Figure 3.9 shows the pedestal detail with anchor rods.

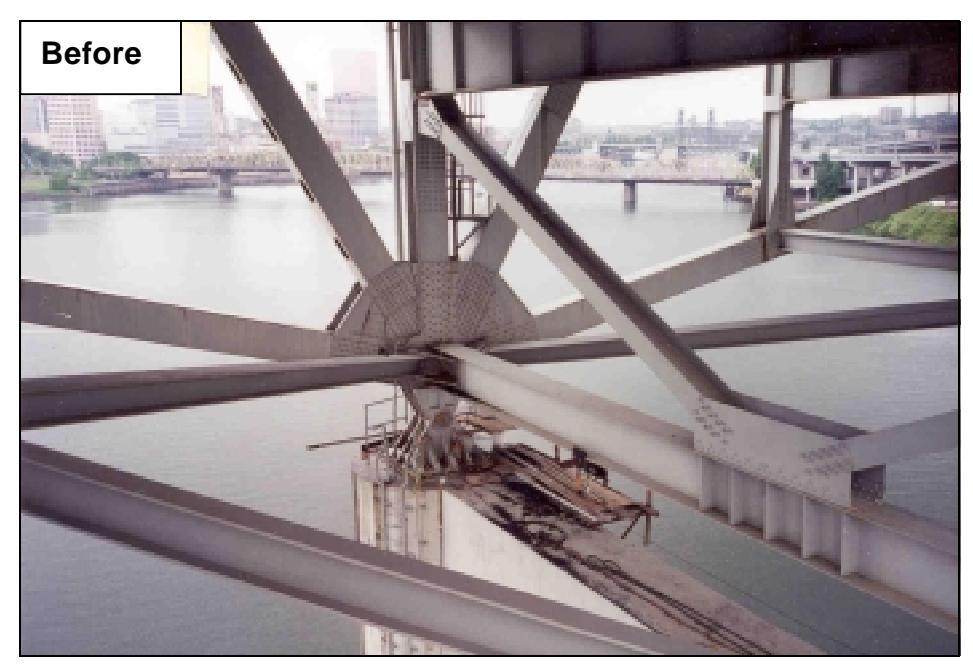
Figure 3.10A: Original Bearings on Pier #3

Figure 3.10 (A & B) shows a "before" picture on Pier #3 with the original bearing and a picture on pier #4 after the VEP 5200 bearing/restraint device installation.

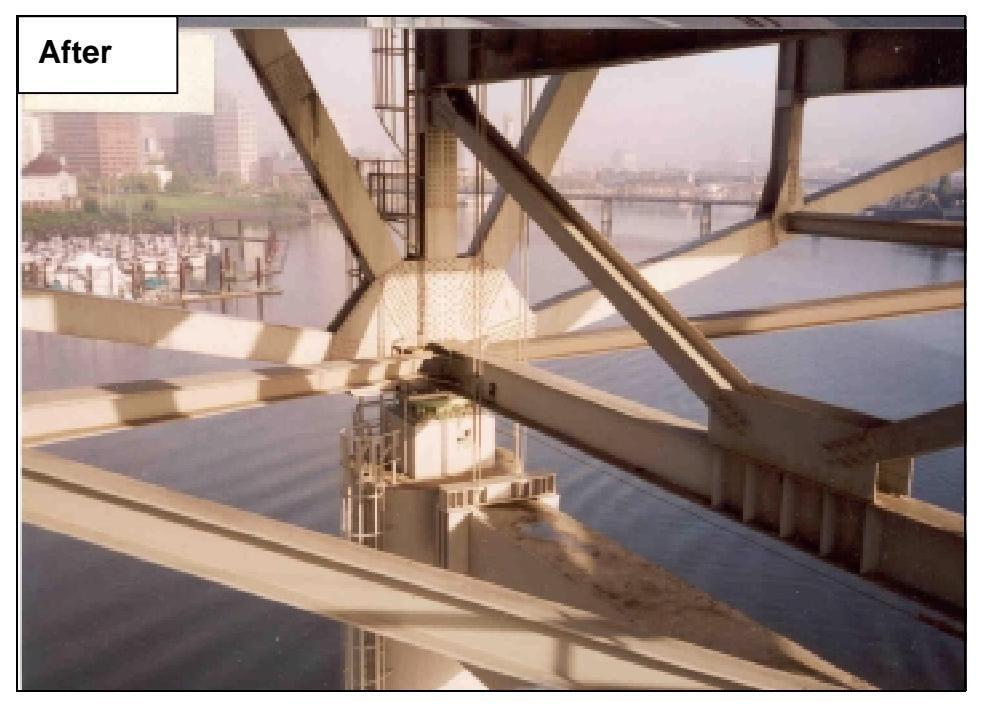
Figure 3.10B: New Bearings on Pier #4

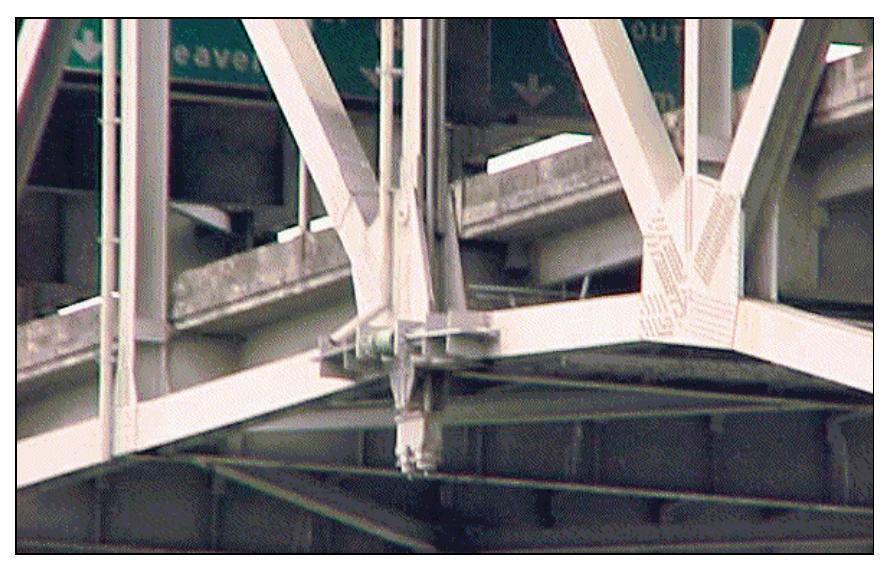
Safety hangers, installed on both sides of the main span of the bridge at panel points 13 and 21, are visible in Figure 3.11. These two panel points are the locations of the expansion joints for the suspended portion of the bridge.

Figure 3.11: Shock Transmission Unit at Panel L13

Shock transmission units were installed on each side of the lower deck bridge truss at panel points 13 and 21 (Figures 3.11 and 3.12). The shock transmission devices are designed to diffuse the rapidly applied loads of a seismic event. With their action, both longitudinal and

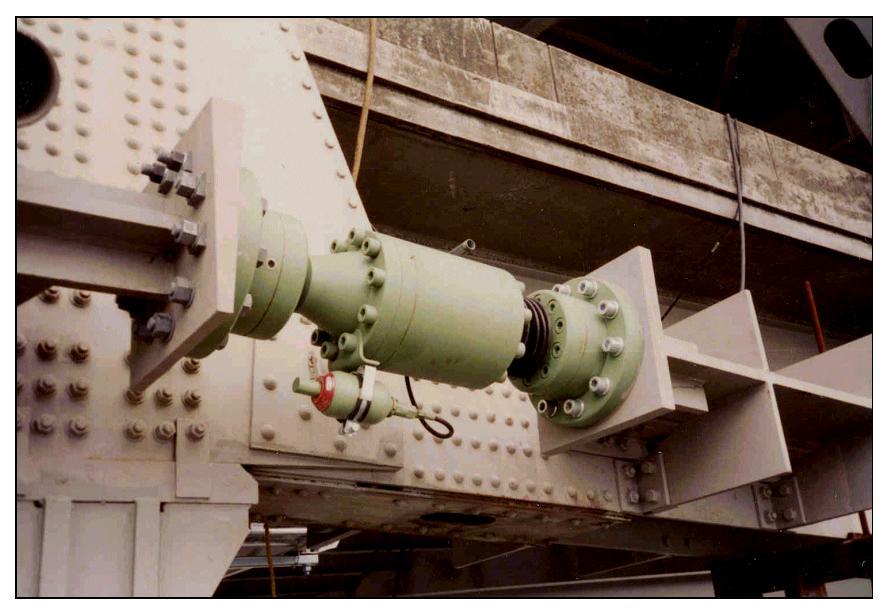
Figure 3.12: Close-up of Shock Transmission Unit
