ARIZONA DEPARTMENT OF TRANSPORTATION

HILFIKER REINFORCED SOIL EMBANKMENT WITH FULL-HEIGHT, CAST-IN-PLACE CONCRETE PANELS

Final Report

May 1992

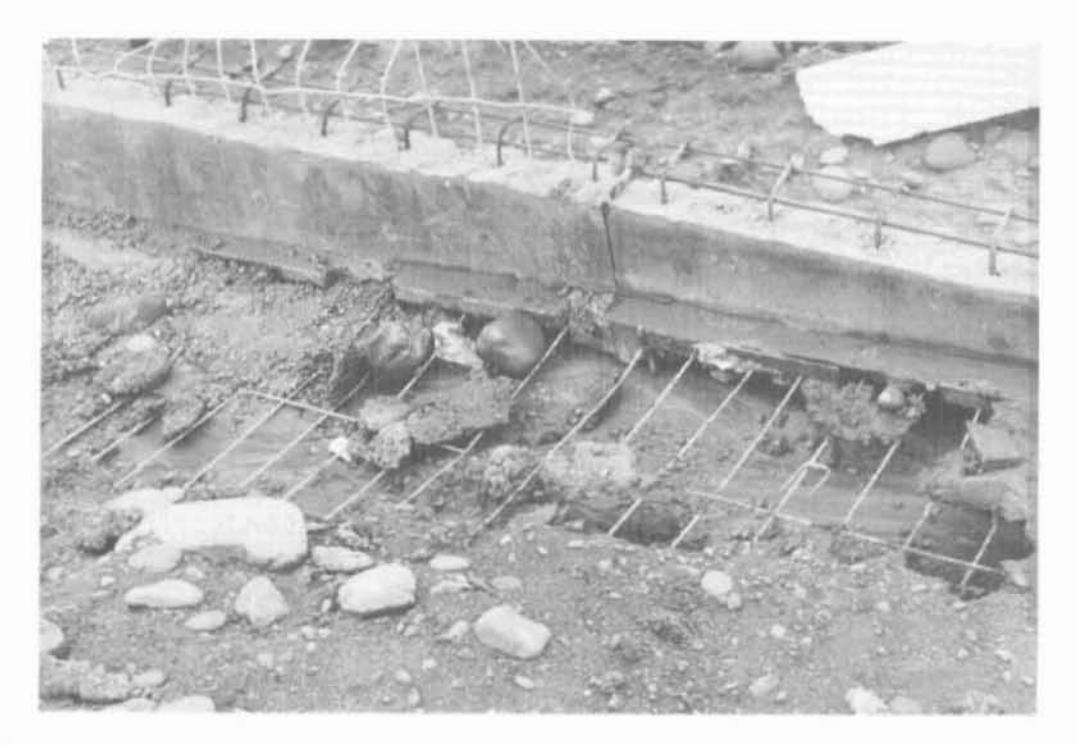
Attempts were made by the contractor to use only backfill material passing a 4" sieve in the 2' nearest the backing mats for the northeast and southwest walls. This was not required in the specifications, and quite often did not take place, as illustrated in Figure 12.

Figure 12 Backfill Material Larger Than a 4 " Sieve Placed Near the Backing Mats.

1. Backfill material used for similar projects should pass a 3" sieve. This recommendation is based on the experiences of this project. The finer material facilitated construction and was more readily compacted.

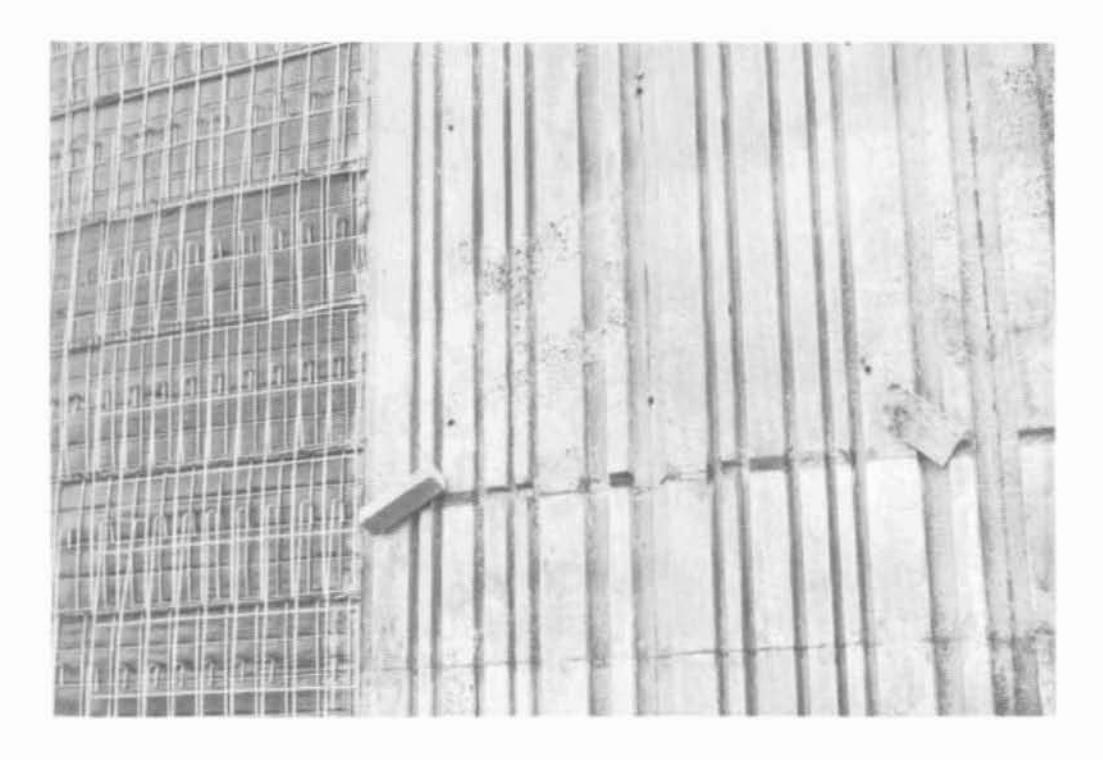
The concrete was mixed at a batch plant and delivered to the site in transit mixers. The concrete was poured down the full face of the embankment, at times over 20'. Upon pouring, the concrete was vibrated with long internal vibrators as shown in Figure 16. After removing the forms, the concrete showed extensive honeycombing and air voids. Therefore, external vibrators were used in addition to the long internal vibrators. However, because the vibrations of the external vibrators did not transfer well through the rubber and wood forms, honeycombing and air voids were still visible. Use of external vibrators is shown in Figure 17. Figure 18 shows an example of the honeycombing and air pockets in the concrete panels.

Figure 18 Honeycombing and Air Pockets Visible in the Full-Height Panels.

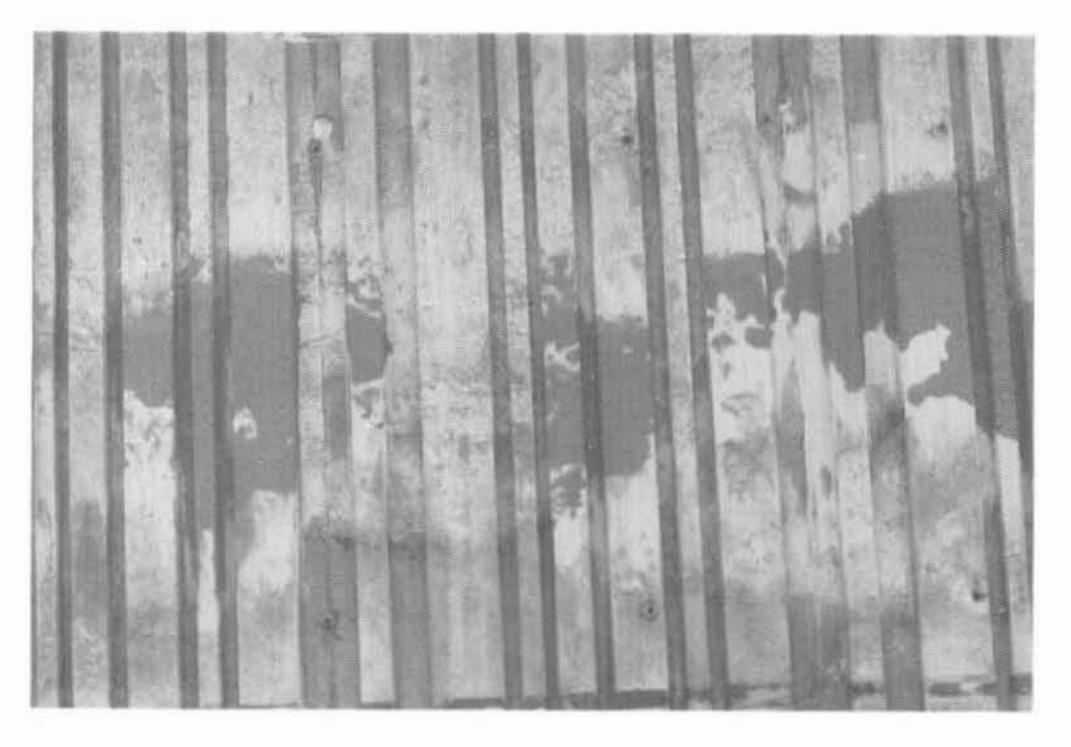
The wall was patched and painted; however, honeycombing and air pockets remained evident as shown in Figure 19.

Figure 19 Honeycombing Was Still Visible After Patching Attempts.

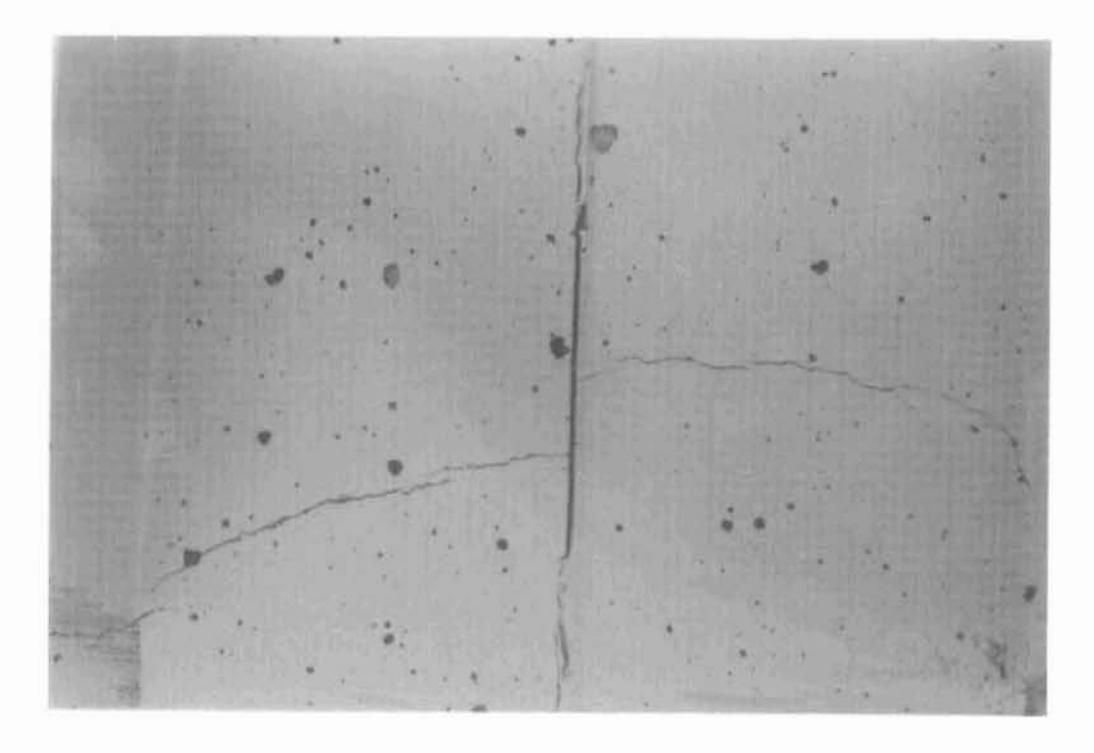
The plans did not provide for drainage outlets in the concrete panels. The panels immediately began to display honeycombing, air voids, and shrinkage and settlement cracks. The cracks were discontinuous and located primarily, but not limited to, the horizontal rustication of the wall. Figures 20 and 21 illustrate the horizontal cracks and air voids.

Figure 20 Hairline Shrinkage or Settlement Cracks and Air Voids.

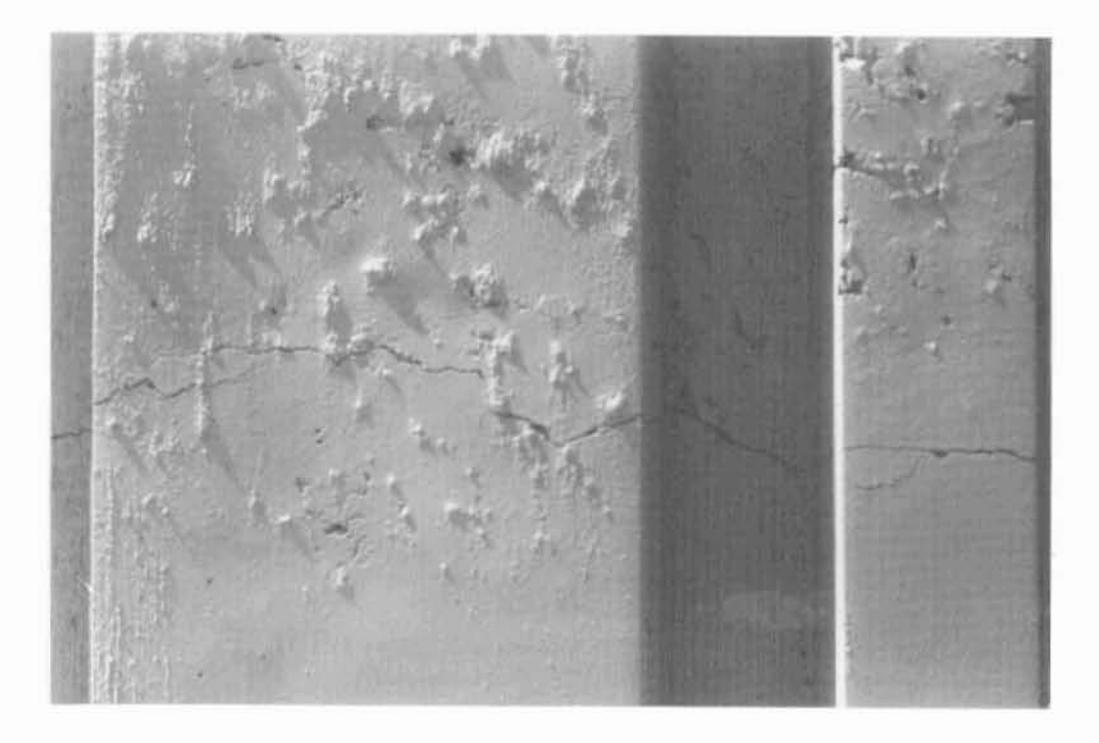
Figure 21 Air Voids and Horizontal Cracks in the Concrete Panels.

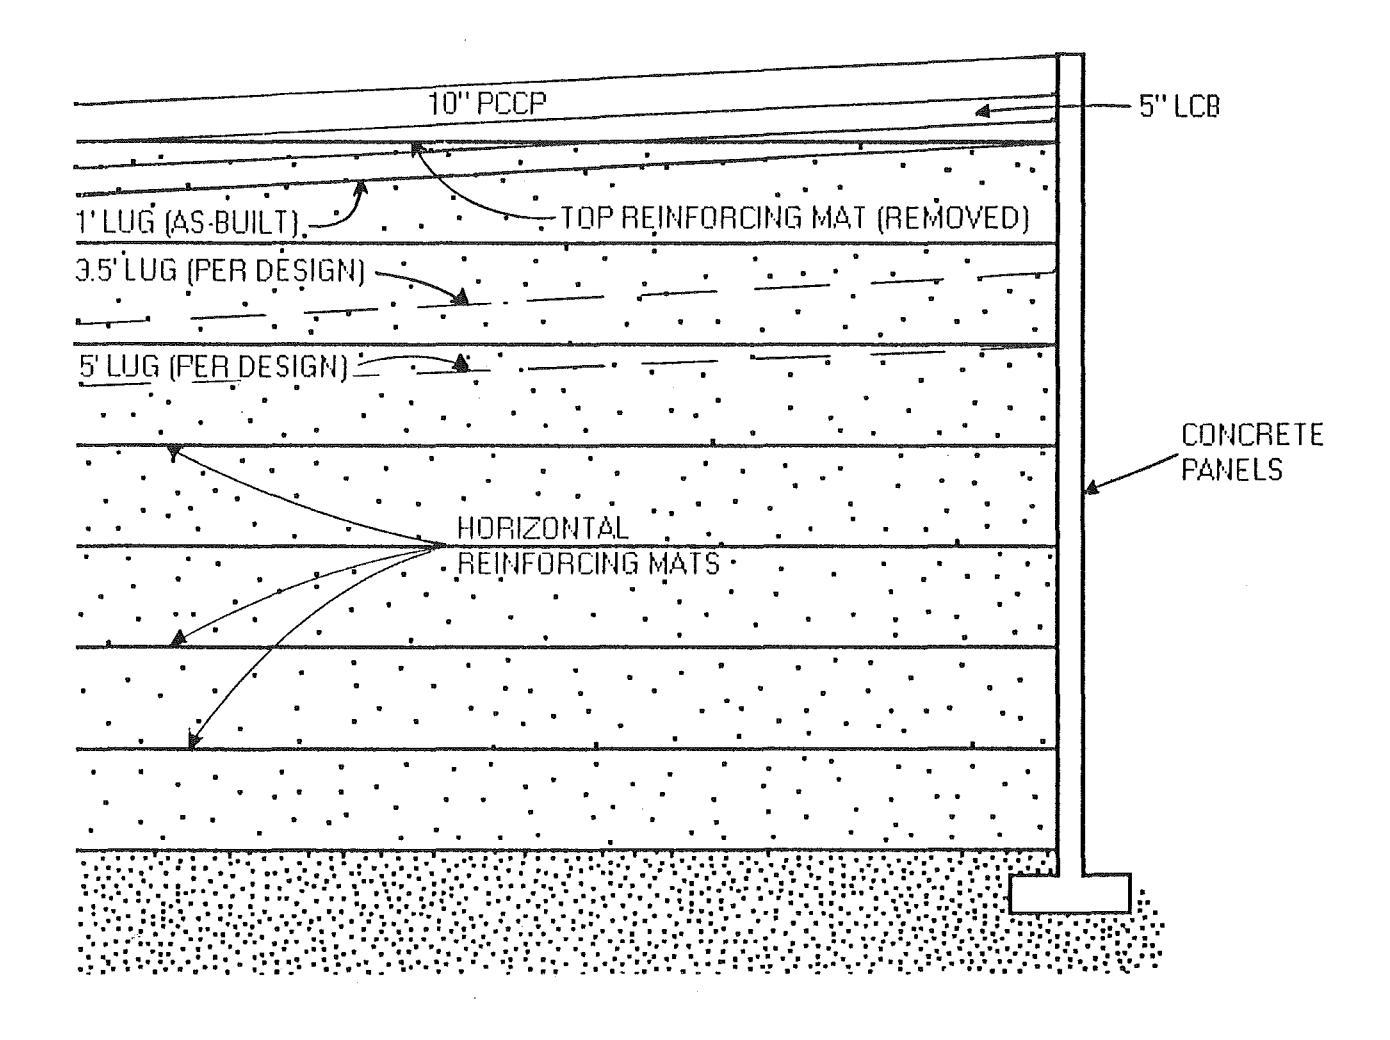
Figure 22 Schematic Diagram Illustrating the Conflict Between the top Reinforcing Mat and the Concrete Pavement (View is a Lengthwise Cross-Section).

Additional work included removing the top reinforcing mat and backfill to accommodate the 15" needed for the concrete pavement (10" Portland Cement Concrete Pavement and 5" Lean Concrete Base). A design error provided only 6" clearance for the pavement. The work was performed under a \$5000 force account. This force account also provided for the shortening of the lugs of the anchor slab to preclude them from interfering with the reinforcing mats. This is illustrated in a schematic included as Figure 22. The lugs were shortened from the standard 5' and 3.5', to 1'. Another force account required the contractor to seal the construction joint between the Hilfiker wall and the new PCCP. The contractor was provided \$5000 to remove the existing filler and apply a bituminous joint sealant.

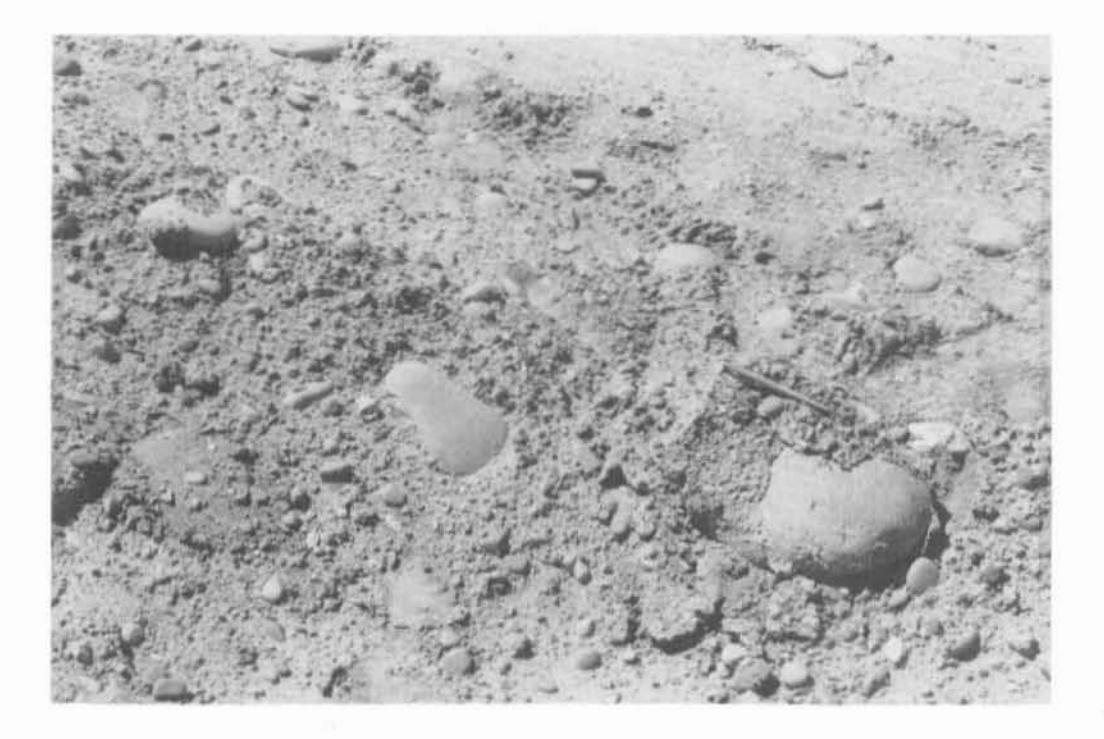
The subgrade for the southwest wall needed to be over-excavated 8.5' to remove existing concrete rubble. A total of 22 field density tests were performed by ADOT during construction of the southwest wall (APPENDIX G). The backfill met density specifications. However, this backfill material did not meet gradation requirements. Project specifications called for all material to pass the 6" sieve. This was clearly not the case as a significant portion of the backfill was greater than 6". Figure 23 shows the varying size of aggregate.

Figure 23 Backfill Material With Rocks Larger Than the 6" Sieve.

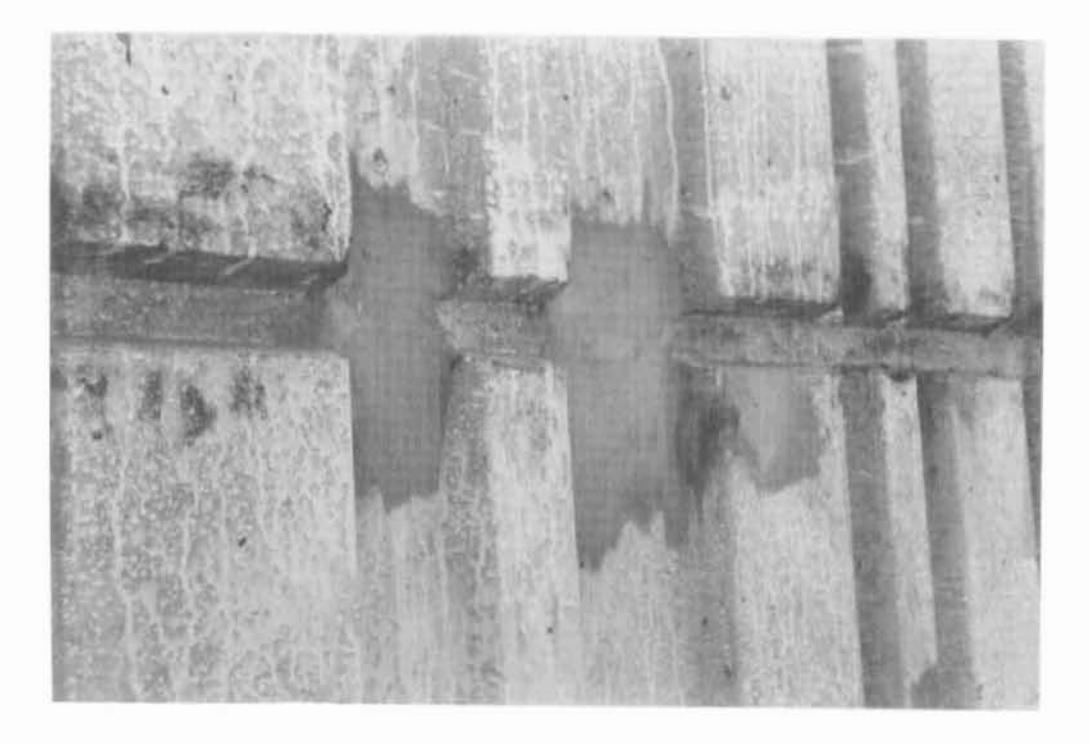
Figure 24 Patched Honeycombed Areas of the Southwest Wall.

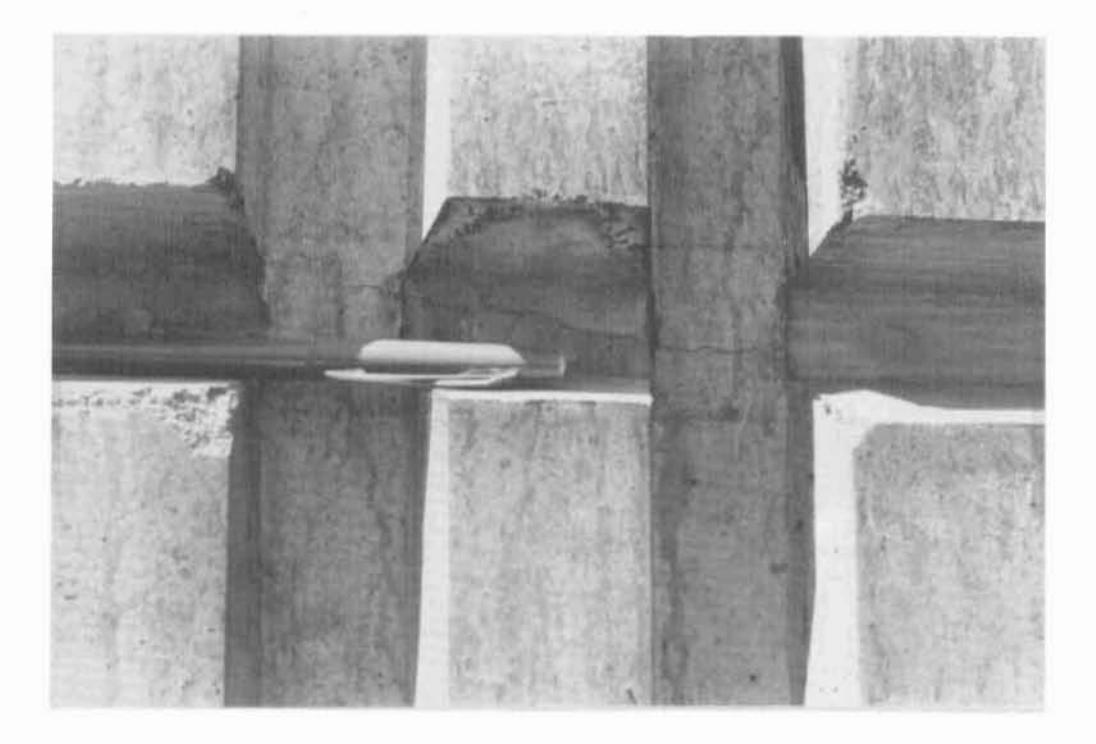
Figure 25 Typical Cracks Along the Horizontal Rustication of the Concrete Panels.

It is believed that these horizontal cracks exist in all of the horizontal rustication of the concrete walls. However, this was not verified at upper portions of the wall due to an inability to access these heights.

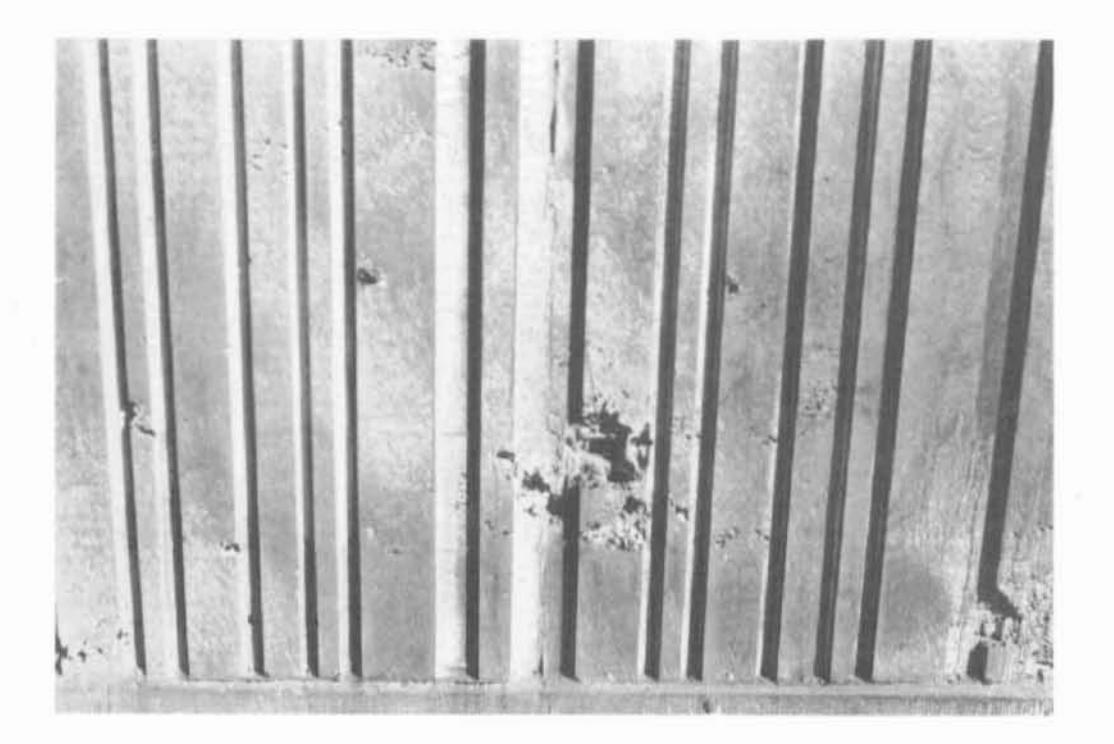
More severe voids and honeycombing, late in the construction of the southwest wall, resulted in the exposure of the embankment reinforcing steel as shown in Figures 26 and 27. In these instances, the contractor broke the face of the panels and replaced them with a higher quality concrete finish. Another remedy was extensive patching, shown in Figure 28.

Figure 26 Exposed Reinforcing Steel Due to Severe Honeycombing.

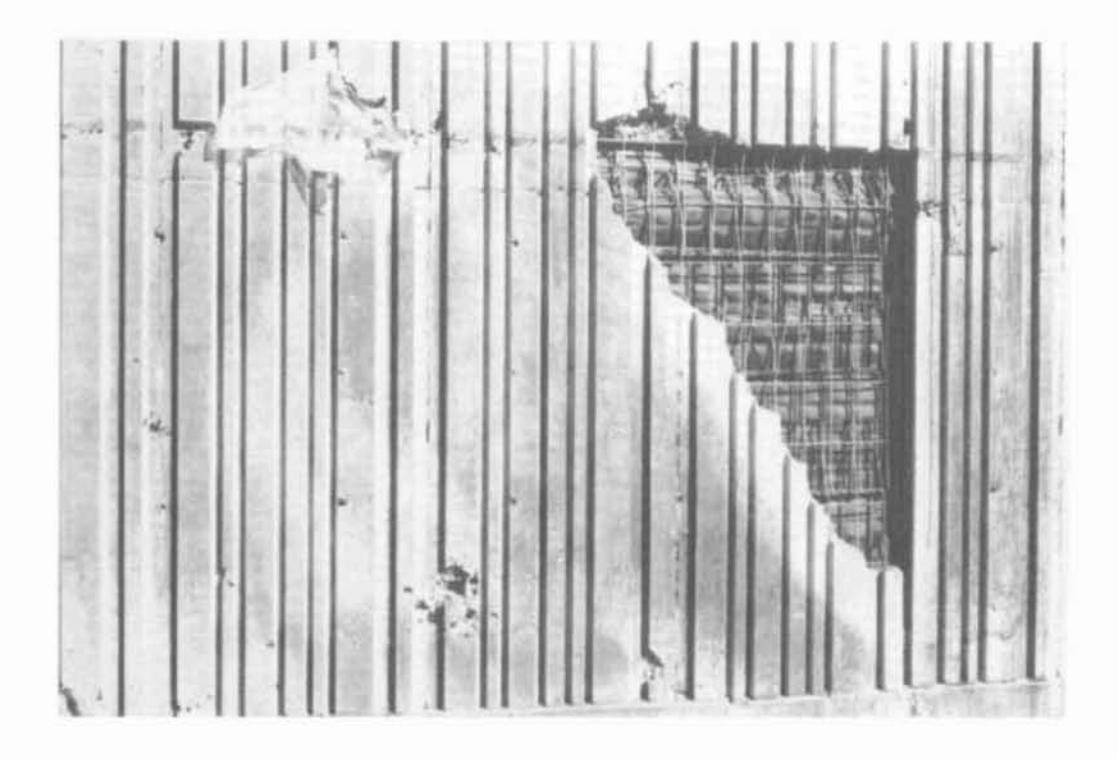
Figure 27 Two Panels That Needed to be Broken Out and Replaced.

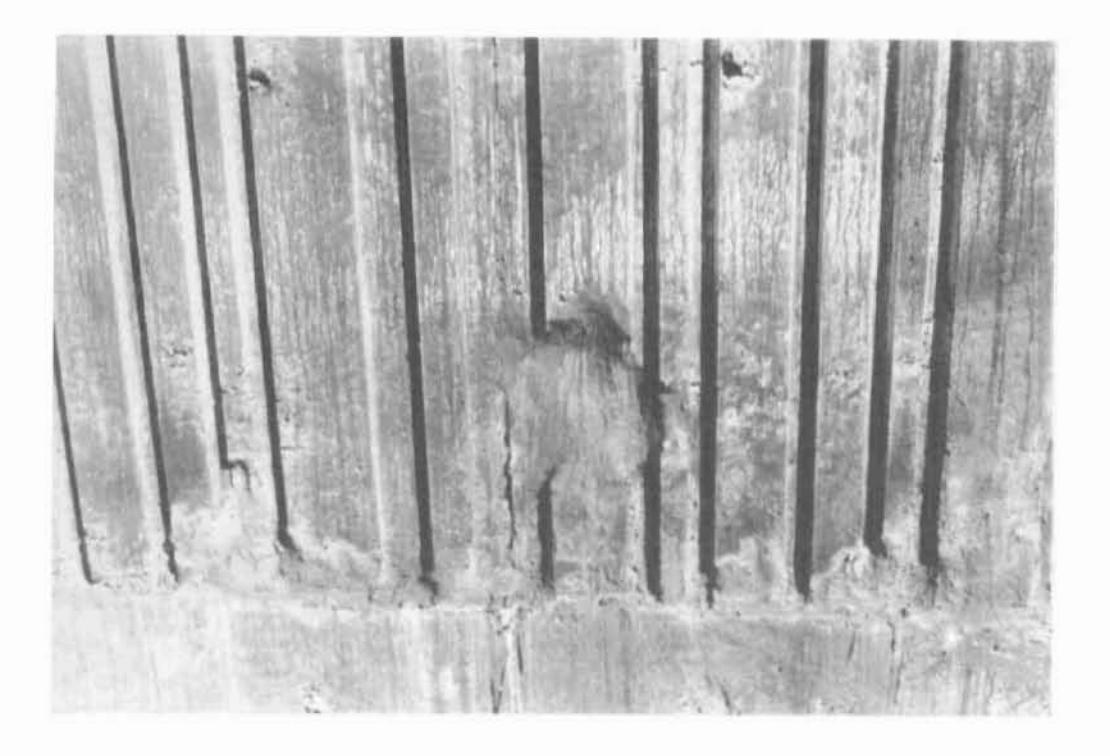
Figure 28 Severe Honeycombing Treated by Patching.

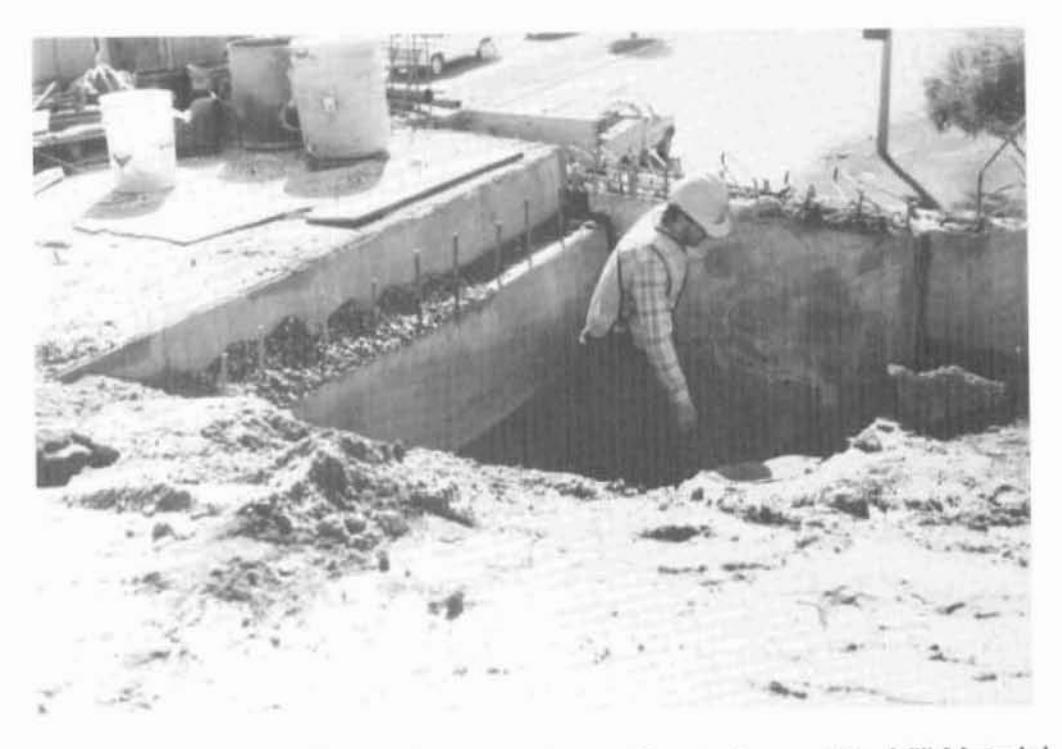
Figure 31 Void at the Top of the Embankment Due to Loss of Backfill Material.

A probable cause of the observed deflection of anchor slab is the formation of a void in the embankment. The void could be caused by the washing out of embankment material through the large vertical crack at the wall - abutment interface. This would be consistent with the washout problems encountered with the southwest Hilfiker wall during construction as seen in Figures 30, 31, and 32.

To remedy this situation, the contractor supported the bottom of the abutment wingwall as shown in Figure 32, and filled the void with a structural backfill material. The material was then compacted with a jetting technique.

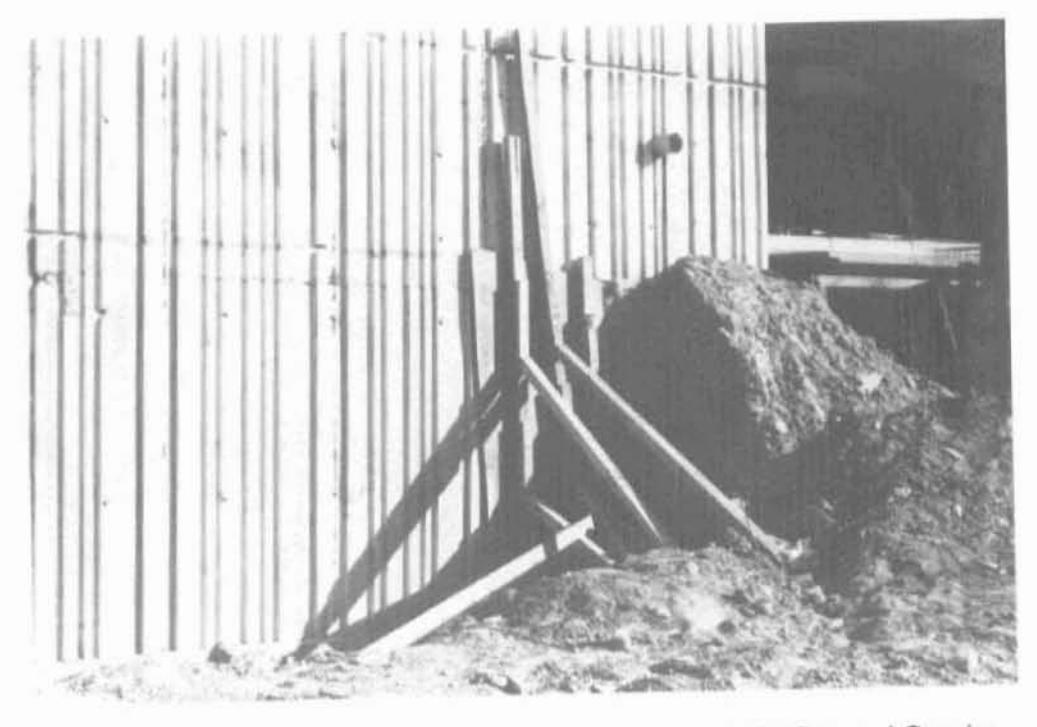
Figure 32 Support to Bridge Abutment for Refilling Rain Caused Crevice.

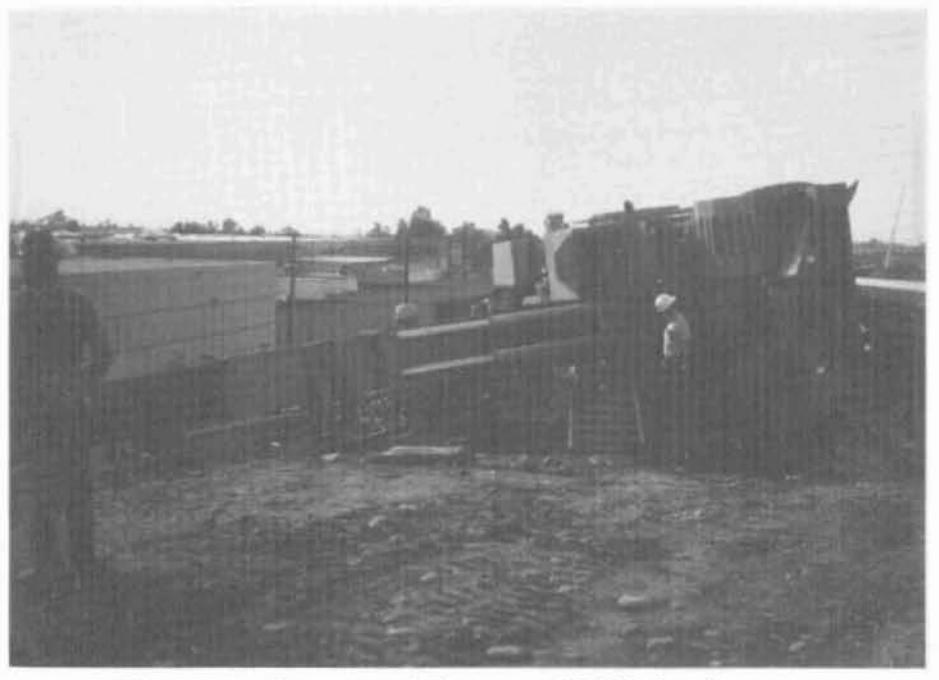
During the placement of the forms for the concrete panels, a crane overturned and damaged the wall's steel reinforcement. Figures 33 and 34 show the overturned crane and the resulting damage. Apparently the operator failed to extend the crane's outriggers prior to lifting some forms. The damage was repaired by straightening the steel and placing additional rebar. Figure 35 shows the site of the damaged section after repairs had been completed.

Figure 33 Overturned Crane on SW Embankment.

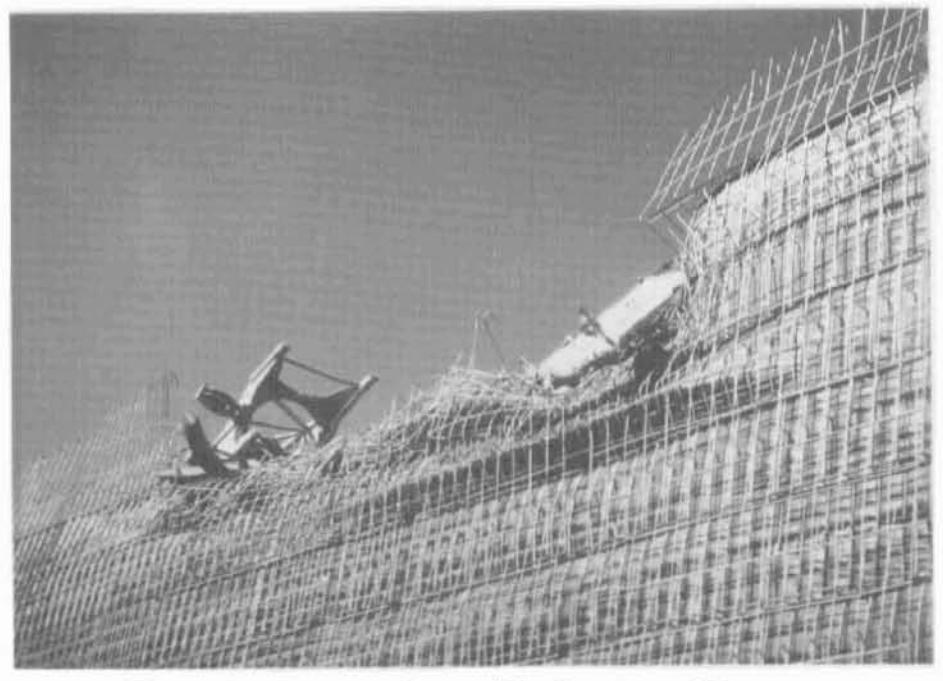
Figure 34 Damage Caused By Overturned Crane.

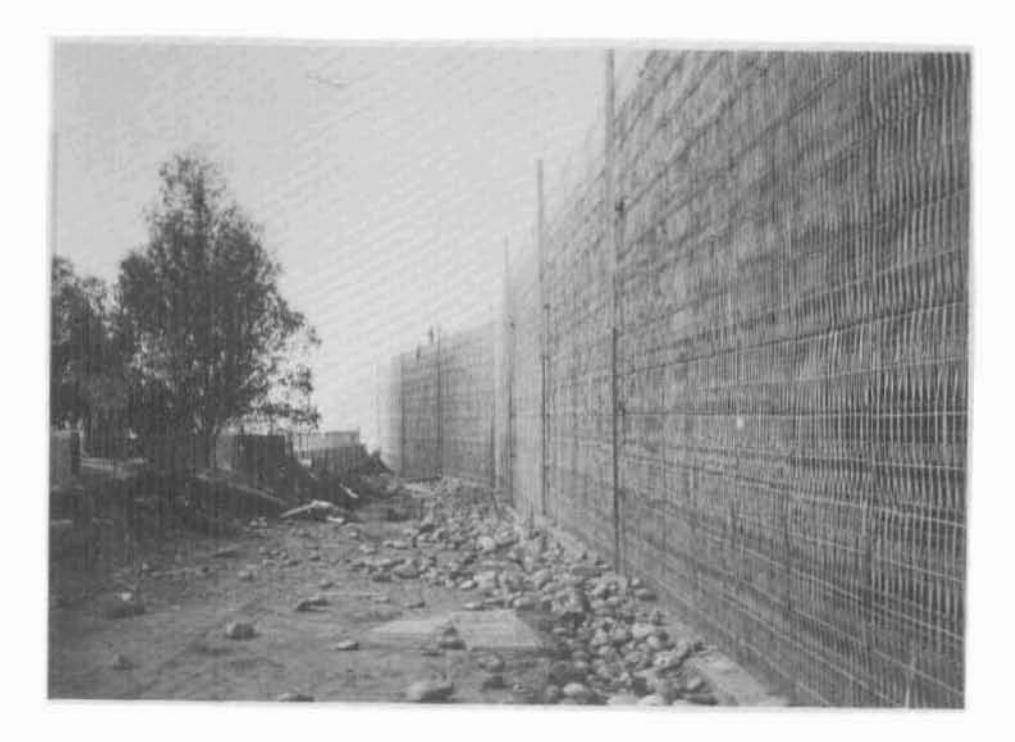
Figure 35 Site of Damaged SW Wall Section After Repair.

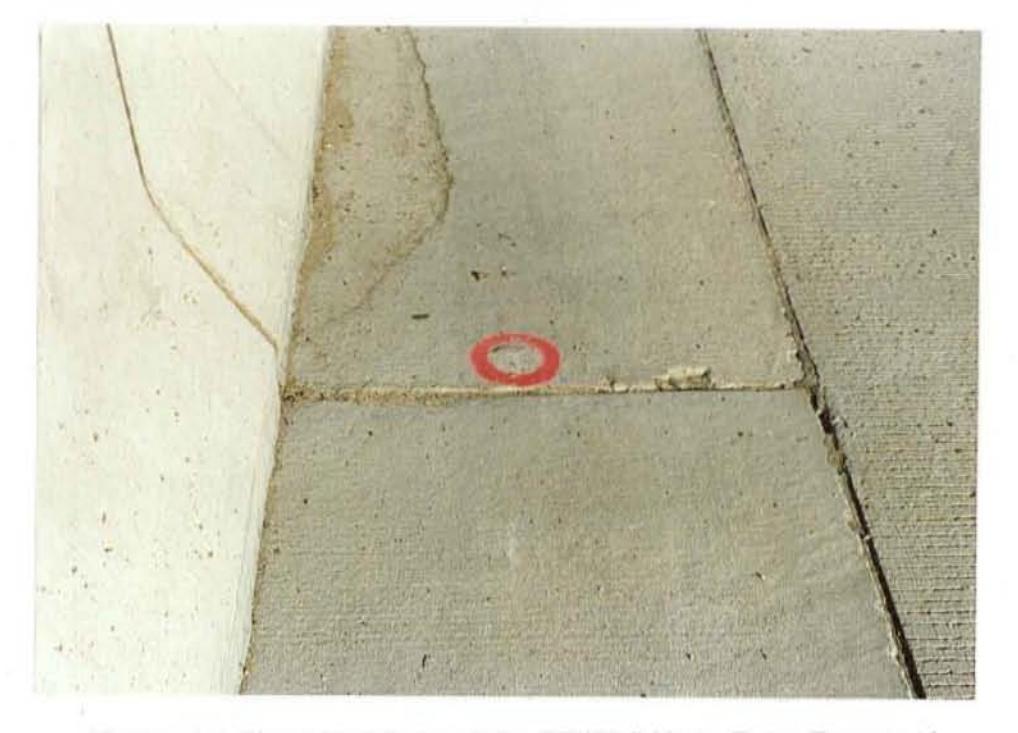
The aluminum caps embedded in epoxy on the southeast wall have been removed. Apparently they were scraped off by some sort of heavy vehicle, although this would be difficult considering the caps proximity to the concrete barriers placed on top of the wall. Figure 44 shows the location of a removed aluminum cap.

Figure 44 Aluminum Caps of the SE Wall Have Been Removed.

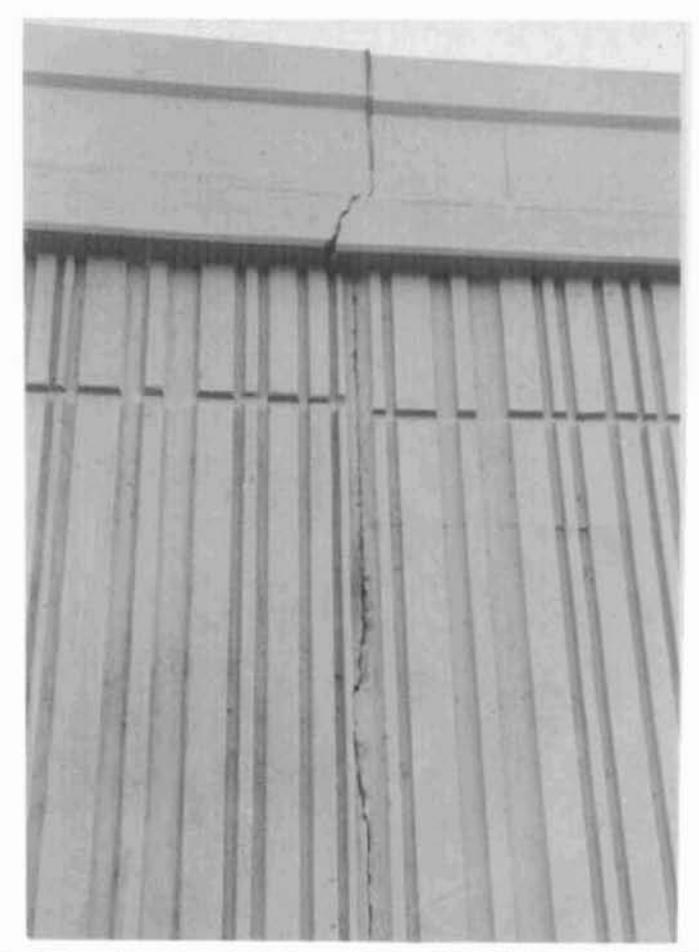
There is a large (0.5" to 1.5") vertical crack at the interface between the southeast Hilfiker wall and the southeast abutment of the I-10 and 24th Street bridge. The retaining wall has settled about an inch relative to the bridge abutment at this point. Figure 45 is a photo of this crack along the face of the wall, and Figure 46 shows the damage to the concrete at the top of the wall at the crack.

Figure 45 Vertical Crack at the Interface of the SE Wall and the Bridge Abutment.

A hypothesis as to the cause of the large vertical crack is differential settlement between the bridge abutment and the Hilfiker wall/embankment. The bridge abutment is on piers, whereas the Hilfiker system is not.

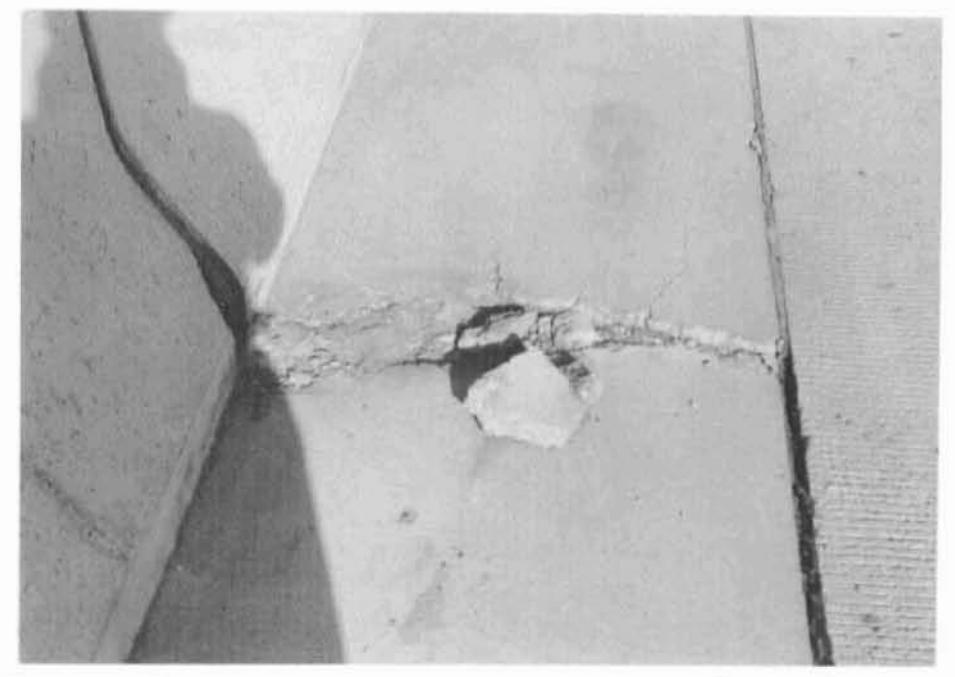
Figure 46 Damage to the Concrete at the Top of the Cracked Interface.

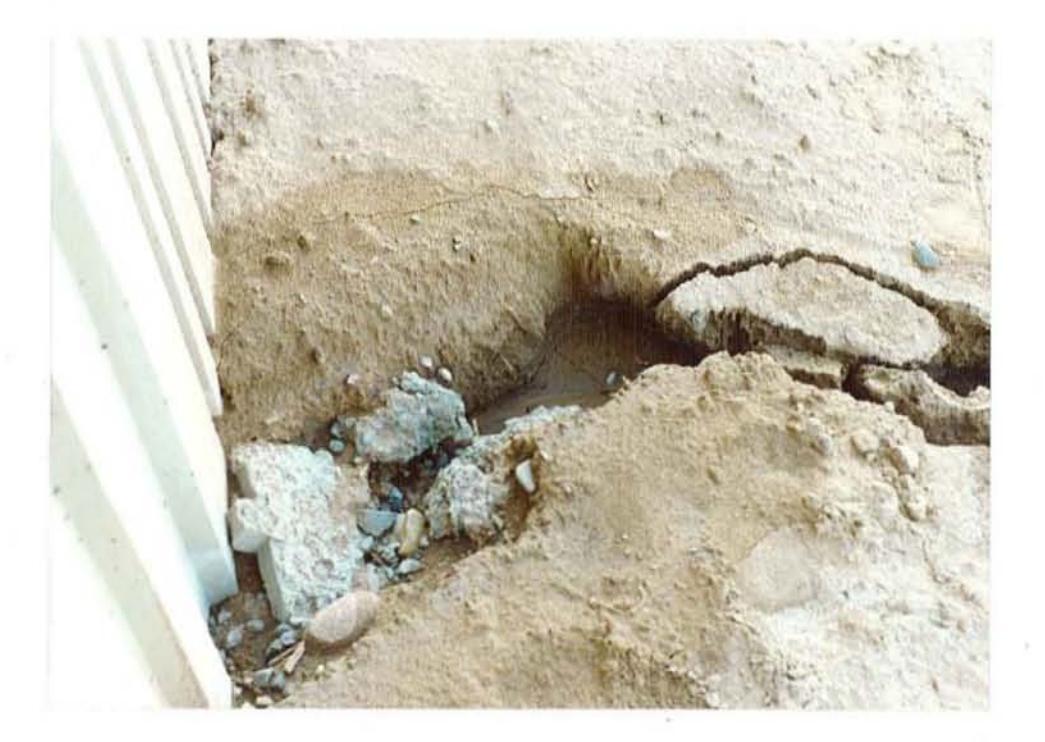
A large erosion channel had formed immediately below the vertical crack, yielding evidence that water was entering the reinforced earth embankment and exiting through this crack. Following rains it was noticed that sediment was carried into 24th Street. Figure 47 shows the erosion channel, which has at times been filled in by landscape maintenance crews.

Figure 47 Erosion Channel Immediately Below Vertical Crack of the SE Wall.

5. Proper drainage should be provided for the retaining system. Drains should include sand or synthetic filters to prevent the loss of material from the embankment. This recommendation is in light of the extreme difficulty in keeping water from entering the embankment.

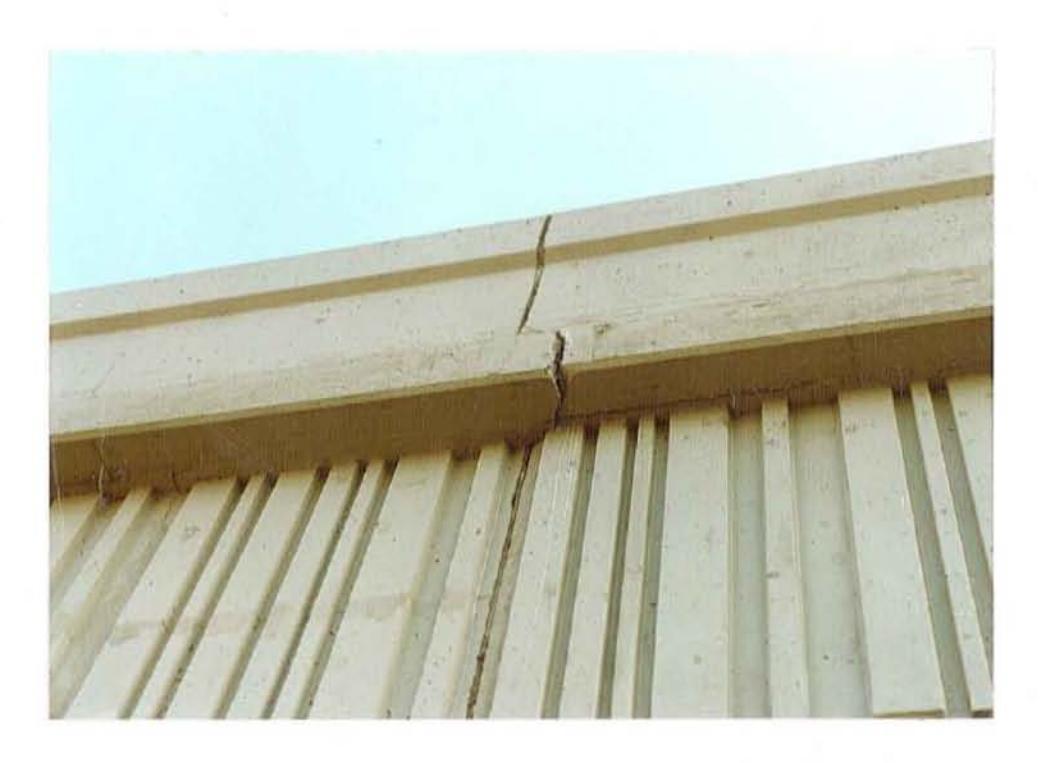
The two other Hilfiker walls were subject to similar phenomena; vertical cracks at the bridge abutment interface. However, the cracks were not as severe. Below the southwest wall crack there was a small erosion channel. There was not a channel below the northeast wall crack. Figures 48 and 49 show the Hilfiker wall - bridge abutment vertical cracks for the southwest and the northeast walls. Many hairline vertical and horizontal cracks are visible throughout all three of the retaining walls at this interchange.

Figure 48 Interface of SW Hilfiker Wall and the 24th Street Bridge Abutment.

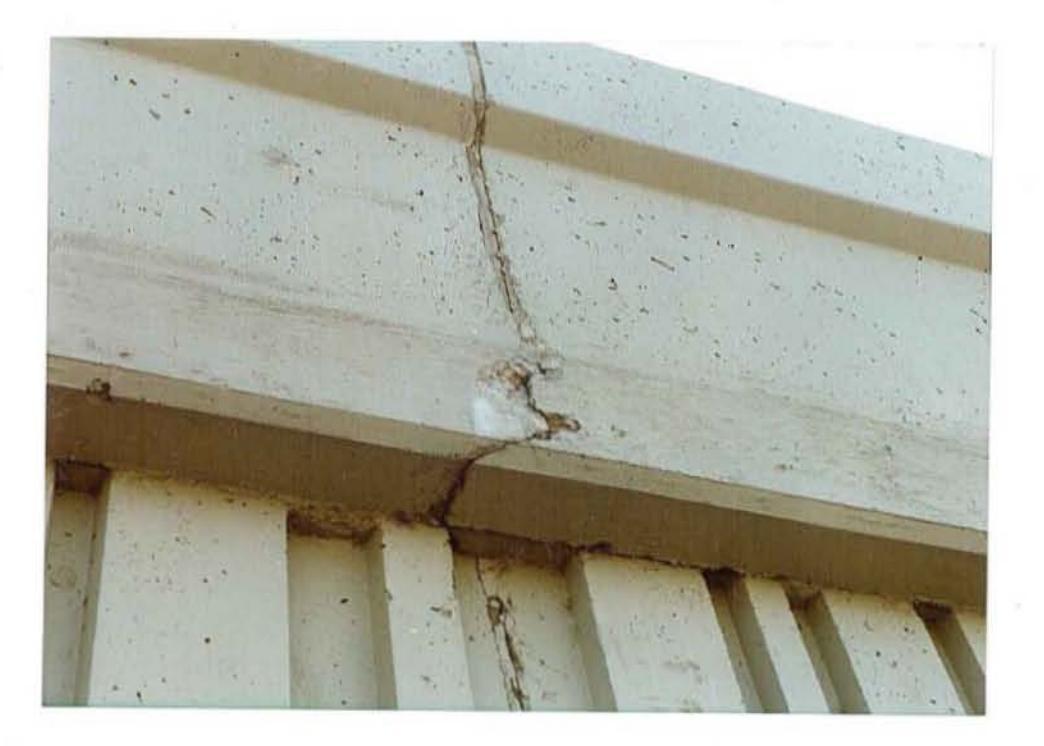
Figure 49 Interface of NE Hilfiker Wall and the 24th Street Bridge Abutment.

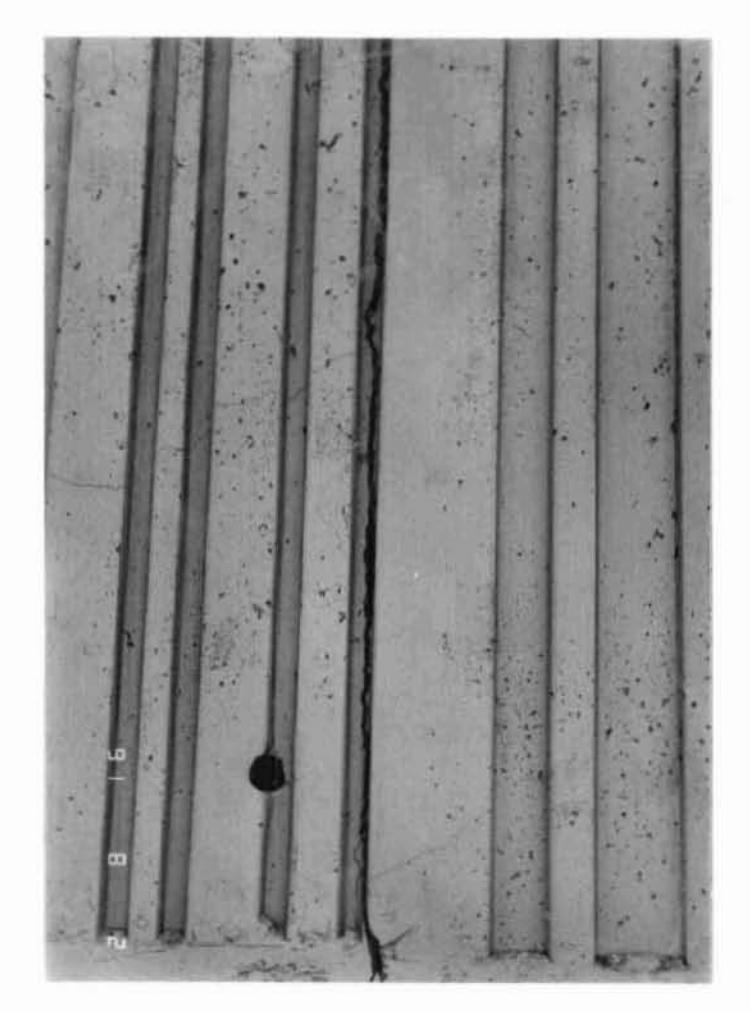
Figure 52 Large Vertical Crack Along the West Face of the Hilfiker Wall at the Moreland Street Drop Structure.

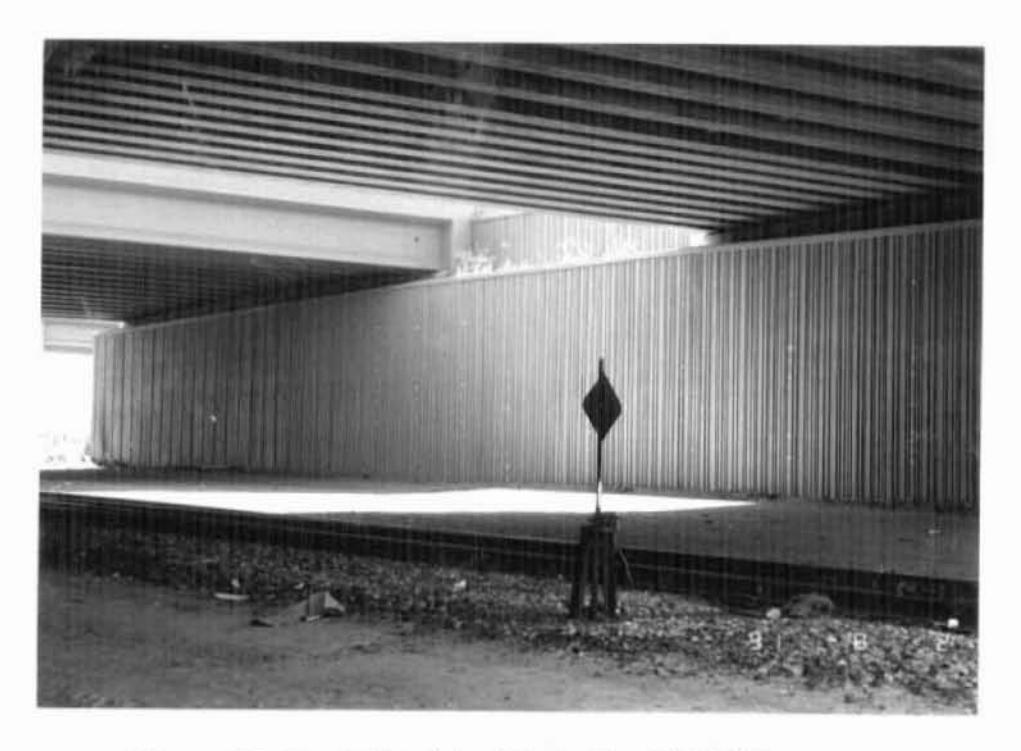
Inspection of the VSL walls revealed many horizontal hairline cracks in the walls. The cracks appeared throughout the height of the walls, but were most frequent in the lowest one-third of the walls.

Figure 53 South Retaining Wall at the SPRR Overpass.
