ARIZONA DEPARTMENT OF TRANSPORTATION

HILFIKER REINFORCED SOIL EMBANKMENT WITH FULL-HEIGHT, CAST-IN-PLACE CONCRETE PANELS

Final Report

May 1992

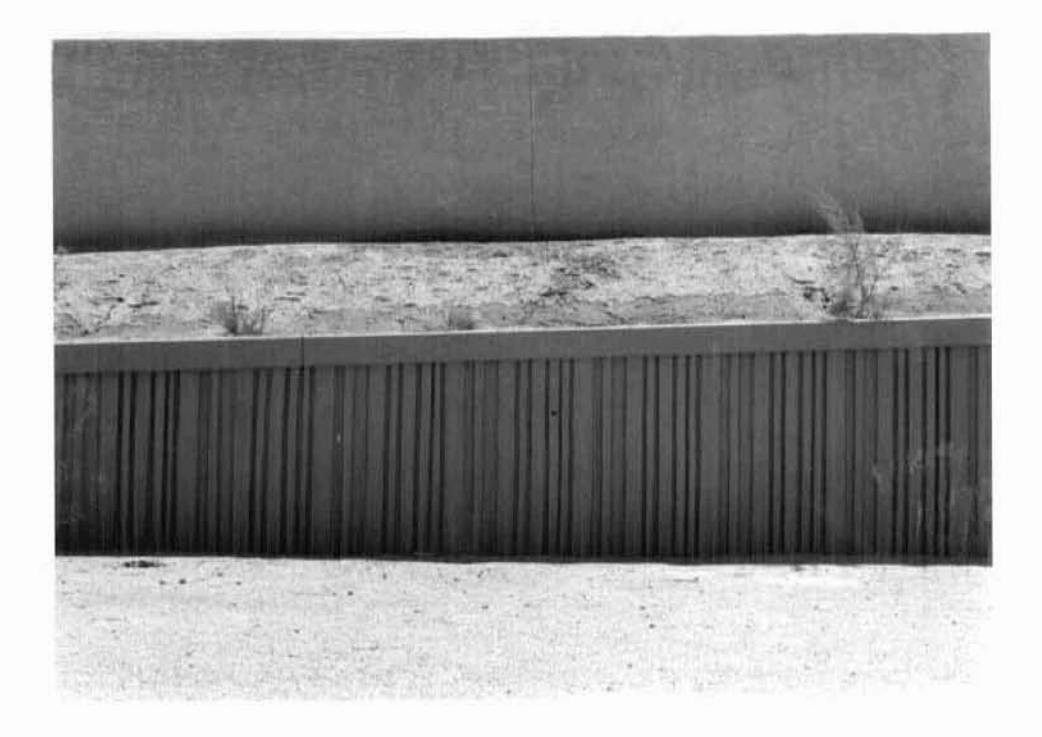
Inspection of this site consisted of walking the length of the retaining wall and recording the location of vertical and horizontal cracks, and expansion joints. The cracks were approximately 0.02" wide. The record is included as APPENDIX J. Figure 55 is a photograph of the retaining wall at the Warner Road Interchange.

There were plant wells placed at 8' intervals along the top of the retaining wall. Plants were no longer growing in these wells, but the drip irrigation system was continuing to operate. Also, irrigation of the plants immediately east of the sound wall was noticeably seeping down slope through the soil beneath the sound wall. The moisture was evident all the way down to the retaining wall. Because of the absence of weep holes in the retaining wall, the situation of additional water in the soil could be reducing the stability of the retaining wall. The drip irrigation system of the vacant plant wells has since been shut down. There were no major distresses visible on the wall.

Figure 55 Hilfiker Wall at the Warner Road Interchange.
