Report No. K-TRAN: KU-06-7 FINAL REPORT

STREAM INSTABILITY COUNTERMEASURES APPLIED AT KANSAS DEPARTMENT OF TRANSPORTATION HIGHWAY STRUCTURES

November 2008

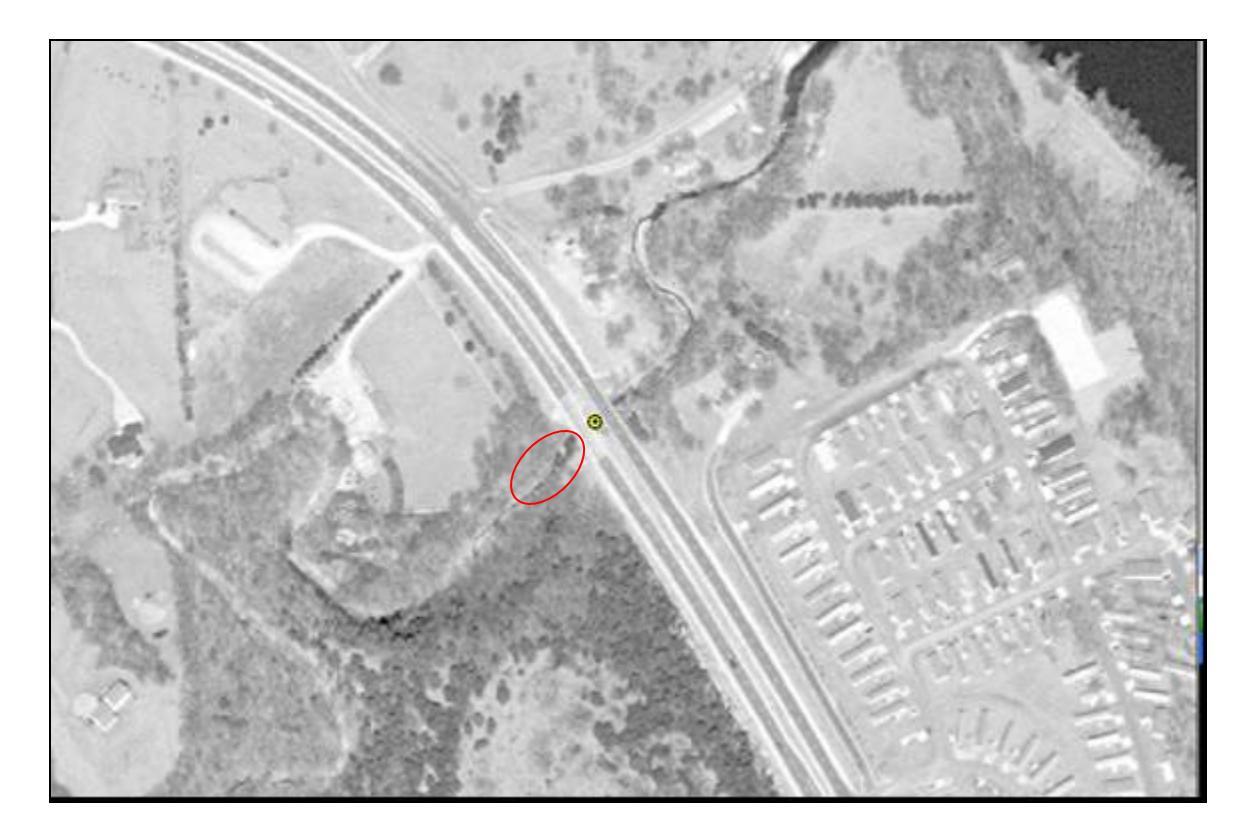
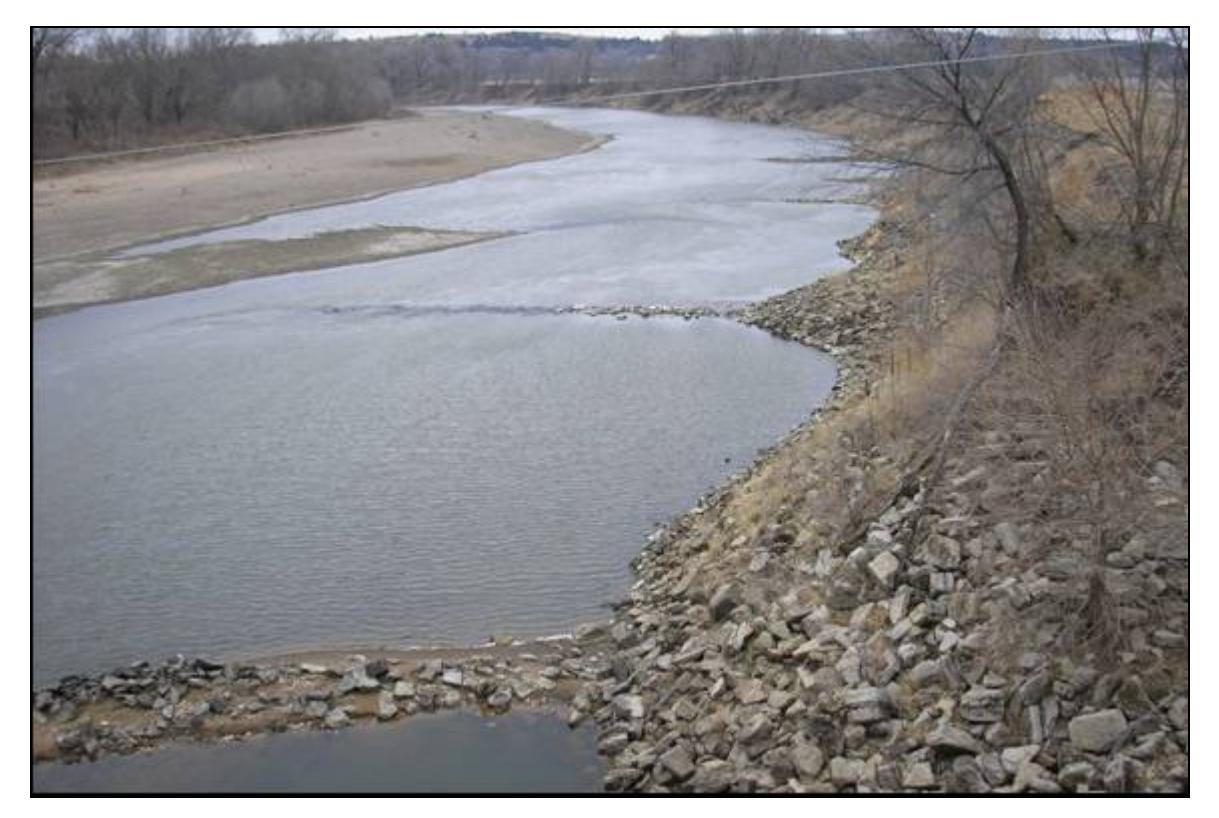
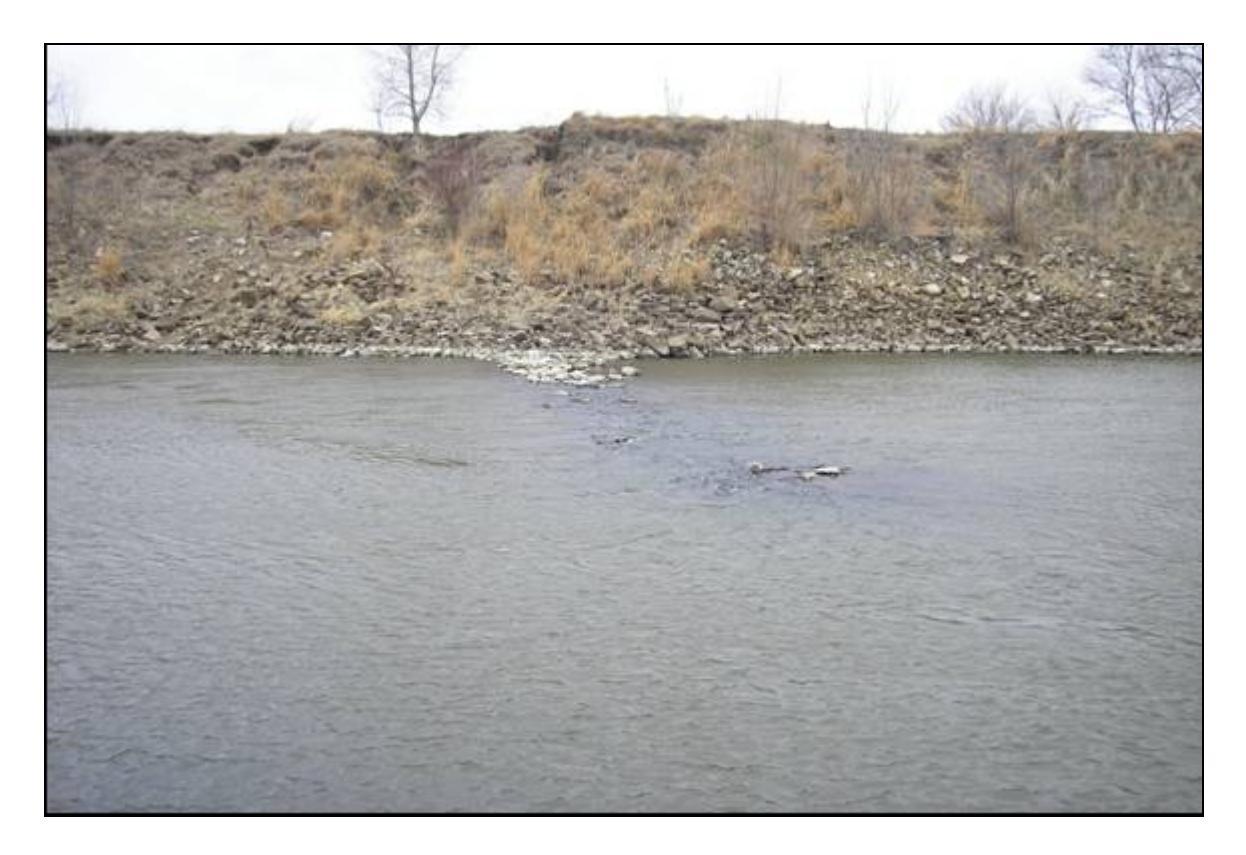
The channel was widening at Site 2 and the left bank of the river was threatening the bridge abutment. The ban was fairly steep. The water was just overtopping the weirs on the day of the field survey but they looked to be in good condition. Figure 2.5-7 show Site 2.

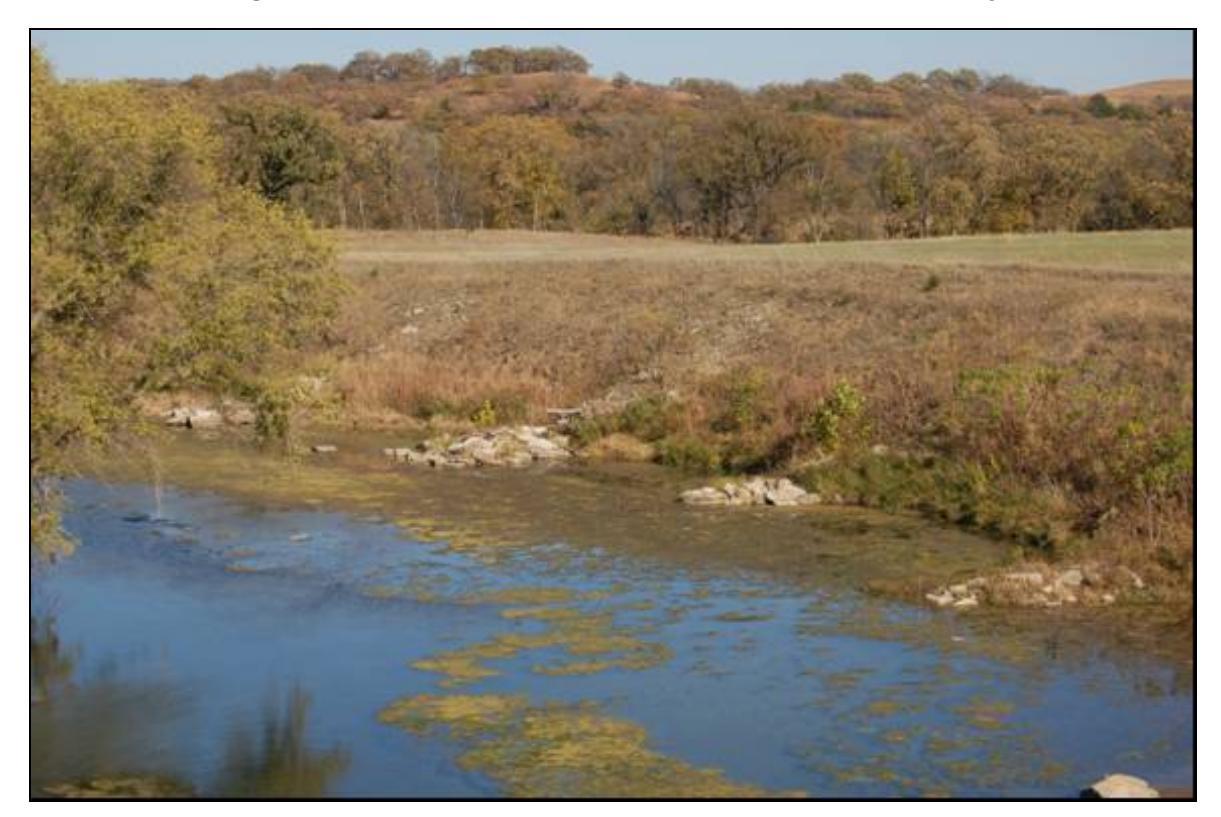
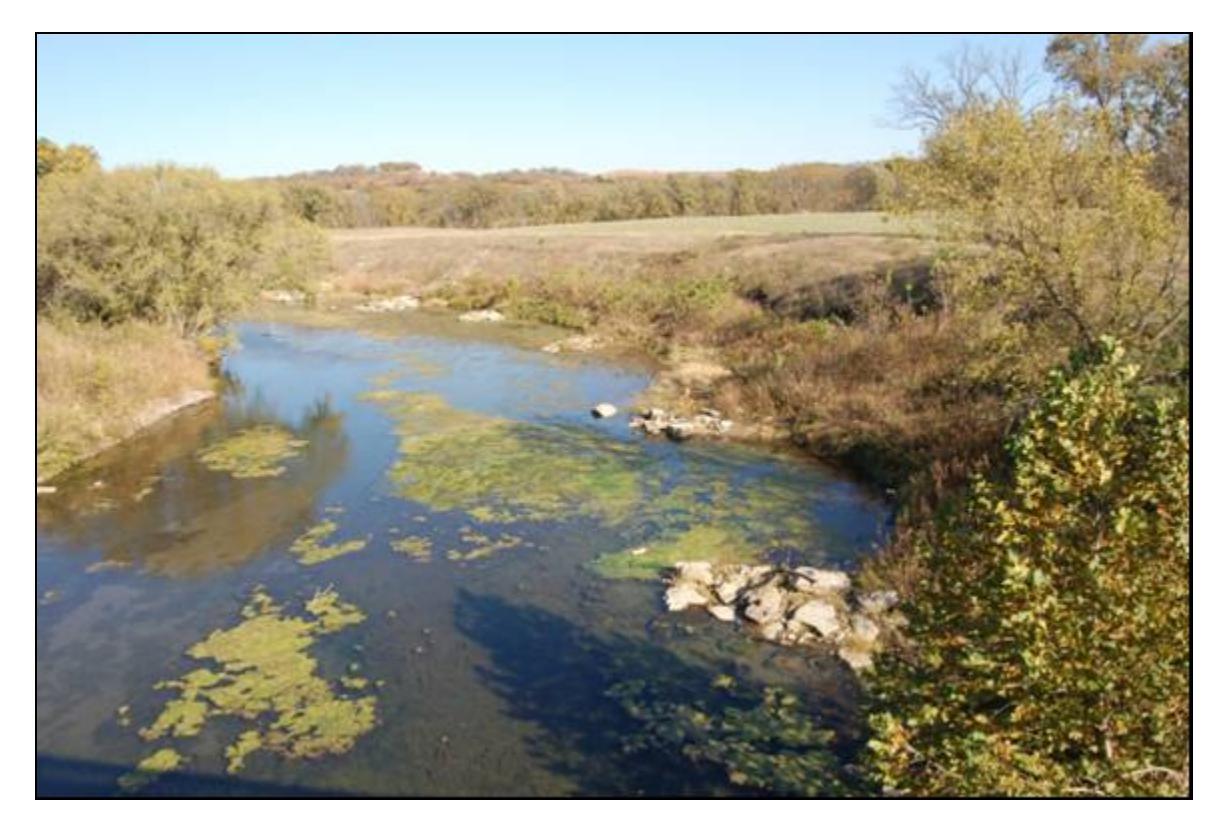
Lateral channel migration on the left side of the main channel posed a potential problem to the roadway and bridge for Site 16. Figures 2.9-11 show the benway weirs from different locations. Overall, the condition of weirs was excellent and the migration of the main channel appeared to have been arrested.

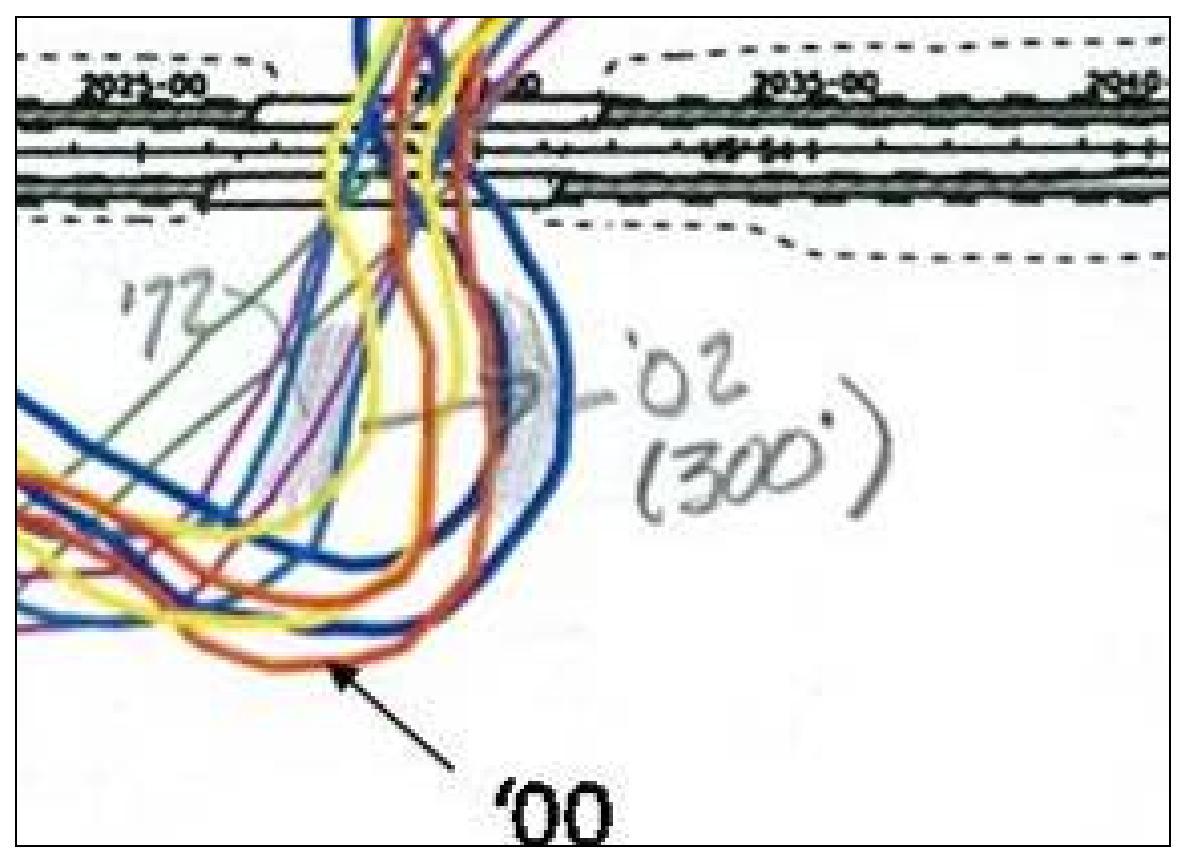
Figure 2.14: Site 17, Channel Migration, Kingman, KS, Kingman County

Figure 2.12 is an aerial view showing the region where sand tube bendway weirs were installed. Figure 2.13 shows the location of the main channel banks in 1938, 1964, 1972, 1983, 1997 and 2000. It is apparent that the right bank of the channel is migrating toward the road. Thus the roadway and the right bridge abutment are threatened. Figure 2.14 is a drawing showing the channel location for all the years displayed in Figure 2.13 but also for 2002. Note that there was significant channel migration between 2000 and 2002. Figure 2.15 through 2.18 show the preparation and installation of a sand tube. Figures 2.19 -2.21 show the sand tubes in operation. Note that they are oriented upstream and the flow passes over them perpendicular to the longitudinal axis of the sand tube, which is directed away from the bank on the downstream side of the sand tubes. The soil in the overbanks was non-cohesive and highly erodible. The sand tubes appeared to be functioning very well in halting the channel migration.

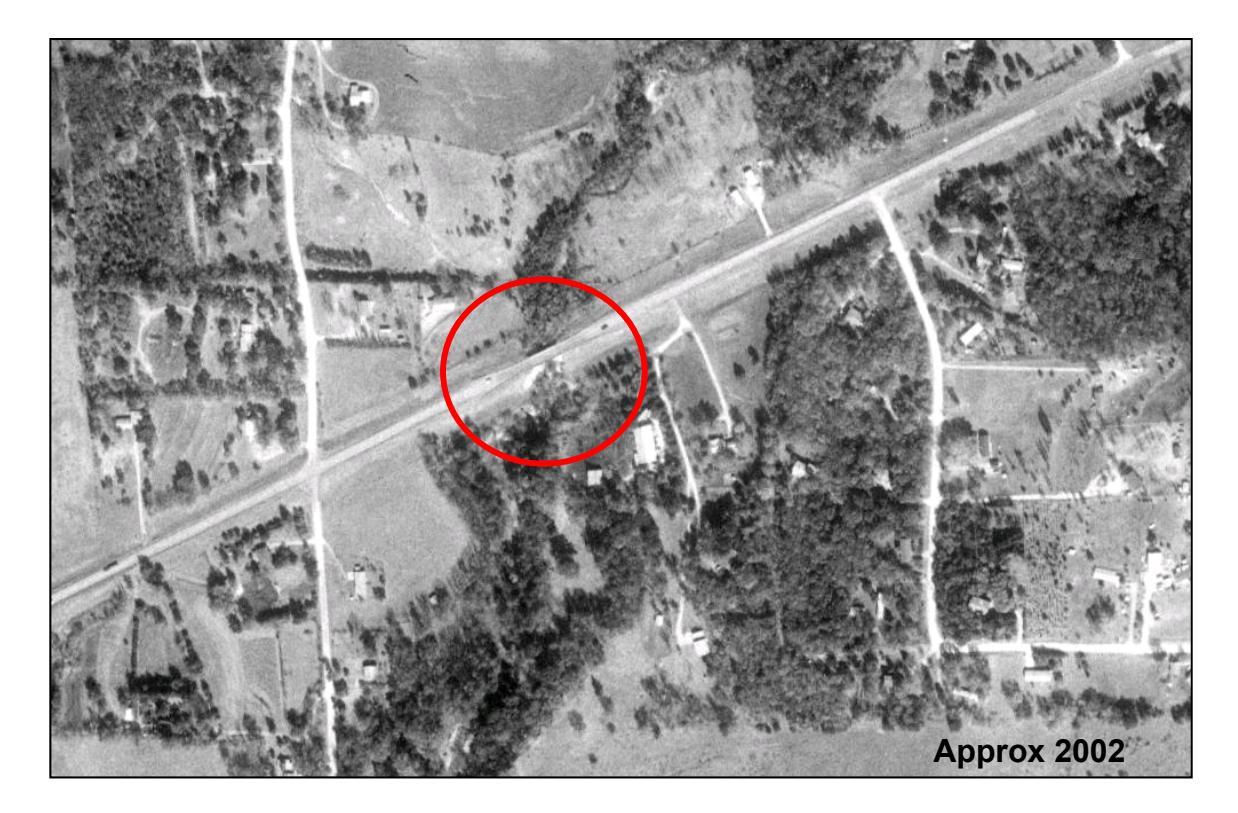
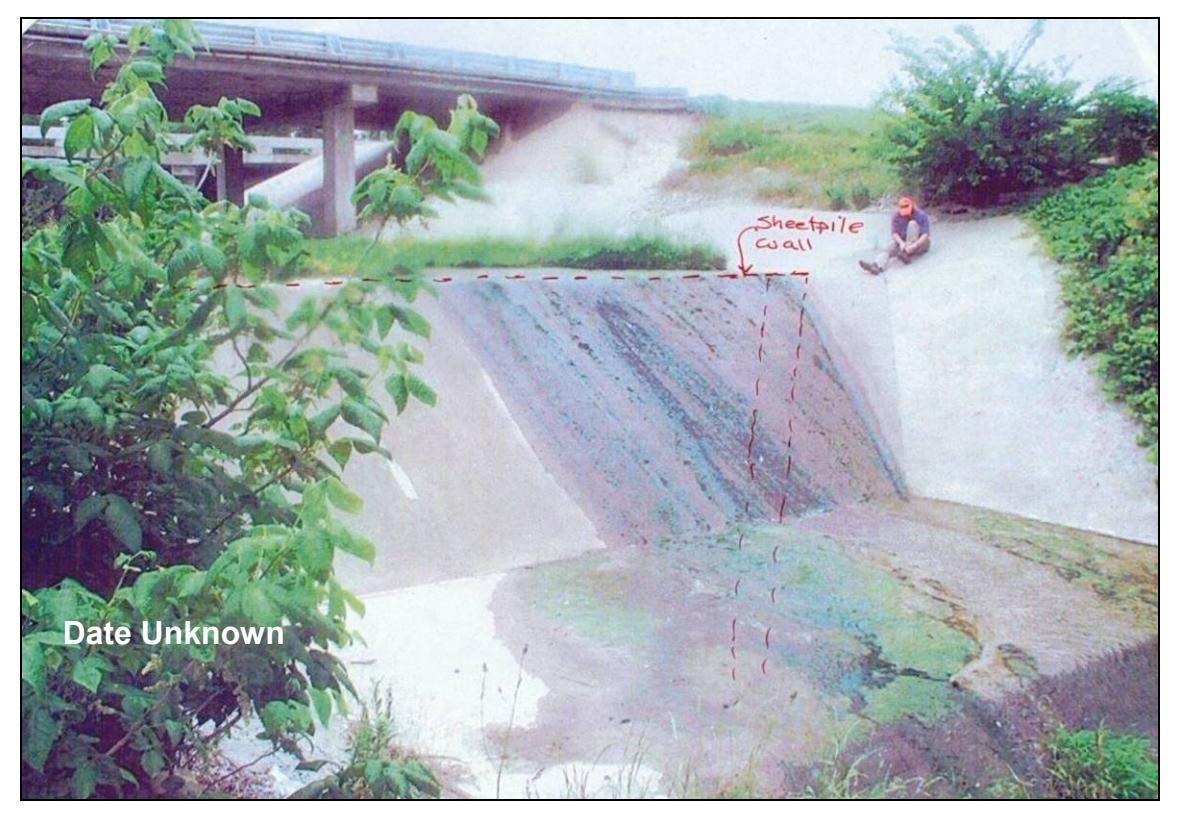
Figure 4.8 shows the location of Site 15. A large head cut was located downstream from the bridge on HW US-24. Figure 4.9 shows the location of the sheetpile wall. Figures 4.10-13 are photographs of the drop structure and upstream and downstream channels.

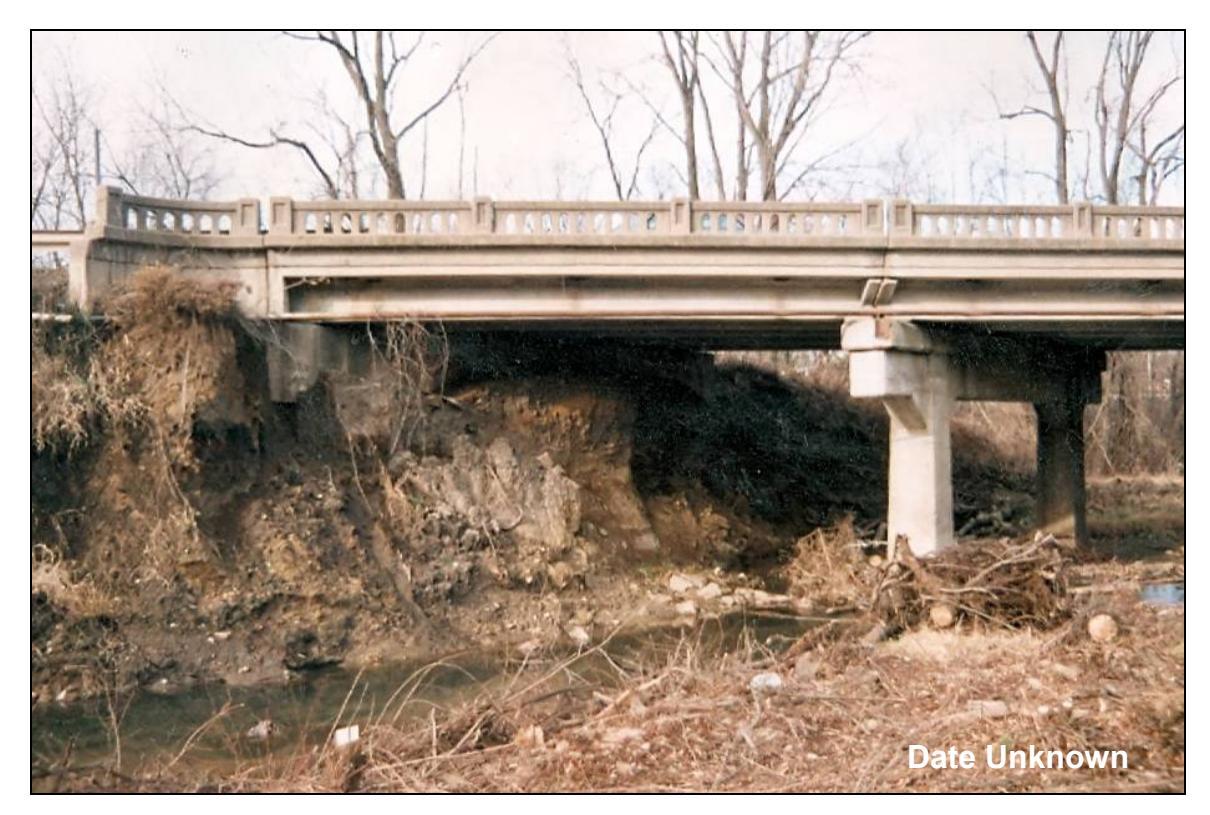
Figure 6.3 Site 11, Atchison KS, Atchison County (Before Countermeasures Installed)

Figure 6.2 shows Site 11 where gabion baskets and bank protection were used to protect a bridge abutment. The damaged left abutment is shown in Figure 6.3. Figures 6.4 and 6.5 show the left abutment in March 1994 right after construction was completed. Figure 6.6 shows the right abutment in 1994. It was also repaired using gabion baskets and riprap bank protection. Figures 6.7-9 show the site in March 2006.

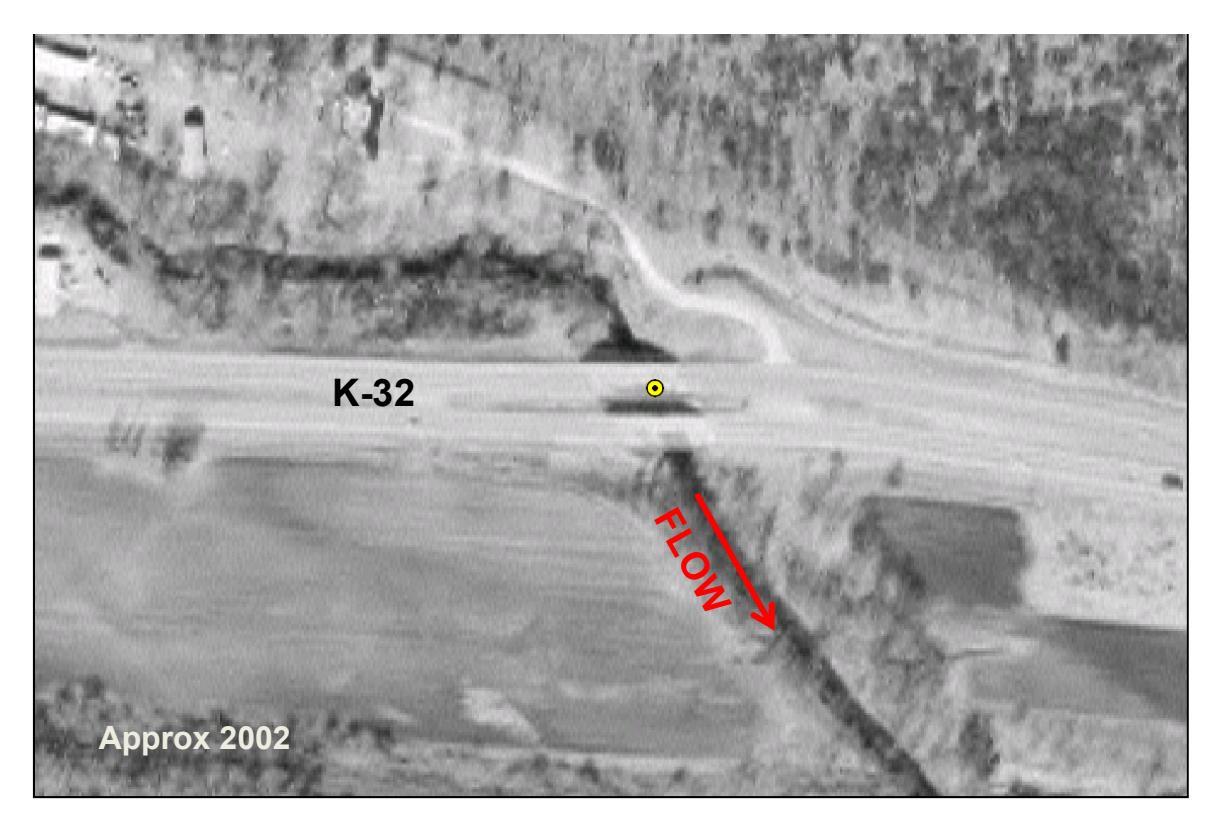
Figure 6.10:Site 12, Aerial, Bonner Springs KS, Wyandotte County Gabion Baskets and Slope Protection

Figure 6.10 is an aerial view of Site 12 in Bonner Springs KS. Note that the channel makes a very sharp bend just upstream from the bridge. Also, the ditch on the upstream east side of the bridge carries flow into the channel directly upstream from the bridge. These flow characteristics may have caused the extensive should shown at the left bridge abutment in Figures 6.11-12. The scour hole allowed a significant portion of the flow to pass through the bridge on the outside of the bridge piers shown in Figure 6.12. Figures 6.13 and 6.14 are sketches from the construction plans showing the backfill and the placement of gabion baskets. Figures 6.14-18 are photographs of the repaired site.
