Smart Infrared Inspection System Field Operational Test

U.S. Department of Transportation
Federal Motor Carrier Safety Administration

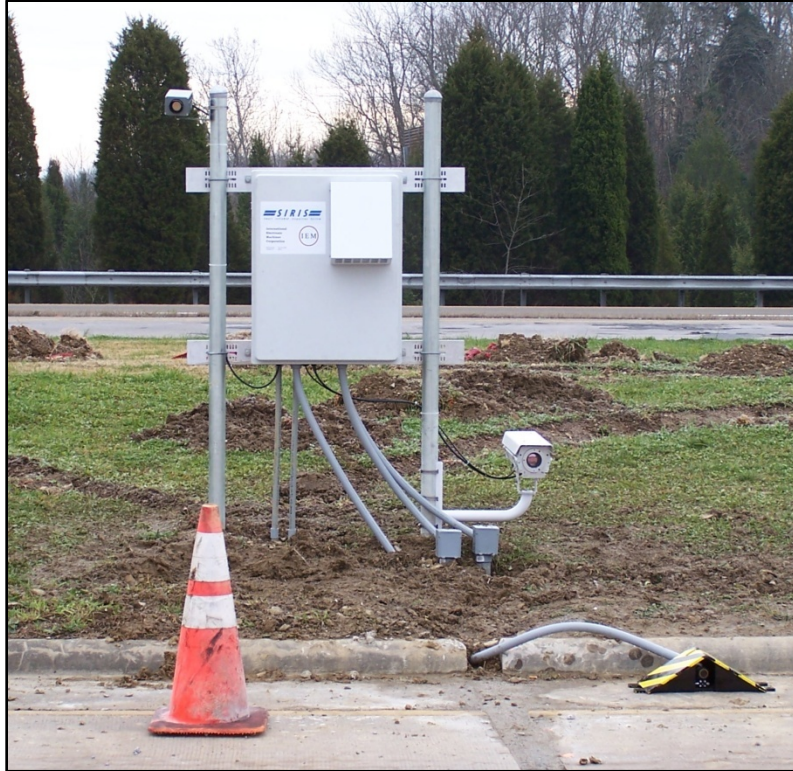
Figure 1. Photo. Driver's side components of the SIRIS system.

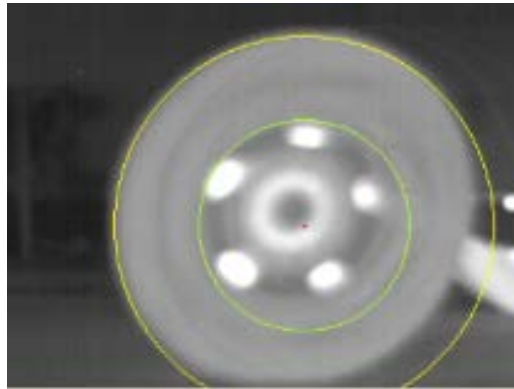
Figure 5. Image. Wheel-end with ROI problems.

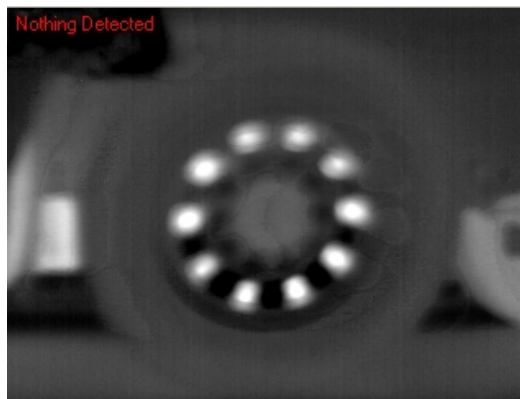
Figure 6. Image. Wheel-end with no ROI detected.

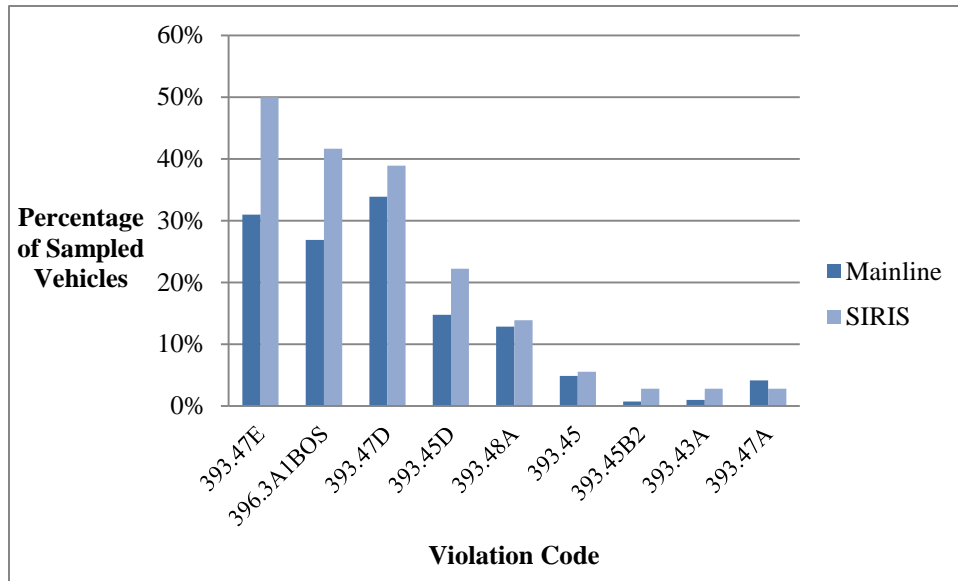
Figure 7. Brake violation correlation.

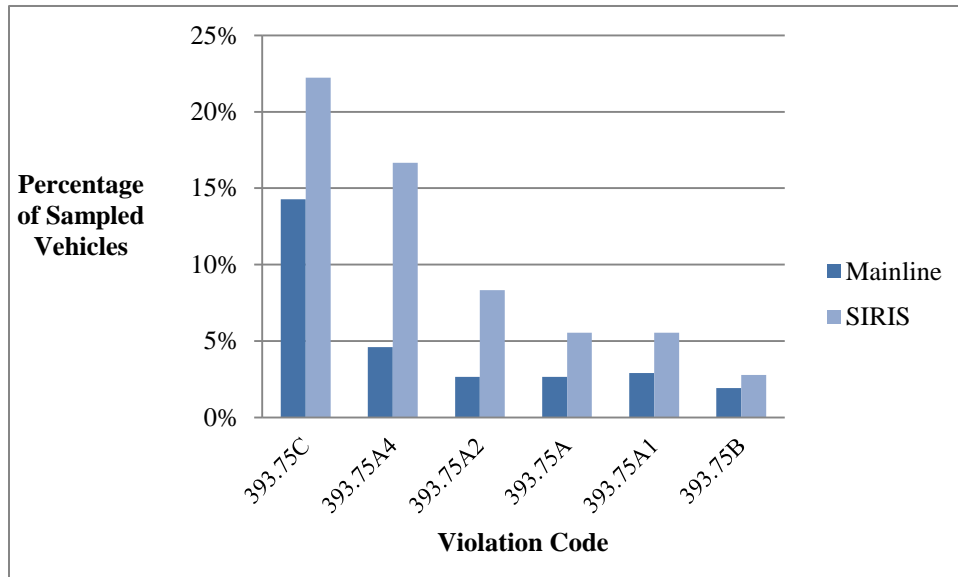
Figure 8. Tire violation correlation.
