CORROSION OF STEEL IN LOCALLY DEFICIENT CONCRETE Contract No. BD544-31 Final Report to Florida Department of Transportation

A. A. Sagüés Principal Investigator Department of Civil and Environmental Engineering

> UNIVERSITY OF SOUTH FLORIDA Tampa, FL 33620 February 28, 2009

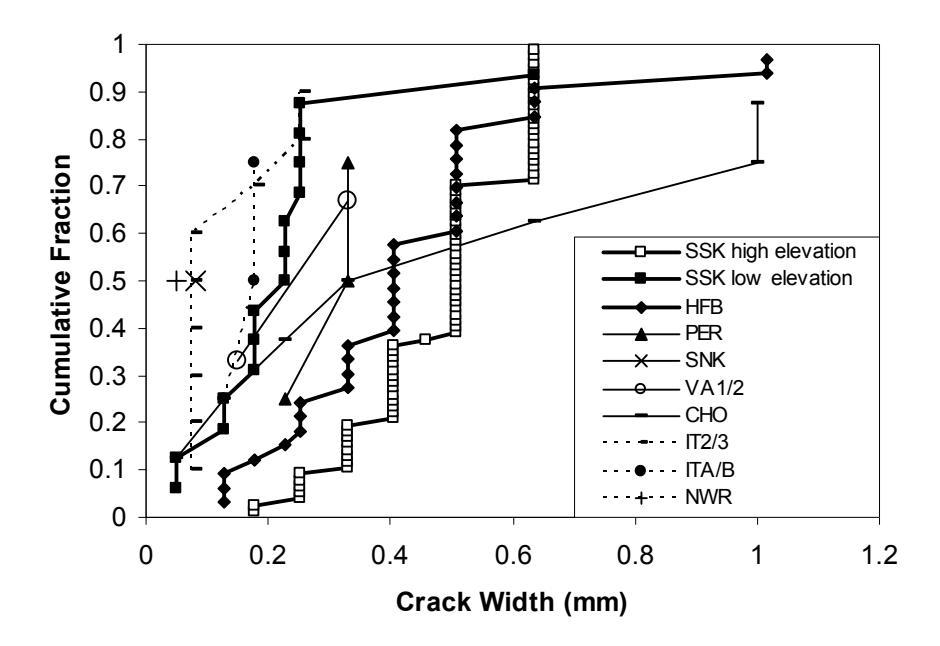
At low elevations, hairline cracks (<0.03 mm) were commonly observed on the concrete footers (<60 cm AHT) and columns (<200 cm AHT). Larger vertical cracks (~0.3 mm, (Figure 1)) with efflorescence were found on the elliptical posttensioned columns. No concrete delamination was observed or detected by hammer sounding on any cracked or sound sections. A total of 16 cores were extracted from these low elevation locations. In the field, no evidence of corrosion was observed on the surface of the epoxy coated reinforcement exposed by coring, except for vestigial rust at small coating breaks such as high points on ribs where the coating had been damaged during or before construction. That rust did not appear to reflect ongoing corrosion. Half cell potentials ranged from values indicative of passive behavior to <- 600 mV. The more negative values were observed at some (but not all) of the lowest elevations. As mentioned above, the significance of these values is limited. The surface resistivity of the concrete at elevations where the concrete was very wet (e.g. <=0.3 m AHT) (Figure 2b) ranged from (~15-150 k Ω -cm), consistent with the low permeability concrete used in this bridge. The large aggregate consisted of limestone. The volumetric porosity of the concrete was ~20%.

The trestle cap beams, at elevations ~7-8 m AHT, often had wider structural cracks (up to 0.6 mm, (Figure 1)), some with heavy efflorescence. No concrete delamination was observed or detected. Moisture was more prevalent at some of the cap beams which were exposed to runoff water at deck expansion joints. Isolated concrete spalls (apparently not corrosion related) in the same vicinity of the cracks were occasionally found in cap beams. A total of 10 cores were extracted from the cap beams. As in the lower elevations, minor to no corrosion was observed on the reinforcement exposed by coring except for vestigial rust at small breaks in the polymer coating. Potentials measured at exposed ECR locations ranged from -70 mV_{CSE} > E >-490 mV_{CSE}. The concrete surface resistivity was 70-300 k Ω -cm with no clear difference between sound and cracked locations.

Figure 1. Widest crack width per substructure unit (e.g. per column, footer, etc.)

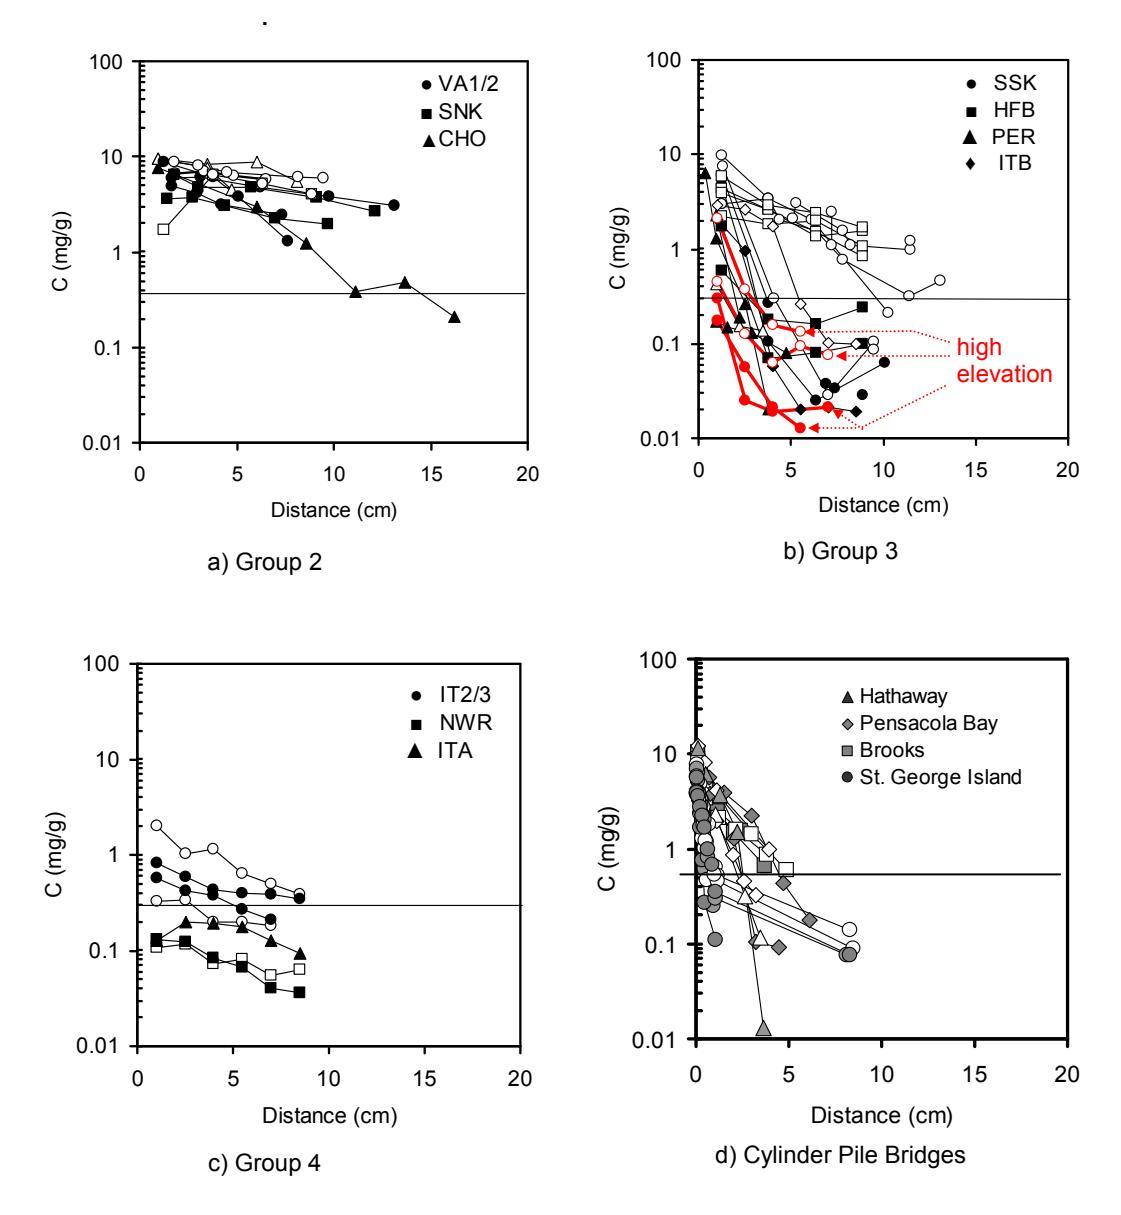
<u>Vaca Cut (VA1/2) and Snake Creek (SNK).</u> The chloride penetration profiles are shown in Figure 4a. The D values for VA1/2 were very high $(1x10^{-7} \text{ to } 2.76x10^{-7} \text{ cm}^2/\text{s})$ and less but still indicative of high permeability for SNK (4.73x10⁻⁸ cm²/s). The average Cs value was similar to those measured in other Florida marine bridges (~7 mg/g, ~17 kg/m³) [1,9]. The chloride content of the cracked concrete samples were higher than in the sound concrete within the area of the drilled shaft susceptible to sea splash (<46 cm AHT) which gives indication of preferential chloride penetration through the cracks.

<u>Sunshine Skyway(SSK).</u> Little to no corrosion was observed at any examined on-water locations despite the presence of pre-existing structural cracks as wide as ~0.3 mm and with well manifested enhanced chloride penetration there at SSK (Figure 4b). At elevations exposed to sea splash, chloride ion concentration at reinforcement depth for cracked concrete was ~2 kg/m³, close to or exceeding typically assumed threshold values [10].

<u>Howard Frankand (HFB).</u> Distinct preferential chloride penetration at cracks was observed in this bridge (Figure 4b), similar to that noted for the SSK, at elevations exposed to sea splash. Chloride ion concentration at the 10 cm

reinforcement depth for cracked concrete was greater than commonly assumed conservative threshold values 0.7 kg/m³). Much lower chloride levels were measured at bar depth in adjacent sound concrete, consistent with the low chloride bulk diffusivity \sim 7x10⁻⁹ cm²/s determined for this low permeability concrete.

Figure 4. Chloride penetration profiles. Solid symbols: sound concrete. Open symbols: cracked concrete. Thick line, arrowed: high elevation trestle cap SSK locations.
 Horizontal line: conservative chloride threshold value ~0.3 mg/g (C_T~0.7kg/m³). Cylinder Pile Bridge data from references [7,8]. Numeric chloride profile data and core identification are given in Appendix I.

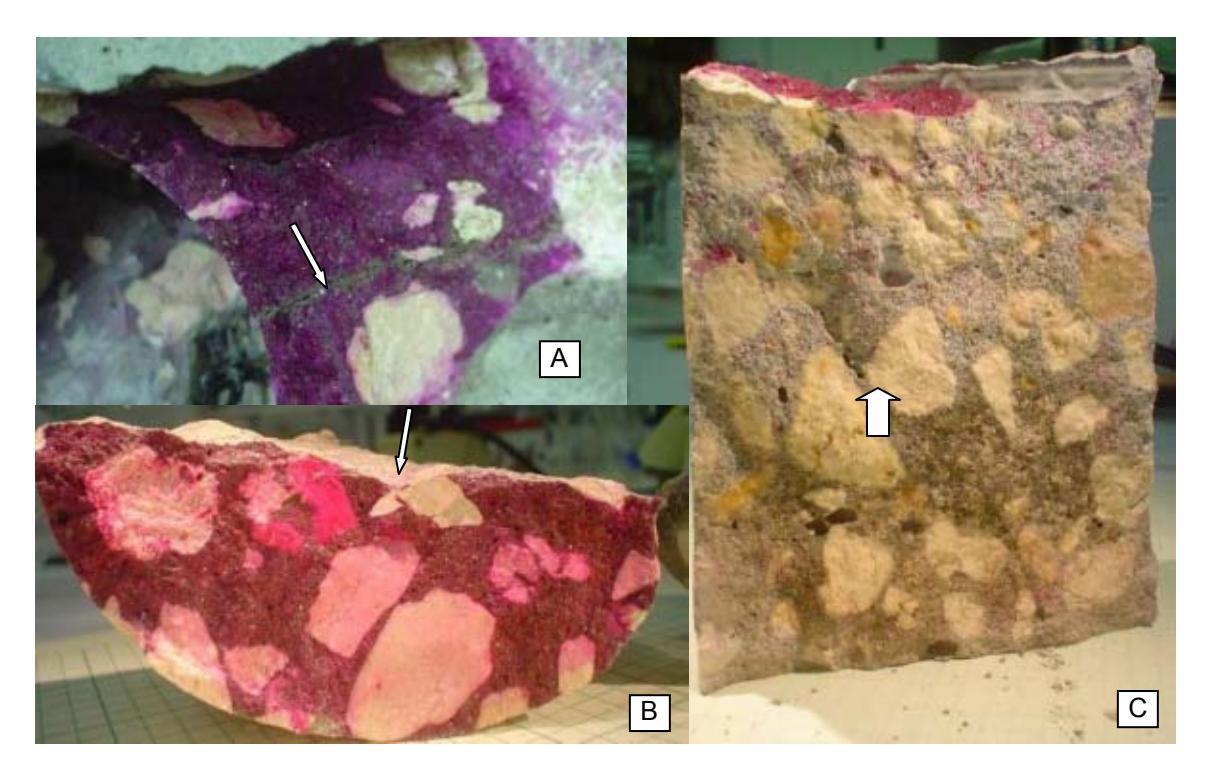
Figure 5. On crack carbonation testing: SSK high elevation trestle cap concrete core. A. On site crack location (SSK140E1). B. Transverse cross section from crack surface (SSK33W1). C. On crack surface (SSK33W1).

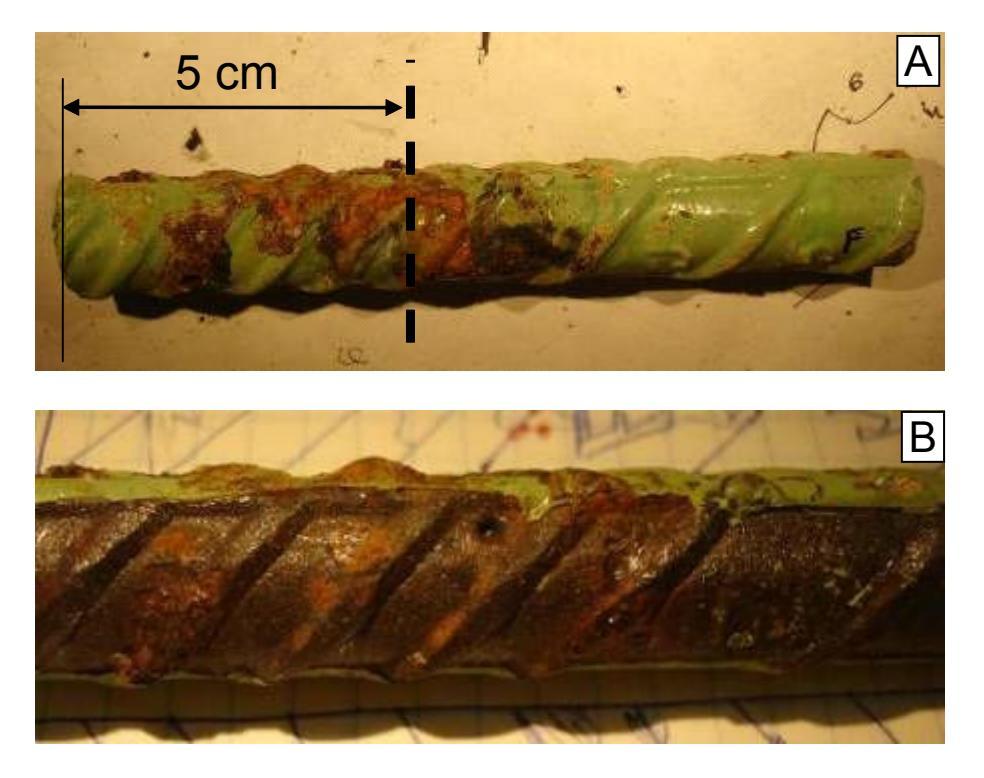
The corrosion observed on the four epoxy coated reinforcement samples extracted from cracked locations from this bridge merits note. The crack plane was usually perpendicular to the rebar. Corrosion products were generally observed around locations with coating defects, especially near the intersection of the crack plane with the rebar. Upon removal of the coating (which was found to be fully disbonded) the underlying surface was relatively dry, with dark corrosion product regions.

Figure 12. ECR corrosion at crack location (HFB 59E1) A. Corrosion products on bar surface. The line represents the location of the crack intersection. B. Appearance after partially removing the coating and exploring into the corrosion products.

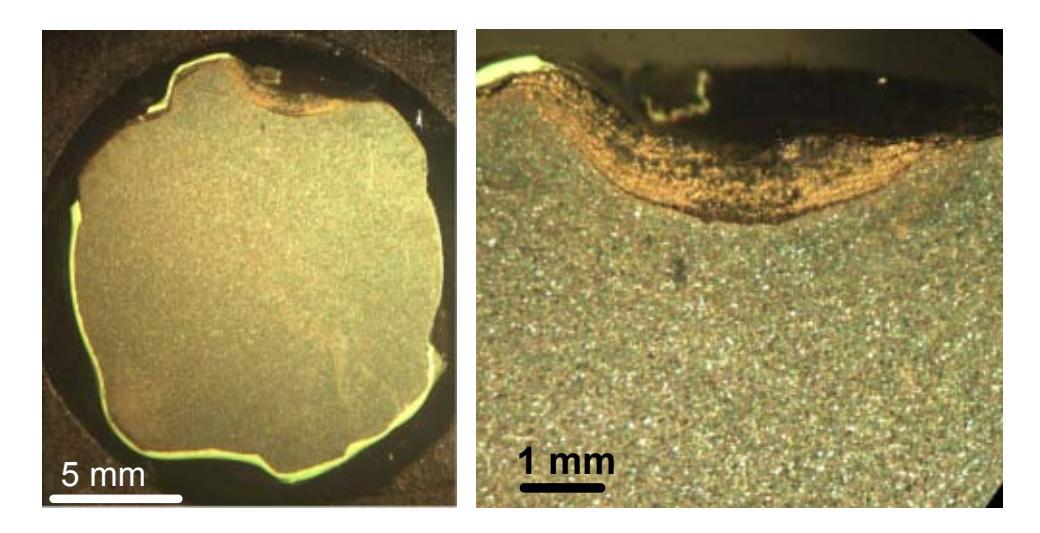
Figure 13. Cross section of ECR bar showing severe corrosion at a crack location of HFB 59E1. Left: Entire Bar cross-section. Right: Close up of corrosion penetration.

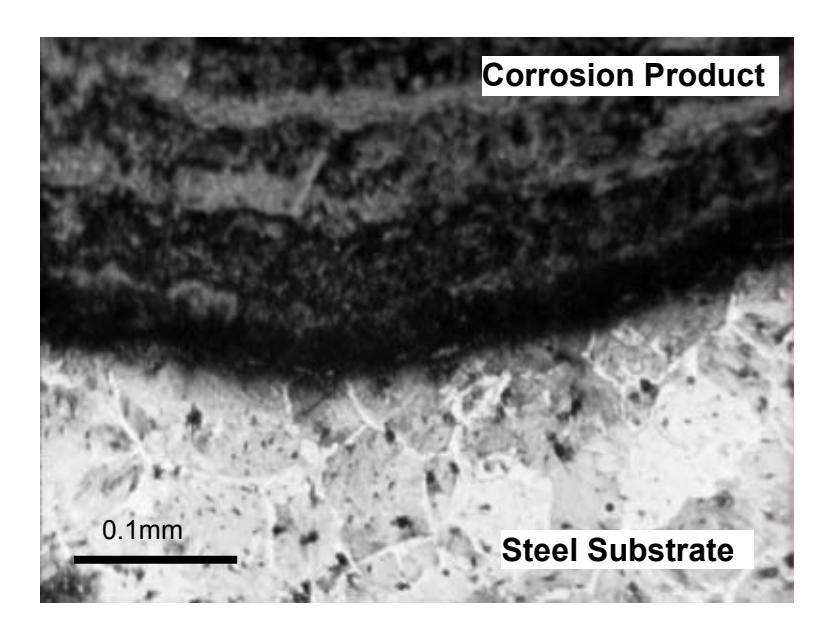
Figure 14. Corrosion product - base metal interface showing progression of corrosion into the microstructure of the rebar steel (HFB 59W1).

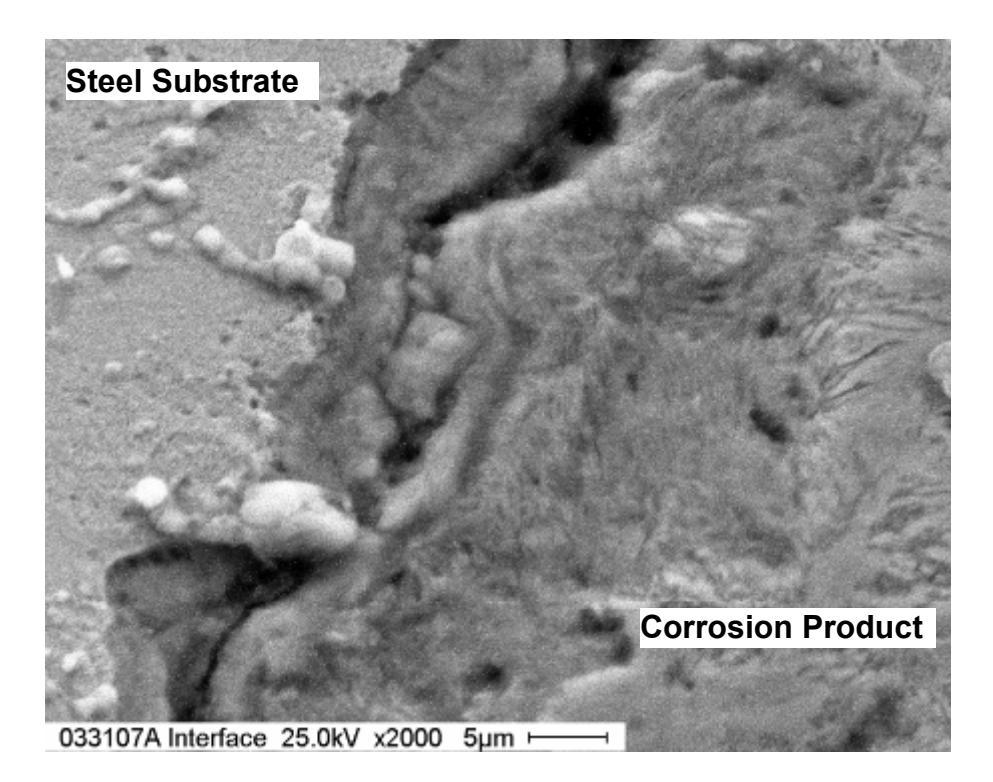
Figure 15. SEM Image of corrosion product (HFB59E1).

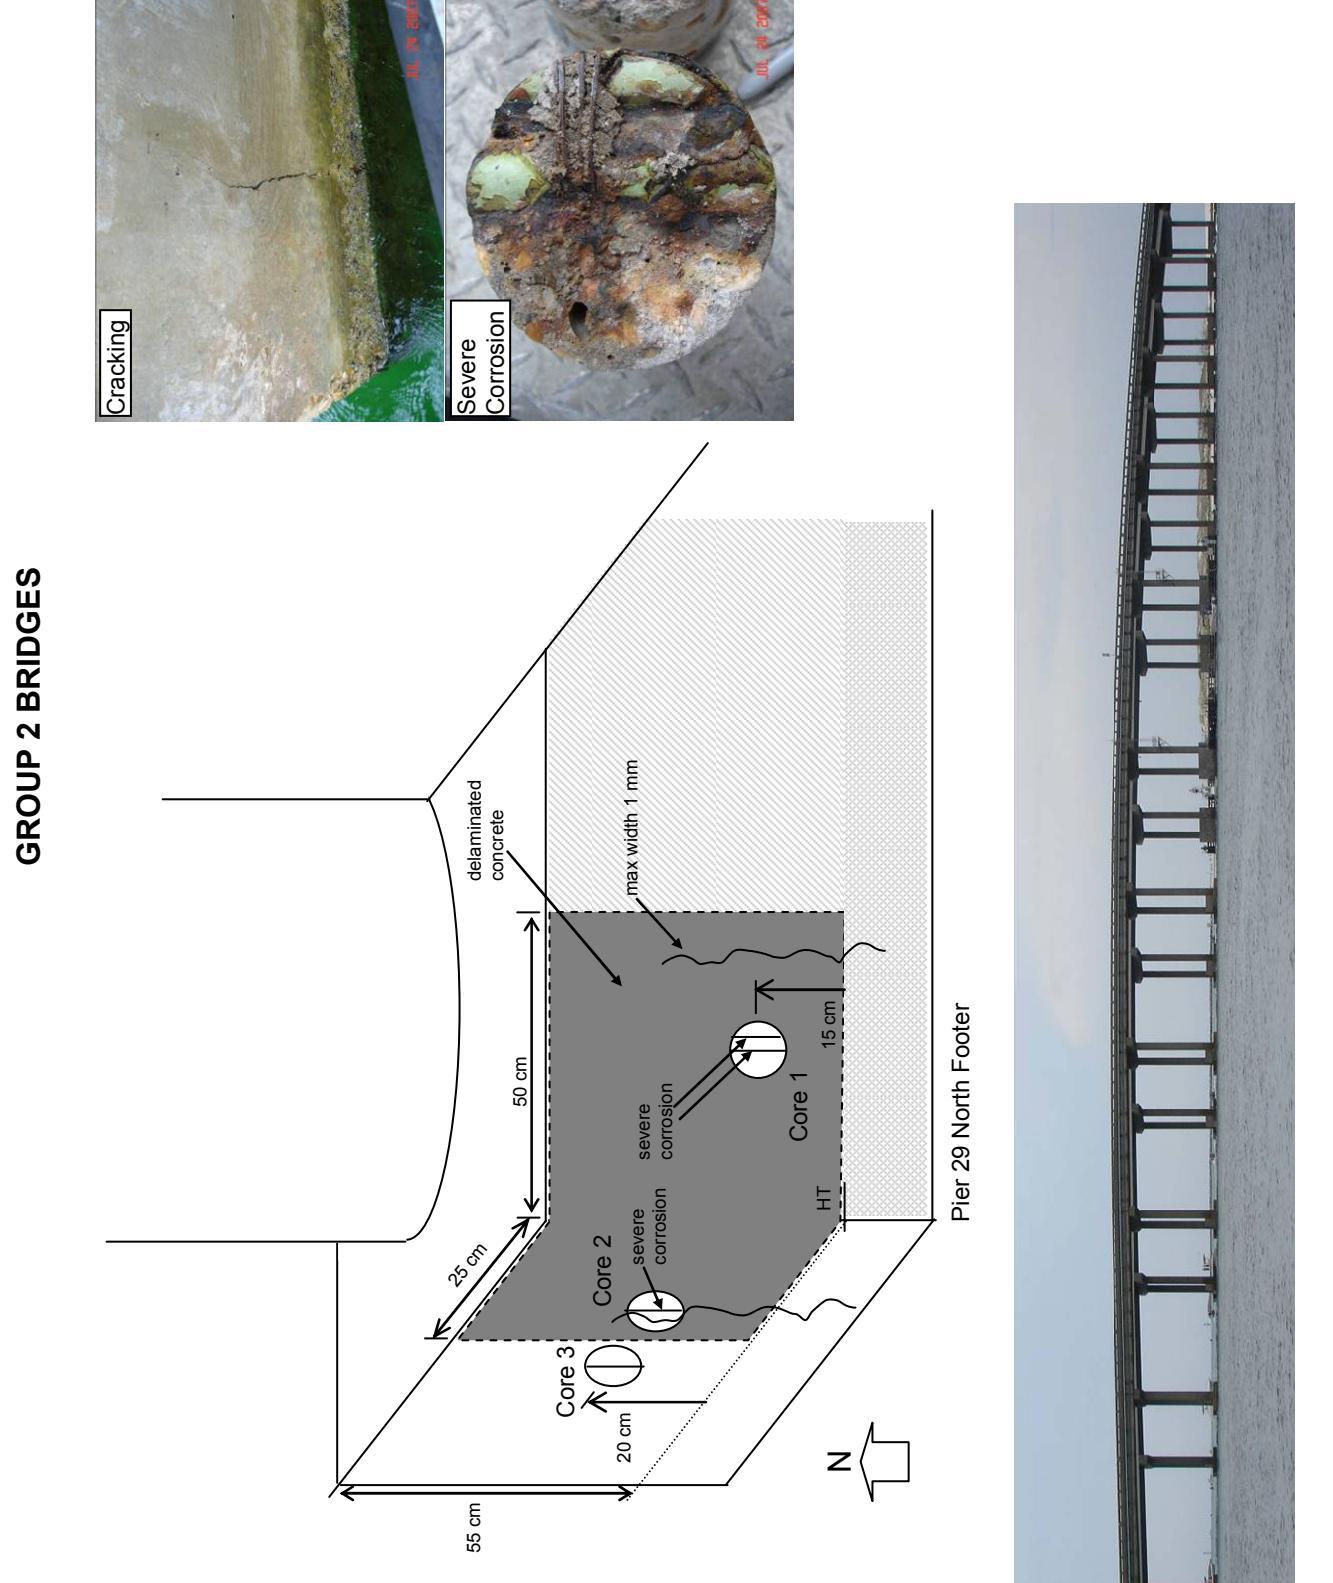
Figure A3. William Marler Bridge (CHO). Footer.

William Marler (CHO). Two of 20 footers from the ten high elevation piers had cracks wider than 1.0 mm; ten of the footers had cracks larger than 0.2 mm. Minor concrete cracking was typical on all of the footers. Vertical and map-type cracking was observed on one of 20 columns from the high elevation piers. Rust bleedout was observed on two columns and one strut. The origin of that bleedout was not confirmed as samples of reinforcement were not obtained, but corrosion of reinforcement may be possible. Core samples were extracted from two footers each with one wide vertical crack (1.0 and 0.63 mm wide respectively). Approximately 0.42 m² and 0.1 m², respectively, of concrete around the crack locations seemed to be delaminated as determined by hammer sounding. Extensive corrosion of the reinforcing steel was observed on both footers at elevations 8.9 to 17.8 cm above high tide level, both where the crack intersected steel and in adjacent sound concrete locations. The concrete cover to vertical bar ranged from 7.1-10.4 cm; nominal design cover was 10.2 cm. Highly negative half-cell steel potentials were measured, -400 to -552 mV CSE. In plain steel rebar such potentials would likely be reflective of the observed ongoing corrosion, but it is cautioned that potential readings in epoxy coated rebar, especially in wet concrete, may not be always reliable indicators of corrosion condition. Concrete surface resistivity measurements on the columns ranged from 46 to 128 k Ω -cm on the columns at elevations 0.6 to 2.4 m AHT. Concrete resistivity on the footer ranged from 16 to 63 k Ω -cm at elevations 0 to 0.55 m AHT. The large aggregate consisted of river rock. The volumetric porosity of the concrete was ~14%.

Concrete Cracking max. width 0.6mm . Severe Corrosion: Core 5 max width 0.6 mm ▲ Core 4 severe Pier 29 South Footer 18 cm delaminated concrete Ħ Core 5 severe max width 0.3 mm Core 6 ა 9 cm 55 cm

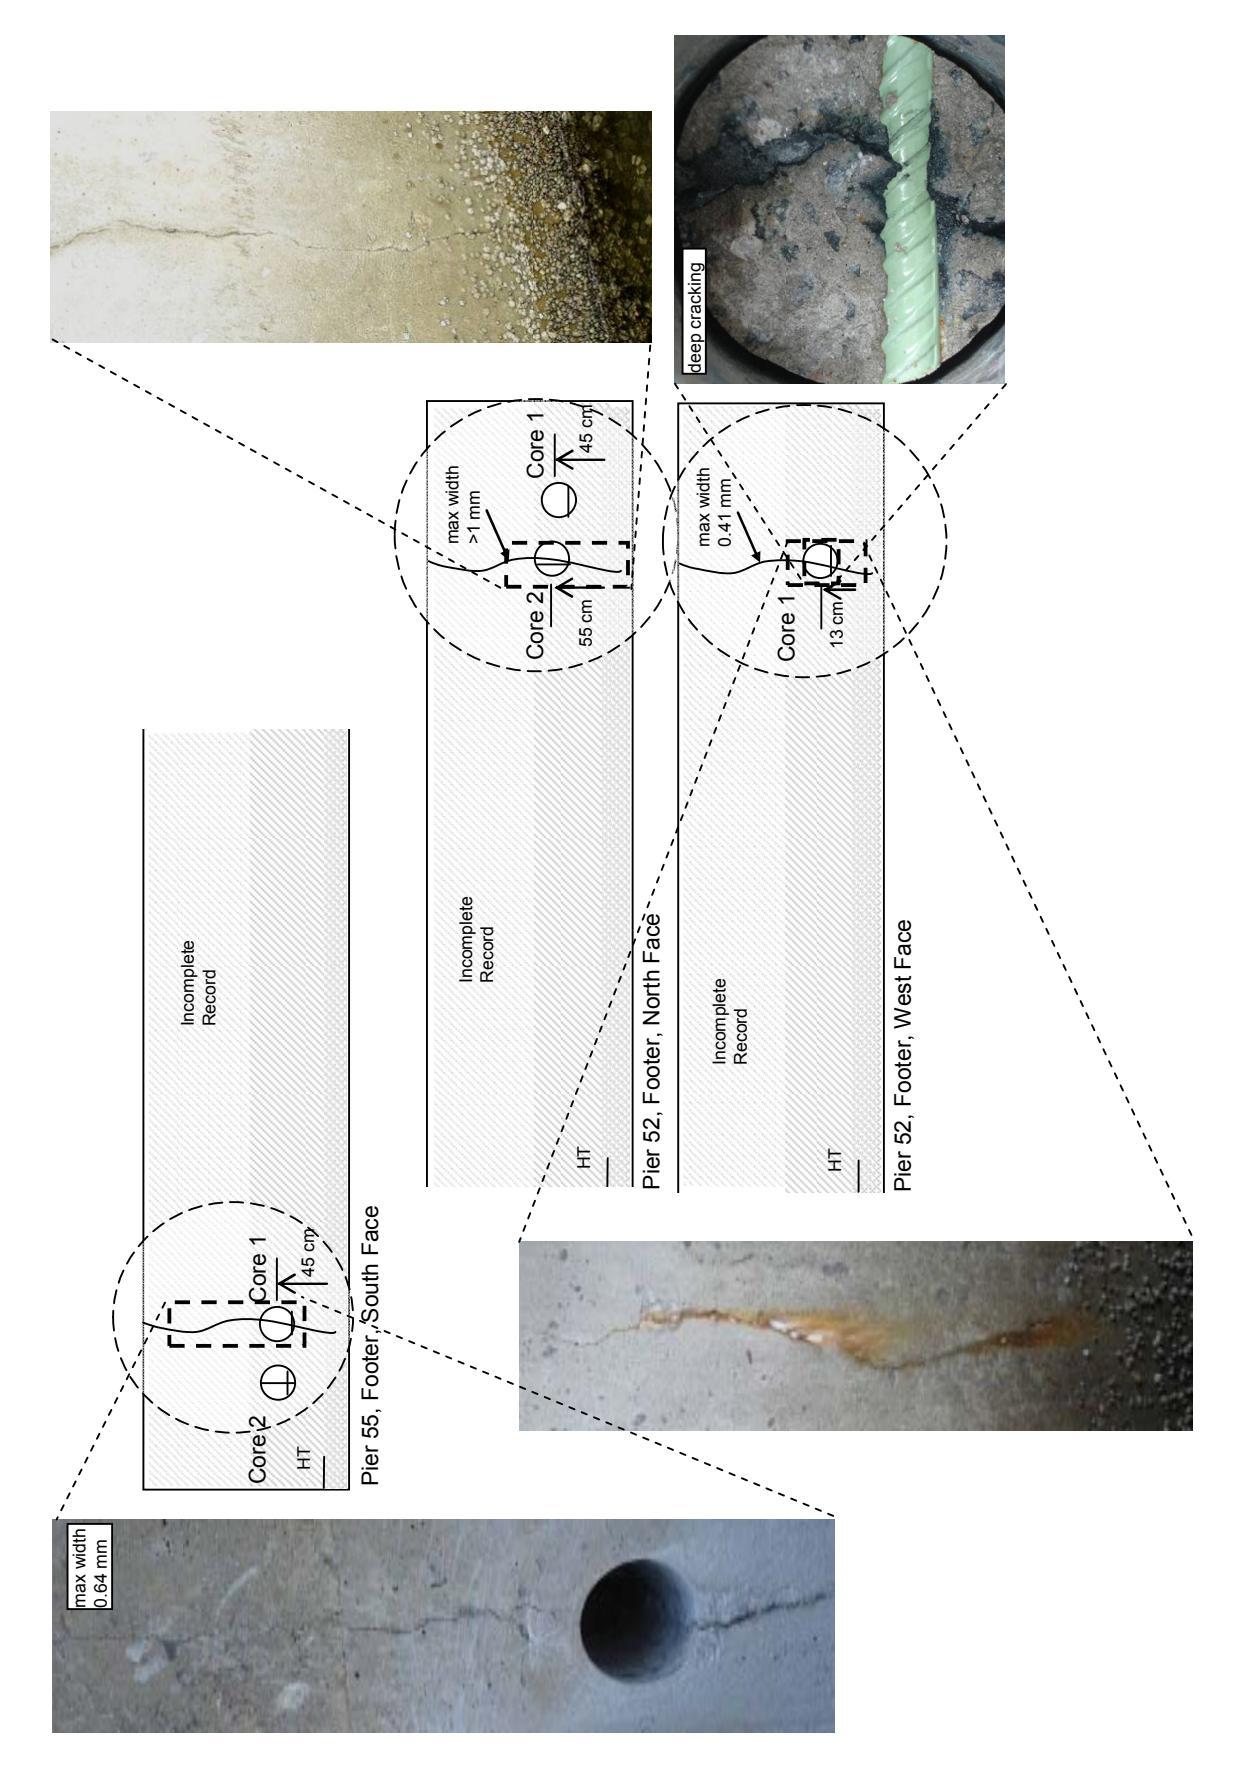
Figure A12. Howard Frankland Bridge (HFB). Footers.

<u>Howard Frankland (HFB)</u>. Vertical cracks were frequently observed on the concrete footers; several large cracks were as wide as 1.0 mm. The trace of the crack observed on the top of the footers of the larger cracks was several feet deep. Cracks of this type had been documented in previous inspections and are likely due to differential curing in the bulk of the concrete. Subsequent coring revealed that cracking sometimes propagated past reinforcement depth (10.2 cm). Six pairs of on-crack/off-crack core samples were extracted at 9.7 to 47 cm AHT from 5 footers (in one of those footers, coring was done on two separate faces). Significant localized corrosion (morphology discussed later) was observed on 4 out of 7 on-crack bars extracted from 4 locations at 3 of the footers. In one instance where two bars were extracted from the same core, only the bar with deeper cover (11.6 cm, 1.6 cm deeper than the bar with lower cover)

showed corrosion. No physical indication of corrosion was observed at any of the matching sound concrete locations. Concrete delamination was not detected at either sound or cracked locations. Concrete clear cover to horizontal reinforcement was 10.9 to 11.7 cm, meeting nominal design requirements (10.2 cm). Half-cell potentials ranged from -200 to -690 mV_{CSE} measured at elevations from tidal zone to 0.9 m AHT. The more negative values were from locations where ECR corrosion took place. As noted above, caution is in order on generalizing the significance of this observation. Concrete surface resistivity was very high (M Ω -cm range) even in the tidal zone (Figure 2b). The large aggregate consisted of granite, and the volumetric porosity of the concrete was ~12%. The high measured surface concrete resistivity may be due in part to low permeability of the large aggregate.
