Interim Report

A NON-OVERLAY CATHODIC PROTECTION SYSTEM

August 1983 VHTRC 84-R5

A non-overlay, impressed-current cathodic protection (CP) system for stopping the corrosion of reinforcing bars in bridge decks was recently installed on a bridge deck on Route 15 that crosses the Willis River in Buckingham County, Virginia. This installation represents Virginia's participation in the Federal Highway Administration's Demonstration Project No. 34.

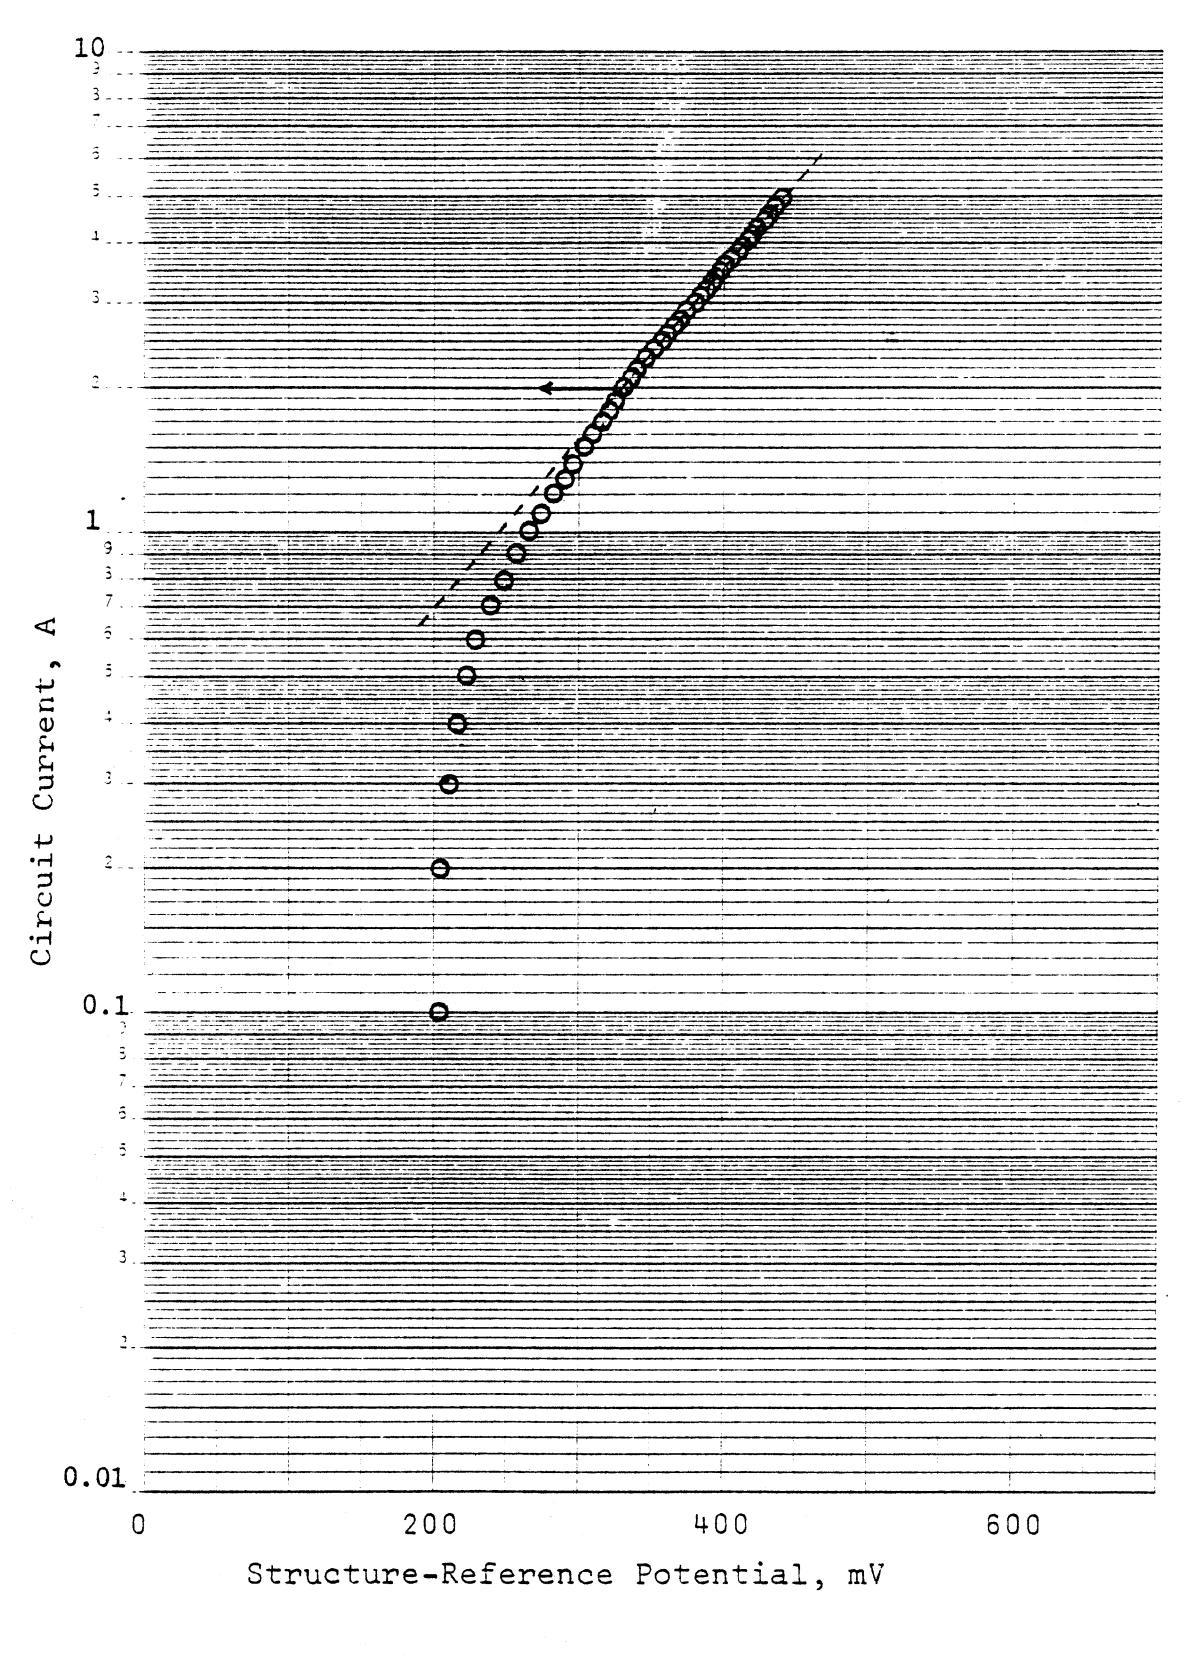
Figure 1. E-log I curve for circuit 1 serving span 3.

One of the criteria recommended by the NACE for CP of a metallic piping system in its electrolyte requires a structureto-electrolyte voltage at least as negative (cathodic) as that originally established at the beginning of the Tafel segment of a E-log I curve. In accordance with this criterion and the E-log I curve obtained for each of the three spans (Figures 1-3), the minimum amperages for the three DC circuits to protect their respective spans were determined and are listed in Table 1. For the entire deck, the total current applied is 4.9 amperes. This translates into 17 mA/m^2 (1.6 $mA/ft.^2$).

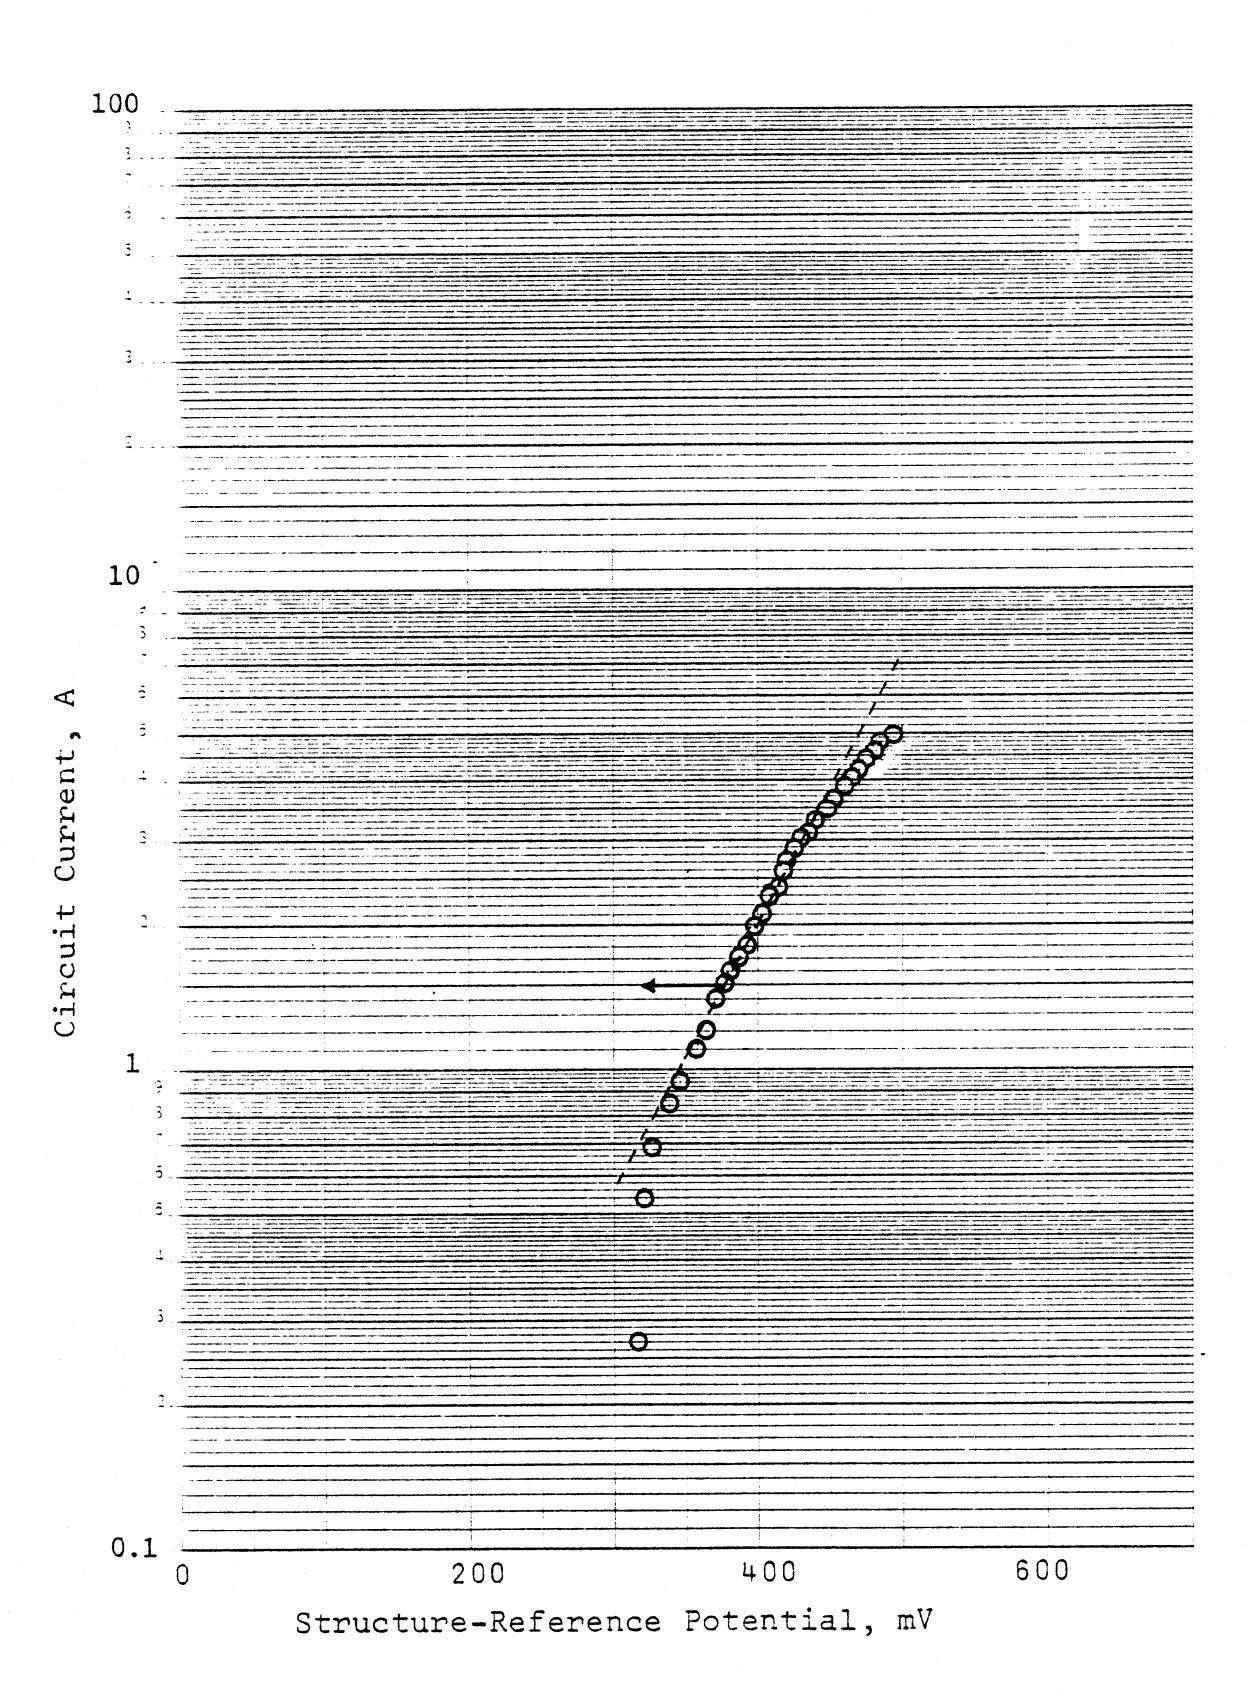
Figure 2. E-log I curve for circuit 2 serving span 2.

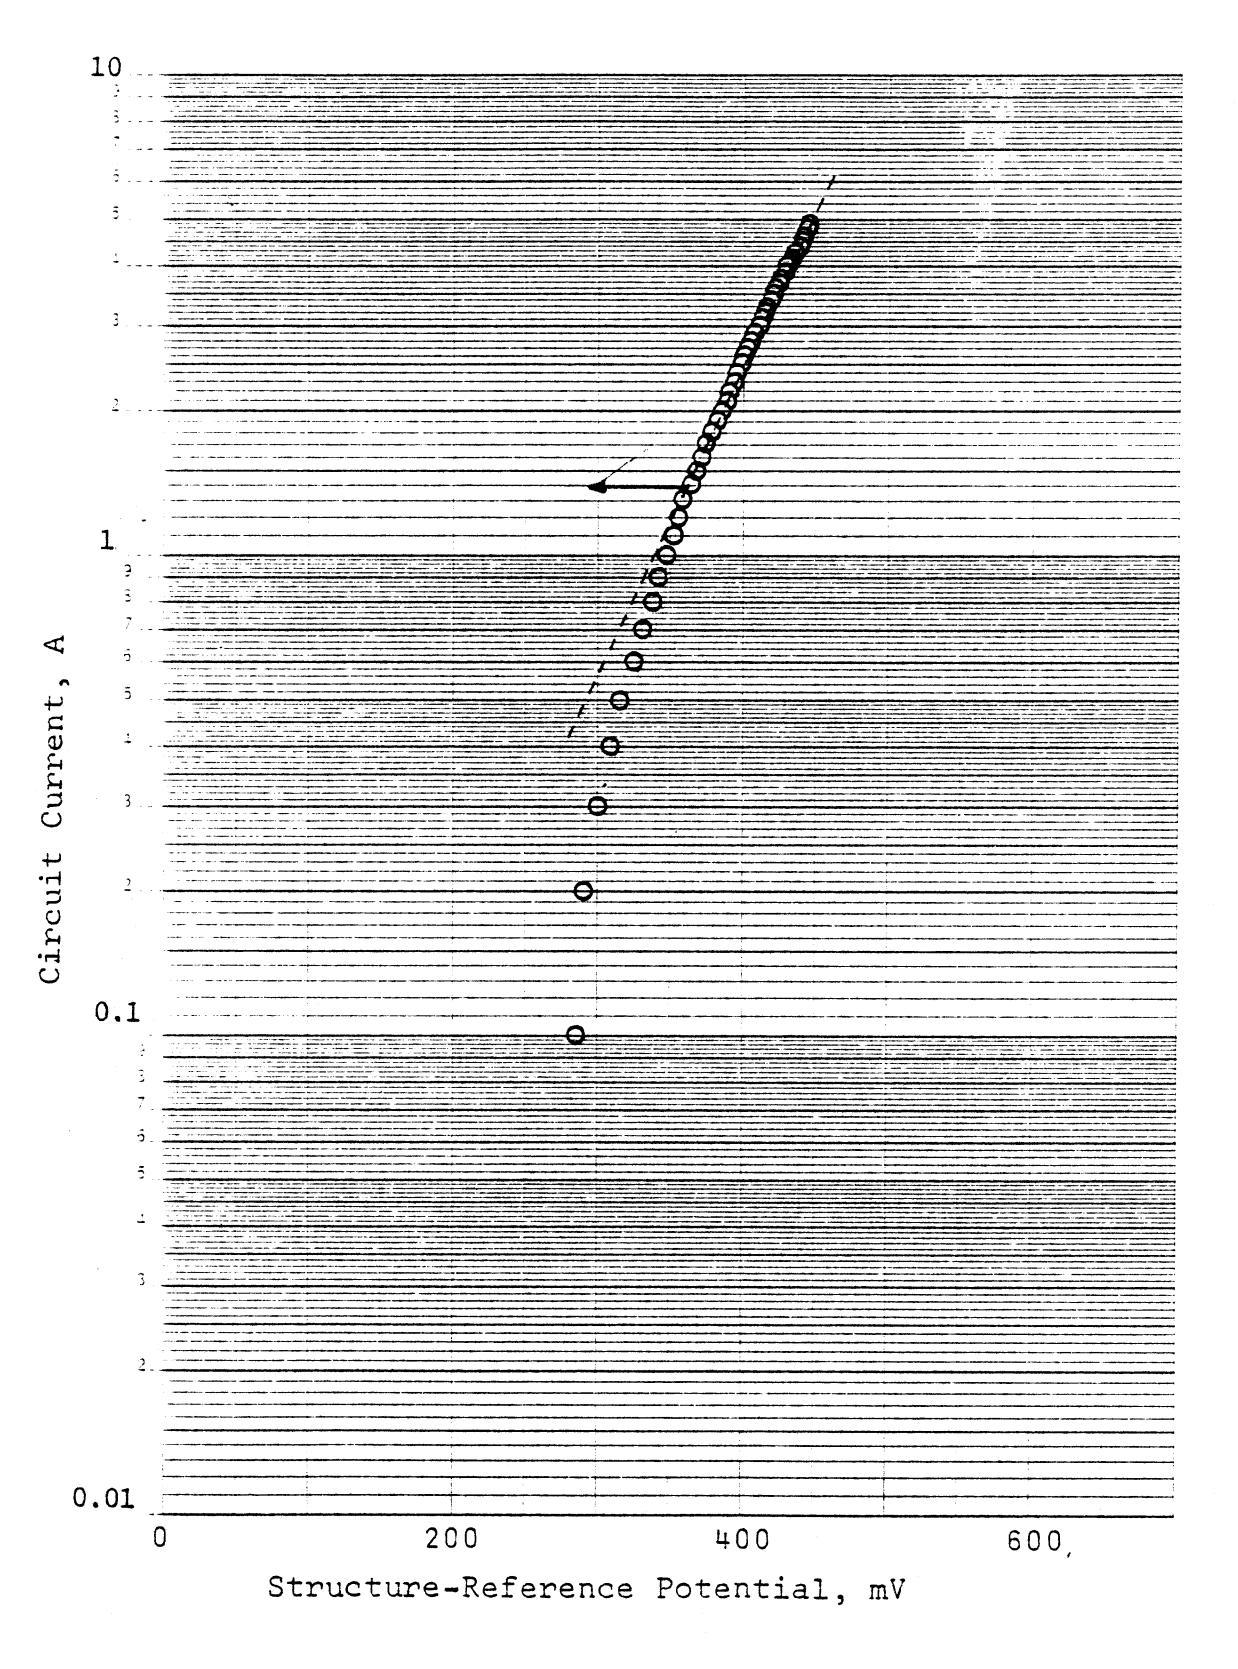
Figure 3. E-log I curve for circuit 3 serving span 1.

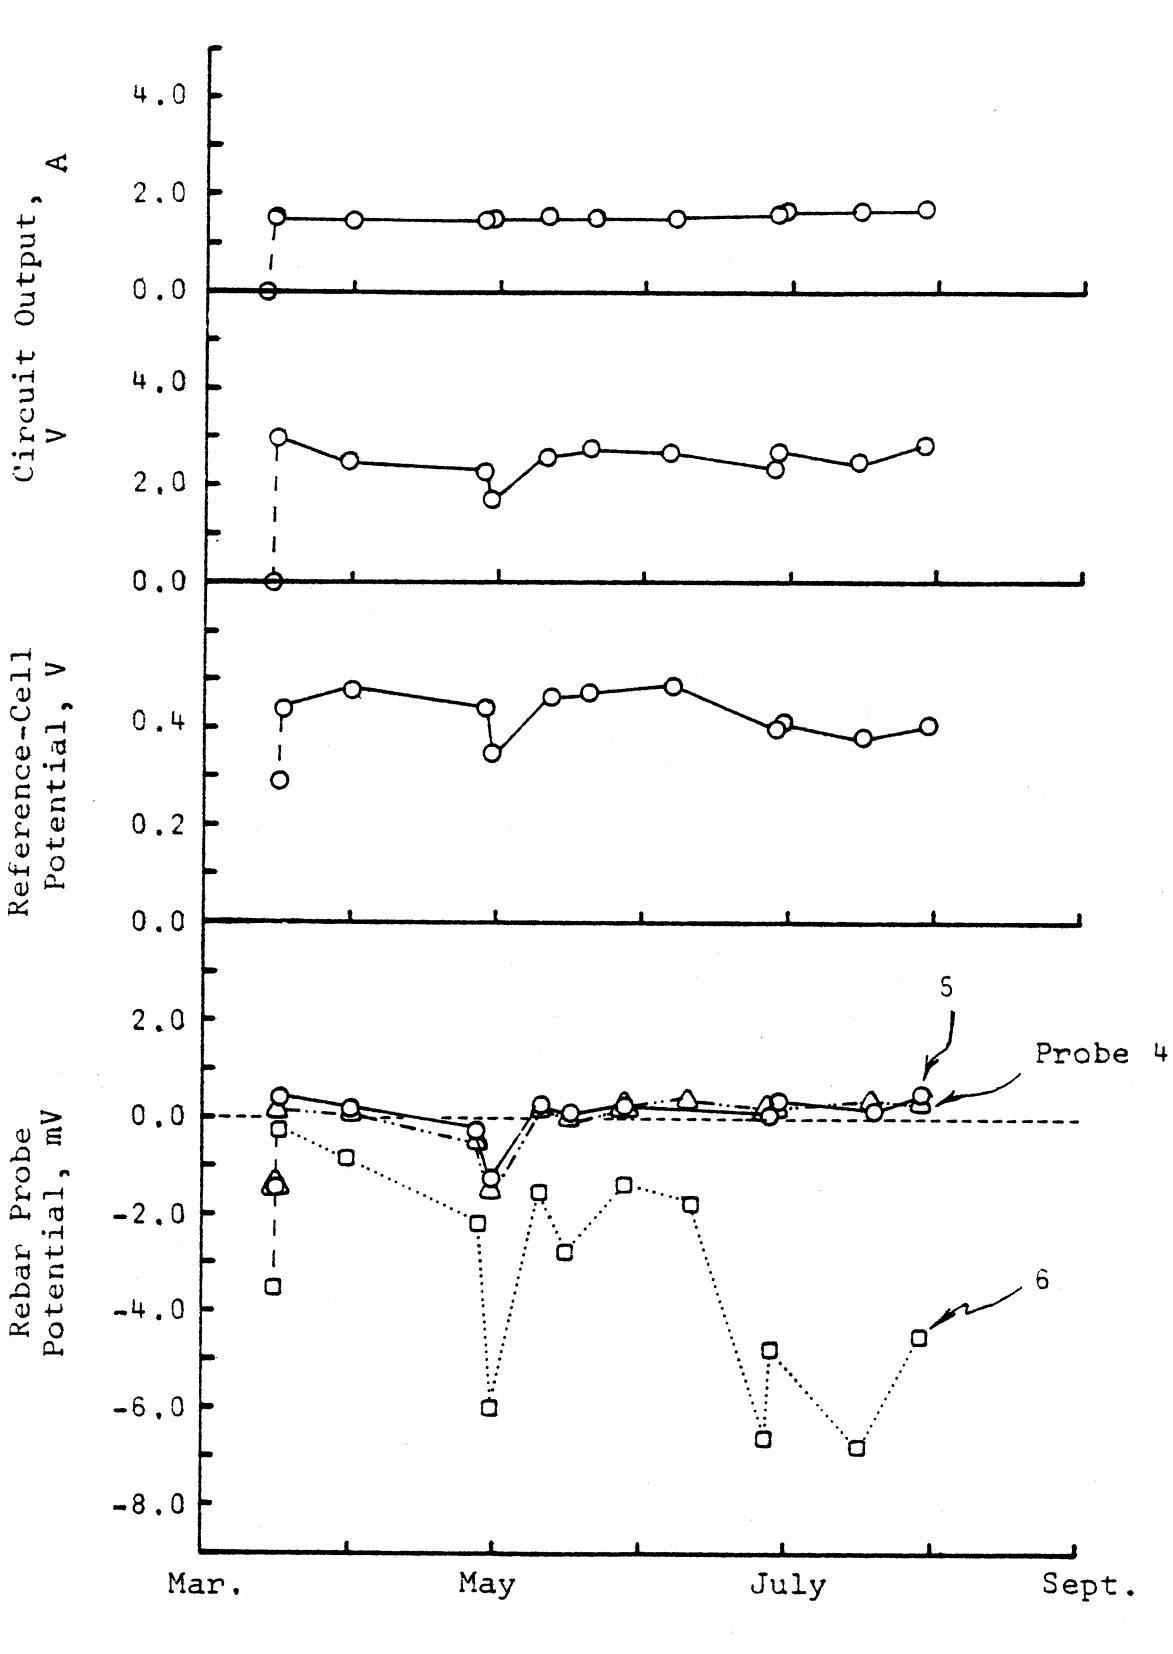
Figure 5. Performance of circuit 2.

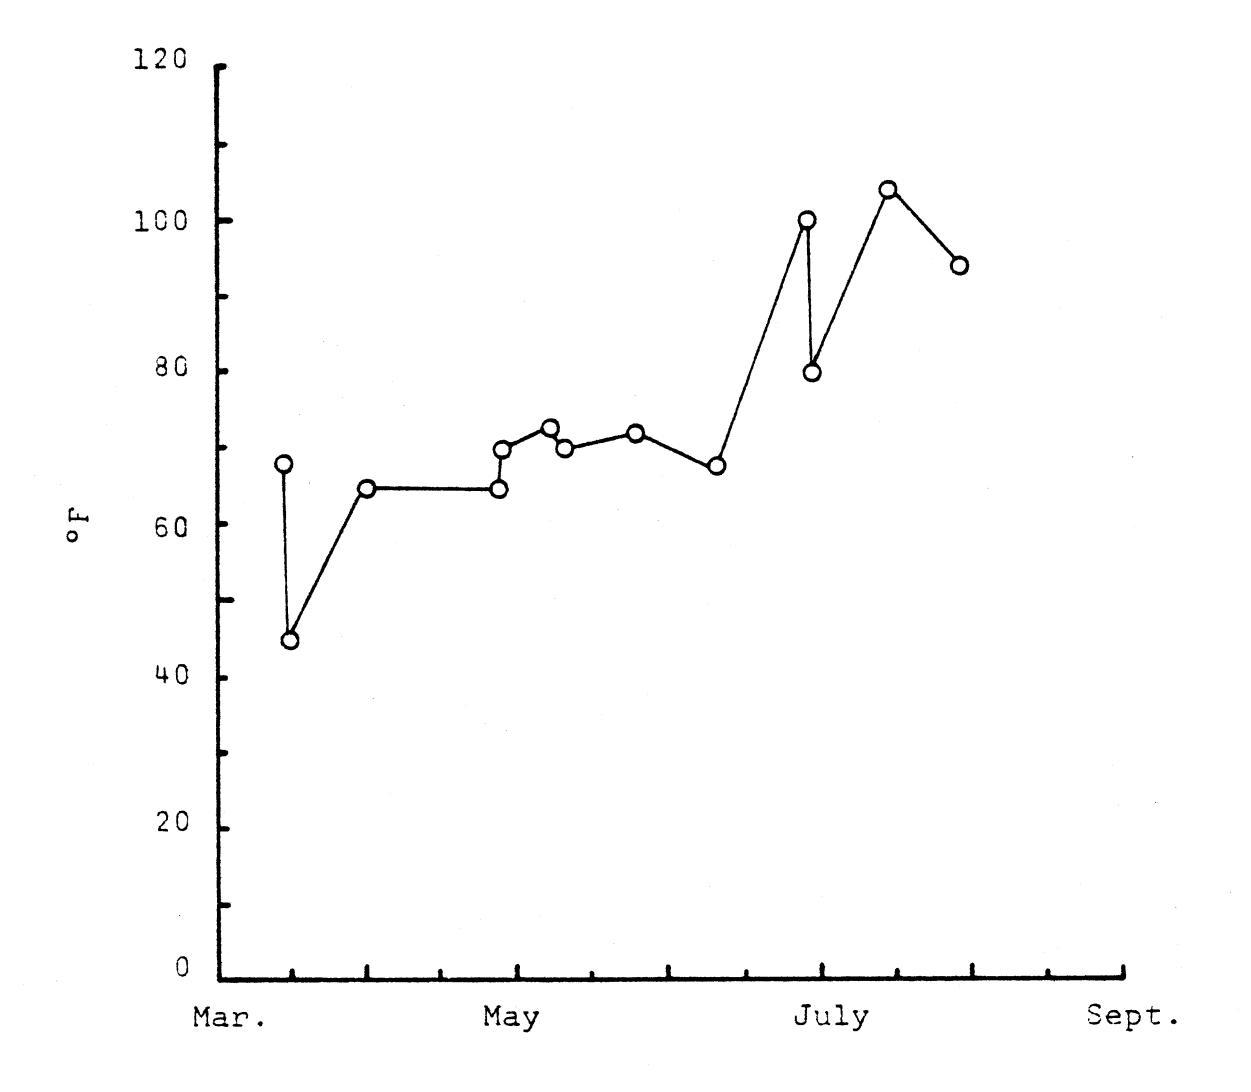
Figure 7. Ambient temperature at the installation site.
