# Forensic Investigation of AC and PCC Pavements with Extended Service Life

Volume 3: Petrographic Examination of Blast Furnace Slag Aggregate Concrete Cores taken from PCC Pavements in Cuyahoga County, Ohio

David Lankard, consultant

Report FHWA/OH-2010/004C

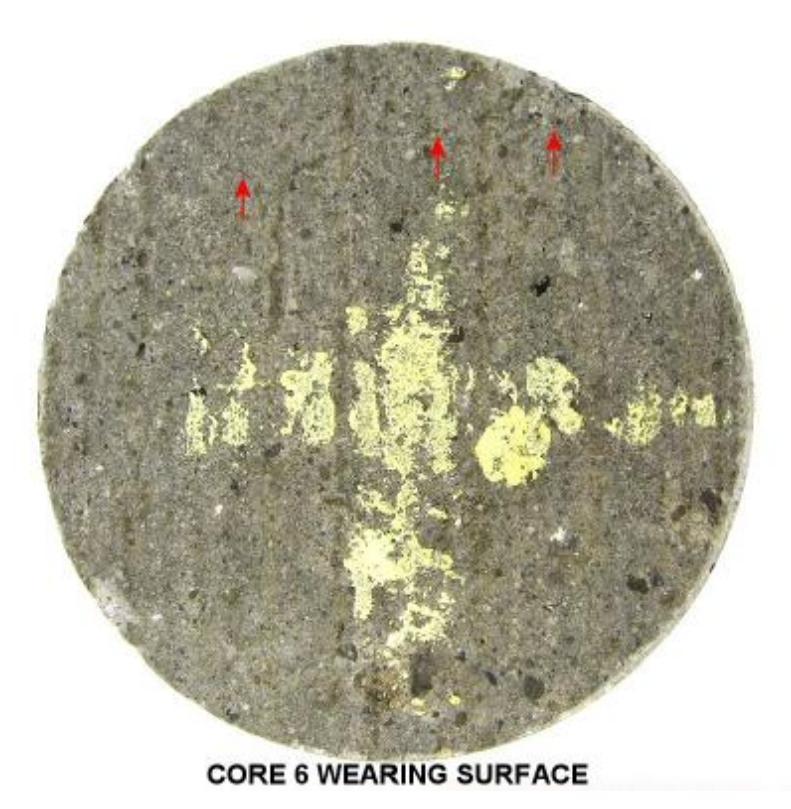
Figure 1. As-received condition of Core 6 taken from the "No Distress" location at the SR 175 @ Concord site. This 10 ¼ in. long core was received in one piece and no sub-surface horizontal cracks could be seen on the cored surfaces. The arrows in the bottom photograph point to a tight longitudinal crack in the textured wearing surface.

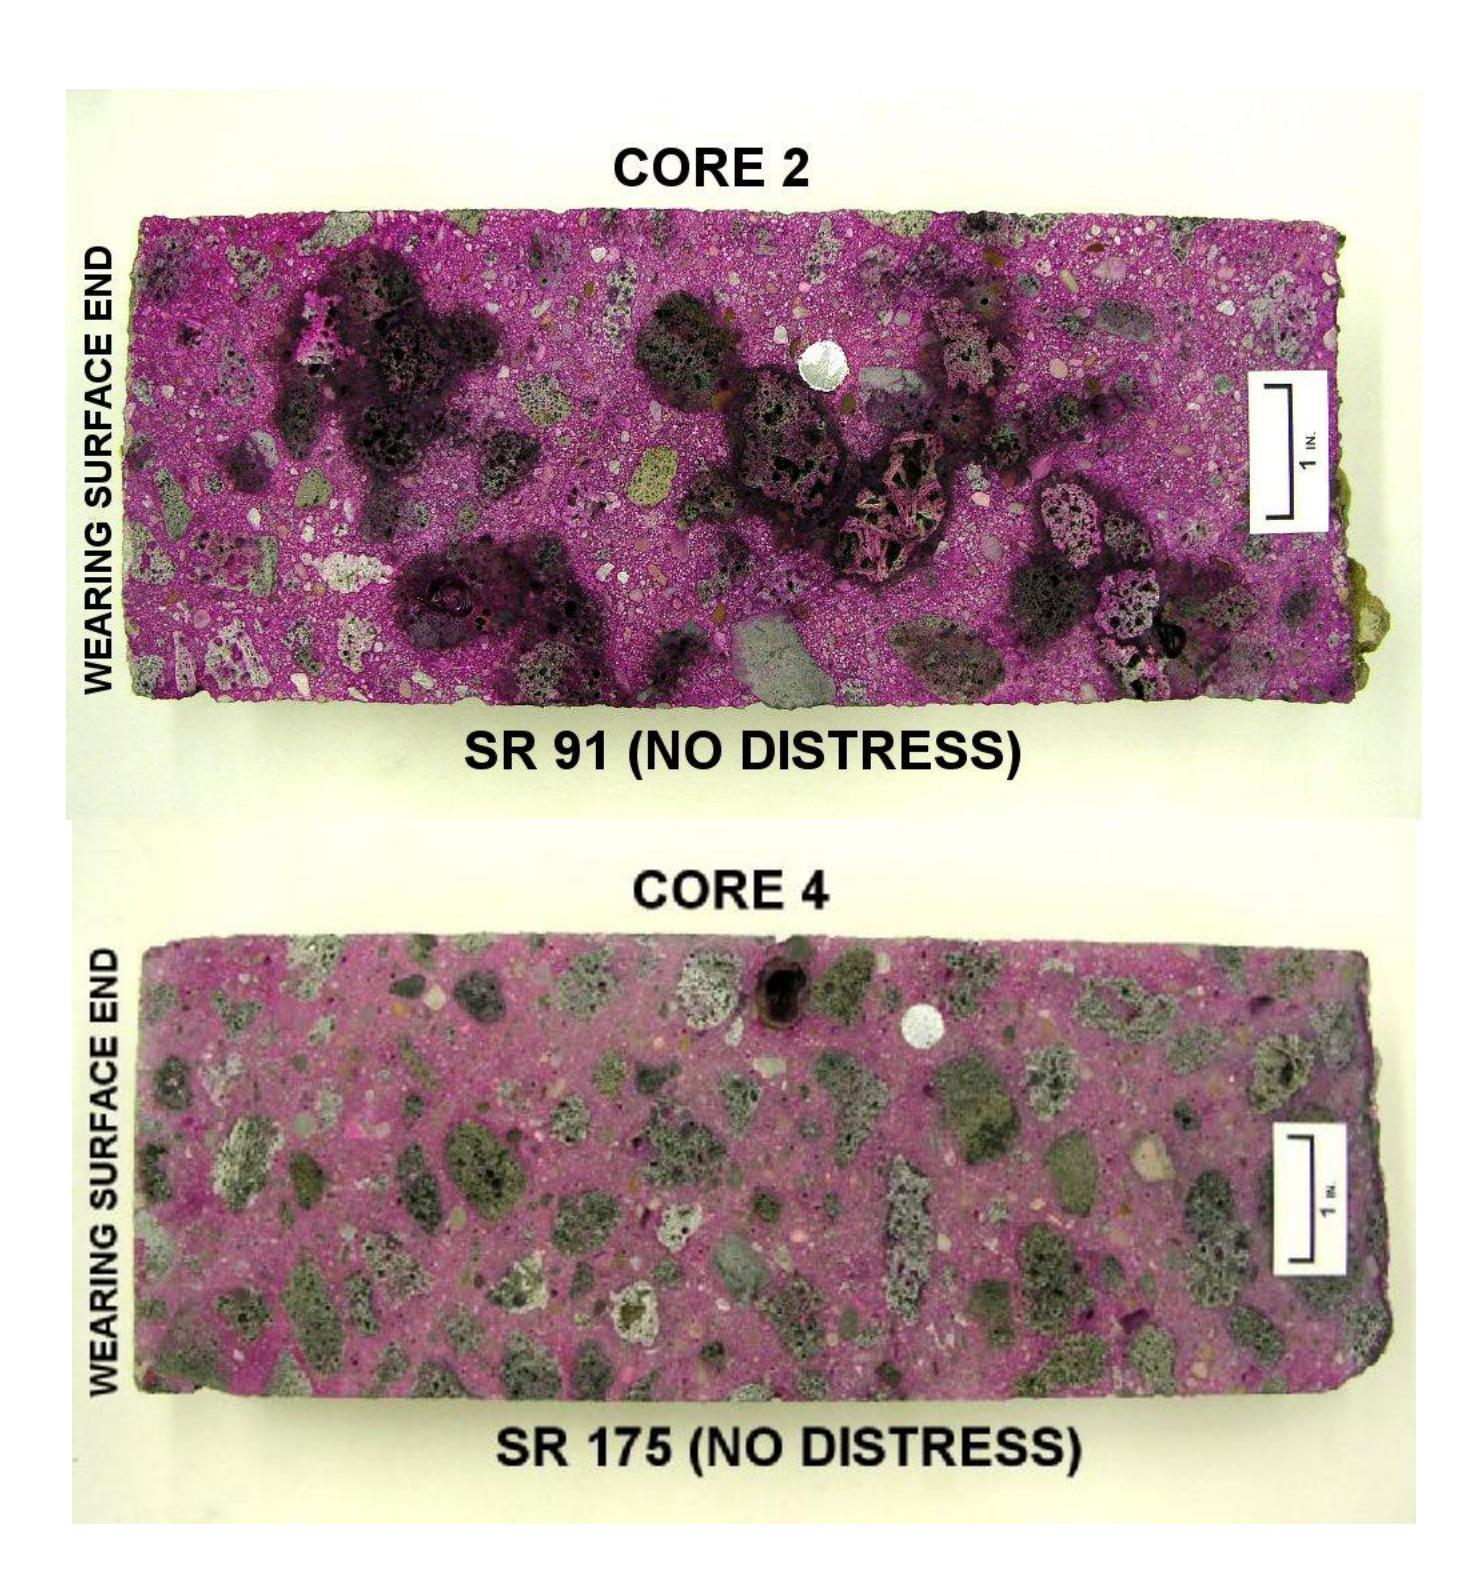
Figure 2 shows a saw-cut surface of "No-Distress" Core 2 (SR 91) and Core 4 (SR 175) following the application of the phenolphthalein solution. The saw-cuts are perpendicular to the plane of the pavement wearing surface. No carbonation has occurred in the cementitious phase in those portions of the surface that are red in color. The only carbonation in these cores is in portions of a thin layer (0 to 1 mm) of the topmost layer of the wearing surface. A similar result was obtained on most of the other cores examined in the study. An exception is Core 1 (SR 91 – Distress), which was taken through a joint crack and which shows some shallow carbonation along the topmost portions along the length of the crack. The global absence of any significant amount of carbonation of the wearing surface is attributed in large part to the good quality (low w/cm) of the cementitious phase of the core concretes.

Figure 2. Saw-cut surfaces of Cores 2 and 4 following the application of the phenolphthalein pH indicating solution. No carbonation has occurred in the red colored areas (virtually the entire thickness of the cores).

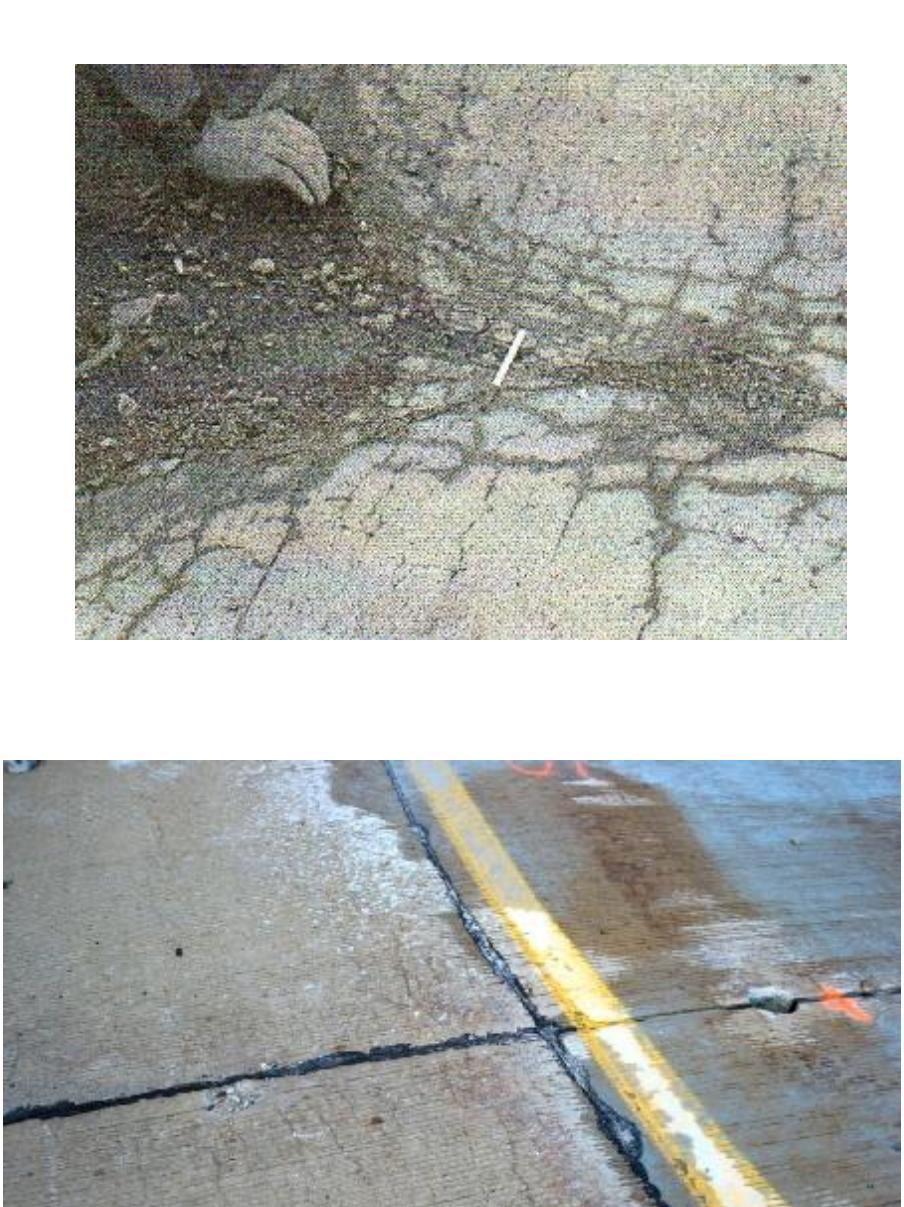
Examples of the cracking distress that is uniquely associated with pavement concretes containing BF slag coarse aggregates are shown in Figure 3 (Figures are presented in Appendix B). The top photograph shows this distress in a Michigan pavement as reported in a 2003 Transportation Research Board paper (Van Dam, 2003). The bottom photograph was taken in 2009 of a pavement in Cuyahoga County, Ohio from which cores examined in our study were taken (Ohio State Route 176).

- In the early stages of the distress the dominant orientation of the cracks as expressed on the pavement wearing surface is longitudinal (see the bottom photograph in Figure 3)

- In the more advanced stages of the distress, intersecting transverse cracks have formed and there is an associated crumbling and spalling of the wearing surface concrete nearest the control joint (see the top photograph in Figure 3).

Figure 3. Examples of the cracking and spalling distress that is uniquely associated with slag aggregate concrete pavements in Michigan and Ohio. The top photograph is an example of advanced deterioration of a transverse joint and map cracking on a tied slag aggregate concrete shoulder in Michigan (Van Dam, 2003). The bottom photograph is cracking distress adjacent to a transverse joint in a 15 year old Cuyahoga County (Ohio) pavement (SR 176) in 2009 (also shoulder panels).

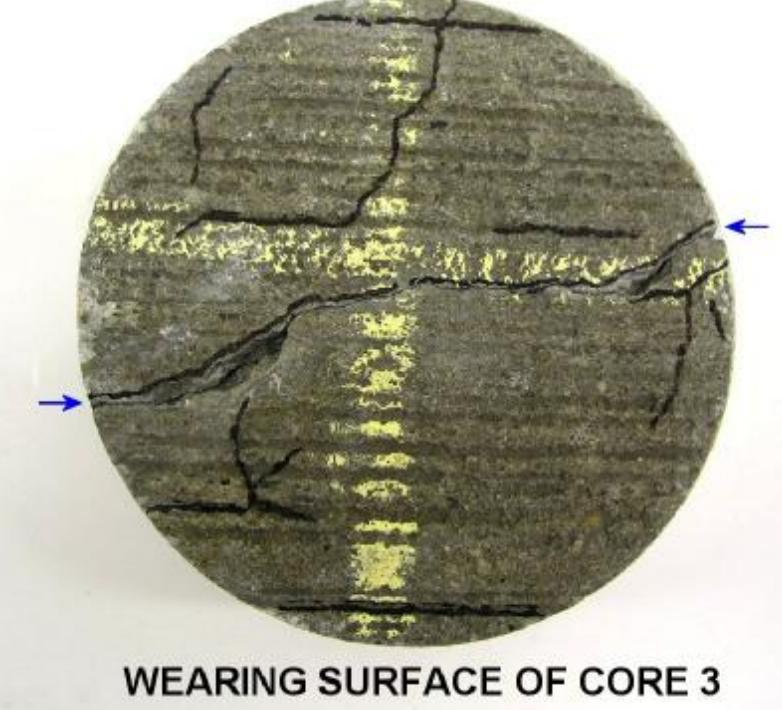
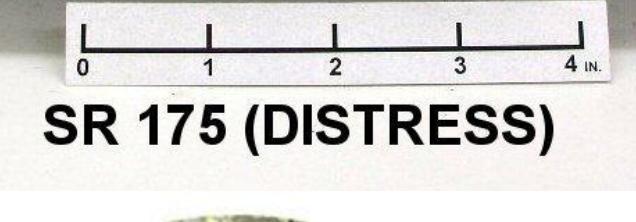
Figure 5. Core 3 taken at a "Distress" location on State Route 175 in Cuyahoga County, Ohio as-received at Lankard Materials Lab on March 3, 2010. This core was taken 1 ft. from a transverse control joint and 1 ft. from a longitudinal joint. Horizontal cracks in the core are marked with black marking pen in the top photograph. Cracks in the wearing surface are also marked with a black pen and the arrows point to a full core width crack along which the top portion of the core was separated into two pieces as-received.

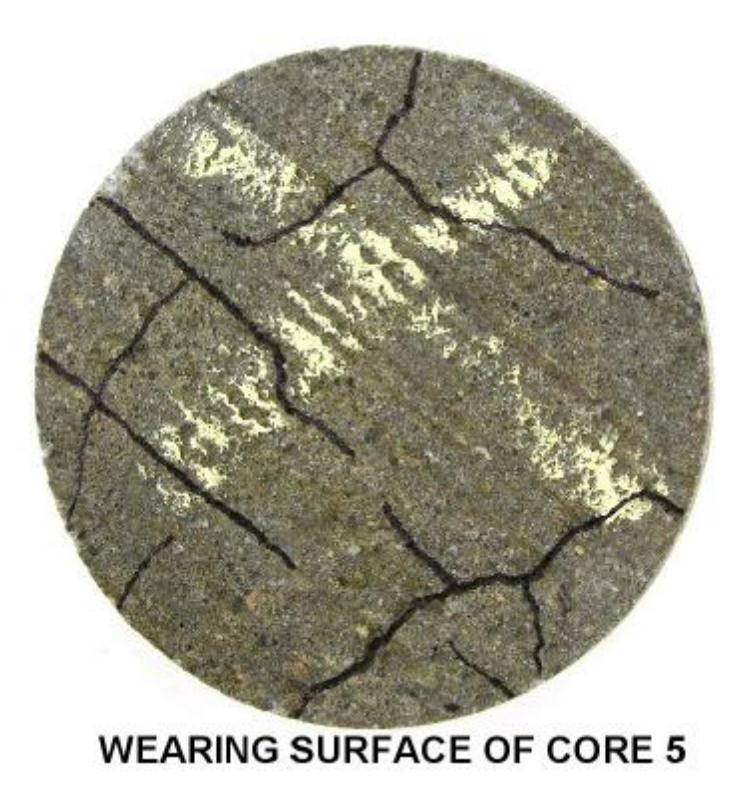
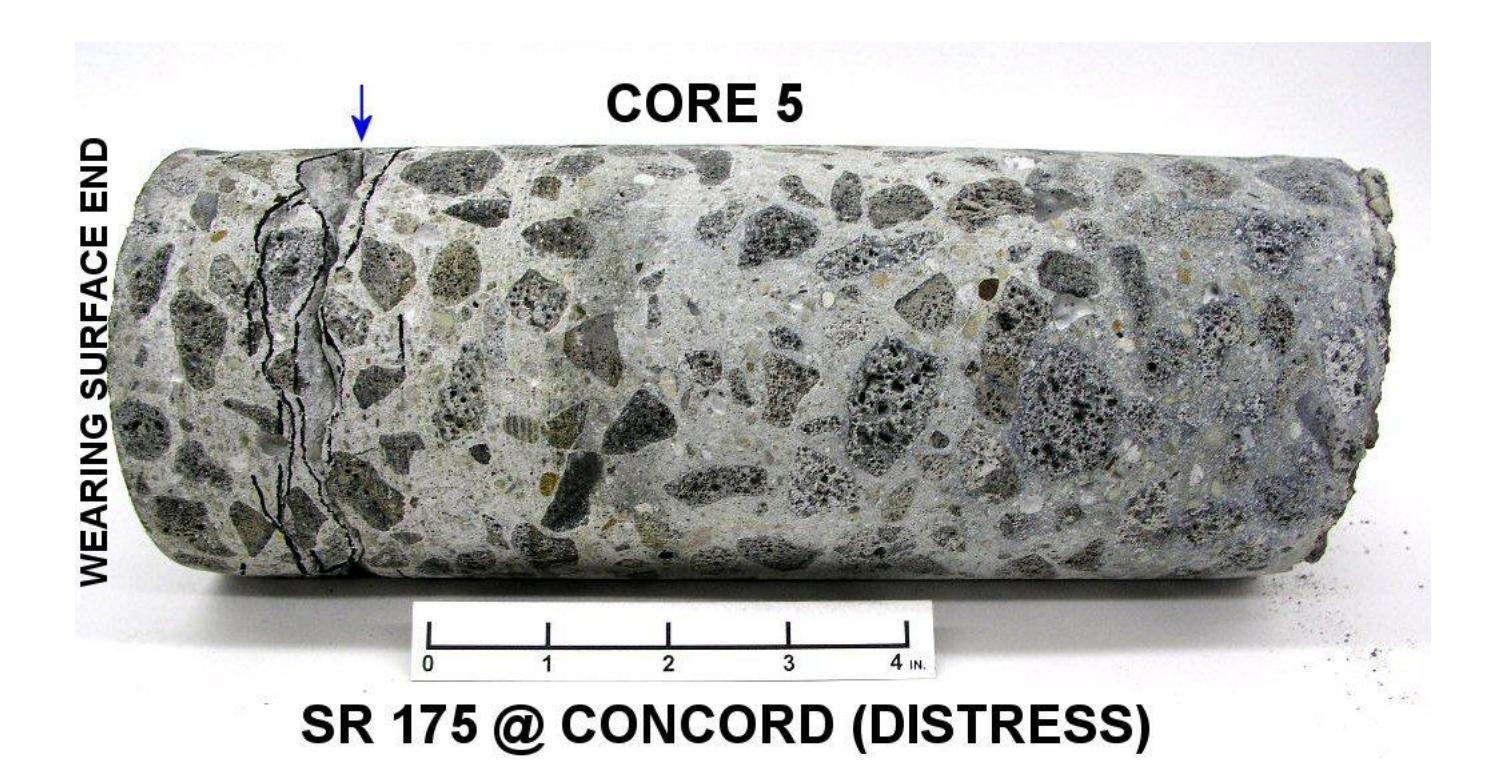
Figure 6. Core 5 taken at a "Distress" location on State Route 175 @ Concord in Cuyahoga County, Ohio as-received at Lankard Materials Lab on March 3, 2010. This core was taken 1 ft. from a transverse control joint and 1 ft. from a longitudinal joint. Horizontal cracks in the core are marked with black marking pen in the top photograph. Cracks in the wearing surface are also marked with a black pen. The arrow points to a full core width crack along which the core was separated into two pieces as-received.

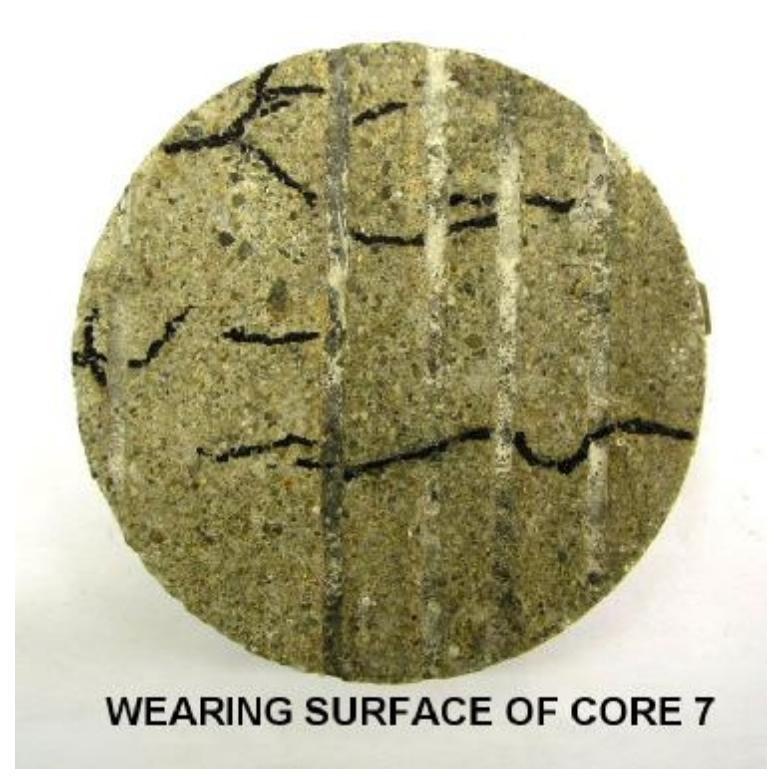
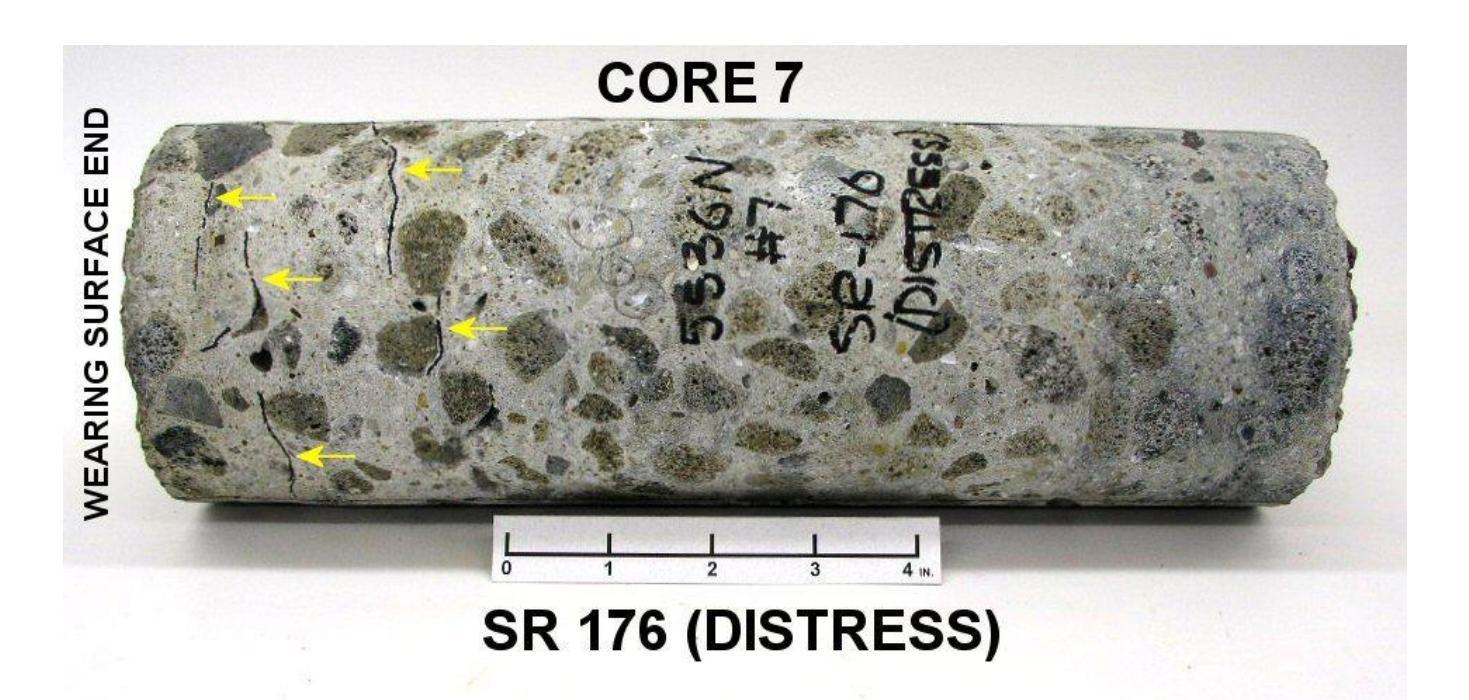
Figure 7. Core 7 taken at a "Distress" location on State Route 176 in Cuyahoga County, Ohio as-received at Lankard Materials Lab on March 3, 2010. This core was taken 1 ft. from a transverse control joint and 4 ft. from a longitudinal joint in the same shoulder slab. Horizontal cracks in the core are marked with black marking pen in the top photograph (arrows). Cracks in the wearing surface are also marked with a black pen. This core was received in one piece.

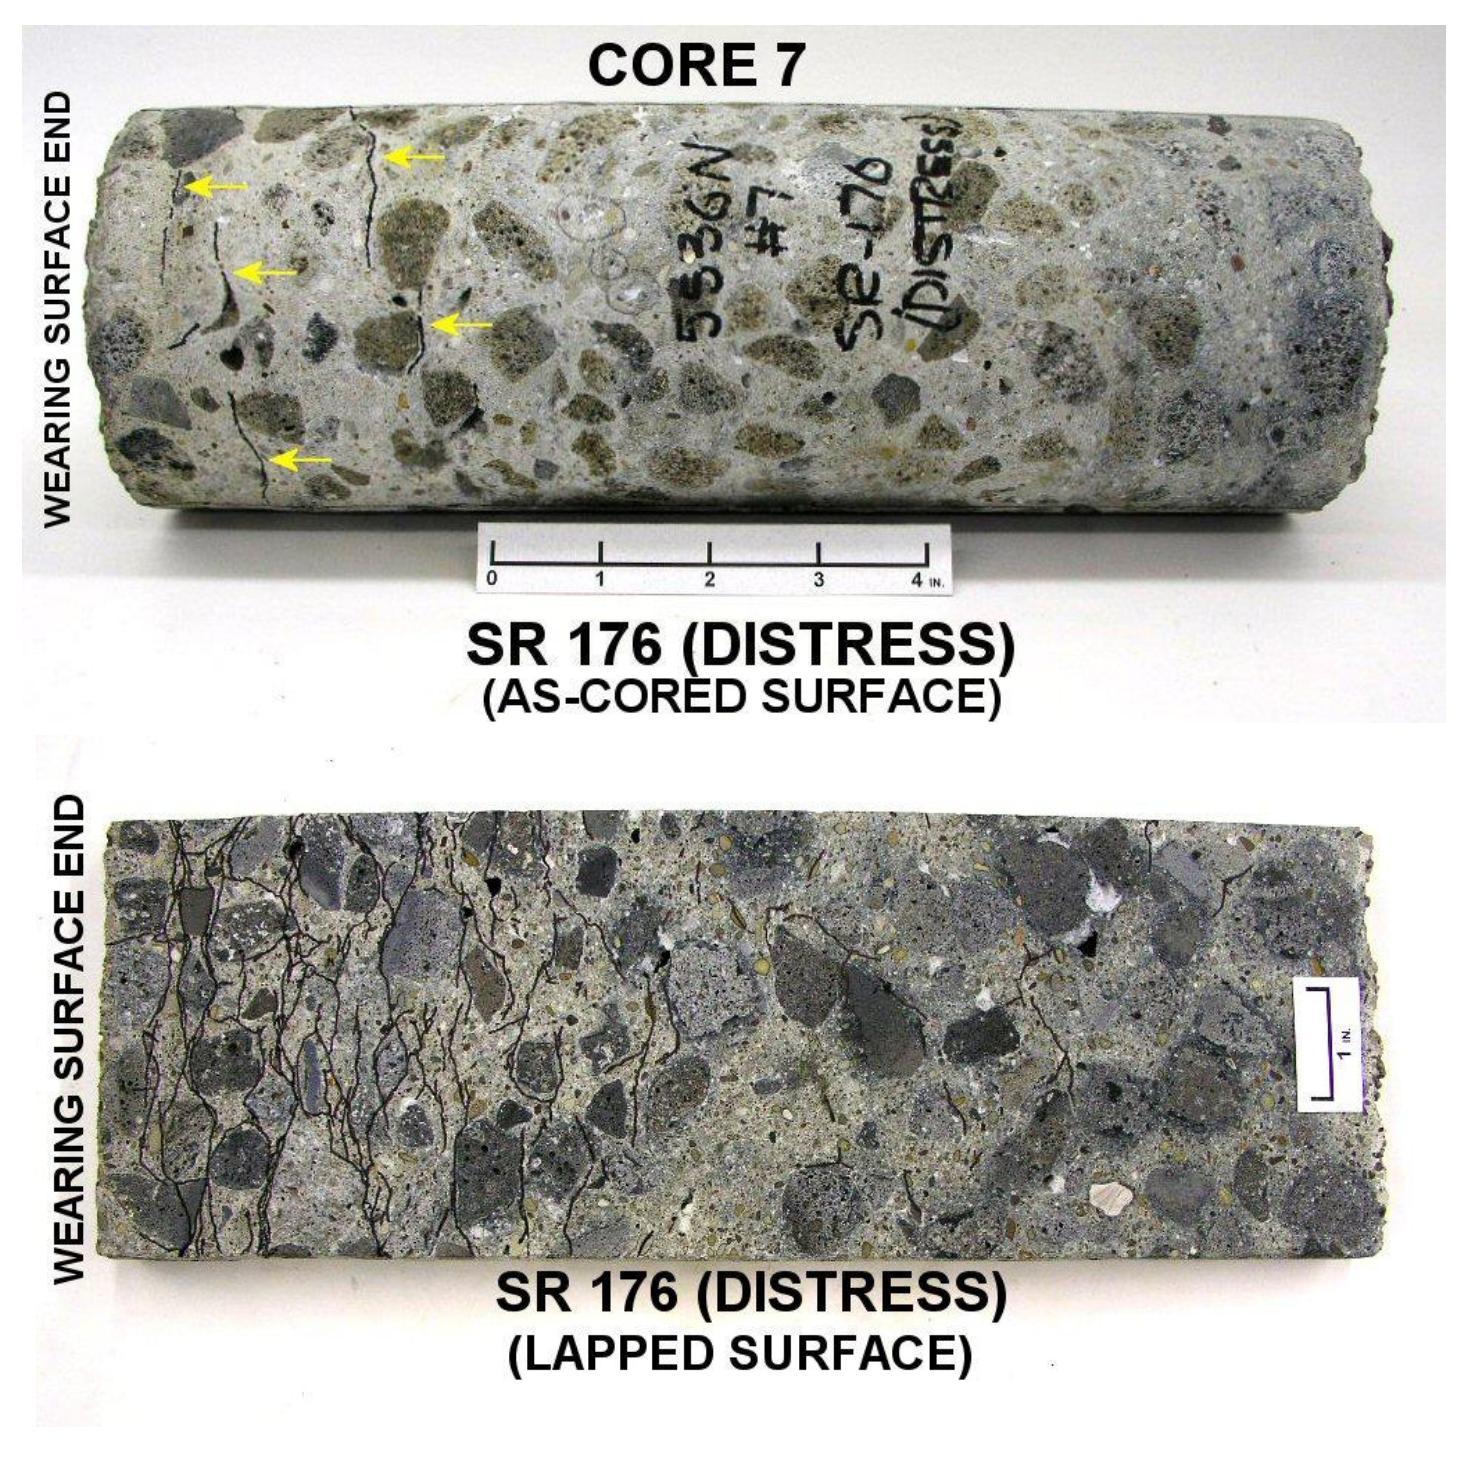
Figure 9. Two views (an as-cored surface and a lapped surface) of Core 7 taken from a "Distress" location on the SR 176 pavement. The lapping operation revealed the presence of many more horizontal cracks in the core concrete than could be detected on the as-cored surfaces. Cracks that were detected in the examinations are marked with a black marking pen.

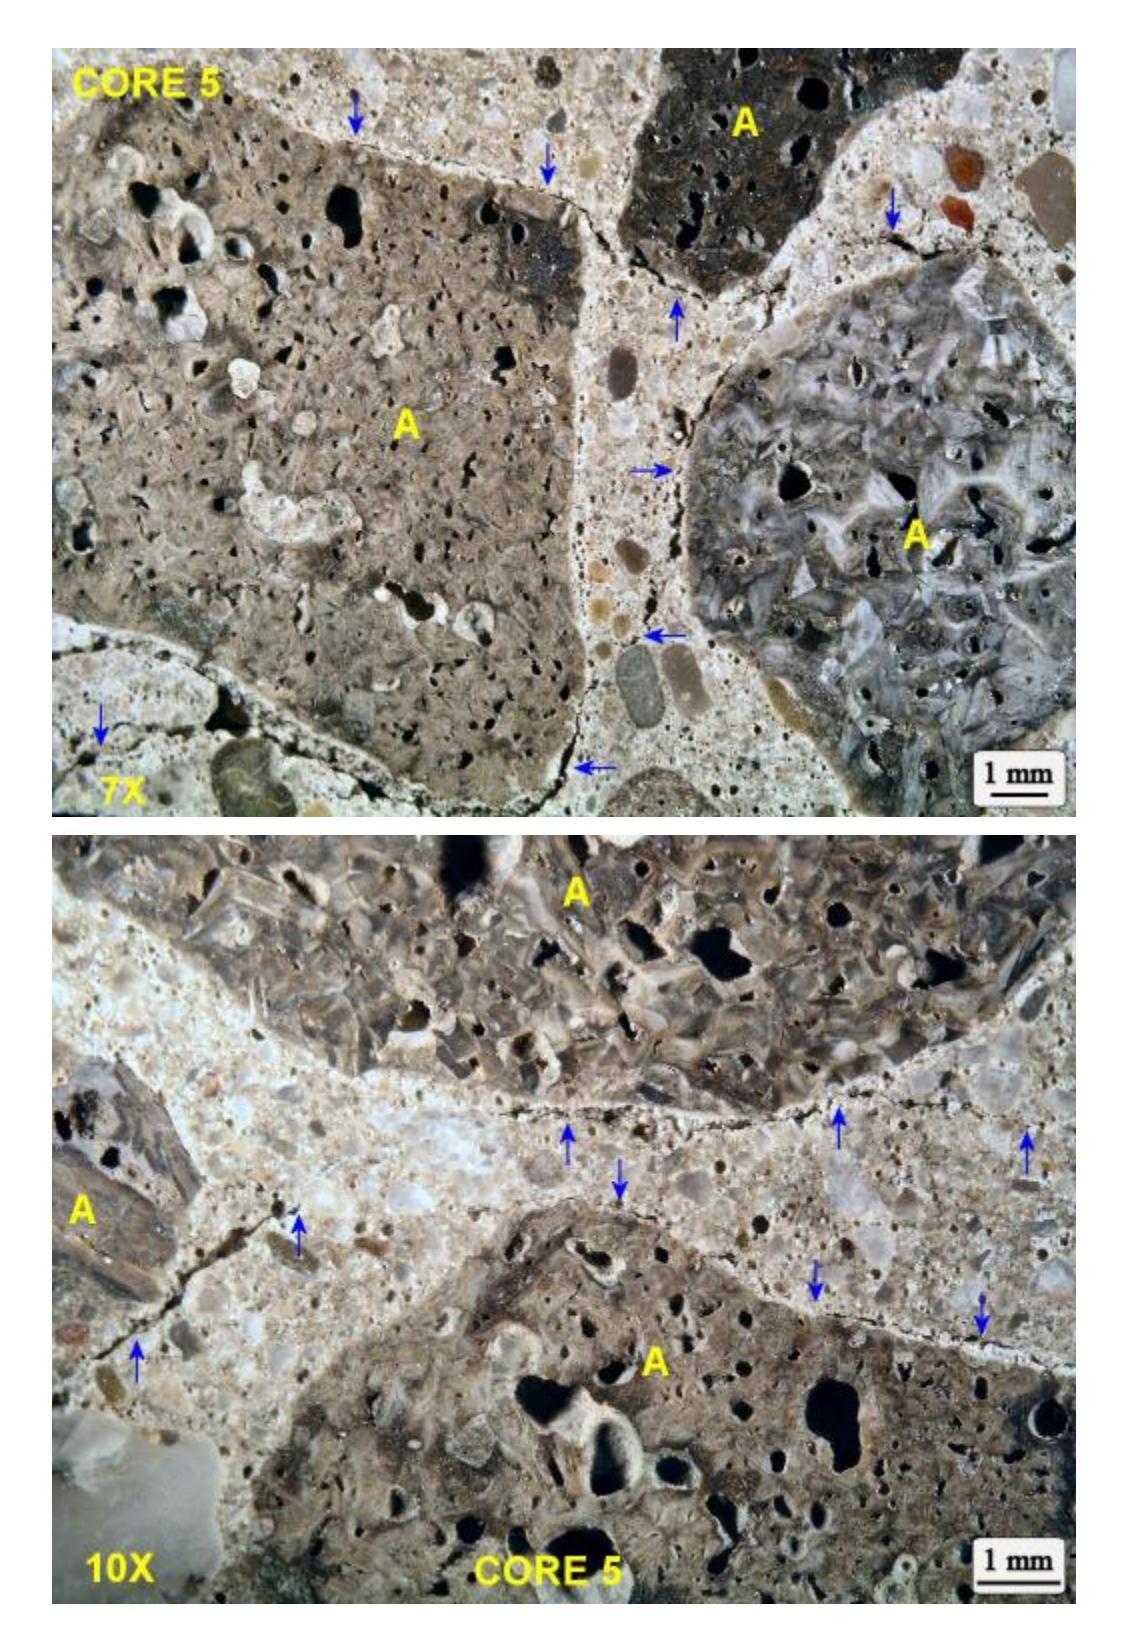
Figure 10. Lapped surface views of Core 5 at a distance of 1 in. below the plane of the wearing surface showing cracks (arrows) that pass around, rather than through slag coarse aggregate particles (A). This microstructural feature is common in the cores taken from the "Distress" locations adjacent to transverse control joints in the ODOT Cuyahoga County, Ohio pavements.

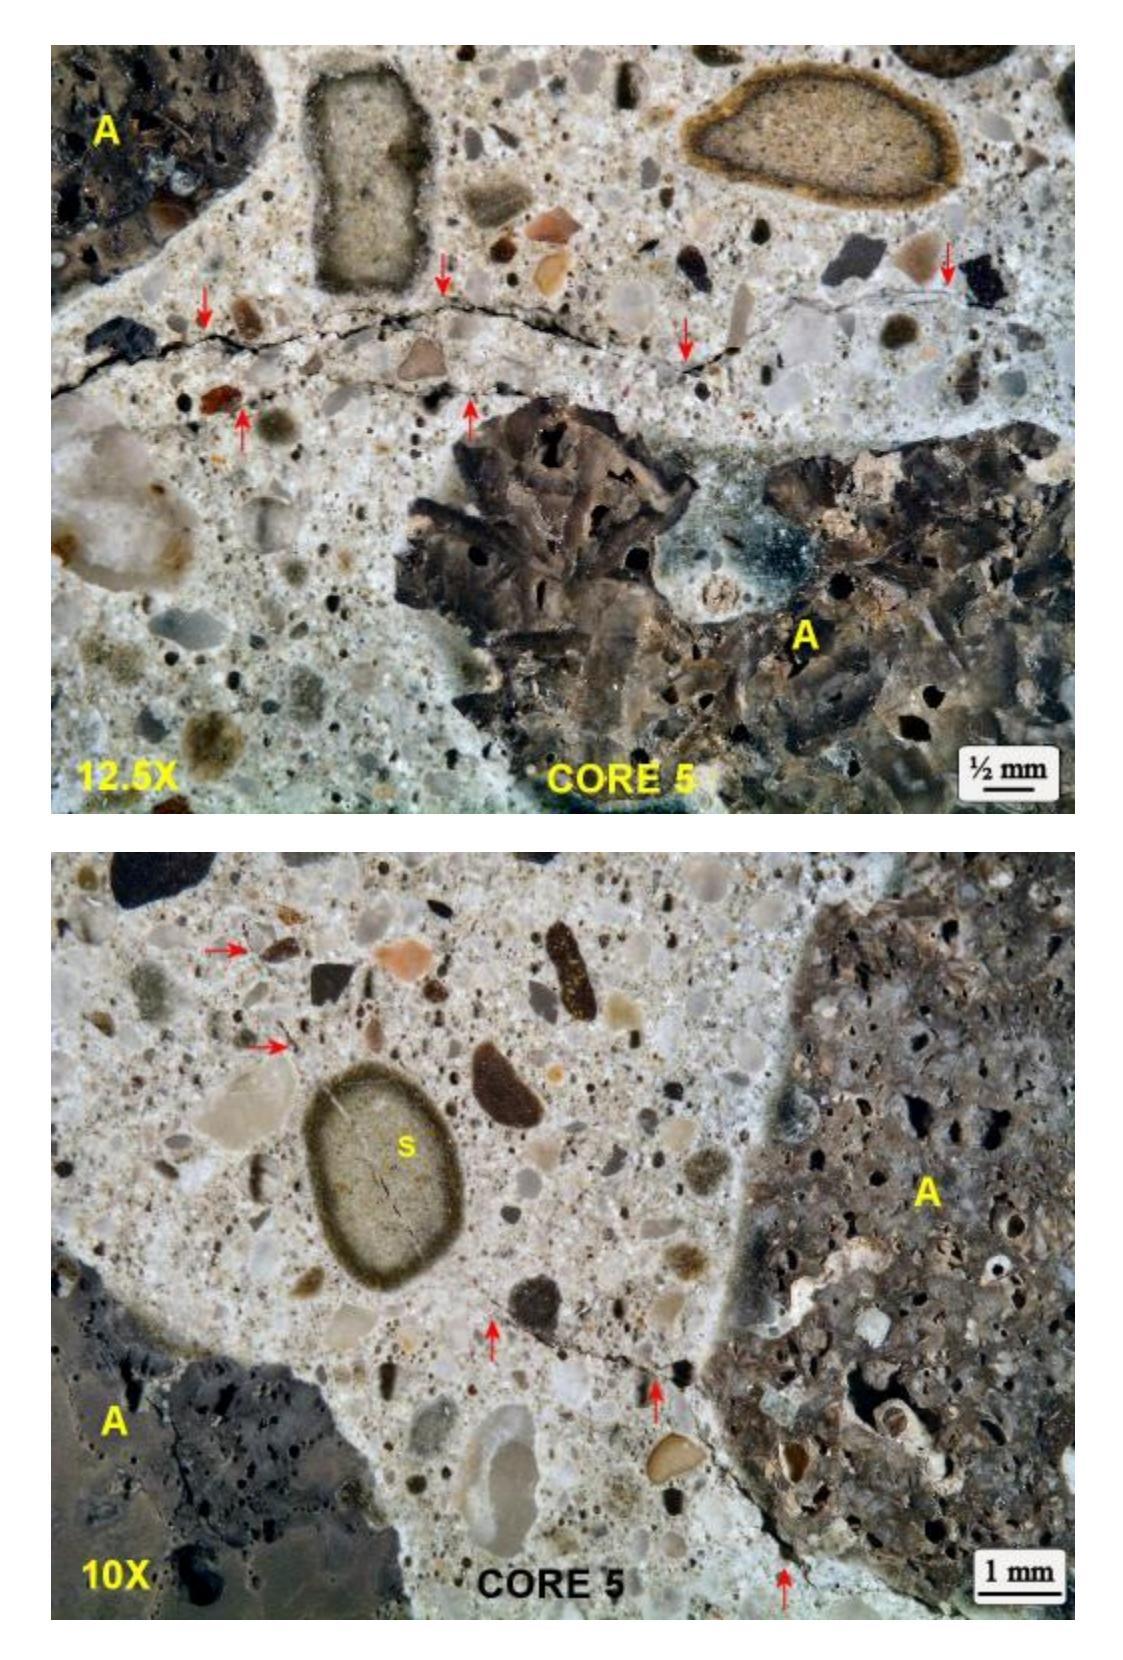
Figure 11. Enlarged lapped surface views showing horizontal cracking within the cementitious matrix in Core 5. These cracks are within the top 3 in. of the core. The wearing surface is at the top in the photographs. The top photograph shows a crack passing around fine aggregate particles. The bottom photograph shows a crack that passes around a slag coarse aggregate particle (A), which intersects a siltstone fine aggregate particle (S).

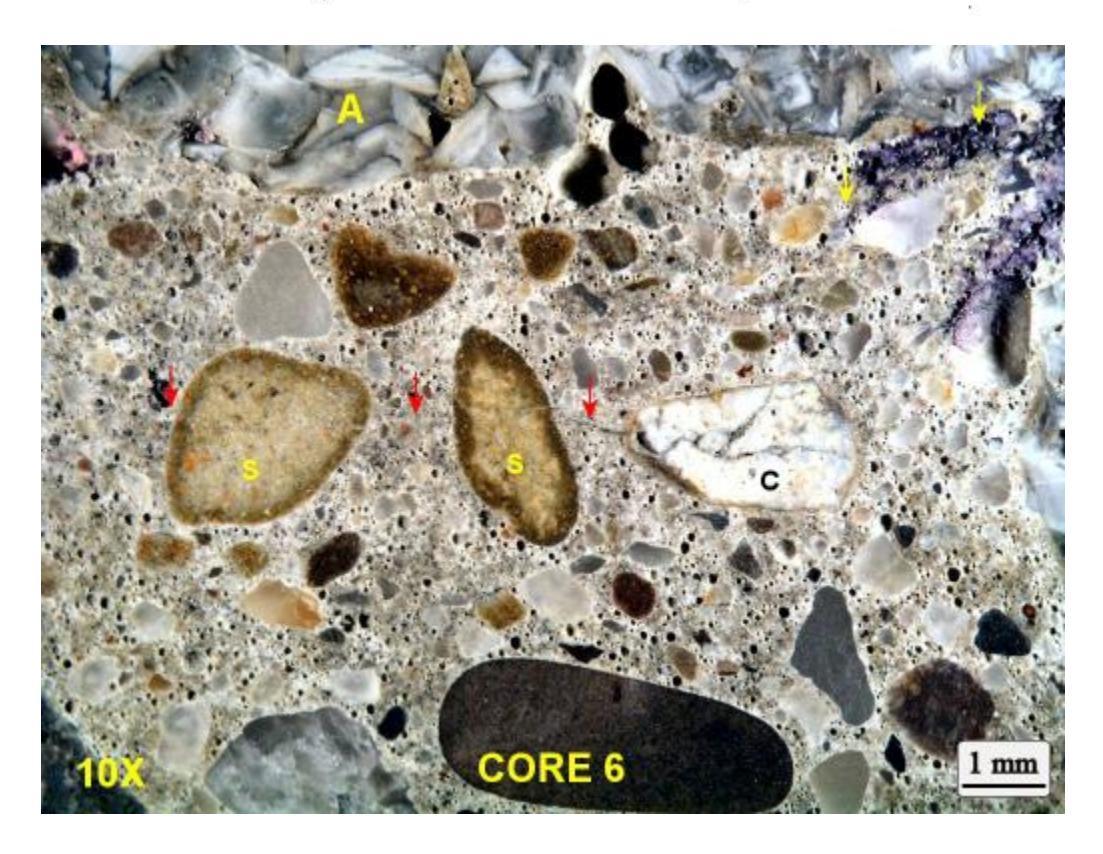
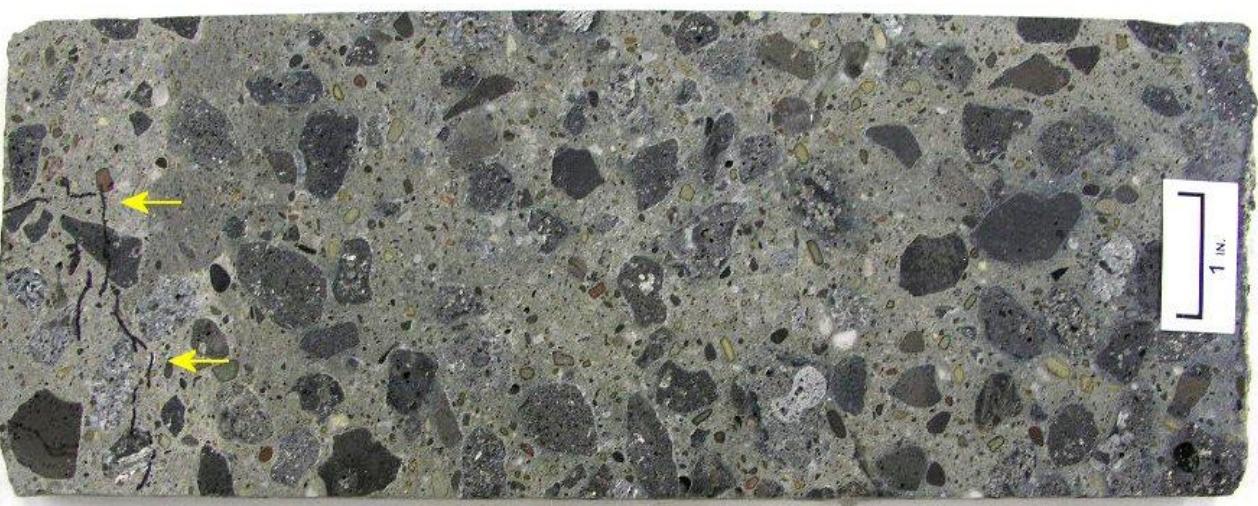
Figure 12. Two views of Core 6 taken from a "No Distress" area of the SR 175 @ Concord pavement. The top photograph is a lapped surface on which horizontal cracks in the top <sup>3</sup>/<sub>4</sub> in. to 1 <sup>1</sup>/<sub>4</sub> in. thickness of the core have been marked (arrows) with a black marking pen. The bottom photograph is an enlarged view (10X) of the lapped surface showing horizontal cracks passing around a slag coarse aggregate particle (A) (yellow arrows) and a horizontal crack passing through a chert (C) and siltstone (S) particles (red arrows).

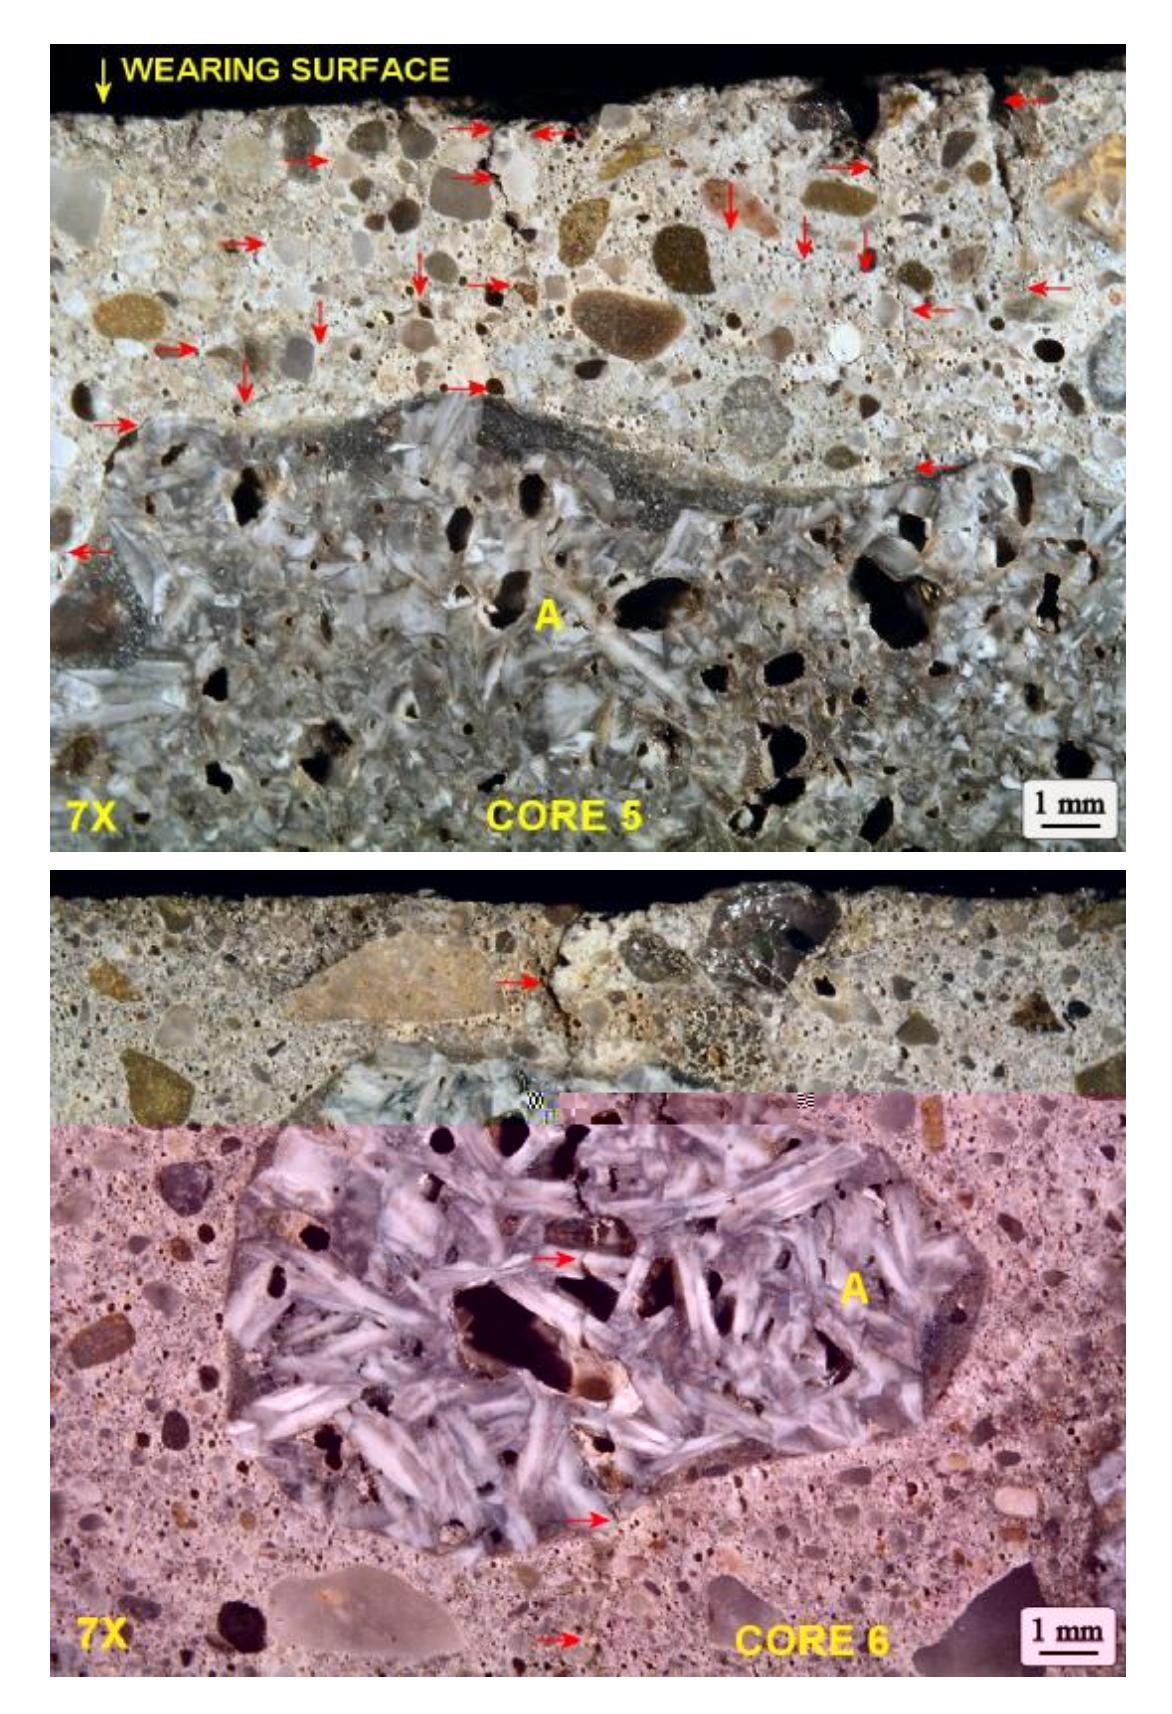
Figure 13. Enlarged (7X) lapped surface views perpendicular to the wearing surface of Core 5 (Distress core taken from SR 175 @ Concord) and Core 6 (No Distress core taken from SR 175 @ Concord). The red arrows point to the path of vertical cracks overlying near-surface slag coarse aggregate particles (A). The cracks pass around and through the aggregate particles (A) and through the matrix phase of the concretes.

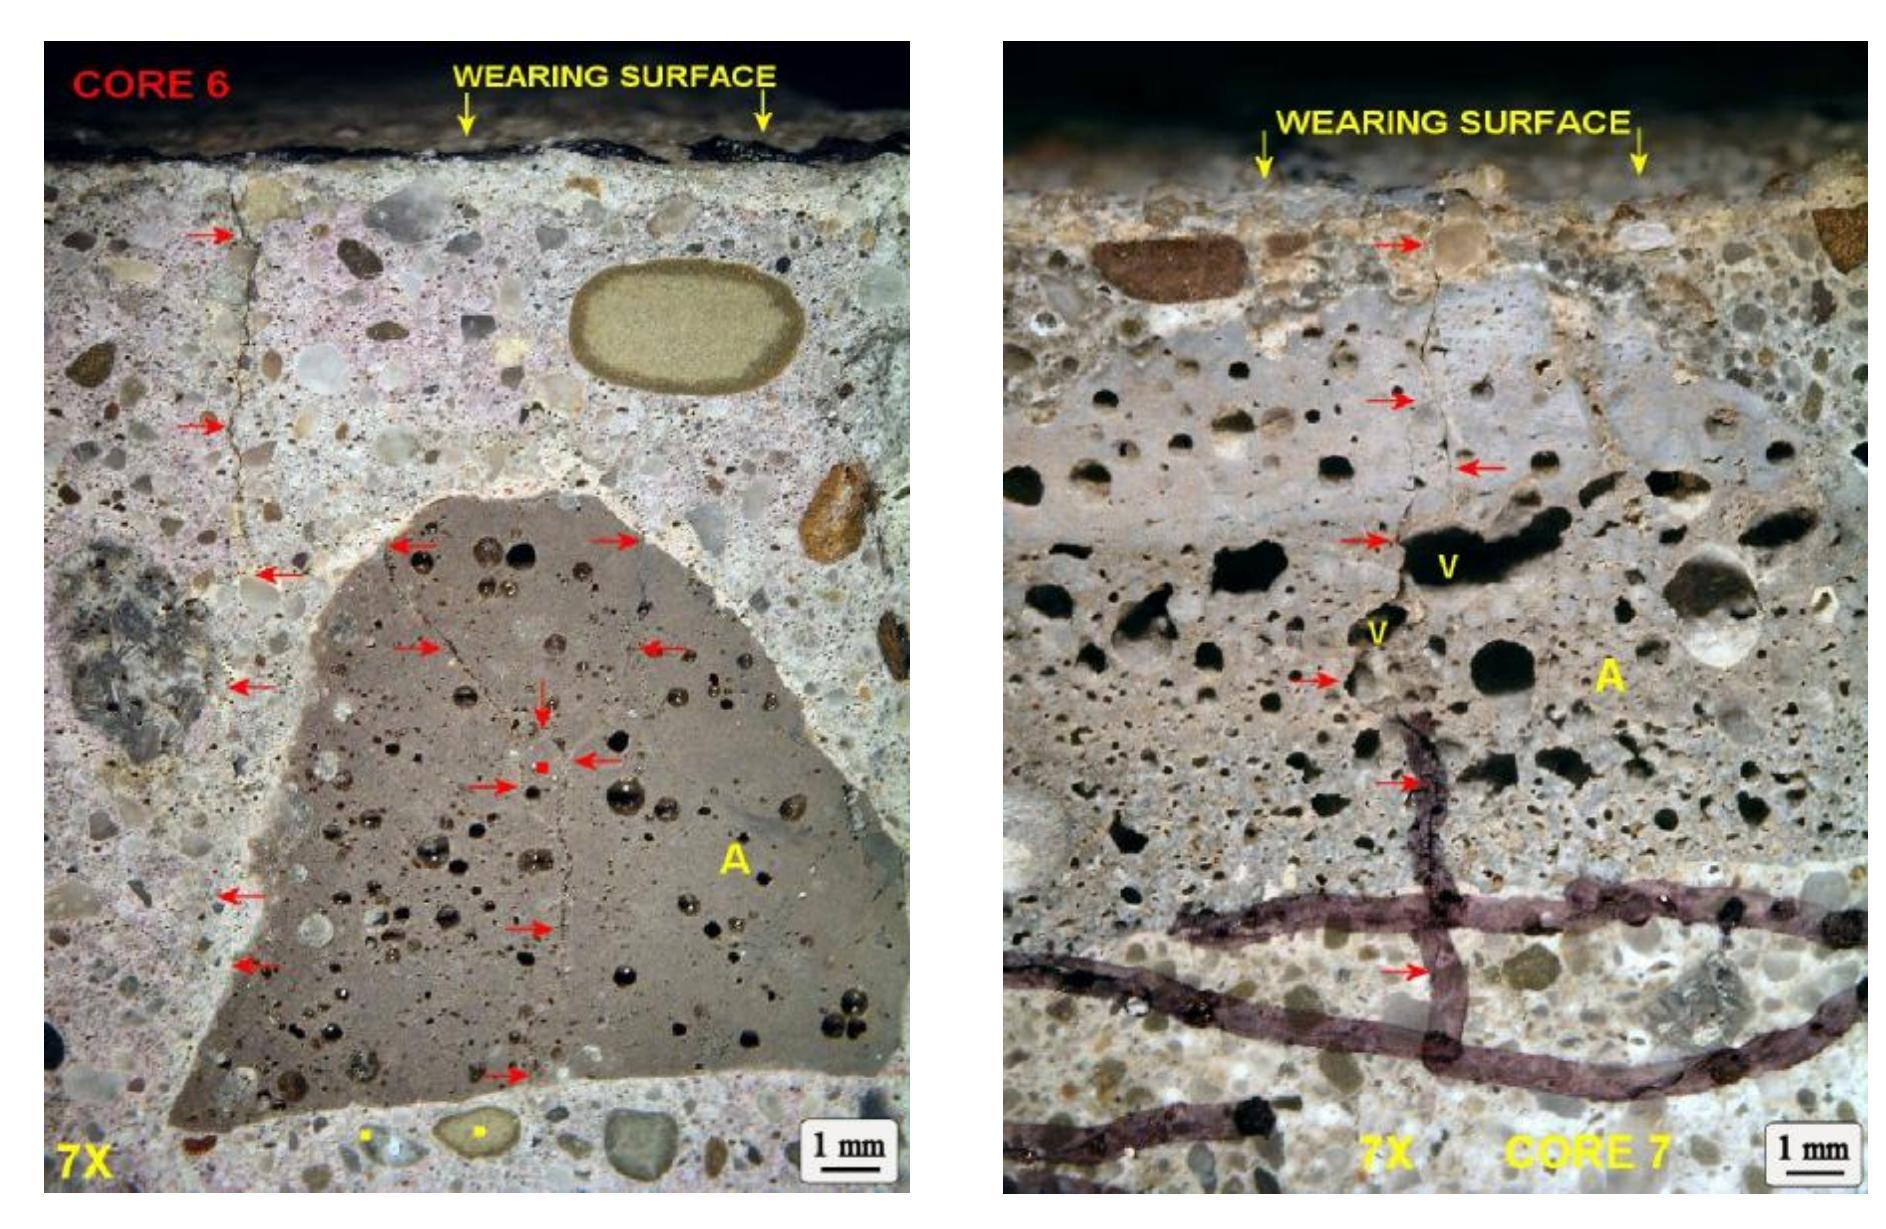
Figure 14. Enlarged (7X) lapped surface views perpendicular to the wearing surface of Core 6 (No-Distress core taken on SR 175 @ Concord) and Core 7 (Distress core taken on SR 176). The red arrows point to the path of vertical cracks that pass around and through near-surface slag coarse aggregate particles (A) and through the matrix phase of the concrete. The yellow dots on the Core 6 photograph are on fine aggregate particles that have a white exudate on their surface. Horizontal cracks in the Core 7 concrete are marked with a black marking pen. The "V" identifies a large void in the slag particle.
