# Forensic Investigation of AC and PCC Pavements with Extended Service Life

Volume 3: Petrographic Examination of Blast Furnace Slag Aggregate Concrete Cores taken from PCC Pavements in Cuyahoga County, Ohio

David Lankard, consultant

Report FHWA/OH-2010/004C

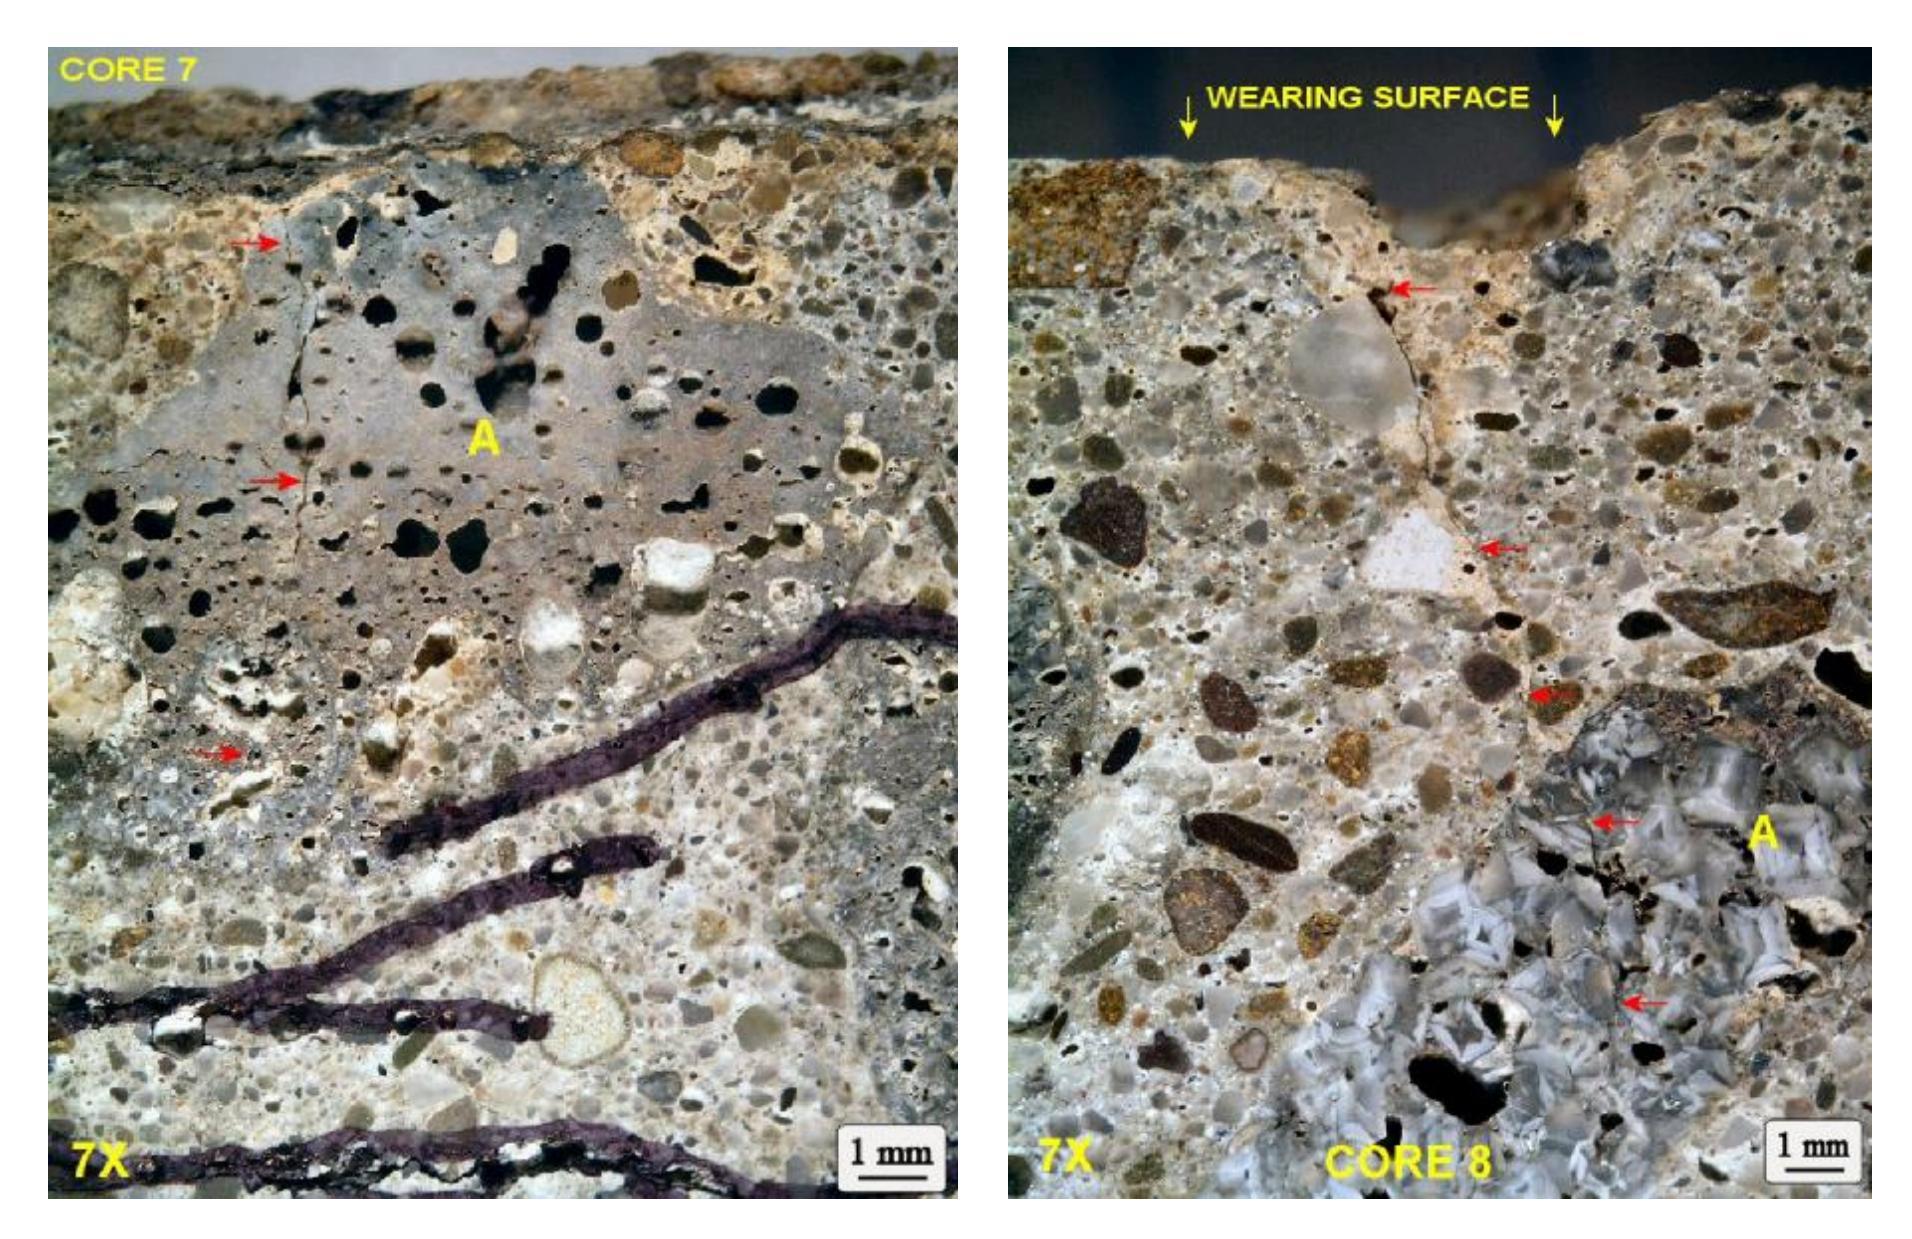
Figure 15. Enlarged (7X) lapped surface views perpendicular to the wearing surface of Core 7 (Distress) and Core 8 (No Distress) taken from SR 176 Pavement Site. The red arrows point to the path of vertical cracks through near-surface slag coarse aggregate particles and through the matrix phase of the concretes. The black lines mark the location of sub-surface horizontal cracks in the concrete of Core 7.

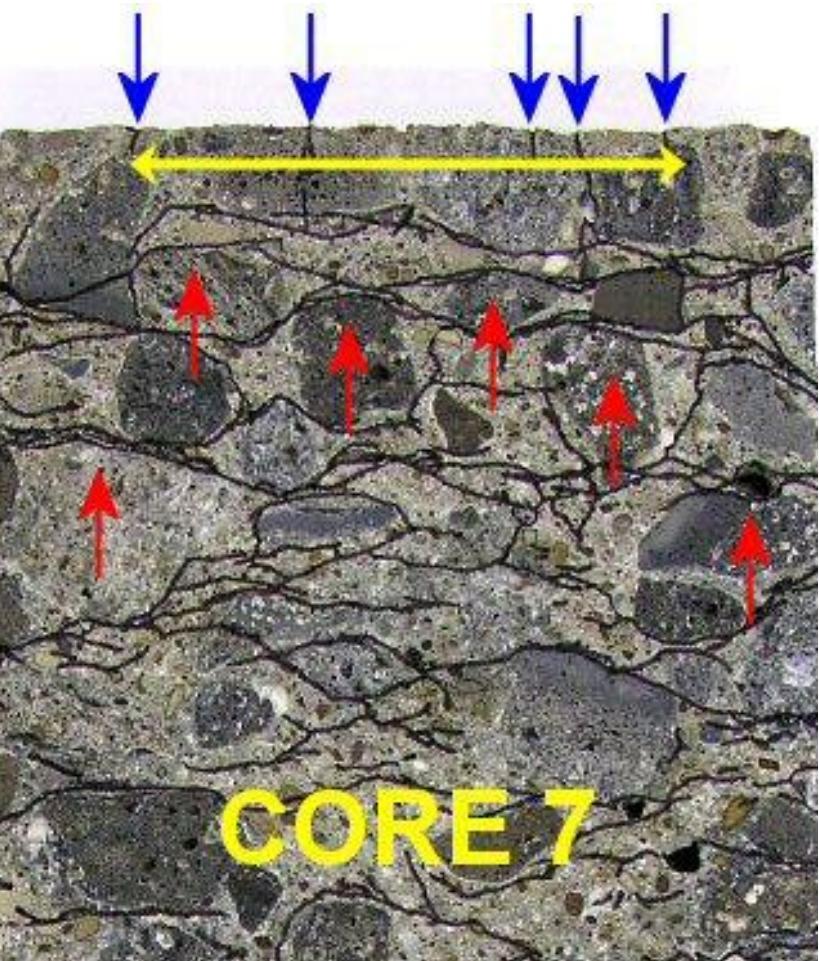
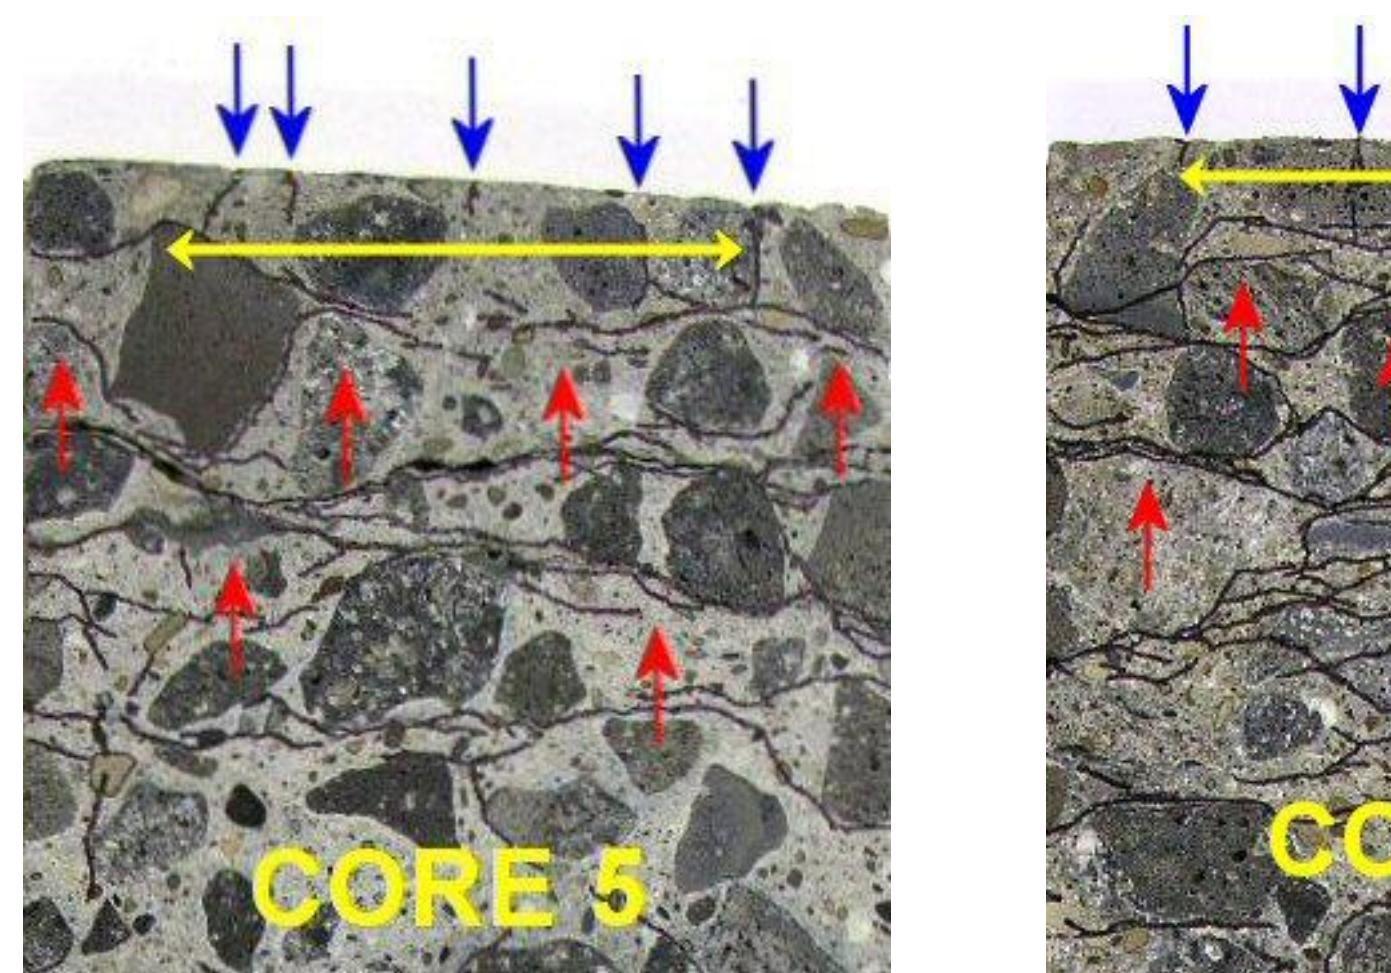
Figure 16. Lapped surface views of Core 5 (Distress Core from SR 175 @ Concord) and Core 7 (Distress Core from SR 176) showing the location of vertical cracks (blue arrows) that penetrate the plane of the wearing surface of the cores. All vertical and sub-surface horizontal cracks that could be detected in the microscopic examination are marked with a black marking pen. The magnification is around 0.9X.

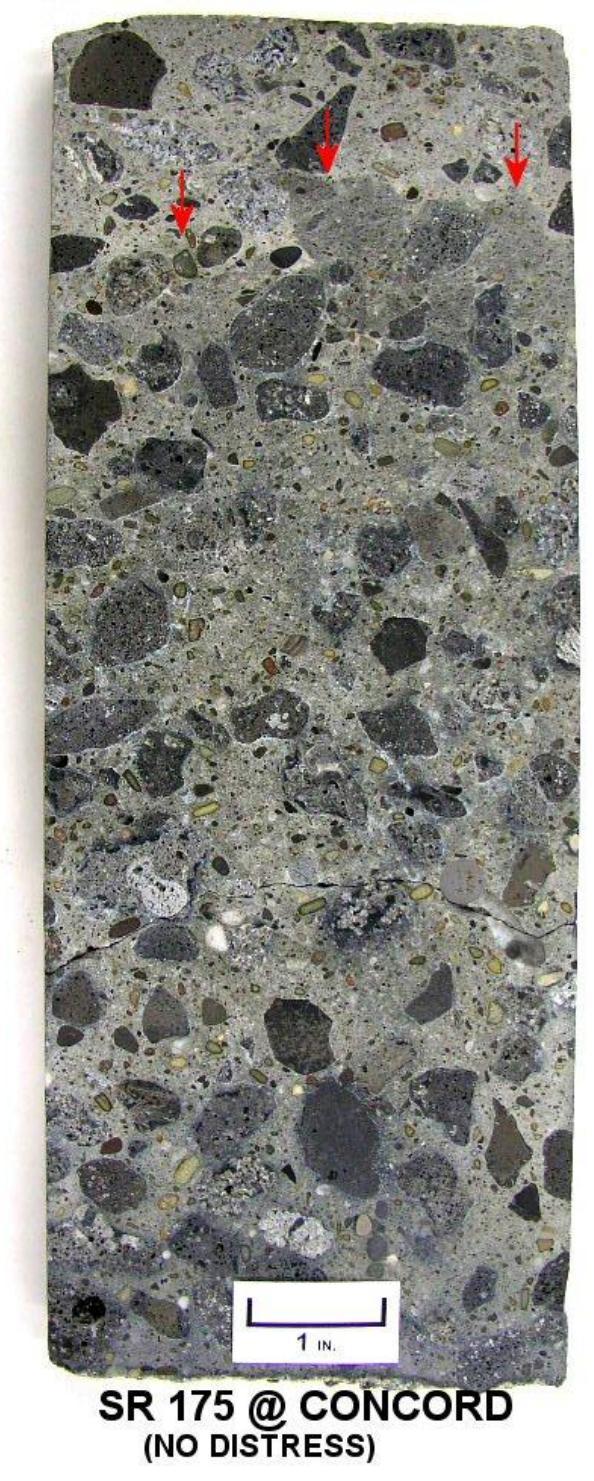
Figure 17. Lapped surface of Core 6 taken from a "No Distress" location on SR 175 @ Concord. The core is 10 ¼ in. long. On the freshly cut and lapped core the cementitious phase of the concrete below the arrows is green in color, while the portion of the core above the arrows is gray. The green coloration is due to the presence of sulfides derived from the slag aggregate that have not yet oxidized. Where the cementitious phase is gray (top 1 ½ to 2 in. [38 to 51 mm]) the sulfides have oxidized. The crack in the core occurred on handling after the lapping step.

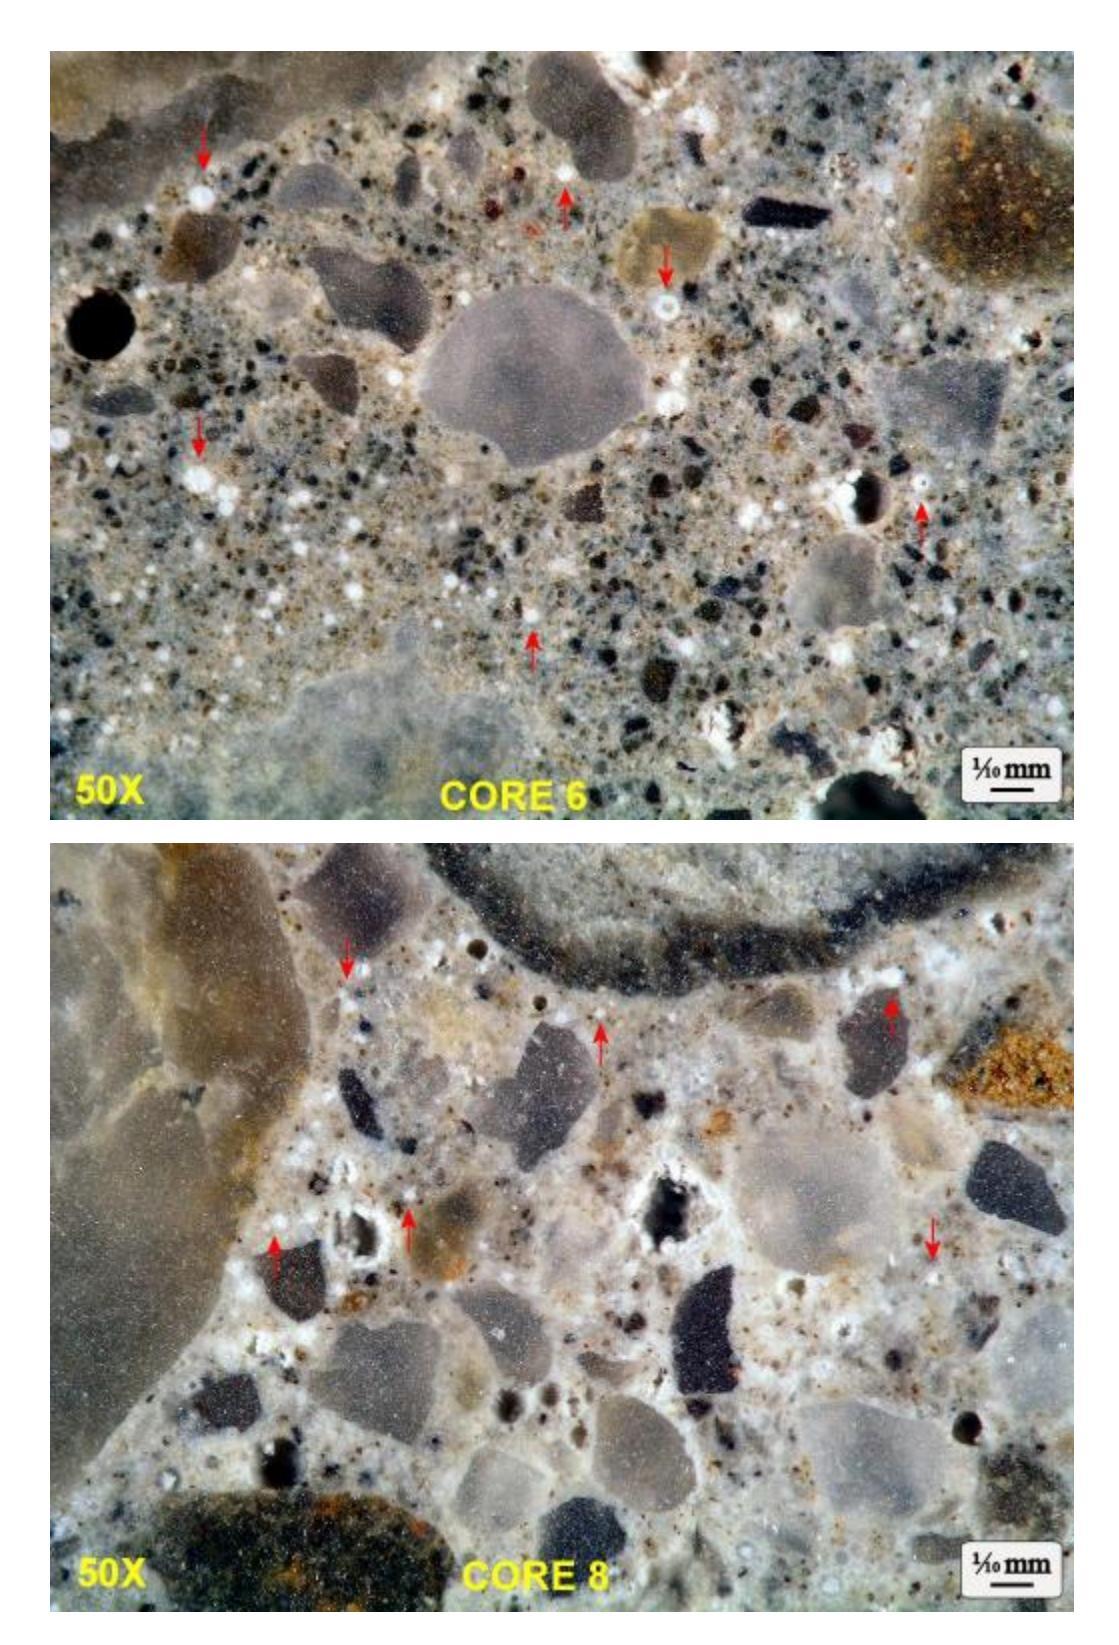
Figure 18. Lapped surface views (50X) of Core 6 (taken from a No-Distress location on SR 175 @ Concord), and Core 8 (taken from a No-Distress location on SR 176), showing entrained air voids that have been fully or partially filled with ettringite (red arrows). The majority of voids less than 0.05 mm in diameter are completely filled. The view in the top photograph is 6 in. (15 cm) below the wearing surface. The view in the bottom photograph is 1 in. (25 mm) below the wearing surface.

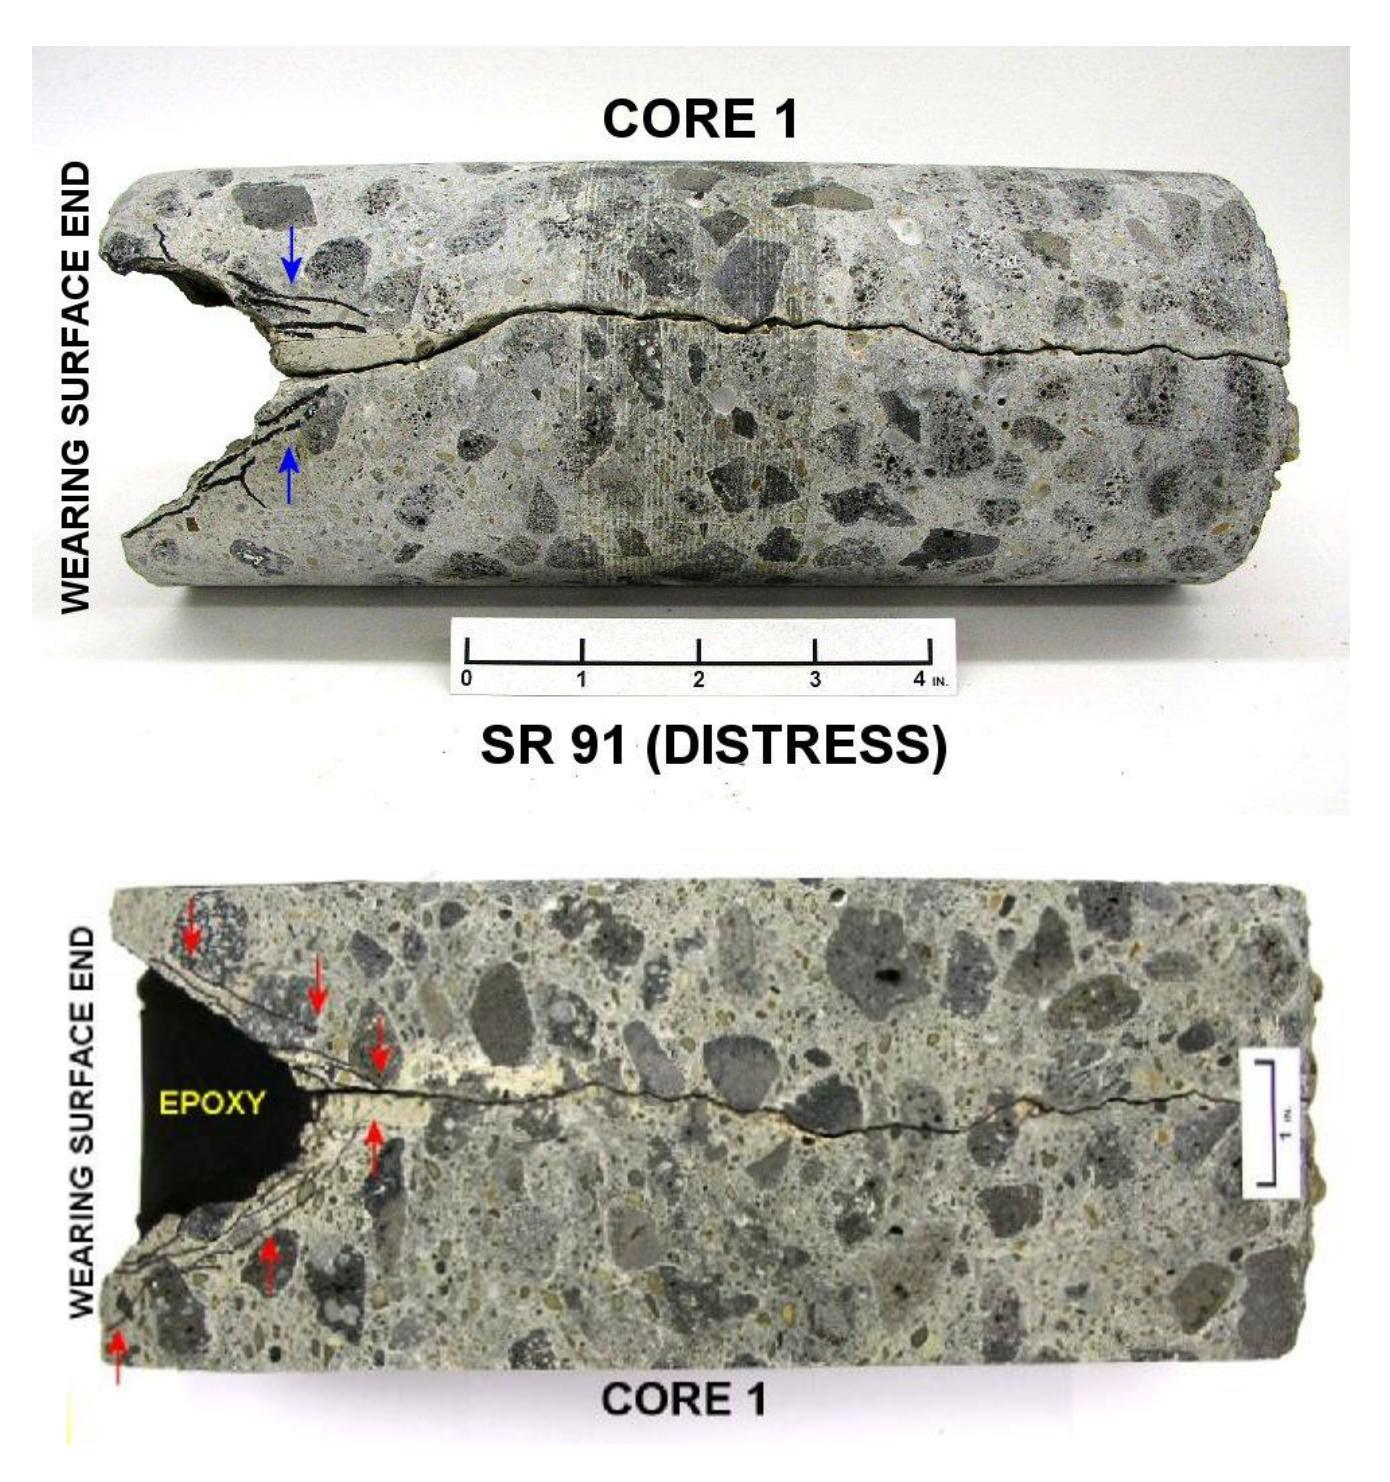
Figure 19. Two views of Core 1 taken through a transverse control joint on State Route 91 at a "Distress" location. The top photograph shows the core in the as-received condition. The two core halves are held together by a steel mesh layer located 7  $\frac{1}{2}$  in. (19 cm) below the wearing surface. The arrows point to cracks in the core that could be detected on the as-cored surfaces. ). The bottom photograph is a view on a lapped surface of the core. Prior to saw-cutting and lapped the spall void and the crack fracture plane were filled with a low viscosity epoxy resin. Cracks in the concrete are marked with a black pen in both photographs.

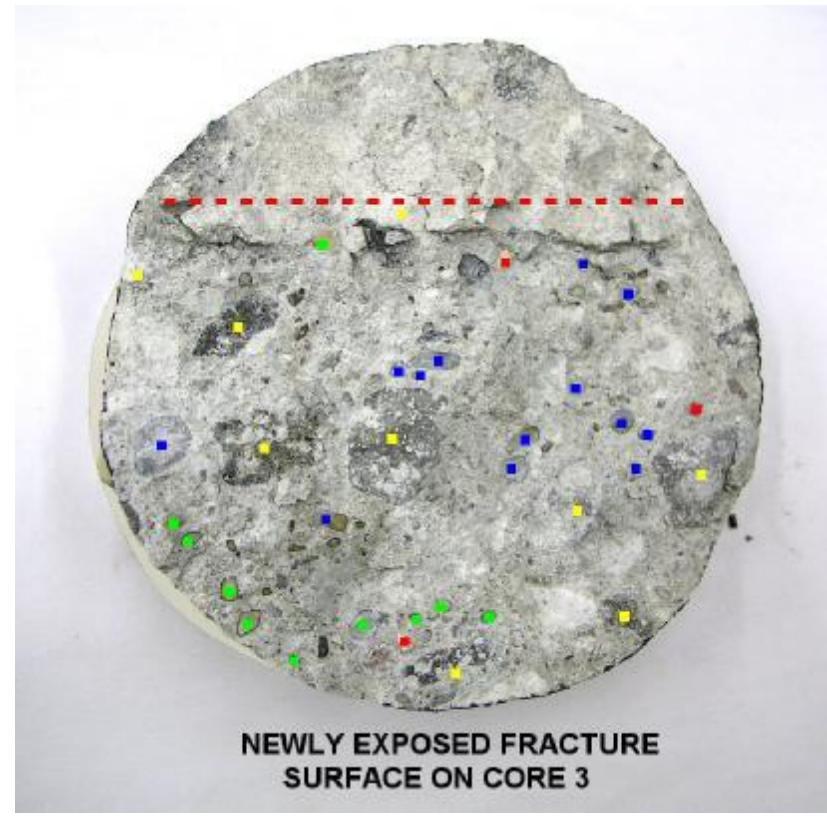
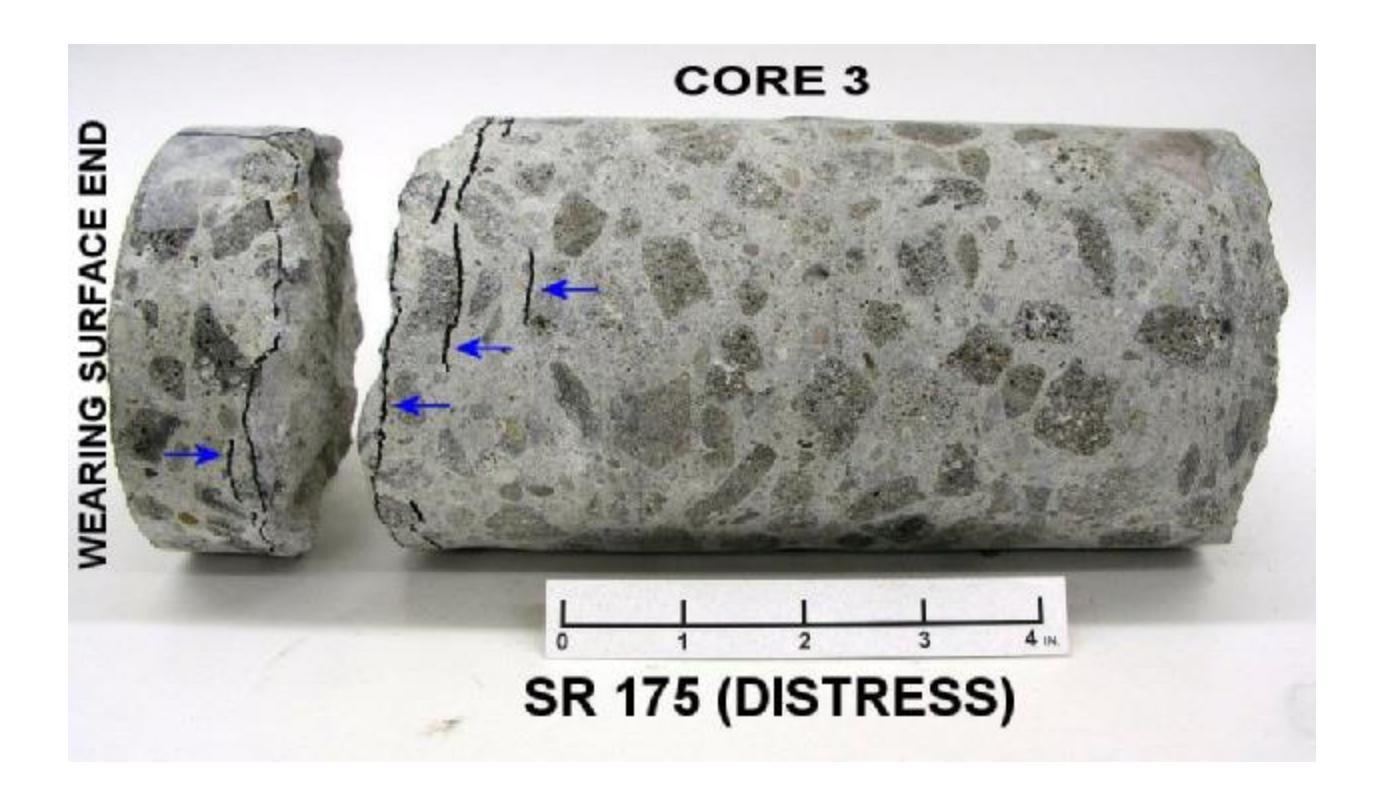
Figure 20. Two views of Core 3 taken from the "Distress" location on SR 175. In the top photograph sub-surface horizontal cracks in the core that could be detected on the as-cored surfaces are marked with a black marking pen. Subsequently, the not-yet-exposed fracture planes (blue arrows) were opened up by inserting the top of a small chisel and lightly tapping until the separation occurred. The bottom photograph shows a plan view of one of these newly-exposed pre-existing fractures surfaces. The colored dots are explained in the text of the report.

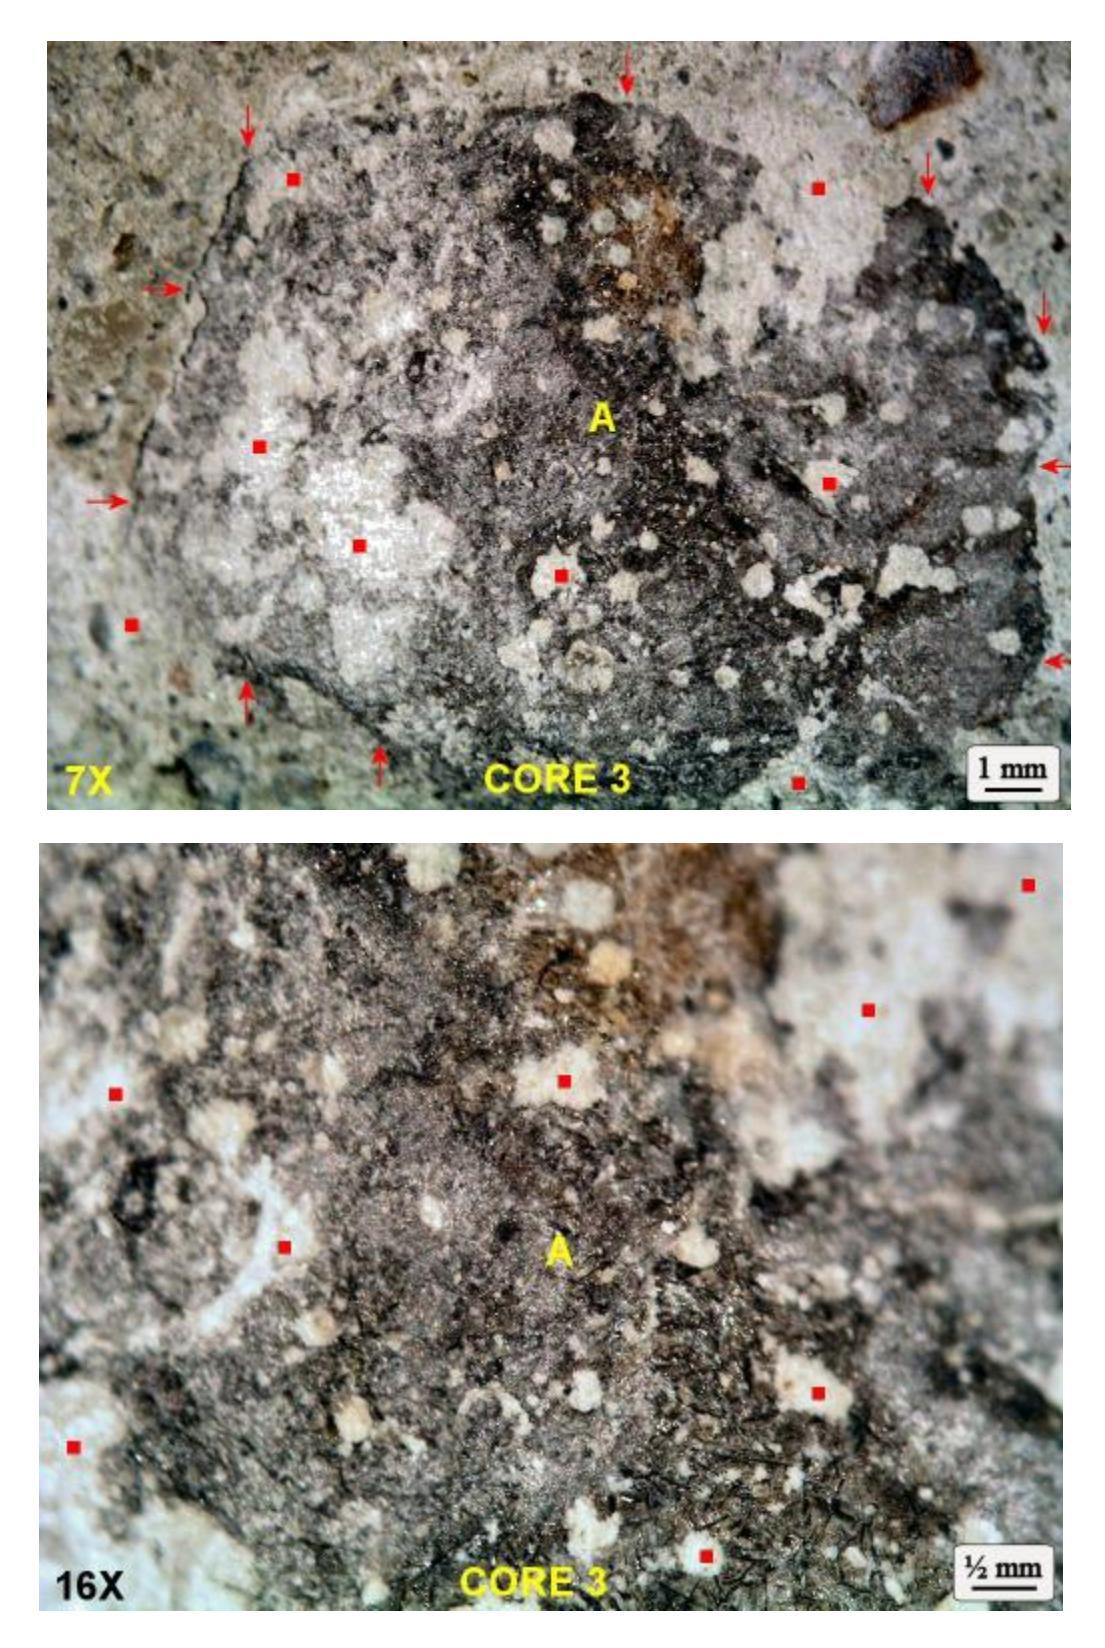
Figure 21. Enlarged views (7X and 16 X) of a newly-exposed, pre-existing horizontal fracture surface on Core 3 ("Distress" location – SR 175), showing a slag coarse aggregate particle (A) that has separated from the cementitious matrix of the concrete. The red arrows in the top photograph point to the cement paste/ aggregate boundary. The red dots are placed on remnants of the cement paste that remain adhered to the surface of the slag aggregate particle after it was pulled out of the matrix.

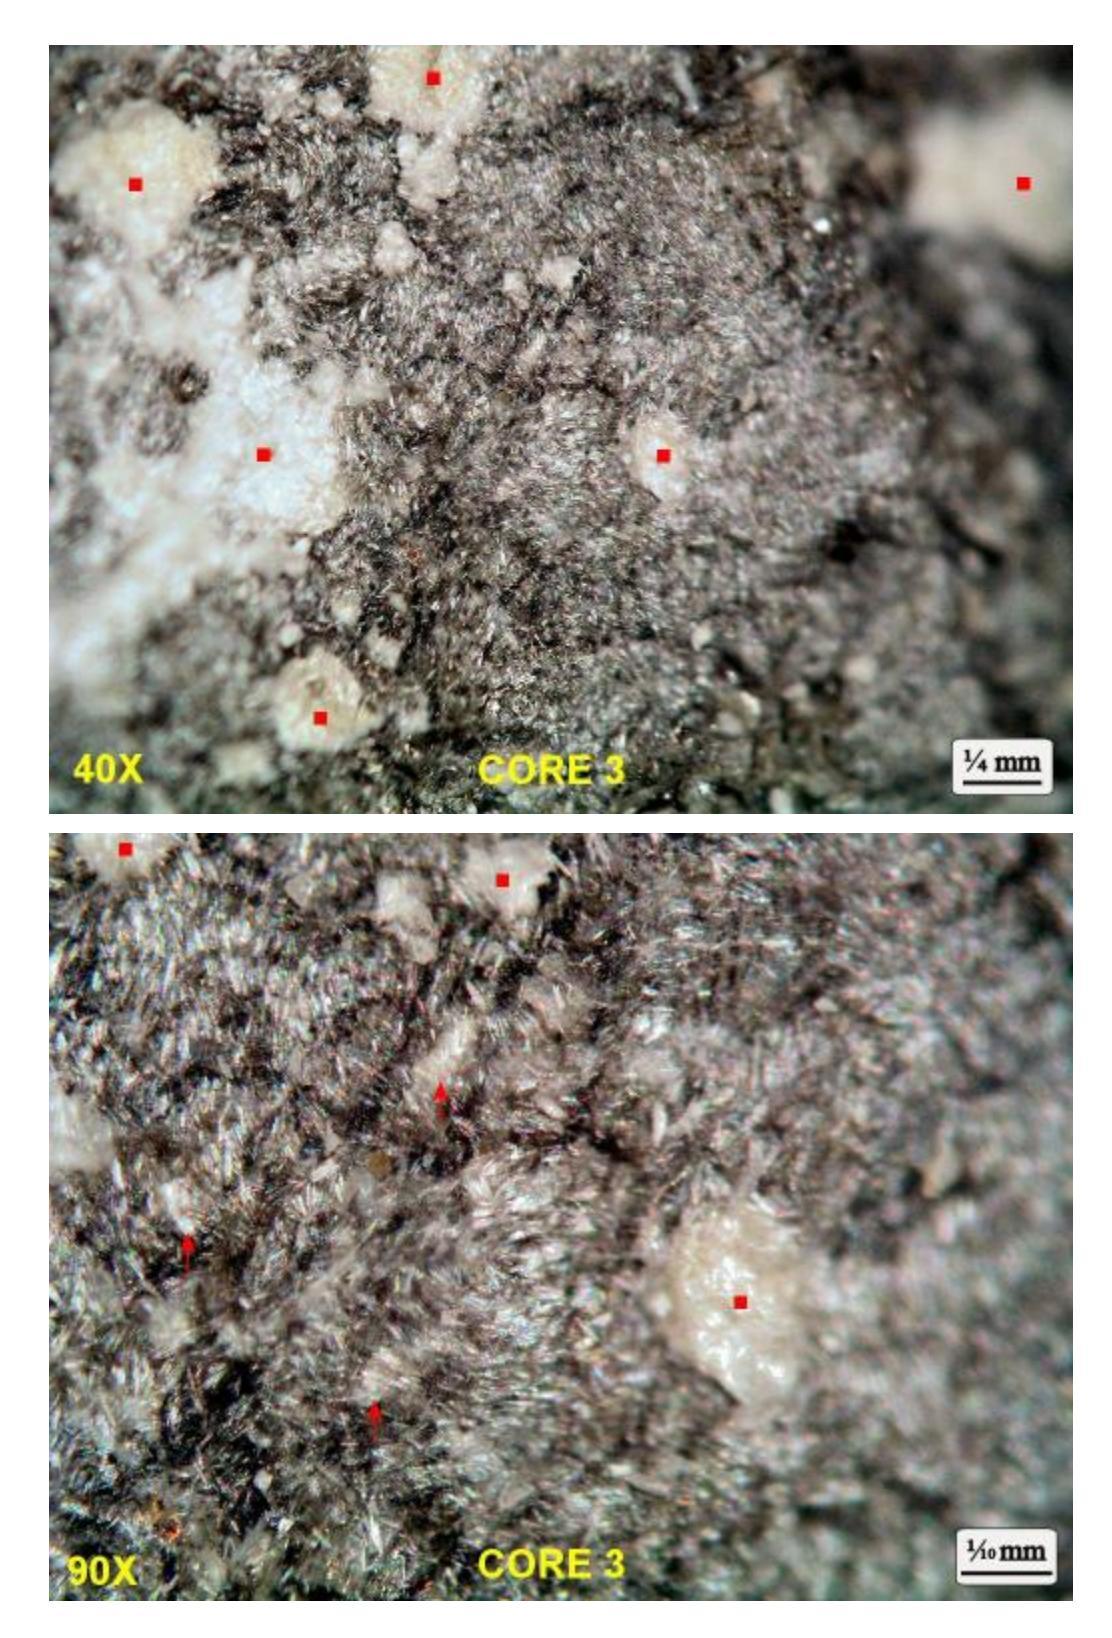
Figure 22. Enlarged views (40X and 90X) of the slag coarse aggregate particle shown in Figure 21 (from Core 3). The red dots are placed on remnants of the cement paste that remain adhered to the surface of the slag aggregate particle after it was pulled out of the matrix. The patches of cement paste contain interspersed acicular fibers, which are ettringite. The red arrows point to smaller regions of the cement paste. The entire surface of the slag aggregate particle is covered with a layer of acicular ettringite crystal laid down like jackstraws.

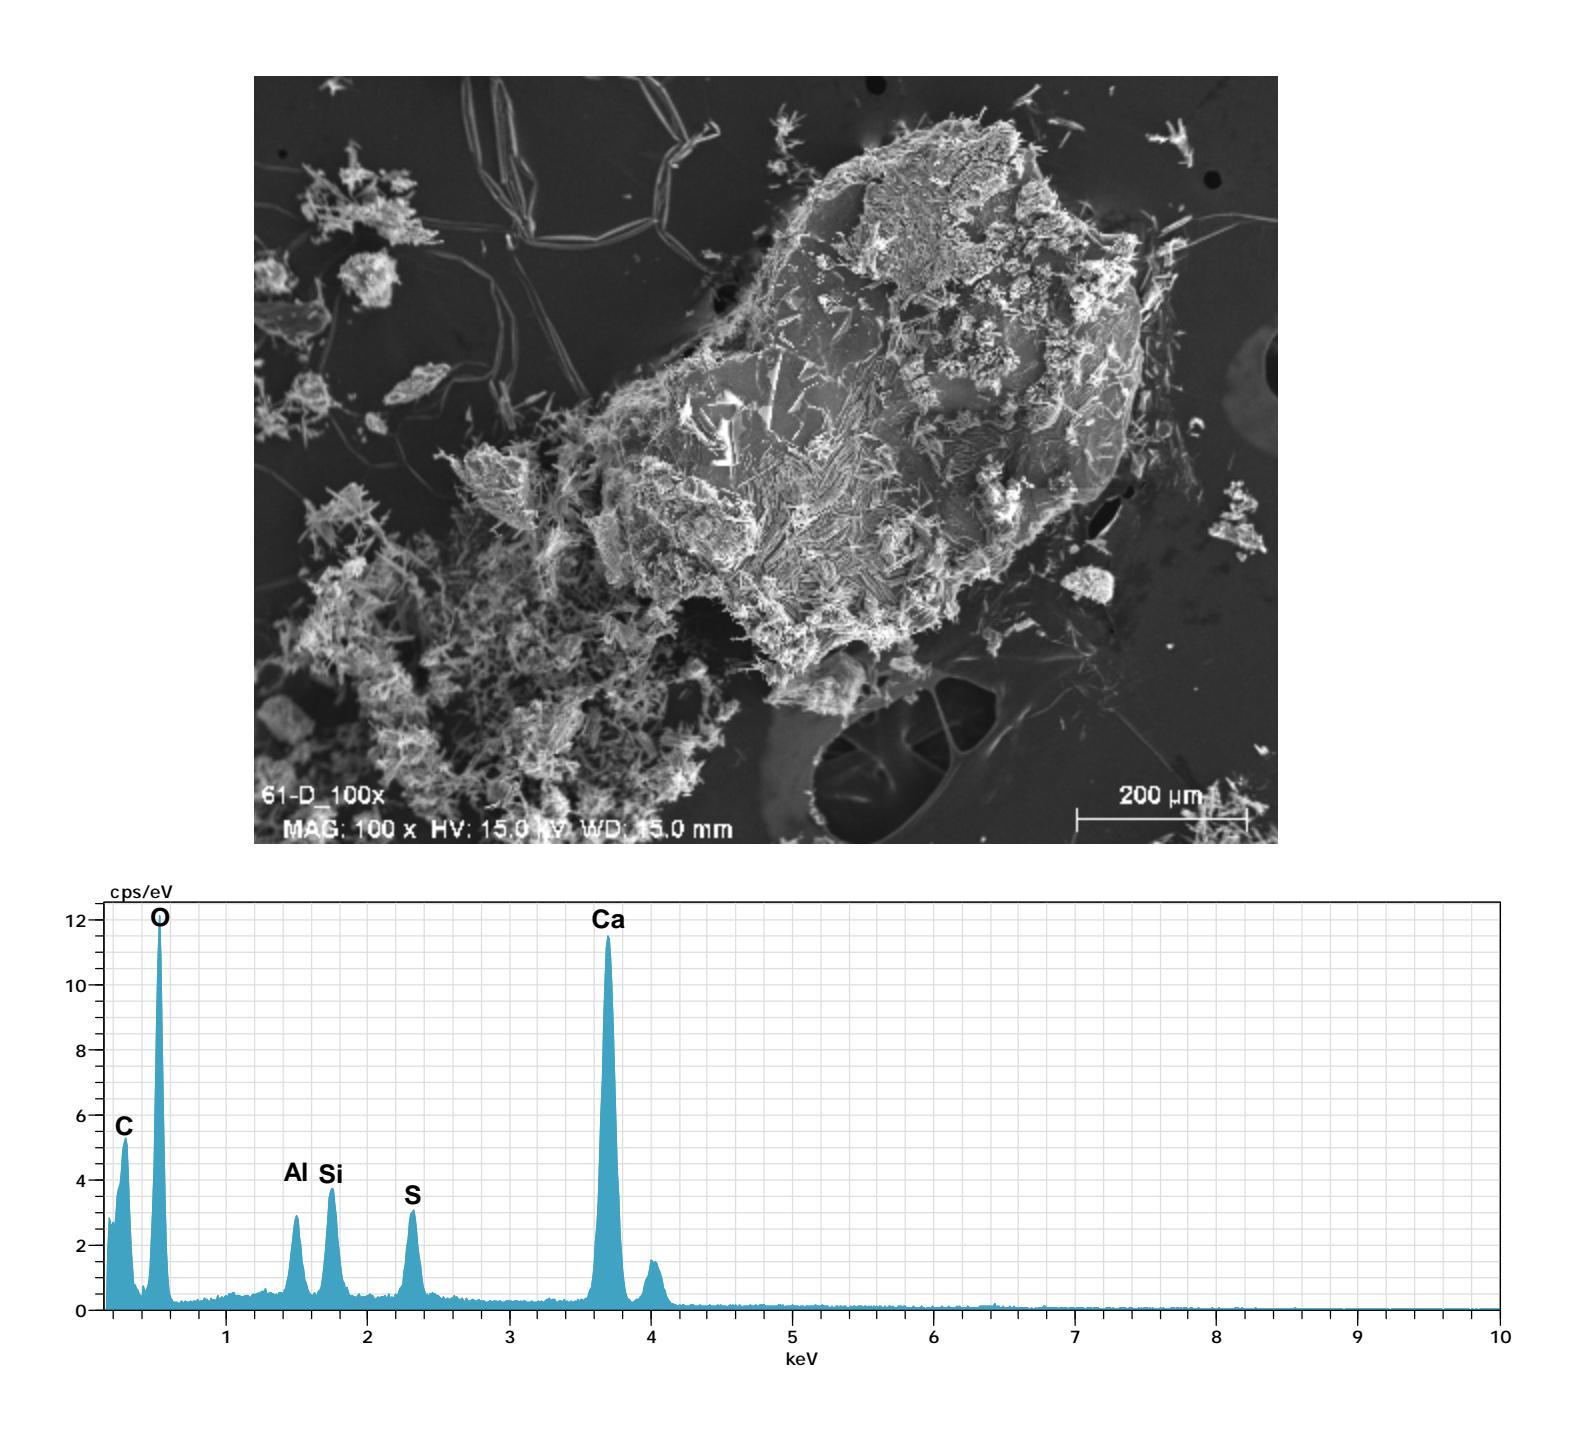
Figure 23. Scanning Electron Microscope (SEM) image and Energy Dispersive X-Ray Spectrography (EDX) spectrum (100X) of a sample of the material taken from the surface of the slag coarse aggregate particle shown in Figures 21 and 22. The material is a mixture of portland cement paste and ettringite.

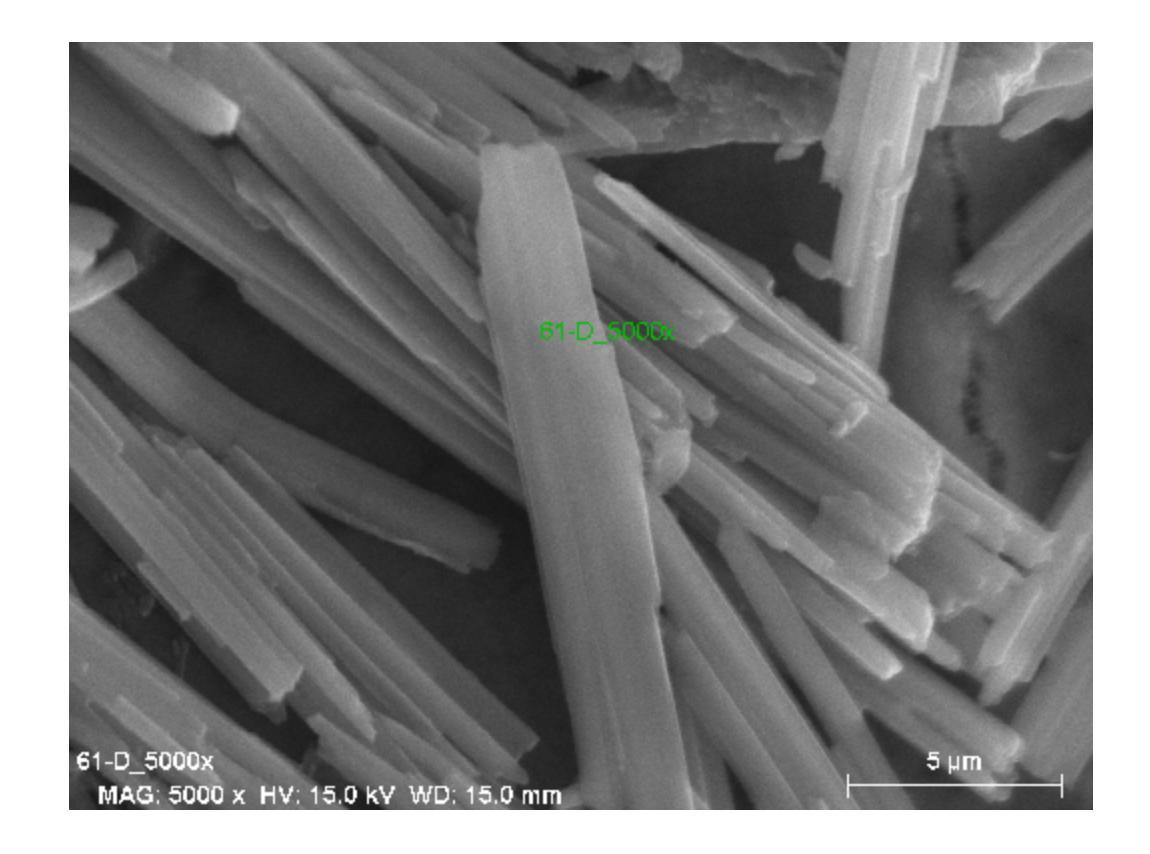
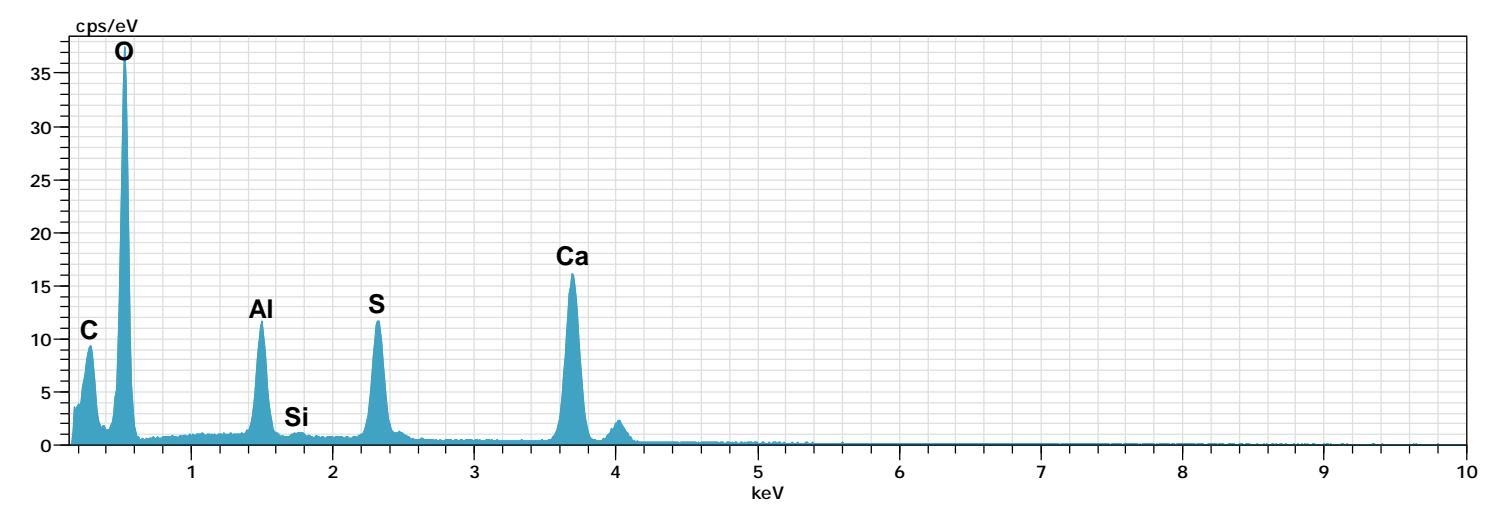
Figure 24. Scanning Electron Microscope (SEM) image and Energy Dispersive X-Ray Spectrography (EDX) spectrum (5000X) of a sample of the material taken from the surface of the slag coarse aggregate particle shown in Figures 21 and 22. The spot analysis on one of the acicular crystals shows that they are ettringite.

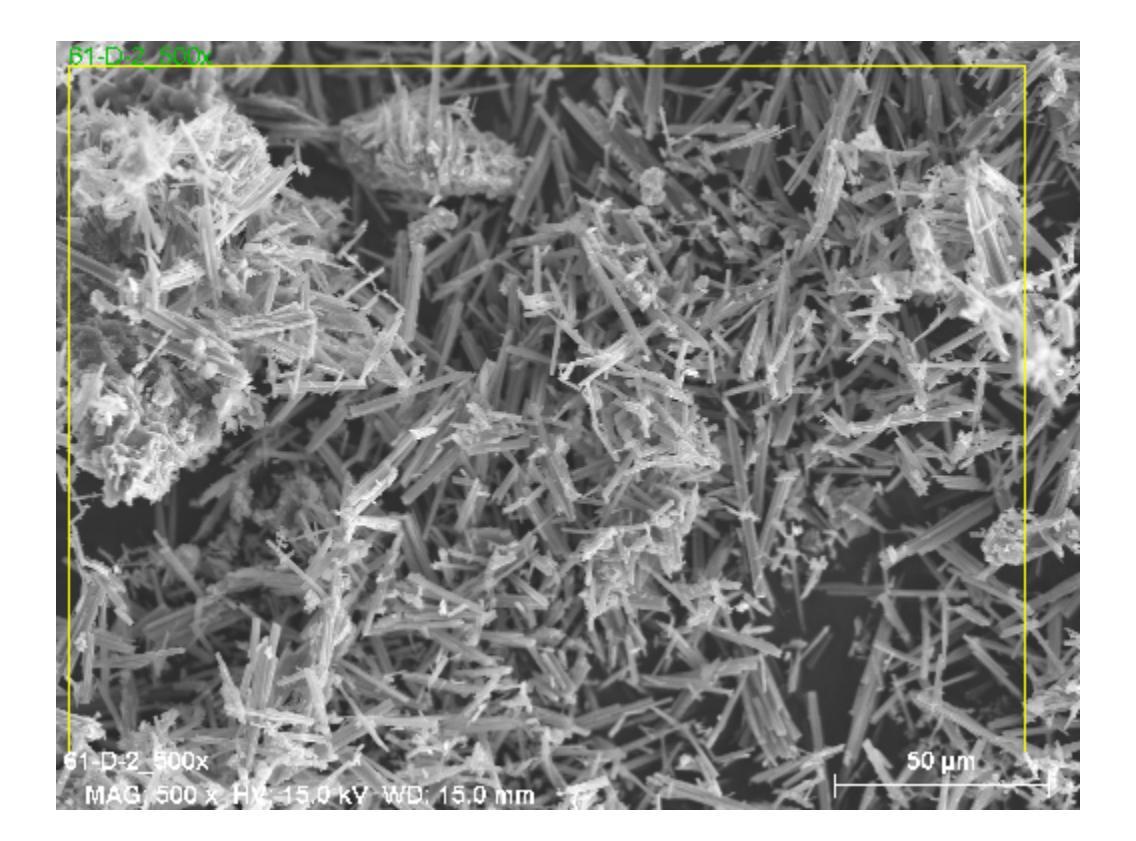
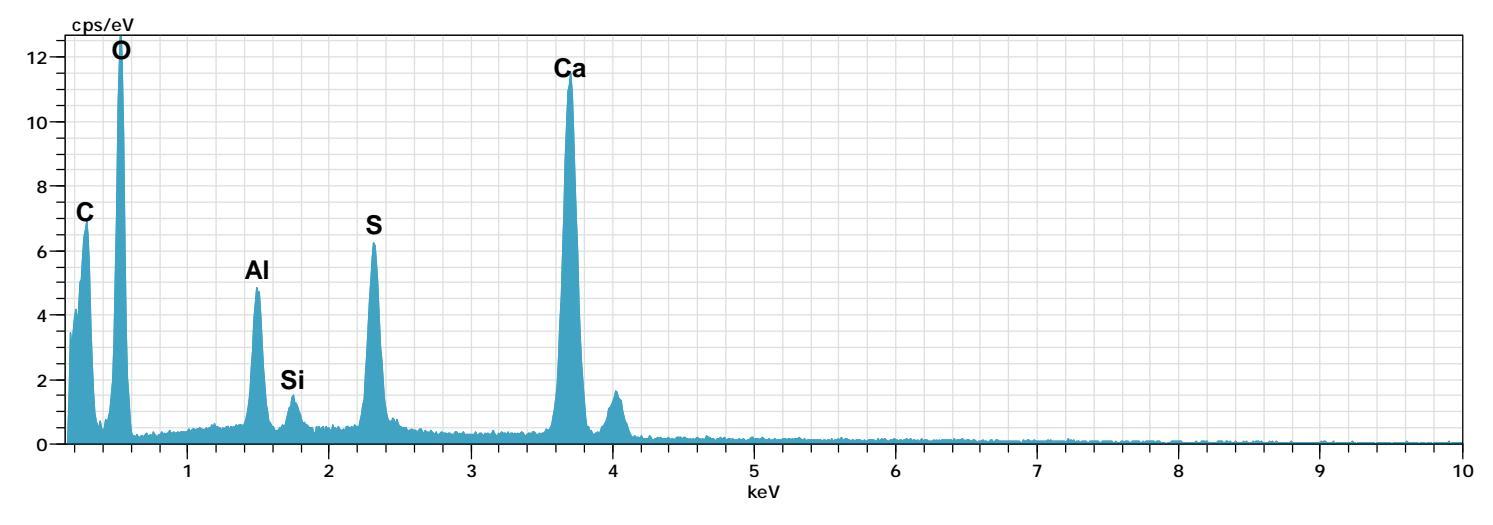
Figure 25. Scanning Electron Microscope (SEM) image and Energy Dispersive X-Ray Spectrography (EDX) spectrum (500X) of a sample of the material taken from the surface of the slag coarse aggregate particle shown in Figures 21 and 22. The individual acicular crystals are ettringite. The "clumped" material in the northwest corner of the photograph is a mixture of hydrated portland cement and ettringite.
