# Forensic Investigation of AC and PCC Pavements with Extended Service Life

Volume 3: Petrographic Examination of Blast Furnace Slag Aggregate Concrete Cores taken from PCC Pavements in Cuyahoga County, Ohio

David Lankard, consultant

Report FHWA/OH-2010/004C

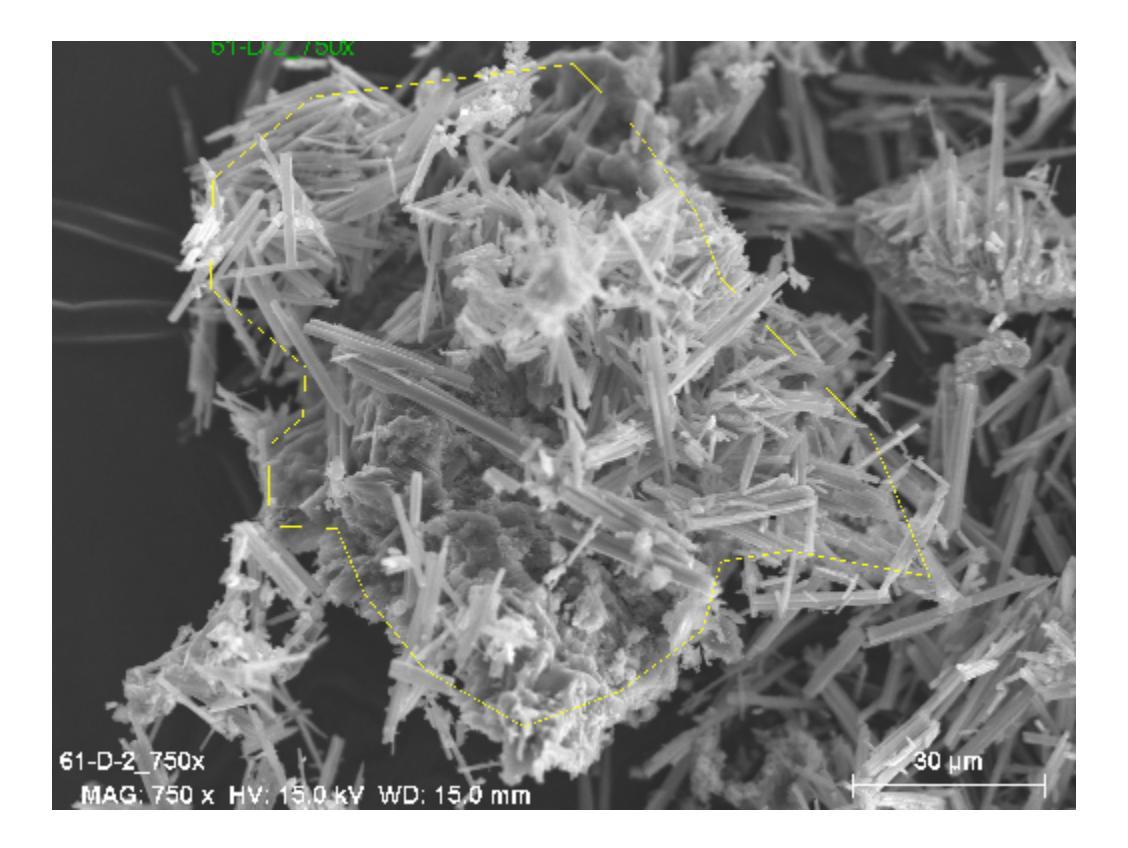
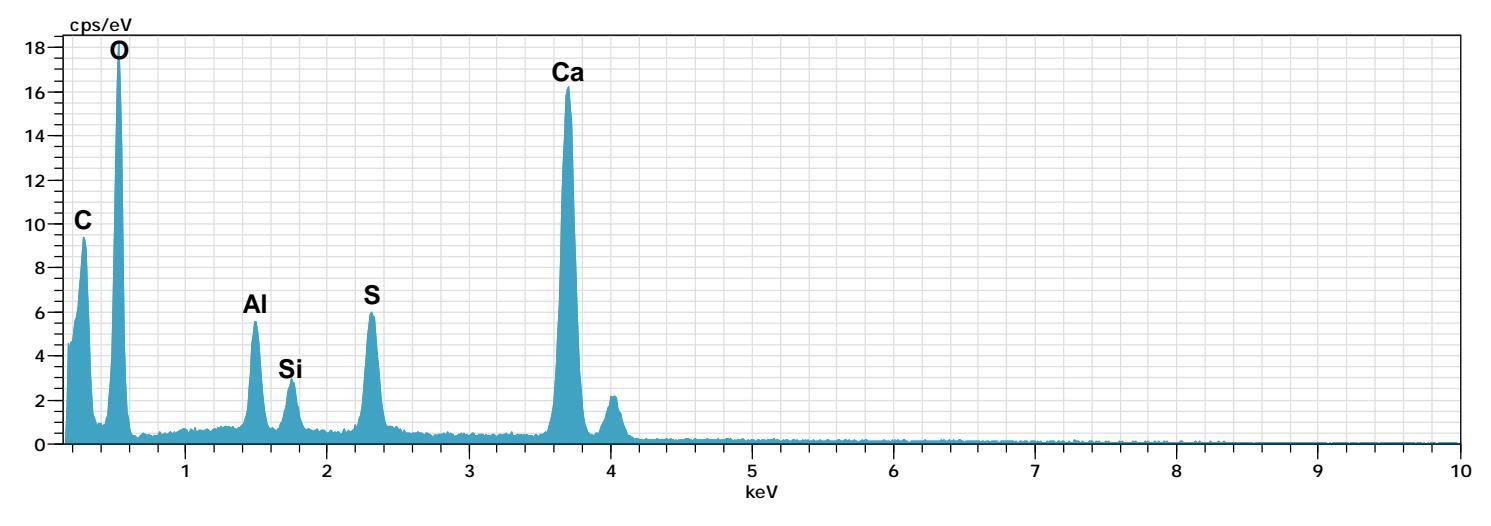
Figure 26. Scanning Electron Microscope (SEM) image and Energy Dispersive X-Ray Spectrography (EDX) spectrum (750X) of the "clumped" material in the northwest corner of the SEM image shown in Figure 25. The individual acicular crystals are ettringite. The matrix material holding the fiber bundle together is hydrated portland cement paste as shown in Figures 27 and 28.

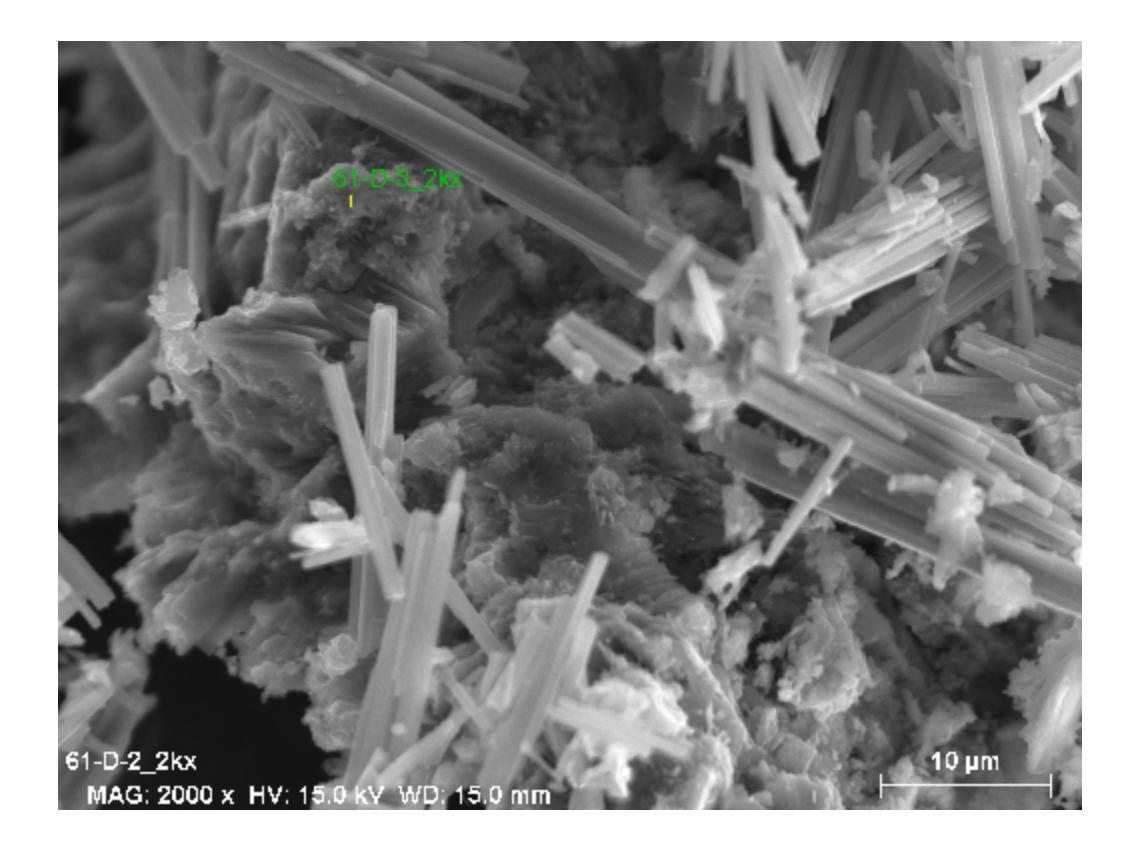
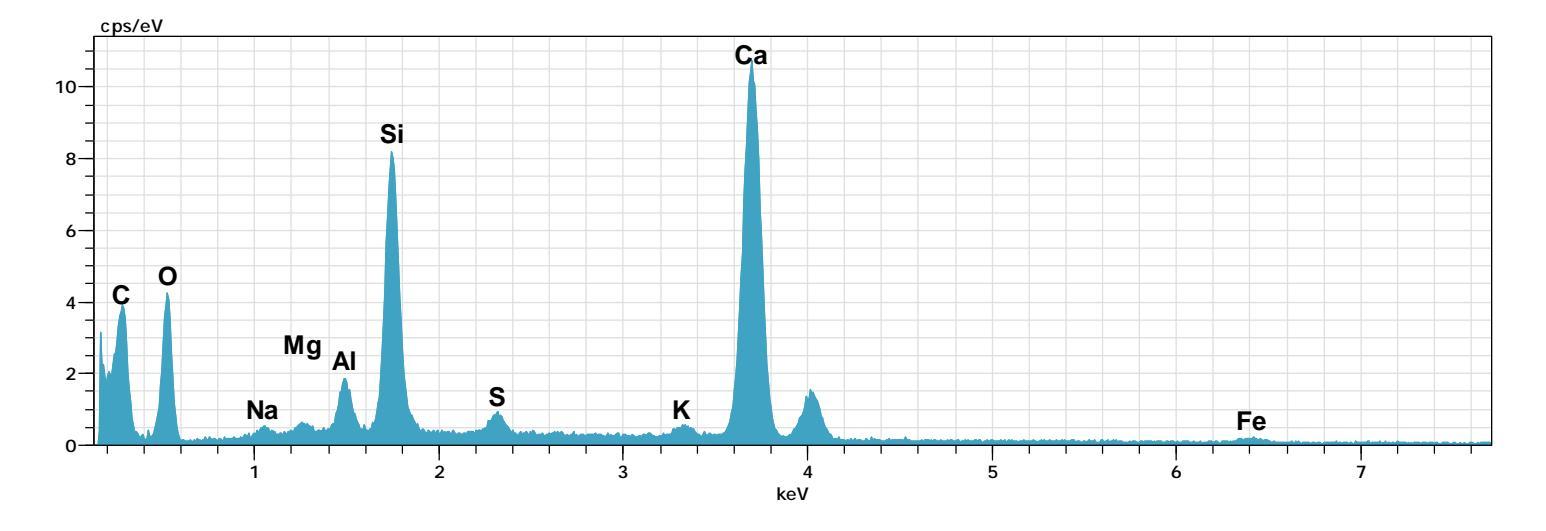
Figure 27. Scanning Electron Microscope (SEM) image and Energy Dispersive X-Ray Spectrography (EDX) spectrum at a magnification of 2000X of the "clumped" material in the northwest corner of the SEM image shown in Figure 25 and in Figure 26. The individual acicular crystals are ettringite. The matrix material holding the fiber bundle together is hydrated portland cement paste.

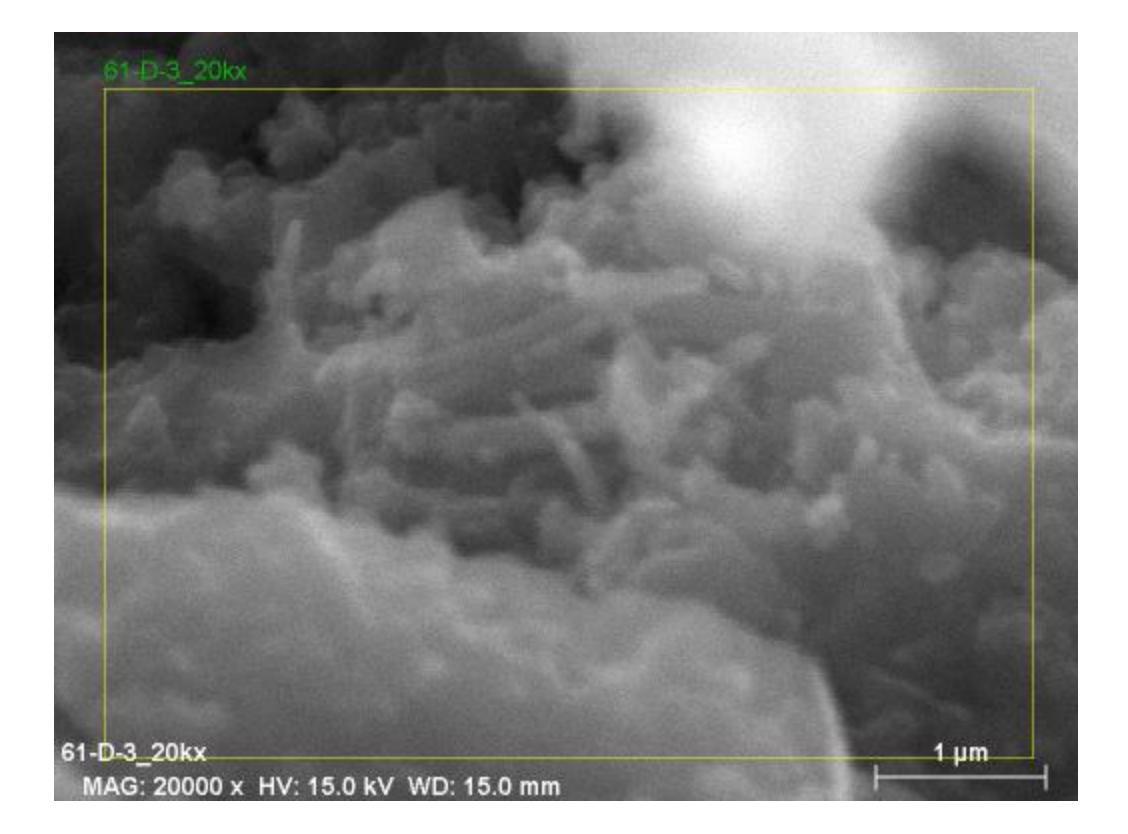
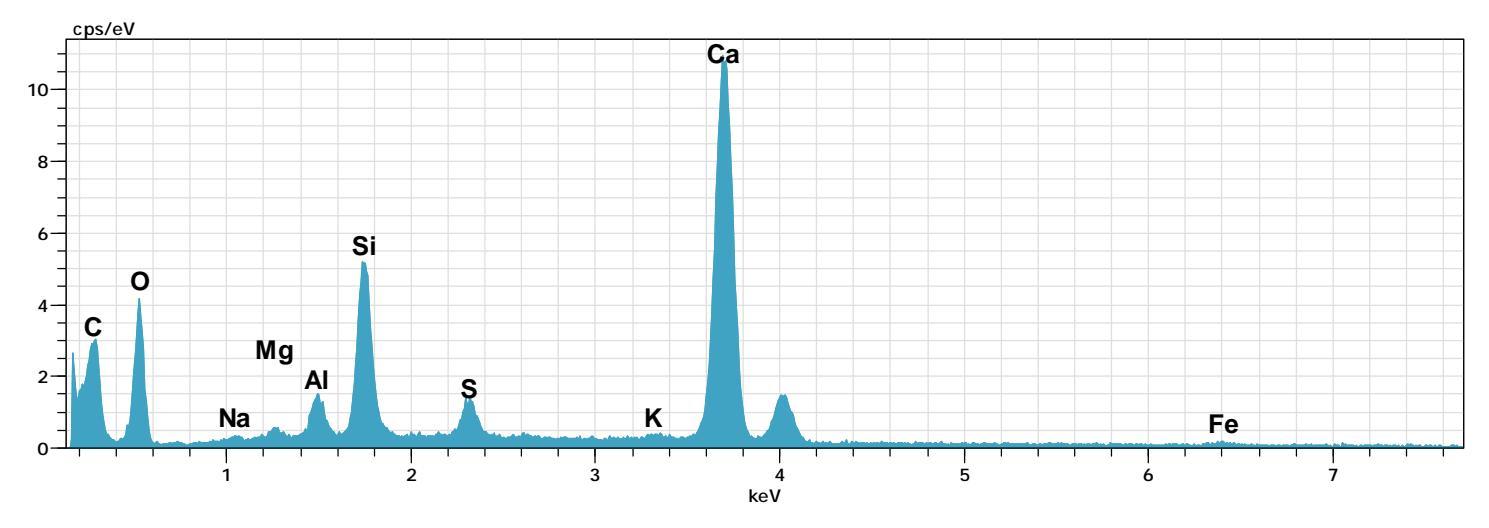
Figure 28. Scanning Electron Microscope (SEM) image and Energy Dispersive X-Ray Spectrography (EDX) spectrum at a magnification of 20,000X on the "matrix" phase of the "clumped" material in the northwest corner of the SEM image shown in Figure 25, 26, and 27. The EDS signature is primarily for hydrated portland cement. Acicular crystals bound up in the matrix are ettringite.

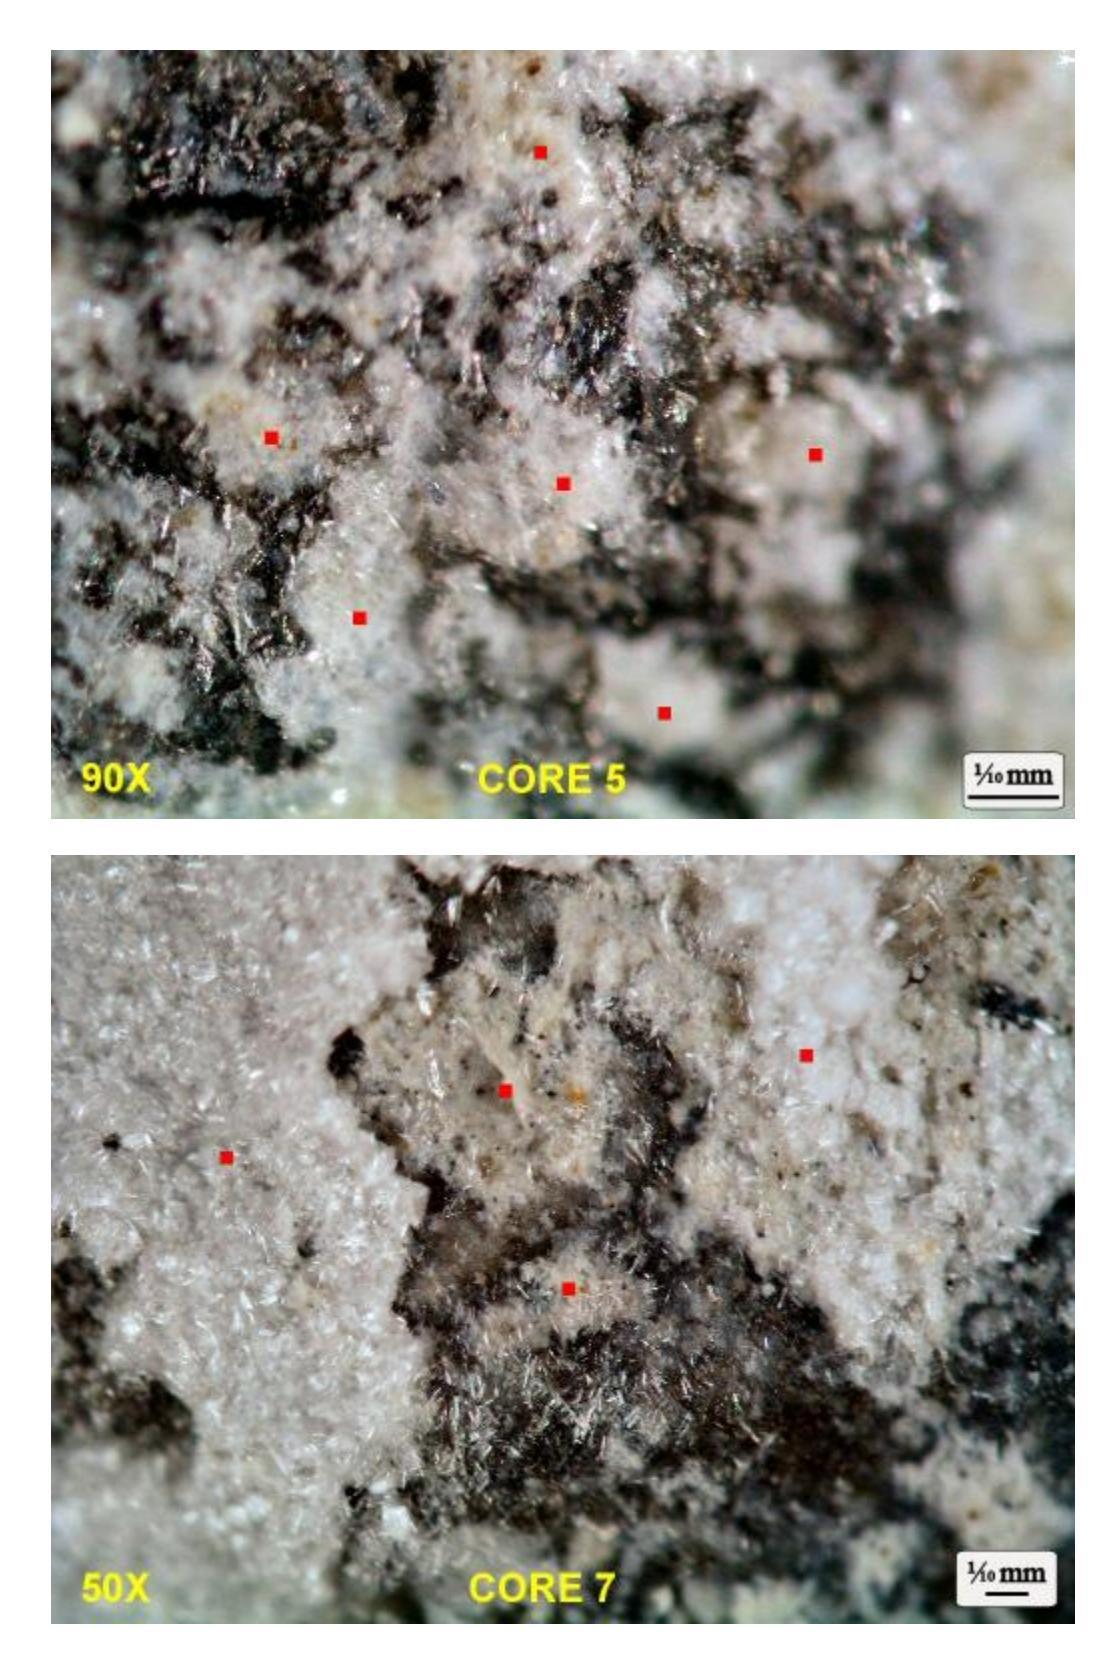
Figure 29. Enlarged views of slag coarse aggregate particles (dark areas) pulled from the cementitious matrix along a pre-existing sub-surface horizontal fracture surface in Core 5 (SR 175 @ Concord – "Distress location) and Core 7 (SR 176 – "Distress location), showing microstructural features associated with destructive internal sulfate attack in these pavement concretes. The red dots are placed on remnants of the cement paste that remained adhered to the slag particle after it was pulled from the matrix. The acicular crystals are ettringite fibers.

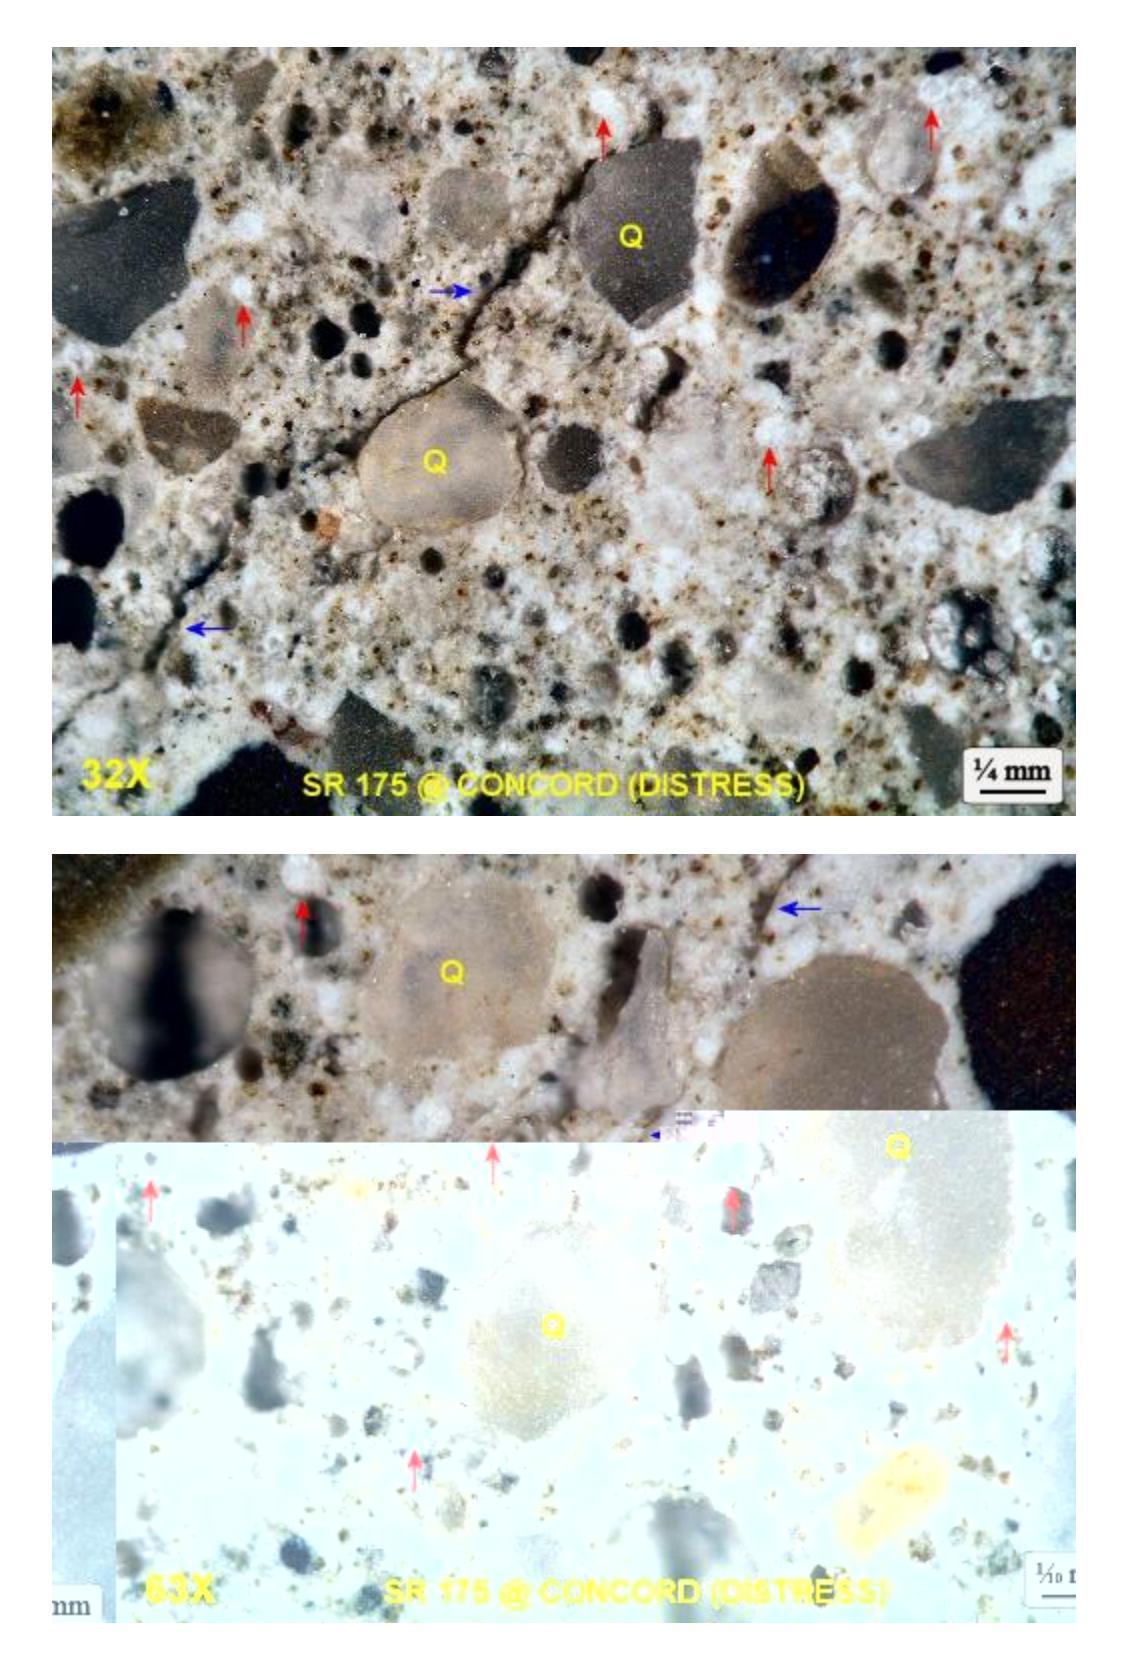
Figure 30. Two enlarged views of a lapped surface of Core 5 (SR 175 @ Concord (Distress) showing latent cracking in the concrete (blue arrows). The tight cracks are within the cementitious phase of the concrete and pass around quartz fine aggregate particles (Q). The red arrows point to a few of the numerous small diameter entrained air voids that are completely or partially filled with ettringite.

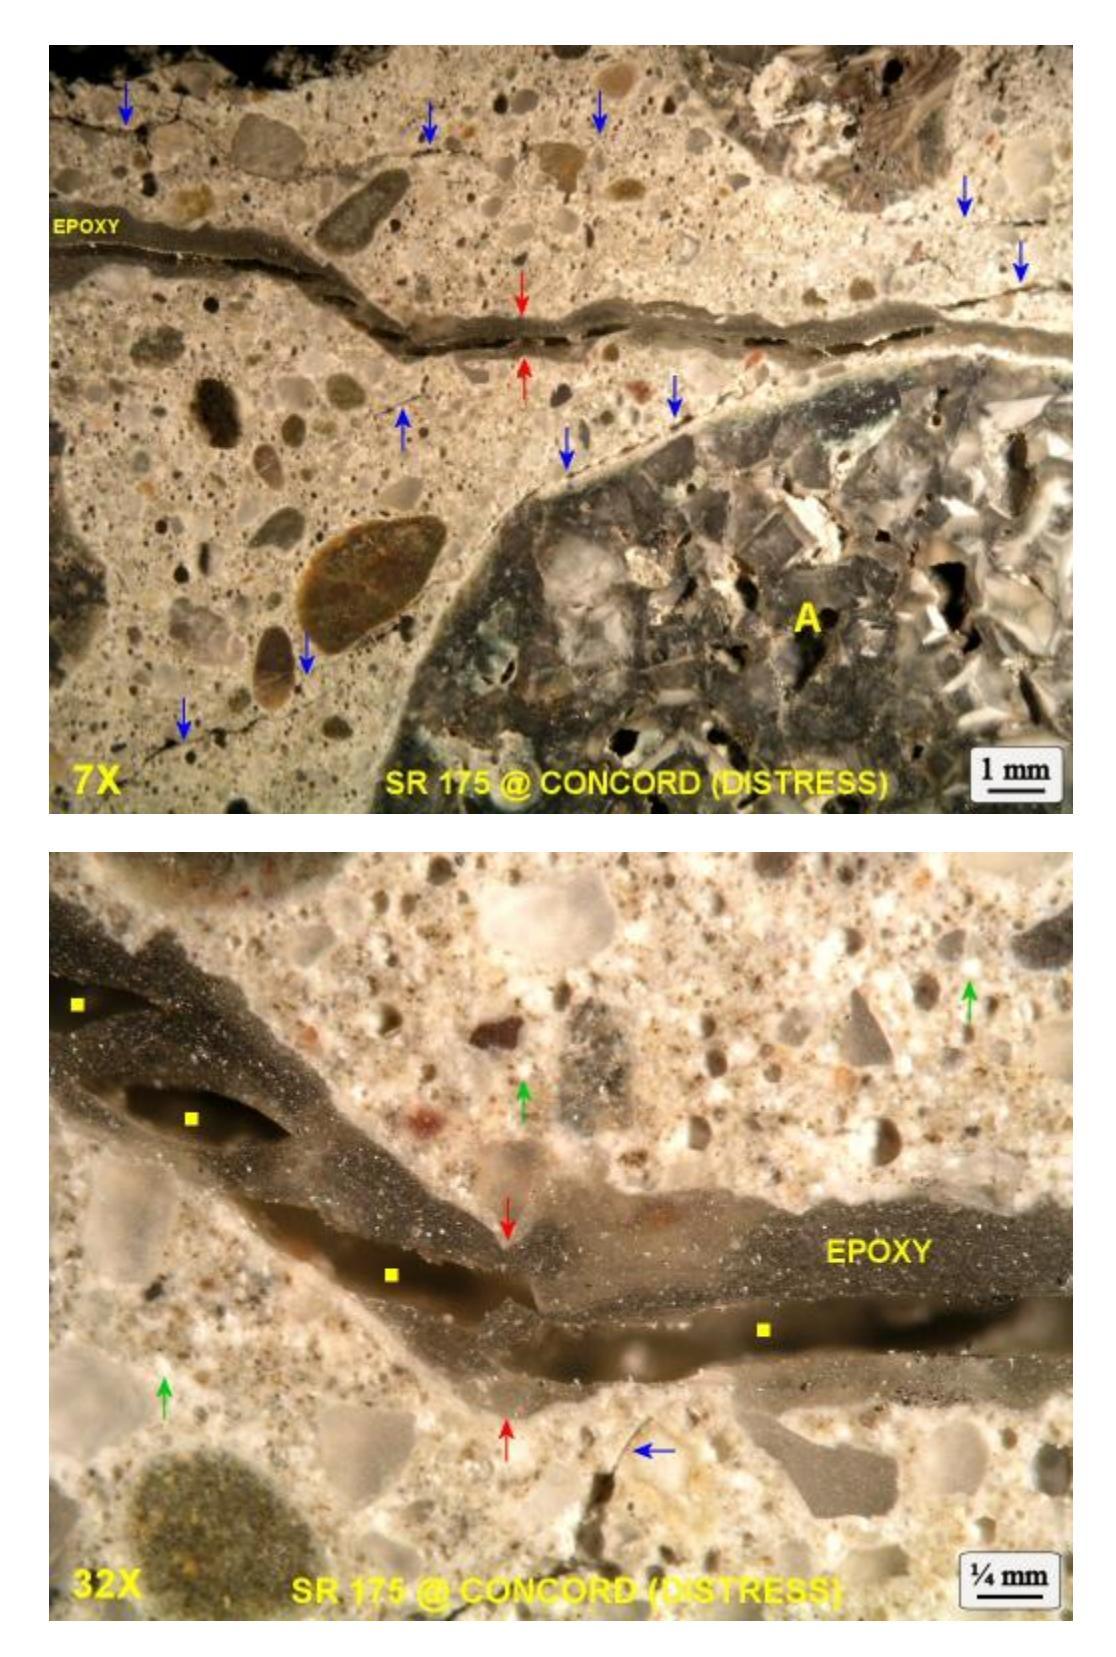
Figure 31. Two enlarged views of a lapped surface of Core 5 (SR 175 @ Concord (Distress) showing the condition of the epoxy adhesive following two weeks of storage of the concrete in a sealed plastic bag. The red arrows show the width of the epoxy seam (ca. 0.5 mm). The epoxy layer has been literally pulled apart resulting in tears within the epoxy layer (yellow dots). The blue arrows point to cracks within the cementitious matrix of the concrete. The green arrows point to a few of the numerous small air voids that have been in-filled with ettringite.

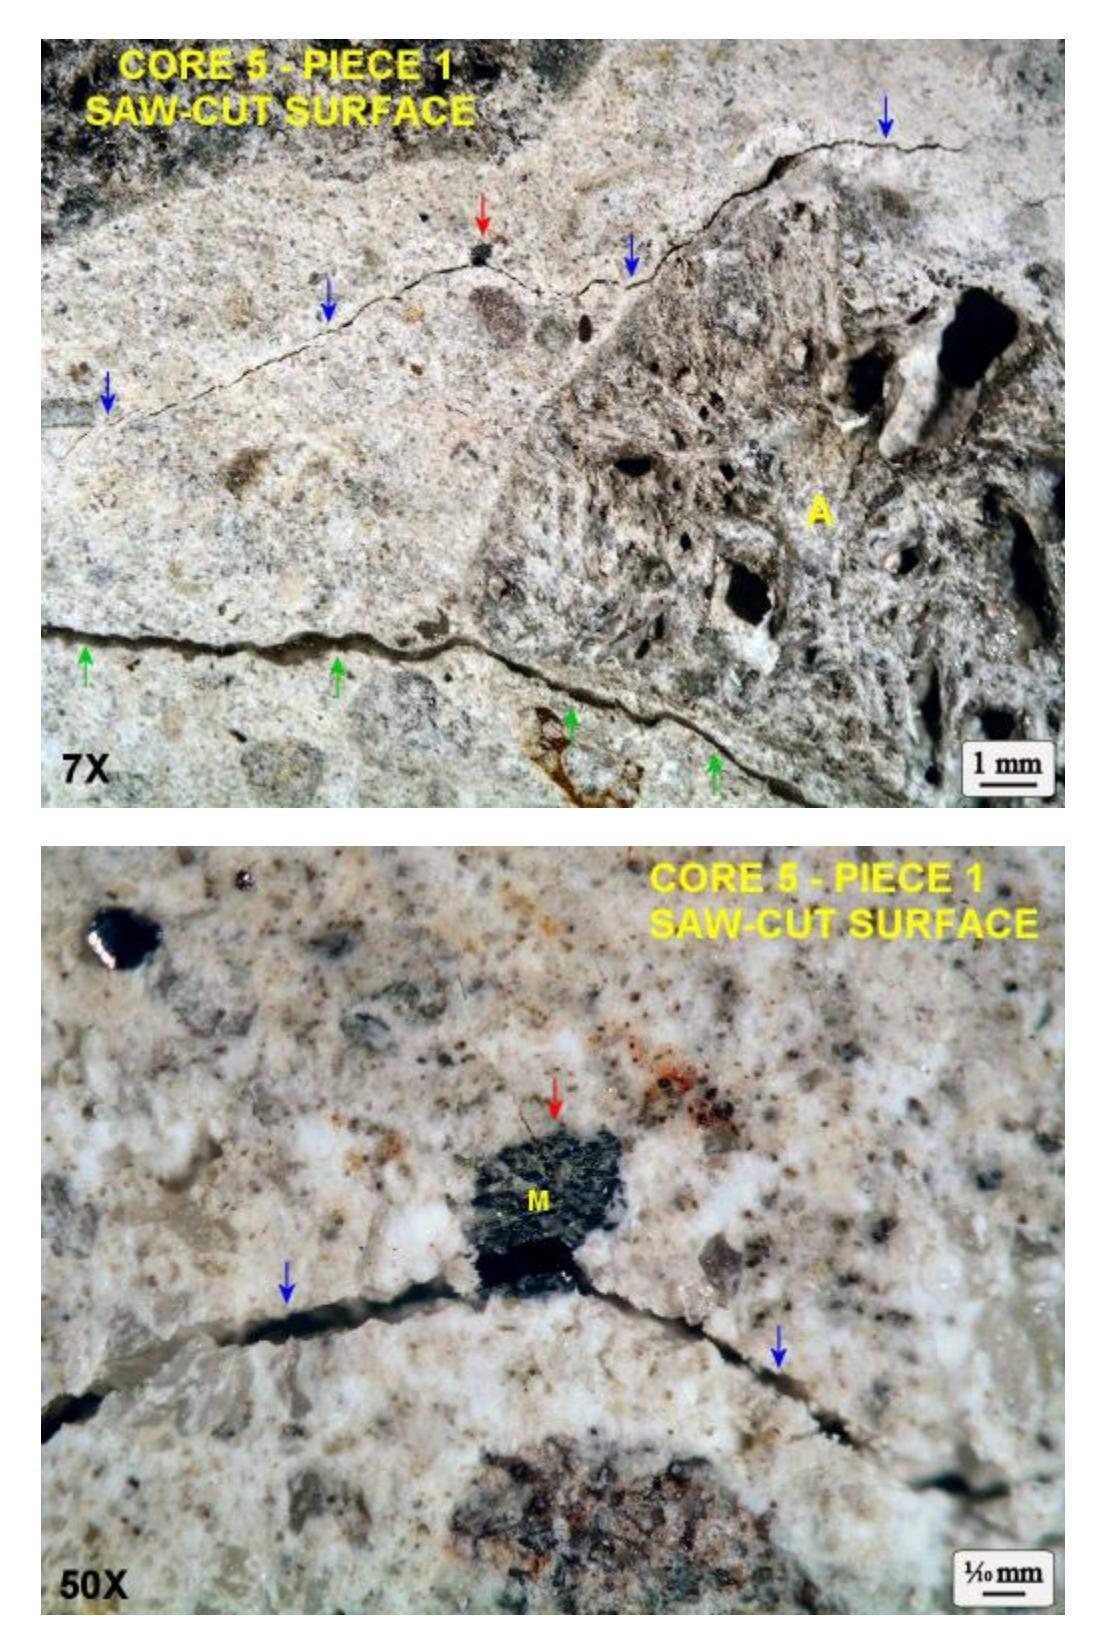
Figure 32. Two enlarged views (7X and 50X) of a saw-cut surface of Piece 1 of Core 5 at a location about 2 in. below the wearing surface. The green arrows in the top photograph point to the pre-existing horizontal crack in Core 5 which is filled with epoxy. The blue arrows point to a crack that was formed in the Core Piece sometime during the 19 day period that it was stored in a sealed plastic bag. The red arrow points to a small mafic mineral fine aggregate particle in the crack fracture plane.

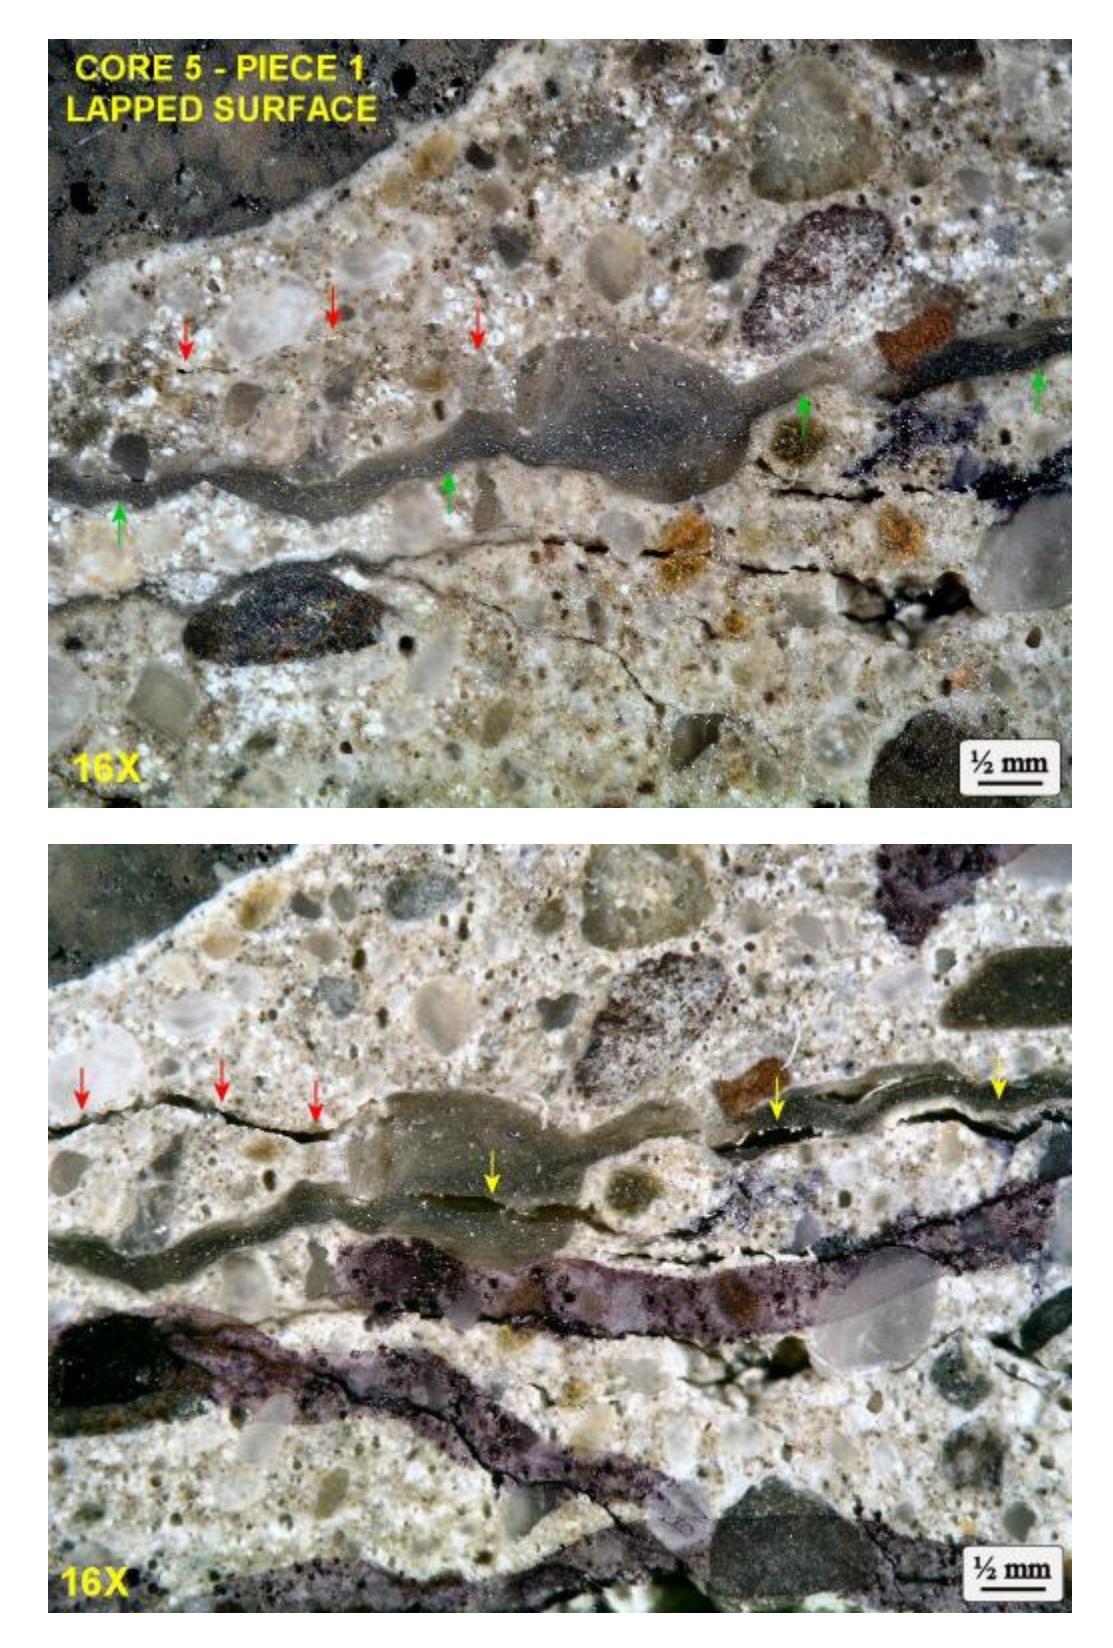
Figure 33. Two enlarged views (16X) at the same location on the lapped surface of Piece 1 of Core 5 at two different times. The top photograph was taken on April 29, 2010 right after the completion of the lapping operation. The bottom photograph was taken on May 18, 2010 after the lapped core piece had been in a sealed plastic bag (for 19 days). The green arrows point to the pre-existing horizontal crack in Core 5 which is filled with epoxy. During the 19 day storage period the concrete expanded, which enlarged the width of the cracks and which created tears in the epoxy seam (yellow arrows).

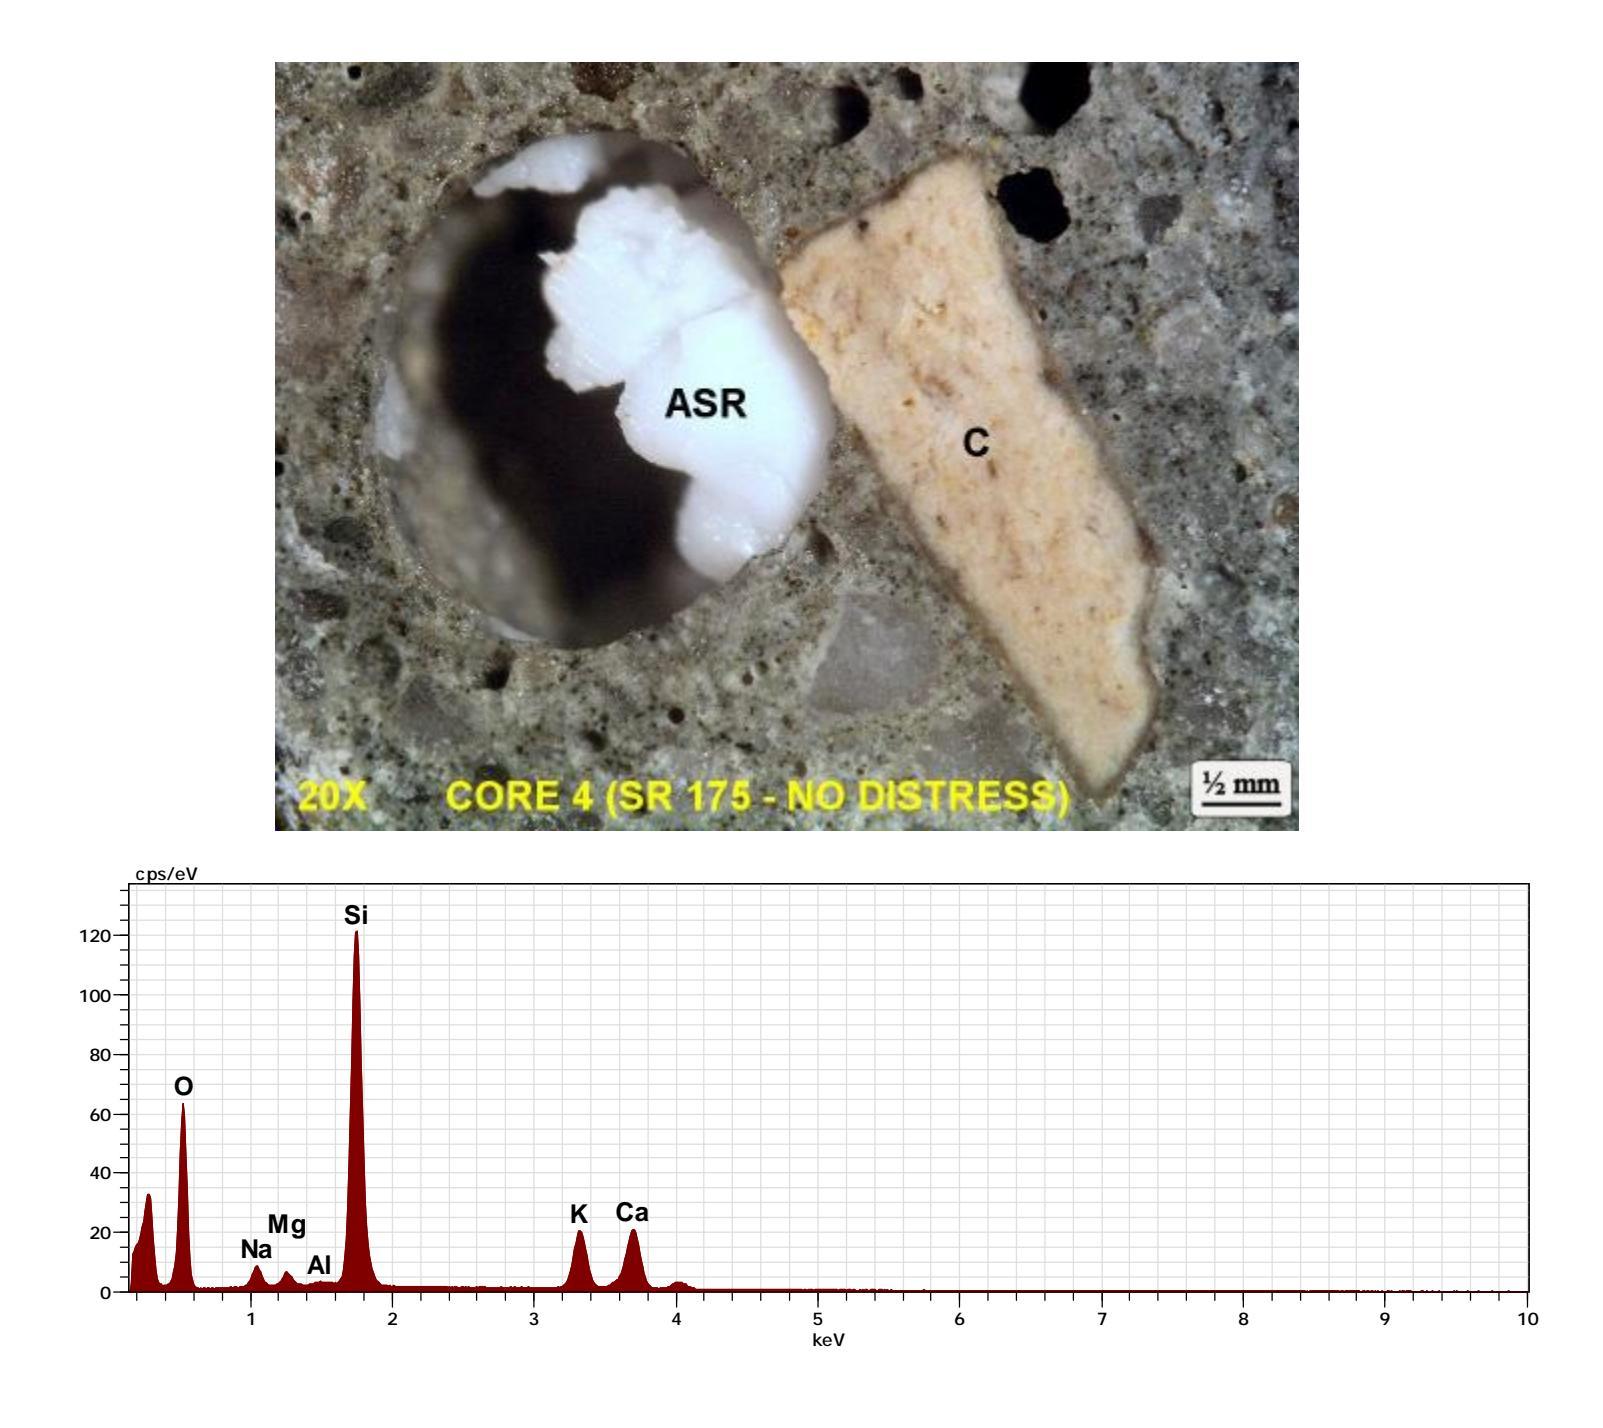
Figure 35. Enlarged view (20X) of a fresh saw-cut surface of Core 4 taken from State Route 175 at a "No-Distress" location. The chert fine aggregate particle (C) has undergone alkalisilica reaction activity and ASR gel has been deposited in an air void adjacent to the particle. The gel was excavated from the air void for the EDX elemental analysis, which was obtained at a magnification of 200X (Scan Number 58-B3).

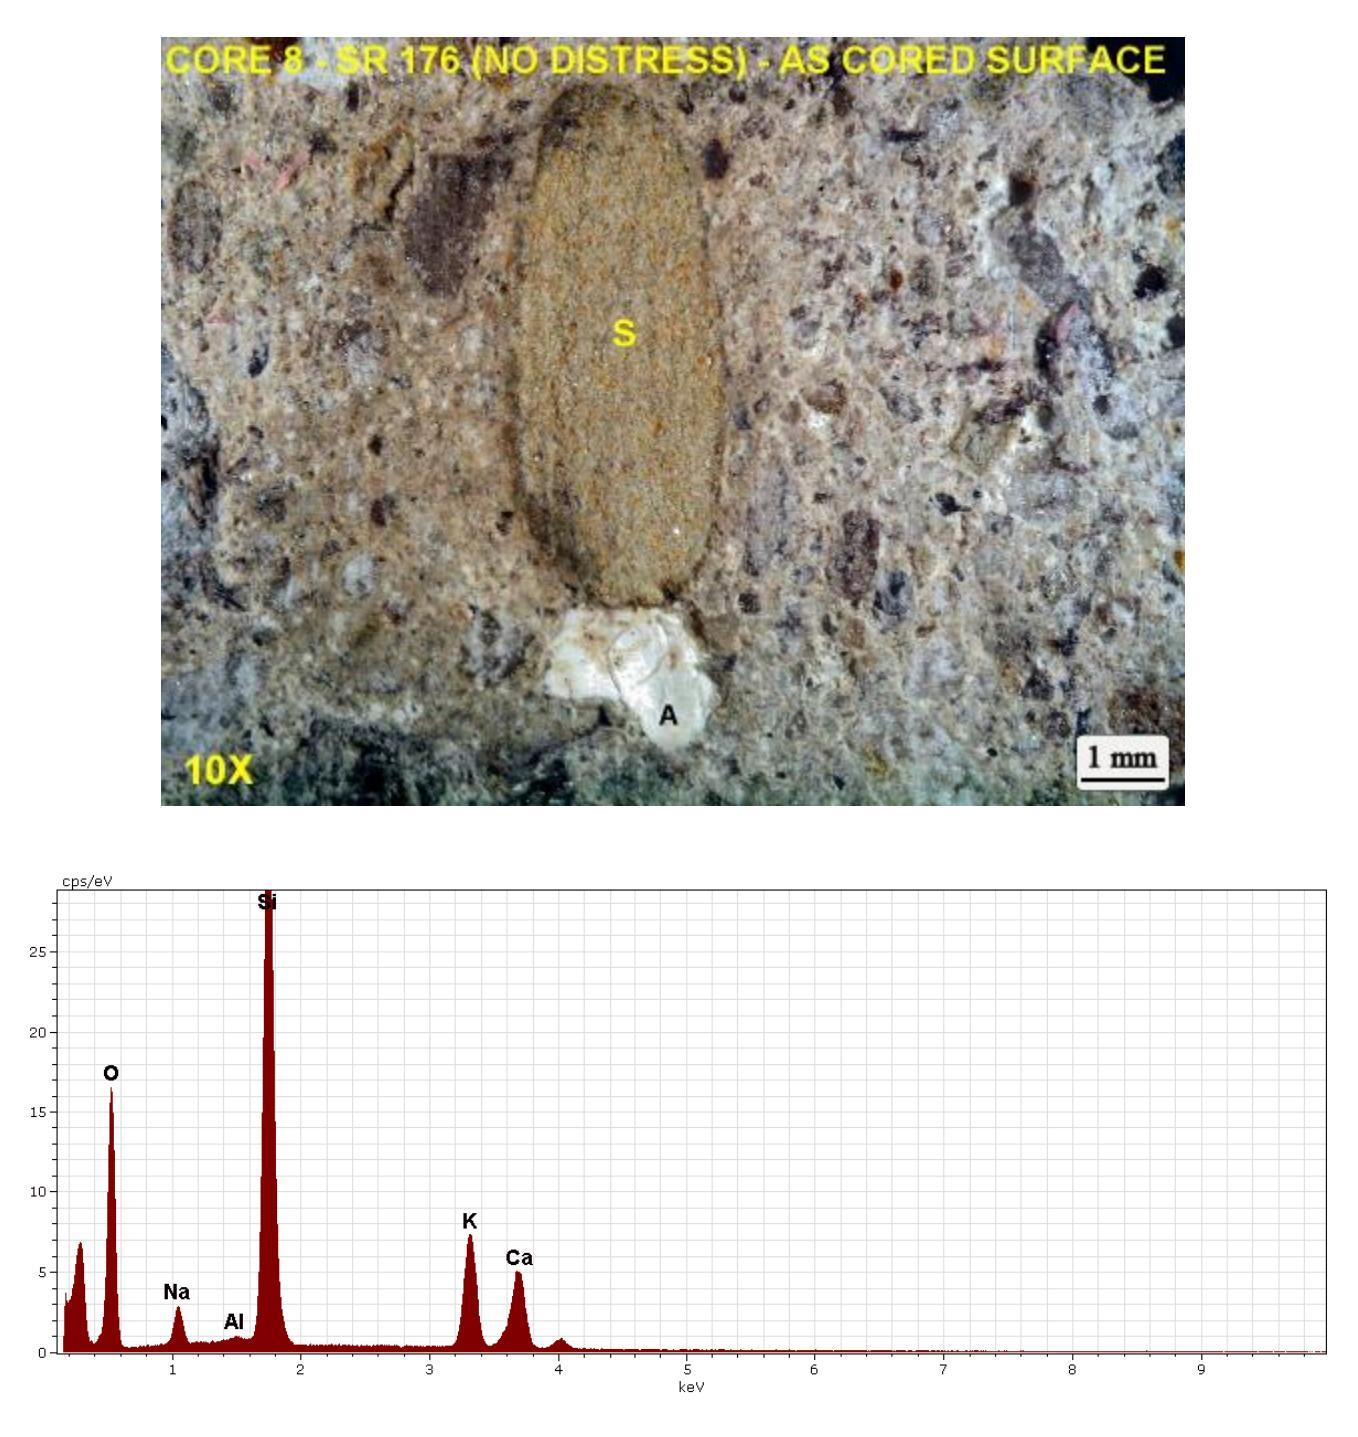
Figure 36. Enlarged view (10X) of an as-cored surface of Core 8 taken from State Route 176 at a "No-Distress" location. A siltstone fine aggregate particle (S) has undergone alkalisilica reaction activity and ASR gel (A) has been deposited in an air void adjacent to the particle. The gel was excavated from the air void for the EDX elemental analysis, which was obtained at a magnification of 1000X (Scan Number 59-C2).

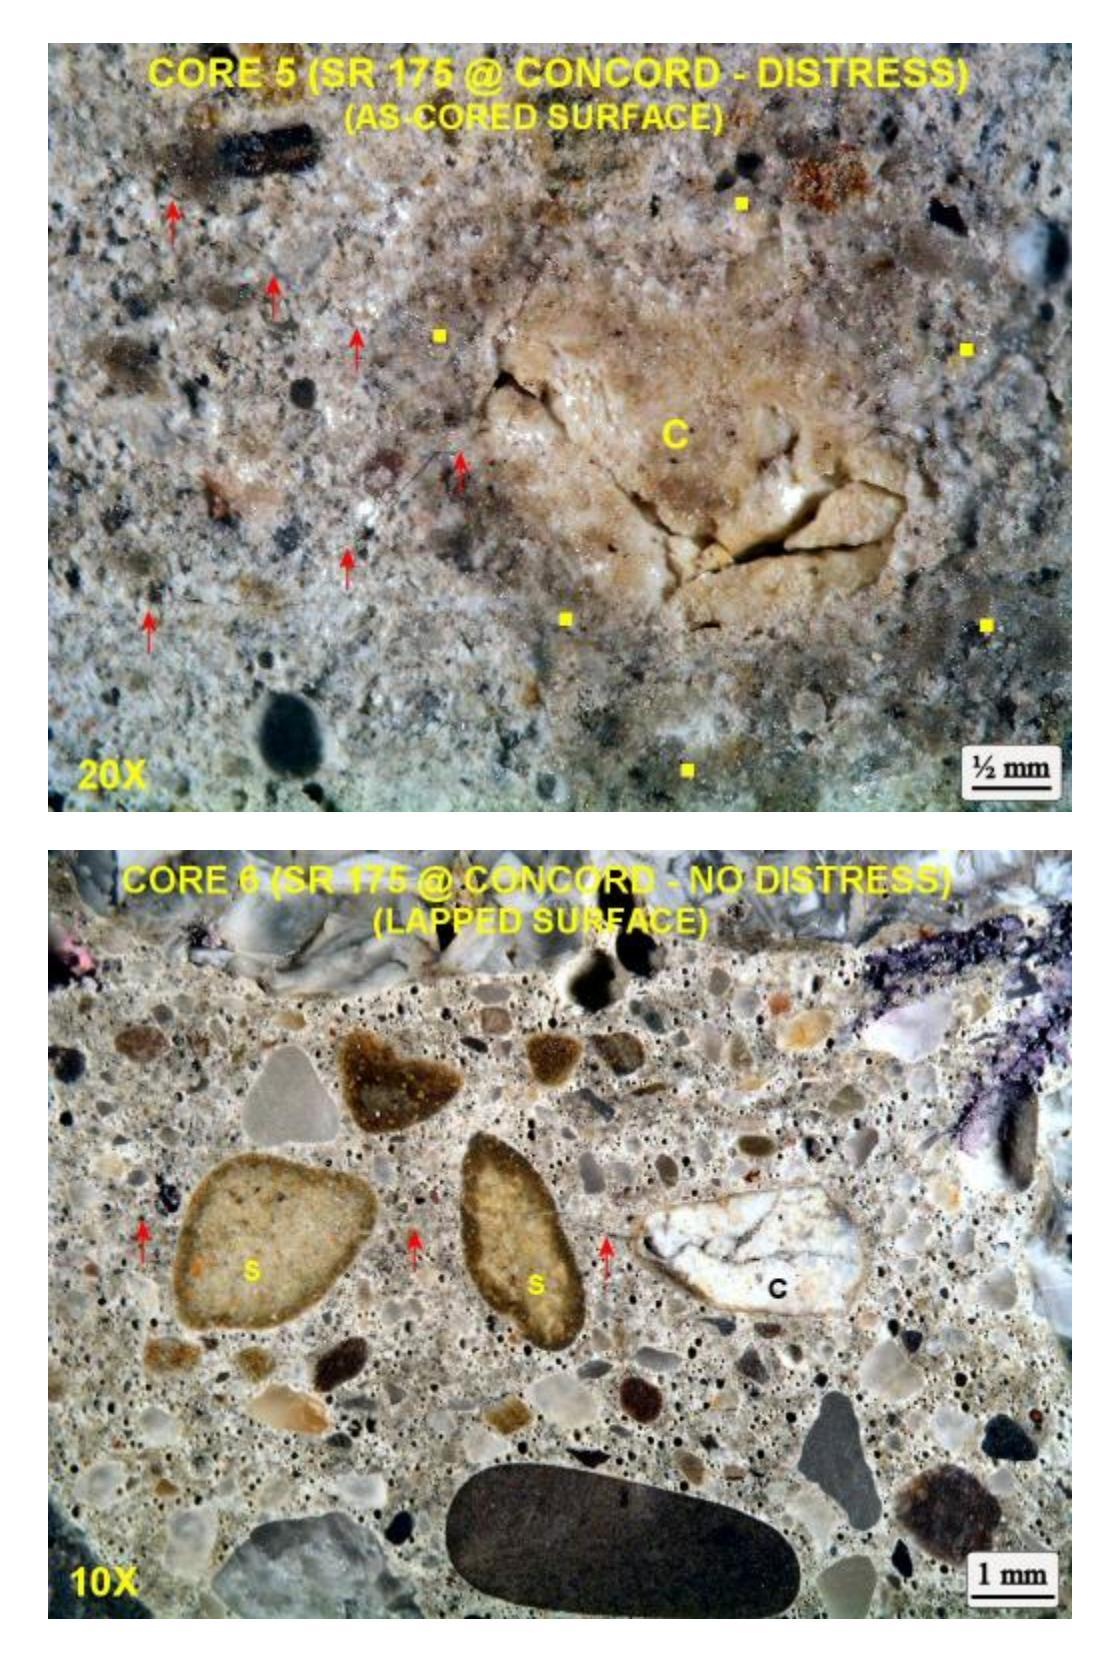
Figure 37. Enlarged views of chert fine aggregate particles (C) that have undergone alkali-silica reaction (ASR) activity in the pavement cores taken from State Route 175 @ Concord. In the top photograph the yellow dots are placed on areas of the cementitious matrix that is darkened due to infiltration of ASR gel. The red arrows in both photographs point to cracks in the cementitious matrix associated with the reaction activity. In the bottom photograph the crack originating in the chert particle passes through two siltstone fine aggregate particles (S).
