# Forensic Investigation of AC and PCC Pavements with Extended Service Life

Volume 3: Petrographic Examination of Blast Furnace Slag Aggregate Concrete Cores taken from PCC Pavements in Cuyahoga County, Ohio

David Lankard, consultant

Report FHWA/OH-2010/004C

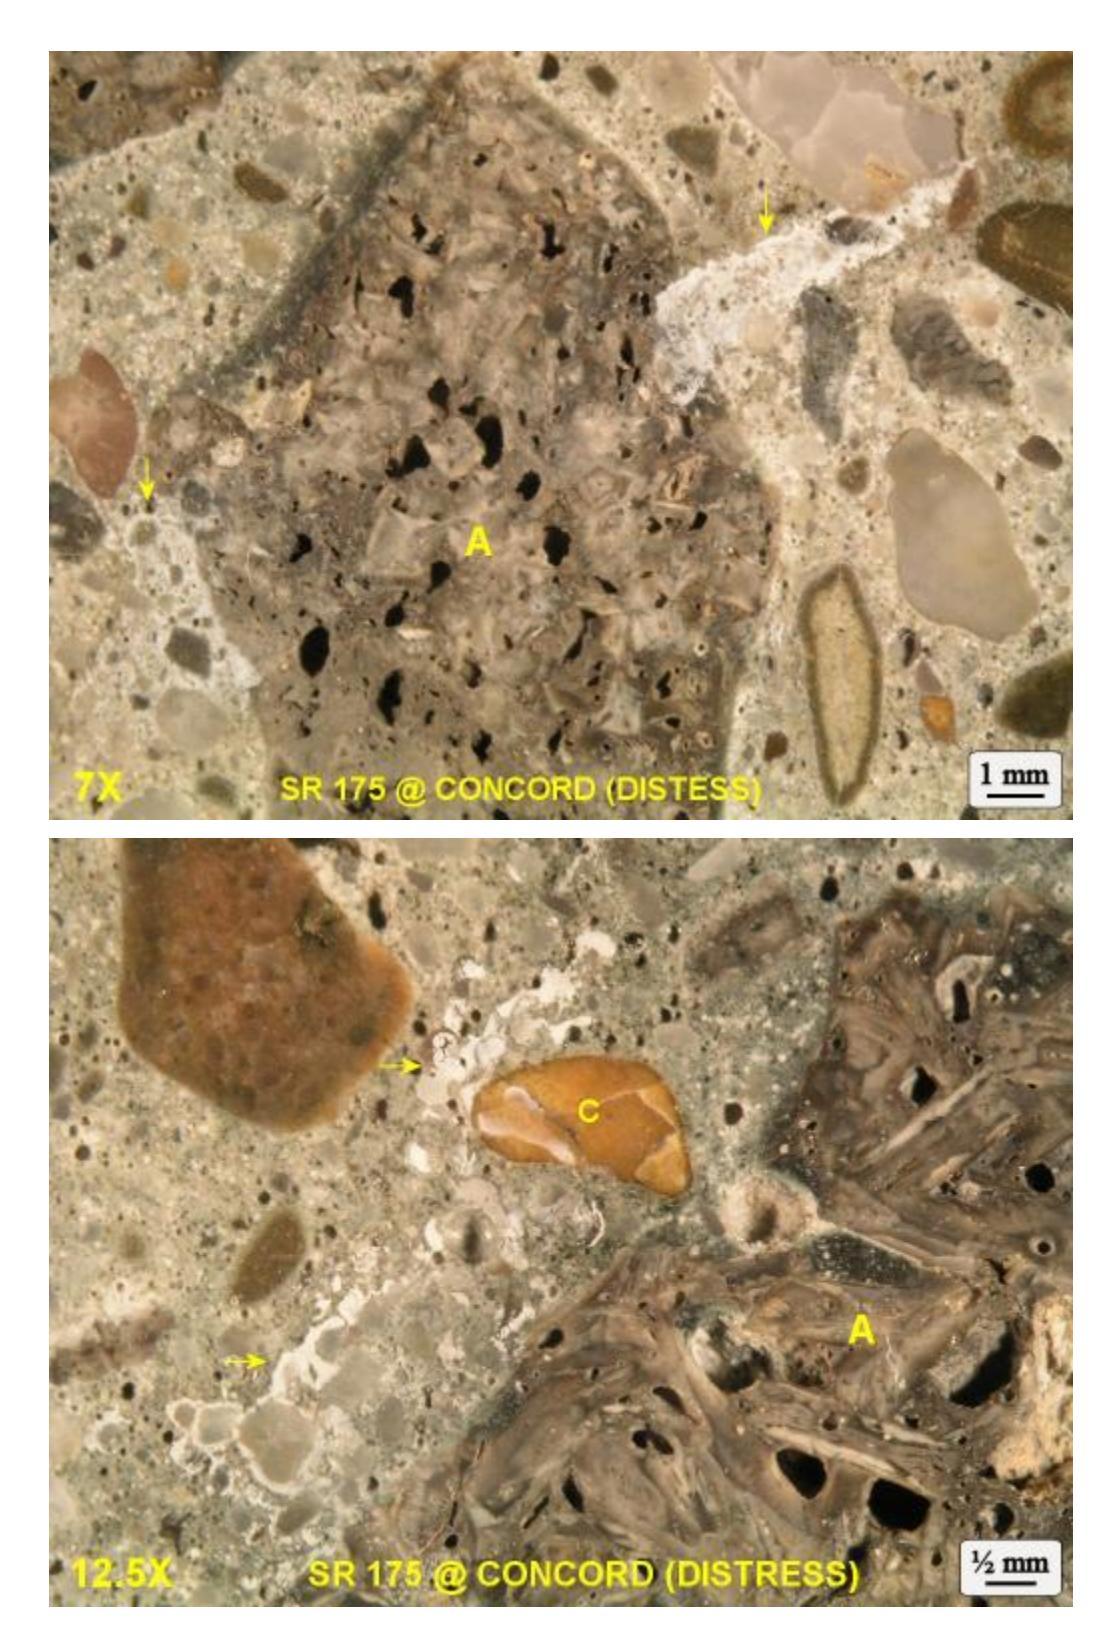
Figure 38. Lapped surfaces of Core 5 taken from SR 175 @ Concord (Distress) showing ASR gel exudate (arrows) deposited on the surfaces following a period of air drying. In the top photograph the exudate is adjacent to a slag coarse aggregate particle (A). In the bottom photograph the exudate is adjacent to a slag coarse aggregate particle (A) and a chert particle (C). WEARING SURFACE END

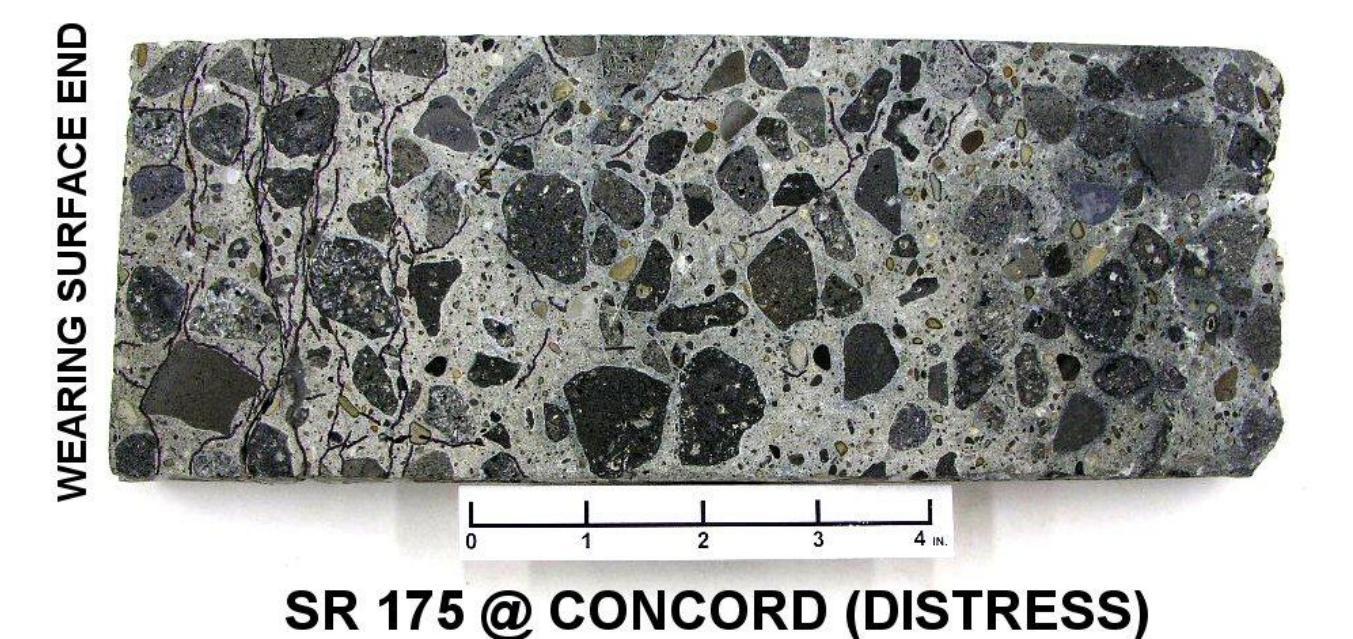
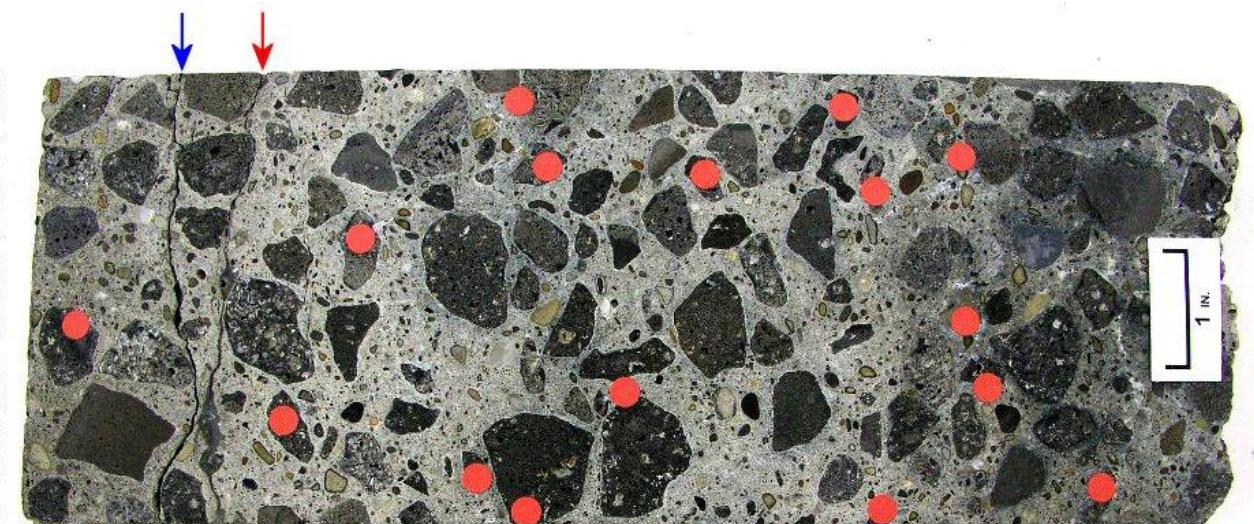
Figure 39. Two views of a lapped surface of Core 5: SR 175 @ Concord (Distress). The red dots in the top photograph are at sites where white patches of ASR gel exudate have been deposited on the surface during drying of the piece. The red arrow points to the full core width crack that was present in the as-received core. The blue arrow points to a full core width fracture that was formed at the end of the lapping operation in a pre-existing crack. The bottom photograph shows the lapped surface of the core slab following 2 weeks storage in a moist condition in a sealed plastic bag. Cracks in the core piece at this time are marked with a black marking pen.

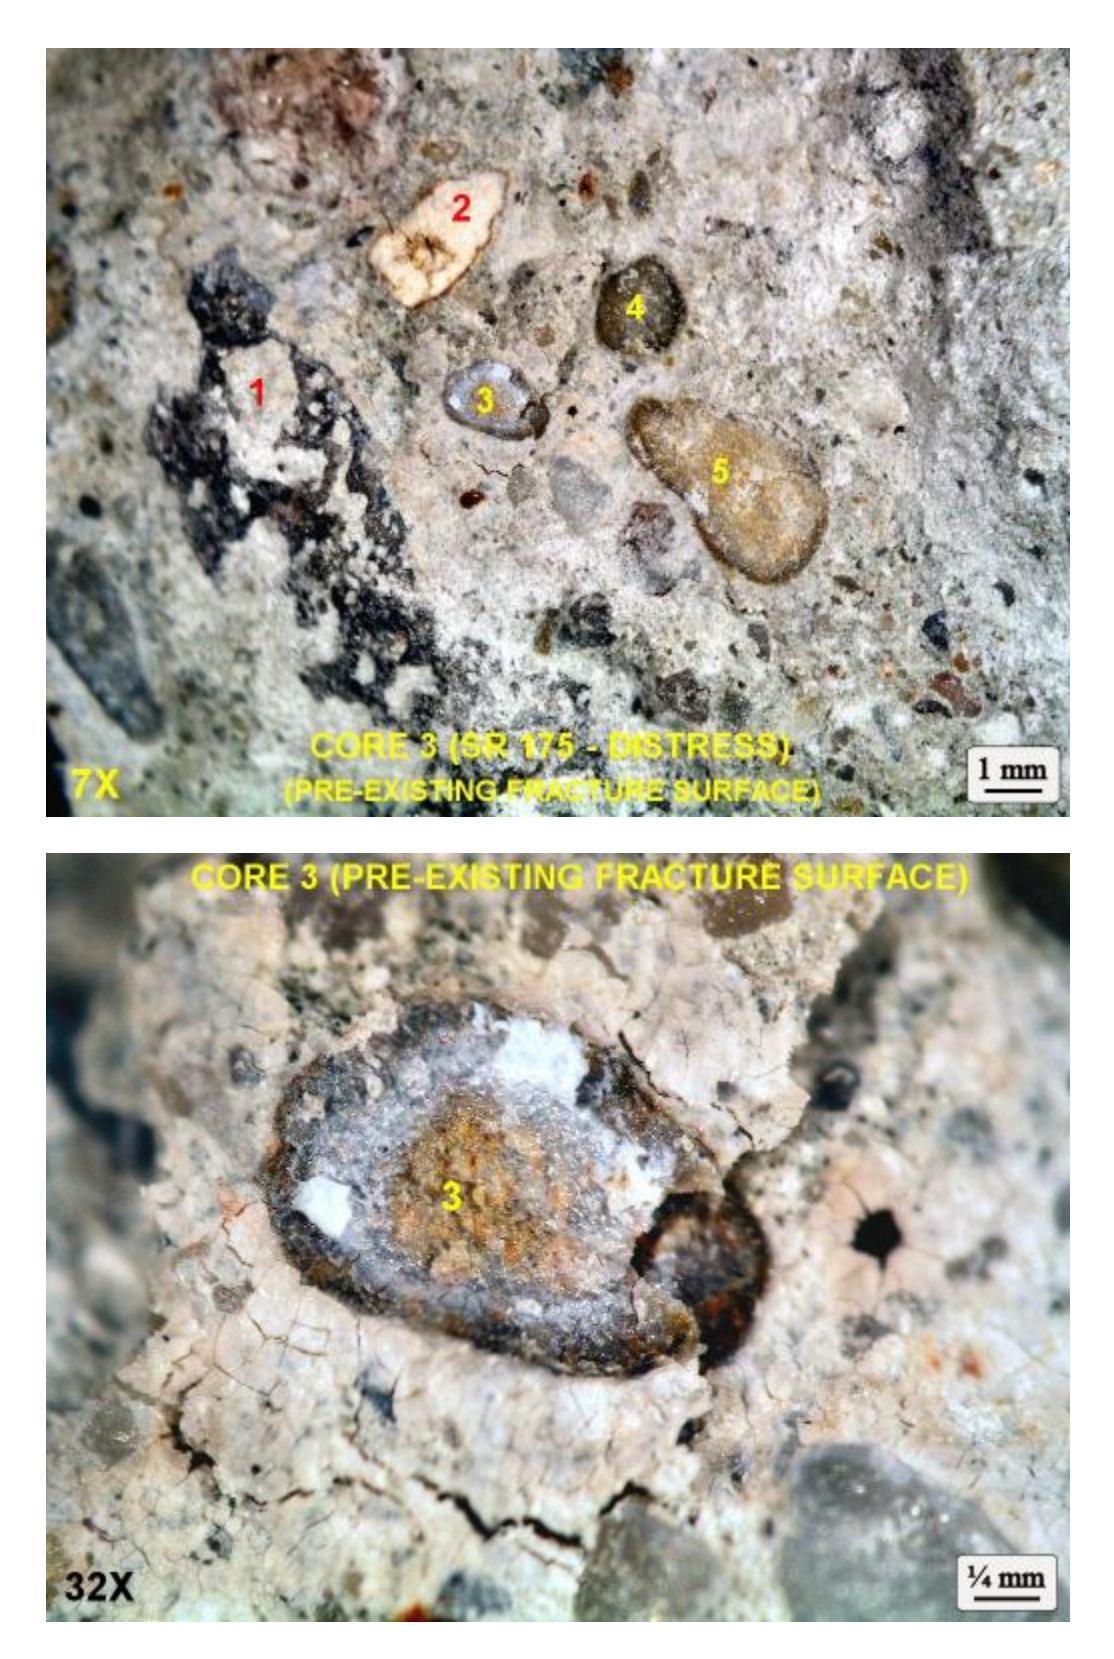
Figure 40. Two views of a pre-existing horizontal fracture surface (freshly exposed) in the top 2 in. thickness of Core 3. Core 3 was taken from SR 175 at a Distress location. Site 1 is a slag coarse aggregate particle. Site 2 is a chert fine aggregate particle. Sites 3, 4, and 5 are siltstone fine aggregate particles.

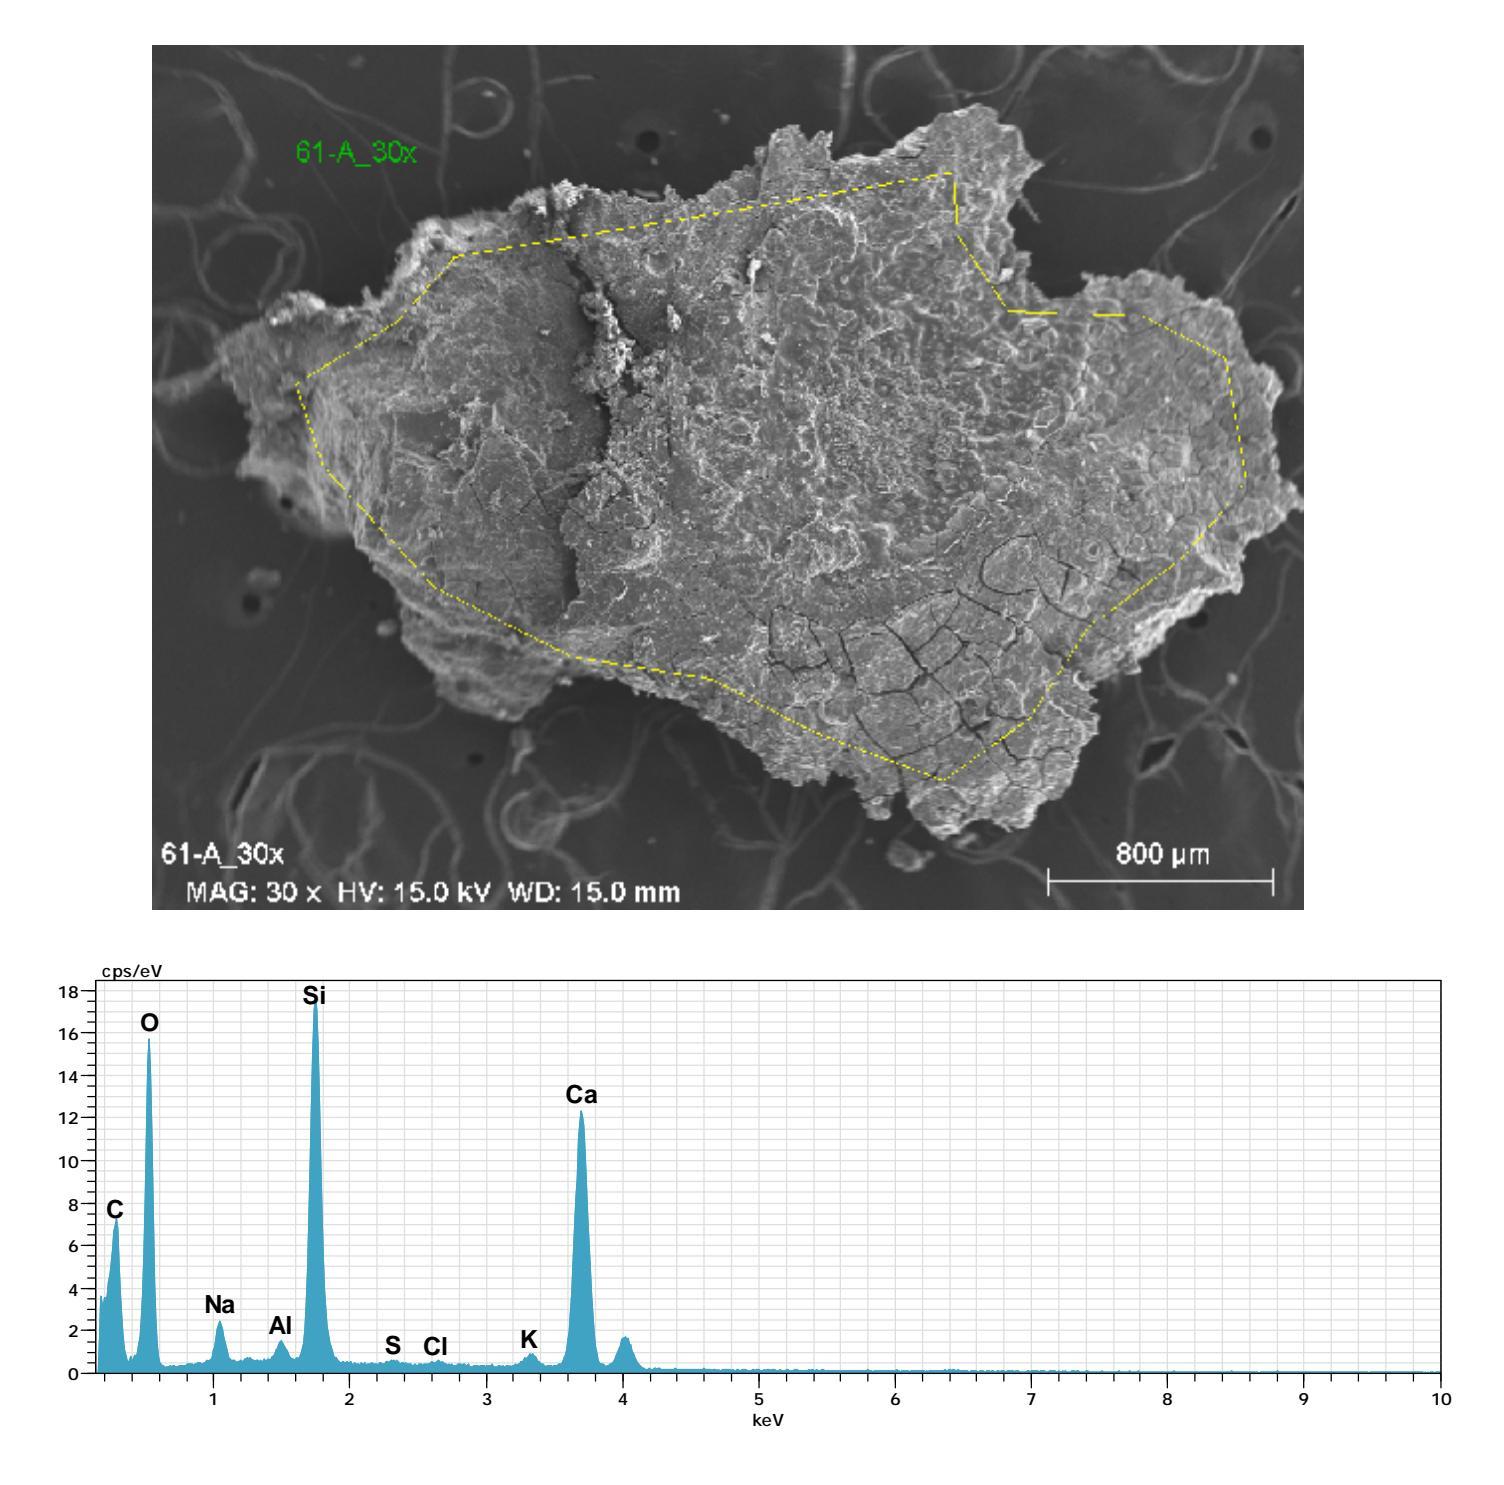
Figure 41. SEM image and EDS spectrum (30X) of Siltstone Particle #3 as shown in Figure 40. The particle was taken from a pre-existing fracture surface of Core 3 as shown in Figure 20. Core 3 was taken on State Route 175 at a "Distress" location. Contributions to the EDX spectrum include (1) constituents of the siltstone particle, (2) ASR gel, (3) ettringite, and (4) hydrated portland cement.

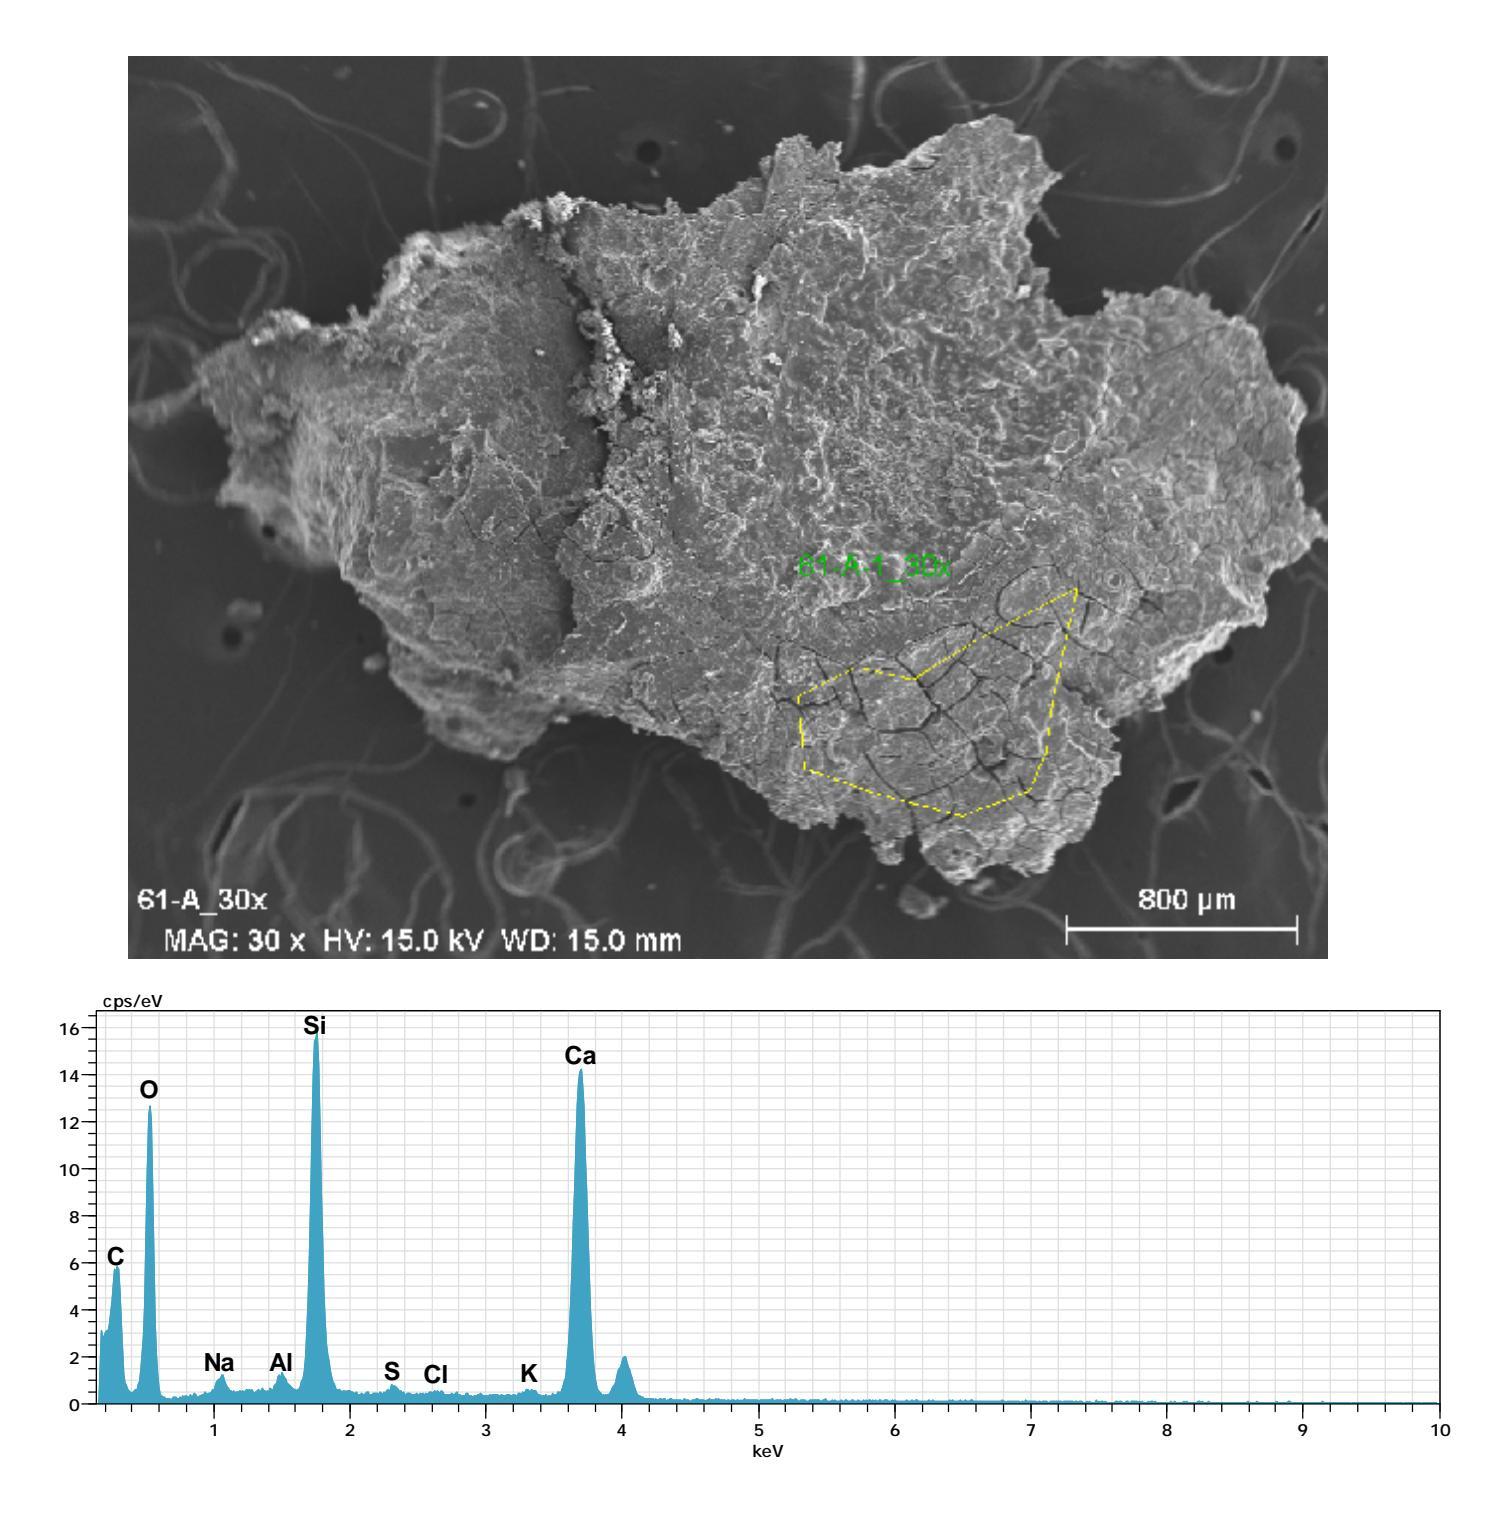
Figure 42. SEM image and EDS spectrum (30X) of the framed area shown in the above image, which is adjacent to Siltstone Particle #3. The spectrum is similar to that shown in Figure 41.

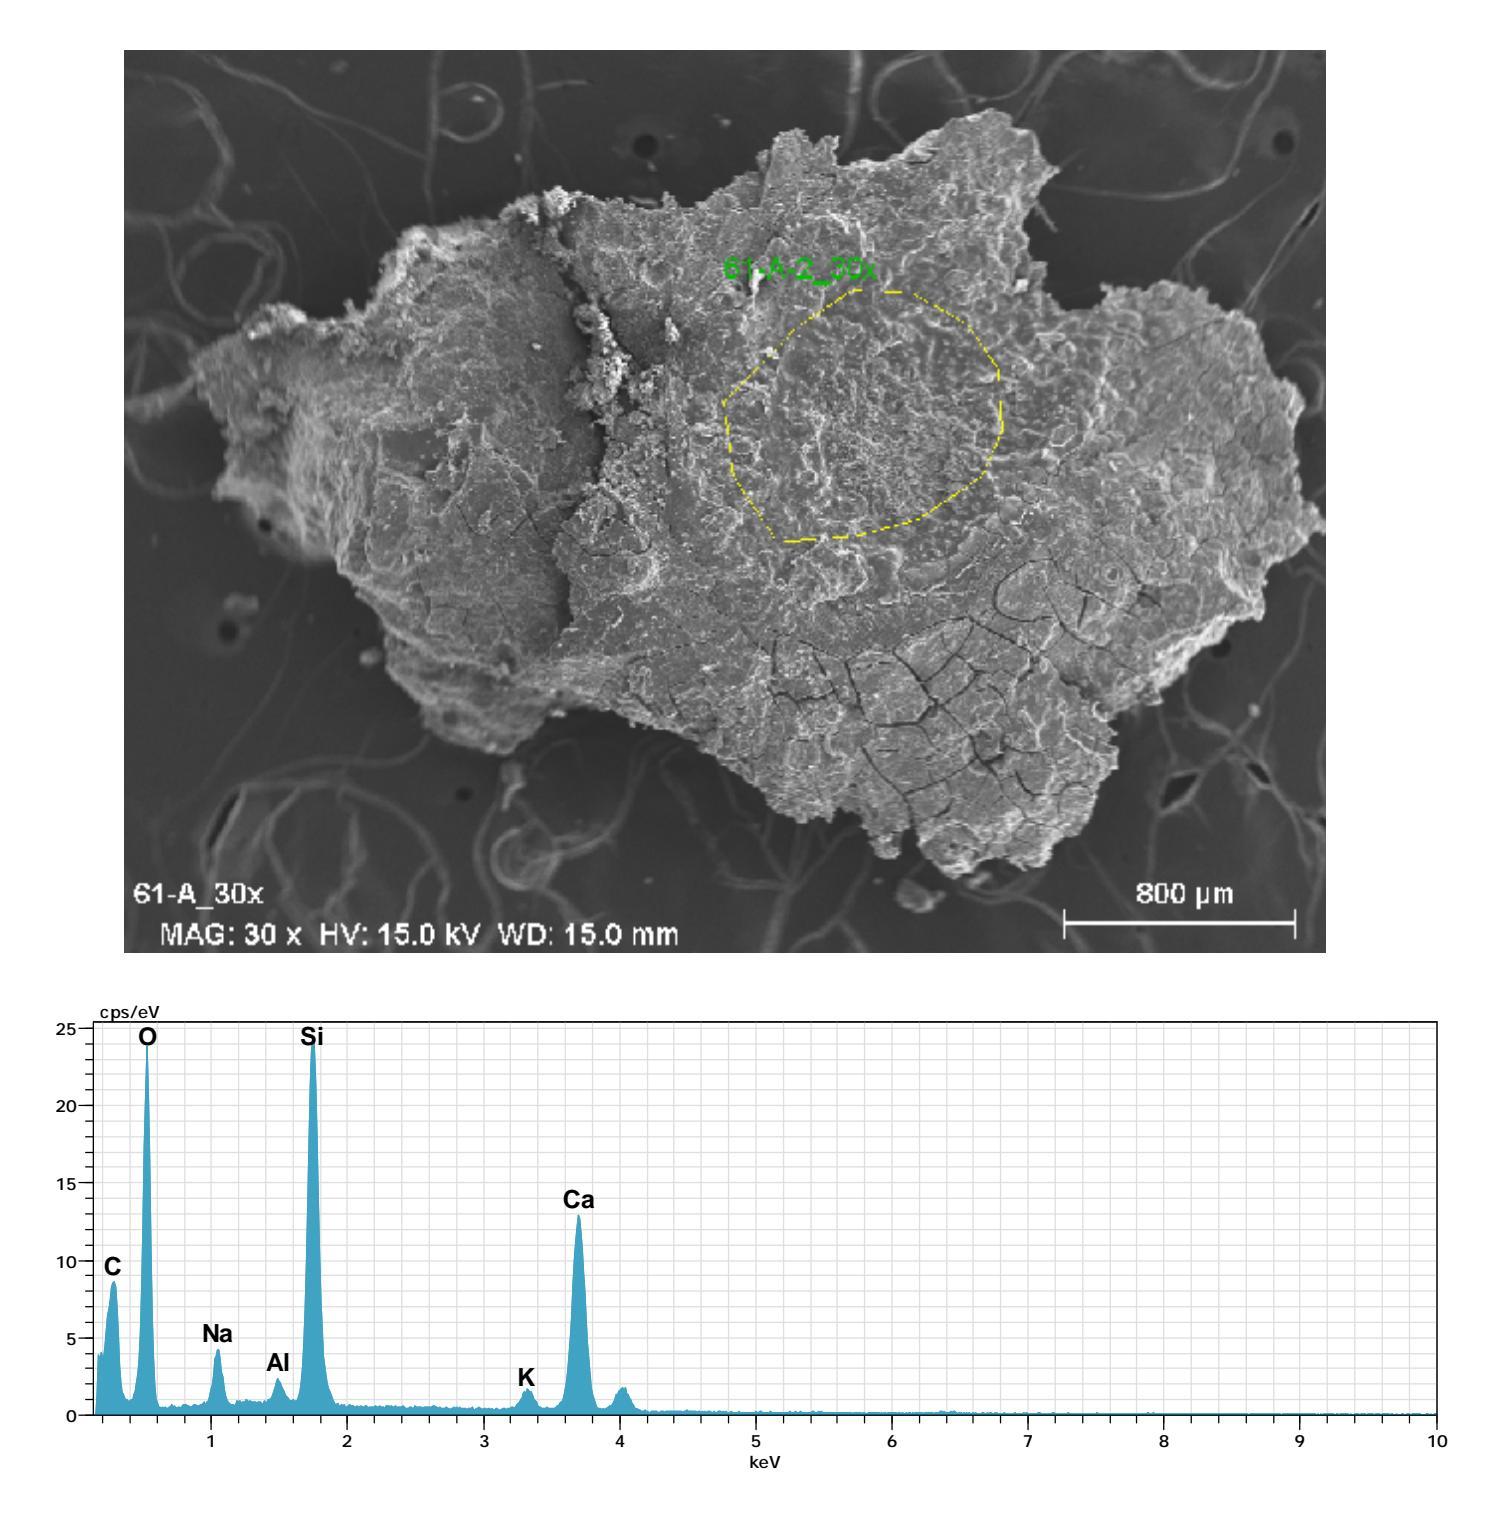
Figure 43. SEM image and EDS spectrum (30X) of the framed area shown in the above image, which is directly over the fracture surface of Siltstone Particle #3.

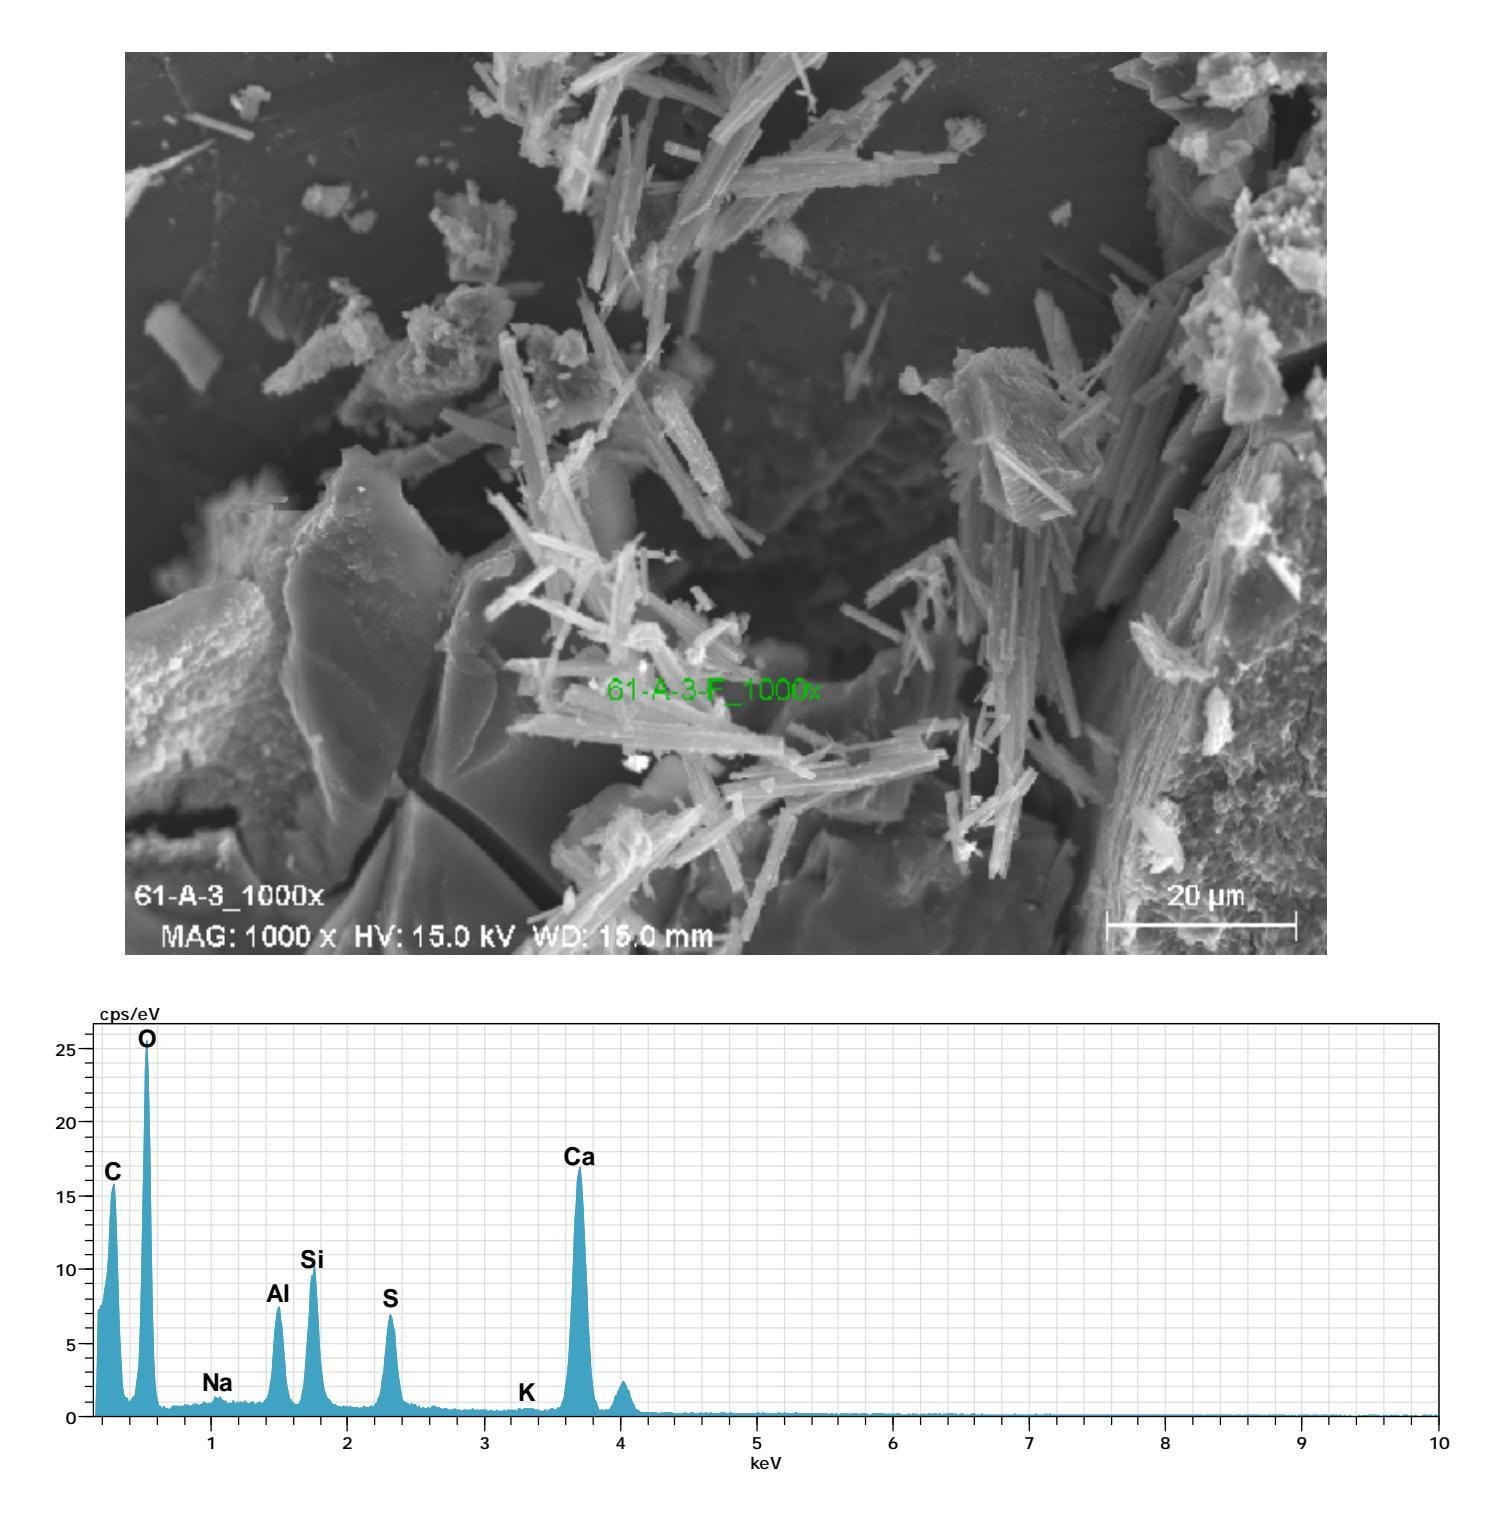
Figure 44. SEM image and EDS spectrum (1000X) of the northwest tip of the SEM study sample shown in Figures 41 through 43. This spectrum is a spot analysis at the site of the (+) on one of the ettringite fibers.

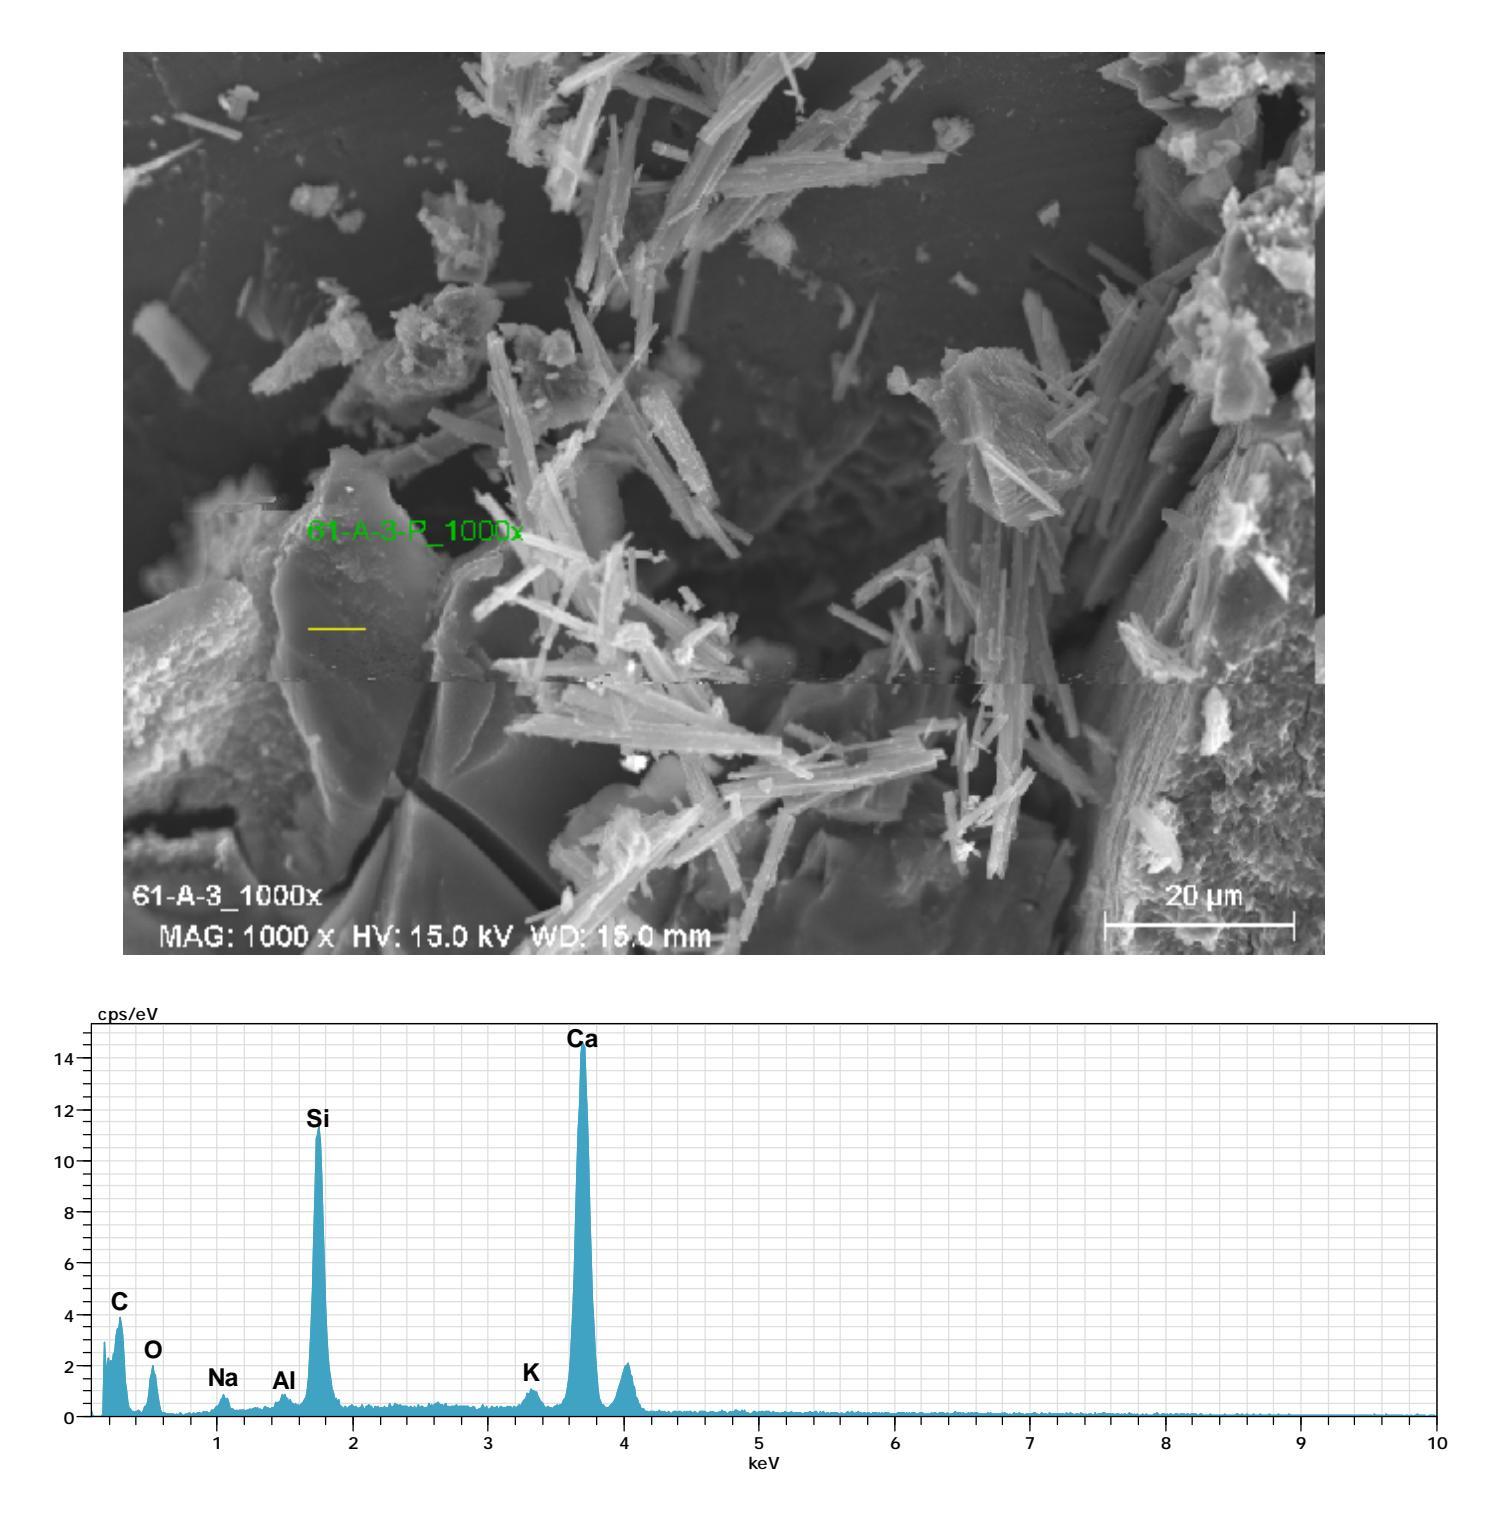
Figure 45. SEM image and EDS spectrum (1000X) of the northwest tip of the SEM study sample (Particle #3) shown in Figures 41 through 43. This spectrum is an analysis of the massive material within the framed area shown in the above image. The material is ASR gel reaction product.

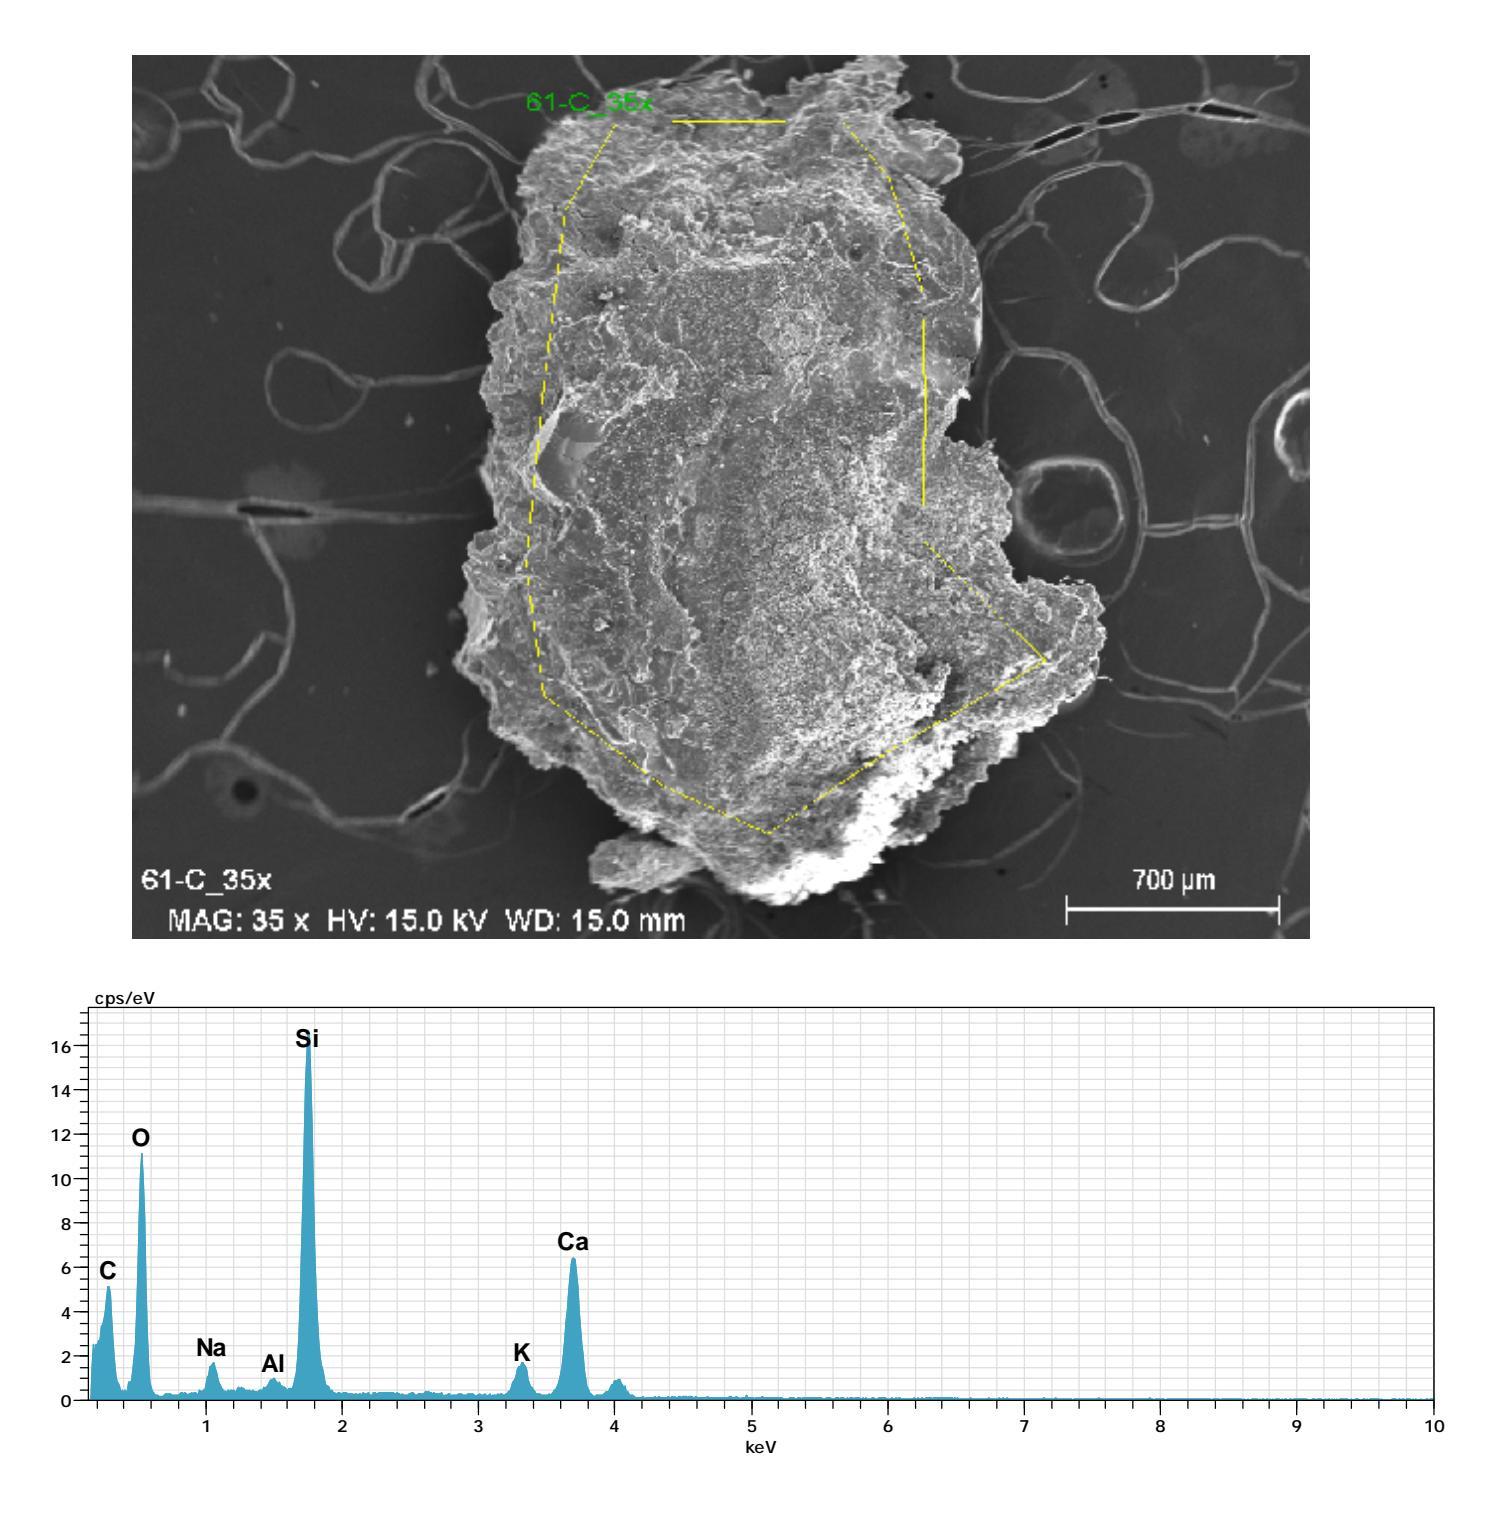
Figure 46. SEM image and EDS spectrum (35X) of Chert fine aggregate Particle #2, which is shown in the top photograph of Figure 40 as it is present on a pre-existing fracture surface of Core 3. Contributions to the elemental chemical analysis include silica from the chert particle itself, and ASR gel.

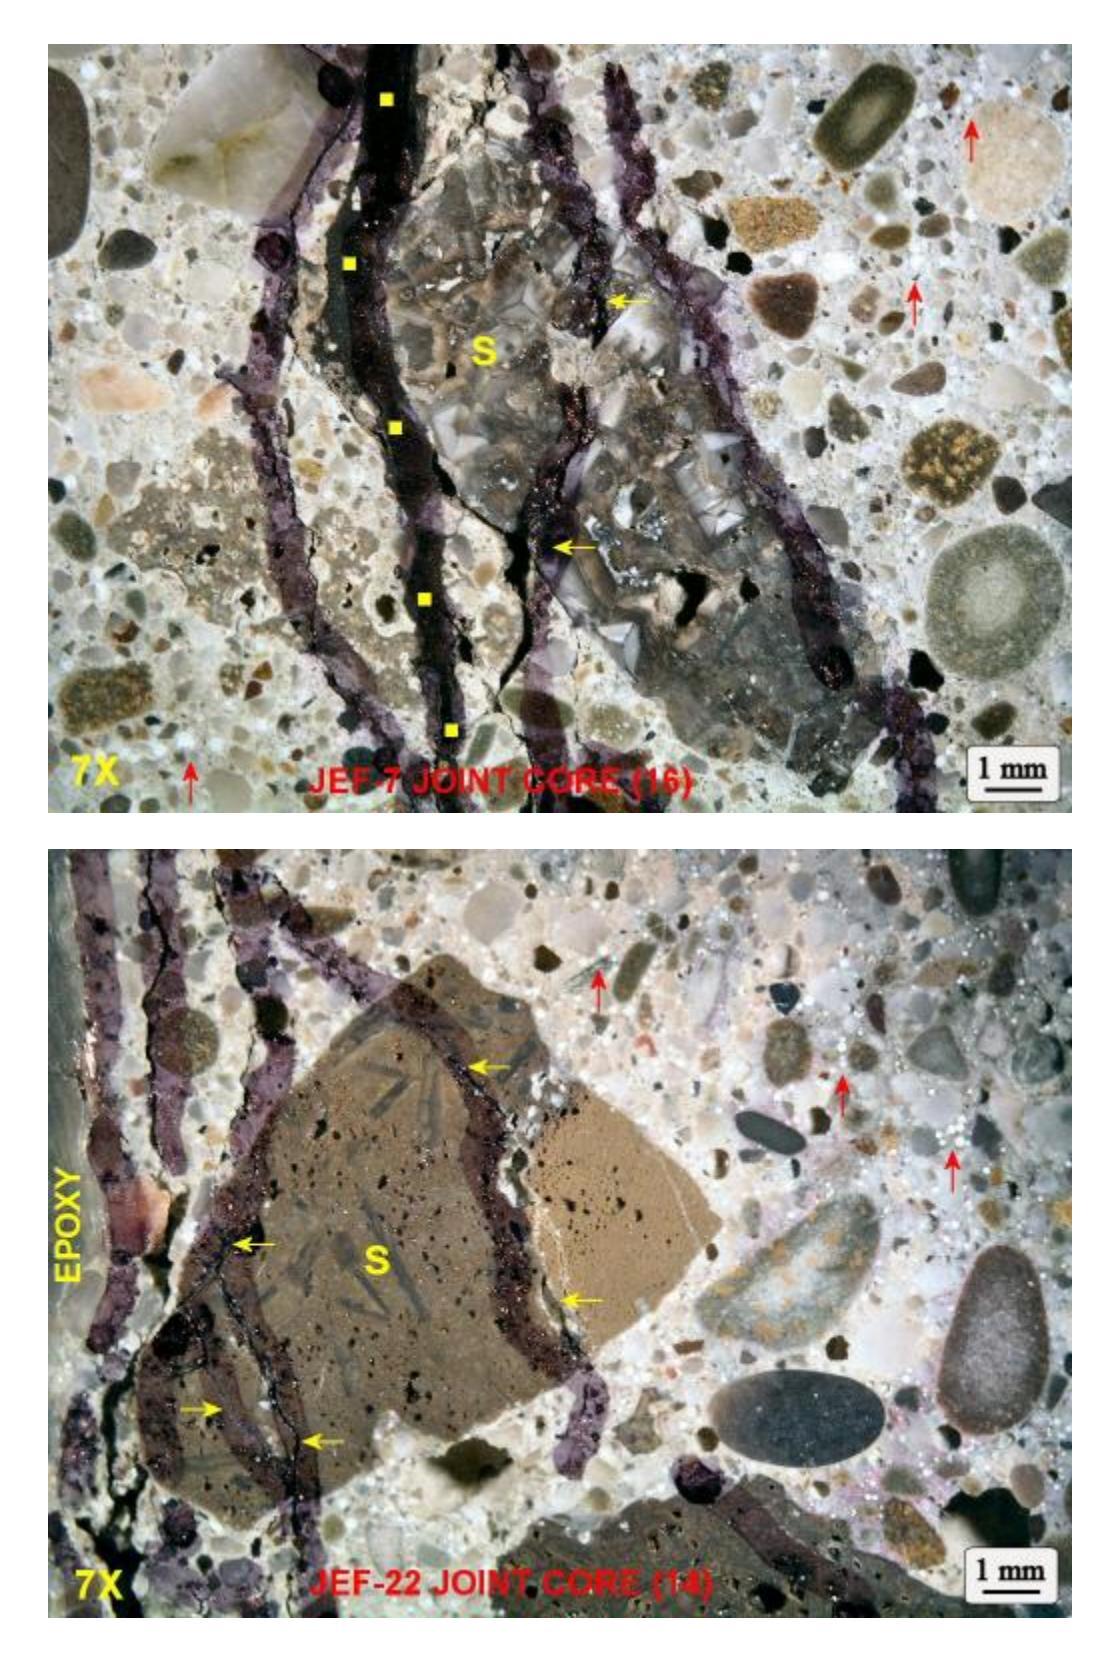
Figure 49. Lapped surface views (7X) perpendicular to the plane of the wearing surface in the Joint Cores taken from the Jefferson County slag aggregate pavements showing freeze/thaw-related cracking in the cementitious phase and slag aggregate particles (S). The red arrows point to a few of the numerous entrained are voids that are filled with ettringite deposits. The epoxy (yellow dots) is the adhesive used to reassemble the two halves of the as-received cores. The wearing surface is at the top in the photographs.
