# Forensic Investigation of AC and PCC Pavements with Extended Service Life

Volume 3: Petrographic Examination of Blast Furnace Slag Aggregate Concrete Cores taken from PCC Pavements in Cuyahoga County, Ohio

David Lankard, consultant

Report FHWA/OH-2010/004C

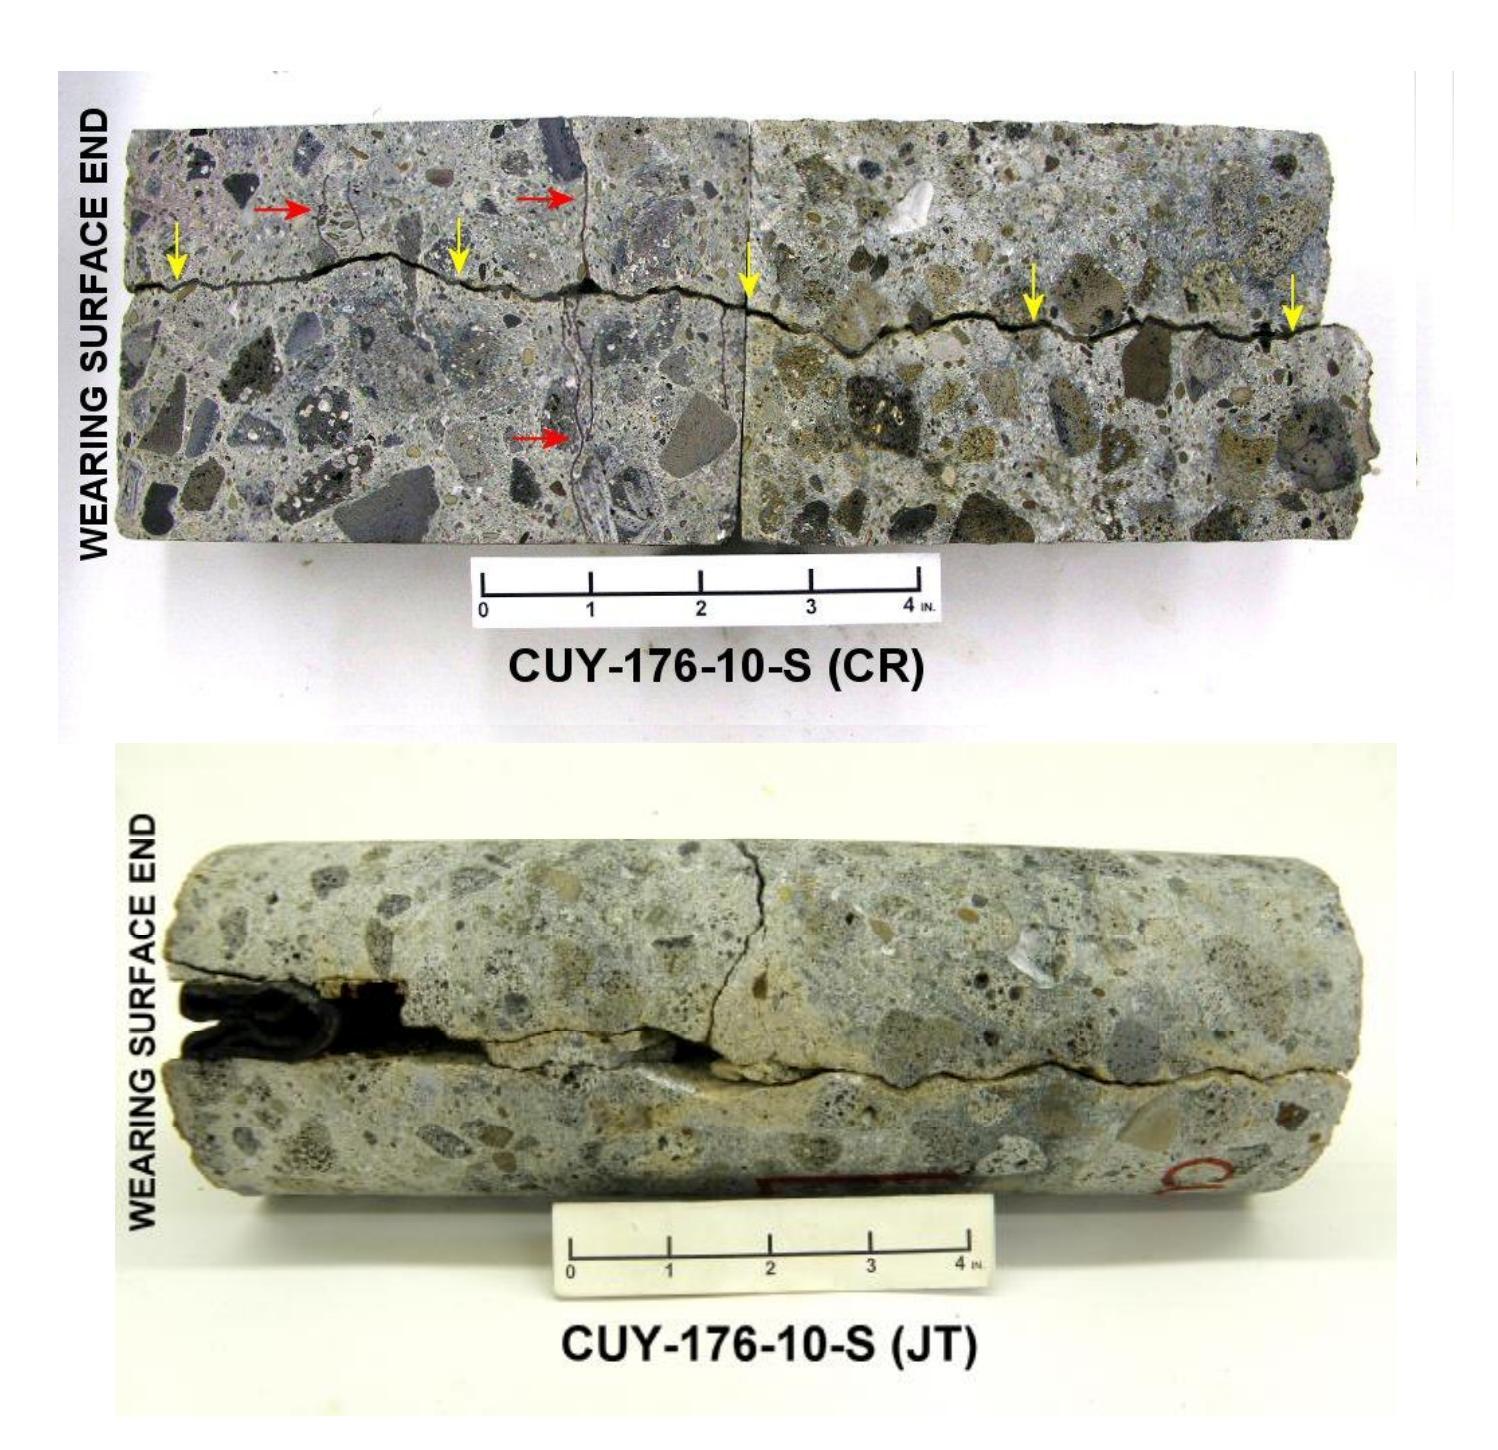
Figure 50. Cores taken from State Route 176 in Cuyahoga County, Ohio. The top photograph is a lapped surface of a core taken through a transverse crack (CR) in the pavement. The transverse crack is marked with the yellow arrows and sub-surface horizontal cracks are marked with red arrows. The bottom photograph is a core taken through a transverse control joint in the condition in which it was received at our laboratory. There is spalling along the joint crack and some sub-surface horizontal cracking about 5 in. (13 cm) below the wearing surface.

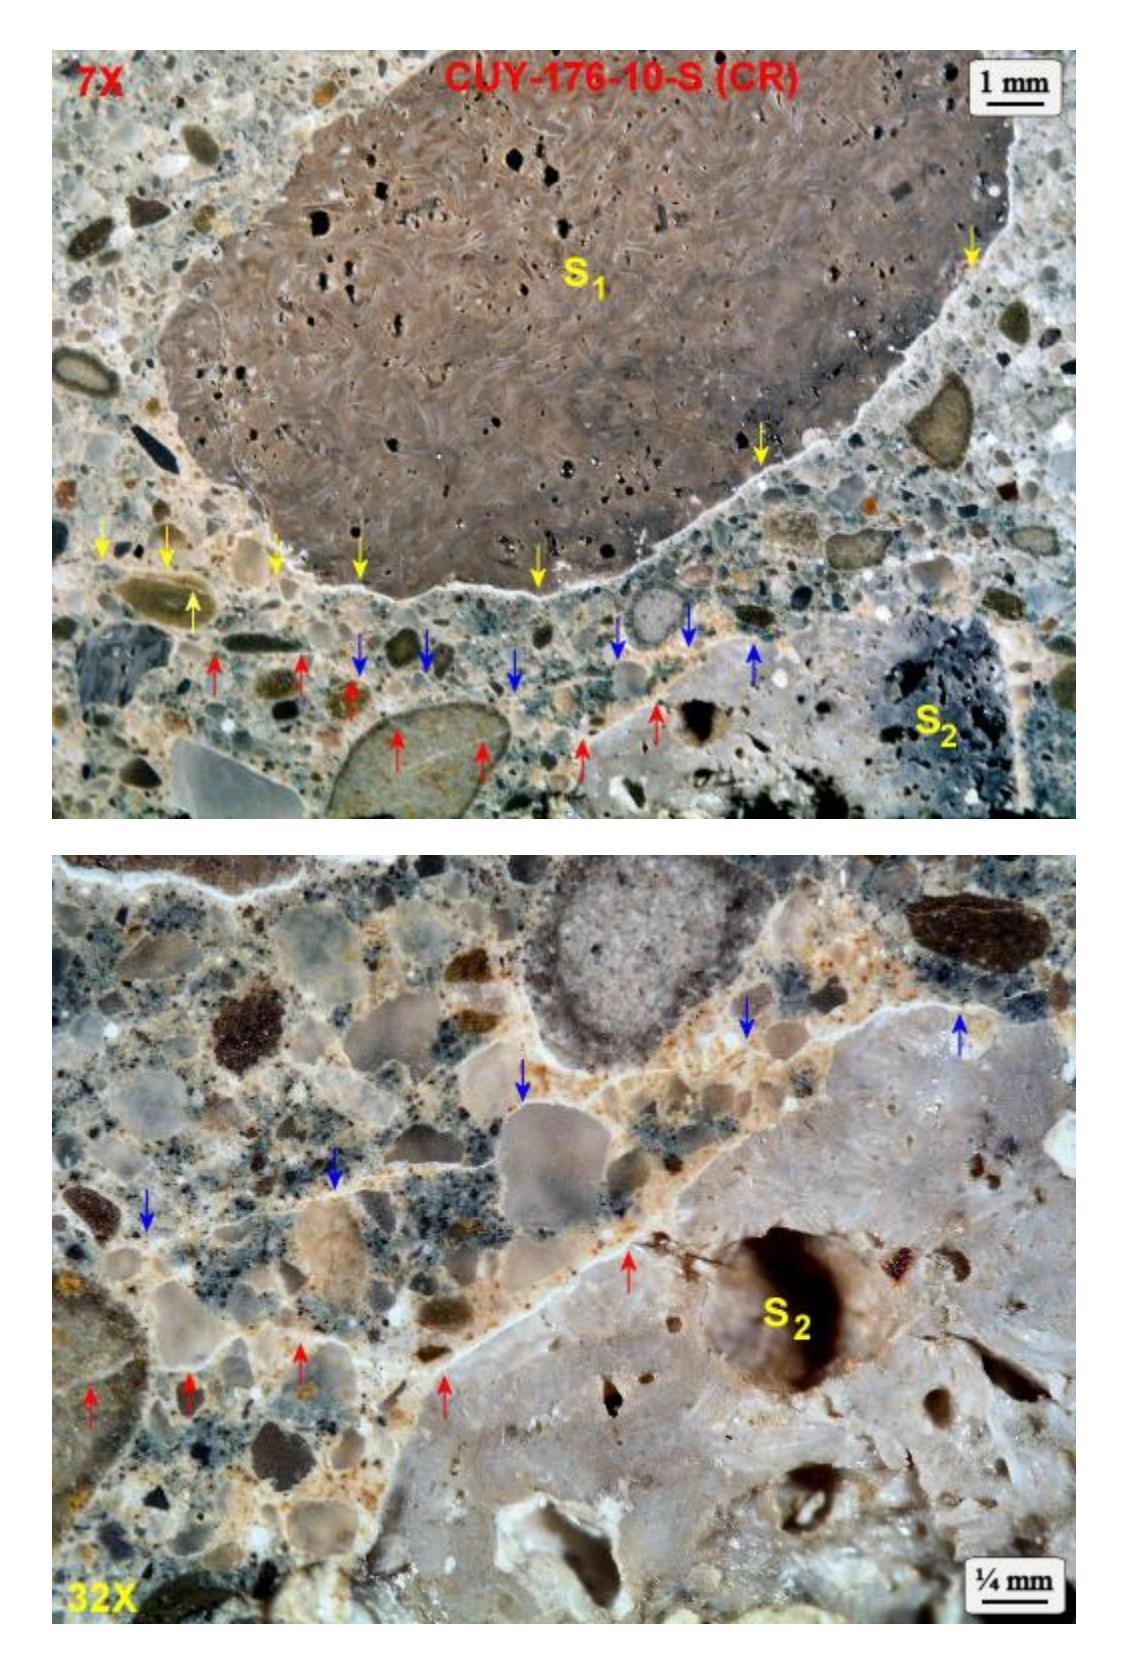
Figure 51. Lapped surface views (7X and 32X) of the Mid-Slab Crack Core taken from the southbound mainline pavement on SR 176 in Cuyahoga County, Ohio. The wearing surface is at the top in the photographs. The location is 5 in. below the wearing surface. The arrows point to the paths of very tight cracks that pass around slag aggregate particles (S1 and S2) and through a number of siltstone particles. The cracks are lined over much of their length with ettringite deposits.
