EVALUATION OF ALTERNATIVE DOWEL BAR MATERIALS AND COATINGS

Final Report

Ohio Department of Transportation Office of Research and Development

> > November 2011

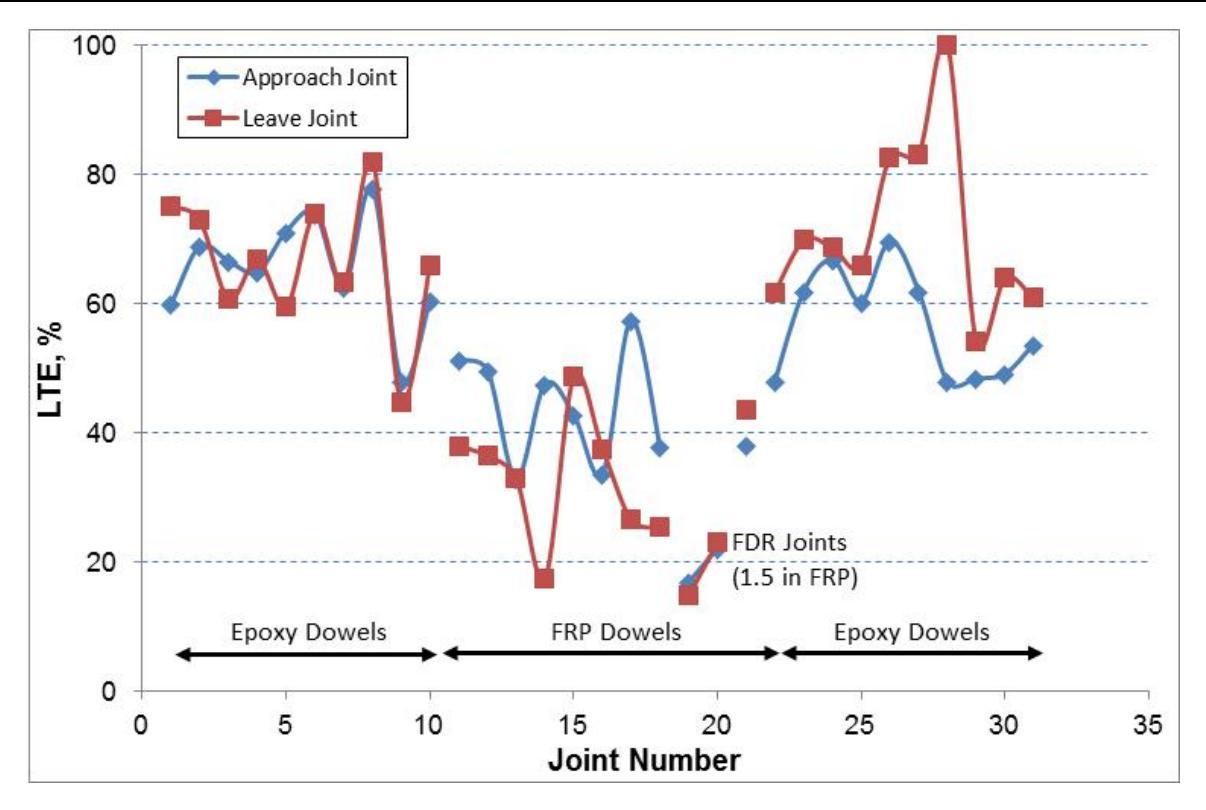
Coring of dowel bars on BEL-7 (see Table C-3 in Appendix C) showed that the only FRP bar retrieved was exhibiting no deterioration, whereas epoxy-coated bars in nearby adjacent joints were showing various types of deterioration, including the splitting of the epoxy coating, rusting of the bar under the coating, and some pitting where the steel had been exposed. It is interesting that the 1.25-in (32-mm) diameter vinyl ester resin with 78 percent E-glass FRP dowels on SR 7 performed significantly better than the 1.5-in (38-mm) polyester resin FRP dowels on U.S. 50, based on similar age comparisons (SR 7 data in 1998 from the MDA [1998] report after 15 years of service, and the U.S. 50 data collected in 2011 after 14 years of service).

Figure 10. 2011 LTE data for BEL-7.

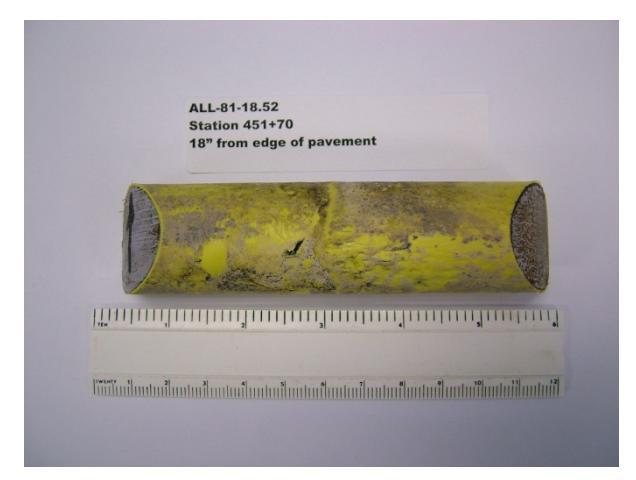
A photo of the dowel coating from a typical core (see Figures 11 and 12) and two photos of the excellent condition of the surface of the pavements (see Figures 13 and 14) demonstrate the outstanding performance of the plastic-coated dowels. Over their 33-year service lives, the pavements on Route 81 in Allen County had sustained nearly 10 million ESAL applications whereas the pavements on Route 59 in Summit County had sustained approximately 6 million ESAL applications.

Figure 11. Photo of plastic-coating of dowel on State Route 81 after 33 years of service.

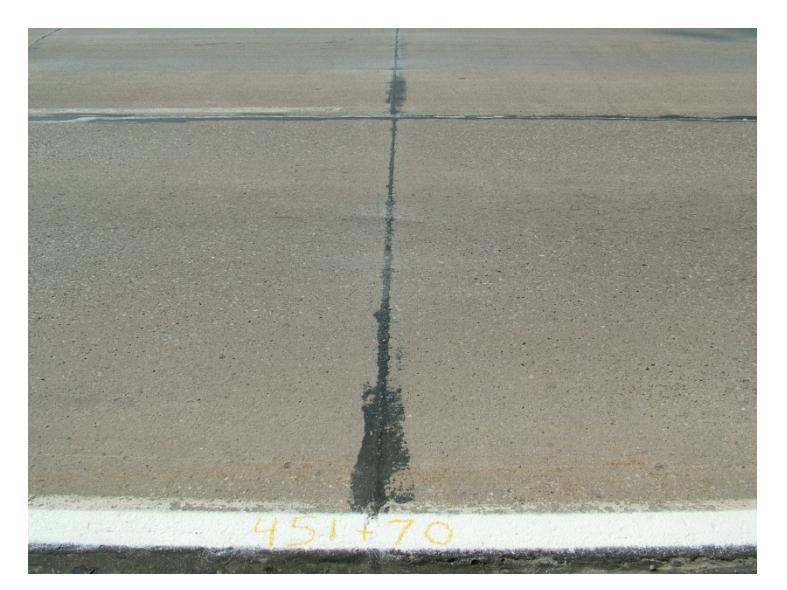
Figure 13. Photo of surface condition of pavement with plastic-coated dowels (State Route 81).

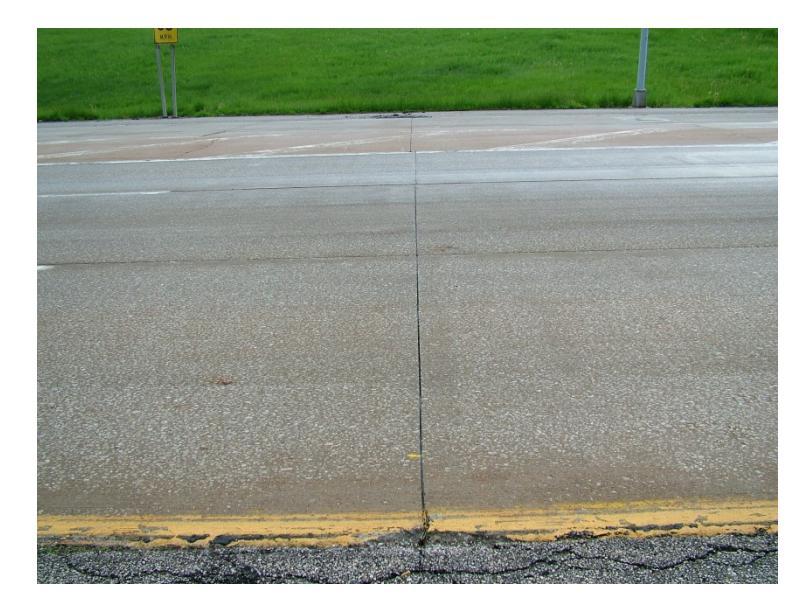
Figure 14. Photo of surface condition of pavement with plastic-coated dowels (State Route 59).

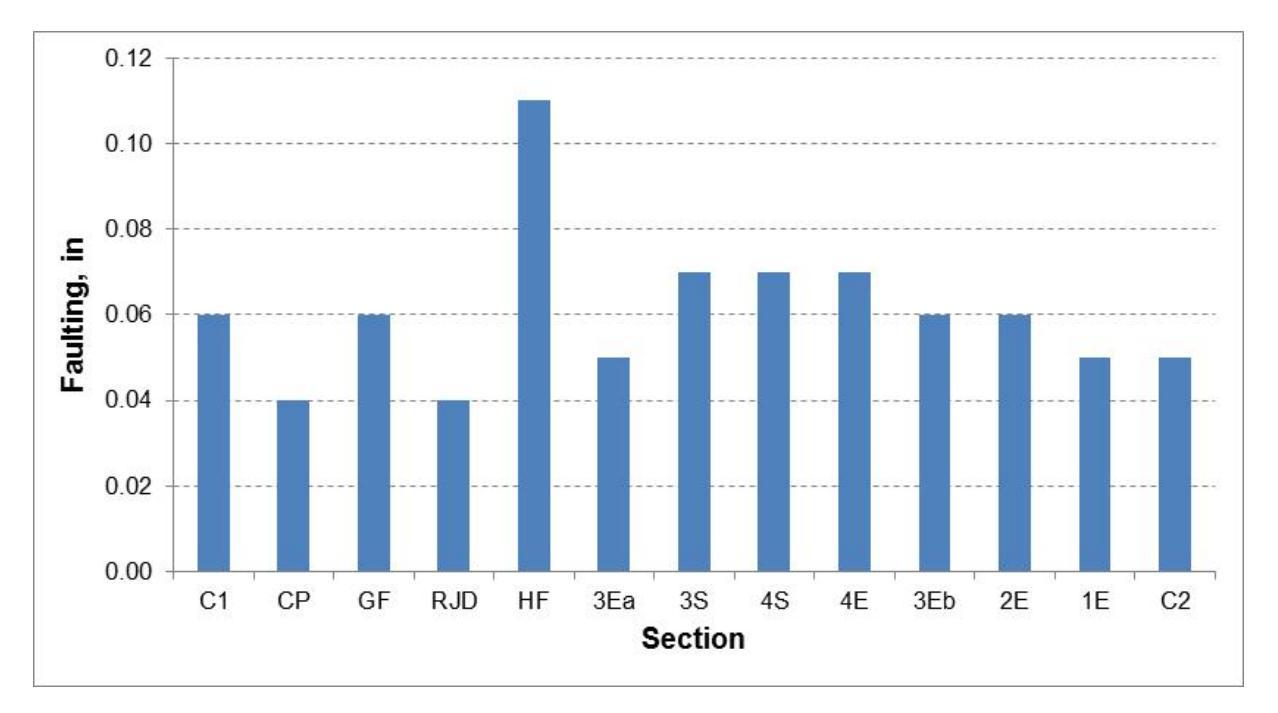
Figure 18 presents the average 2010 faulting data for each of the WI 2 sections. The faulting levels are generally reasonable for a 13-year-old pavement, with levels exceeding about 0.1 in (2.5 mm) beginning to have a noticeable effect on ride. To date, only one section has exceeded that value (HF, the section with stainless steel tubes).

Figure 18. Average 2010 faulting values for WI 2 sections.

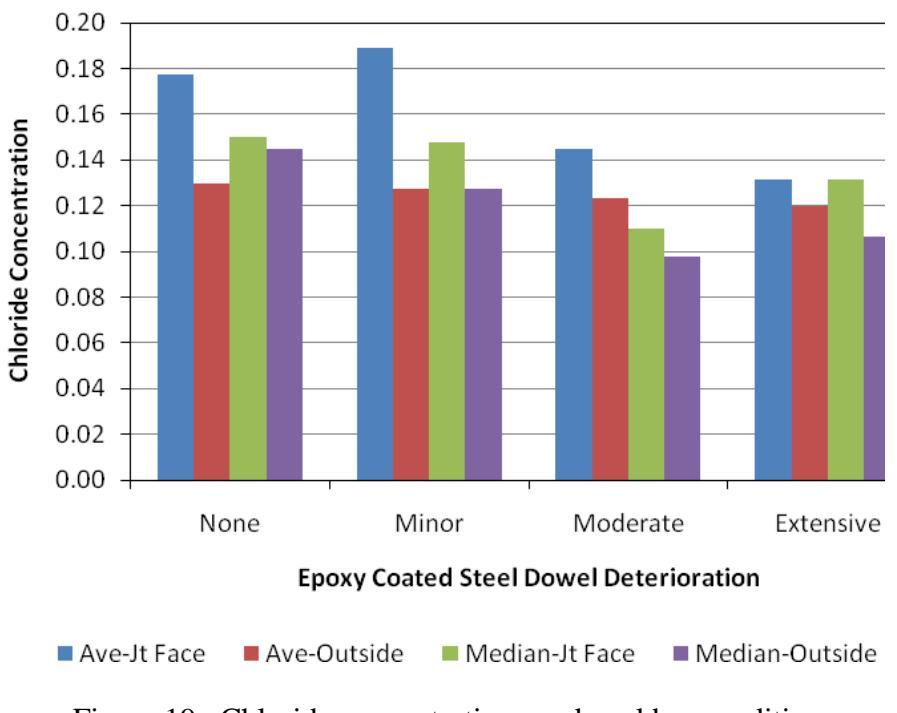
The limited investigation of the dowel bars on this experimental section after 13 years of traffic verified the low LTEs on the FRP dowel sections, which likely will affect their long-term performance. Larger diameter dowels or closer dowel spacing will be required to help increase the LTE. The greater flexibility of the FRP dowels also appears to decrease performance compared to the epoxy-coated mild steel dowels used as control when poor support conditions (poor durability of the concrete at the joint, or poor support of the base/subbase/subgrade) are present. There was minor corrosion/deterioration of one of the FRP dowels likely due to abrasion of the surface. One of the four epoxy-coated dowels removed from the cores showed loss of a small section of coating at the joint and one dowel bar had some loss of section due to corrosion at the joint.

Figure 19. Chloride concentration vs. dowel bar condition.

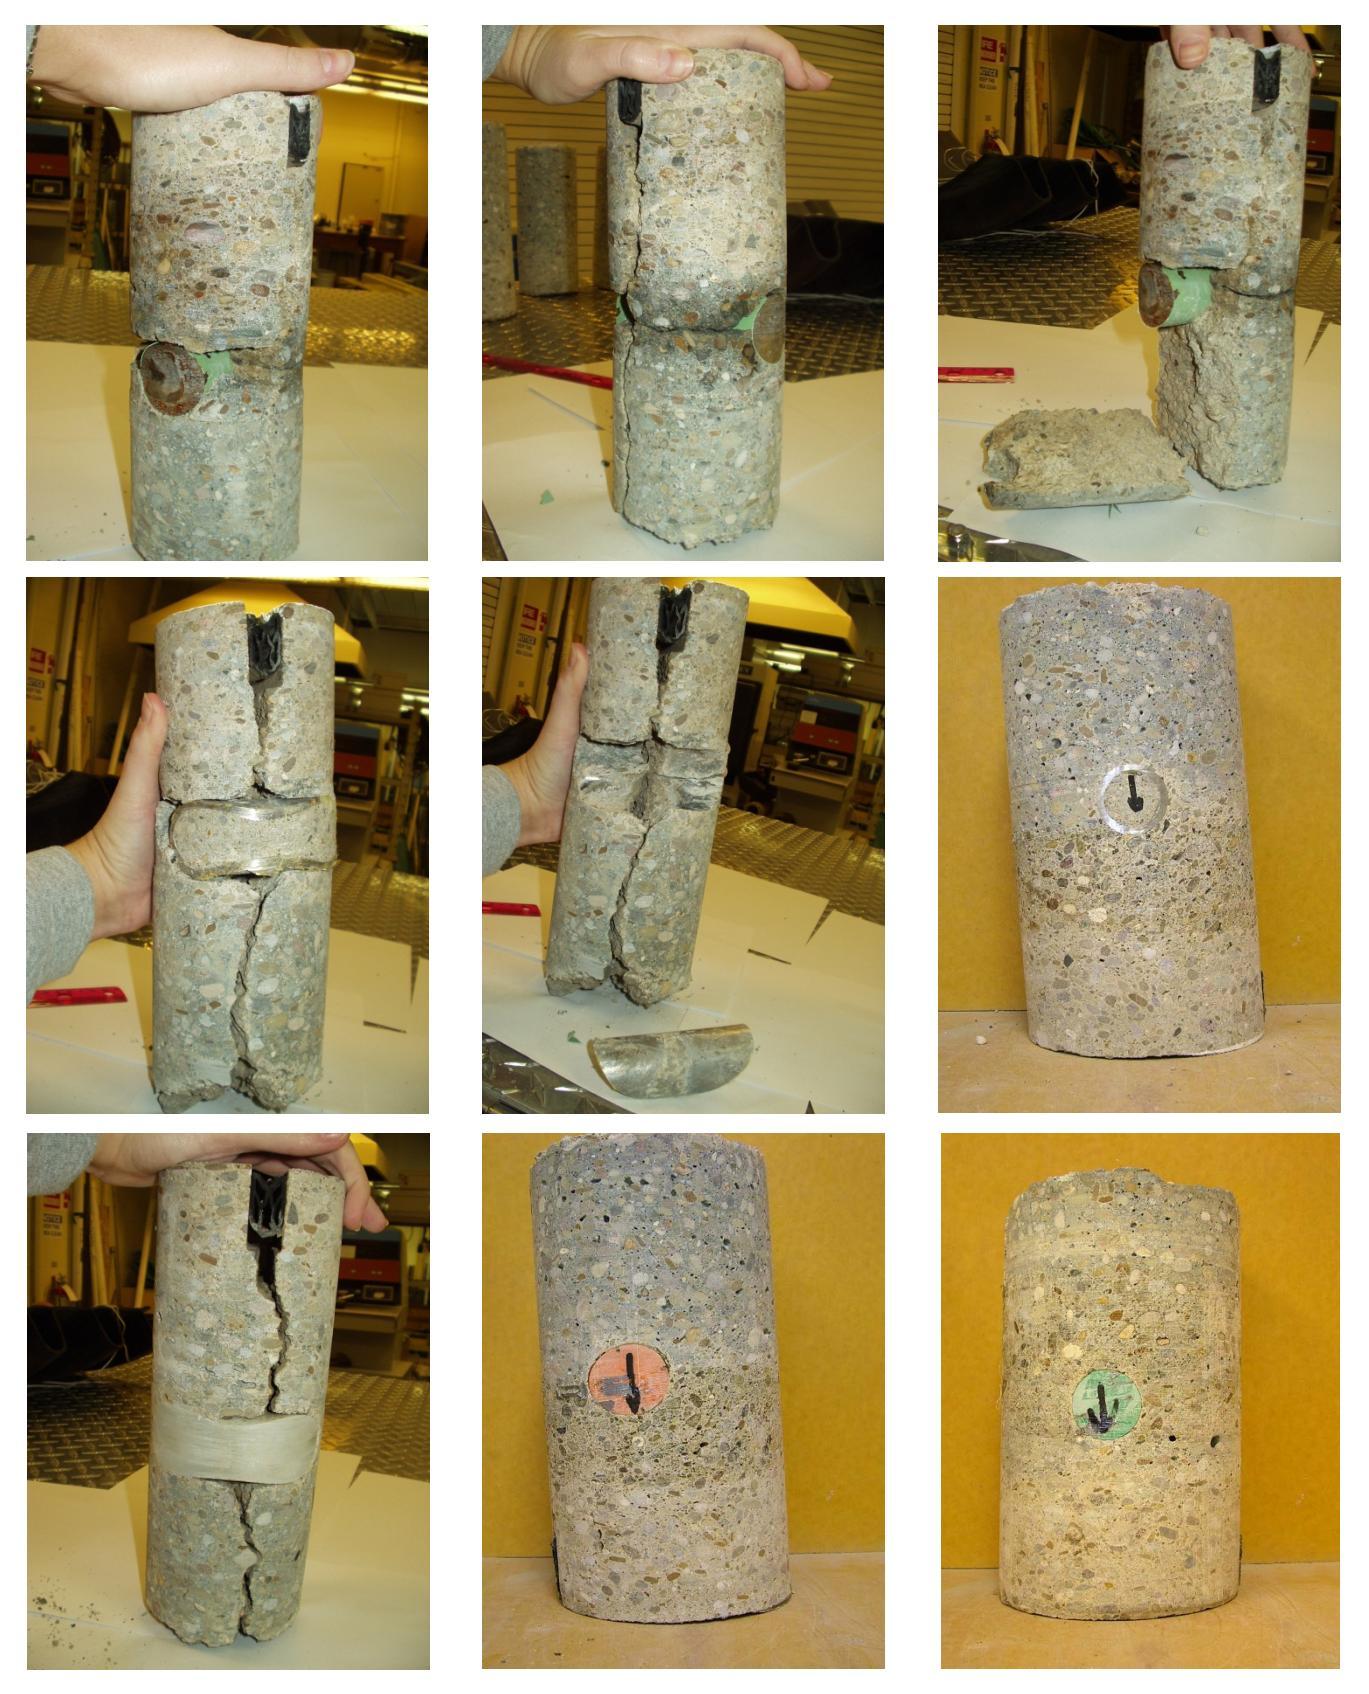
Figure C-1. Cores taken from OH 2 (ATH-50). Top: Epoxy-coated dowels; Middle: Stainless steel tubes filled with mortar; Bottom: FRP bars

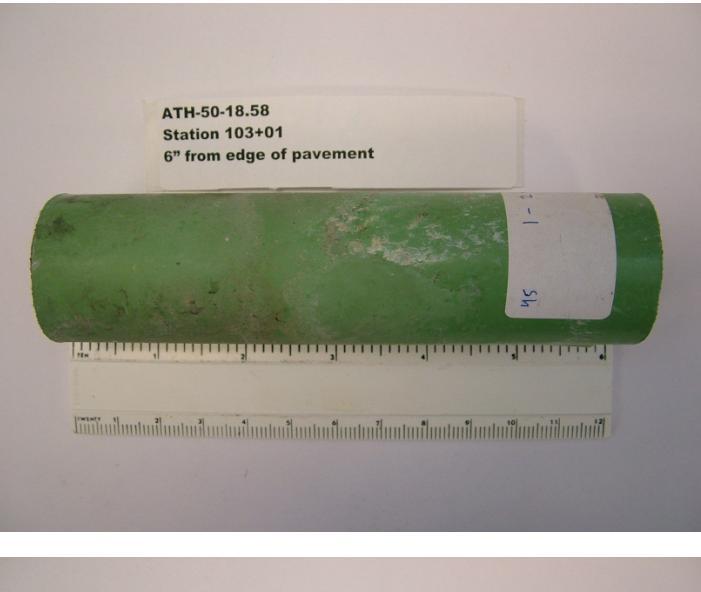
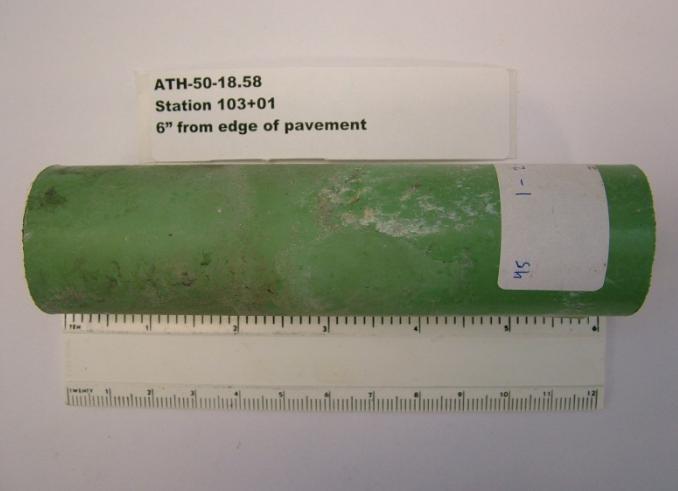
Figure C-2. Epoxy-coated dowels from OH 2 (ATH-50).

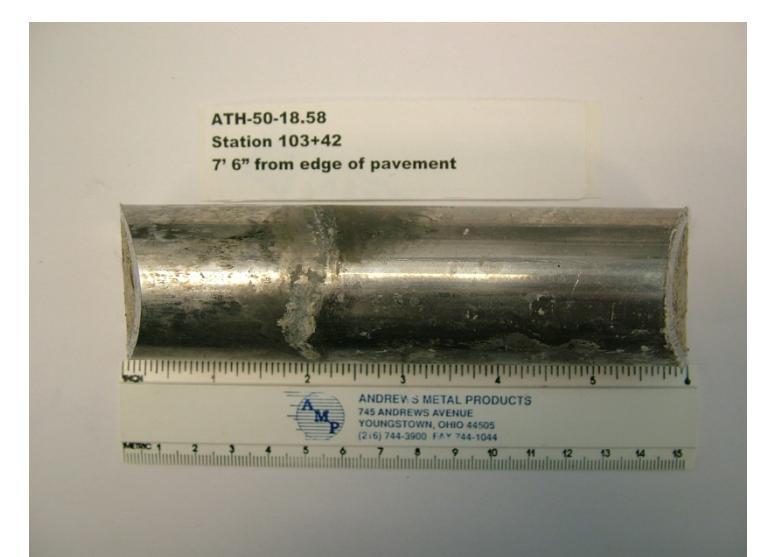
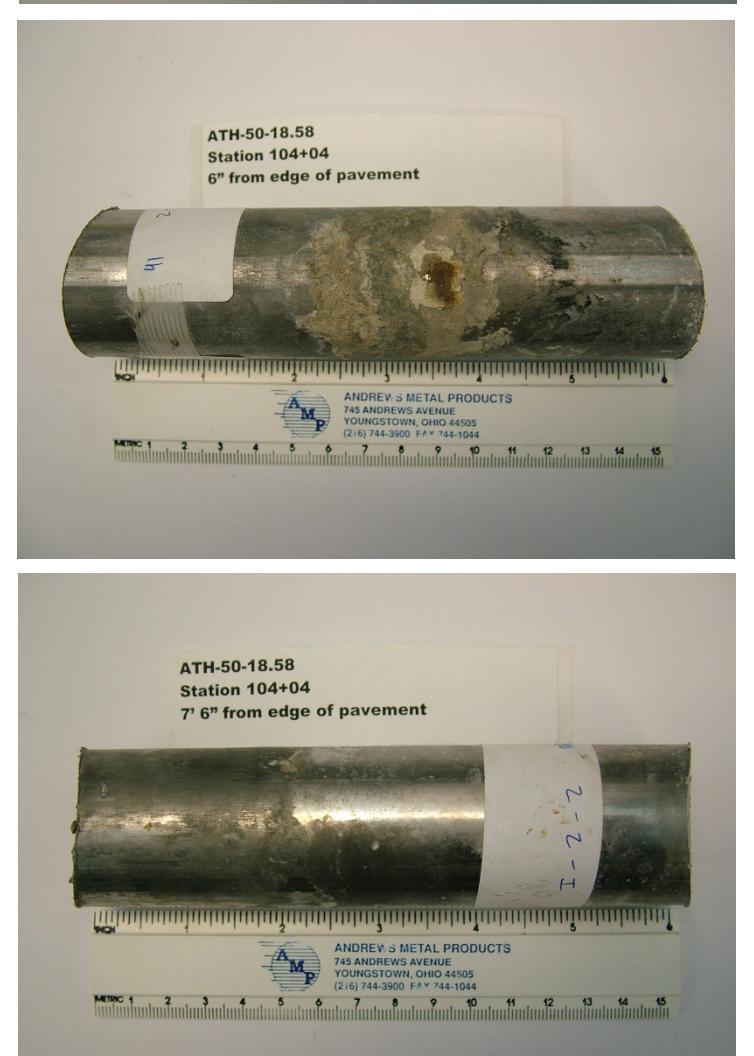
Figure C-3. Stainless steel tubes from OH 2 (ATH-50).

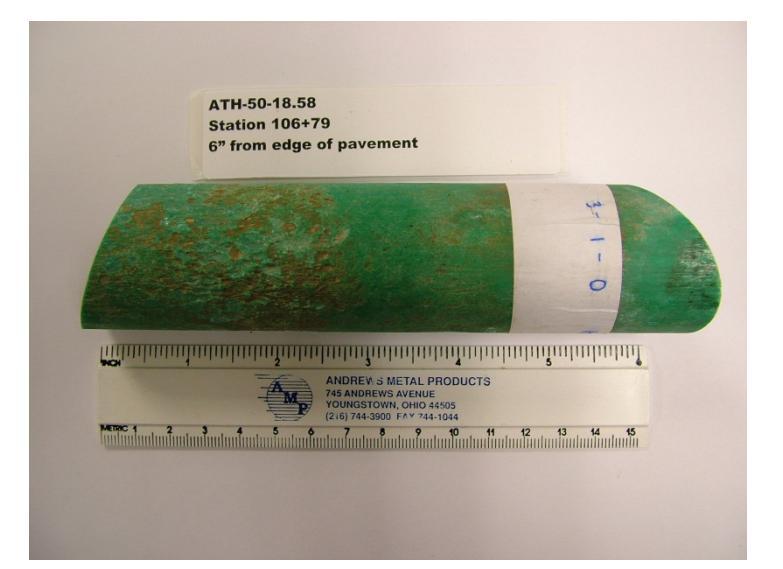
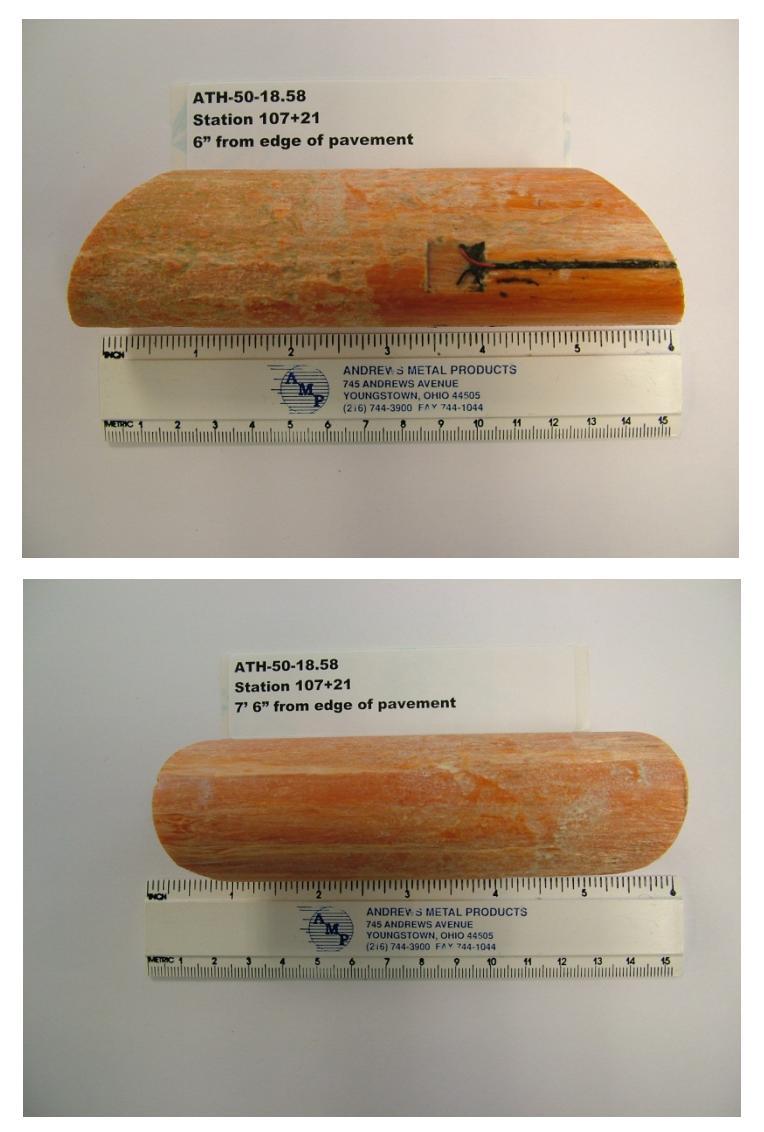
Figure C-4. FRP dowel bars from OH 2 (ATH-50).

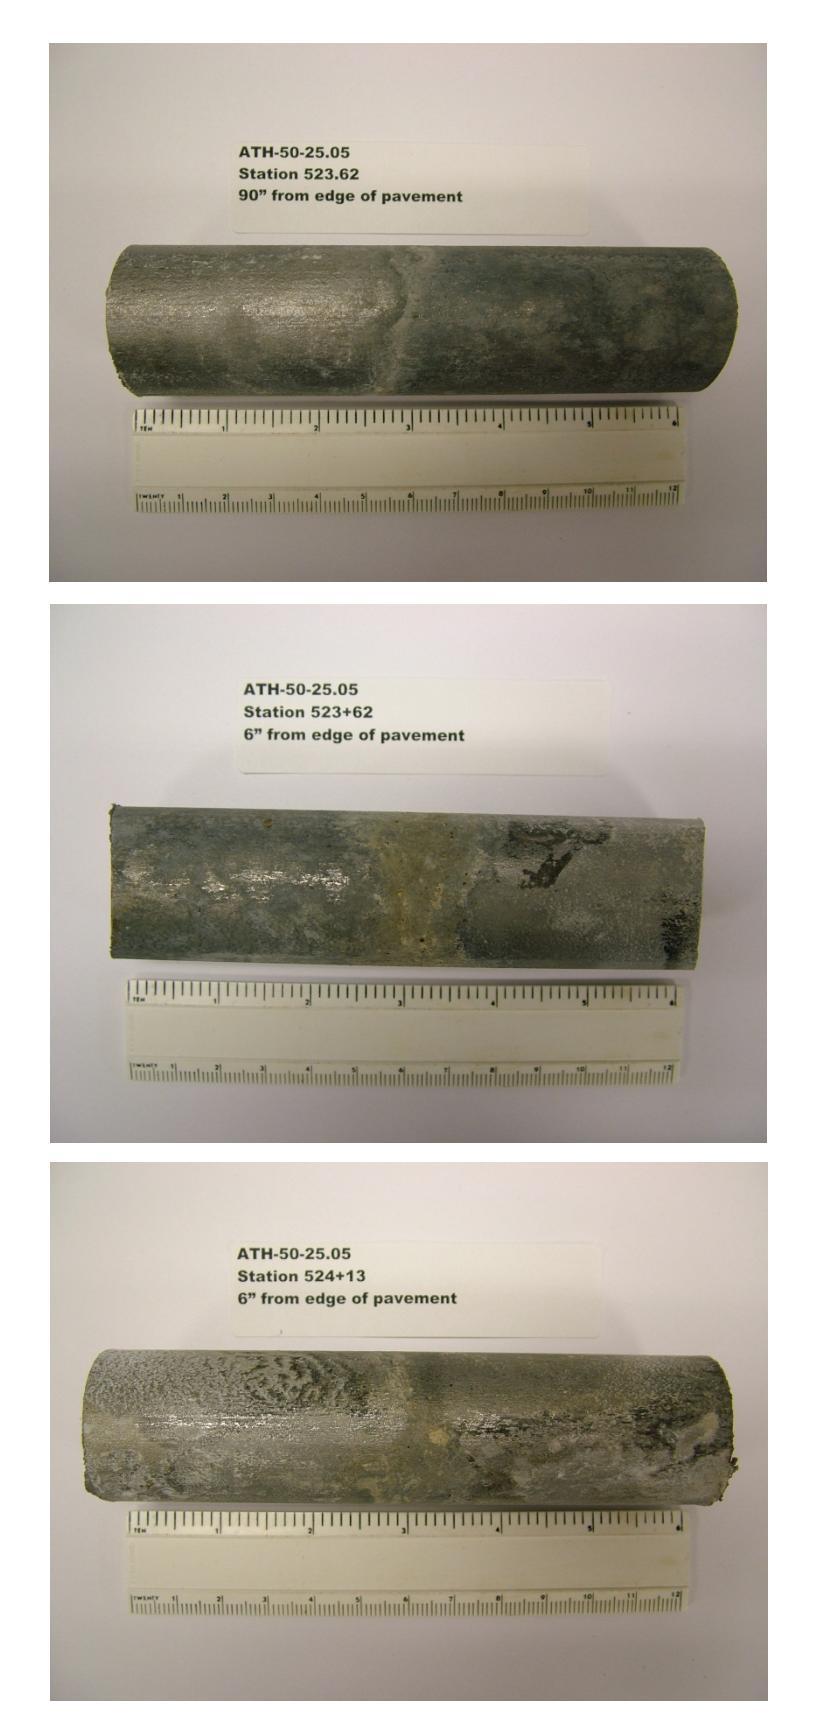
Figure C-5. Stainless steel clad dowel bars from OH 2 (ATH-50).
