Use of Electroluminescence Technology for Highway Signage

Nick J. Rahall, II Appalachian Transportation Institute
Marshall University
Huntington, WV 25755

September 2001

Technical Report Documentation Page

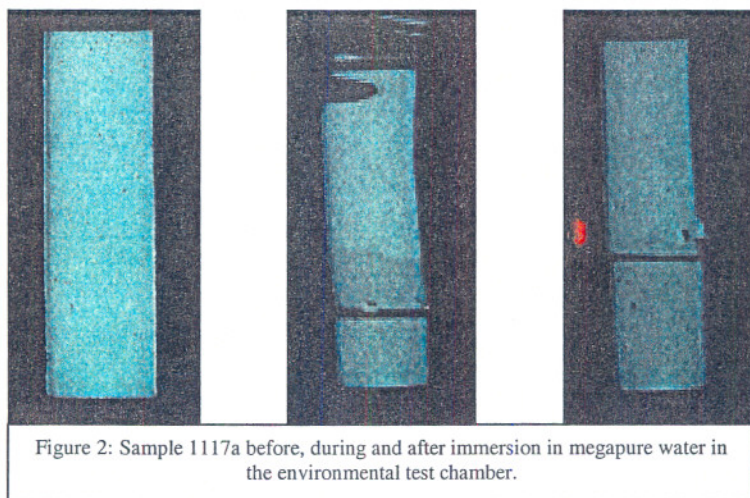
It was determined whether light-emitting panels could function properly during immersion testing. As seen in Figure 2, there is no immediate change observable in the panels in the presence of water. However, in video recordings of an unprotected lamp, such as this one, corrosion became visible after only 20 hours of immersion. Observations indicated that surface defects grew to occupy approximately 75% of the entire panel following a week of the immersion process.

Figure 2: Sample 1117a before, during and after immersion in megapure water in the environmental test chamber.

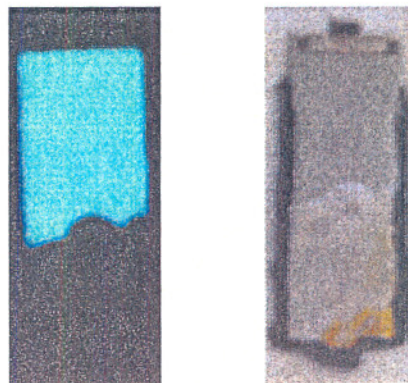
It is anticipated that edge protection may be accomplished using materials with poor optical properties. To determine the ability of some materials to protect panel edges from corrosion, only these areas were initially coated. Apiezon black wax, usually employed as a vacuum sealing wax in air-sensitive applications, was the first of the edge protectants tested. The wax is packaged as small black strips. One strip was heated in the flame of a Bunsen burner to render it malleable. Once warmed, the liquid was spread along the edges of a panel, taking care to cover them completely, see Figure 4. When solidified, power was applied to the panel and it was left illuminated for 24 hours so that the wax could acclimate to the panel's temperature. At this stage the panel was immersed in megapure water in the environmental test chamber. Although signs of corrosion were observed with 24 hours, the resulting damage was insufficient to completely prevent function for 6 full days, as shown in Figure 4. This study leads to the conclusion that the interfaces present at the edges are not the only sites of corrosion. In fact, corrosion initiated at the front surface currently appears to be the chief failure mechanism. At this point efforts were redirected towards finding a protectant capable of preserving the front face of the panel itself.

Figure 4: Left, sample 1215bw whose edges are reinforced with Apiezon black wax, before testing; center, 1215bw after 5-day immersion; right, sample 1215bw after 6-day immersion.

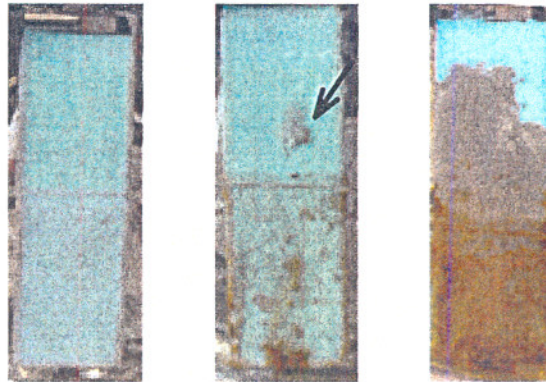
The first of the surface-protecting agents evaluated was Plasti-Kote Clear Coat, a spray-on acrylic lacquer employed in the automotive industry. A glazed panel was cleaned with 95% ethanol and left to air dry. The Clear Coat was applied according to manufacturer directions and left to dry overnight. At this point, the sample was immersed in the test chamber. After 4 days, water damage was observed on the panel above the water line. This was believed to be due to condensation within the chamber. After 8 days, extensive damage covered approximately 80% of the panel surface. This sample ceased to function after 17 days. This progression can be observed in Figure 5.

Figure 5: Sample 1229cc initial immersion in megepure water. Center, defect observed above water line at 5 days. At right, extensive damage reduces amount of area capable of emitting light.

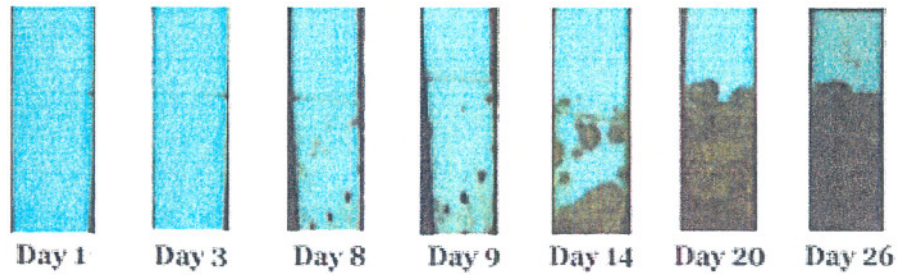
Dow Corning Metal Protective Coating, a spray-on organic wax, was the next protectant evaluated. A green glazed panel was cleaned as before, and the spray applied as directed. The sample was allowed to dry overnight before immersion. This proved to be one of the best protectants studied, in that, this coating proved to delay the effects of corrosion for a considerably longer time than any other application. After 3 days there was little observable damage, and after the corrosion process began, the panel was able to remain functioning for an extended period. This progression can be seen in Figure 6.

Figure 6: Corrosion progression of Sample 0102ow, a green glazed solid state ceramic lamp coated with Dow Corning Organic Wax.

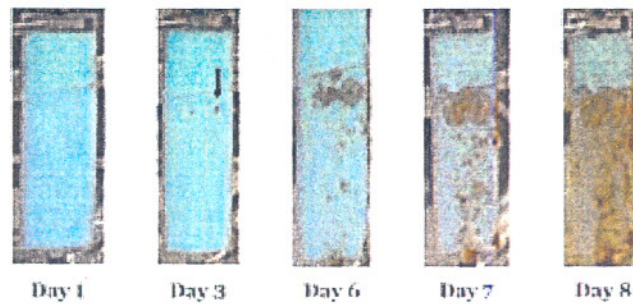
Another coating evaluated, Rustoleum, a commercially available clear enamel, proved to be a reasonably good protectant. Rustoleum was able to extend lamp performance to 9 days, with the first signs of corrosion only appearing after 3 days, as shown in Figure 7.

Figure 7: Corrosion progression of Sample 0116R, a panel coated with Rustoleum. The arrow in the Day 3 image indicates an area analyzed by SEM, to be discussed below.

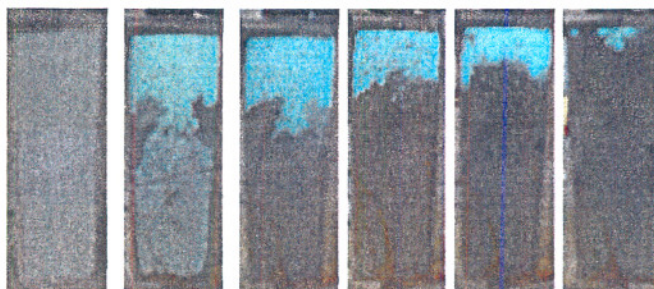
After X-ray analysis by SEM showed chloride deposits on the surface of sol gel-coated panel, alternative acids for catalysis were evaluated. In addition to re-evaluating the performance of a solution prepared with concentrated hydrochloric acid, solutions catalyzed with 85% phosphoric acid and glacial acetic acid were applied to green unglazed panels. The sample coated with acetic acid-catalyzed sol gel proved to be the most durable, outlasting by an average of 4 days. Sol gel as an encapsulant showed great potential in that degradation appeared after 3 days, rather within the first 24 hours as with the traditional glass encapsulation. In the progression below, days 1, 3, 7, 9, 11, and 13 are shown, respectively.

Figure 9: Progression of corrosion on an acetic acid-catalyzed sol gel coated unglazed panel. Notice that the panel was able to function in areas where damage had not extended. This panel ceased to function when phosphor damage reached the silver bus, located at the top of the images.

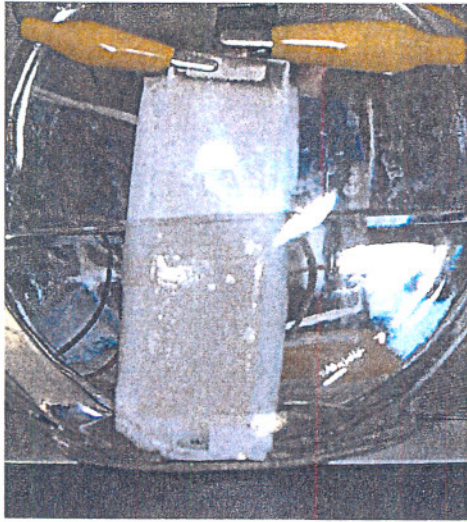
Day 1

This combination has proven to be quite successful. Not only has the panel maintained all of its function, but it has also shown absolutely no signs of corrosion over the 16 days of the ongoing trial. The only problem that has surfaced during this investigation has been the air bubbles that have formed within the POF 1160 film. After discussing the problems with a road sign manufacturer, careful application of the overlay film should eliminate this problem. Further investigations are planned for future work

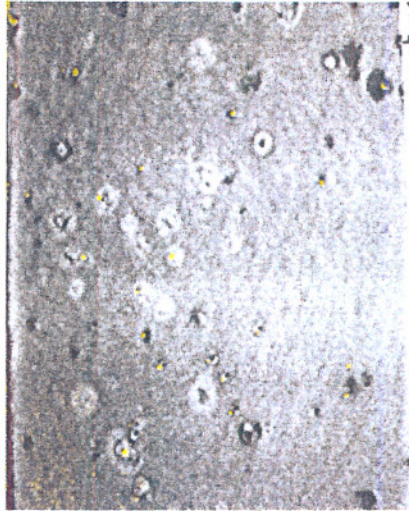
Time Lapse Photo Showing the Sites of Methylene Blue Entry in Yellow

The initial photographs were overlaid directly on top of the image of the corroded sample. The picture above shows one portion of the panel under investigation where the methylene blue was changed from its blue color to a bright yellow color to aid in seeing it contrast against its background. A surprisingly high 91.8% of those (102 actual imperfections) sites that took on the methylene blue led to corrosion on the following day. While over 90% of those sites where the methylene blue there was still 60 corrosion sites, 37% of the total number of corrosion sites, which cannot be accounted for in this experimental setup. More investigations into these findings will follow, chiefly changing the amount of time that the panels are allowed to be exposed to the methylene blue and the corrosion time to see how much of an effect that it could have upon the results.

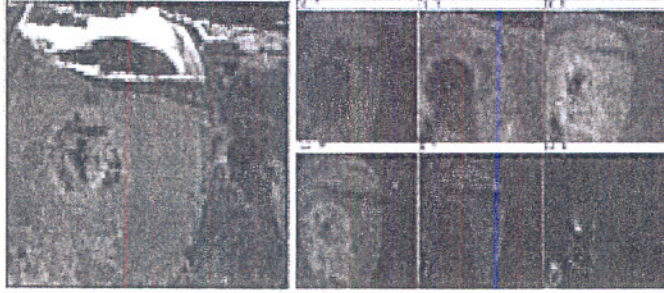
It is believed that corrosion of all test panels occurred through essentially the same mechanism. A mechanism involving water penetrating the lamp at some point was inferred from SEM analysis. Once an entrance pathway for water has been established, it can diffuse through the respective layers until it reaches the dielectric/metal interface. Once reaching this area, water is trapped and accumulates. The increasing volume of water separates the dielectric layer from those above it and causes delamination. Using SEM imaging and Quantitative Analysis corrosion defects such as the one indicated in Figure 7 were further interrogated. Figure 10 shows one corrosion site that possibly caused the failure mechanism. The secondary image (on the left) supports the delamination theory because the area around the defect is distended. The mapgroups show the location of the observed elements and their relative intensity, implying that all layers above the dielectric/metal interface were penetrated.

Figure 10: The left image is a secondary image of a defect such as the one indicated by an arrow in Figure 7. It was taken at 50x and 15kV by a JEOL 5310-LV Scanning Electron Microscope. The images at right are a mapgroup of the same area determined by X-ray analysis.
