**Final Report**

State Study No. 140

**Evaluation of E-Krete for Rut Filling**

**Research Division Mississippi Department of Transportation**

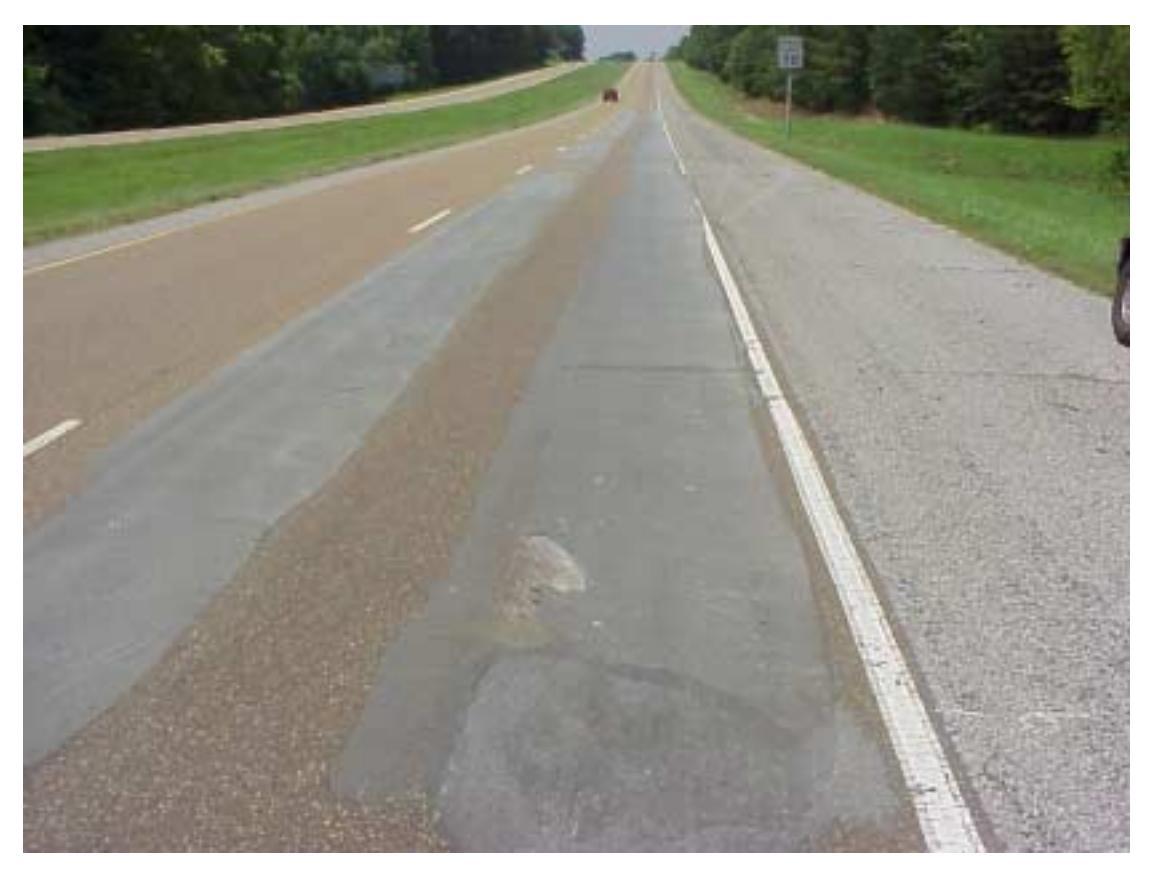
For this test location, E-Krete was placed only in each wheel path (See Figure 2).

Figure 2 – E-Krete evaluation section near Winona, MS

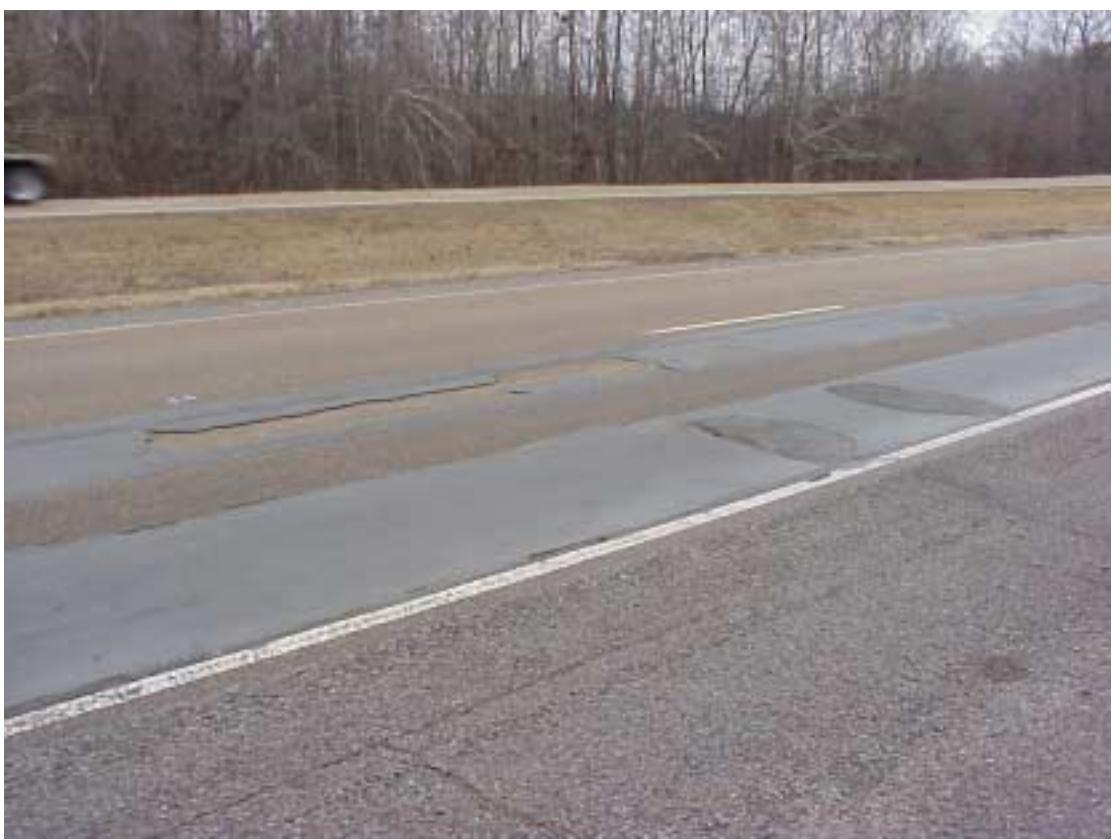
Approximately one month after the application of E-Krete, delaminations of the product from the existing asphalt began to occur. In addition to the delamination, approximately forty (40) transverse cracks were observed throughout the section. MDOT required the contractor on numerous occasions throughout the life of the project to repair areas throughout the test section.

Figure 3 – Patches and delamination in Winona test site

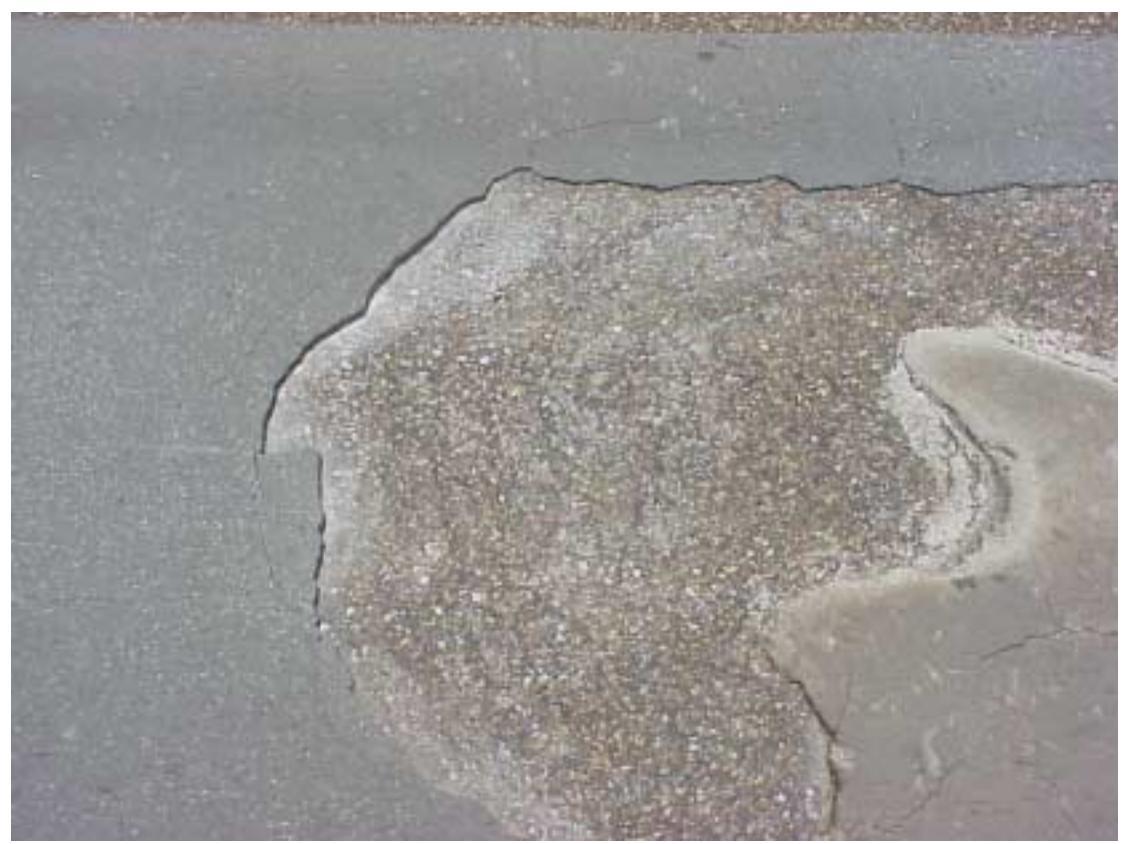
Figure 4 – Close-up of delaminated area

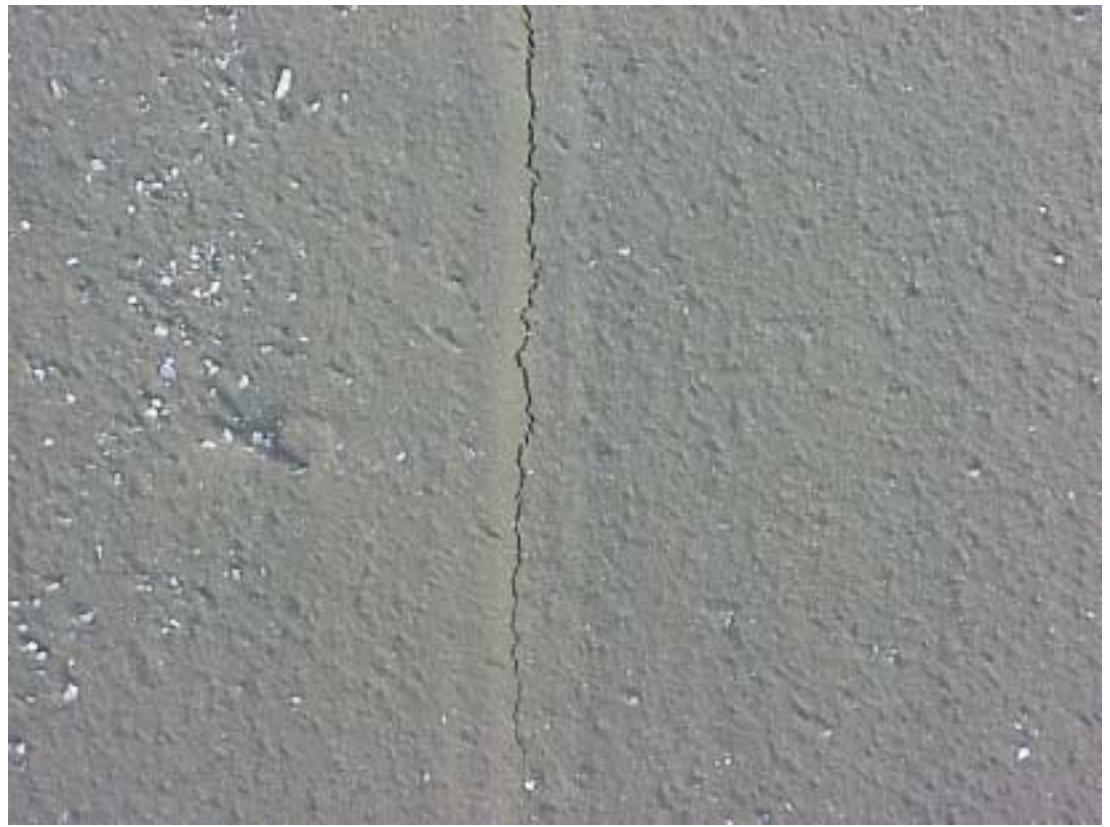
On September 14, 2000, construction of the evaluation section began. The contractor, Polycon Inc., elected not to perform any surface cleaning of the existing asphalt surface prior to application of the product. A portion of the test section was primed in the wheel path with the liquid component of the E-Krete system (See Figure 7). During the priming process, the three components (liquid, dry mix & aggregate) of the product were mixed in a mortar mixer. Upon completion of the priming, a 4' wide screed assembly was utilized to apply the E-Krete mixture to the wheel paths (See Figure 8). Production was slow with many starts and stops due to the small amount of E-Krete that could be mixed using the contractor's equipment. These delays caused indentions to be placed transversely by the screed and produced a "weak plane" which led to premature cracking (See Figure 9).

Figure 9 – Transverse crack at a screed stoppage during the previous days pour

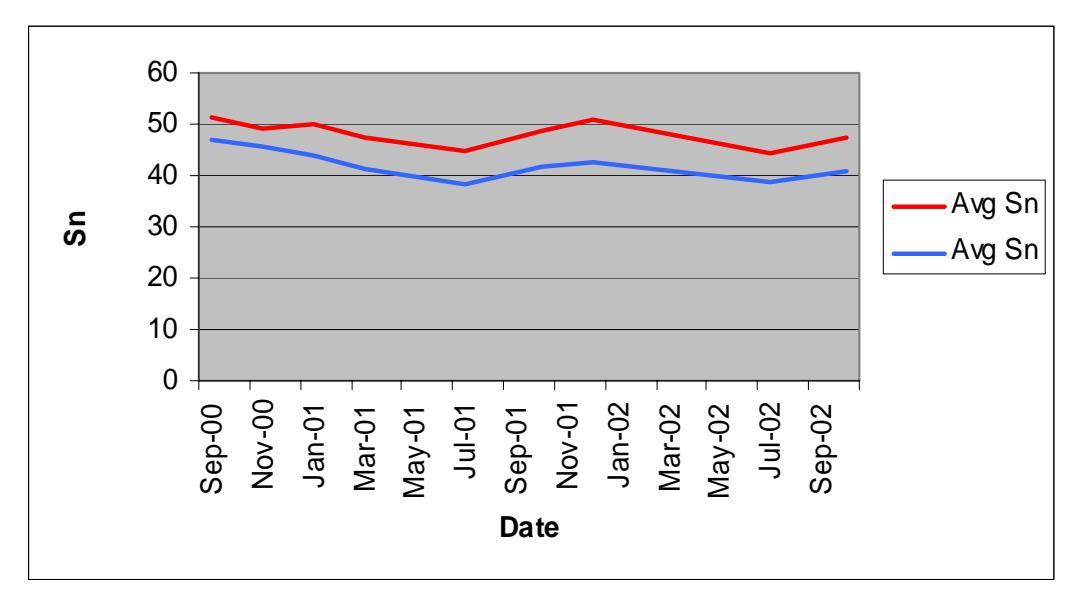
Figure 16 – Graphical Representation of Average Skid Number (Red = Section 1, Blue = Section 2)

MDOT's policy on friction is to maintain a skid number of thirty-five (35) or greater on all of our pavements to ensure the safety of the traveling public. The skid results from the E-Krete test section on U.S. 49 in Madison County never fell below the required thirty-five (35), however test section #2 (single E-Krete application) did approach the minimum requirement on multiple occasions. Test section #1 (multiple E-Krete applications) consistently yielded higher skid numbers than did test section #2 (single E-Krete application).

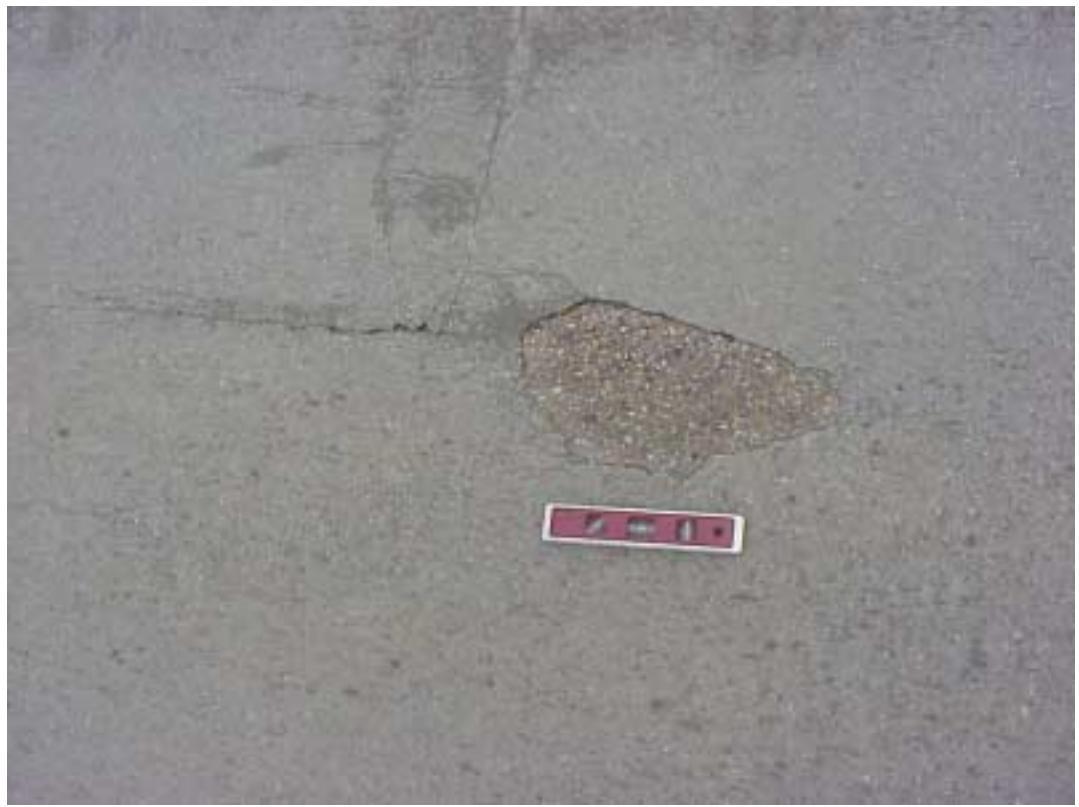
In addition to excessive cracking throughout the evaluation section, there were several areas of delamination that concerned the Department. Even though the magnitude of delamination was not as great as was observed on the Interstate 55 section near Winona, MS, MDOT was still not satisfied with the results.

Figure 19 – Delamination in multiple application with priming area approximately one year after E-Krete application

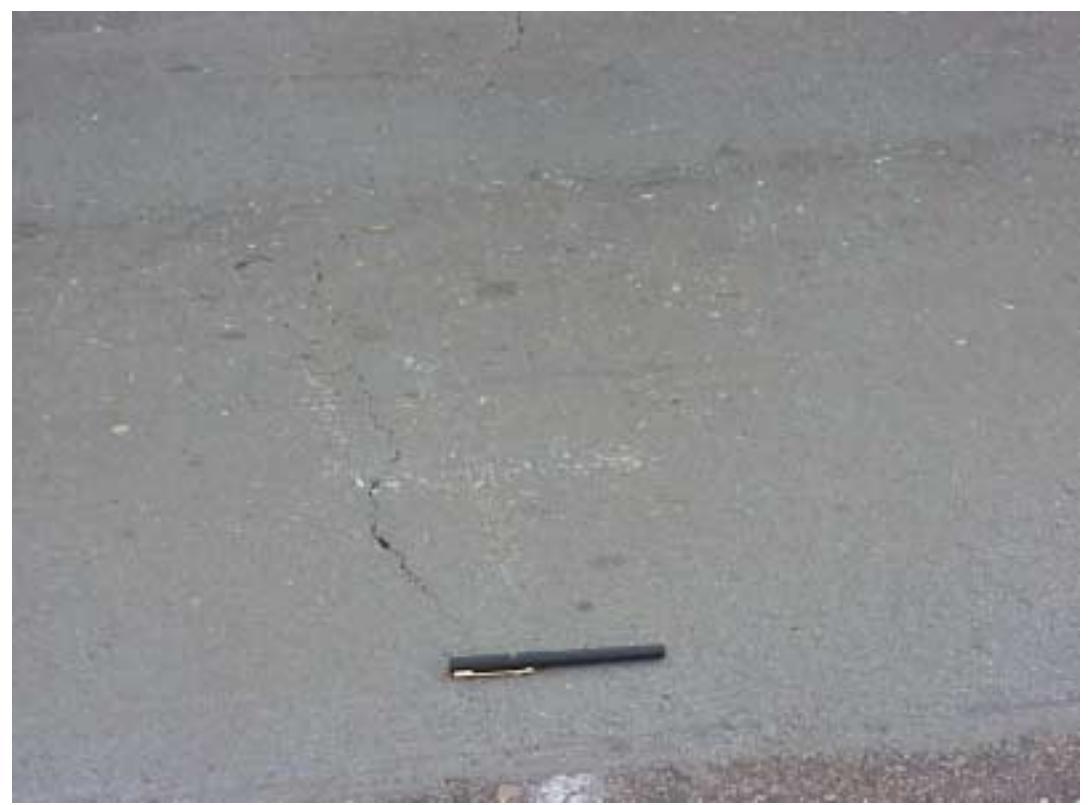
Given the performance of the initial E-Krete trial on Interstate 55 near Winona, MS, MDOT was interested in determining if the U.S. 49 test in Madison County would suffer a similar fate. Approximately one year after the application of E-Krete, MDOT surveyed the entire evaluation section for cracking. Appendix D contains the results of that survey.

Figure 20 – Cracking in E-Krete approximately three months after application

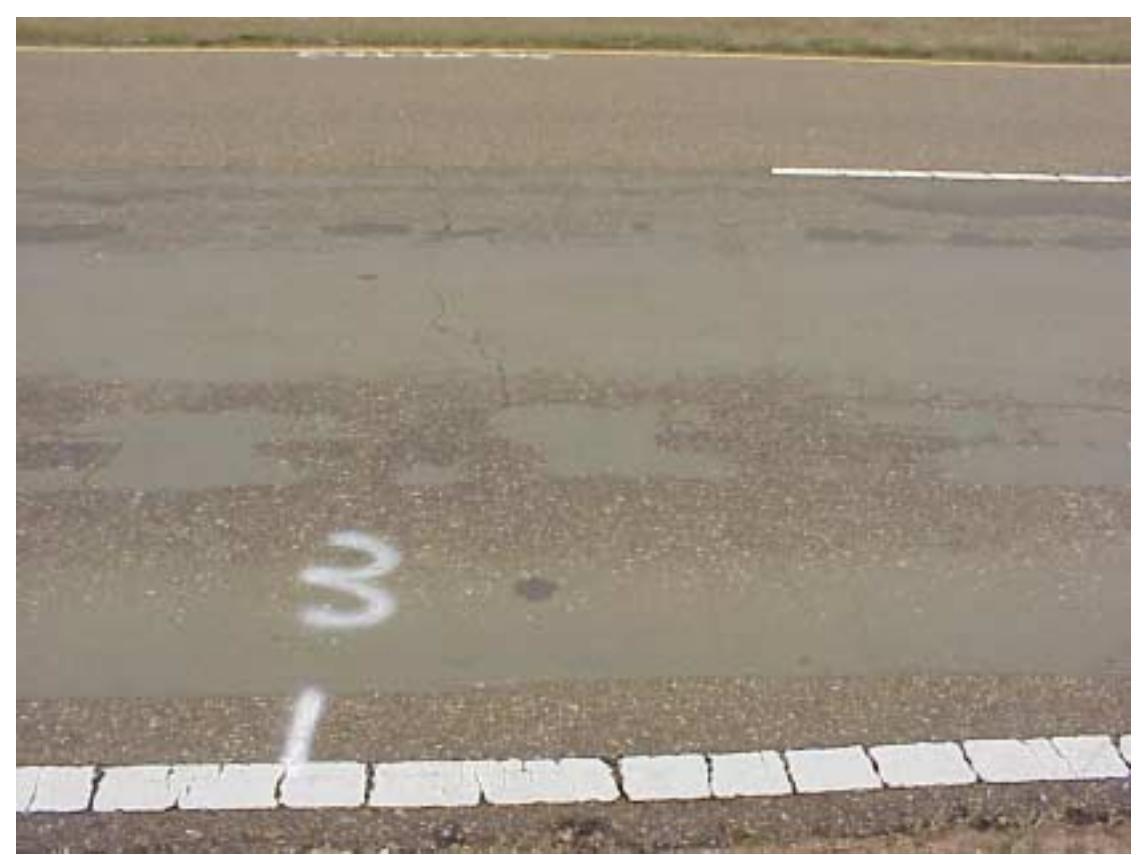
Over the two year evaluation period, the E-Krete appeared to wear throughout the entire test section. This was not limited to, but most prominently apparent in the "Single Application-No Priming" analysis section. An analysis of the rut data would support this observation, since within a year of application, the ruts had returned to pre-E-krete application levels in the single application section. Therefore, one could conclude that the durability of E-Krete is not adequate for this particular application.

Figure 21 – Wearing of E-Krete after one year
