**FIELD APPLICATION OF Z-SPIKE REJUVENATION
TO SALVAGE TIMBER RAILROAD BRIDGES**

Richard M. Gutkowski, Ph.D., P.E.
Nathan J. Miller, M.S.
Dept. of Civil and Environmental Engineering
Colorado State University
Fort Collins, Colorado

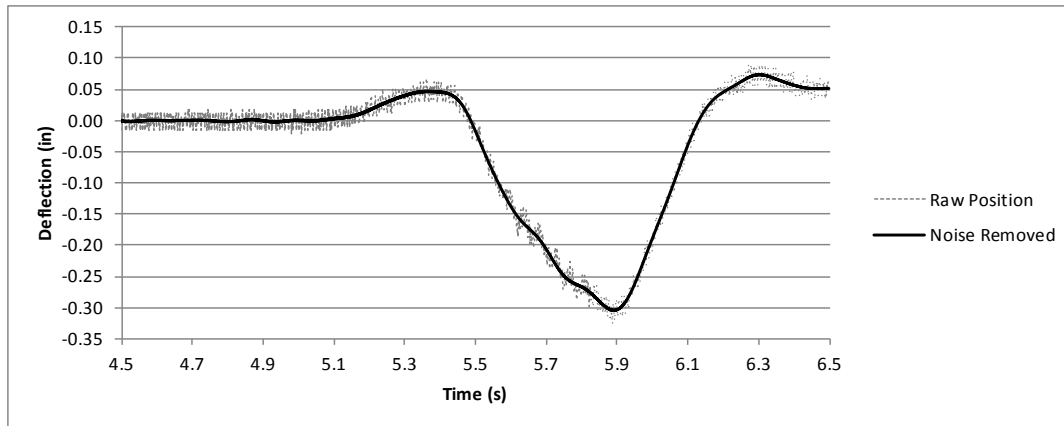
Figure 5.6 Noise removed from position data of record shown in Figure 5.3.

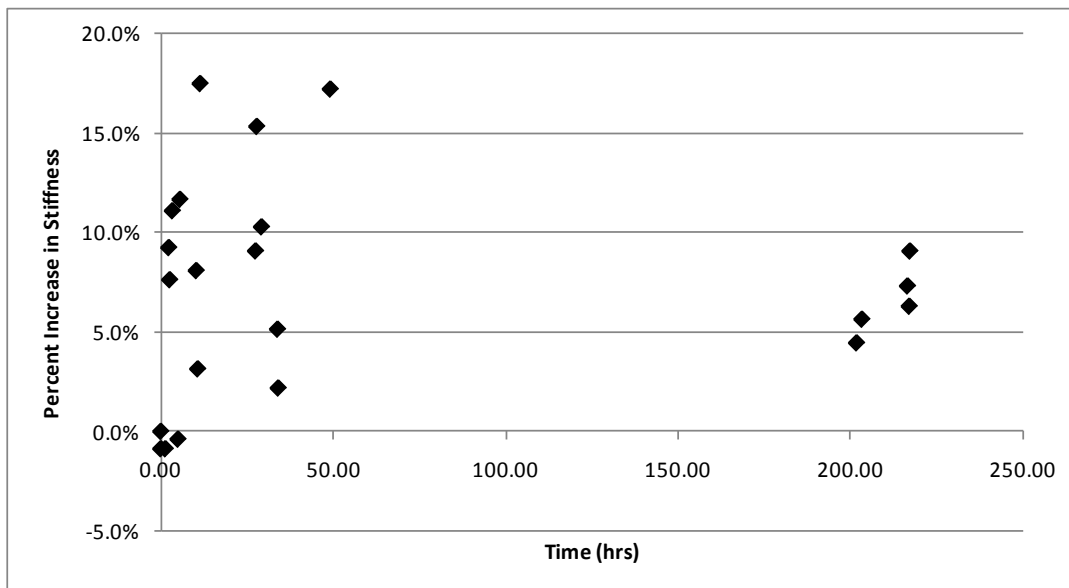
Figure 5.7 Percent increase in Measured Bridge stiffness vs. Time for all trains.

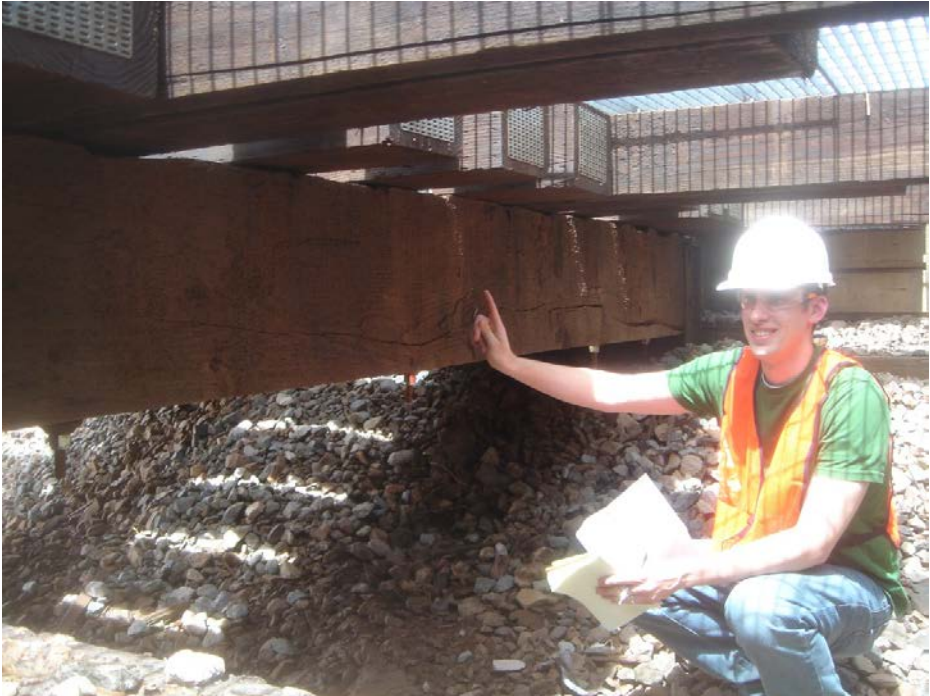
Figure C.2 Close up of crack in stringer 1, span 1. Coded 2A

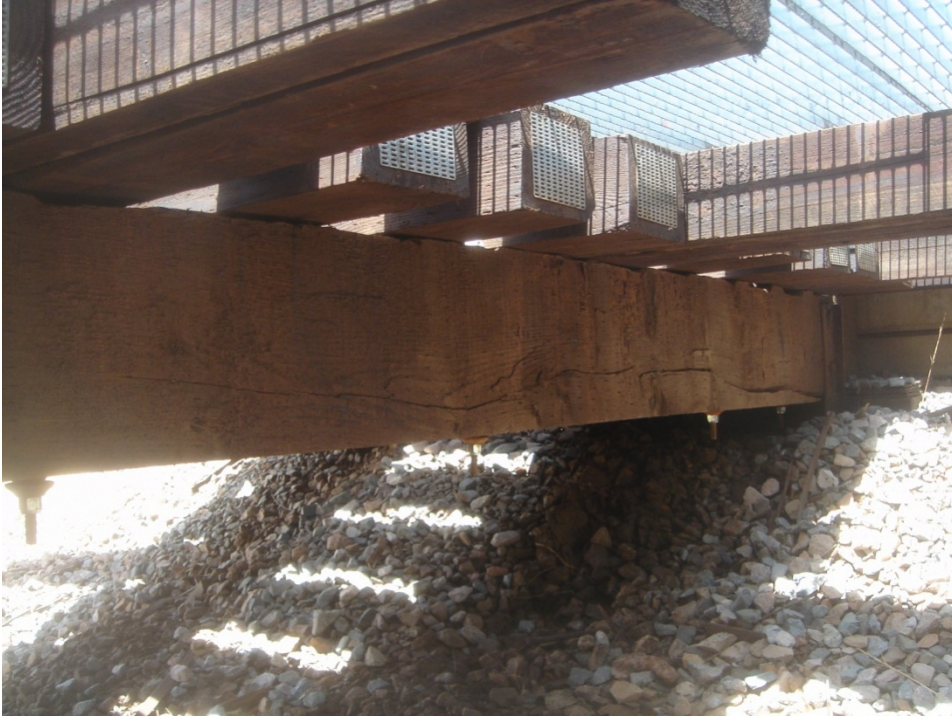
Figure C.3 Span 1, Stringer 1, badly cracked due to large knots and split near abutment.

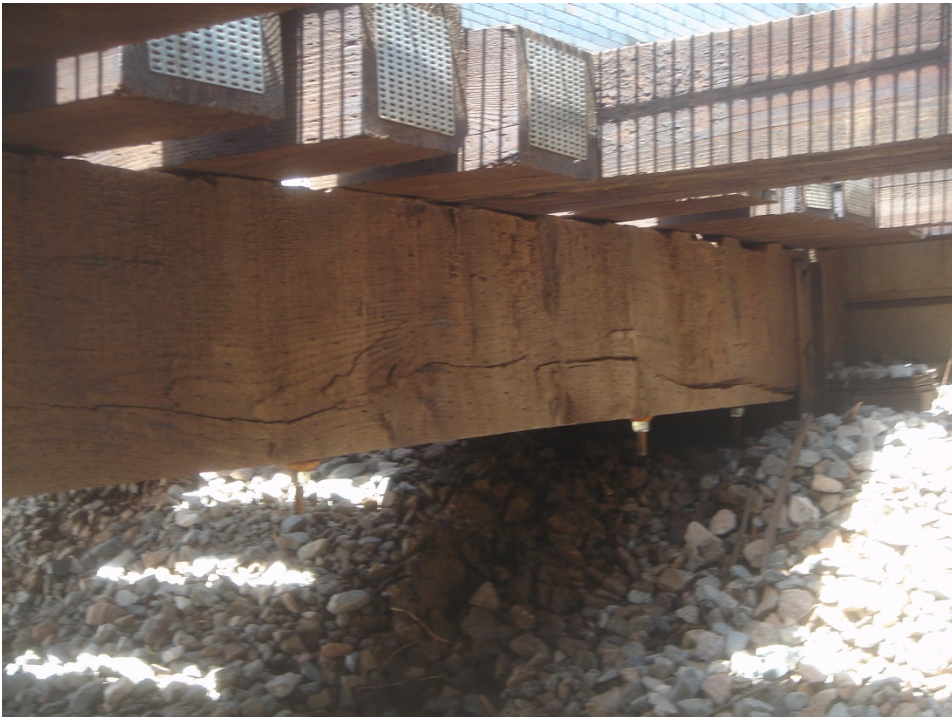
Figure C.4 Span 1, Stringer 1, badly cracked due to large knots and split near the abutment.

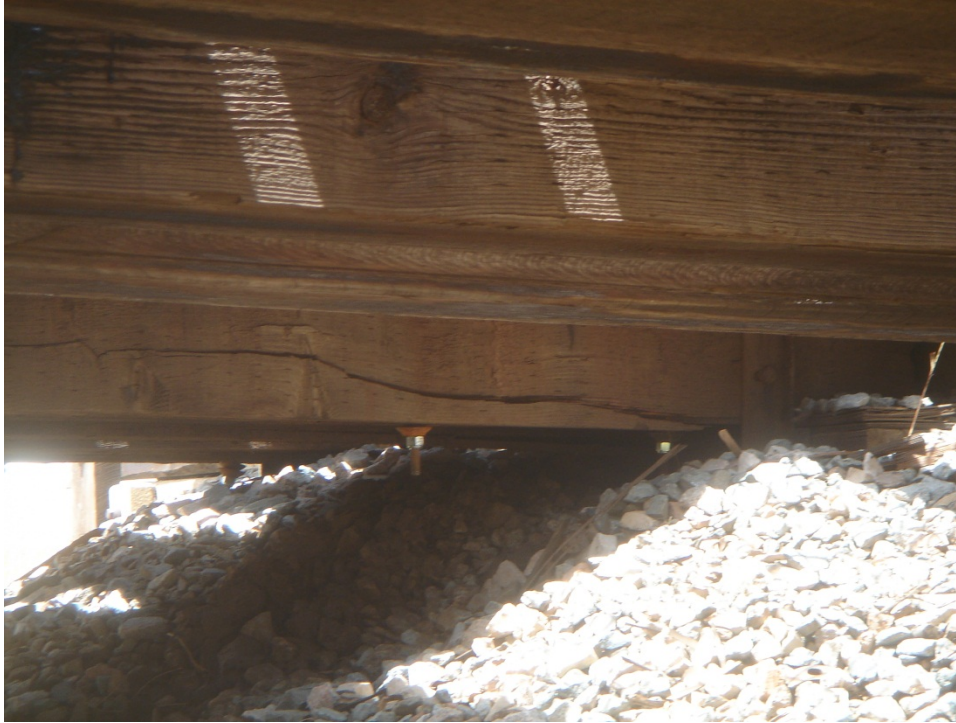
Figure C.5 Span 1, Stringer 1, badly cracked due to large knots and split near the abutment.

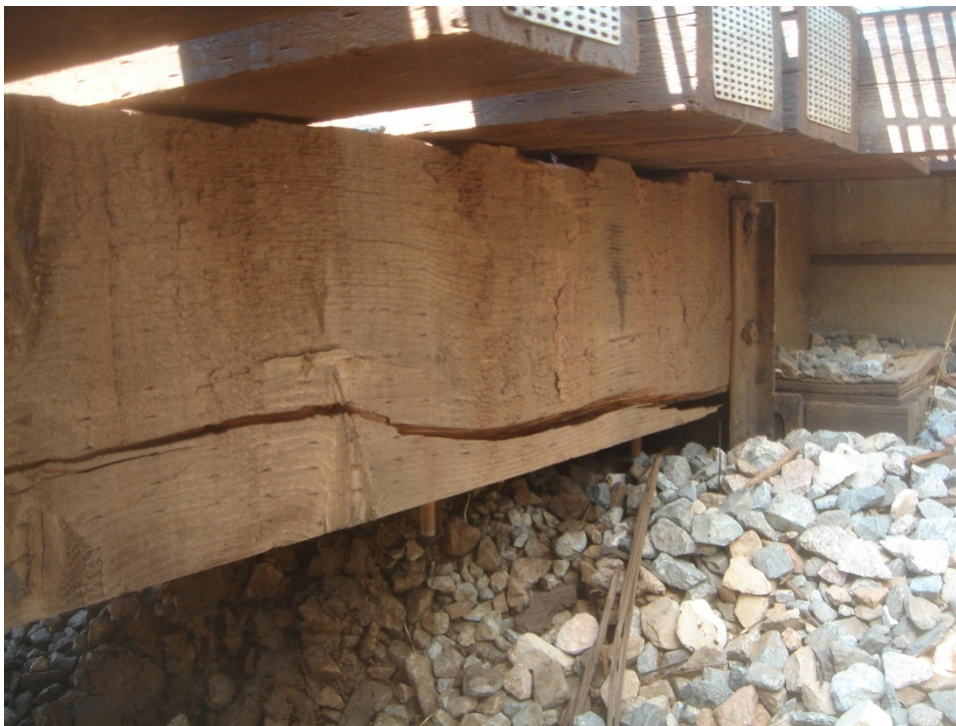
Figure C.6 Bad knots, flexural cracks - Span 1, abutment end of Stringer 1.

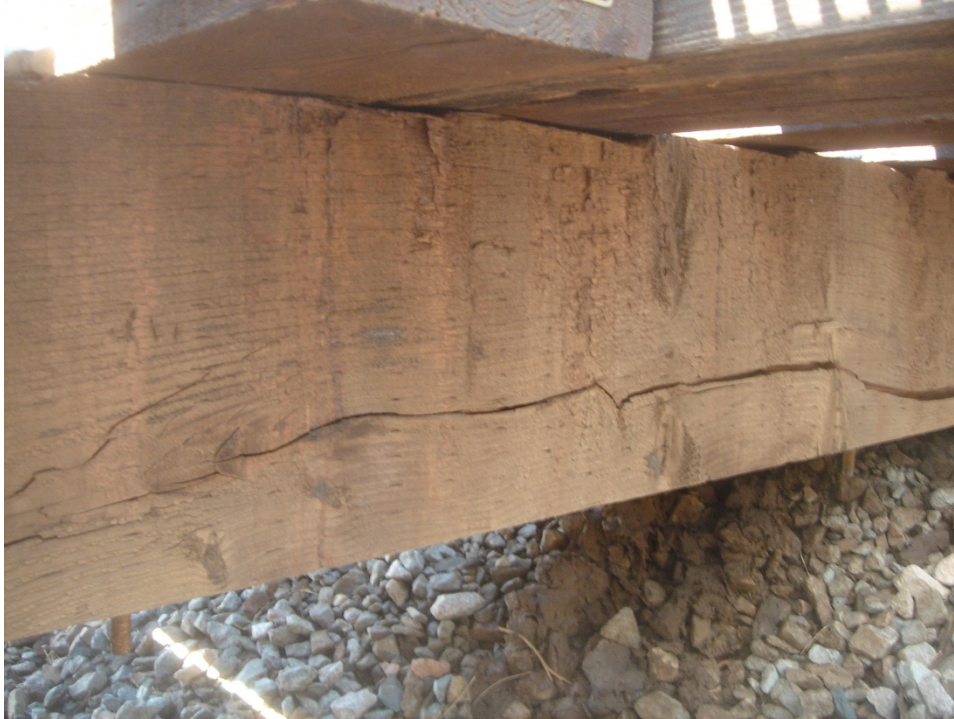
Figure C.7 Bad knots, flexural cracks - Span 1, mid span of Stringer 1.

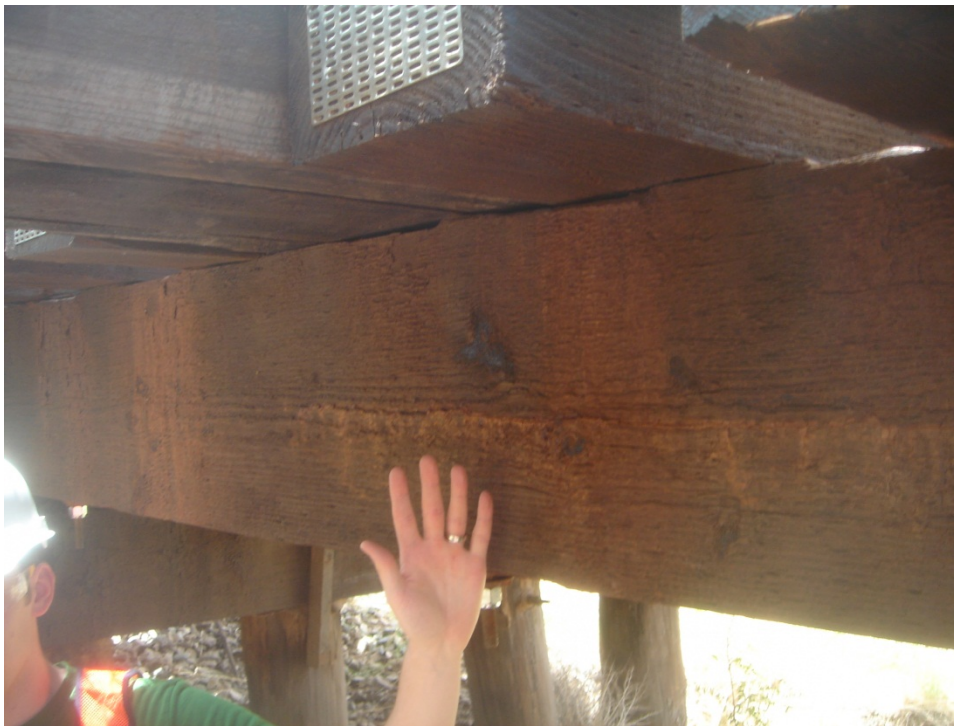
Figure C.10 Horizontal Shear Crack in Stringer 1, Span 2. Coded 4A

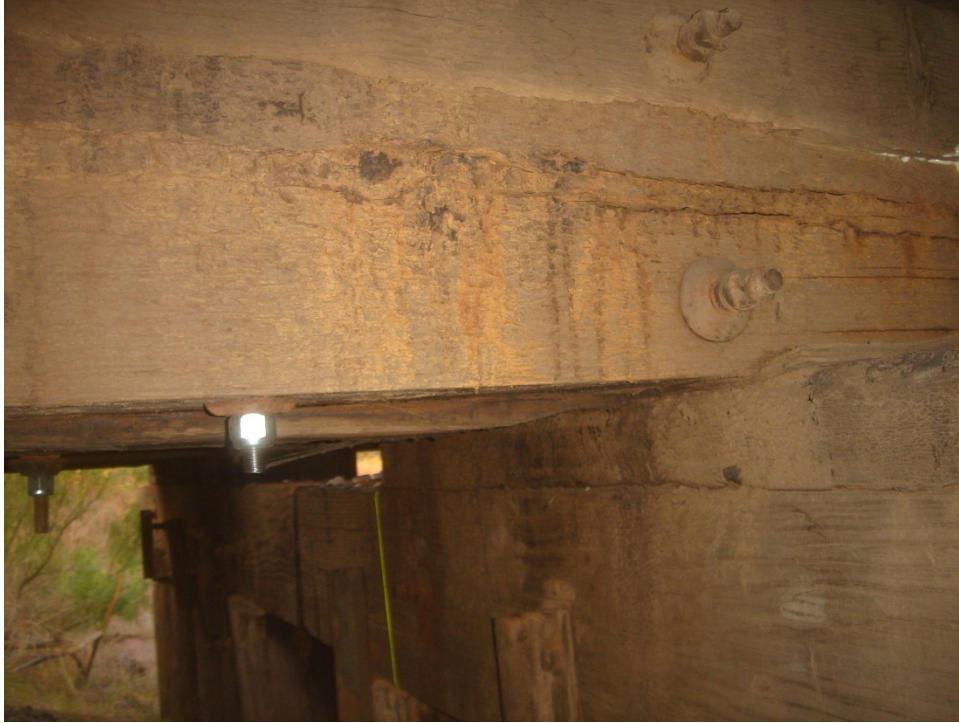
Figure C.25 View showing compressed Stringer 3, Span 1

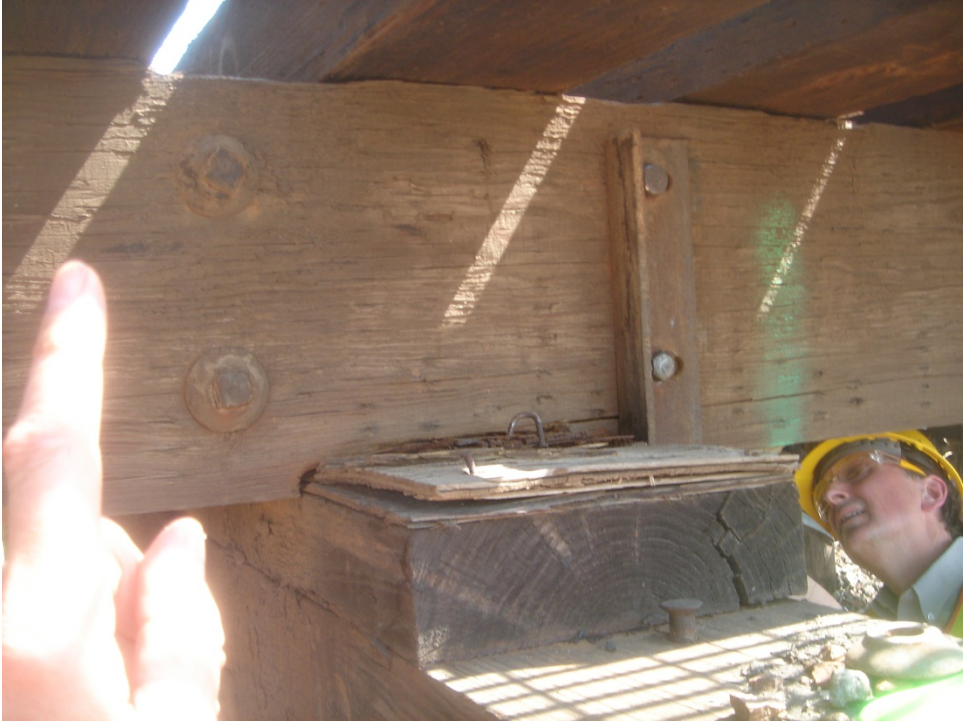
Figure C.32 Stringer 8 – Close up of damage over pier

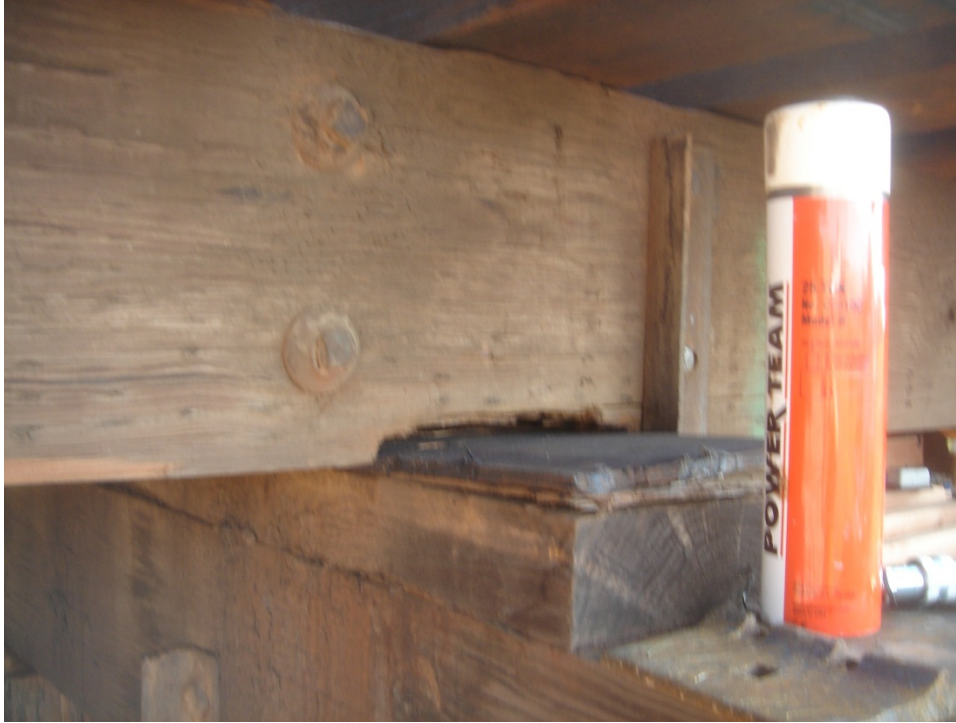
Figure C.33 Stringer 8 - Shim added below end of Span 1, Span 2

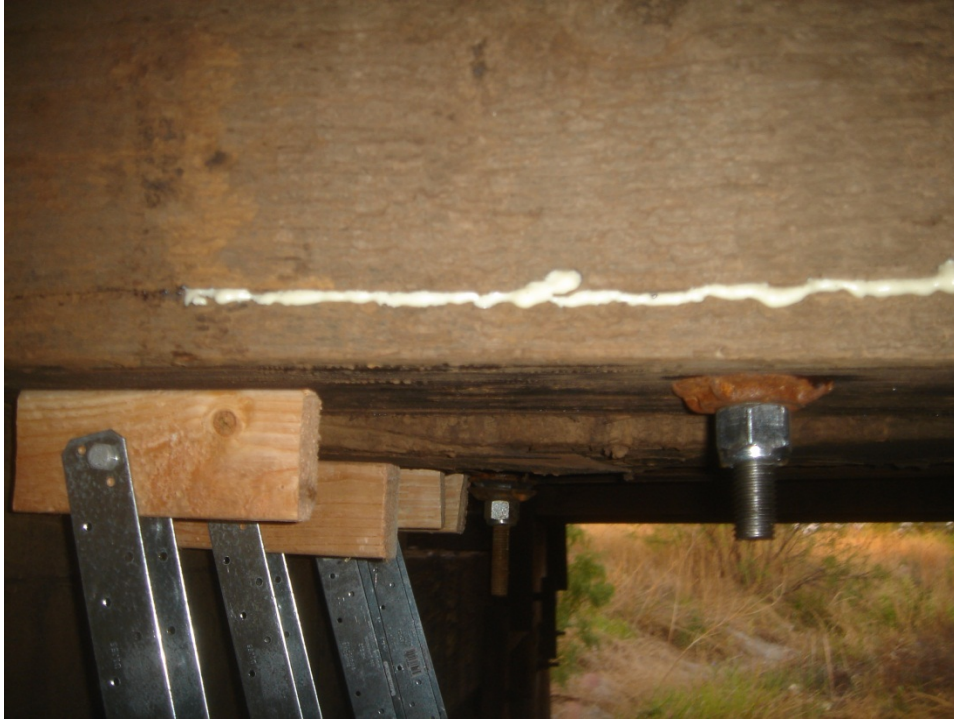
Figure C.37 Spray foam used to fill cracks

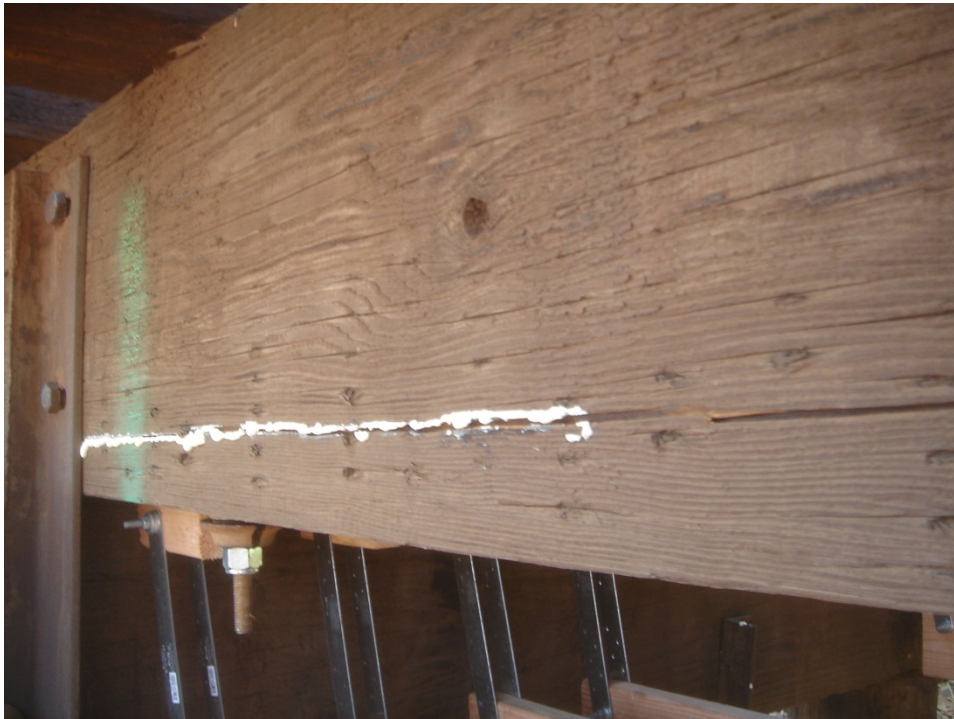
Figure C.38 Spray foam used to fill cracks

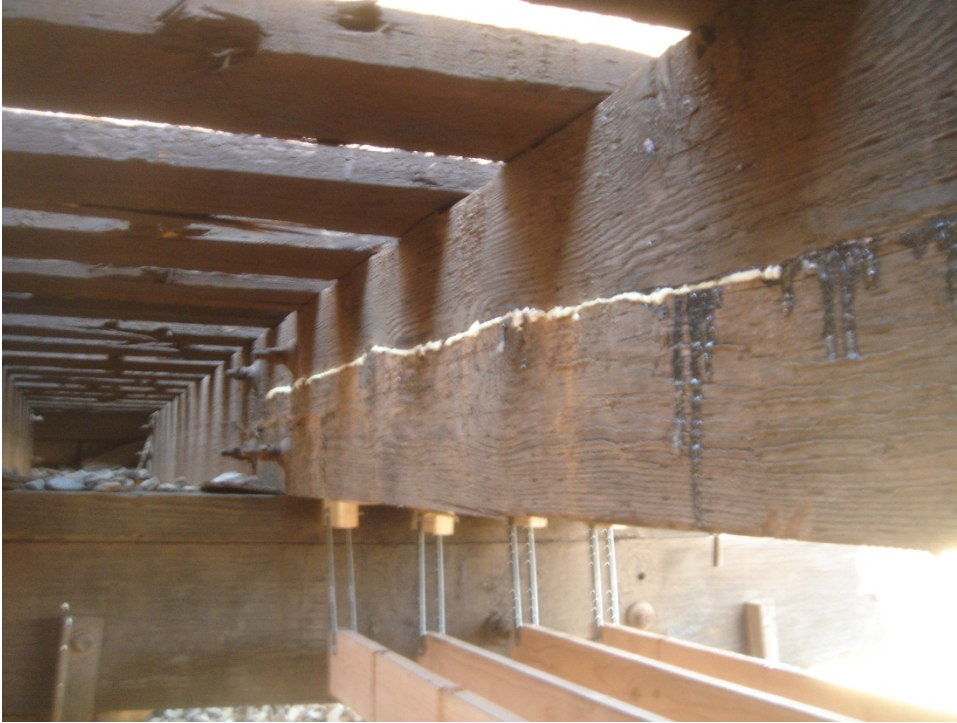
Figure C.39 Spray foam used to fill cracks
