Determination of Section 404 Permit and Habitat Mitigation Requirements

Final Report 589
September 2012

Arizona Department of Transportation
Research Center

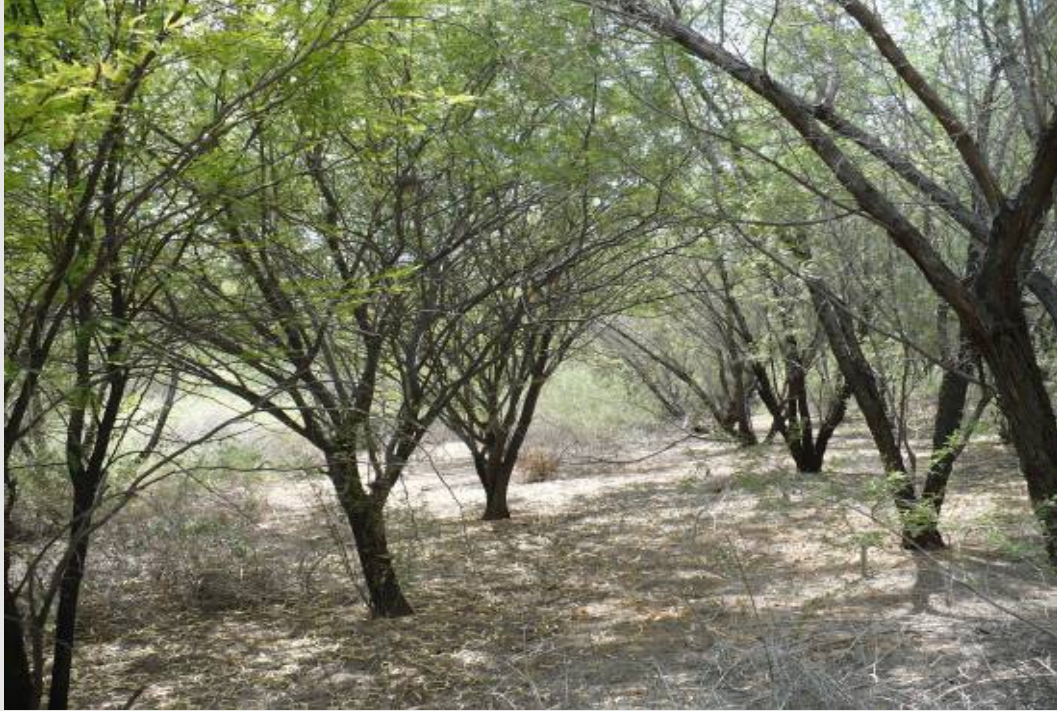
Conclusions: This habitat restoration project was successful, probably because of the presence of perennial water and supplemental irrigation. Preplanting soil testing and depth-to-groundwater testing were also unique features of this restoration project that aided site selection and contributed to the success. Due to this testing, planting occurred in areas where the depth to water table was within 8 feet and where soil salinity and pH readings were within the tolerances of the species planted. The irrigation was monitored frequently and adjusted as necessary during the first growing season.

**Figure 4. Evenly Spaced Plantings at the Northern End of the
'Ahakhav Tribal Preserve Project Site.**

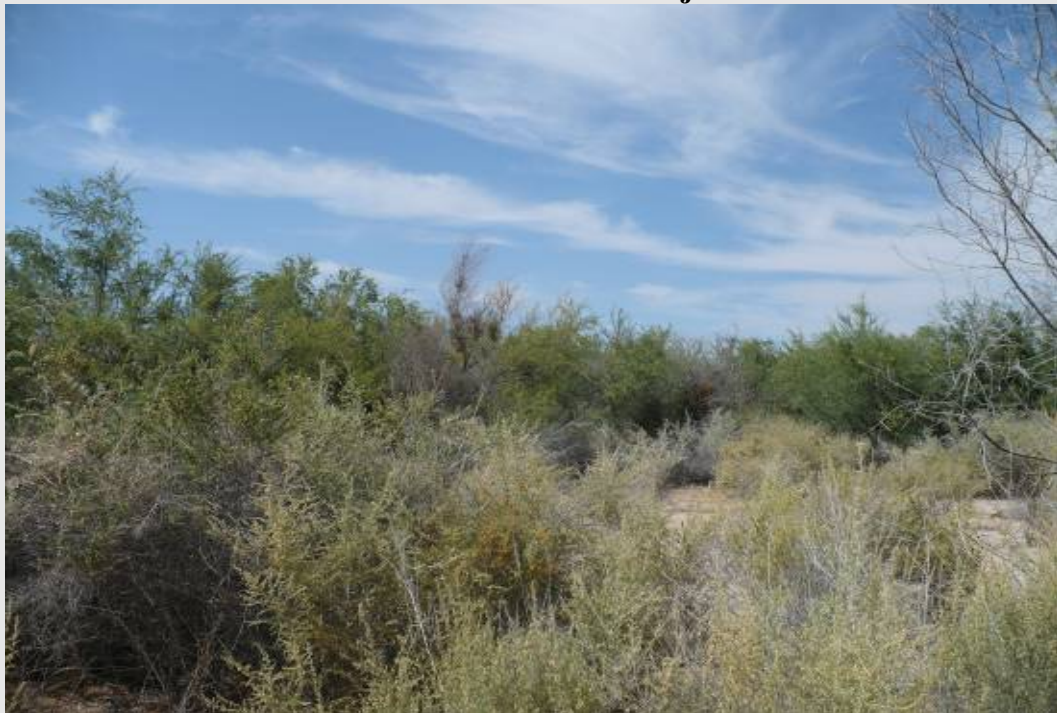
Figure 5. Dense Cover Behind the 'Ahakhav Tribal Preserve Nursery.

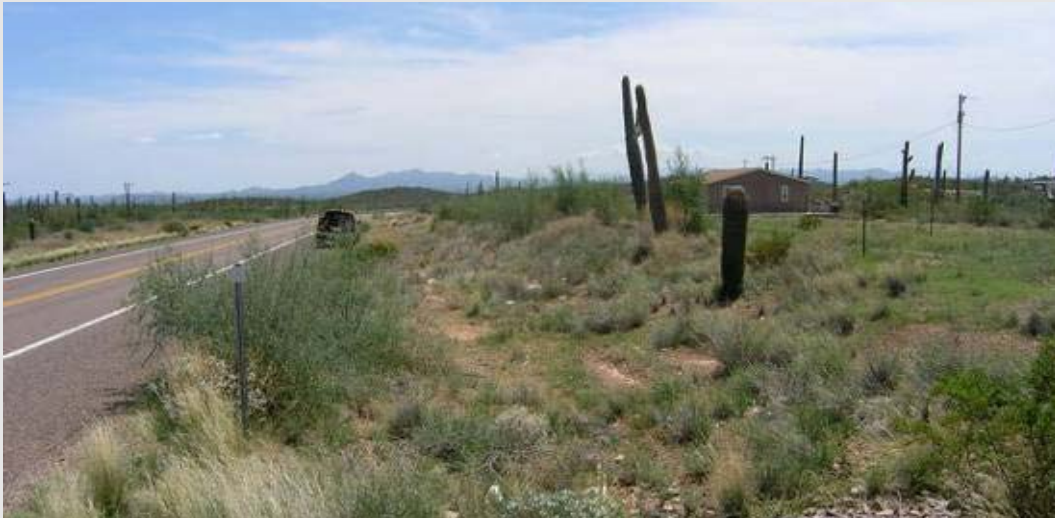
Conclusions: Clearly supplemental irrigation was provided to saguaros and nursery-grown trees for some period following their planting. Given their high survivorship, the mitigation effort was successful. Many blue paloverde and mesquite trees bore seed pods, and recruitment was high. Plants apparently incorporated within the reseeding mix, such as brittlebush, desert marigold, galleta grass, and purple three-awn, are thriving. Recruitment of perennial shrub species from the surrounding Sonoran desertscrub community also appeared to be high.

Figure 6. Relocated Saguaros at the Western End of the Covered Wells, Why–Tucson Highway (SR 86) Project Site.

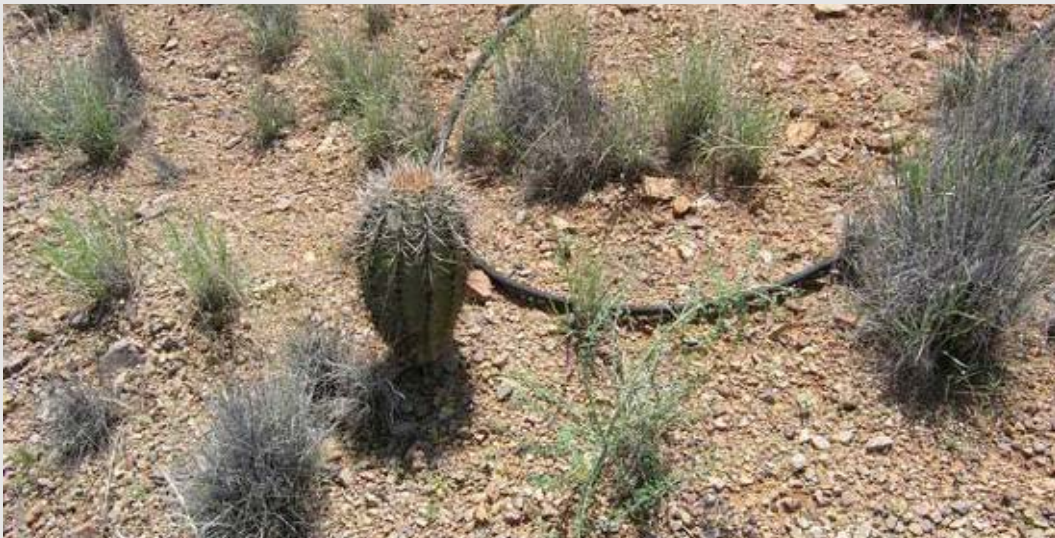
Figure 7. An Actively Growing Saguaro Near the Irrigation Tube at the Covered Wells, Why–Tucson Highway (SR 86) Project Site.

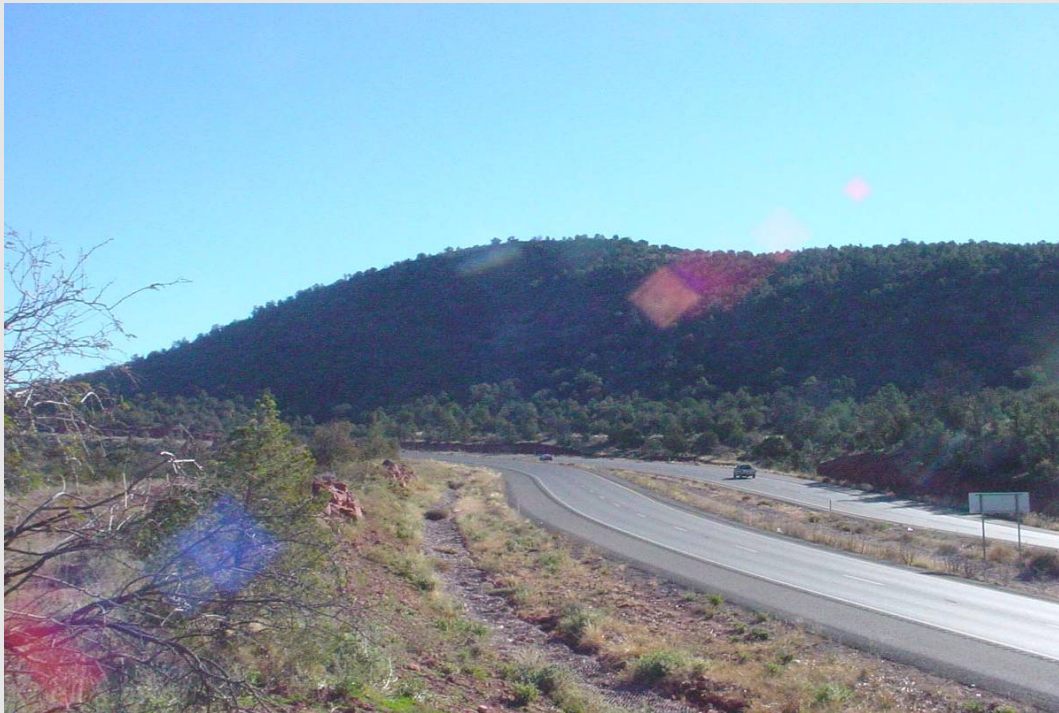
Conclusions: Monitoring was completed as planned. Irrigation was removed prematurely, leading to the death or stress of many trees. Hydroseeding for acacia and mesquite was unsuccessful. Some of the plants were destroyed by cattle.

Because of the initial failure of one of the three mitigation sites, additional costs were incurred to replant the site, reinstall the irrigation system, and extend the original monitoring period by three years.

Figure 8. Revegetated Area Adjacent to and West of the SR 89A, Cornville Road to Sedona Project Site (Facing North).

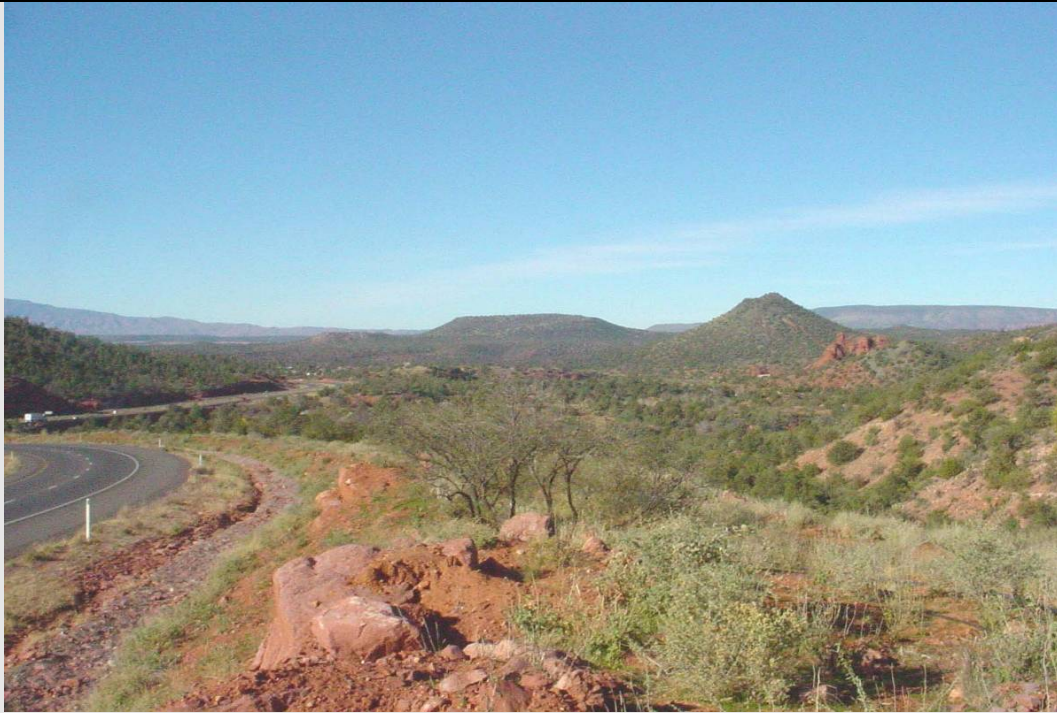
**Figure 9. Revegetated Area Adjacent to and West of the SR 89A,
Cornville Road to Sedona Project Site (Facing South).**

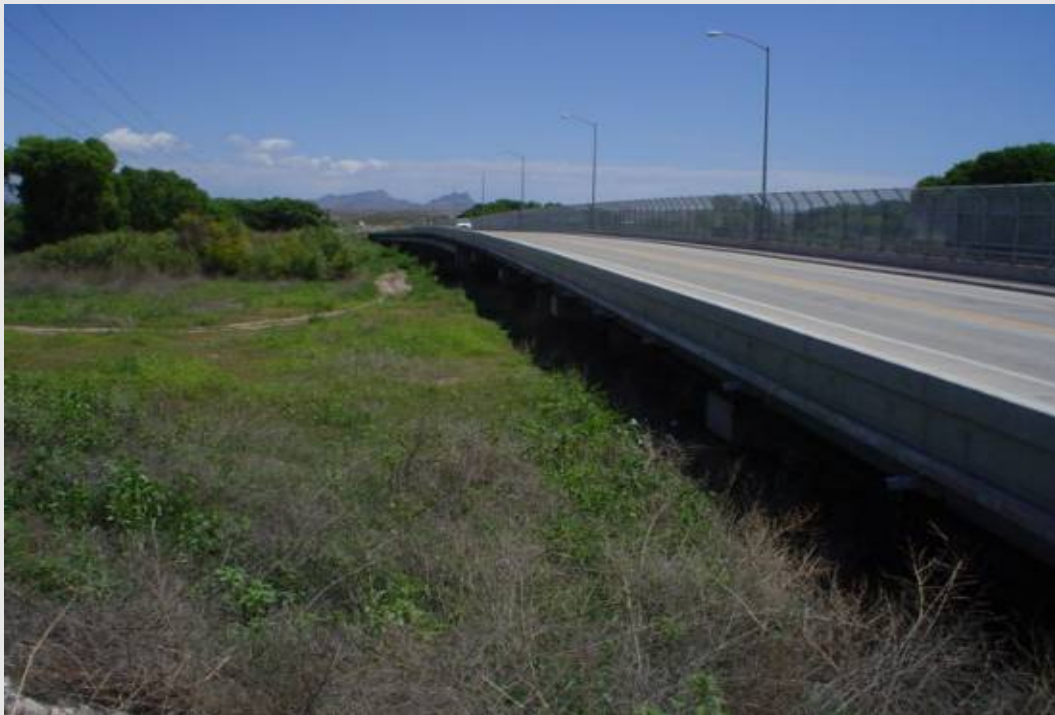
Site Visit: EcoPlan conducted a site visit on August 19, 2008. No pole plantings appeared to have been planted on the site (Figure 10). However, naturally recruited willow (*Salix* sp.), mesquite (*Prosopis* sp.), and tamarisk (*Tamarix* sp.) make the mitigation area appear healthier than before construction (Figure 11). There was evidence of postproject all-terrain vehicle use in the floodplain. There were no trees growing higher in the floodplain.

Conclusions: No conclusions can be drawn about the effectiveness of mitigation practices on this site because mitigation did not occur. However, riparian vegetation was developing in patches through natural recruitment near the river, likely due to the presence of perennial water.

Figure 10. The 40-Foot-Wide Mitigation Strip Along the West Side of the SR 75, Gila River Bridge #311 Project Site.

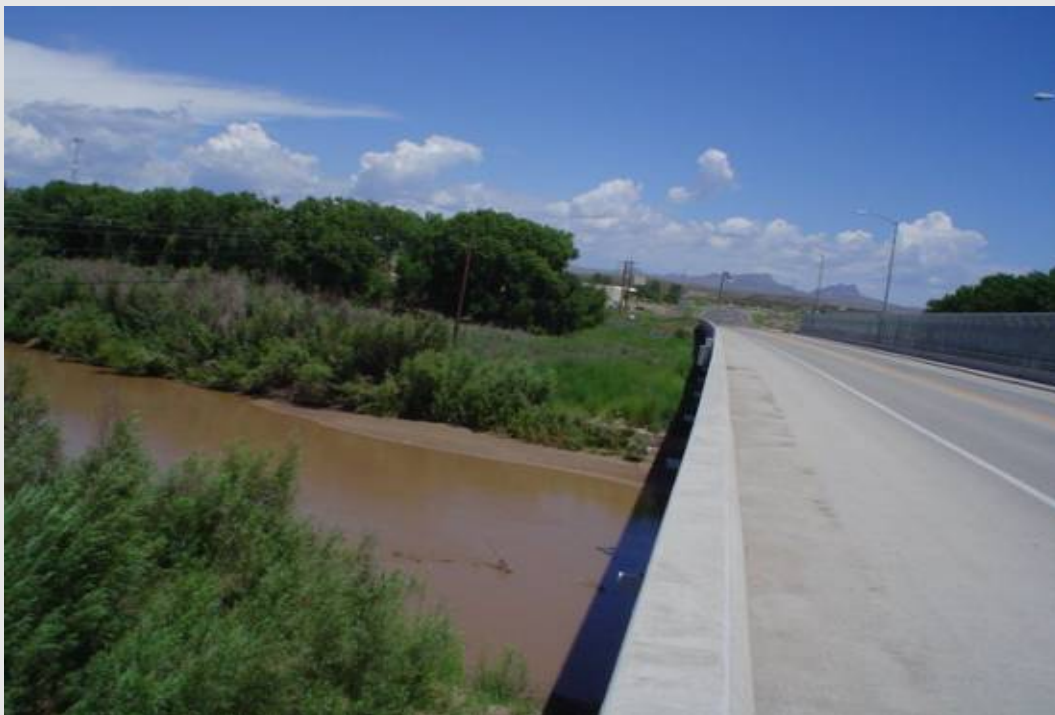
Figure 11. Dense, Naturally Recruited Riparian Trees Along the West Side of the SR 75, Gila River Bridge #311 Project Site.

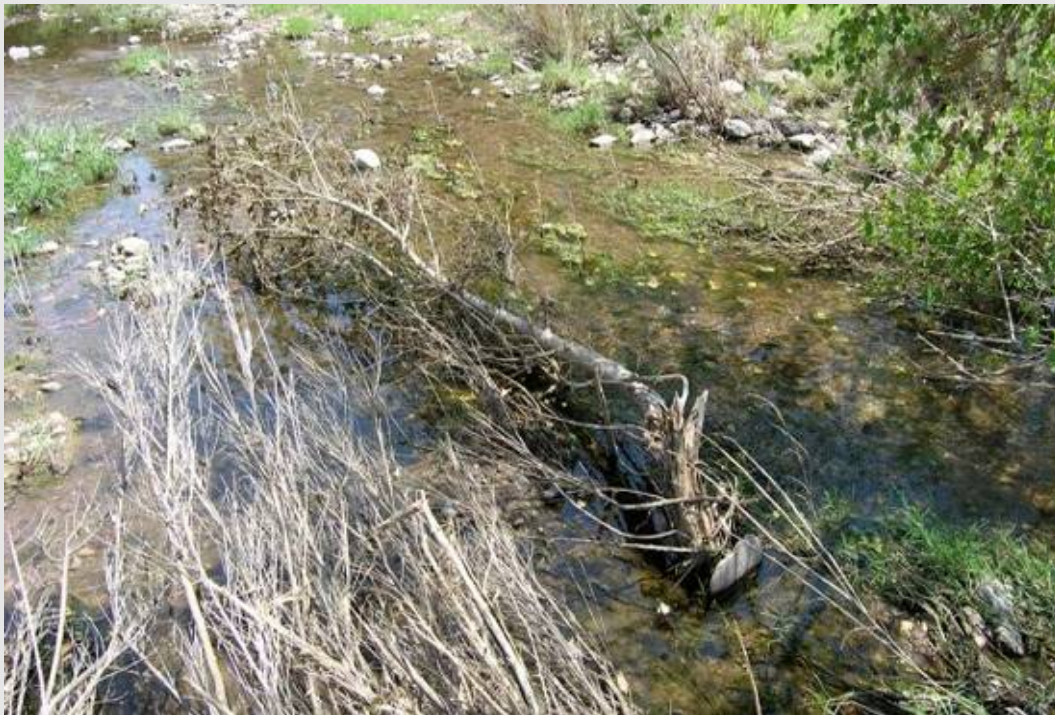
Figure 12. Pole Planting Knocked Down by Flooding at Peck Canyon Bridges Project Site, Between the Frontage Road and the I-19 Bridges.

Browsing by cattle is especially destructive to low vegetation. One suggestion to mitigate the effect of browsing is to install exclusionary fencing to protect the plantings while not excluding cattle from watering areas or travel corridors to which they may legally be entitled.

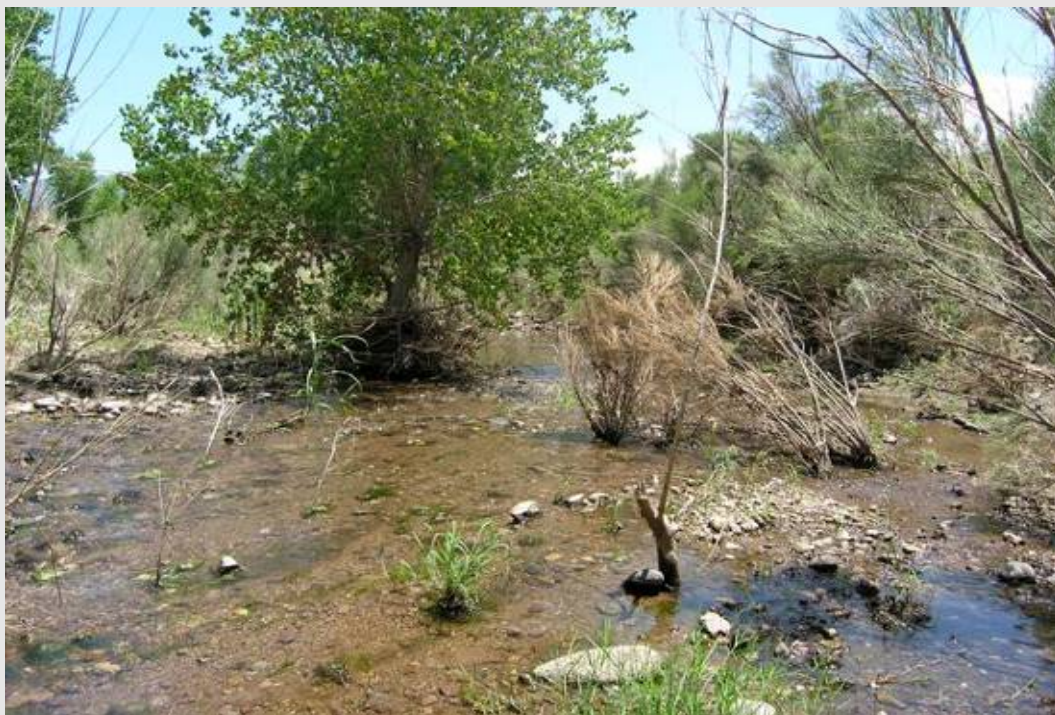
Mitigation for this project called for a significant percentage of the pole plantings to be planted east of I-19. At the time of construction, there was already abundant growth of young cottonwood trees along the Peck Canyon drainage east of I-19. To accommodate additional plantings within suitable habitat, it was necessary to plant immediately adjacent to existing young trees, increasing the size of existing patches. Even with overgrazing by cattle in this area, additional plantings only contributed to the excessive numbers of trees already present. To avoid this problem, the percentage of overplanting to meet survivorship requirements must be determined on a site-by-site basis. Avoidance of trees and other vegetation outside the construction footprint may do more to restore a project area than planting additional vegetation.

Figure 13. Growing and Dead Pole Plantings Downstream at the Peck Canyon Bridges Project Site.
