# Stabilization of Horseshoe Lake Road using Geofibers and Soil-Sement®

## Final Report

AUTC # S12609

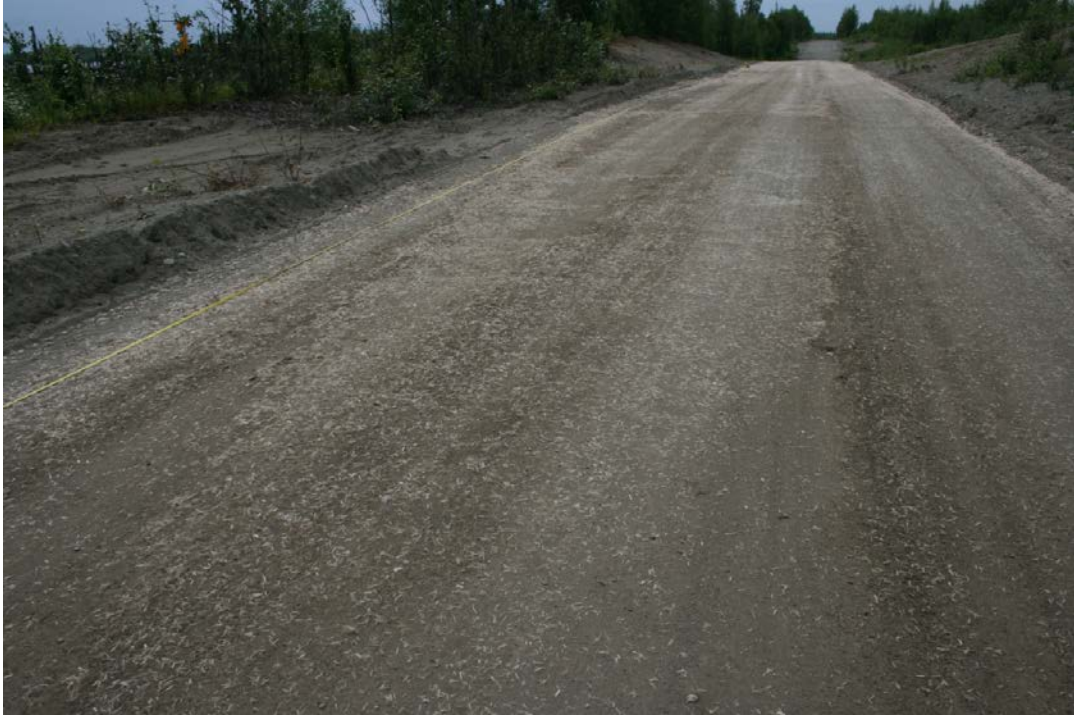
Some initial visual observations noted that some fibers had collected on the surface of the road near the center; this redistribution was most likely due to the wind from passing vehicles picking up the surface fibers and redepositing them. The fibers in the center of the road are visible in [Figure 19](#). It is evident that at the front of the road (photo foreground) there are fewer fibers on the surface, but closer to where the people are standing it is clear there are significantly more fibers in this area.

Figure 18: Roadway one week after construction

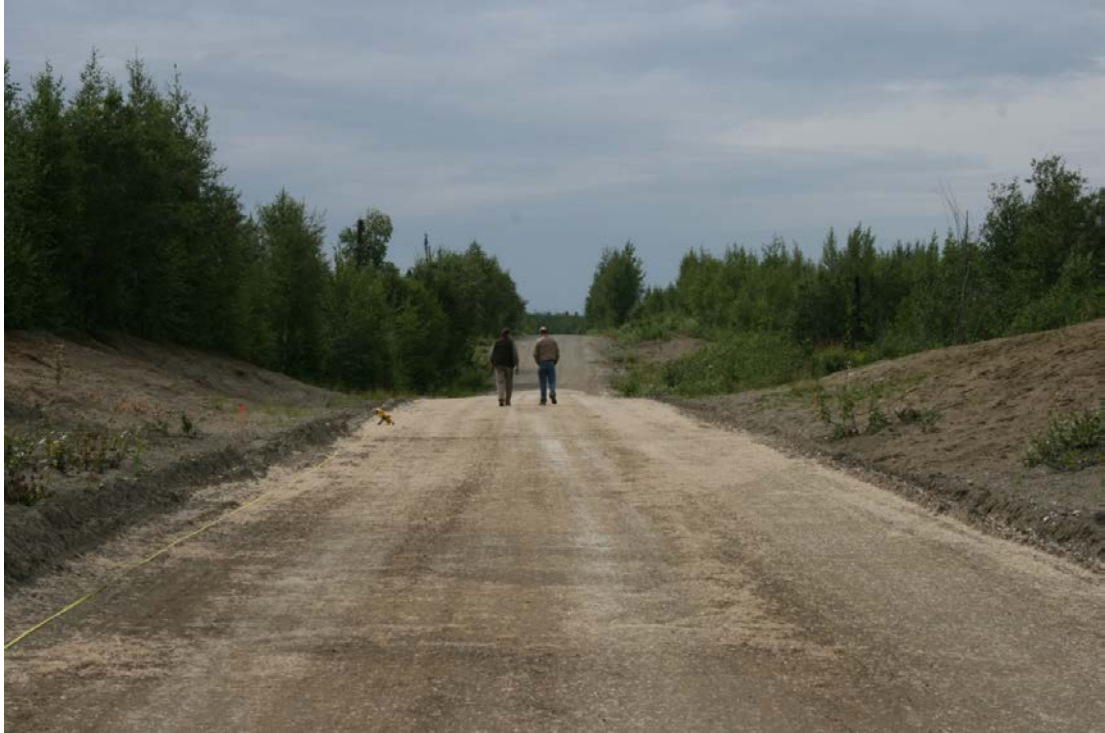
The readings taken on the road three weeks after treatment (August 28<sup>th</sup>) were slightly lower than the ones taken on August 7<sup>th</sup>. This could be attributed to the low volume of traffic on the road not yet activating the potential stiffness increase offered by the geofibers. The results of the stiffness measurements are presented in [Table 5](#); the average CBR value in the center of the road is 15, with values of 11 and 10 on the tree and lake sides of the road respectively.

Figure 19: Roadway three weeks after construction (August 28<sup>th</sup>, 2010)

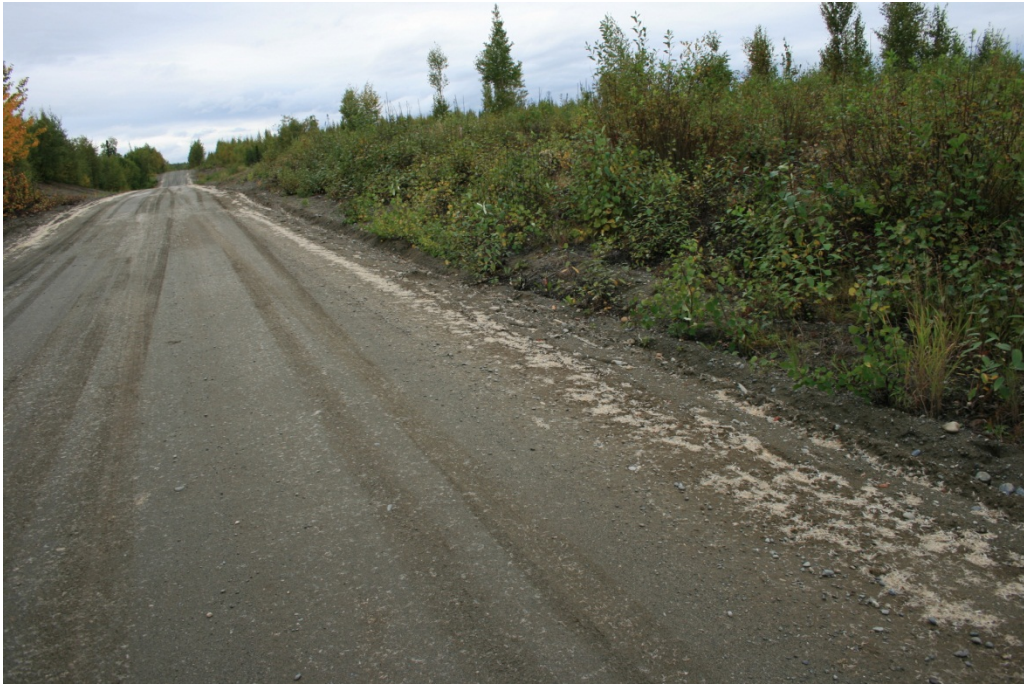
Figure 20: Test section September 7, 2010

was no degradation of the surface or soil strength over the winter, a major concern in cold climates. Indeed, the surface looked exactly the same as the previous fall as shown in [Figure 20](#).

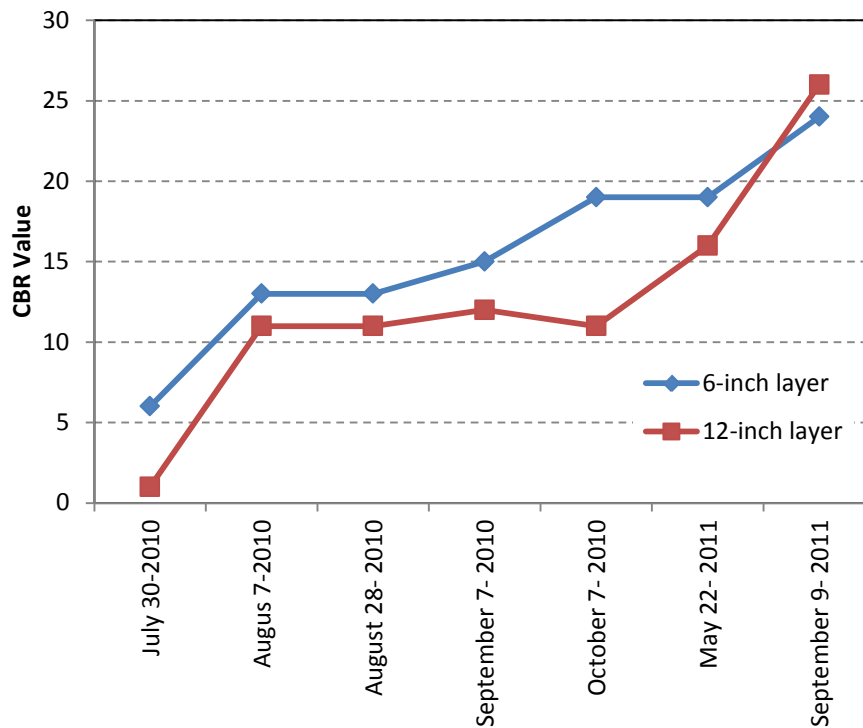
Figure 21 shows the average of CBR values over time for both the 6 inch and 12 inch test sections. Both sections show a steady increase in strength over time. However, the 12 inch section has lower CBR values until the September 9 measurements. This is likely due to inadequate compaction effort on the 12 inch section.

Figure 21: CBR over time

The second problem was that the compaction equipment was undersized. In the future, a 8 ton rubber tire roller is recommended. The kneading action of the rubber tires should help tension the fibers, thus improving the strength of the surface. The additional weight would allow compaction to a greater depth than the compactor used in this first field test allowed. For the 12 inch lift section, the compaction of the lower six inches of the fiber is likely inadequate.
