# Maine Department of Transportation Transportation Research Division

**Technical Report 00-19** *Comparison of "Saw and Seal" Procedure and Performance Grade Binder to Minimize Thermal Cracking*

Interim Report - Fourth Year/Final Report, December 2008

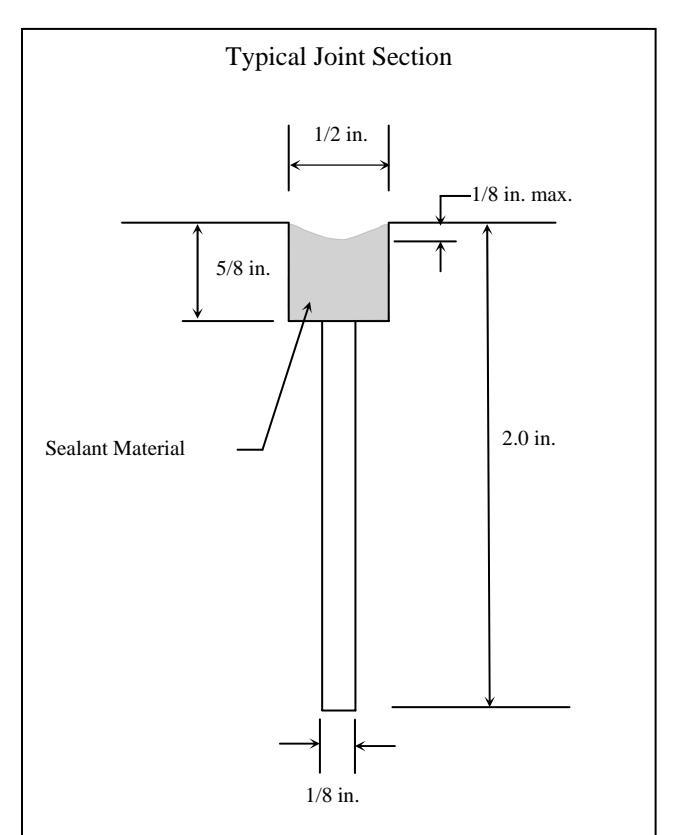
Figure 2: Saw and Seal details

The saw and seal process was completed on October 13, 2000. Full width joints, 7.2 meters (23.6 feet) in length were introduced to the surface using two passes of the pavement saw. The first pass completed the 15.75 mm (5/8 inch) reservoir; the second and final pass completed the approximate 50 mm (2 inch) depth of joint as recommended. Figure 2 contains dimensions of a typical Saw and Seal joint.

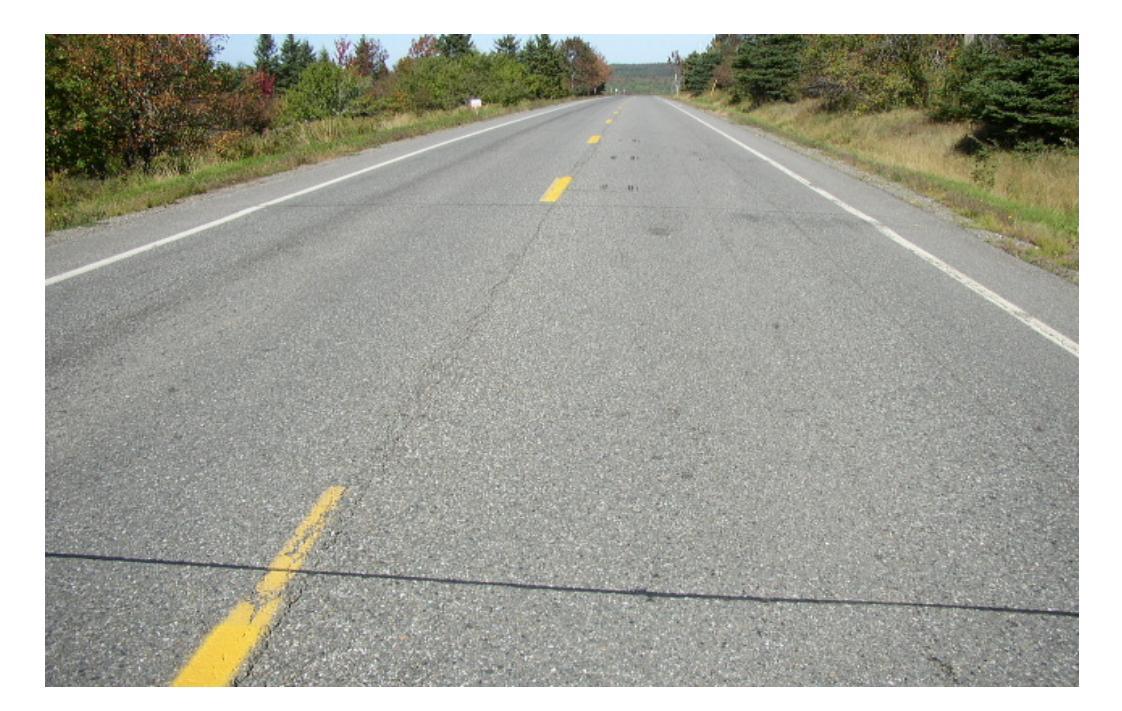
#### Saw and Seal Section

Overall pavement condition remained good for both the 2004 and 2005 evaluations. The average wheel rut depth increased slightly from 6 mm (0.25 in) in 2003 to a measured depth of 7 mm (0.25 in) in both 2004 and 2005. The centerline joint has separated throughout the entire section. Saw joint sealant continues to be pliable and well adhered to the sidewalls of the sawed joints. The two transverse cracks noted as part of the 2003 evaluation continue to be the only transverse cracks observed in this section. The length of each of these cracks has increased minimally. Longitudinal and Load Associated cracking increased in each of the evaluations and is summarized in Table I below.

Beginning with the 2004 evaluation, cracks extending from one or both ends of the sawed joints were identified and recorded. In 2004, eight sawed joints had a crack extending from one end, while ten showed cracks extending from both ends of the joint. For 2005, seven joints had a crack extending from one end and 17, or half of the total number of 34 joints introduced to the pavement, had cracks extending from both ends. This cracking has also been identified on each of the other two Saw and Seal experimental sections constructed and monitored previously within the State. Those projects will be discussed in more detail in the Conclusion section of this report.

In 2004, three sawed joints showed some signs of raveling. This number increased to 15 in 2005. Nine of the sawed joints were also noted as having some parallel cracking during the 2005 evaluation.

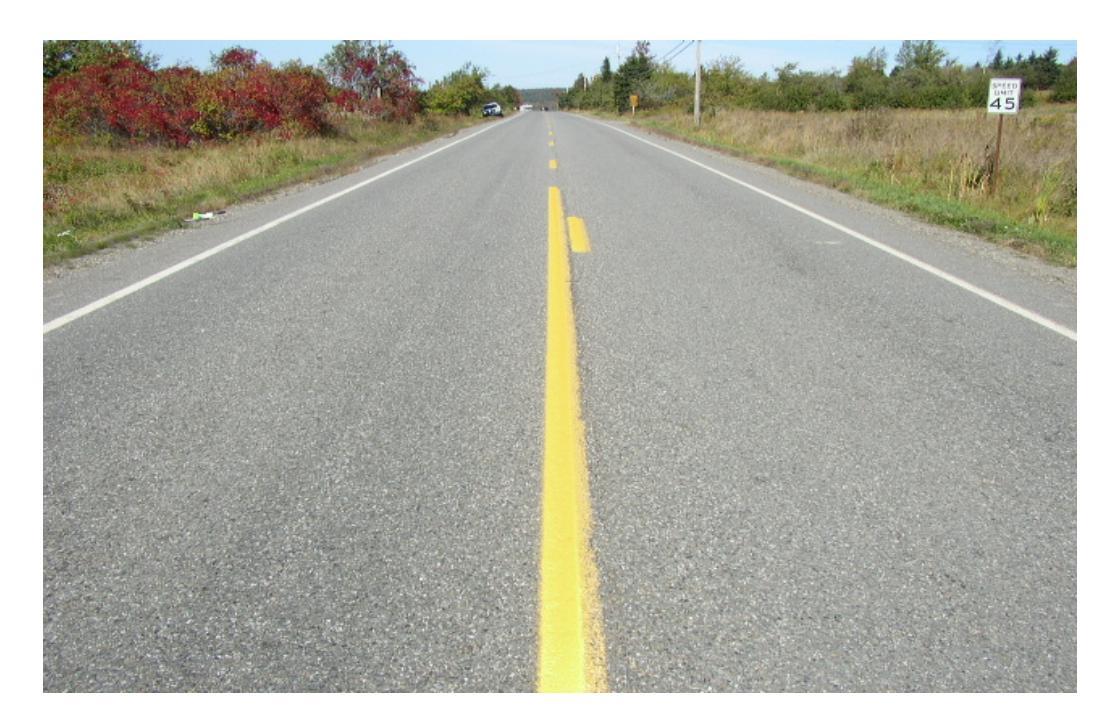
# **Control Section**

Pavement condition for both the 2004 and 2005 evaluations was considered good. The average wheel rut depth for the 2004 evaluation did not show an increase from the 2003 value of just less than 6 mm (0.25 in). In 2005 however, the average rut depth increased to just less than 12 mm (0.5 in). The centerline joint

has separated the entire length of the section. The three transverse cracks identified as part of the 2003 evaluation remain the only transverse cracks within the section. As noted in 2003, two of the transverse cracks are occurring at cross-pipes. The third is the result of a poor quality construction joint and is not considered a thermal related transverse crack for this evaluation. Table II summarizes the Longitudinal and Load Associated cracking for the 2003, 2004 and 2005 visual evaluations.

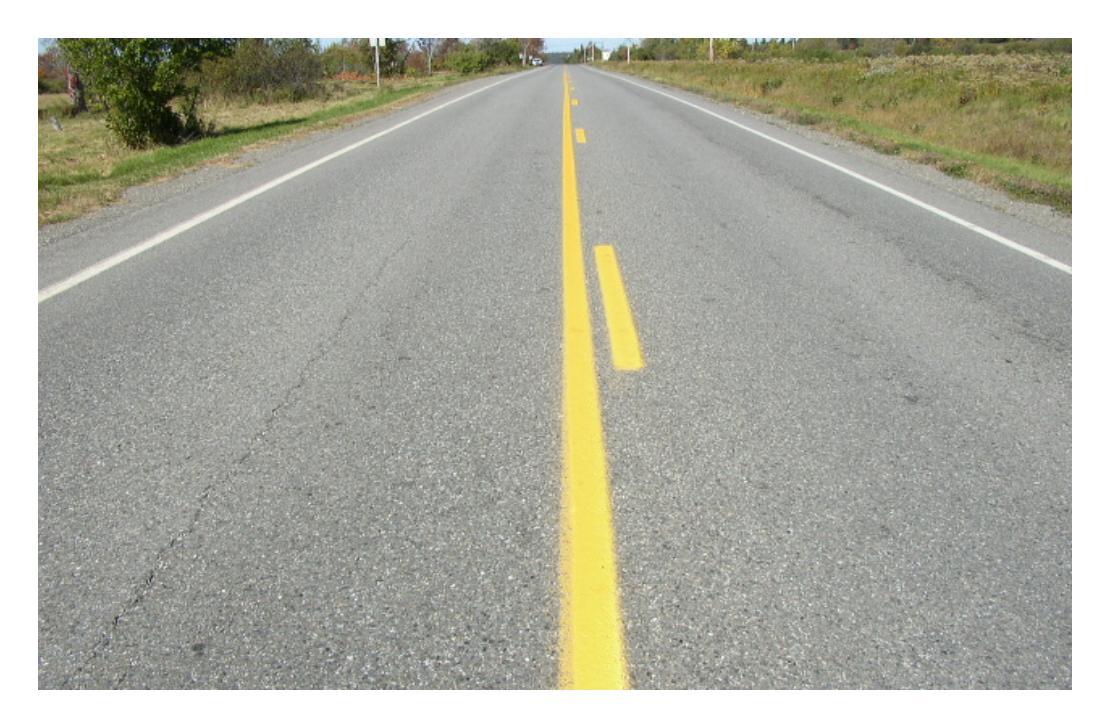
#### Performance Grade Binder (58-34) Section

As with the other two sections in this experimental area, cracking has increased in each of the evaluation years. For the 2004 evaluation, the centerline joint had opened to a total length of 151 meters (495 feet). In 2005 that length had expanded to 192 meters (630 feet). Rutting continued to be more significant in this section. In 2004 the average rut depth increased to 12 mm (0.5 in) and for 2005 that depth had increased to 18 mm (0.75 in). No transverse cracks were identified in either the 2004 or 2005 evaluation. One cross-pipe was resurfaced in this area some time between the 2004 and 2005 evaluations. As was the case with the Saw and Seal section, it is unclear if this had any impact on the crack evaluation. Longitudinal and Load Associated cracking reported for each of the three evaluations is summarized in Table III below.
