Final Report No. 605601 Report Date: July 2016

Development of Delineator Material/Impact Testing Specific to Managed Lane Use for Optimization of Service Life

Test Nos.: 605601-1-6

State of Florida Department of Transportation

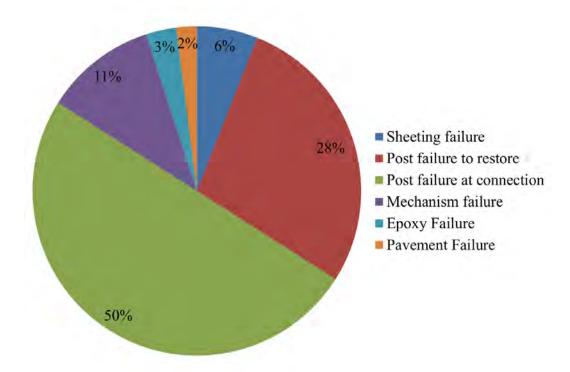
Figure 2. Distribution of Failure Modes in Phase 1 of I-95 Express Lanes.

In Phase 1, the researchers followed a two man crew tasked with repairing and/or replacing failed (damaged) delineators in the northbound direction of I-95 at night. The researchers followed the crew while they replaced 100 delineators. For each delineator, the failure mode was noted. There were no data available to identify the type of impact(s) (i.e., vehicle tire or bumper) that likely caused each failure. The time required for the crew to repair or replace the delineator was documented for a sampling of the failures. Figure 2 shows the distribution of failure modes seen in Phase 1. Notice that no base failures were documented in the field.

The first three failure modes (sheeting failure, post failure to restore, and post failure at connection) comprised 84 percent of the repair/replace activities witnessed in Phase 1. All of these failures required replacement of the post to correct. The workers used a cutting tool to remove any portions of the failed posts (as shown in Figure 3) and attached the new post by shoving it down onto the connector. Each of these repairs took about 15 seconds for one worker to perform.

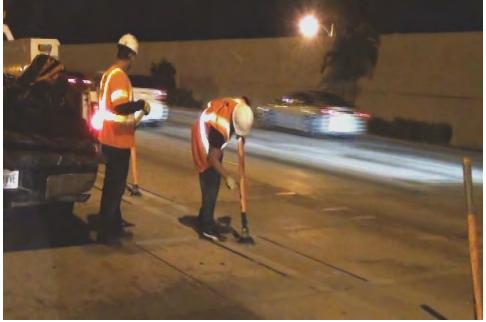
Figure 3. Sheeting Failure and Post Failure Replacement.

Sheeting failure: The retroreflective sheeting is damaged from abrasions or tearing and is not providing sufficient retroreflectivity at night.

Post failure to restore: The post is kinked or ruptured above the connection to the mechanism. This usually occurs around vehicle bumper height.

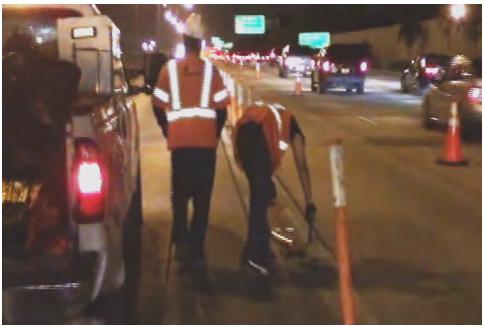
Figure 4. Mechanism Failure Replacement.

Mechanism failure: The proprietary connection has failed and no longer keeps the post erect.

When the mechanism failed (as shown in Figure 4), the worker removed it by hammering the pin out from one side, pulling the mechanism out, cleaning debris from inside the base, inserting a new mechanism, and hammering the pin back into place. A new post was installed as well. Each of these repairs took about 90 seconds for one worker to perform.

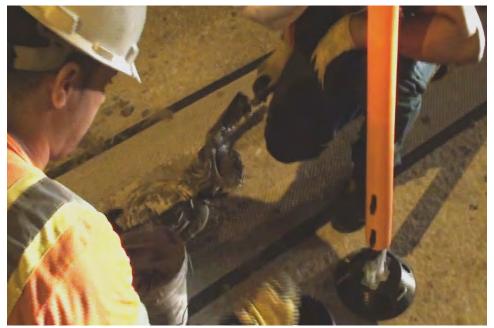
Figure 5. Epoxy Failure and Pavement Failure Replacement.

Epoxy failure: The epoxy has become completely separated from either the base or the pavement.

Pavement failure: The entire delineator is missing and a portion of the pavement is also missing.

When the epoxy or the pavement has failed, a new delineator was installed. The workers swept a small area of the pavement by hand and mixed a small batch of two-part epoxy directly on the pavement (as shown in Figure 5). A new delineator was placed and the workers set the

delineator by rotating it in the wet epoxy, checking for proper alignment, and stepping on the top of the base to force the epoxy up into the pockets in the bottom of the base. This process took about 4 minutes for two workers to perform.

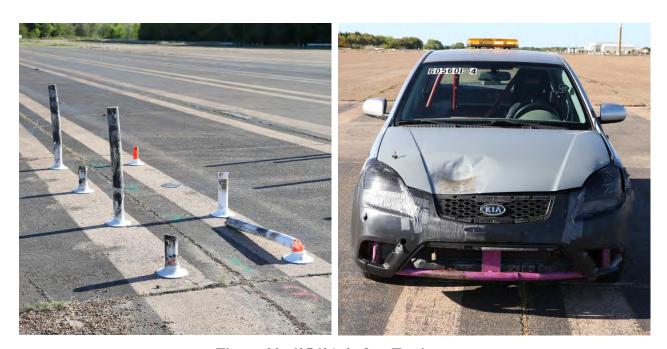
Figure 20. 605601-4 after Testing.

Table 5 documents the list/lean and failure modes witnessed under Test #605601-4. All samples that were impacted by the bumper of the vehicle failed to resist 200 impacts. Fifty percent of samples that were impacted by the tire resisted all 200 impacts. The primary mode of failure was rupturing of the samples at the base. The maximum list recorded prior to failure was 3°, and the maximum lean recorded prior to failure was 4°.

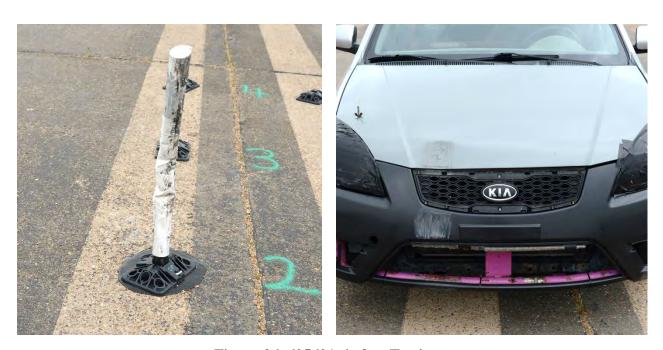
Figure 26. 605601-6 after Testing.

Table 7 documents the list/lean and failure modes witnessed under Test #605601-6. For the Shur-Flex Surface Mount sample, all samples failed to resist 200 impacts. The primary mode of failure was exceeding the maximum allowable degree of lean/lean. The maximum list recorded was 4° , and the maximum lean recorded was 50° .
