Alternative Stream Channel Maintenance at Bridge Crossings

February 2017

Final Report

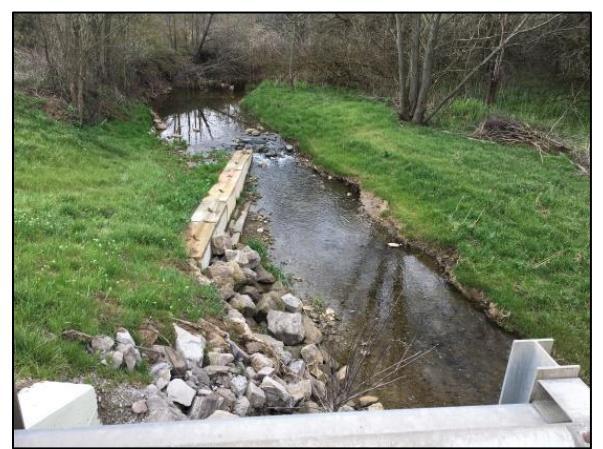
Figure 26 After one winter and spring high flows note the stability on the river right bank and the location of the scour downstream from mid-way along the vane.

The upstream end of the vane intercepted the channel bed in an existing riffle. Subsequent to construction, much of the riffle has been replaced by a scour hole. The bed has become lower, exposing the upstream end of the vane. We wonder if a smooth transition, tangent between the vane and the streambed, might be preferable to the 1.5 foot elevation the upstream end of the vane now has above the stream bed. No instabilities or debris accumulation have yet been observed. On future projects, we will consider extending the vane farther upstream, buried down into the channel bed, as insurance.

The experience and performance with this project leads us to think that moving the vane downstream to abut the wing-wall might be preferable for results and simplicity. By having the vane abut the bridge wing-wall the risk of scour around the vane and between the vane and the bridge structure would be reduced without the use of bank armoring.

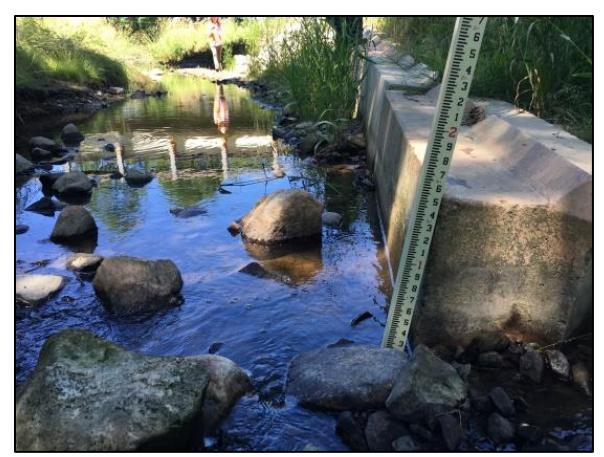
Figure 27 The upstream end of the vane is stable but has become more exposed from the vane inducing scour of a riffle.

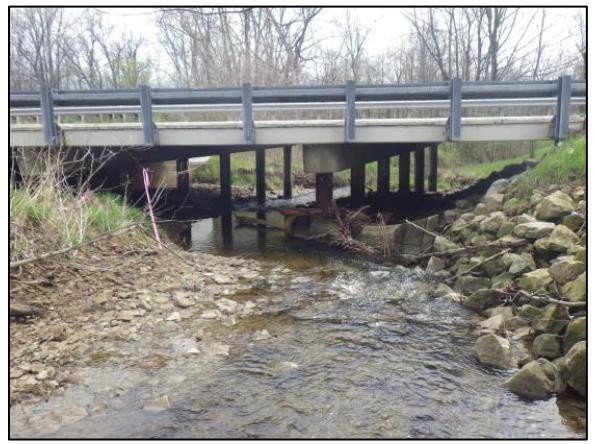
Figure 29 Poor alignment of low and intermediate flows with debris collecting on the right piers.

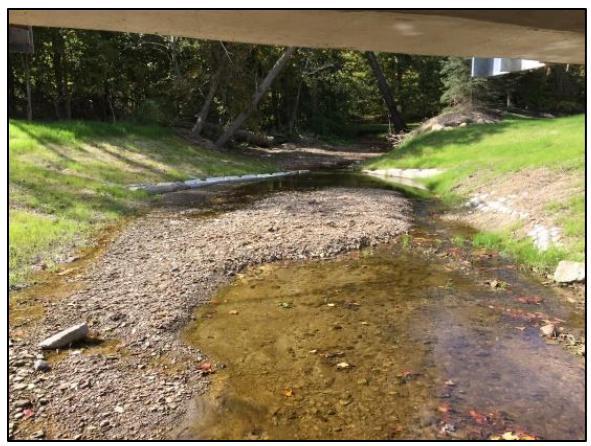
Shortly after construction, bed material started to accumulate upstream from the bridge, in the area where scour was intended to occur.

Figure 33 Looking upstream from the bridge at the cross vane and accumulating bed material.

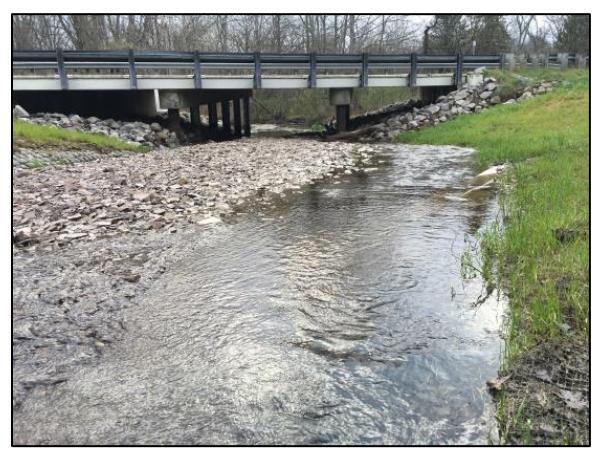
After one season of high flows, the project has not performed satisfactorily. Bed material has accumulated between the cross vane and the bridge, a bar has begun to re-form in the left side of the channel and the alignment is developing off to the right of center toward the right piers.

Figure 34 Looking downstream the vane mostly obscured by accumulated bed material. Note the channel width should be similar to the width between the piers.

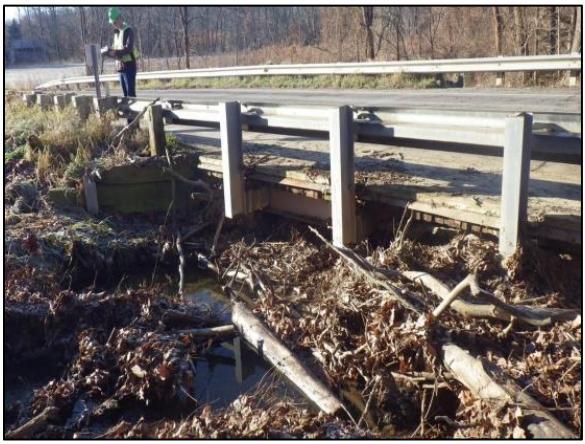
The stream naturally has a large amount of bedload sediment. The bedload supply increased further, in recent years, by channel instability in the watershed. Throughout the watershed the stream has adequate sediment transport competence, until it meets the broad flat floodplain of Black Fork Mohican River. It is made even flatter by backwater from the Charles Mill Lake dam. State Route 603 crosses at the natural transition from a single thread channel to an alluvial fan. In the past, channelization had extended the stream through the alluvial fan to the river. However, sediment has completely filled the channelized reach. Flows have been actively developing new courses that dissipate and disappear well before reaching the river.

Figure 35 Minimal capacity from aggradation and debris.

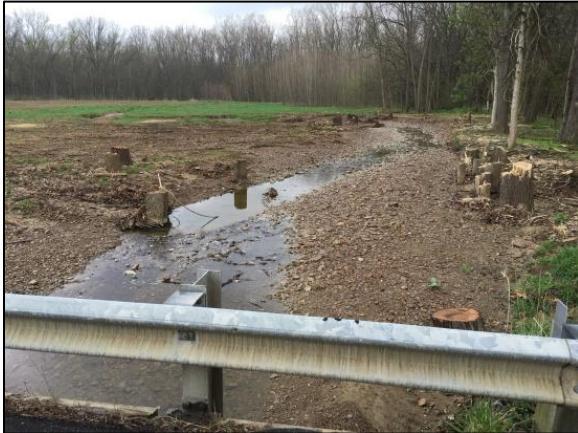
Figure 36 Aggradation downstream reduced slope and at the bridge.

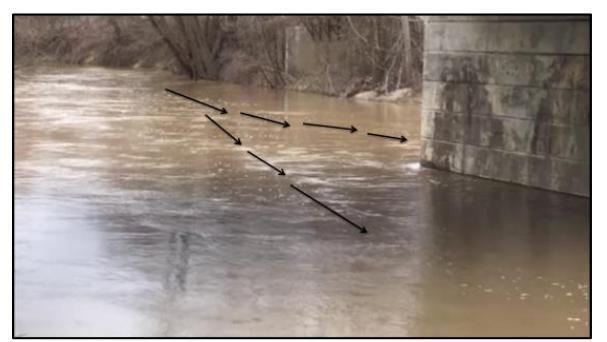
Construction was done in November, 2015. Since then, three high flows (1.1 RI) occurred, two of which were observed. The structure was submerged. No turbulence or drop over the w-weir was perceptible. However, the flow and the path of small debris could be seen clearly shifting away from the pier and directed through the spans.

Figure 50 High flow with w-weir submerged and shifting flow away from the pier.

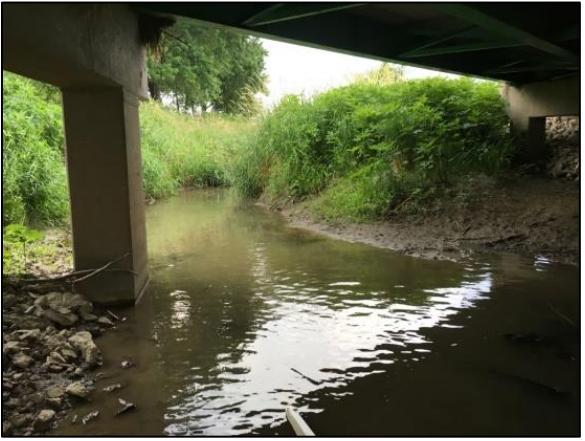
Figure 51 Poorly aligned channel viewed looking upstream.

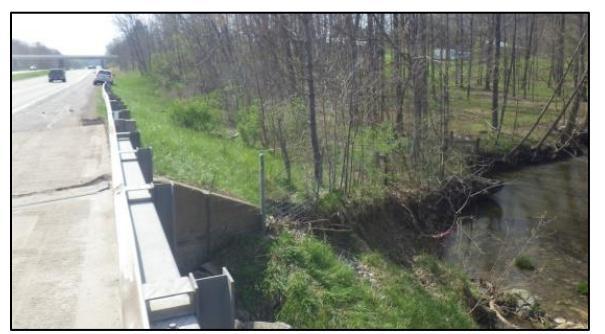
Figure 565 Looking upstream at the eroding roadway embankment.

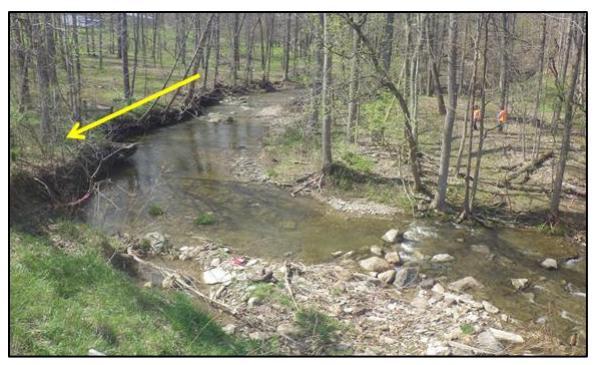
Figure 58 The first bend upstream has moved down valley.

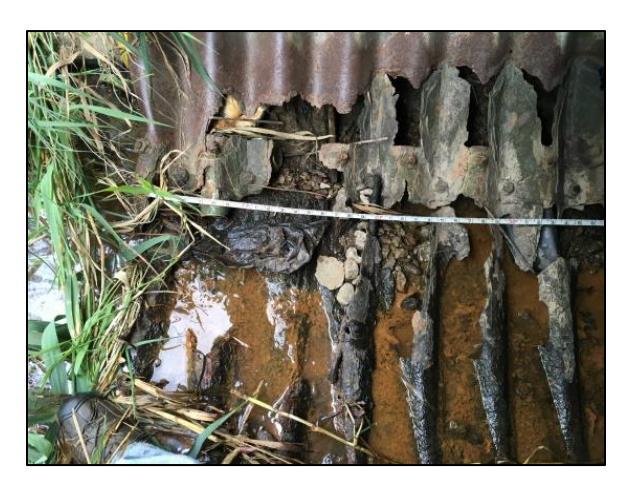
Figure 1. Severe corrosion at the upstream end of the CMP.

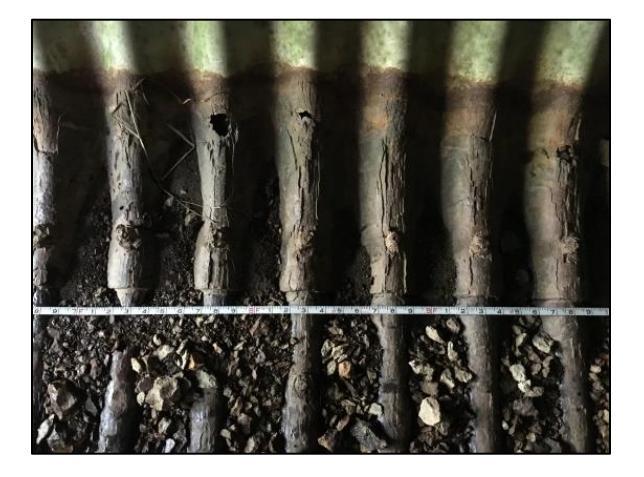
Figure 68 Corrosion 8 feet from the upstream end.

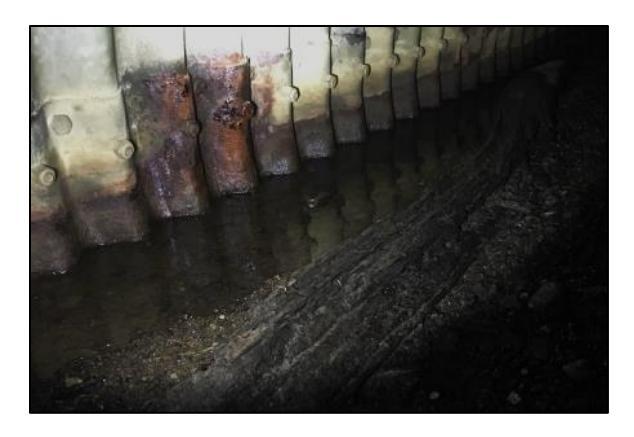
Figure 69 Beyond 50 feet the CMP is less corroded.

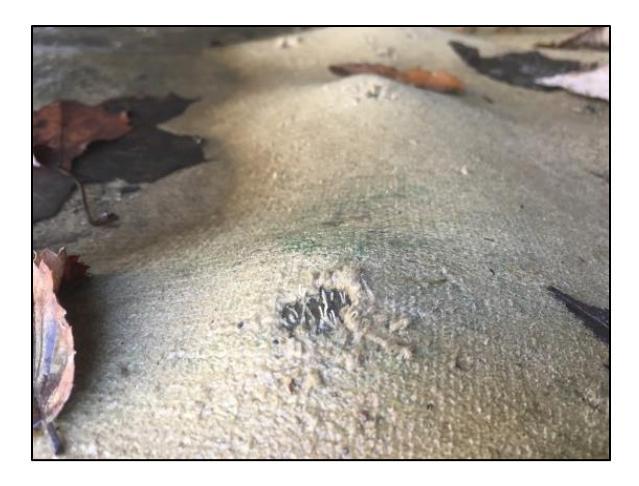
Figure 13 Abrasion over the CMP's bolts.

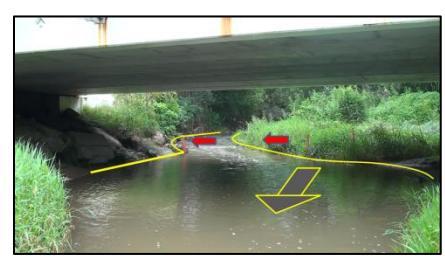
Figure 72. During initial construction of this bridge, flow was well-aligned with the bridge opening (approximated by the yellow arrow). However, the bridge opening that was constructed to pass the design discharge rate was much wider than the bankfull channel dimensions of the stream. This created a disruption in sediment transport through the 'over-wide' section of the reach. In response, gravel and sediments were deposited forming the bar (located at the red arrow on the right of the figure) which vegetated and narrowed the flow to regain sediment transport capacity. As the bar developed, flow was redirected to the channel banks (red arrow on the left) causing erosion, which now threatens the embankment.
Throughout Ohio the scenarios described above are common. Many bridges and the stream channels they cross require frequent and costly maintenance to function properly. Maintenance activities are carried out at the local-level by ODOT county garage crews. These maintenance activities typically fall into the following categories: 1) dredging of deposited sediments, 2) removal of debris accumulations, 3) hardening of stream banks, and 4) placement of materials to protect bridge structural components (e.g. piers, abutments, etc.) from local scour. A more detailed discussion of these maintenance activities is provided in the following paragraphs.

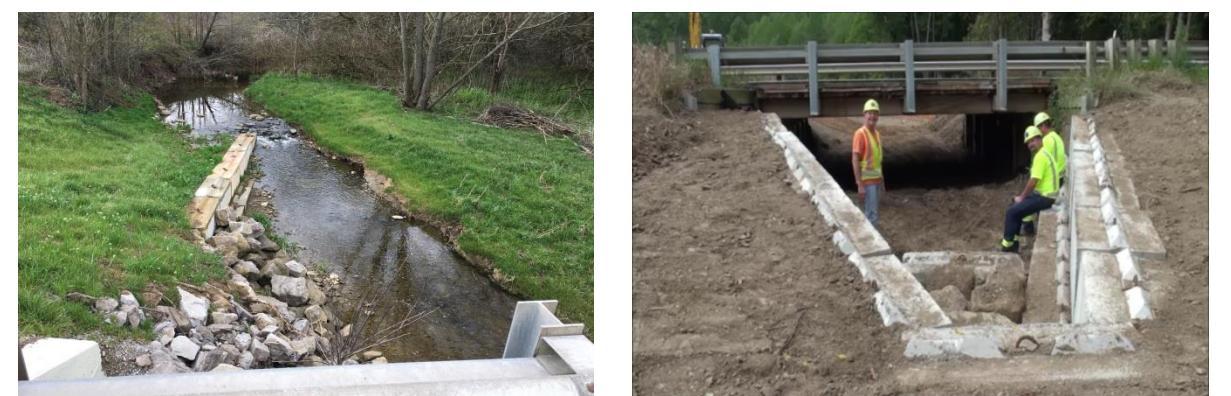
Figure 2. Left: A single-arm vane installed in Wayne County (SR 604) to better align flow and redirect it to the center span of the bridge, which will protect the embankment along the outer bend of the stream channel. Right: Construction of a cross-vane structure through a bridge opening in Ashland County (SR 603) to promote scour in the center of the channel and mitigate deposition of sediment, which had severely reduced conveyance through the bridge opening and led to frequent flooding and closure of the roadway.
