Evaluation and Repair of Existing Bridges in Extreme Environments

KOREY POUGH M.Sc.
DARION MAYHORN, M.Sc.
GARY S. PRINZ, Ph.D., P.E.
ROYCE W. FLOYD, Ph.D., P.E.
SPTC14.1-58-F

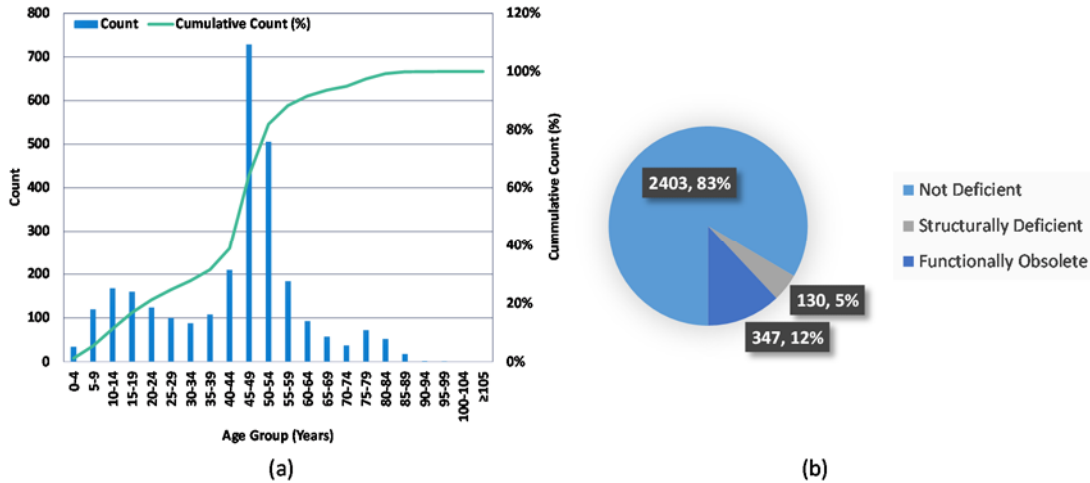
Figure 2-3: (a) Age of principal arterial multi-girder bridges in region 6, (b) status of principal arterial bridges in region 6

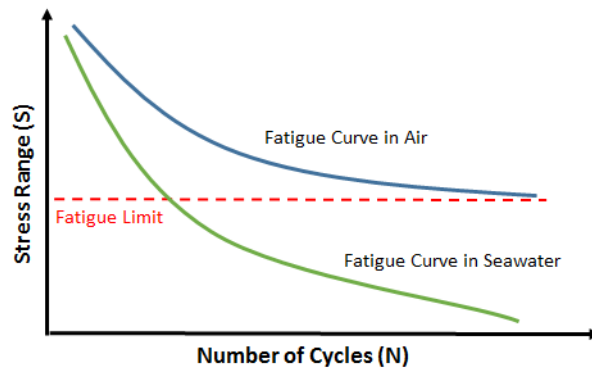
Figure 2-4: S-N Curve for typical metal in air and in seawater.

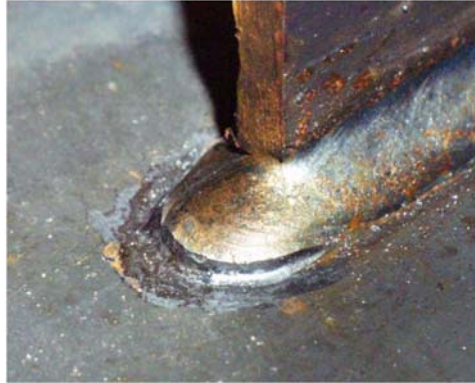
Figure 2-5: Impact treatment and geometry improvement of a weld toe [5]

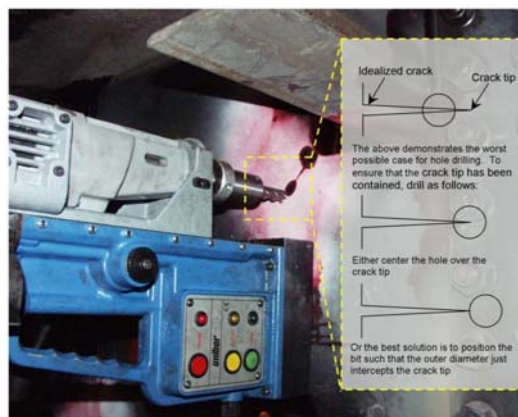
Figure 2-6: Hole-drilling and proper positioning for crack containment [5]

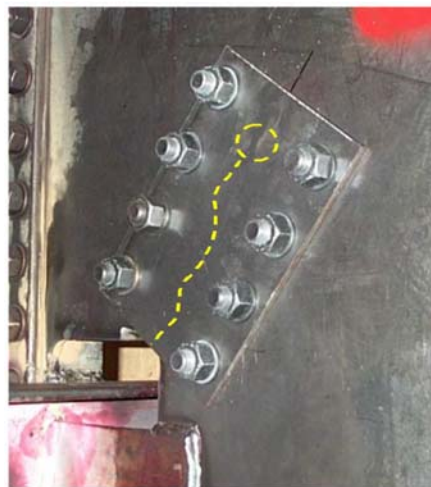
Figure 2-7: Splice plate installed using high strength bolts [5]

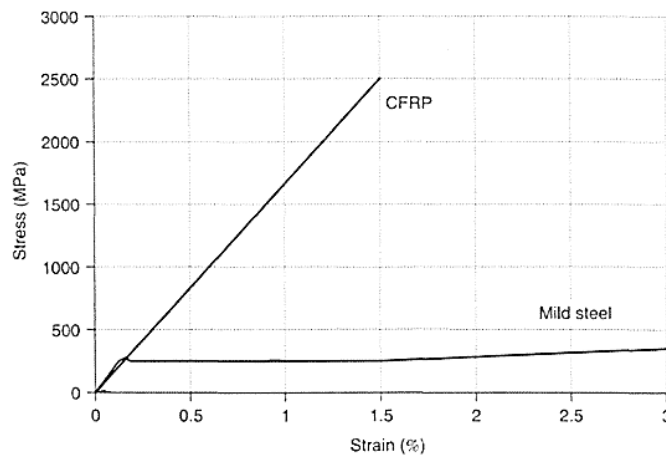
Figure 2-8: Stress-strain curve for CFRP and mild steel [7]

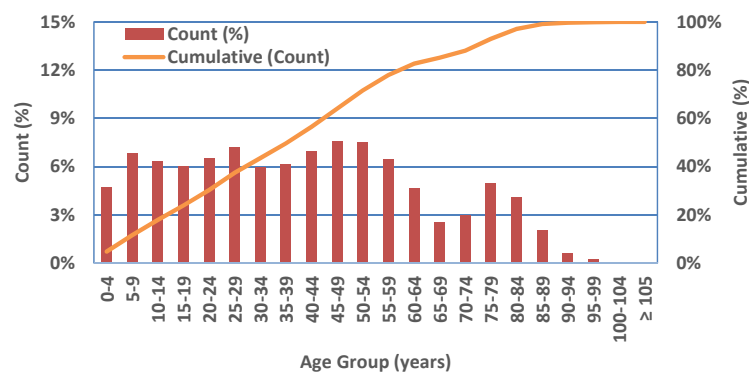
Figure 2-9: Distribution of concrete bridge age within region 6

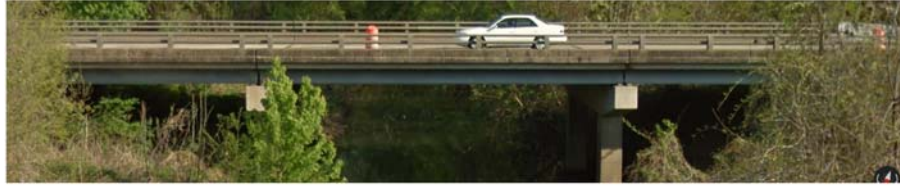
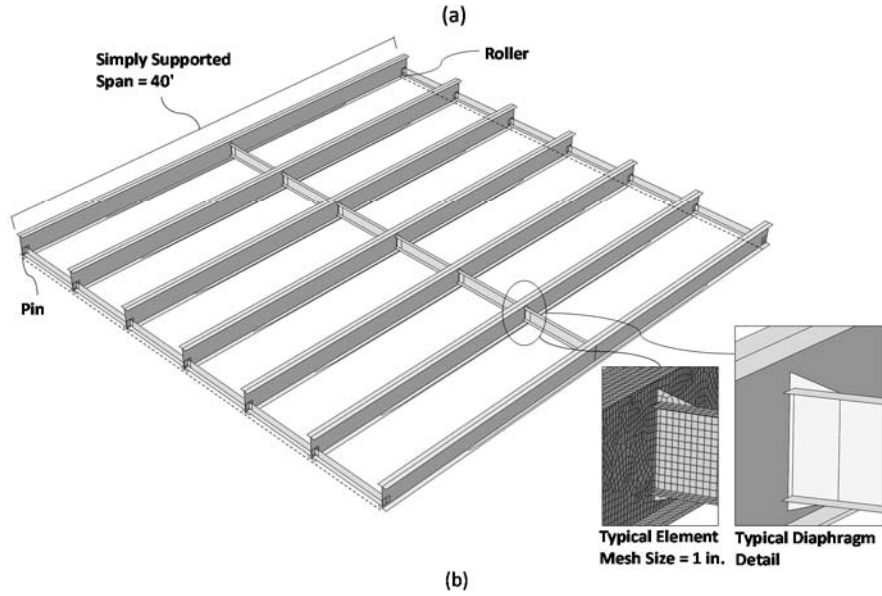
Figure 3-2: Bridge A-3956 (a) elevation picture [41] (b) ABAQUS model

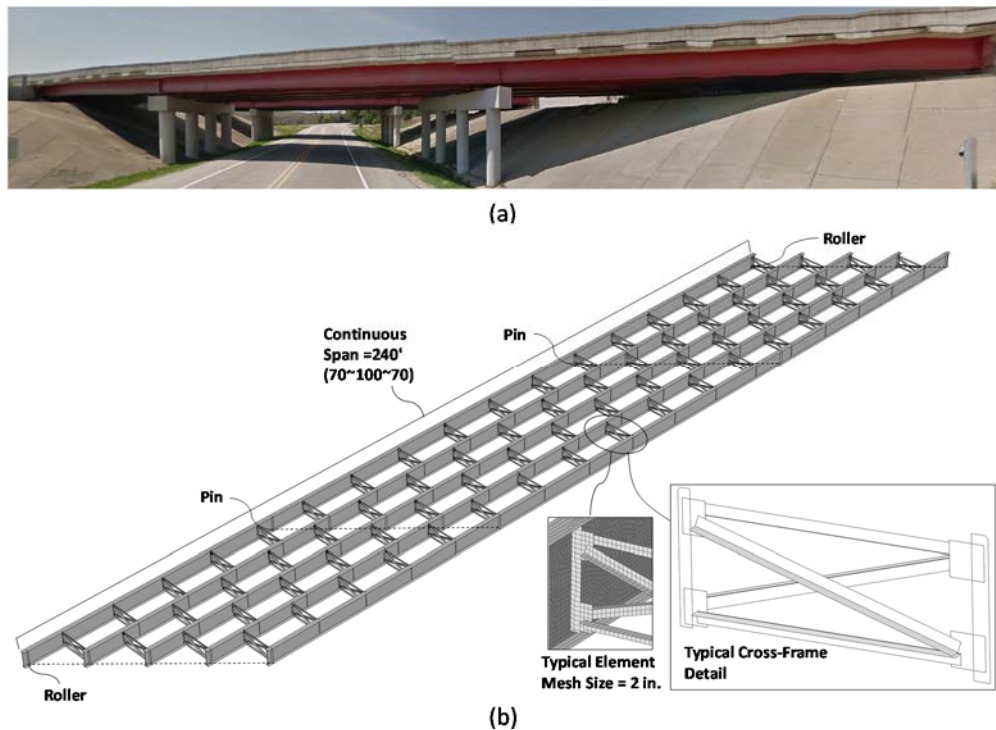
Figure 3-5: Bridge A-6243 (a) elevation picture [41] (b) ABAQUS model

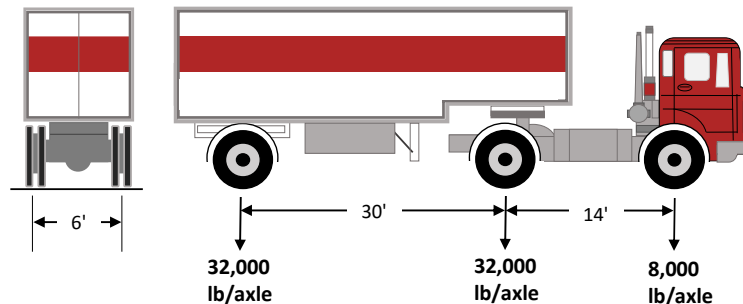
Figure 3-6: Characteristics of the AASHTO fatigue design truck HS 20-44

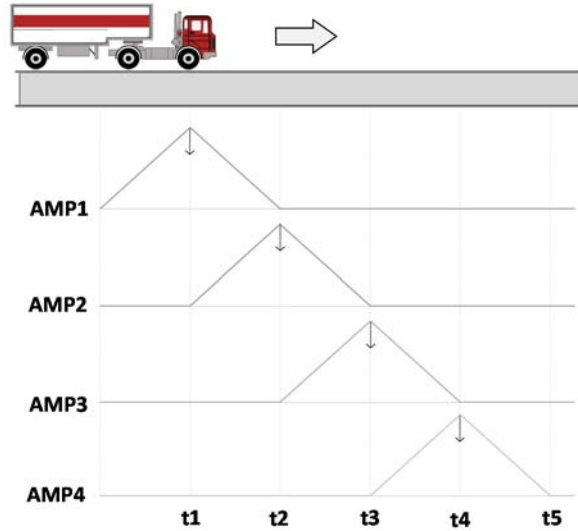
Figure 3-8: Wheel loading scheme

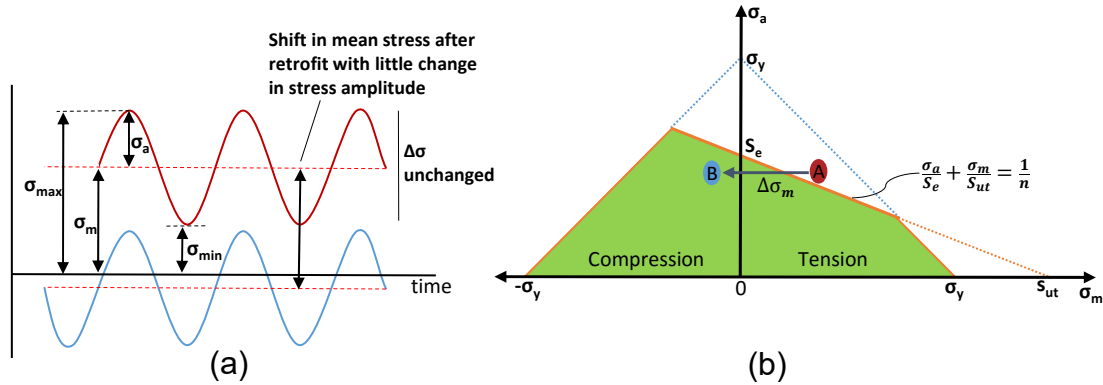
Figure 3-9: (a) Sample stress history (b) CLD representing the modified Goodman criteria

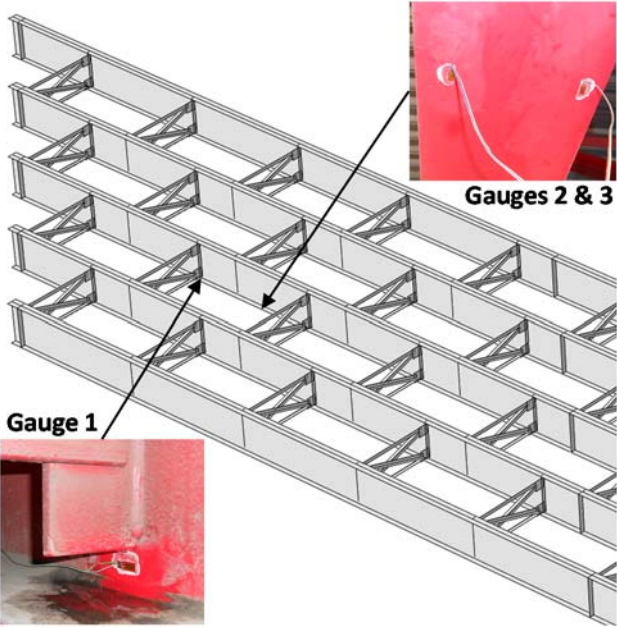
Figure 4-2: Location and picture of installed strain gauges

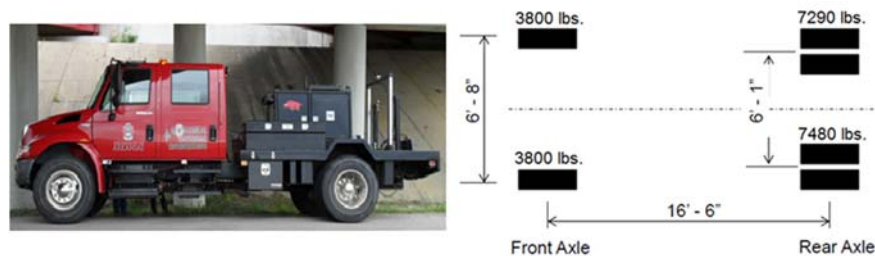
Figure 4-3: Vibroseis truck axle weights and individual wheel loads

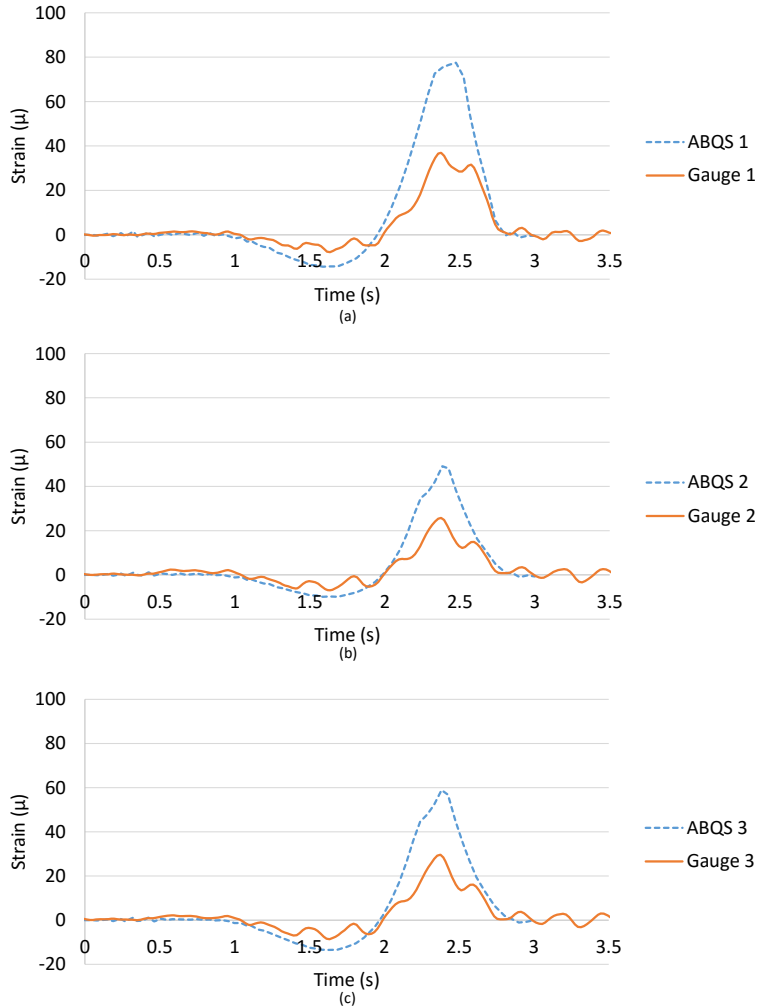
Figure 4-4: Comparison of strain gauge measurements with FEM results at (a) gauge 1, (b) gauge 2, and (c) gauge 3 locations

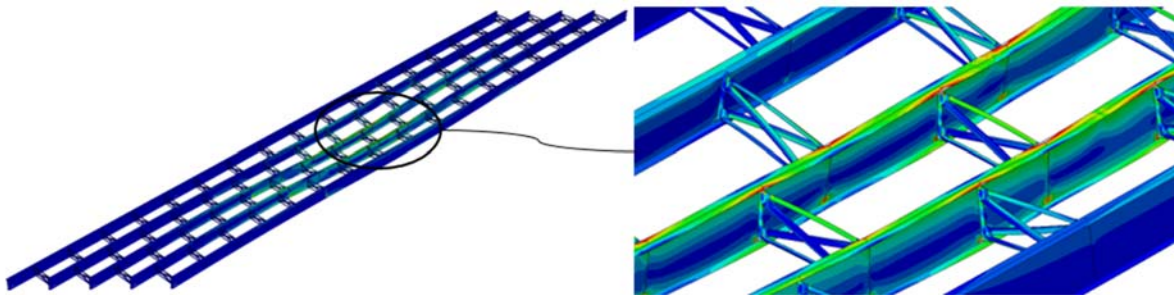
Figure 4-5: von Mises stress distribution at mid-span in bridge A-6243
(Note: Deflections are scaled 30 times)

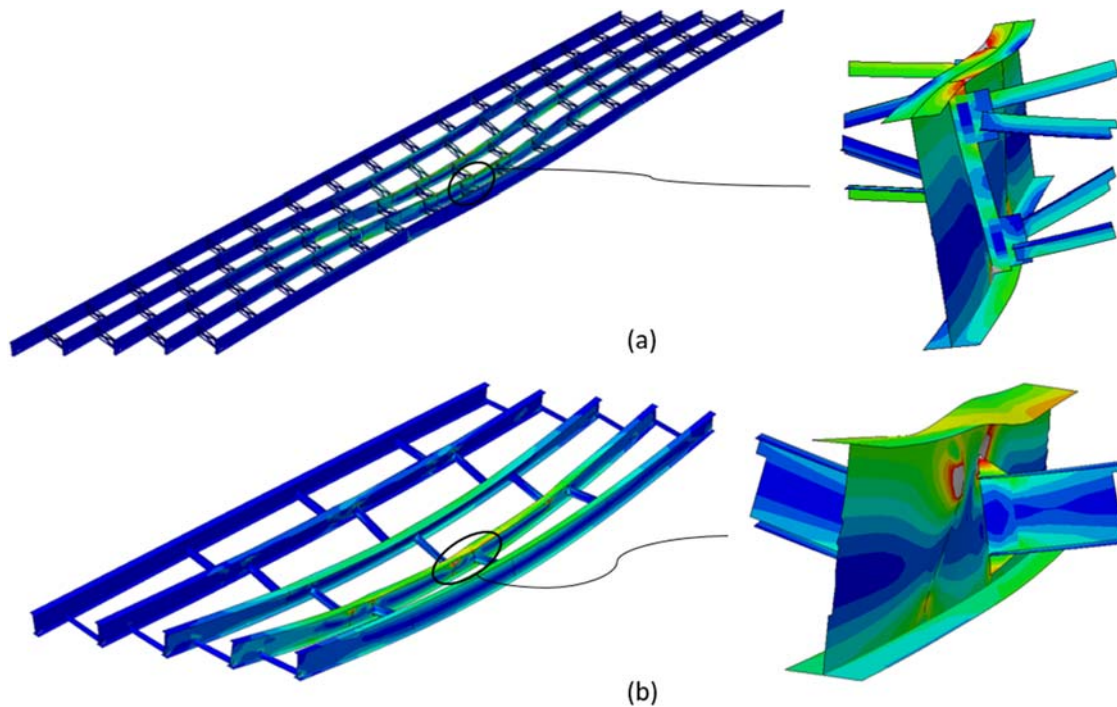
Figure 4-7: von Mises stress distribution showing distortion in the girder web of bridges (a) A-6243 and (b) A-3958 (Note: Deflections are scaled 50 times for visualization.)

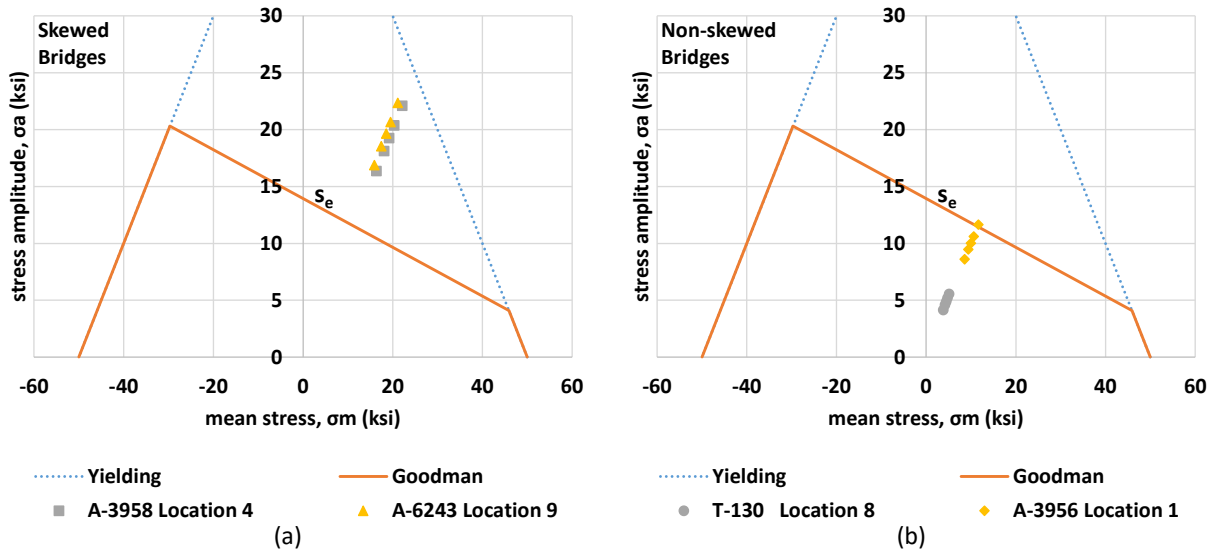
Figure 4-8: Goodman plots for the critical fatigue detail in the (a) skewed bridges (A-3958 & A-6243) and (b) non-skewed bridges (A-3956 & T-130)

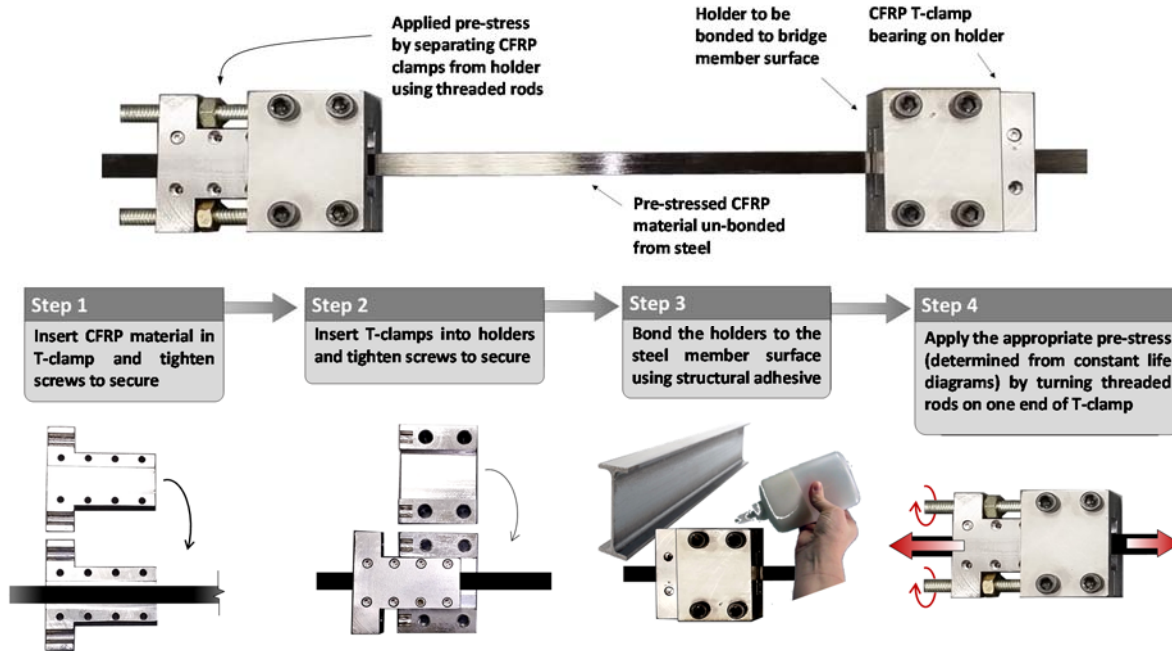
Figure 5-1: CFRP retrofit and installation procedure

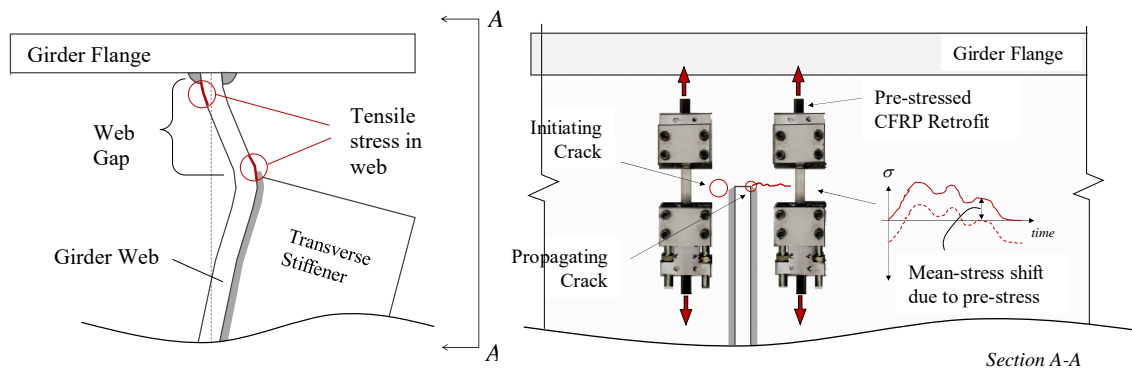
Figure 5-2: Example of retrofit installation on a partial depth web attachment showing shift in mean stress due to the pre-stressed CFRP.

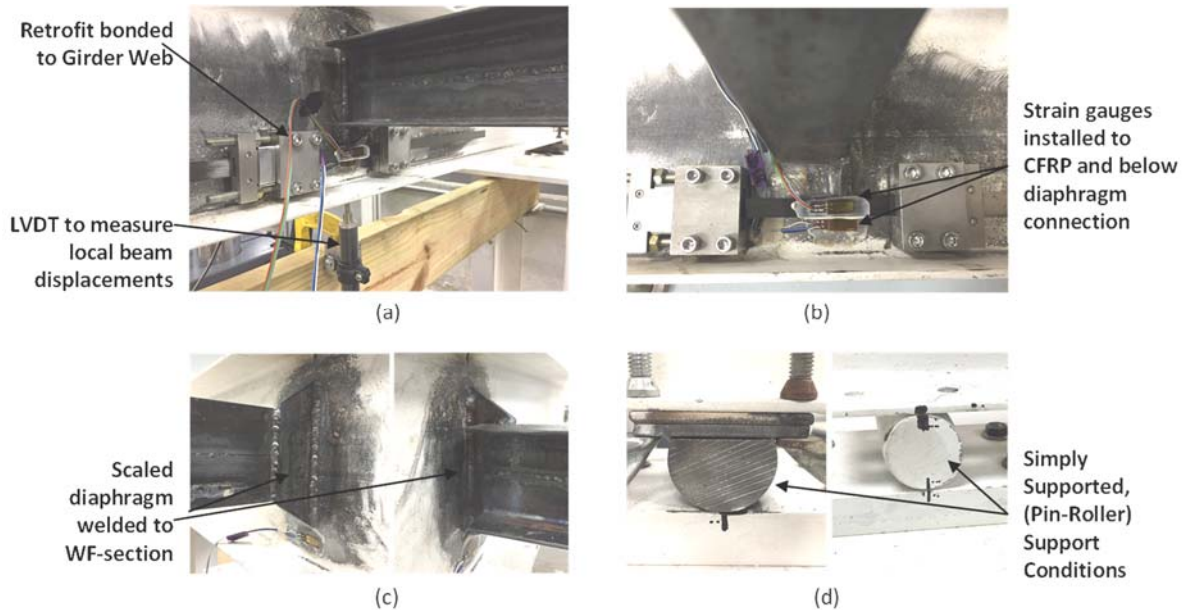
Figure 5-6: Pictures of experimental test setup showing (a) retrofit bonded to structure, (b) installed strain gauges, (c) diaphragm to web connection detail, (d) test support conditions

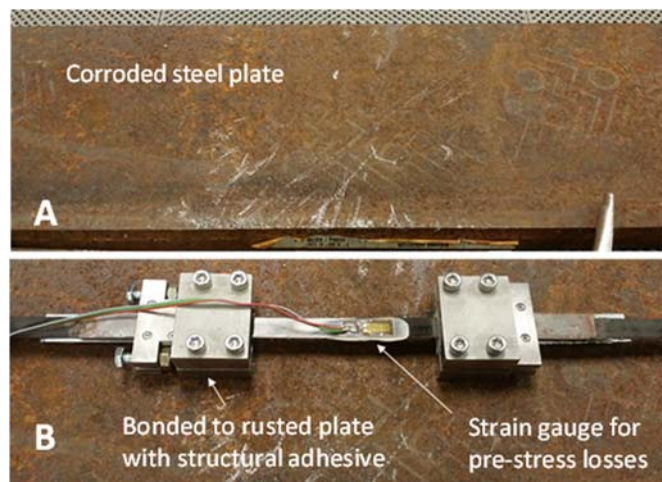
Figure 5-8: Corroded steel plate and bonded retrofit

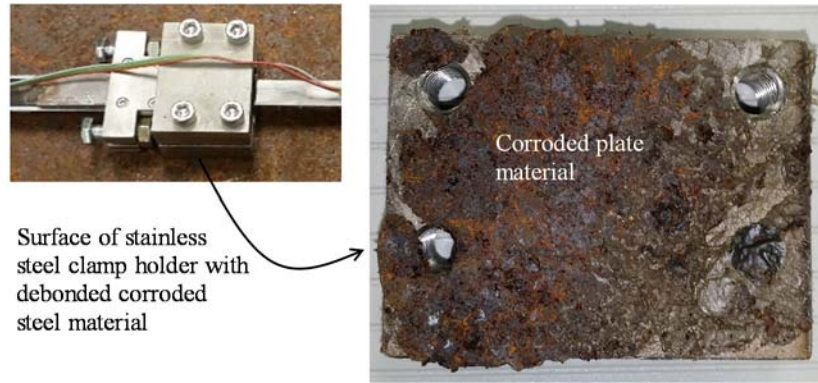
Figure 5-9: De-bonded retrofit with corroded plate material attached

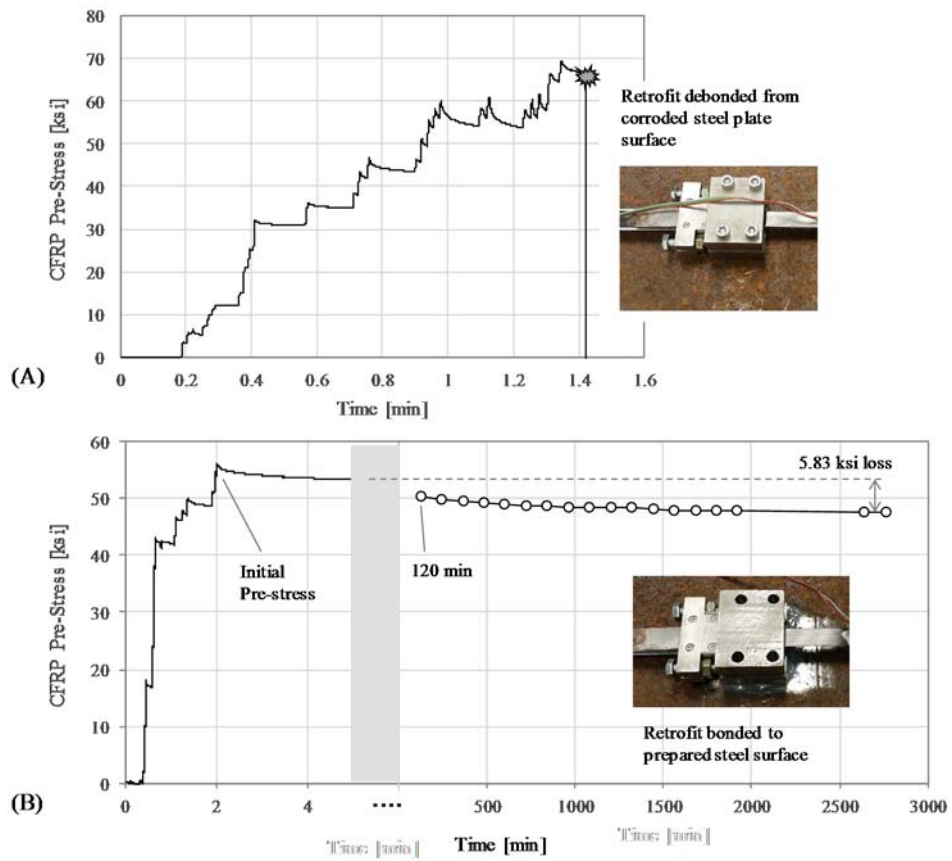
Figure 5-10: Pre-stress measurements for retrofits bonded to A) unprepared corroded steel surface, and B) prepared steel surface

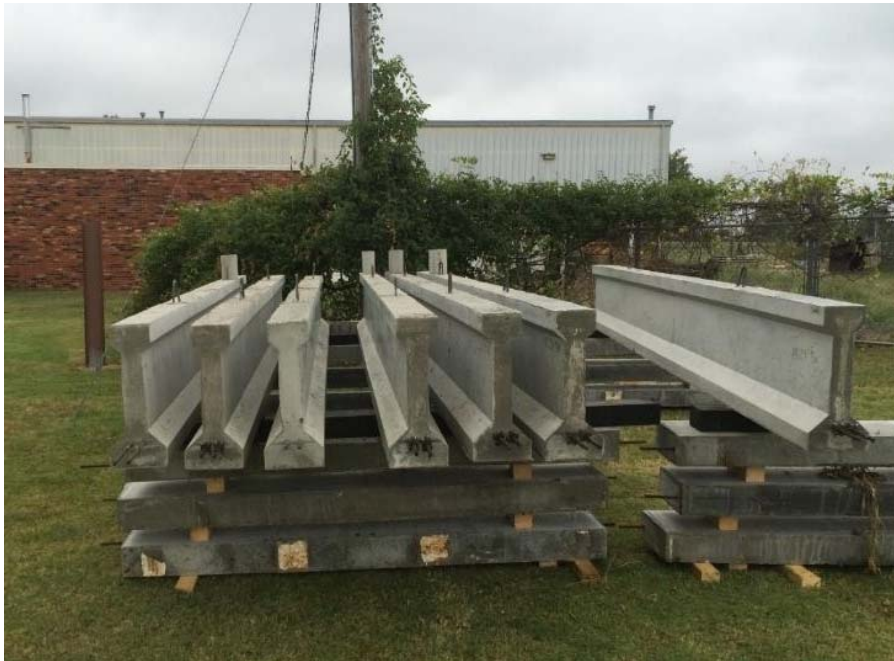
Figure 6-2: Half-scale prestressed concrete girder specimens immediately before subjecting to the accelerated corrosion process

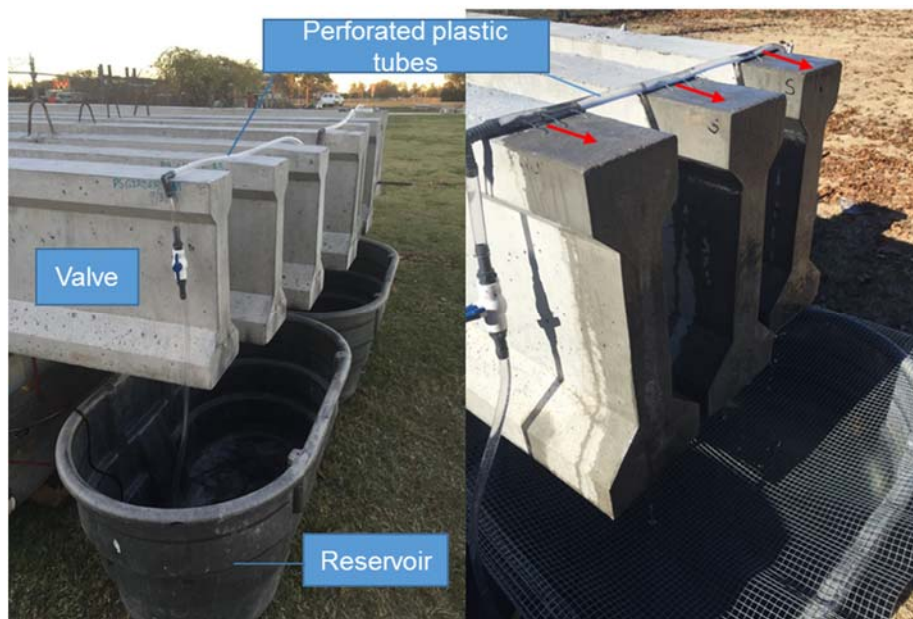
Figure 6-3: Corrosion accelerant setup (red arrows indicate the direction of flow from the perforated tubes)

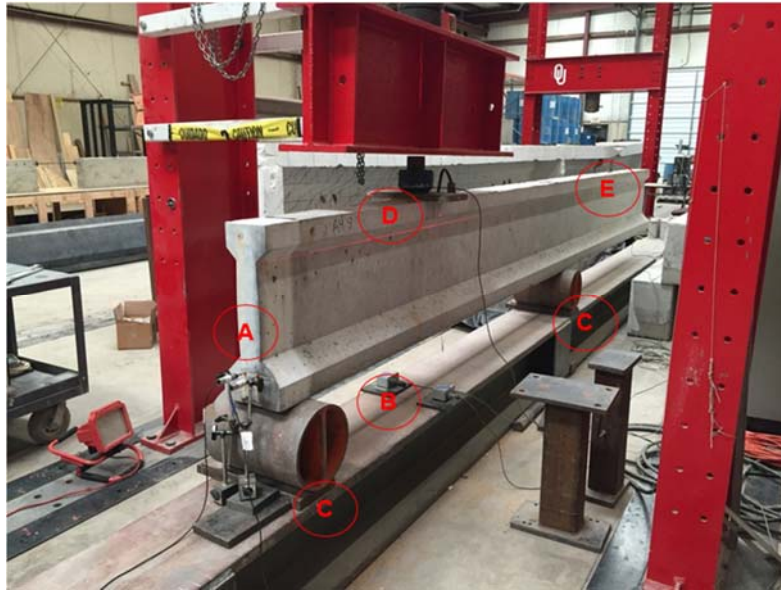
Figure 6-4: Typical shear test setup looking towards the north – (A) LVDT 1 & 2, (B) wirepots 1 (west) & 2 (east), (C) supports at 9 ft center-to-center, (D) single load point with load cell at 41 in. from end of beam, and (E) 8 ft - 8 in. overhang of the beam

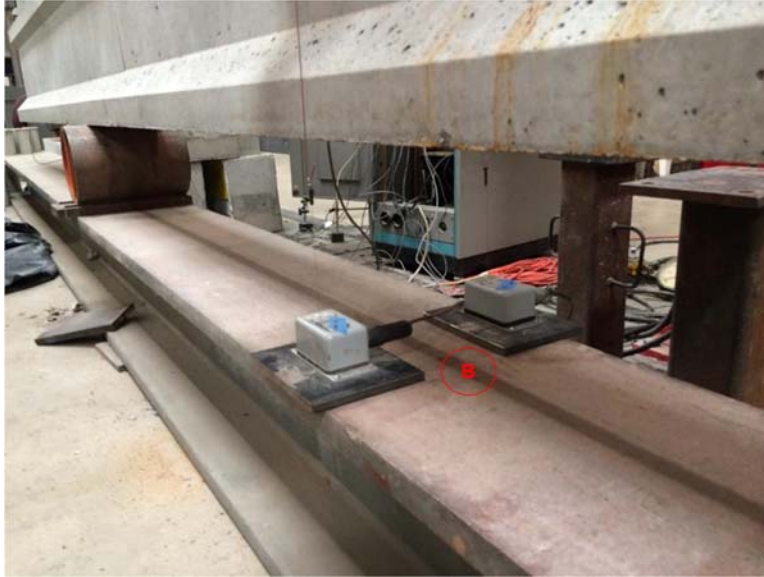
Figure 6-8: Close-up view of location (B) from Figure 6-4 looking toward the north showing wire pot 1 (left/west) and wire pot 2 (right/east)

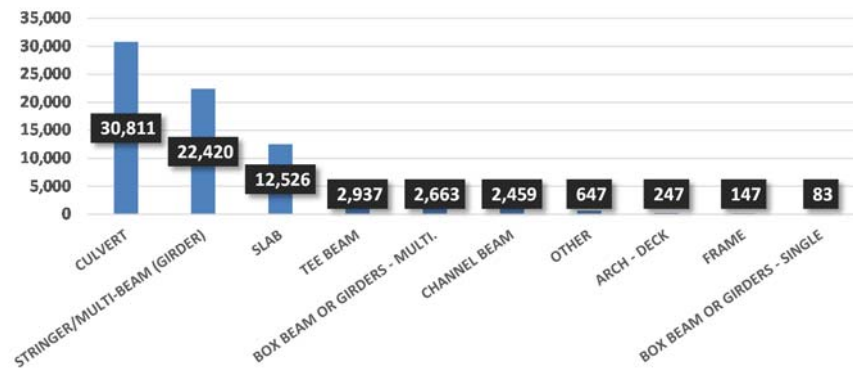
Figure 7-1: Distribution of concrete bridge types within Region 6.

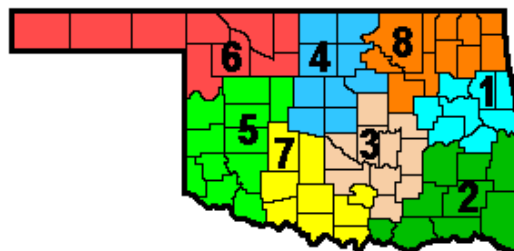
Figure 7-2: Geographical location of ODOT Field Divisions [49]

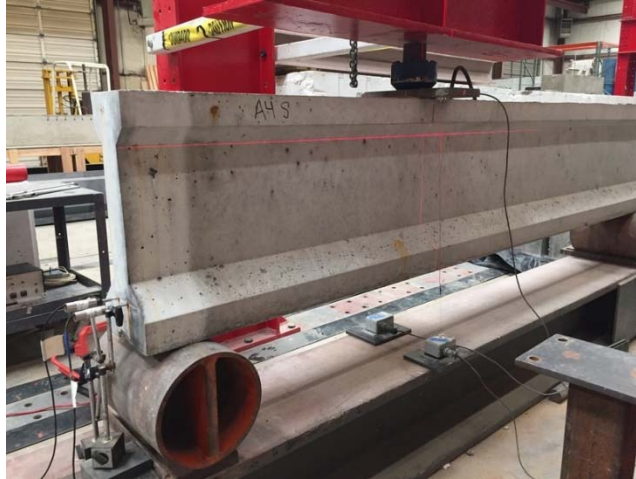
Figure 8-1: Specimen A4SC before shear testing

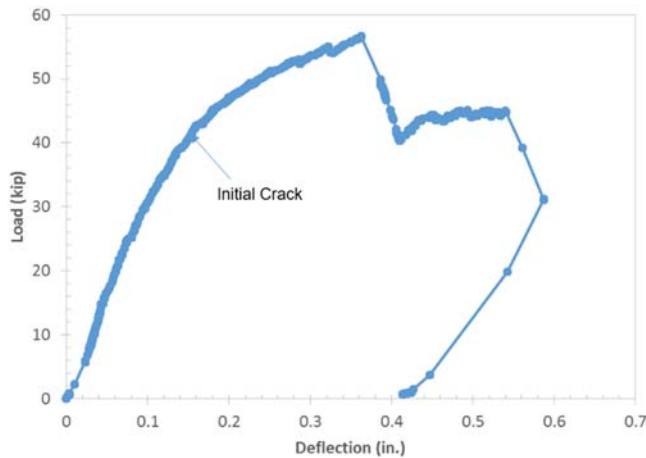
Figure 8-2: Load versus deflection for specimen A4SC

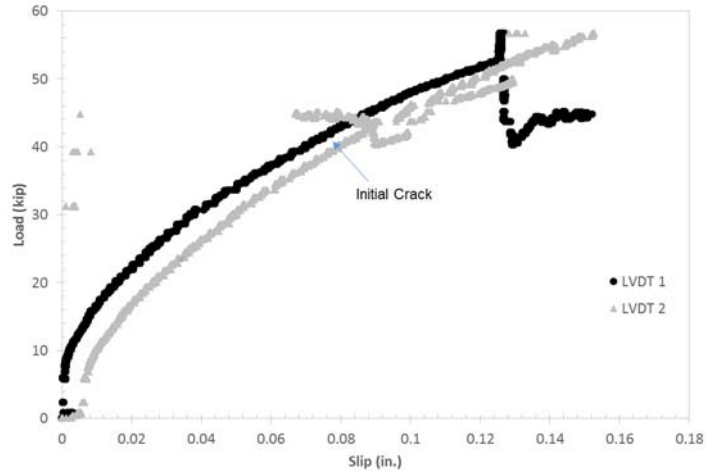
Figure 8-3: Load versus strand slip for specimen A4SC

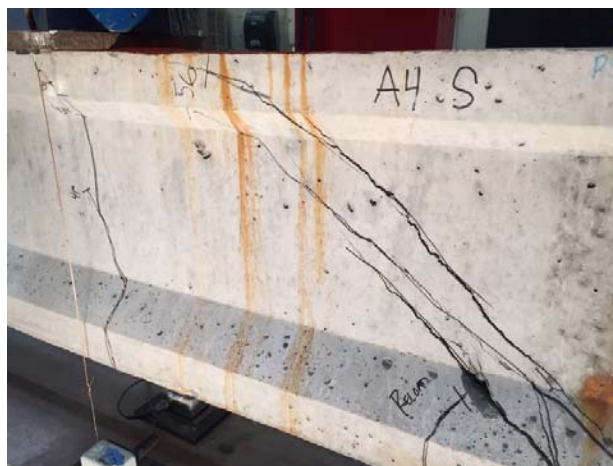
Figure 8-5: Visual map of cracking for shear test of specimen A4SC

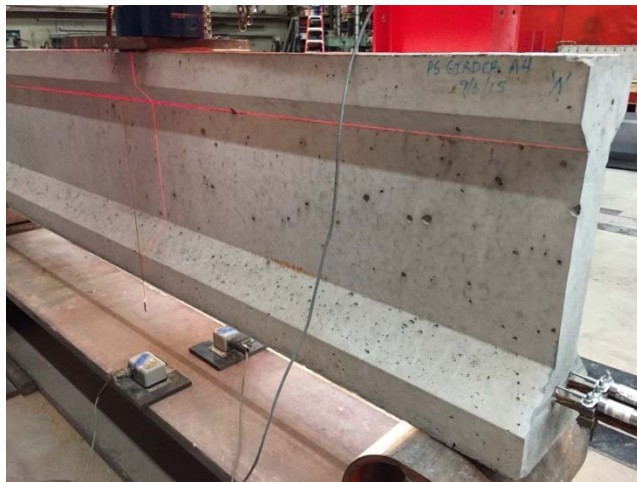
Figure 8-6: Specimen A4N before shear testing

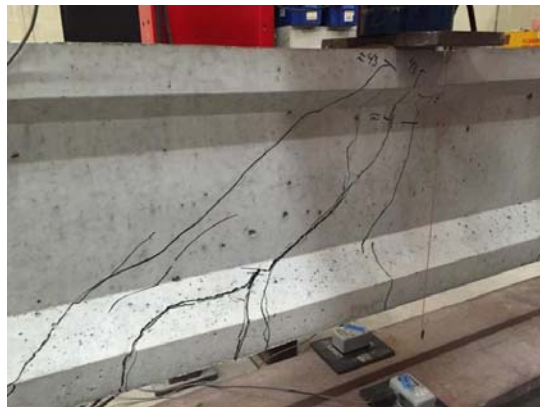
Figure 8-9: Visual map of cracking for shear test of specimen A4N

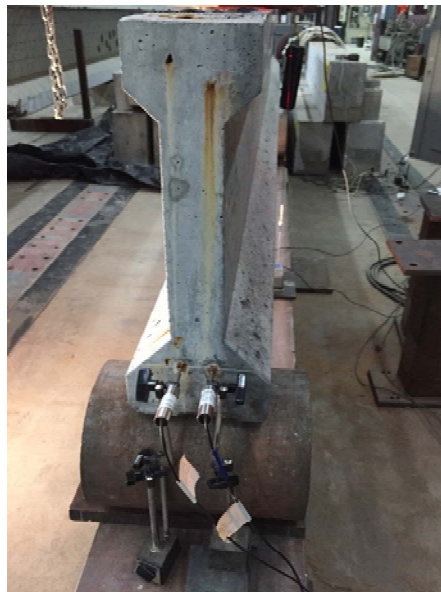
Figure 8-10: Specimen C1NC before shear testing

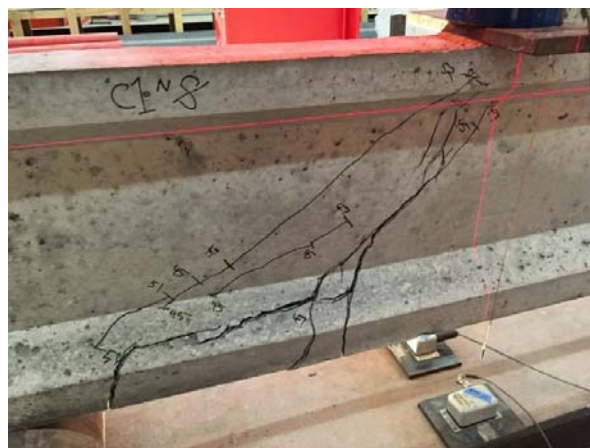
Figure 8-13: Visual map of cracking for shear test of specimen C1NC

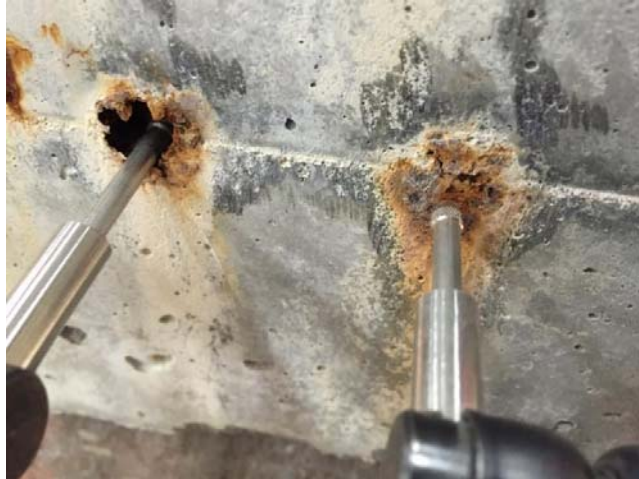
Figure 8-14: Visible strand slip for LVDT 2 (left) after shear test of specimen C1NC

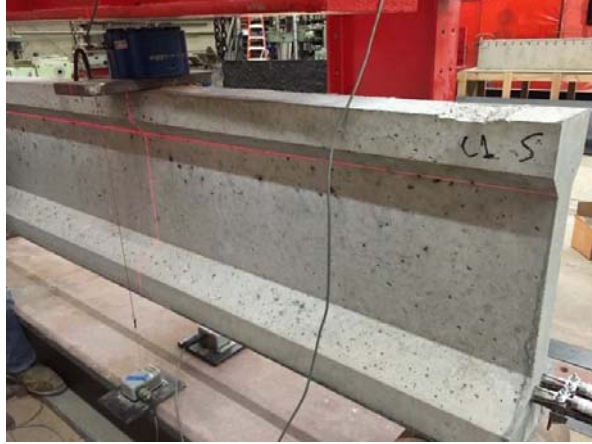
Figure 8-15: Specimen C1S before shear testing

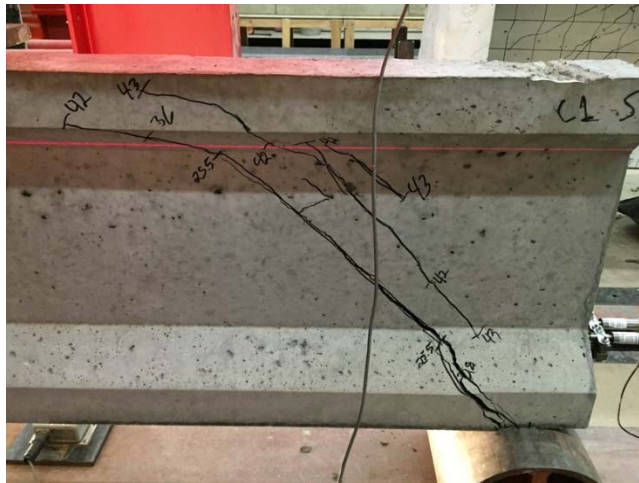
Figure 8-19: Visual map of cracking for shear test of specimen C1S

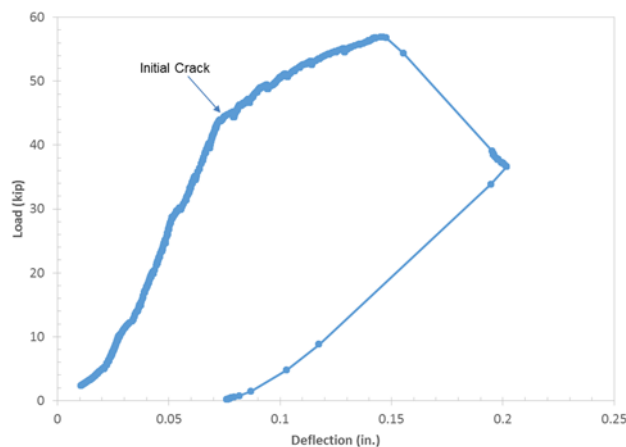
Figure 8-20: Load versus deflection for specimen A3SC

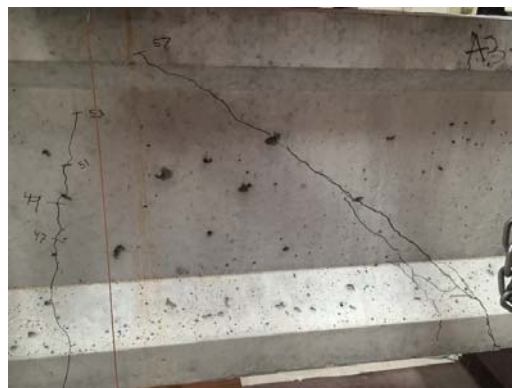
Figure 8-21: Visual map of cracking for shear test of specimen A3SC

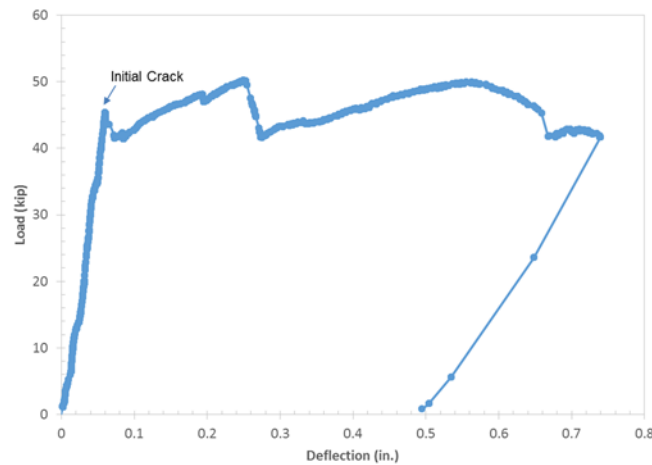
Figure 8-22: Load versus deflection for specimen A3N

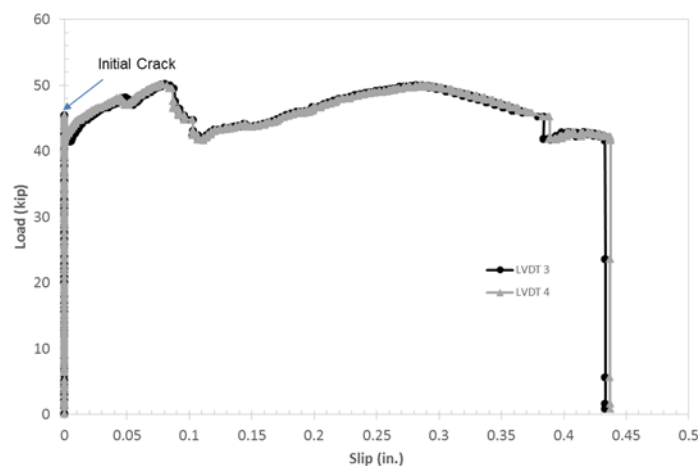
Figure 8-23: Load versus strand slip for specimen A3N

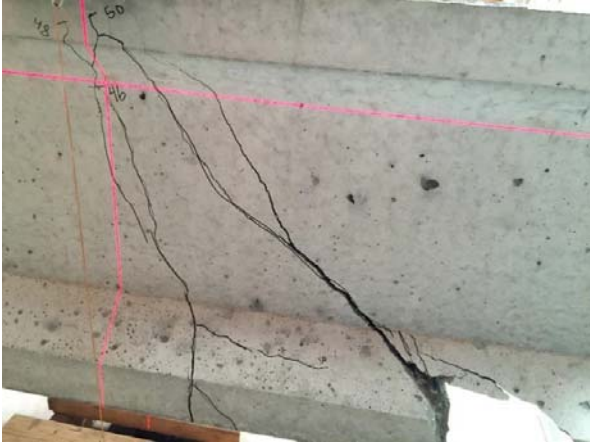
Figure 8-24: Visual map of cracking for shear test of specimen A3N

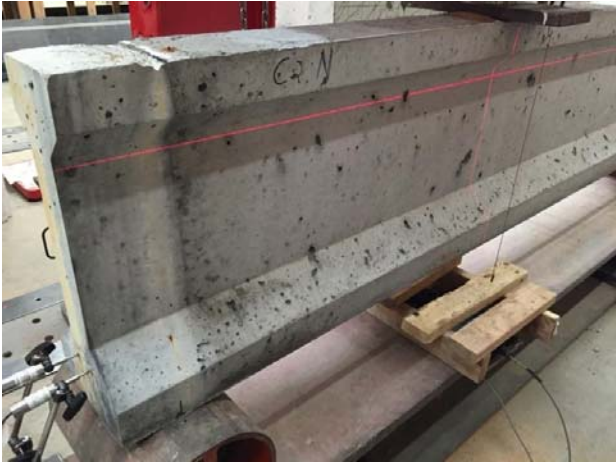
Figure 8-25: Initial condition of specimen C2NC

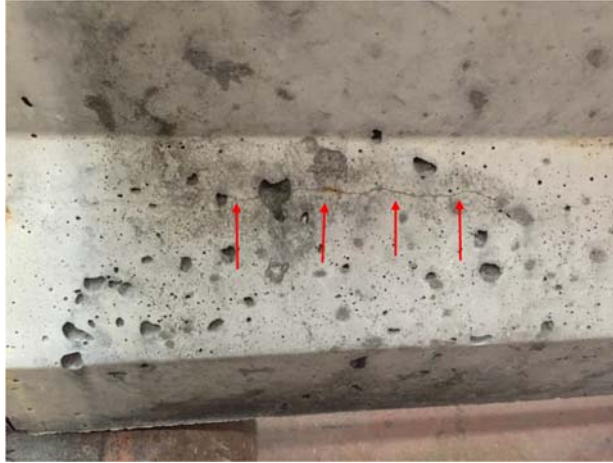
Figure 8-26: Horizontal crack below the web/flange interface of specimen C2NC before testing

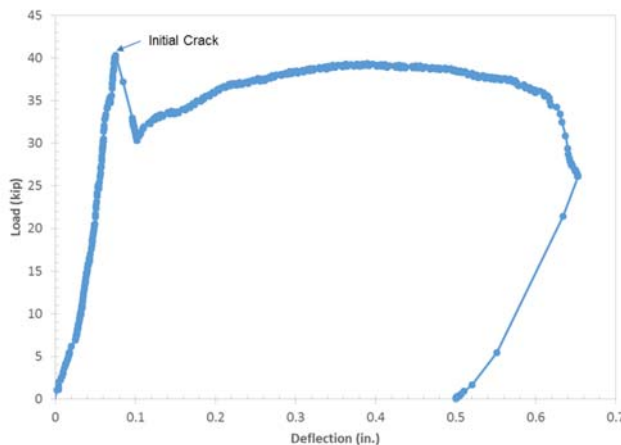
Figure 8-27: Load versus deflection for specimen C2NC

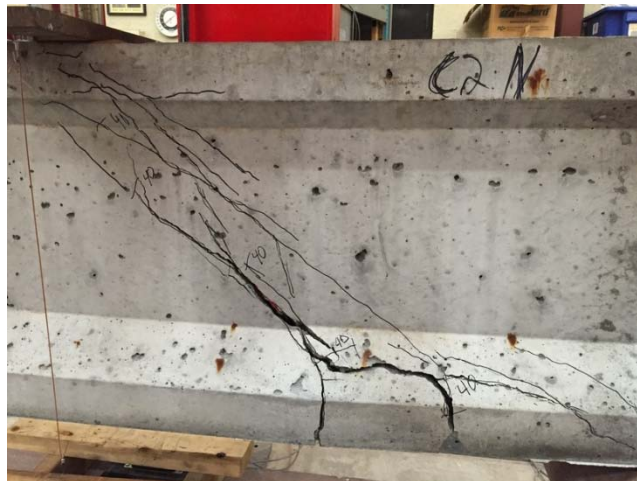
Figure 8-29: Visual map of cracking for shear test of specimen C2NC

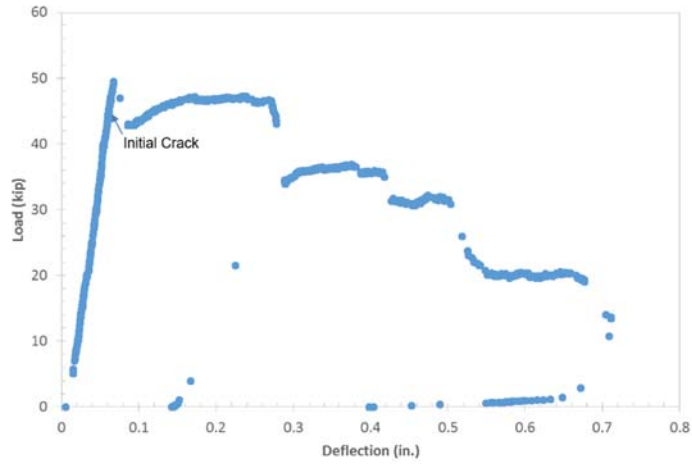
Figure 8-30: Load versus deflection for specimen C2S

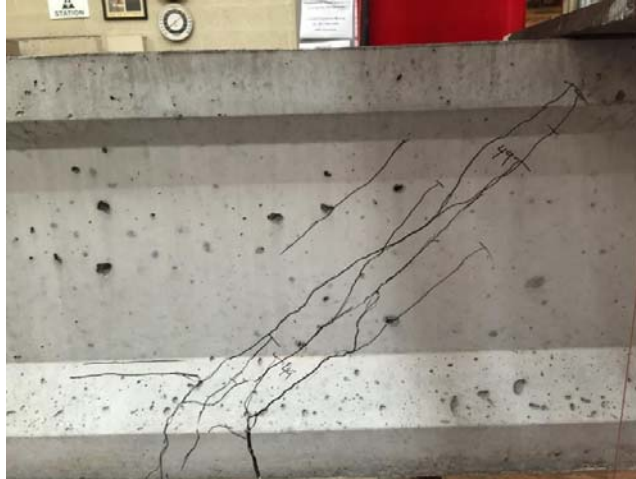
Figure 8-32: Visual map of cracking for shear test of specimen C2S

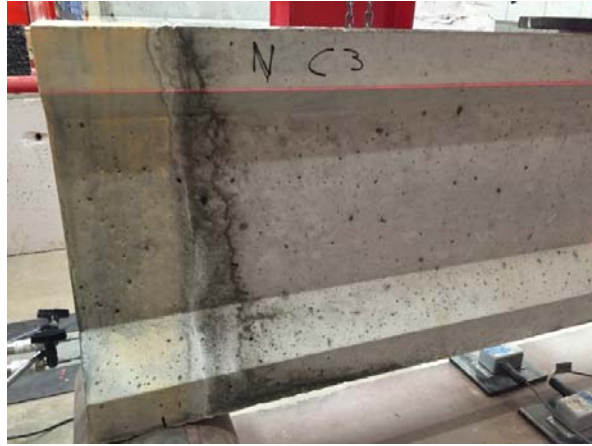
Figure 8-33: Initial condition of specimen C3NC before testing

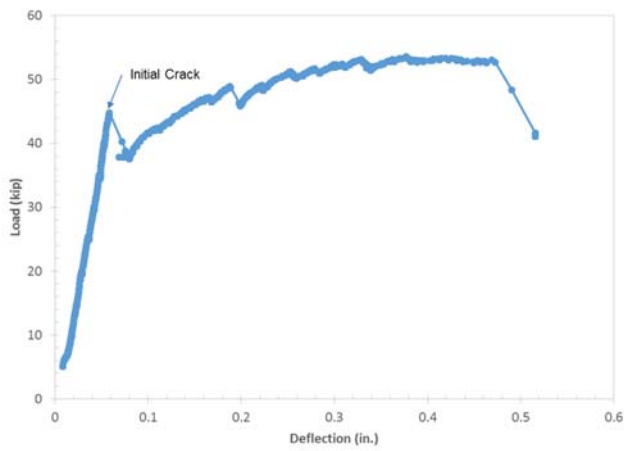
Figure 8-34: Load versus deflection for specimen C3NC

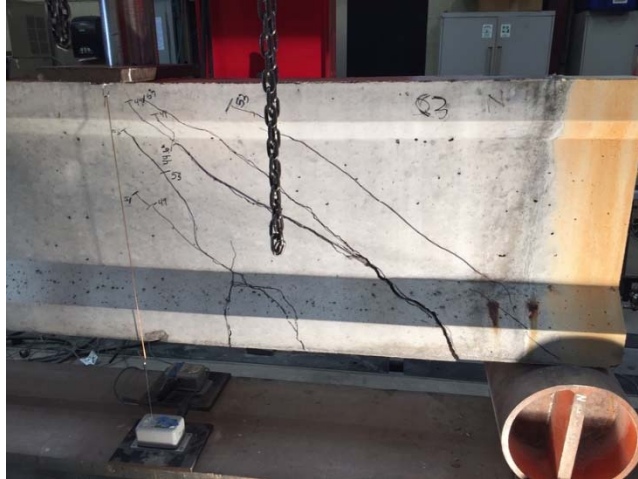
Figure 8-36: Shear cracking of C3NC after shear test

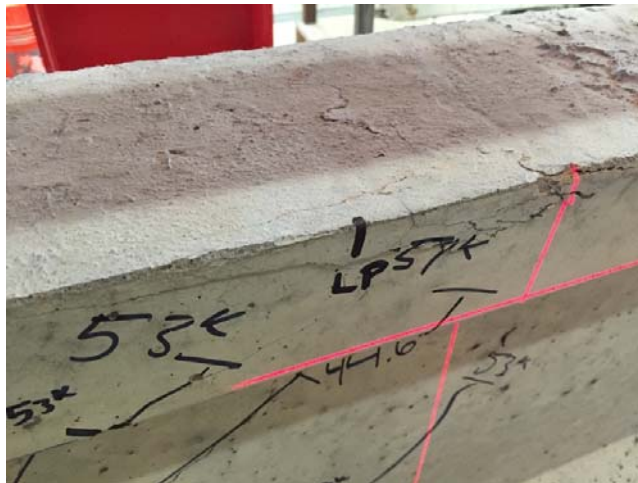
Figure 8-37: Concrete crushing at top of top flange at failure of specimen C3NC

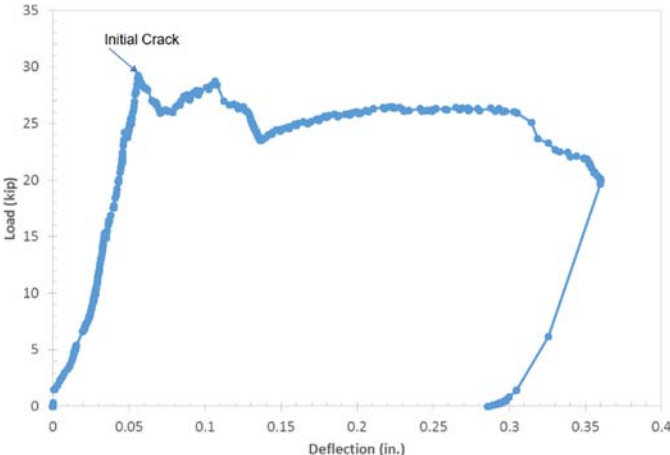
Figure 8-38: Load versus deflection for specimen C3S

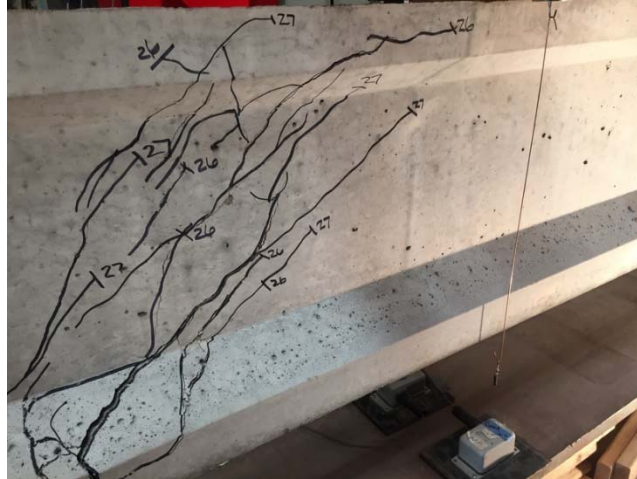
Figure 8-40: Visual map of cracking for specimen C3S

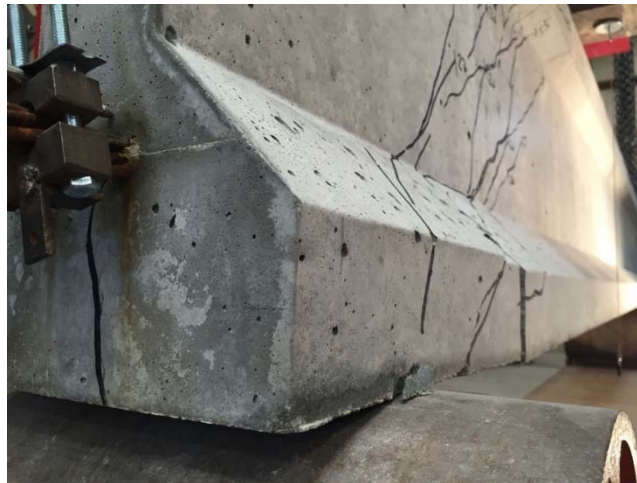
Figure 8-41: Cracking near the support and in the end of specimen C3S
