Evaluation and Repair of Existing Bridges in Extreme Environments

KOREY POUGH M.Sc.
DARION MAYHORN, M.Sc.
GARY S. PRINZ, Ph.D., P.E.
ROYCE W. FLOYD, Ph.D., P.E.
SPTC14.1-58-F

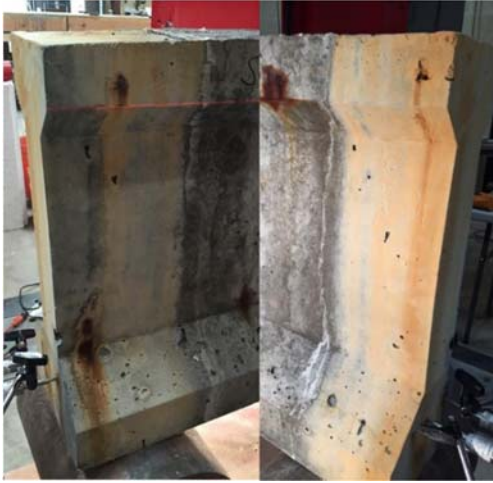
Figure 8-42: Condition of specimen A2SC prior to testing

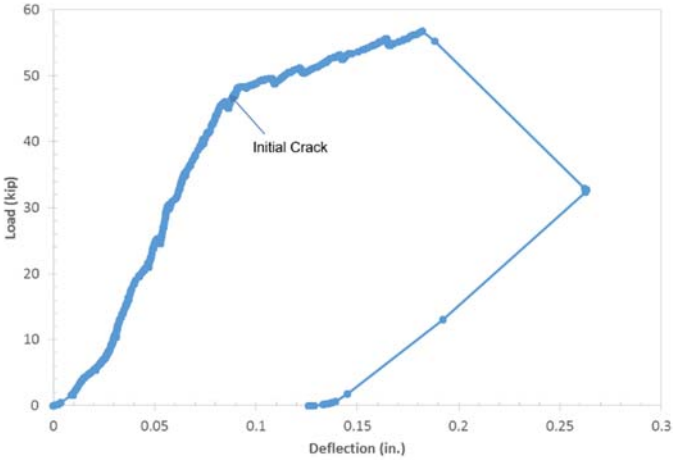
Figure 8-43: Load versus deflection for specimen A2SC

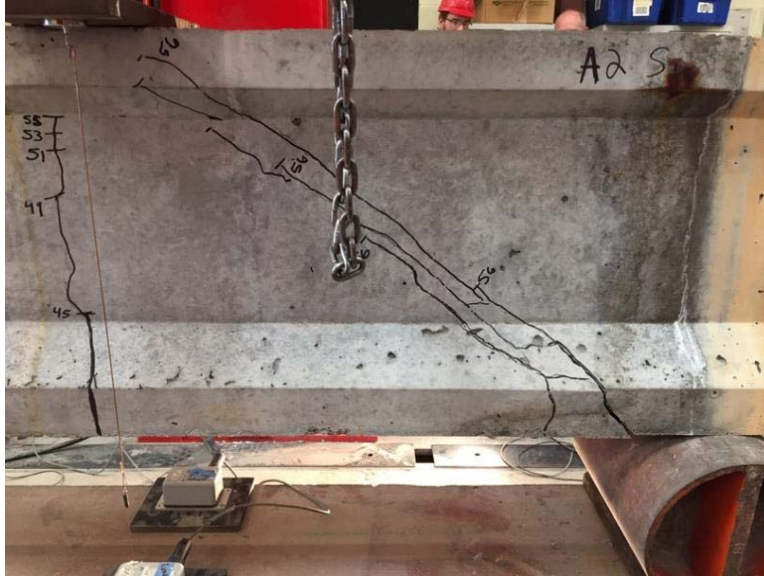
Figure 8-44: Visual map of cracking for specimen A2SC

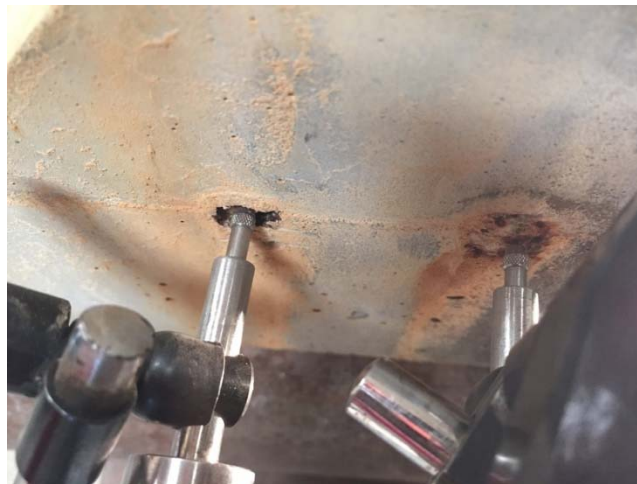
Figure 8-45: Visible strand slip after testing specimen A2SC

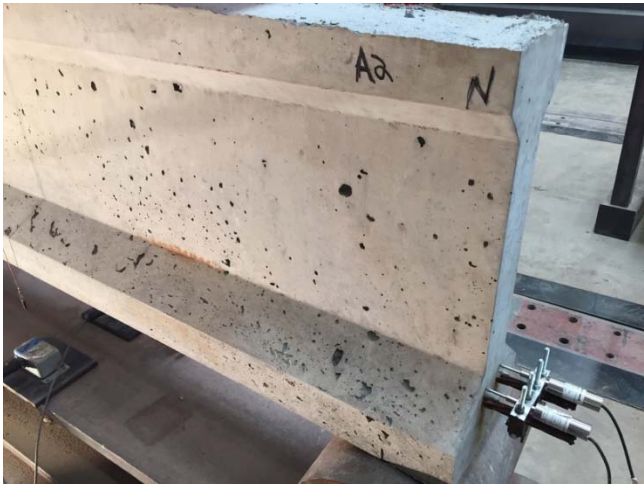
Figure 8-46: Condition of specimen A2N prior to testing

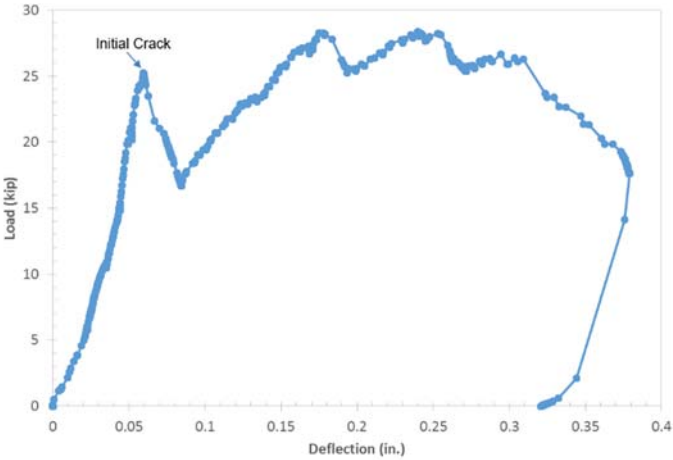
Figure 8-47: Load versus deflection for specimen A2N

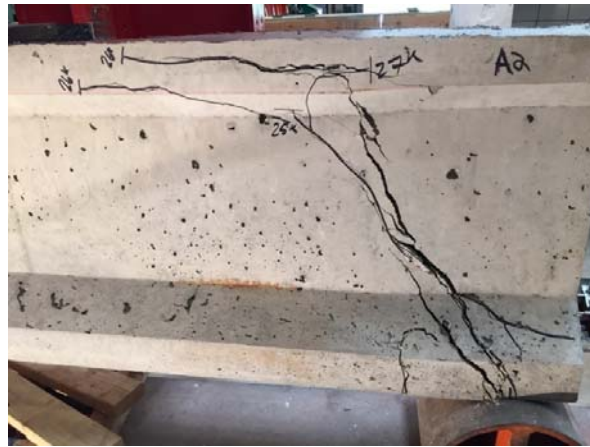
Figure 8-49: Cracking along the flange and web for specimen A2N

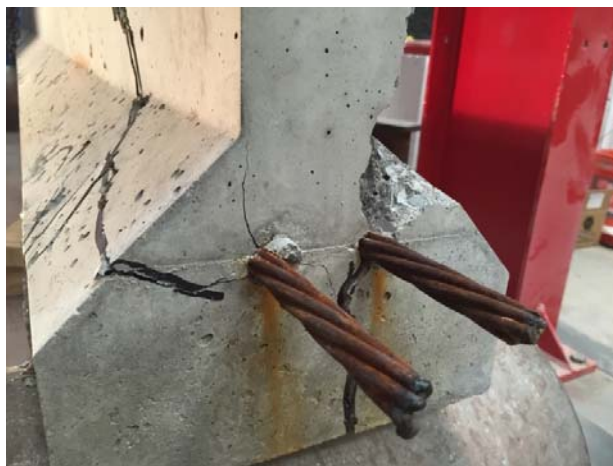
Figure 8-50: Cracking near the prestressing strands at the end of specimen A2N

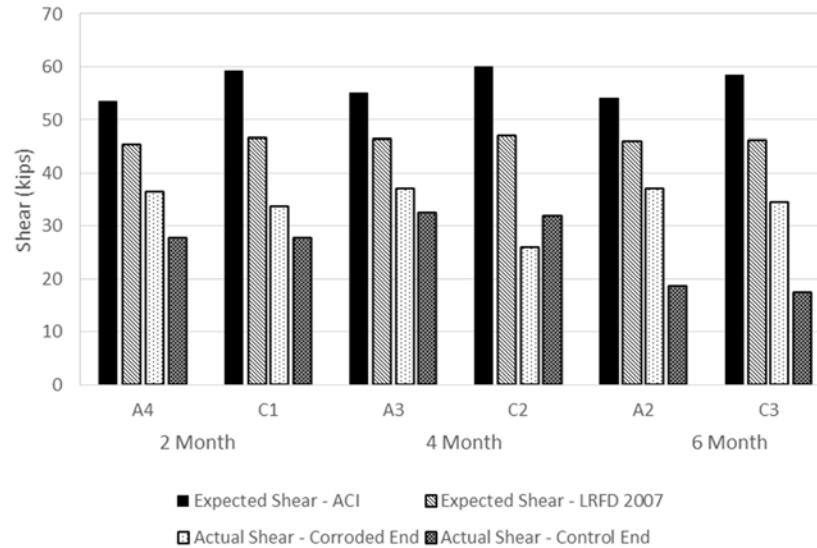
Figure 8-51: Design shear capacity compared to measured shear at failure for each specimen

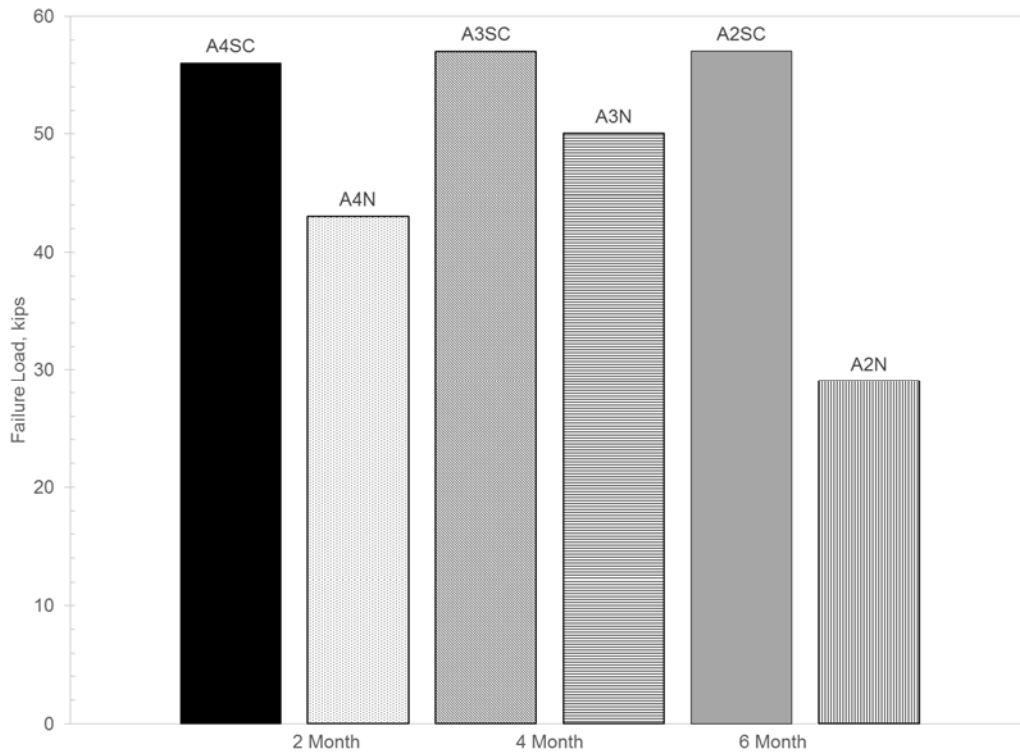
Figure 8-52: Comparison of failure loads for Girder A design

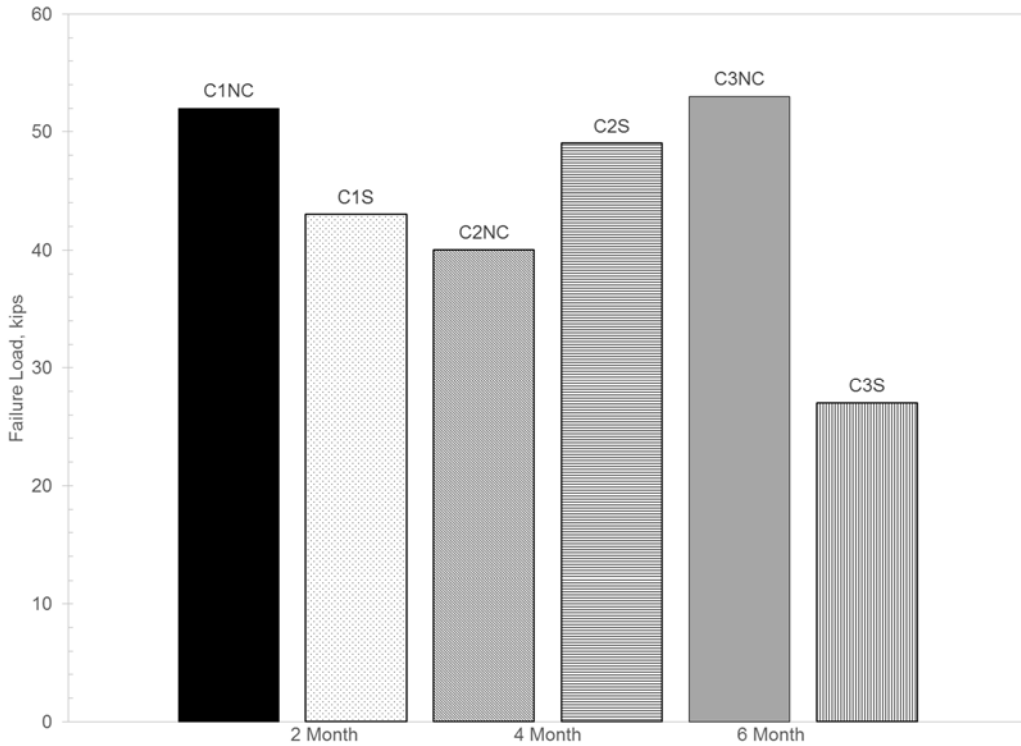
Figure 8-53: Failure loads for Girder C design

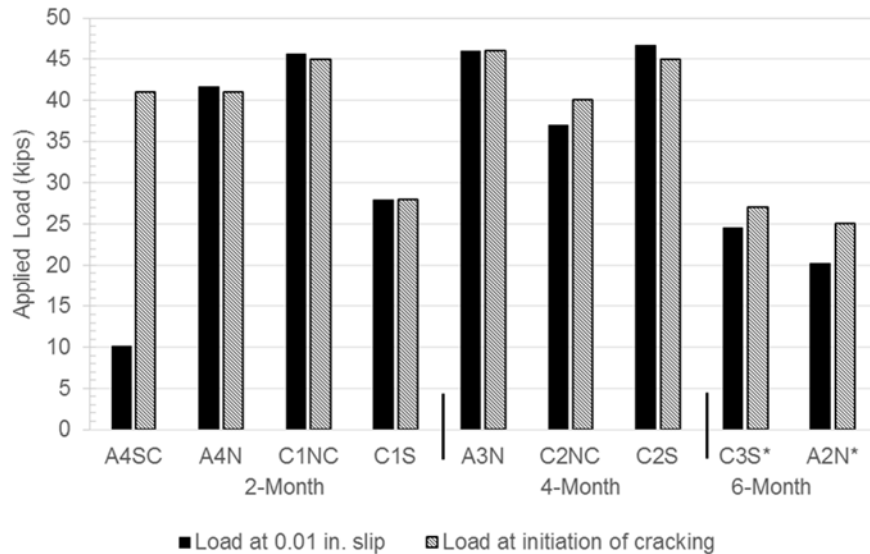
Figure 8-54: Comparison of load at 0.01 in. slip and initiation of cracking (*Note: C3S and A2N decreased in loading after cracking and then slip occurred at that decreased load)

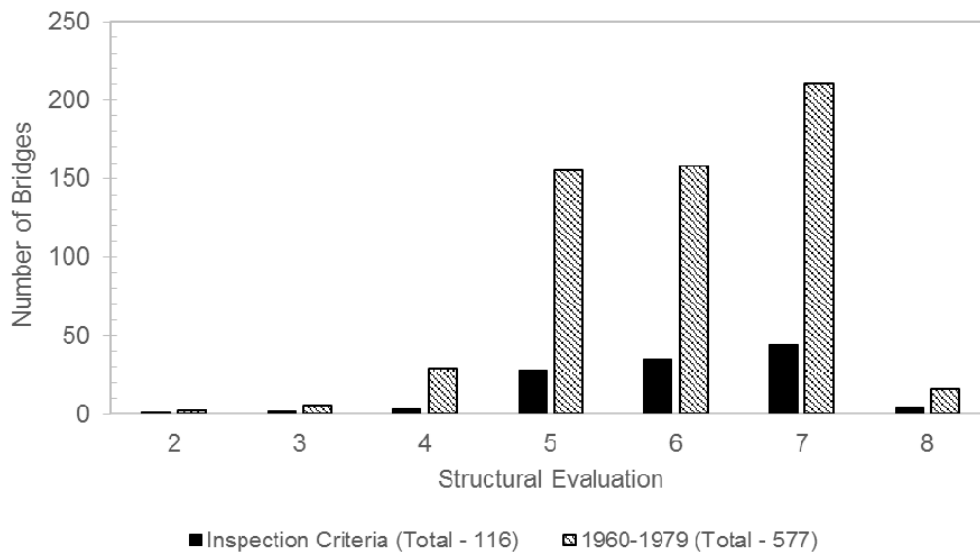
Figure 9-1: Oklahoma prestressed concrete girder bridges built between 1960 and 1979 and meeting inspection criteria by structural evaluation

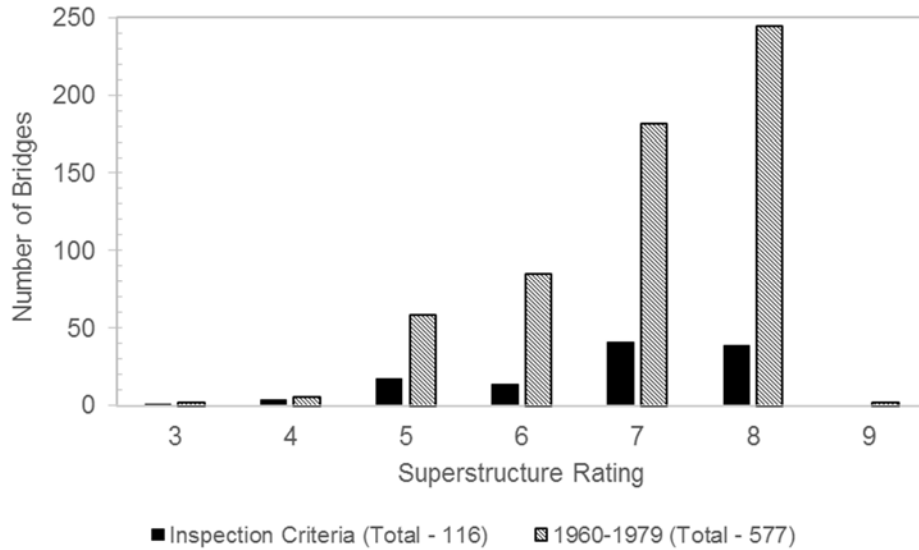
Figure 9-2: Oklahoma prestressed concrete girder bridges built between 1960 and 1979 and meeting inspection criteria by superstructure rating

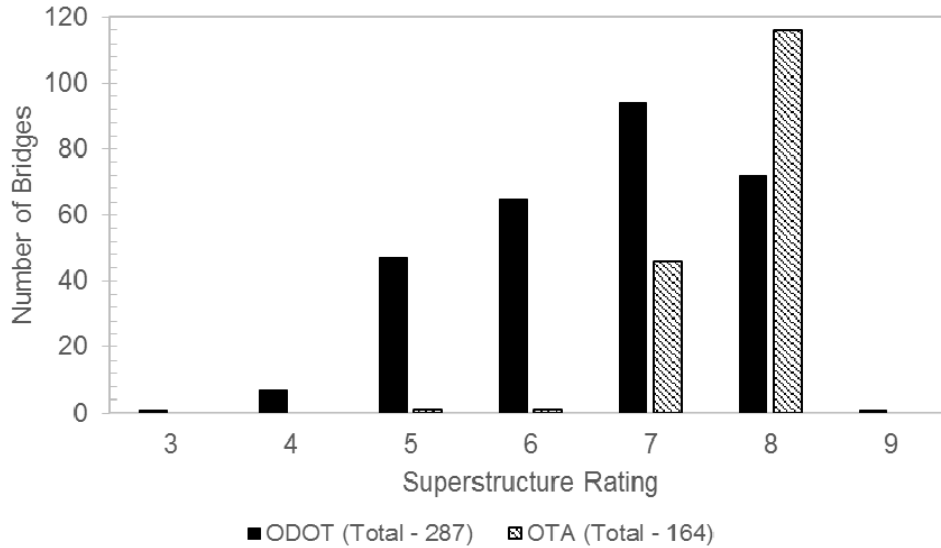
Figure 9-3: Oklahoma prestressed concrete girder bridges built between 1960 and 1979 by superstructure rating and ownership

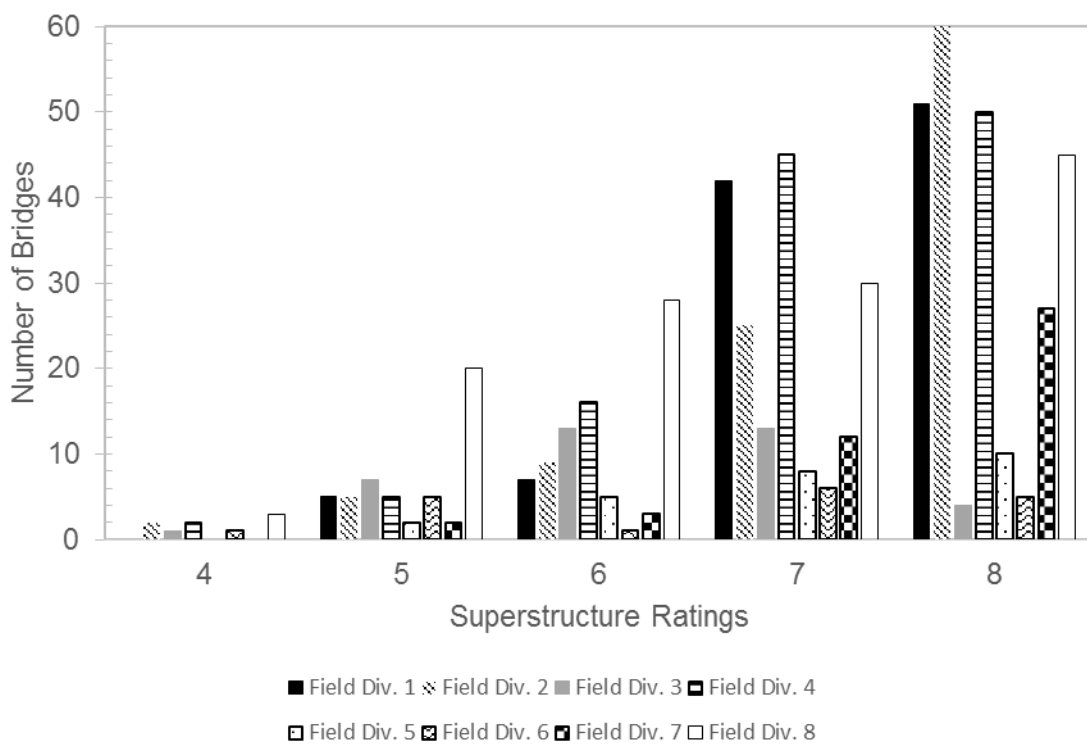
Figure 9-5: Oklahoma prestressed concrete girder bridges built between 1960 and 1979 by superstructure rating and field division

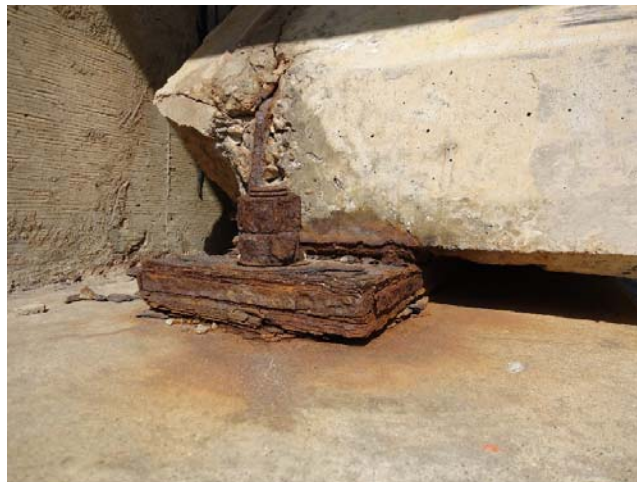
Figure 9-6: Example of corroded bearing plate

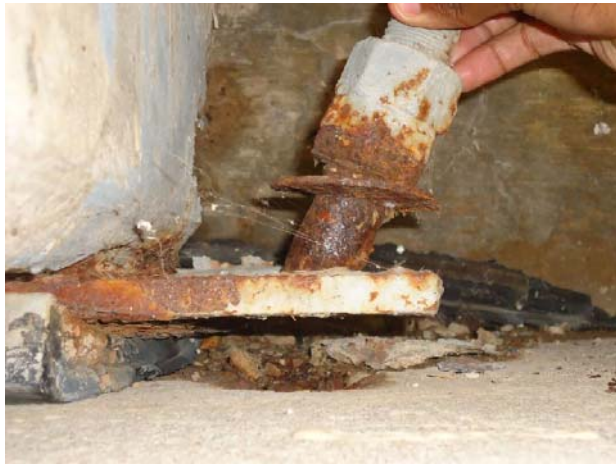
Figure 9-7: Example of corroded anchor bolt

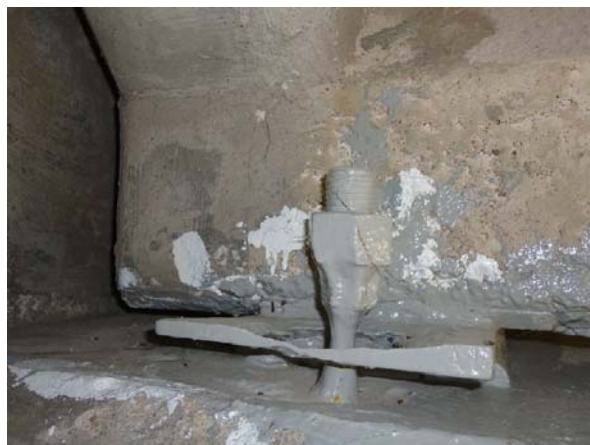
Figure 9-8: Example of coated, damaged anchor bolt and nut

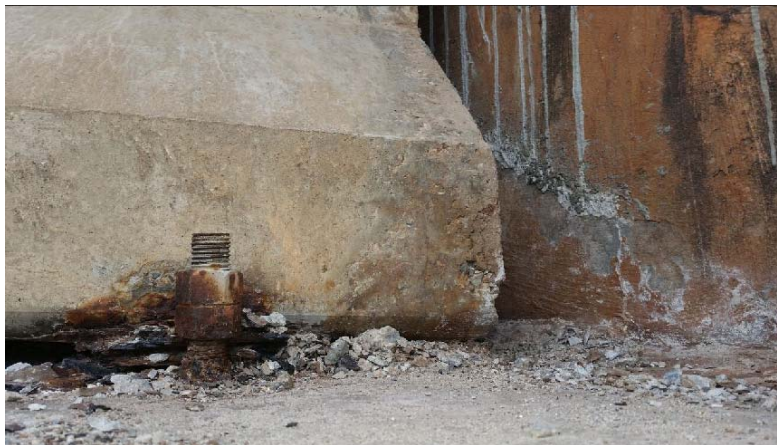
Figure 9-9: Example of spalling above bearing support

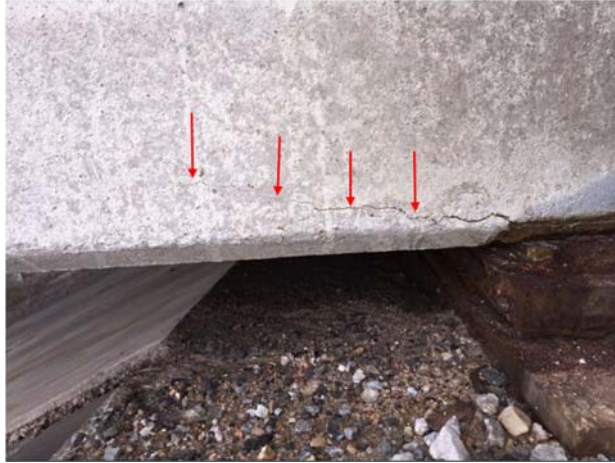
Figure 9-10: Example of crack from damage around the bearing plate

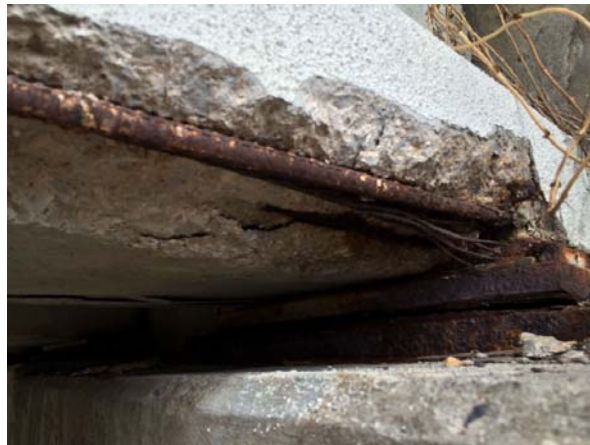
Figure 9-11: Example of exposed reinforcing steel

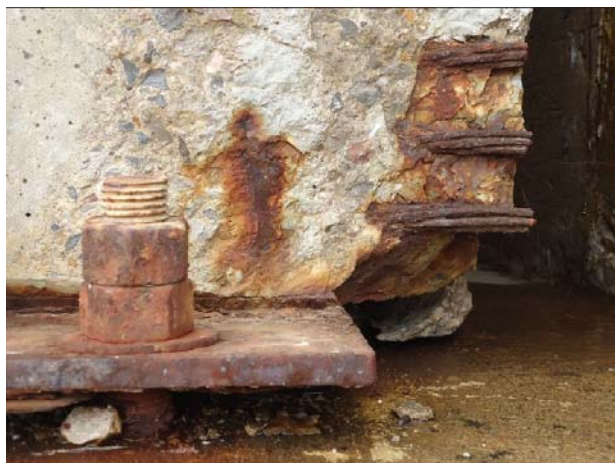
Figure 9-12: Example of exposed prestressing strands

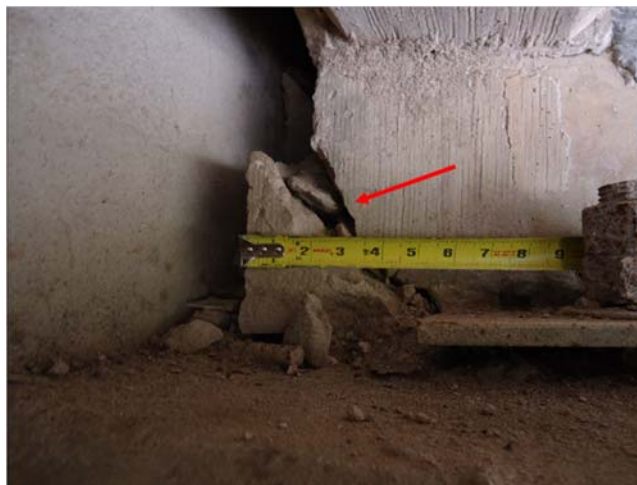
Figure 9-13: Example of back diagonal cracking

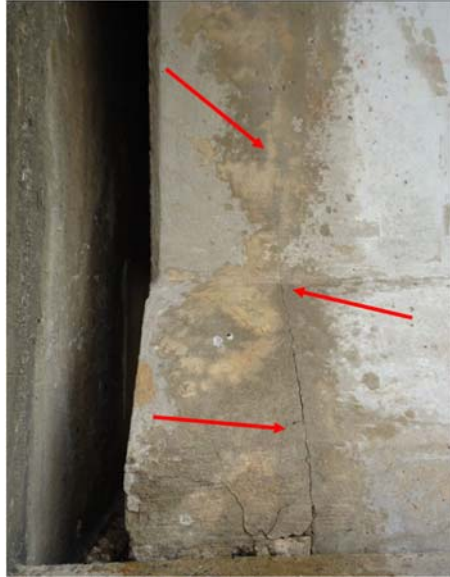
Figure 9-14: Example of vertical cracking along diaphragm and girder

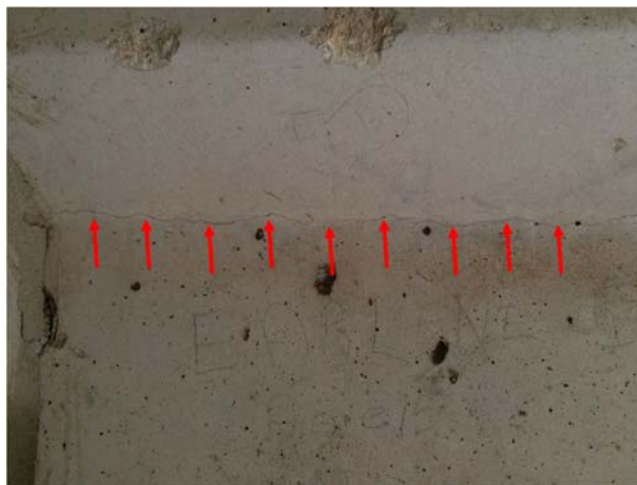
Figure 9-15: Example of horizontal cracking along the top flange and web interface

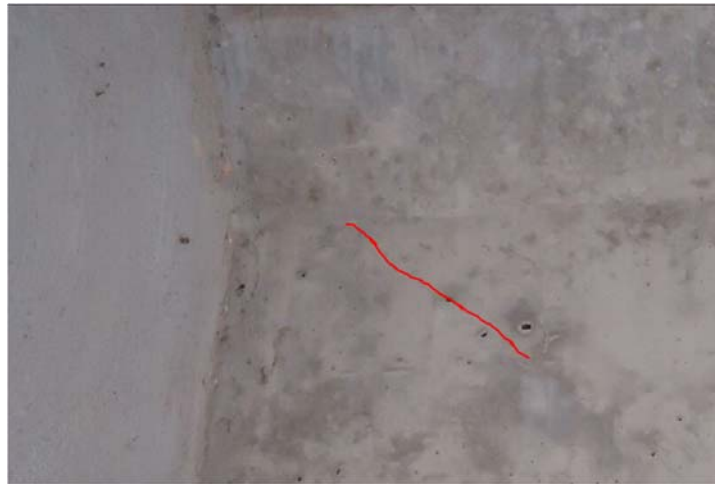
Figure 9-16: Example of diagonal cracking from the top flange and web interface

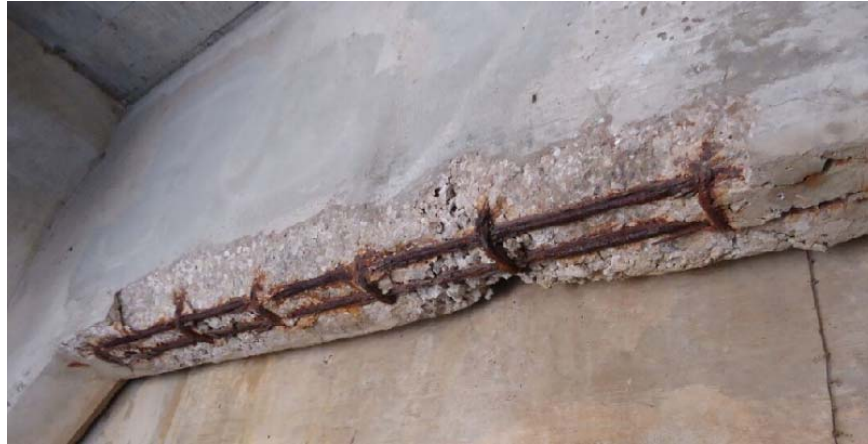
Figure 9-17: Example of diaphragm deterioration

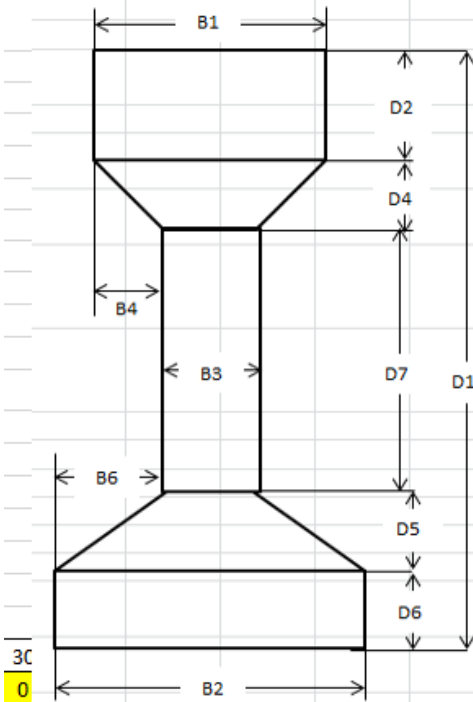
ACI Shear Capacity Calculation			
Properties		Loadings	
Type	2		
cgs (in.)	4		
h (in.)	22.5		
d _p (in.)	18.50		
d' (in.)	2.00		
b _w (in.)	3		
w _d (k/ft)	0.110		
w _i (k/ft)	0.000		
P (kips)	62.365	62.365	
A _g (in ²)	105.75		
A _{ps} (in ²)	0.33		
L (ft) supports	9		Simplified Shear
l _c (ft)	3.083333333		V _c (kips) 41.43
a (ft)	3.083333333		V _{min} (kips) 8.60
b (ft)	5.92		V _{max} (kips) 21.50
V _{de} (kips)	0		Detailed Shear
V _{d(-support)} (kips)	0.99140625		V _{ci} (kips) 26.14
V _{d(+support)} (kips)	0.991		V _{ci,min} (kips) 7
V _{dc} (kips)	-0.340		V _{cw} (kips) 23.7
M _{dc} (k-ft)	-0.523624674		Final
V _{ue 1} (kips)	40.99921296		V _c (kips) 23.66
V _{ue 2} (kips)	21.36578704		V _s (kips) 30.525
V _{uc} (kips)	40.65956452546		V _n (kips) 54.18
M _{cu} (k-ft)	125.8906153		ϕV _n (kips) 40.63522
V _i (kips)	40.999		M _n (k-ft) 126.4149
M _{max} (k-ft)	126.41424

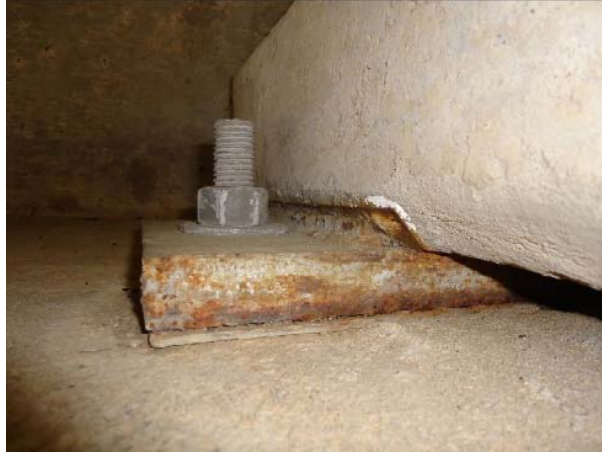
Figure D-2: Example of a corroding bearing plate (3W-S)

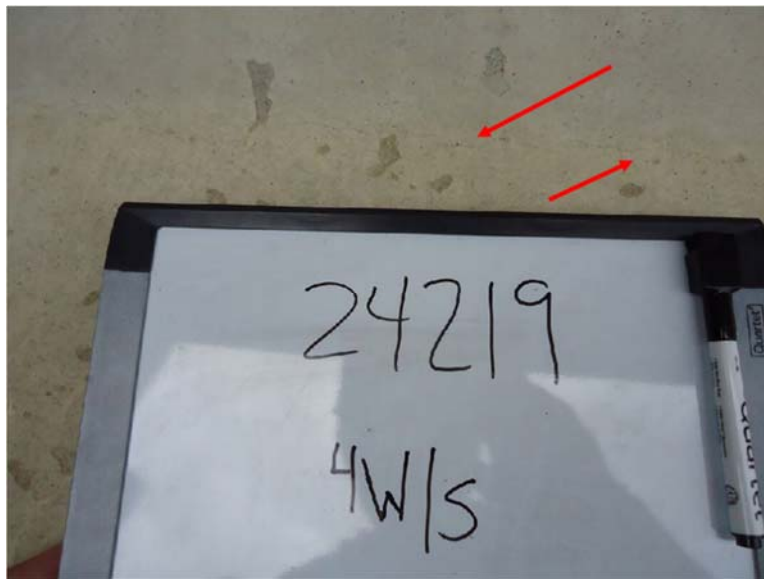
Figure D-3: Horizontal crack at top flange/web interface (4W-S)

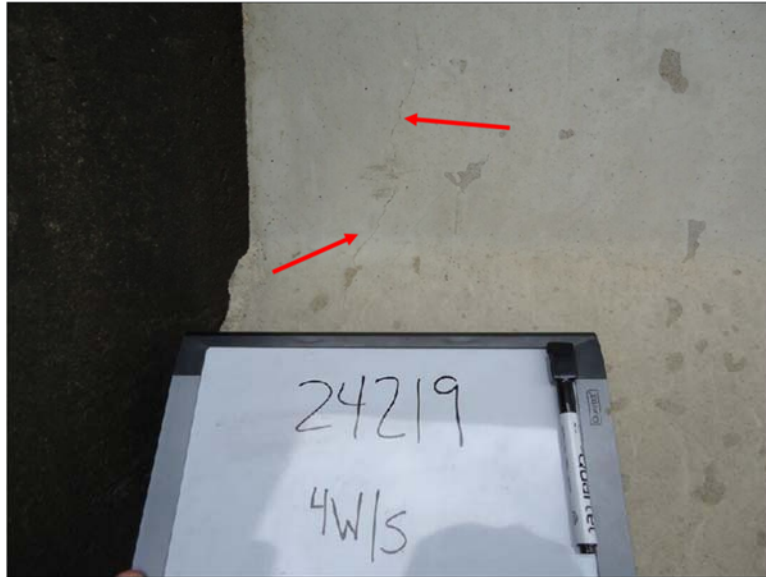
Figure D-4: Vertical crack from web through bottom flange (4W-S)

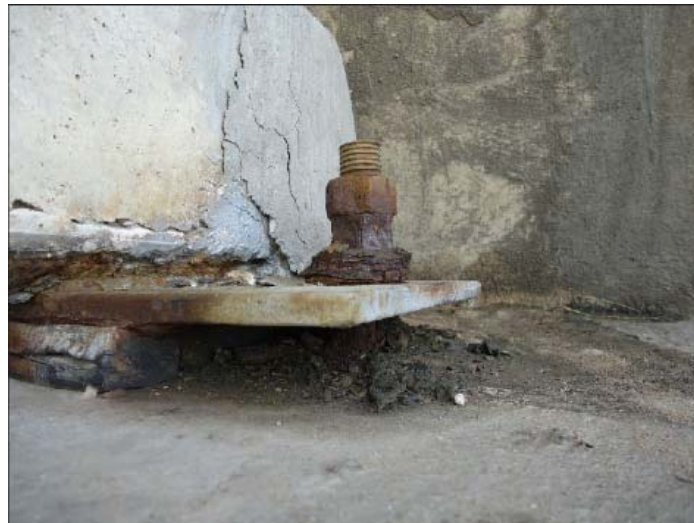
Figure D-5: Corroded anchor bolt (1S-W)

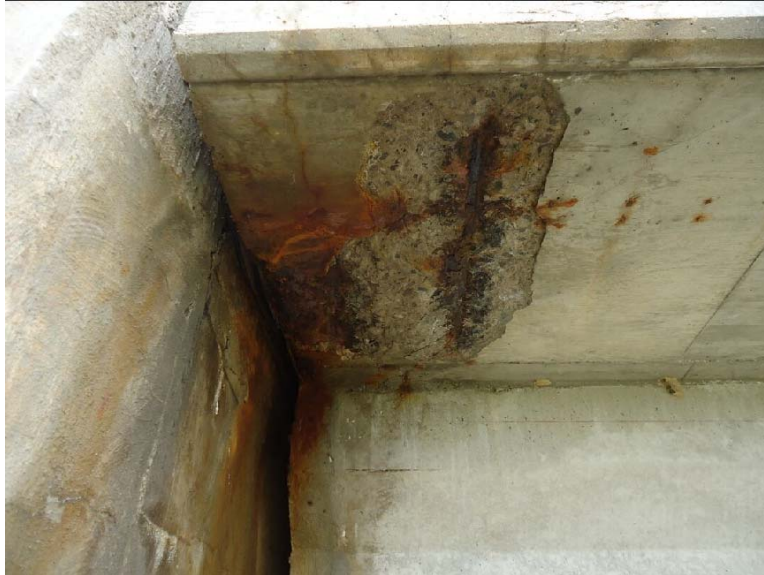
Figure D-6: Exposed rebar, showing insufficient concrete cover at end of bridge deck (1N-W)

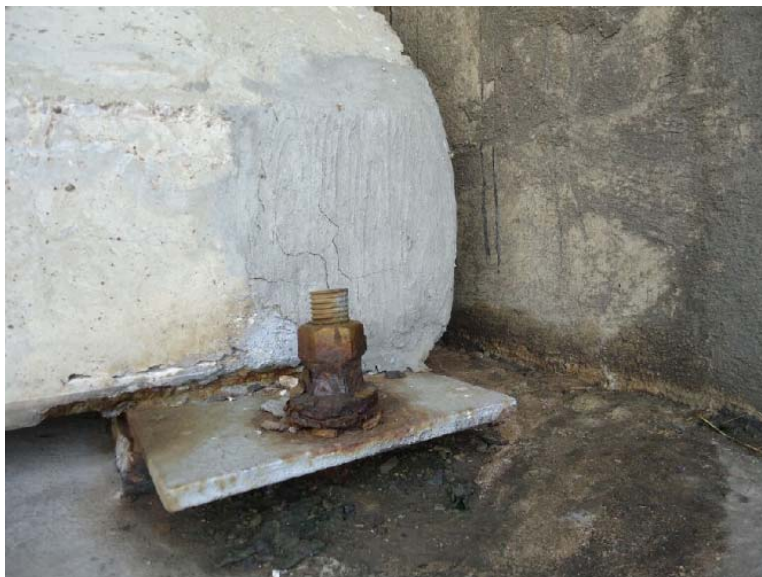
Figure D-7: Repaired concrete on girder end and corroded bolt (1S-W)

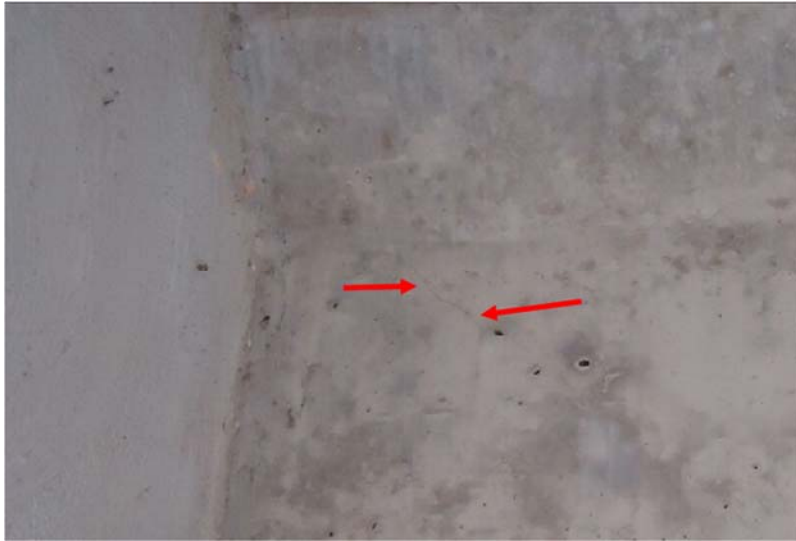
Figure D-8: Diagonal cracking on the web of the beam (3N-W)

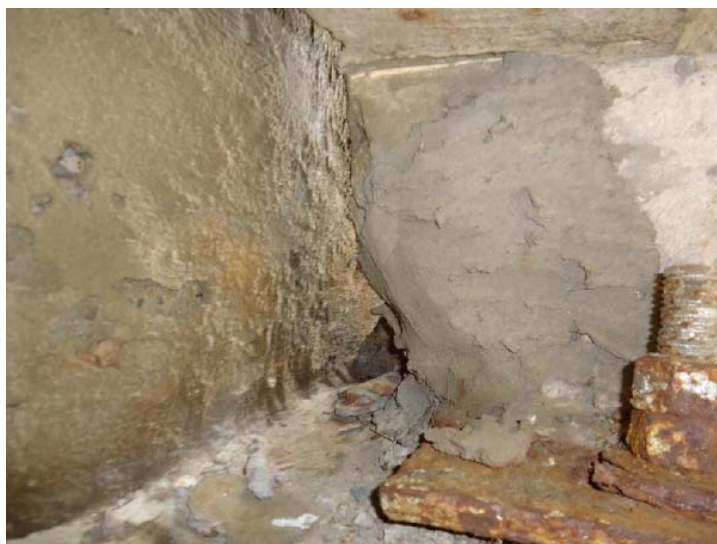
Figure D-9: Repair to spalled back corner (6N-W)

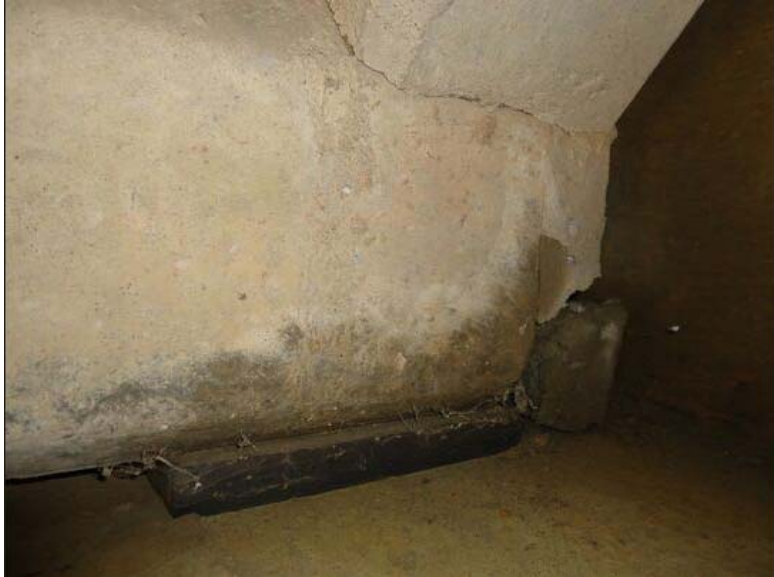
Figure D-10: Back diagonal crack in the beam end (3N-E)

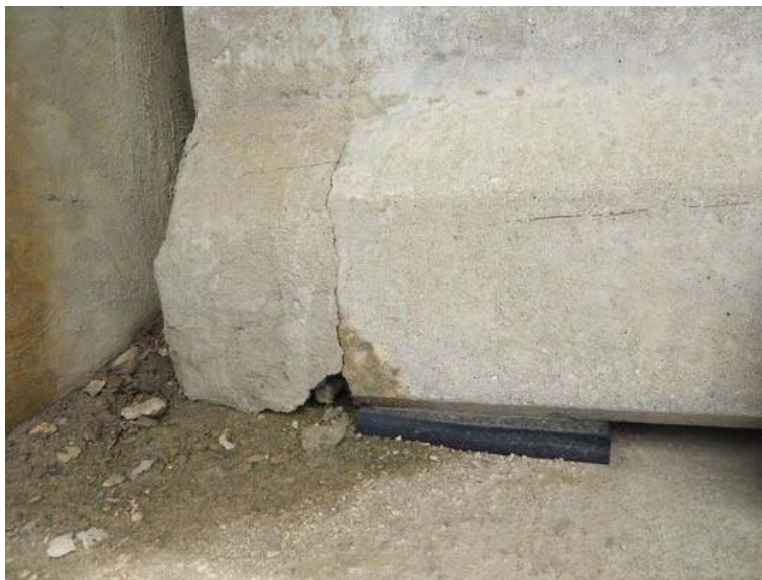
Figure D-11: Separation at the diaphragm and girder end (1N-W)

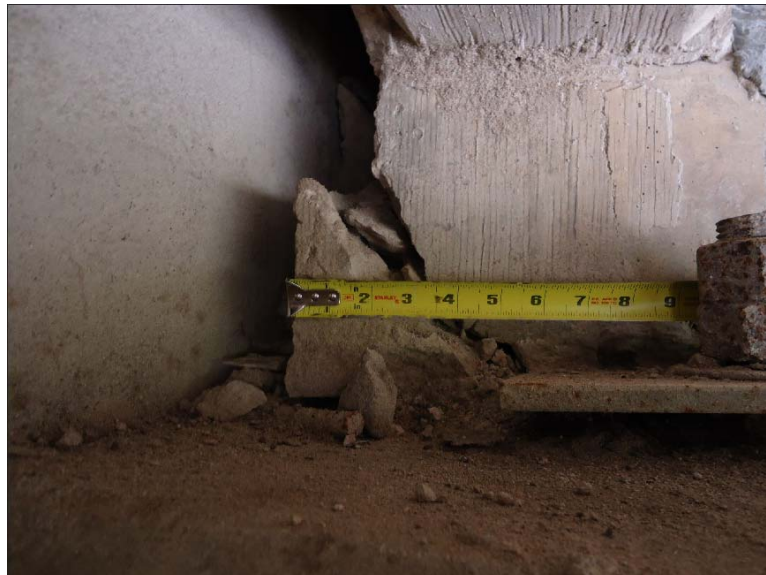
Figure D-13: Spalled back corner of beam end (4E-N)

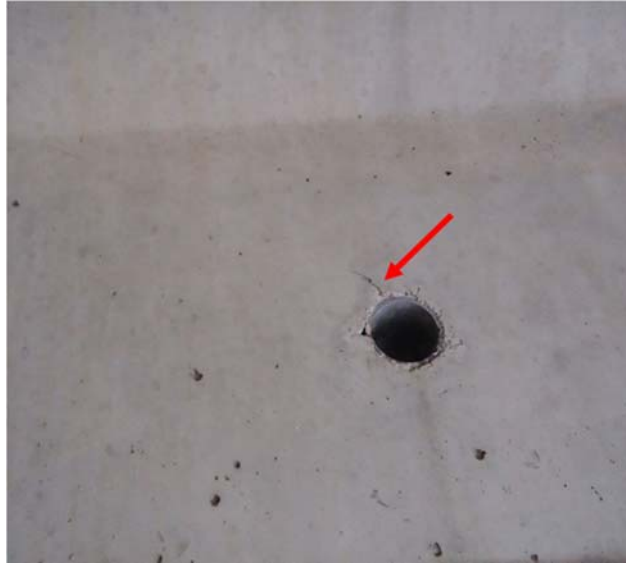
Figure D-14: Crack from interior pipe that runs through web of beam (4E-N)

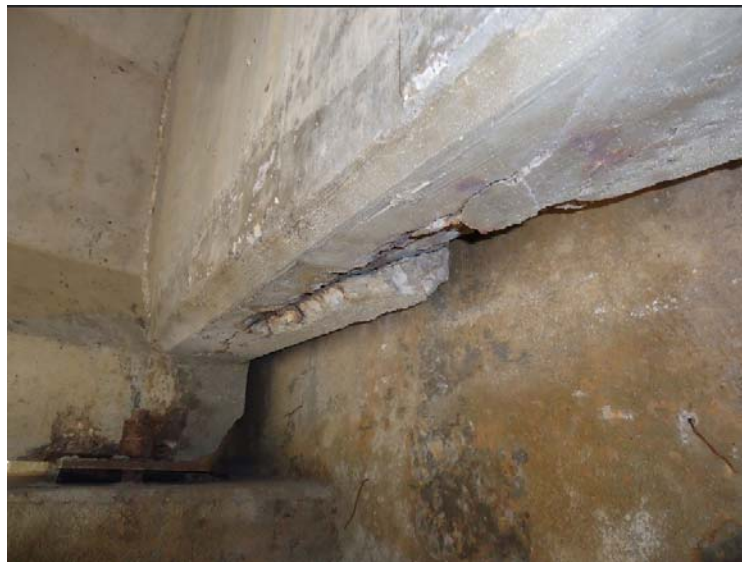
Figure D-15: Deterioration of an interior end diaphragm (6W-N); the diaphragm connects two interior beam ends

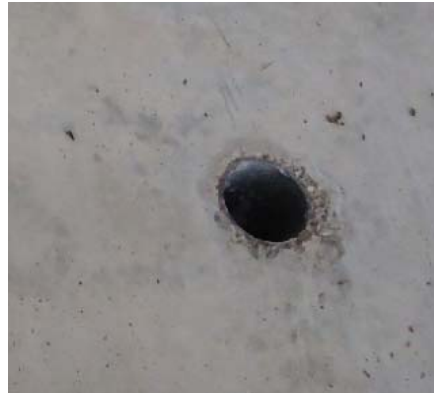
Figure D-16: Spalling around pipe interface with exterior of concrete girder (3E-N)

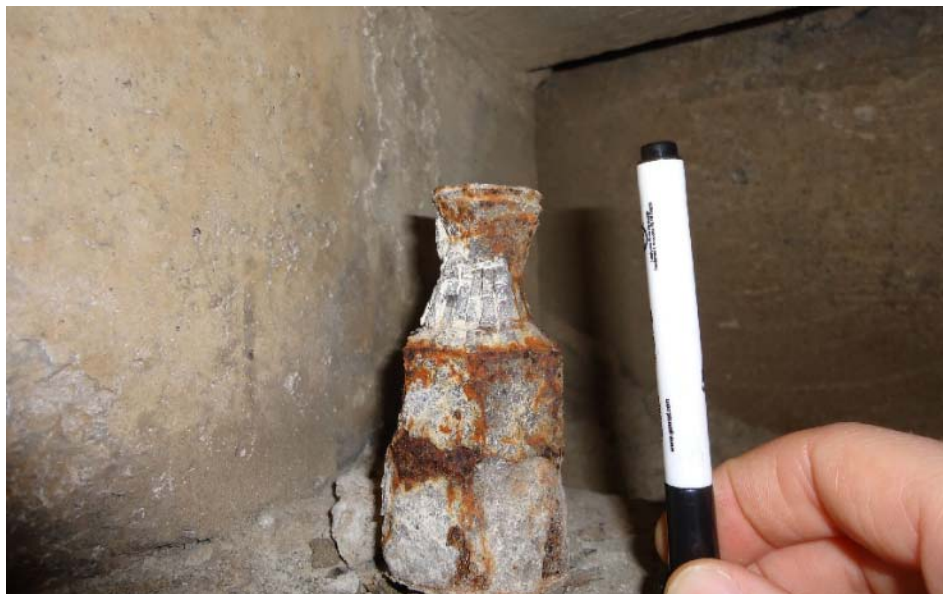
Figure D-17: Close-up of deterioration of anchor bolt, with necking at the top (4E-S). The pen is shown in the picture to illustrate the amount of necking occurring to the steel member.

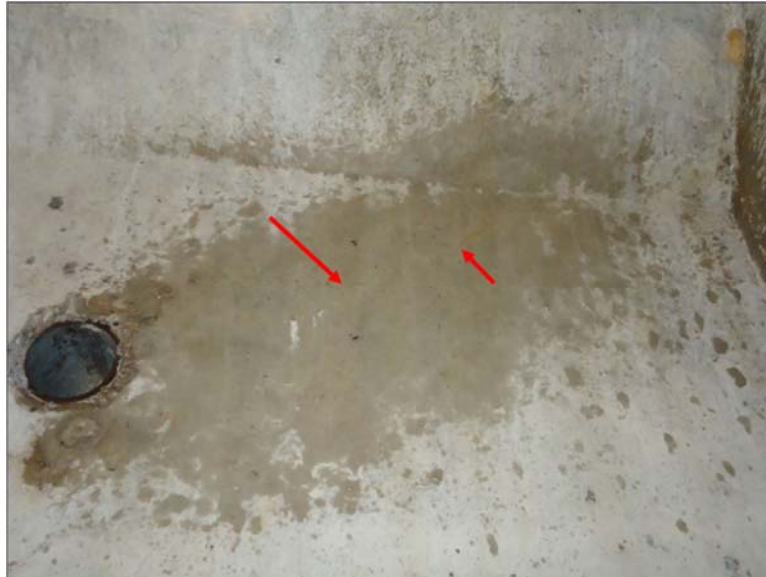
Figure D-18: Hairline diagonal cracks from top flange/web interface towards pipe on interior beam (5W-N)

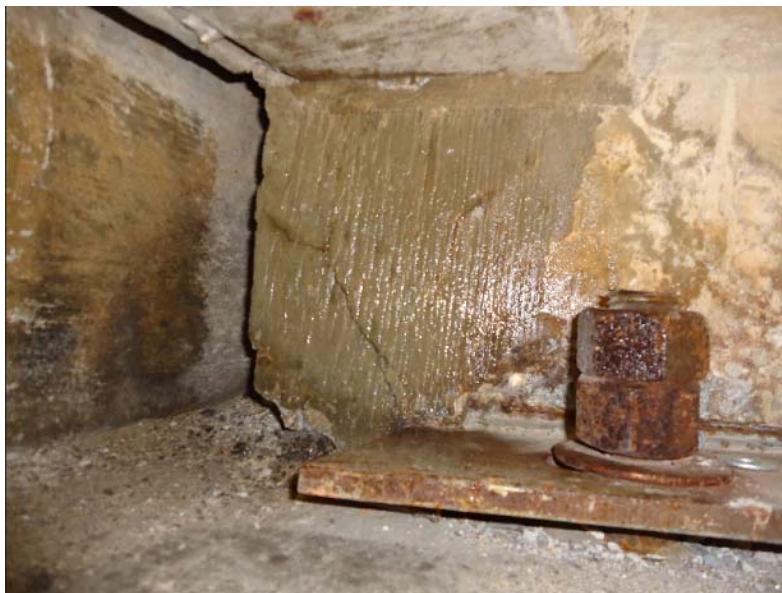
Figure D-19: Back corner diagonal cracking of beam end (5W-S)

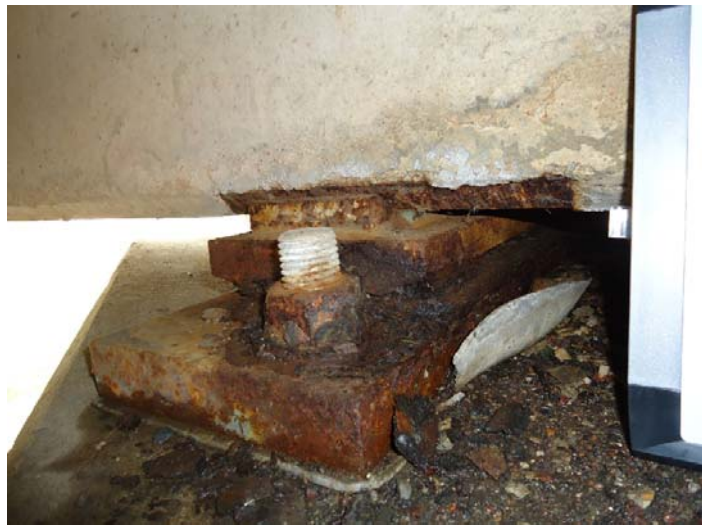
Figure D-20: Corroded bearing plate and minor spalling above the bearing plate (1E-S)

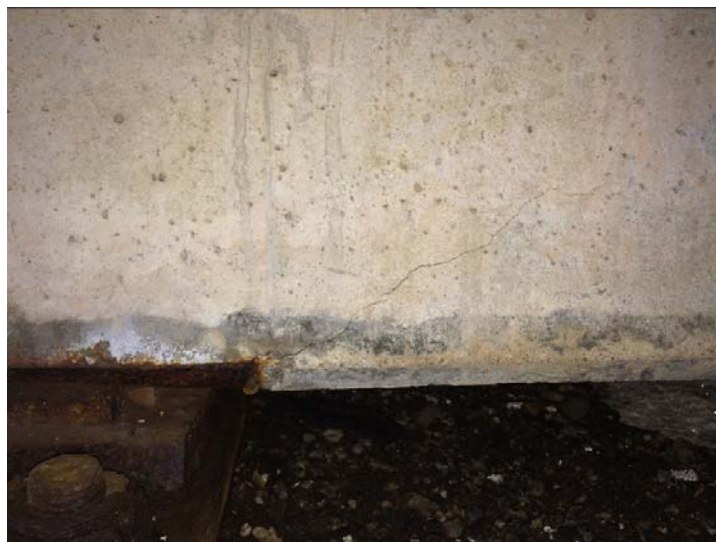
Figure D-21: Diagonal crack in bottom flange of beam from corroding support (10W-N)

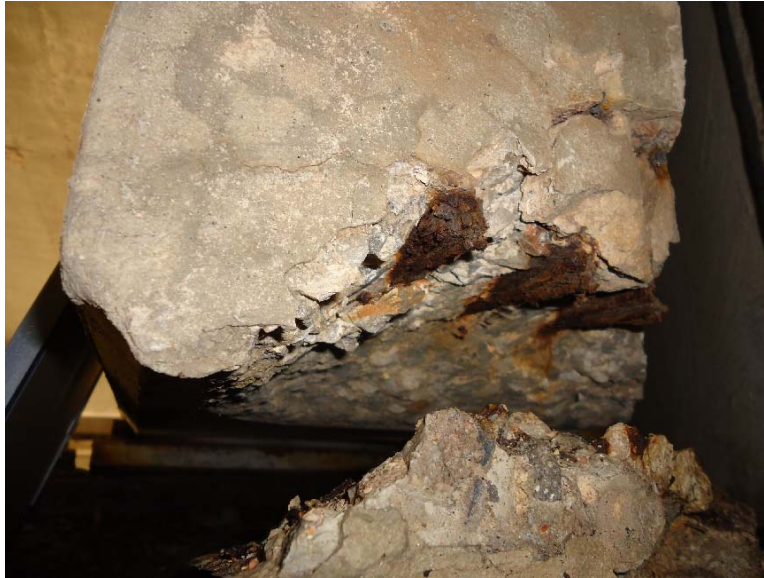
Figure D-22: Spalled back corner and exposed prestressing strands

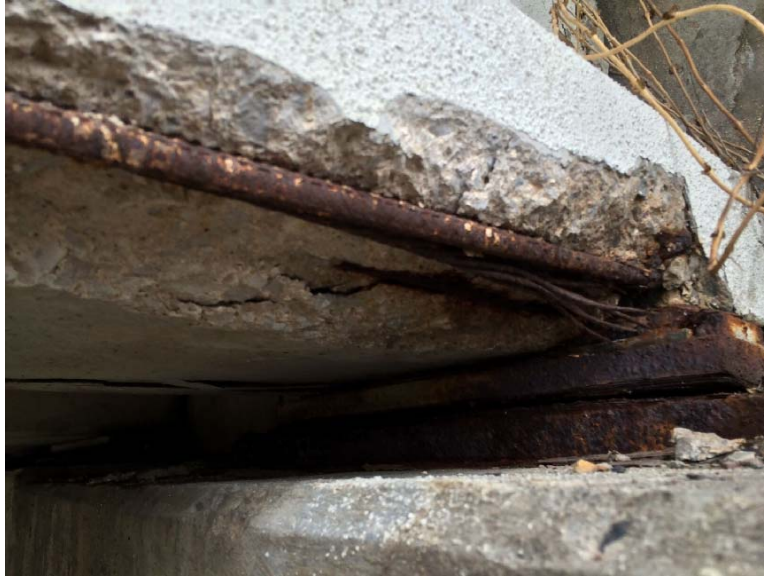
Figure D-23: Exposed rebar due to spalled concrete on the bottom of an exposed, exterior girder (1N-E)

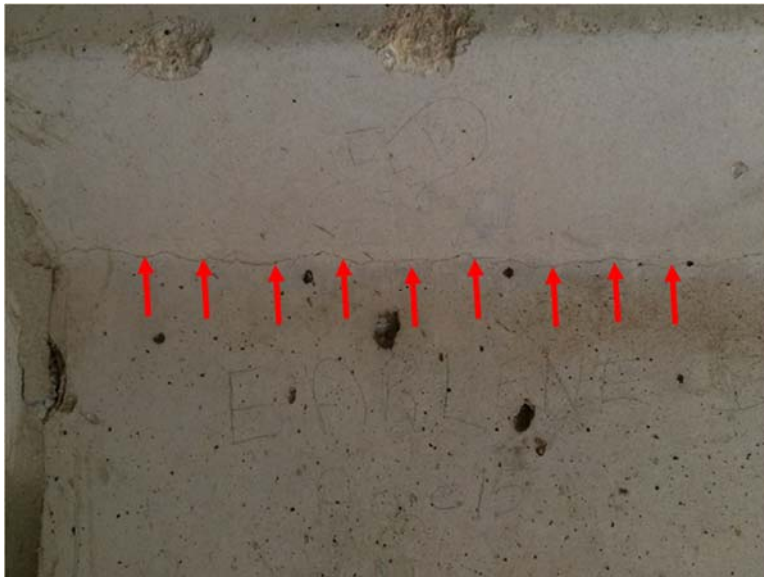
Figure D-24: Crack along intersection of the top flange and web

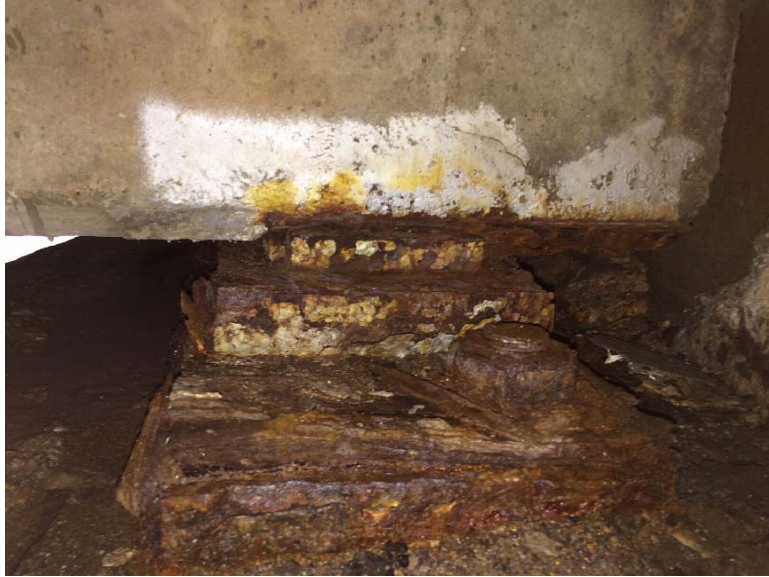
Figure D-25: Corroded, and deteriorated bearing plate (8N-E)

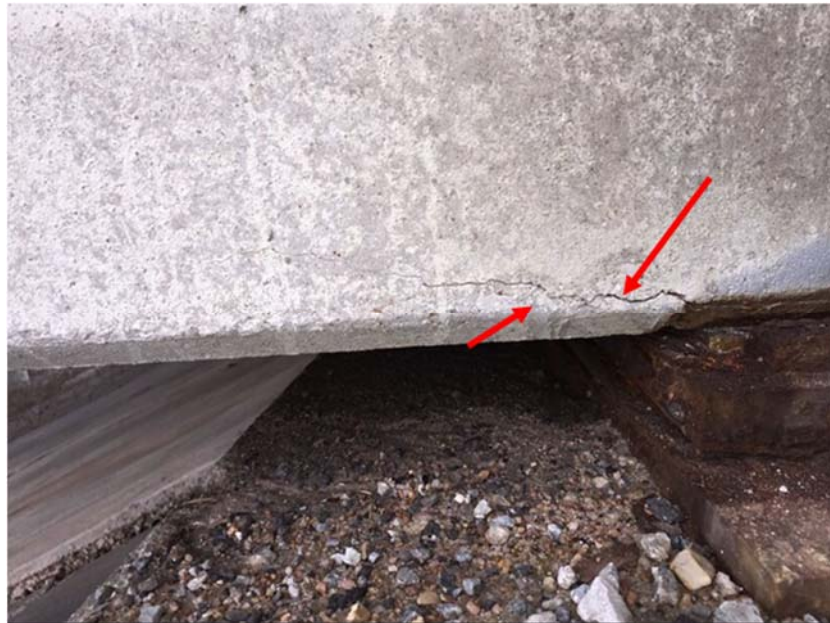
Figure D-26: Cracking from corroded bearing plate into bottom flange (10S-W)

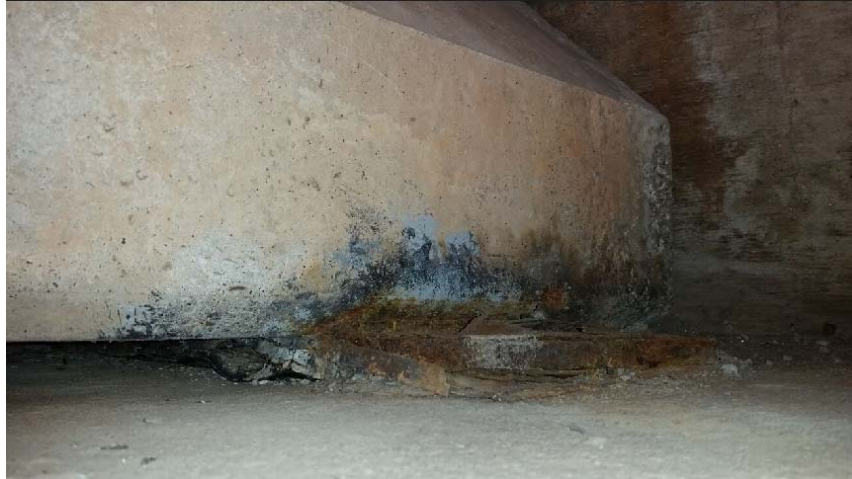
Figure D-29: Corroded bearing plate and spalling along bottom of girder and girder end (3S-W)
