Evaluation and Repair of Existing Bridges in Extreme Environments

KOREY POUGH M.Sc.
DARION MAYHORN, M.Sc.
GARY S. PRINZ, Ph.D., P.E.
ROYCE W. FLOYD, Ph.D., P.E.
SPTC14.1-58-F

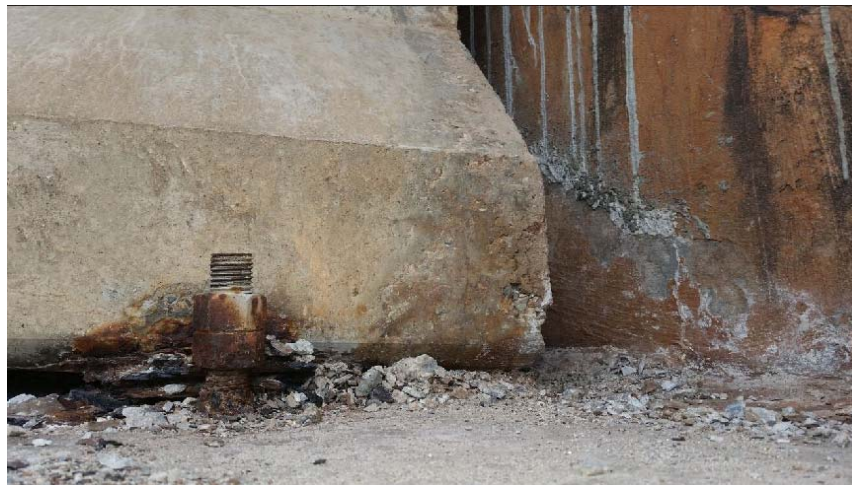
Figure D-30: Corroded anchor bolt and spalling along bottom of girder and girder end (5N-E)

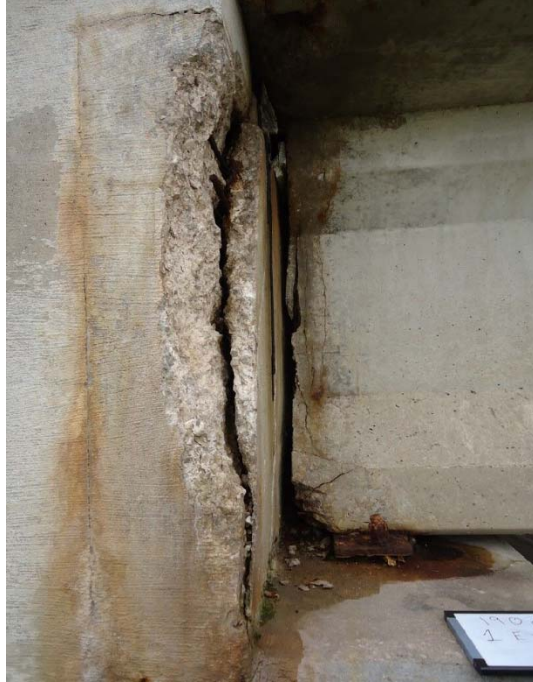
Figure D-31: Deterioration of back wall and girder end due to moisture/water (1E-N). The exposed, exterior girder has a corroded bearing plate and spalling occurring at the end.

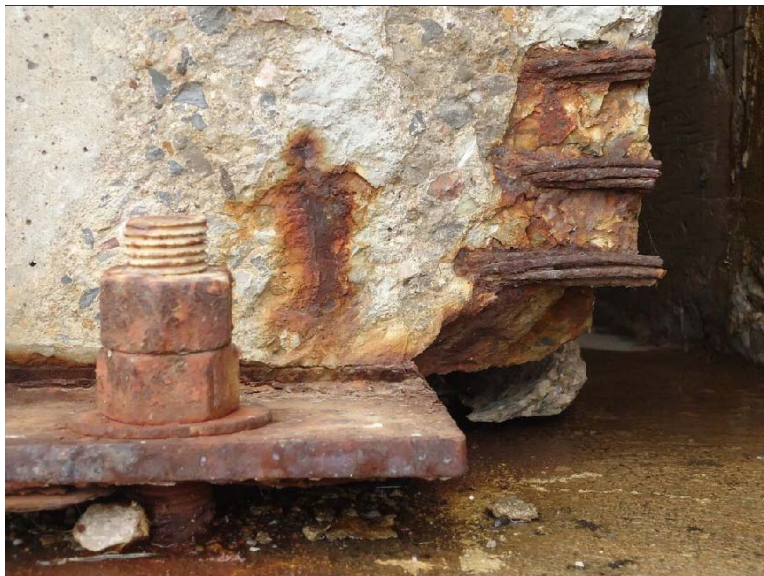
Figure D-32: Exposed prestressing strands of an exposed, exterior girder (1W-N)

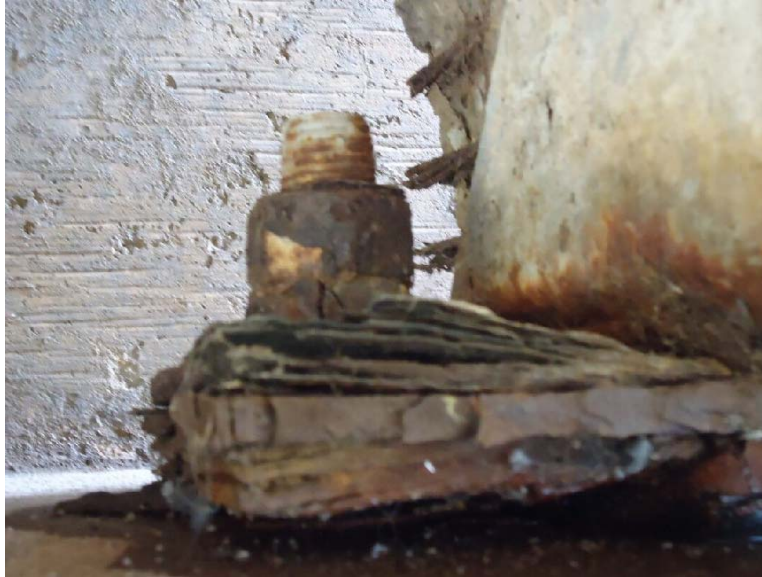
Figure D-33: Corroded and flaky bearing plate (1W-S)

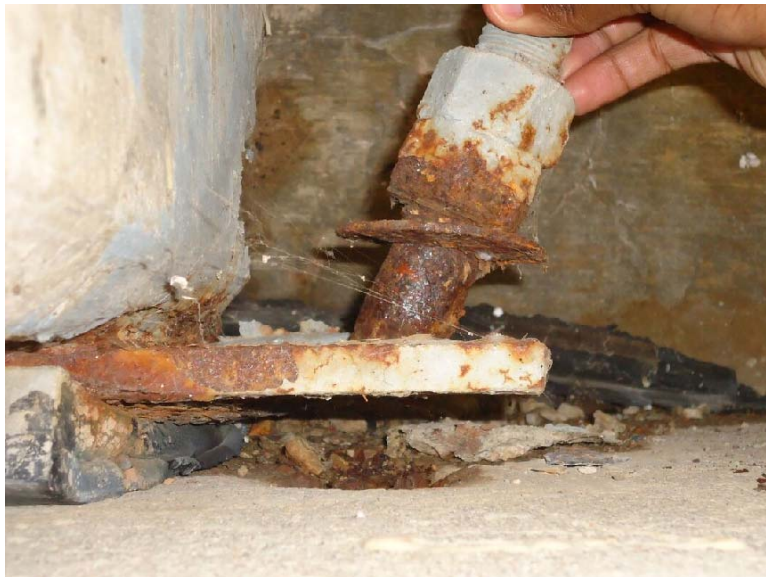
Figure D-34: Corroded anchor bolt that has been sheared in two (7E-S)

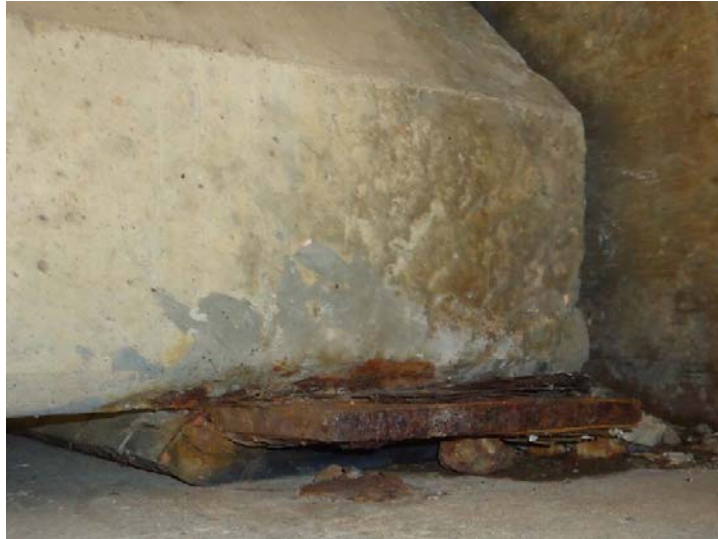
Figure D-35: Spalling above corroded bearing plate and missing anchor bolt (10E-S)

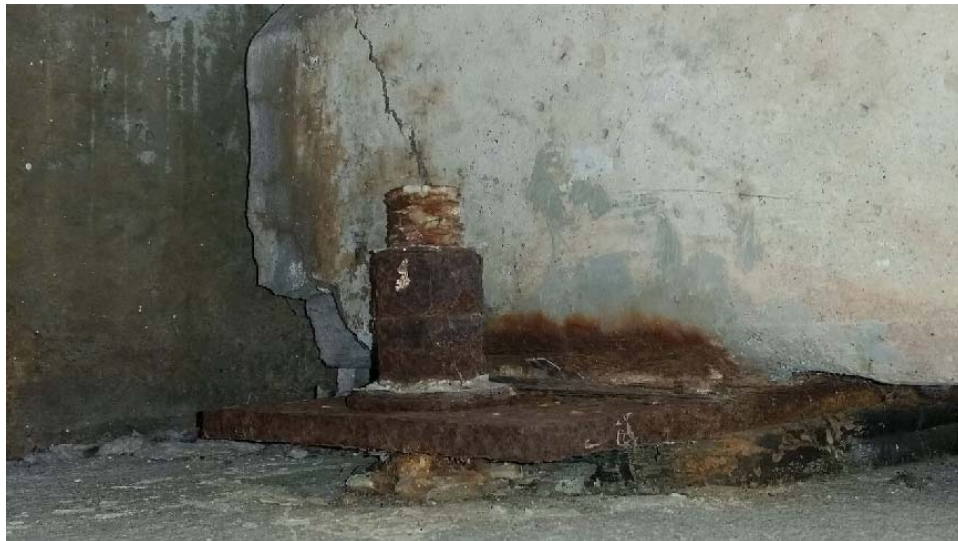
Figure D-36: Back corner diagonal cracking on beam end (11W-S)

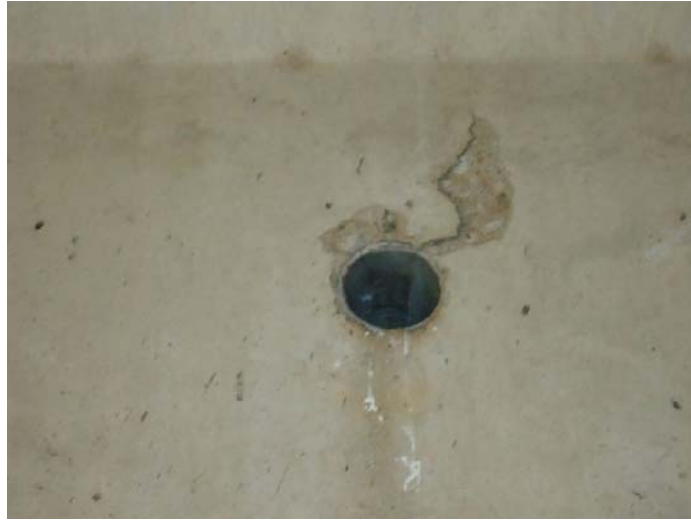
Figure D-37: Spalling and cracking above pipe in web (1N-E)

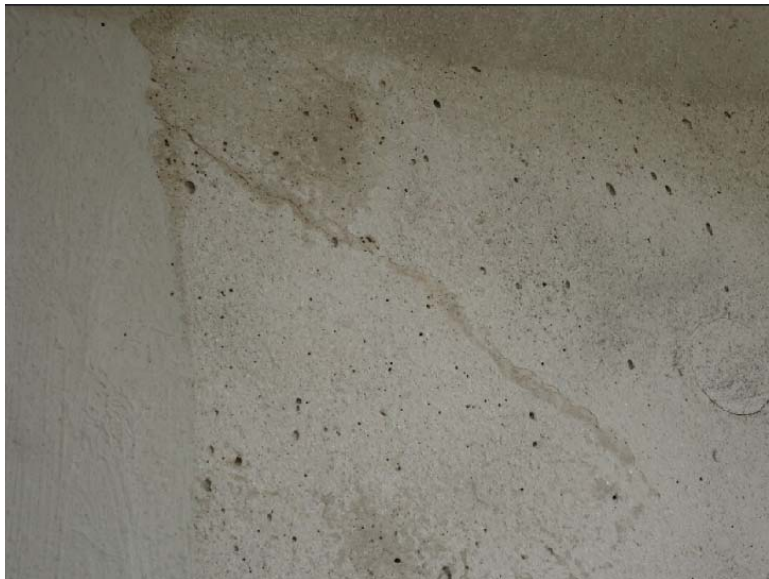
Figure D-38: Diagonal crack in web from top flange towards bottom of beam (1N-W)

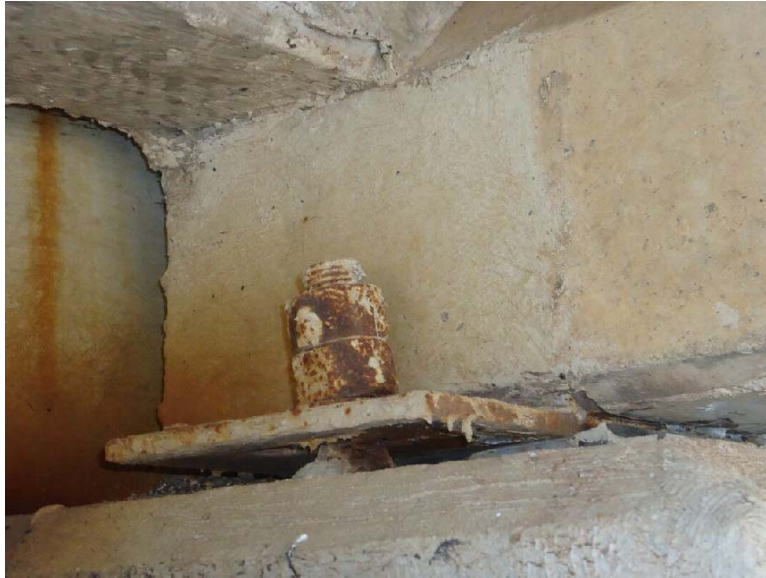
Figure D-39: Corroded anchor bolt (4S-E)

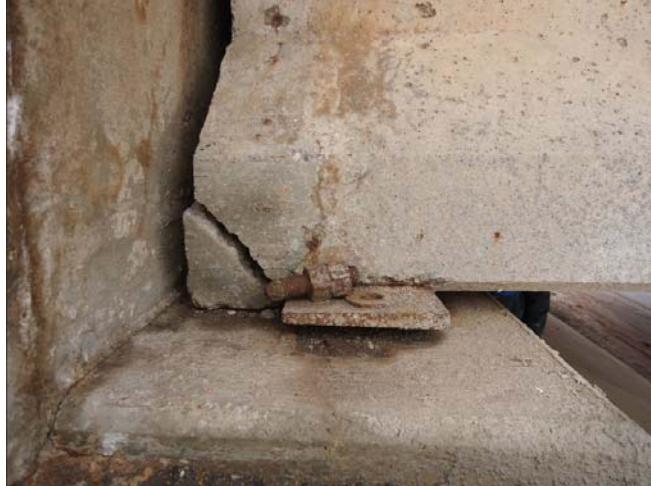
Figure D-43: Back corner diagonal crack of exposed, exterior beam (1E-N)

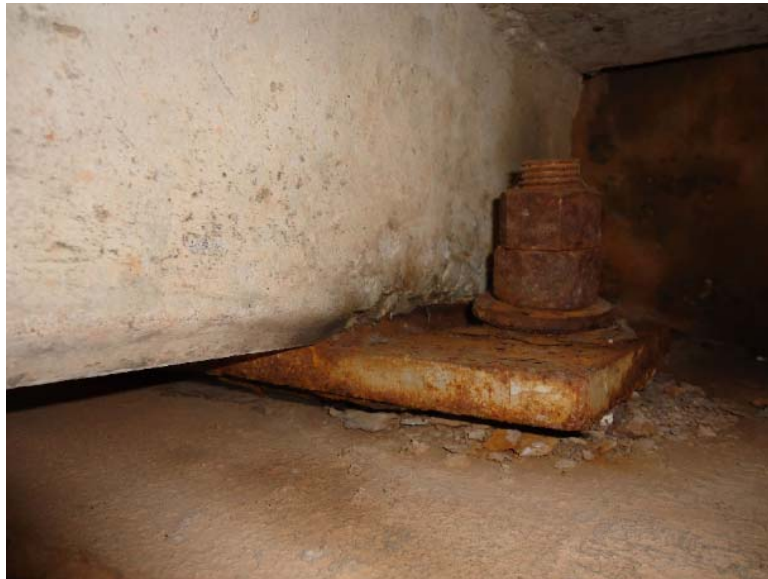
Figure D-44: Corroded bearing plate and anchor bolt with spalling above the support (5E-S)

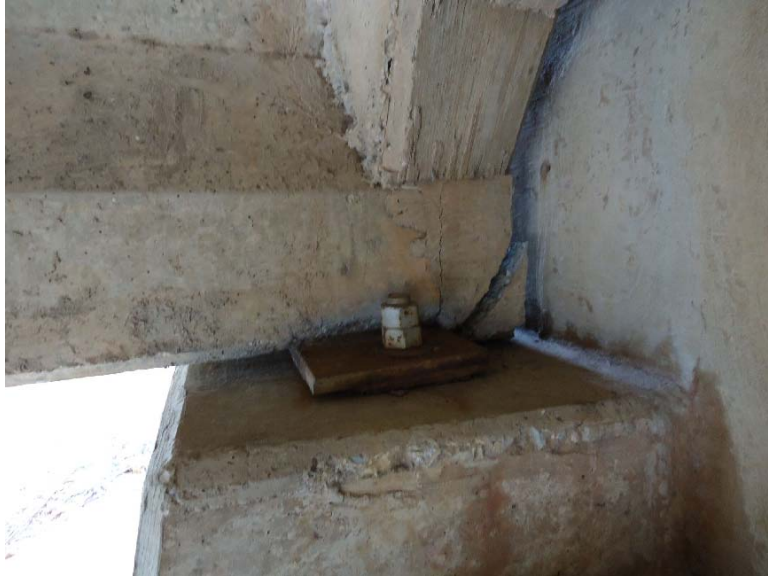
Figure D-45: Back corner diagonal cracking of exterior beam (1E-S)

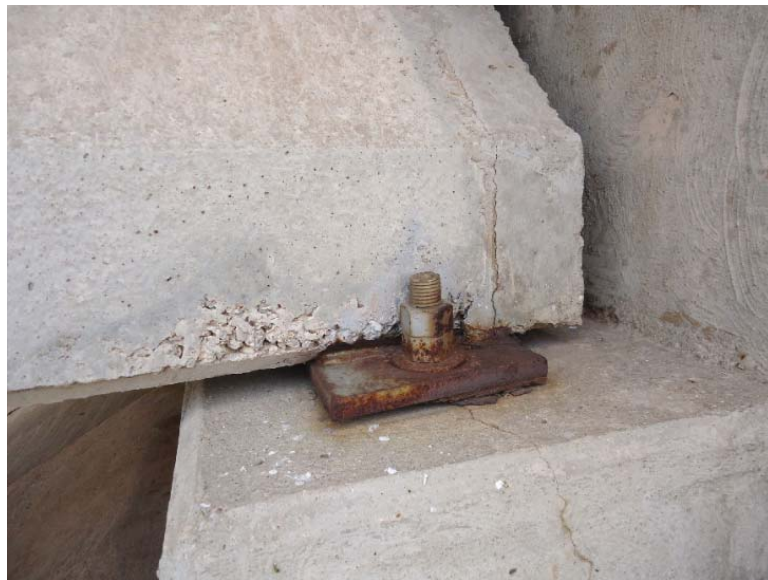
Figure D-46: Spalling above the corroded bearing plate (1W-N)

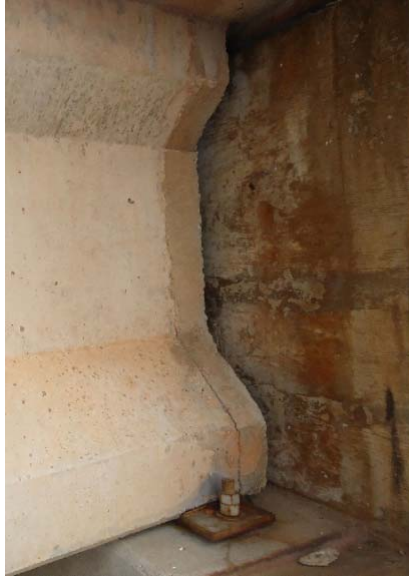
Figure D-47: Vertical separation of diaphragm and girder at interface (5E-S)

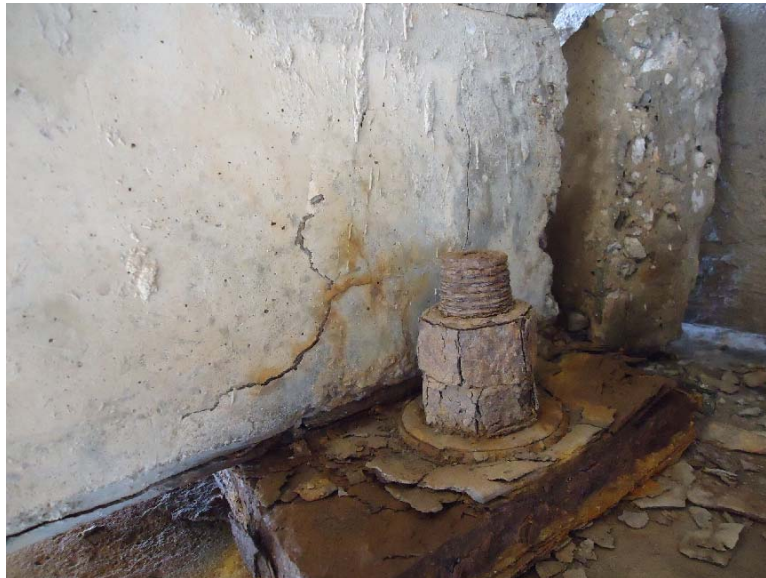
Figure D-48: Corroded bearing plate and anchor bolt, with spalling and cracking above the corroded bearing plate (5W-N)

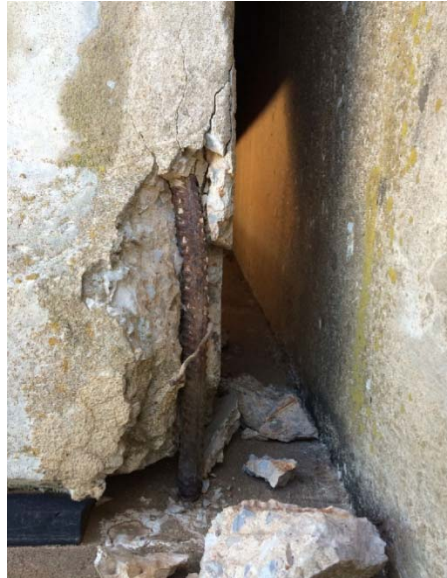
Figure D-49: Exposed vertical rebar due to spalling at the end of exposed, exterior girder (1W-N)

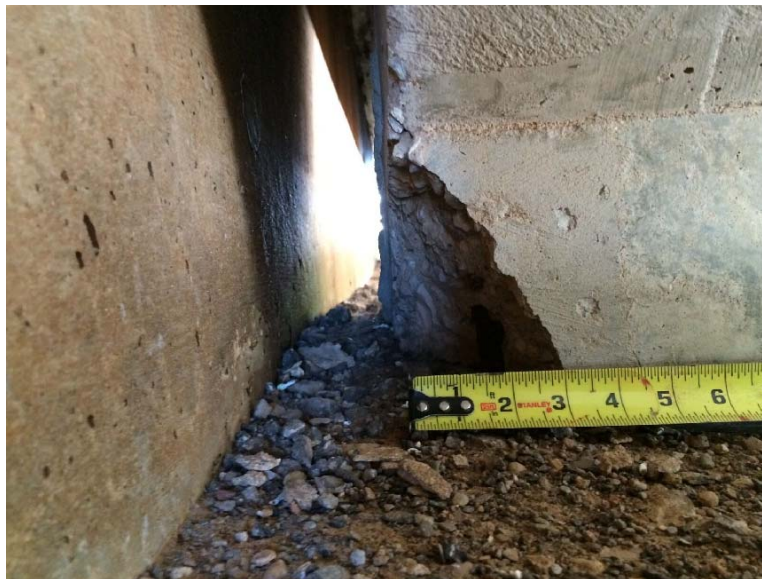
Figure D-50: Spalling resulting from back corner diagonal crack (2E-N)

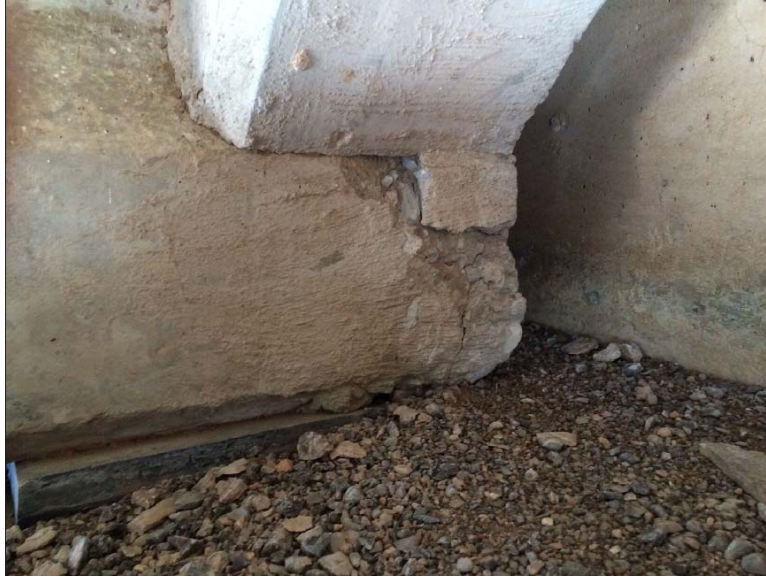
Figure D-51: Spalling at diaphragm and girder interface (3W-N)

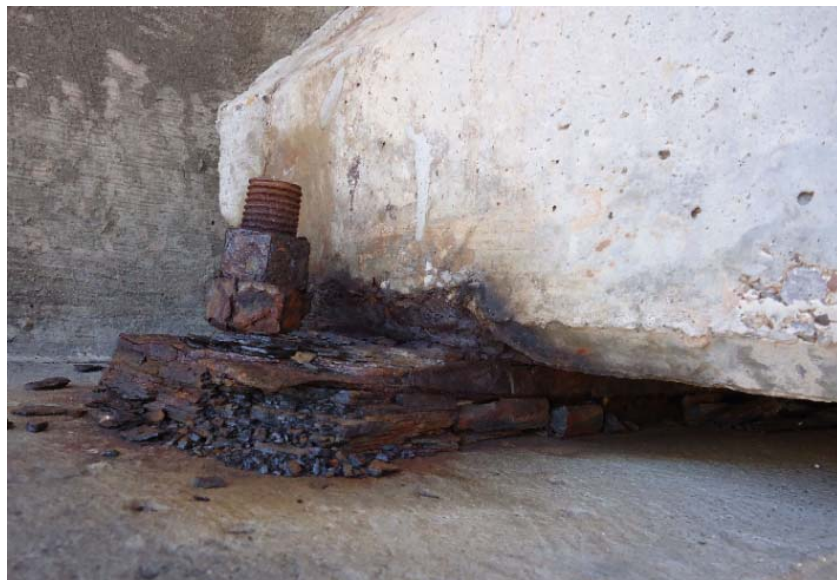
Figure D-52: Corroded bearing plate, bolt, and nut along with spalling above the support of an exposed, exterior girder (1E-N)

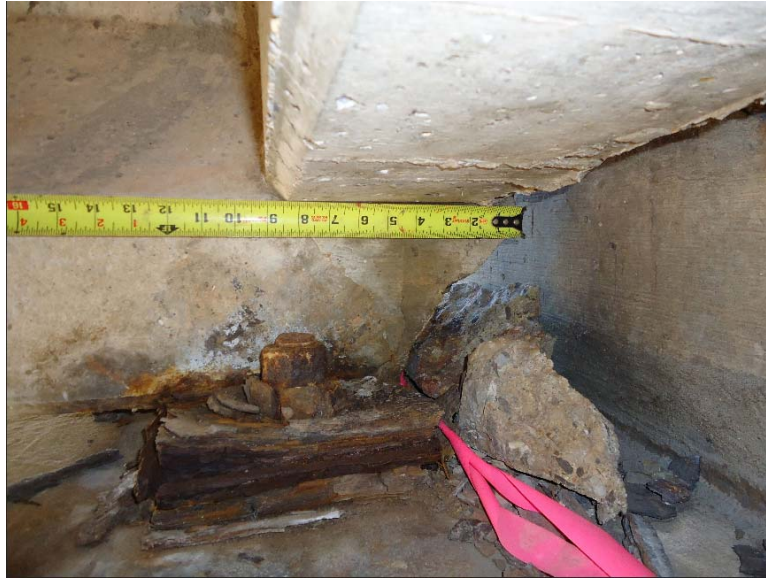
Figure D-53: Corroded bearing plate and spalling from a diagonal back corner crack with a maximum width of approximately four inches

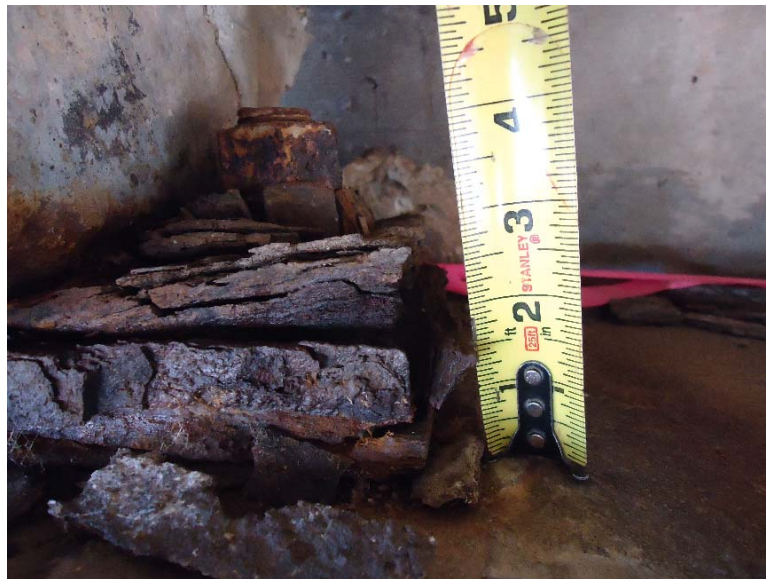
Figure D-54: Corroded, flaky bearing plate

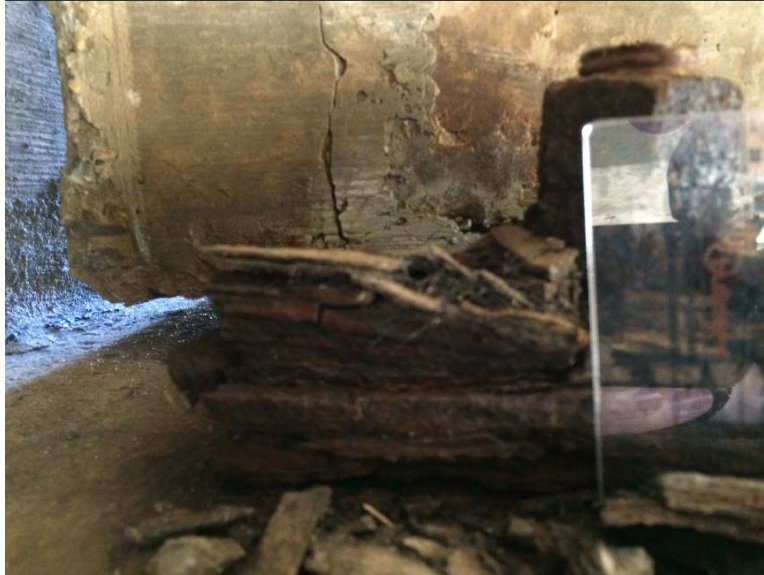
Figure D-55: Vertical crack along interface of girder end and diaphragm (1W-S)

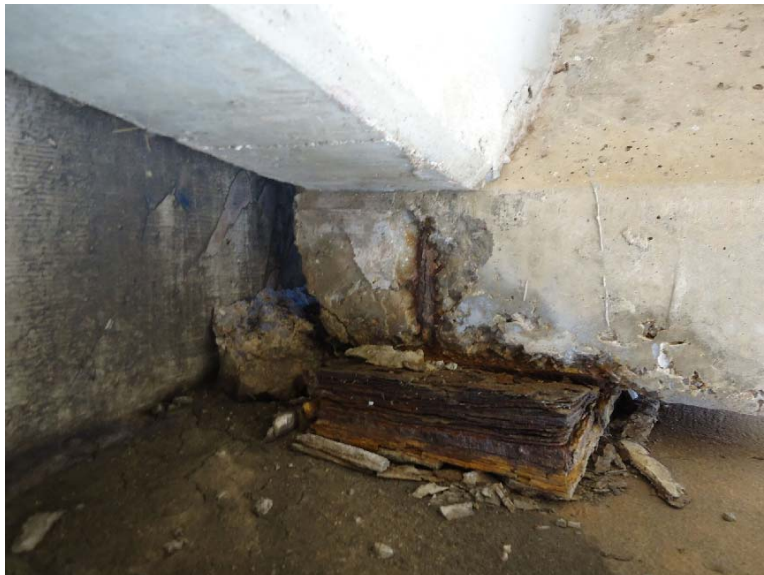
Figure D-56: Exposed rebar, corroded, flaky bearing plate, and spalling of concrete (5E-N)

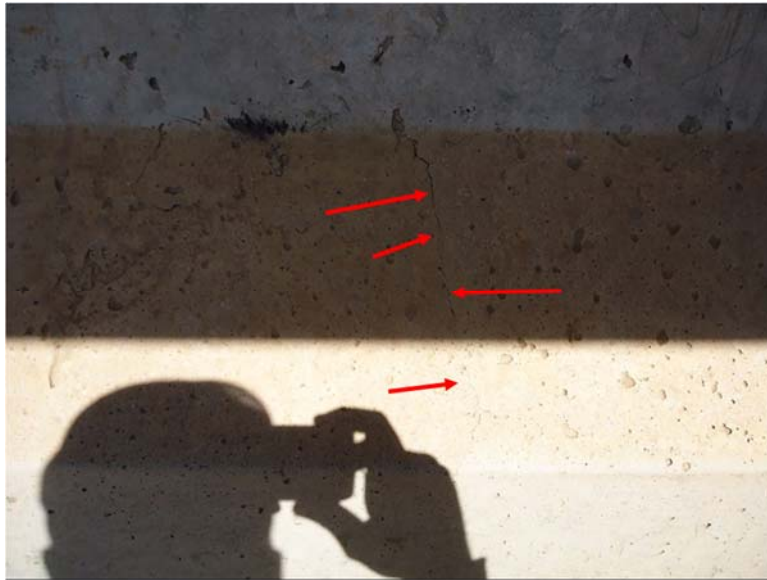
Figure D-57: Crack along the web of girder (5E-S)

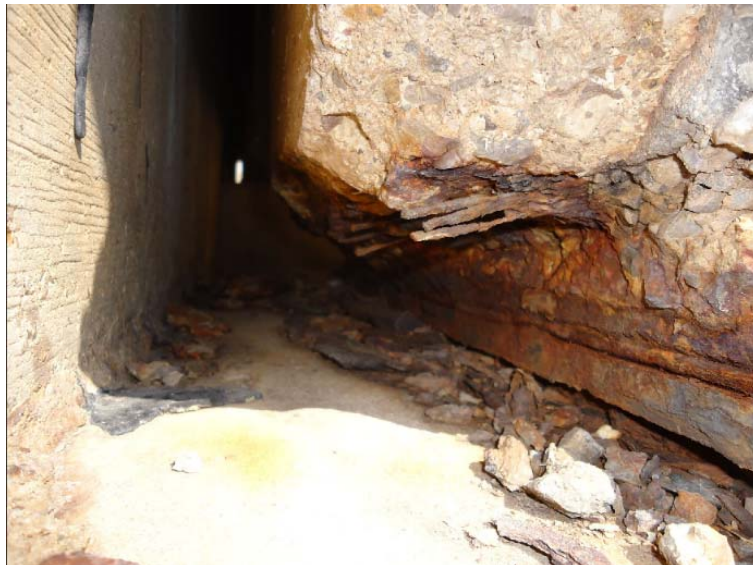
Figure D-58: Diagonal back corner spalling and exposed prestressing strands (5W-S)

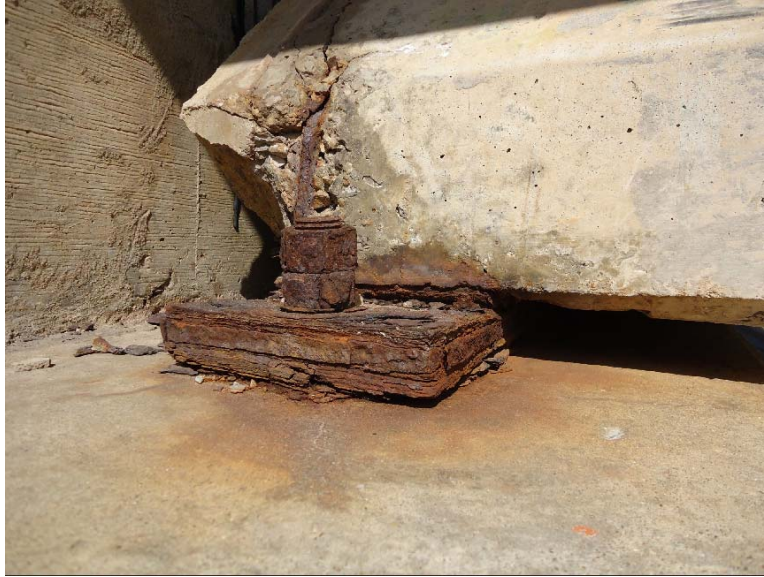
Figure D-59: Corroded bearing plate, exposed rebar, and spalled back corner of girder (5W-S)

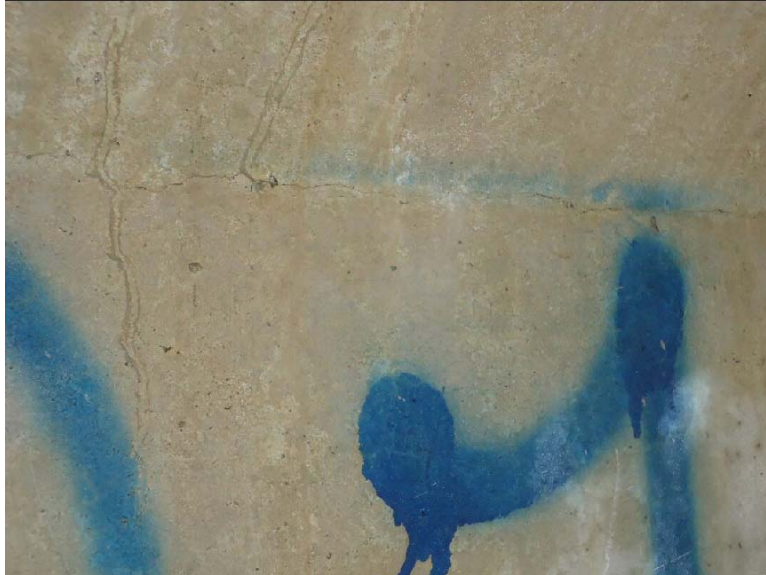
Figure D-61: Horizontal crack at top flange and web interface extending approximately one foot into the beam (1S-E)

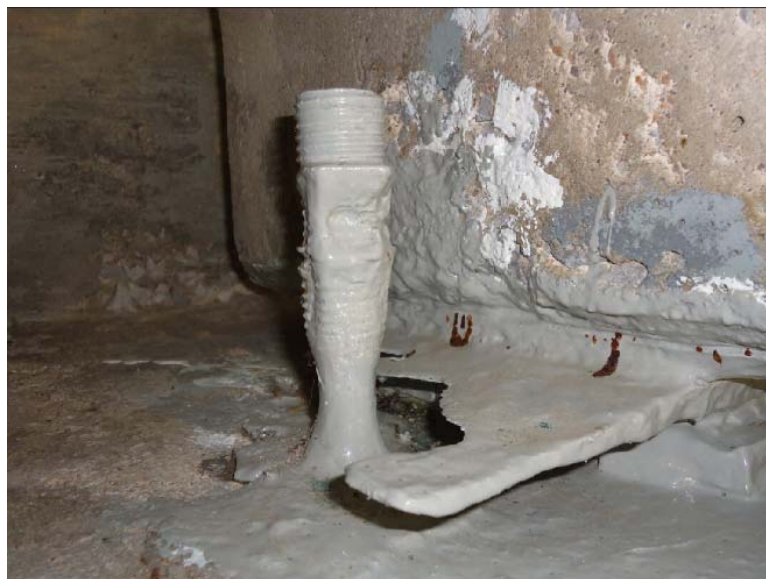
Figure D-62: Severely corroded anchor bolt and bearing plate covered with protective coating (1S-E)

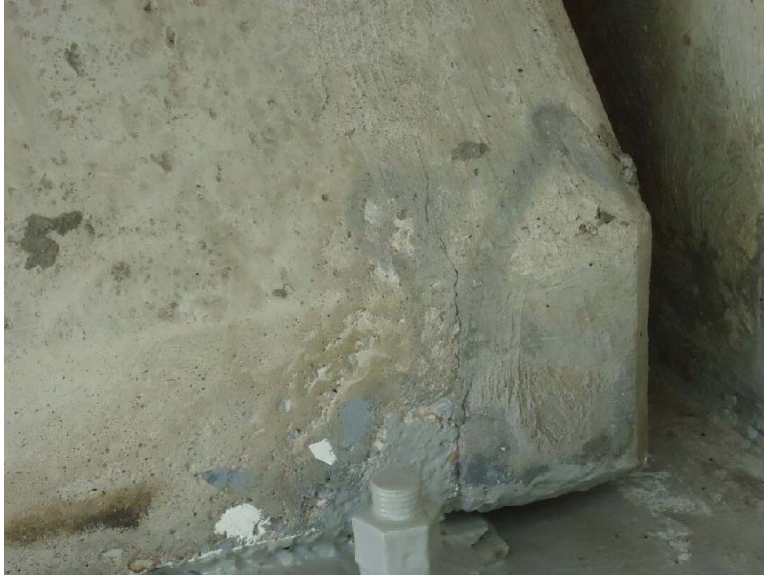
Figure D-63: Vertical crack at girder and diaphragm intersection (1S-W)

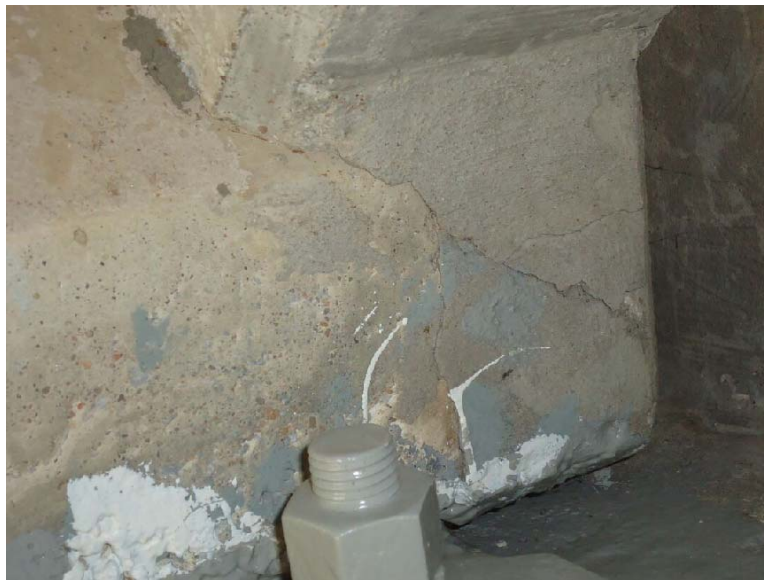
Figure D-64: Diagonal crack at back corner of girder end (2S-W)

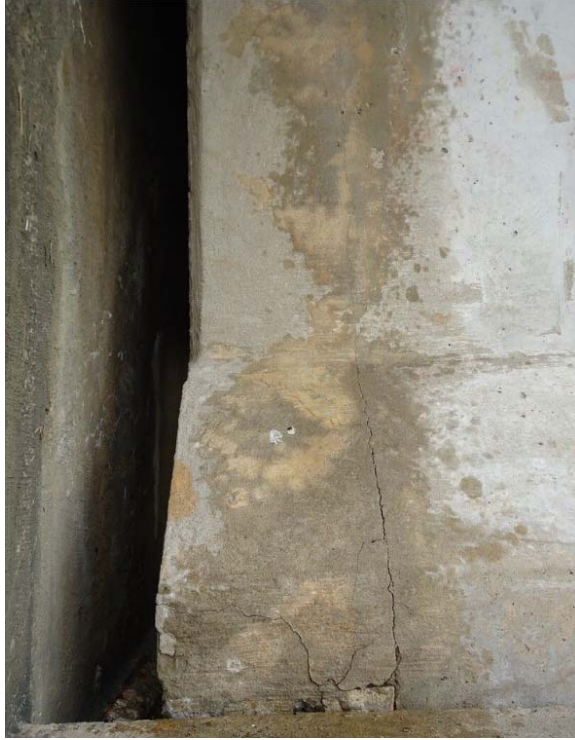
Figure D-65: Vertical crack at girder/diaphragm interface (1N-W)

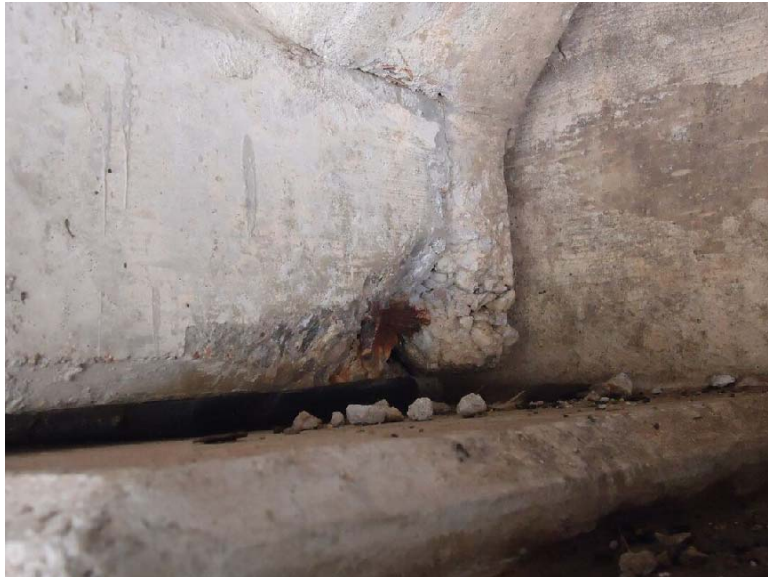
Figure D-66: Exposed rebar, back corner spalled (2S-W)

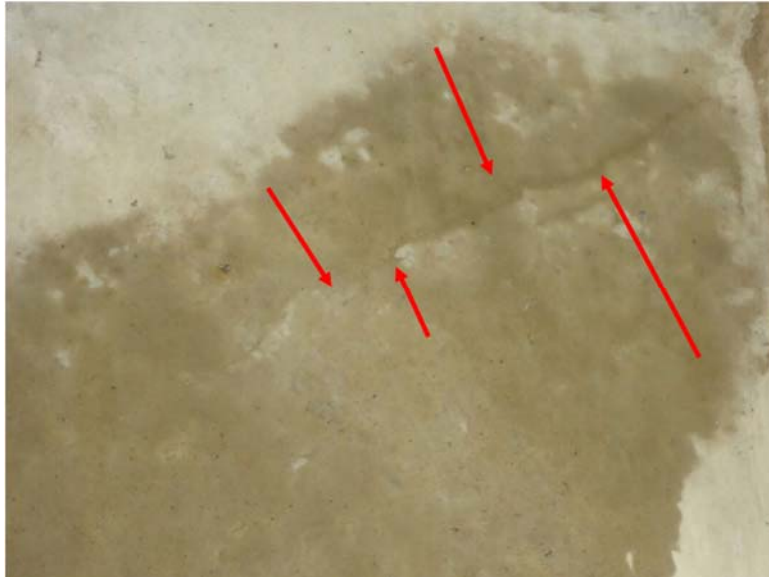
Figure D-67: Diagonal crack from top flange and web interface

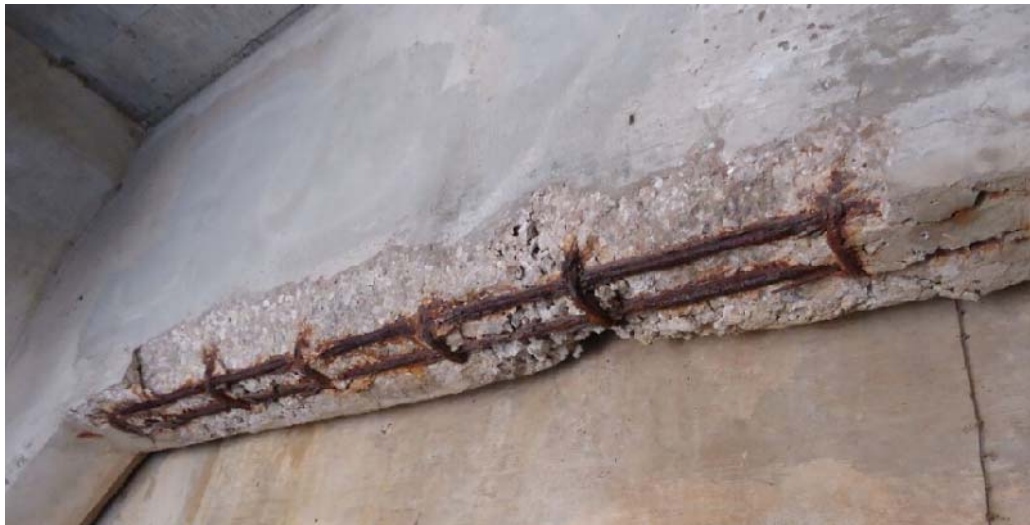
Figure D-68: Corrosion on underside of end diaphragm with exposed and corroded rebar

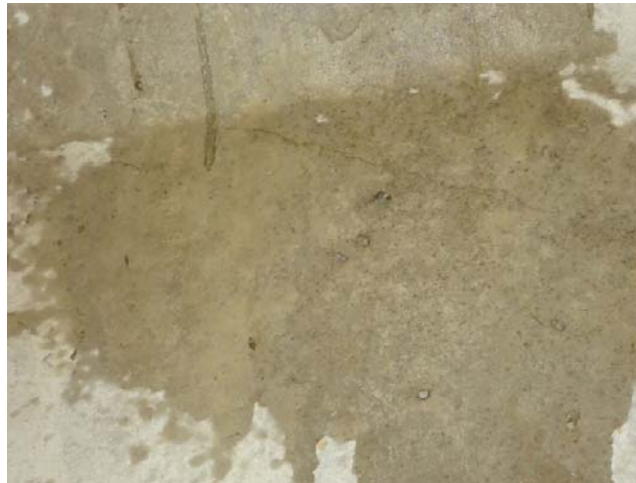
Figure D-69: Diagonal web crack extending from top flange and web intersection (5N-W)

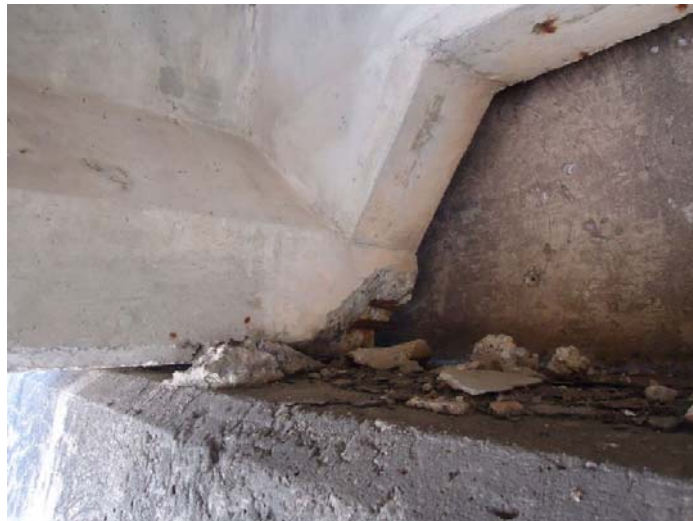
Figure D-70: Diagonal back corner spalling of diaphragm and exposed prestressing strands (5S-W)
