1. Report No.	2. Government Accession No.	3. Recipient's Catalog No.
4. Title and Subtitle Cost-Effective and Rapid Concrete Repair Techniques		5. Report Date February 8, 2016

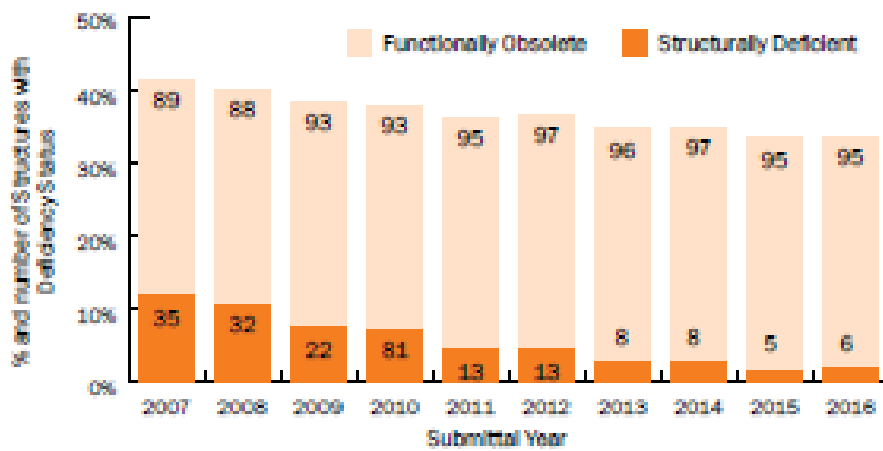
### State Highway Structure Trends

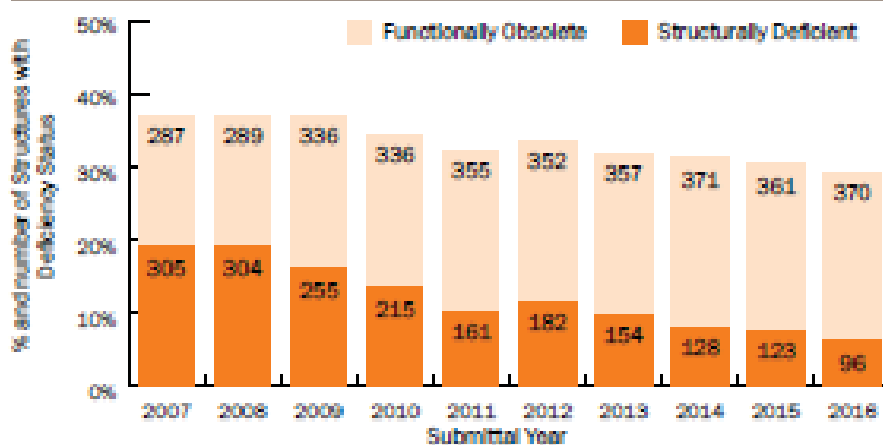
Figure 1.1 Downward trends of percent structurally deficient and functionally obsolete bridges in Vermont (VAOT 2017)

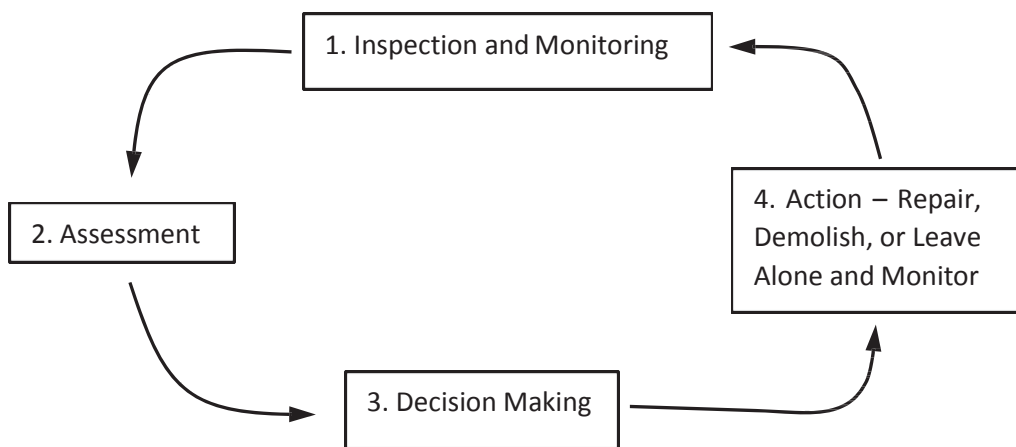
**Figure 1.2 Cyclic nature of structural maintenance and repair**

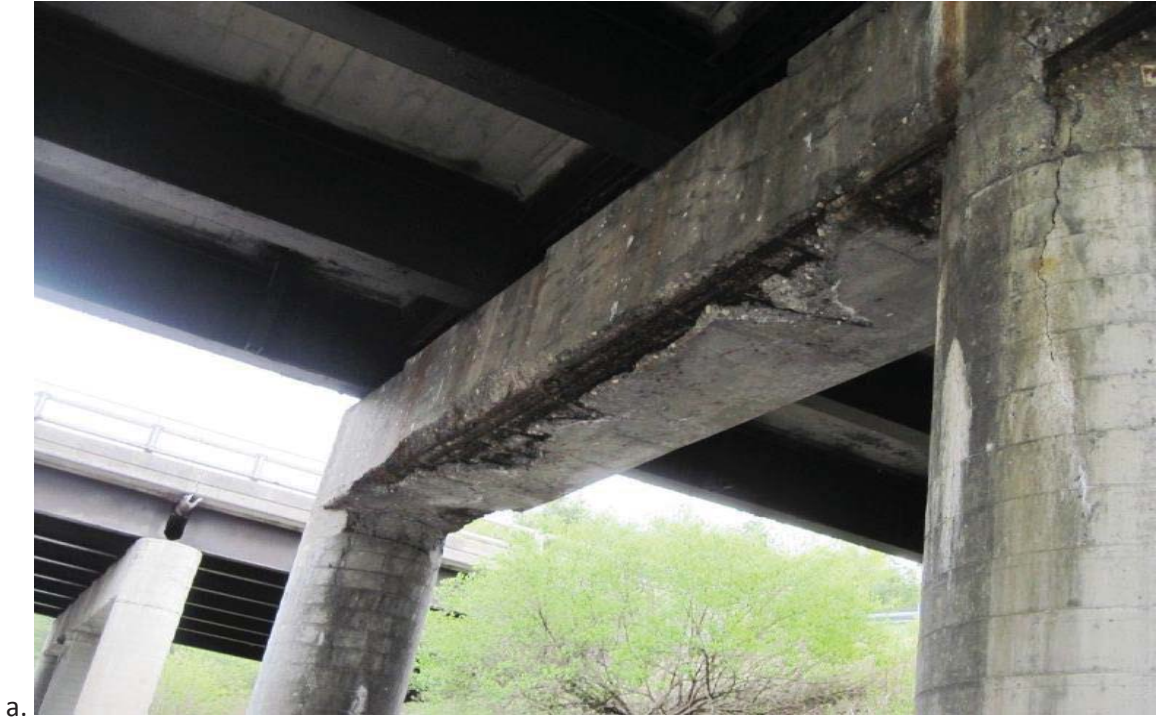
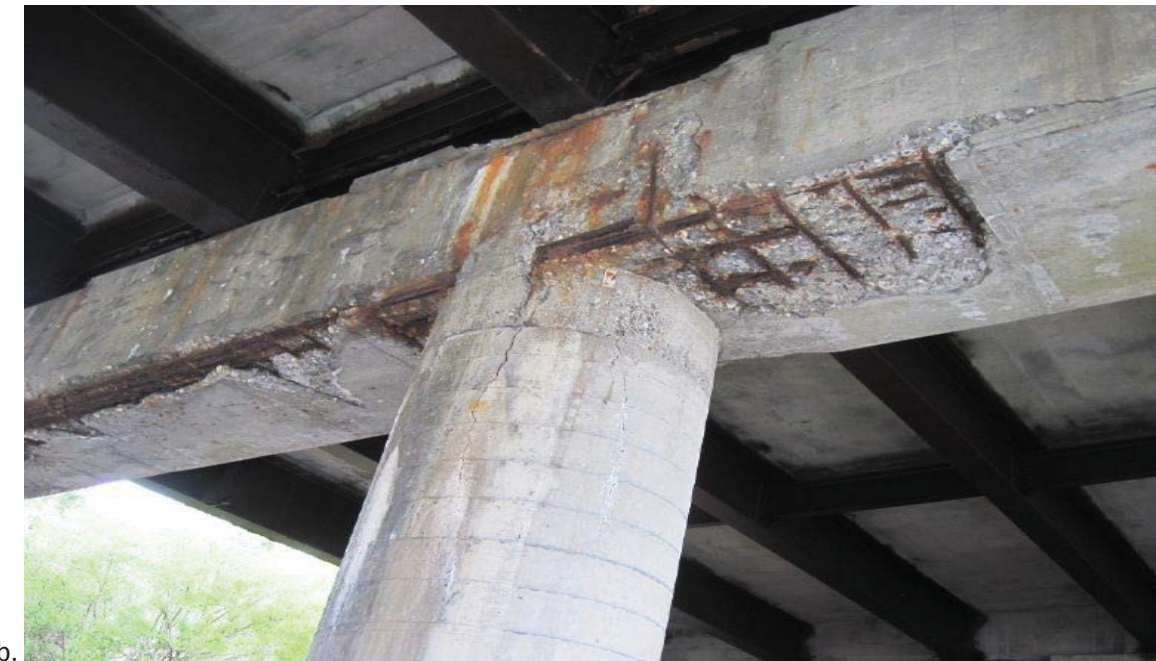
Figure 4.1 I-89 Middlesex Br.#45 S

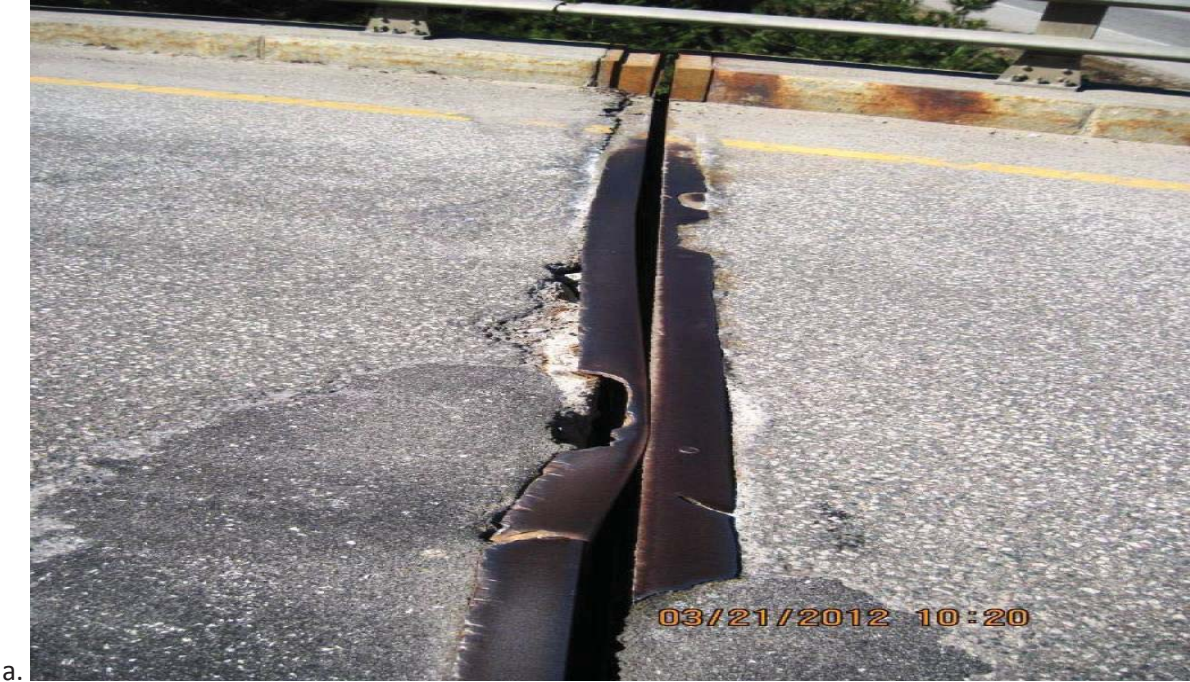
4.3 shows a damaged steel expansion joint and bearing for Vt. Rte. 903 Conn Berlin Br. #1. Figure 4.4 shows a replacement that eliminates the steel joint.

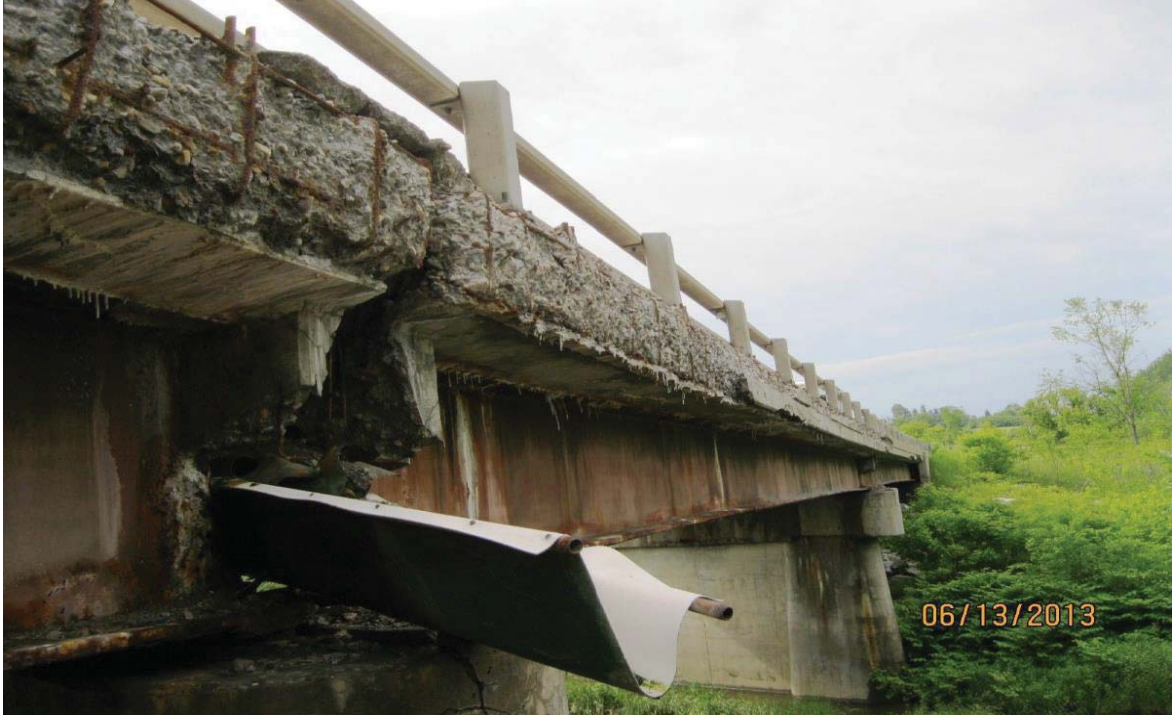
Vermont has multiple highway overpass bridges with severely distressed fascia. Spalling concrete is a safety issue for vehicles passing underneath. Many of the fascia have integrated guard rail systems and pose a safety risk if the rails fail to contain out of bounds vehicles. Figure 4.5 shows a severely damaged fascia on US 7 New Haven Br.#129. Figure 4.6 shows the reconstructed curb and fascia, along with new guard rail and fencing.

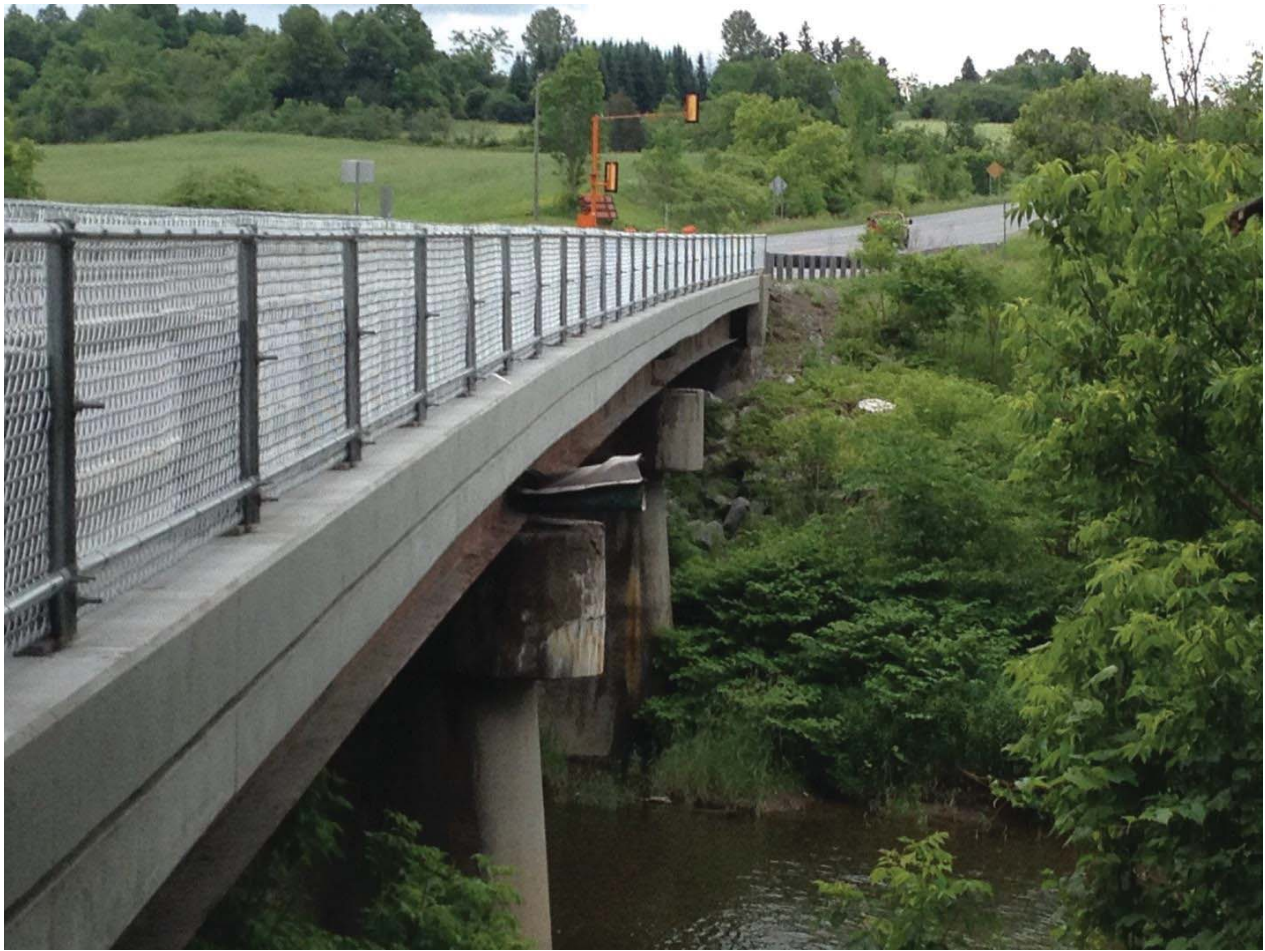
**Figure 4.6 US 7 New Haven Br. #129 – REPAIRED Fascia/Curb Reconstruction, \$350,000**

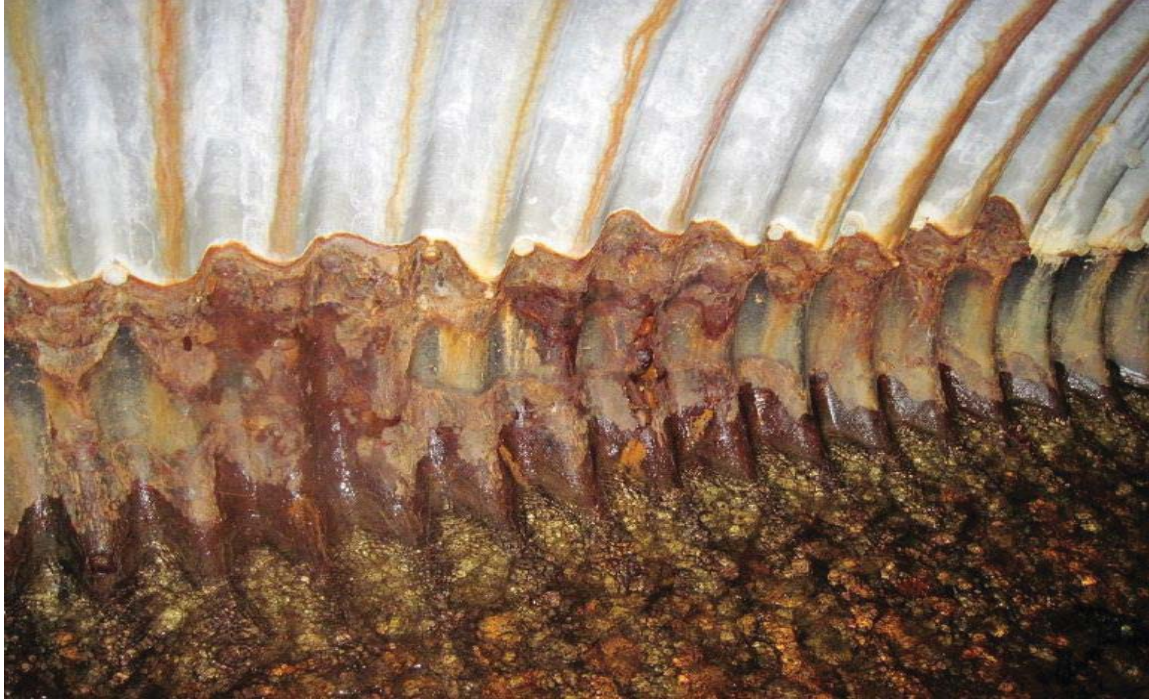
Bridges with integrated water flow structures, such as corrugated steel arches, can suffer damage at the water flow line due to corrosion and erosion. Figure 4.7 shows the Vt. Rte. 30 Winhall Br. #45 with a severely damaged corrugated steel flow line. Figure 4.8 shows a repair that replaced the flow line with concrete.

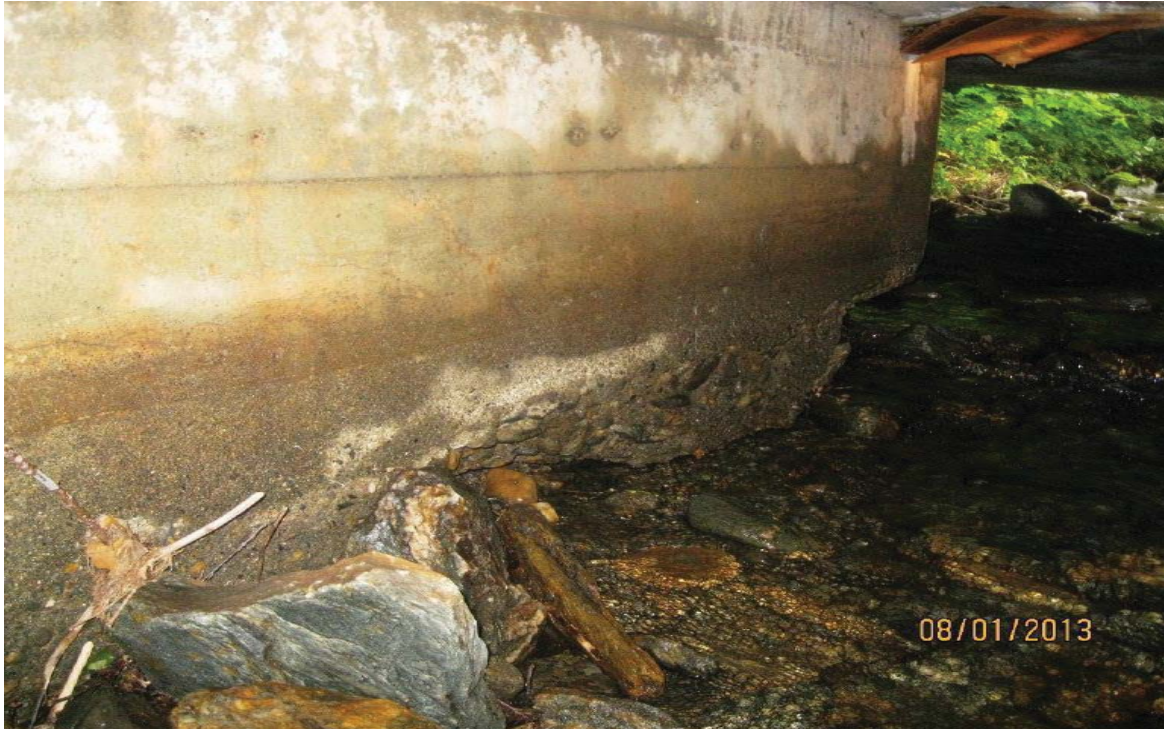
Concrete footings placed in stream flows are constantly subjected to hydraulic erosion effects. Figure 4.9 shows a footing on Vt.Rte.108 Stowe Br. #11 with erosion damage. Figure 4.10 shows a cast-in-place repair to the footing.

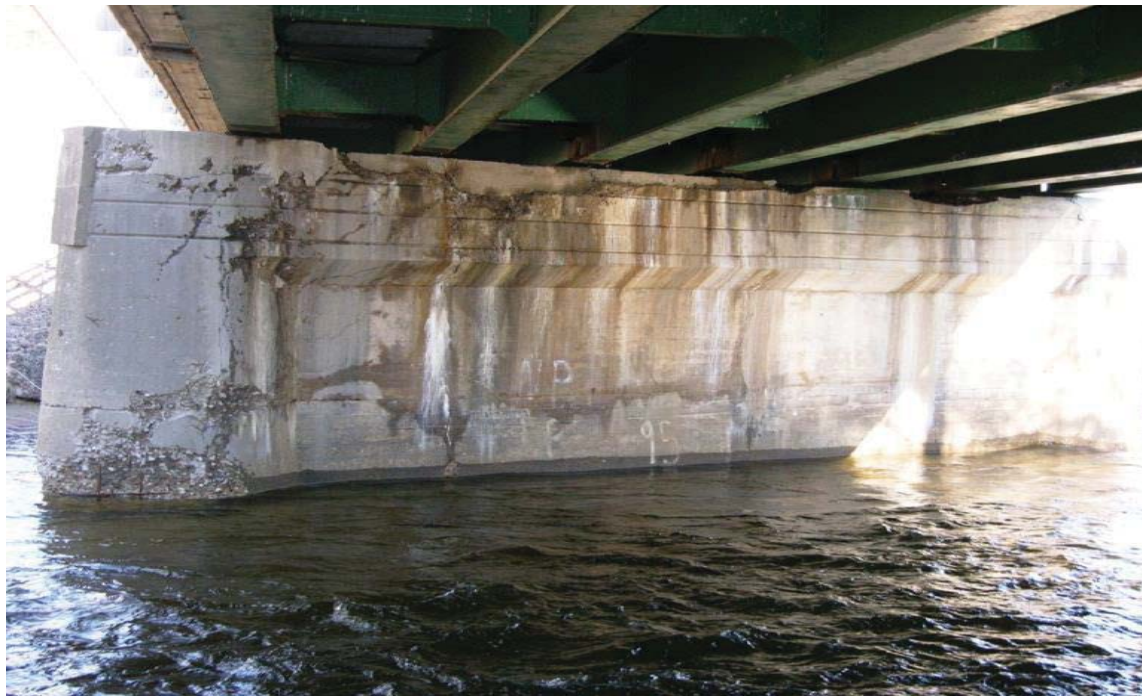
**Figure 4.12 US4 Hartford Br. #65A – REPAIRED Pier/Pedestal Reconstruction, \$150,000**

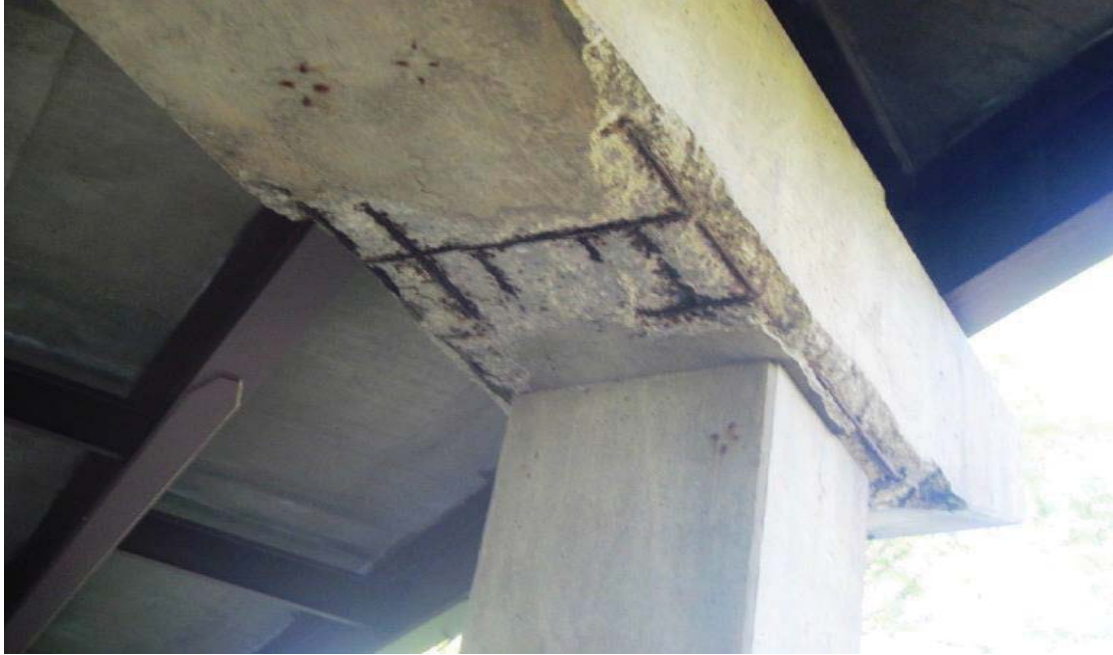
**Figure 4.14 Vt. Rte. 11 Londonderry Br. #27 – REPAIRED Pier Repairs, \$120,000**

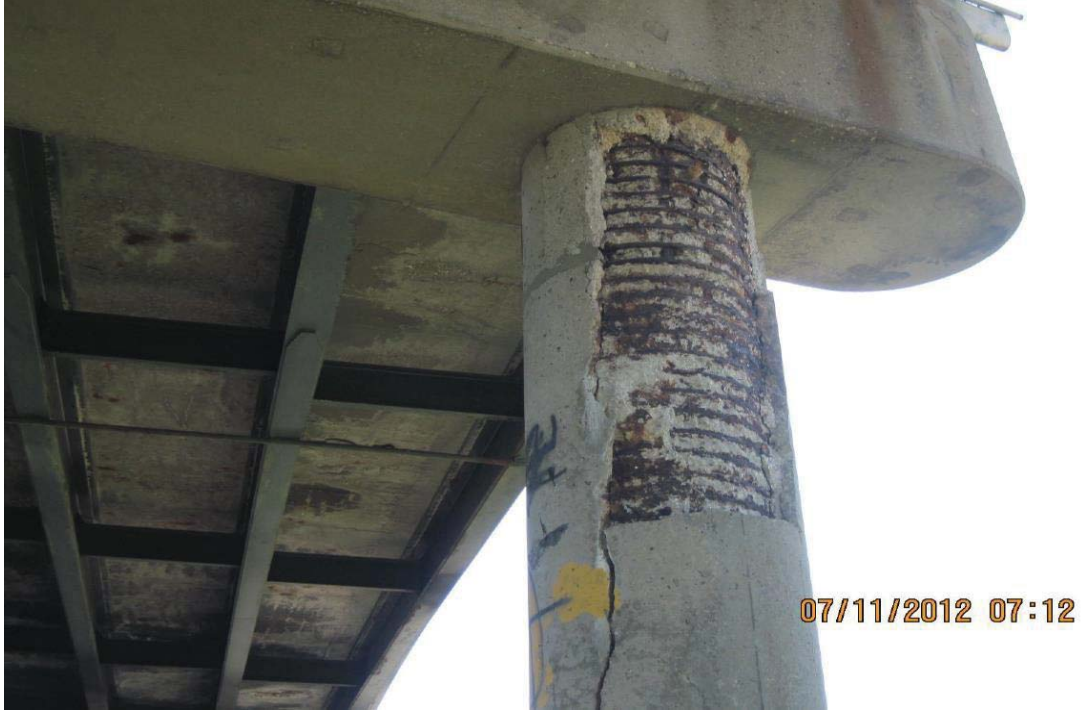
**Figure 4.16 | 89 Richmond Br. #55 S – REPAIRED Bearing Seat/Pier repairs, \$150,000**

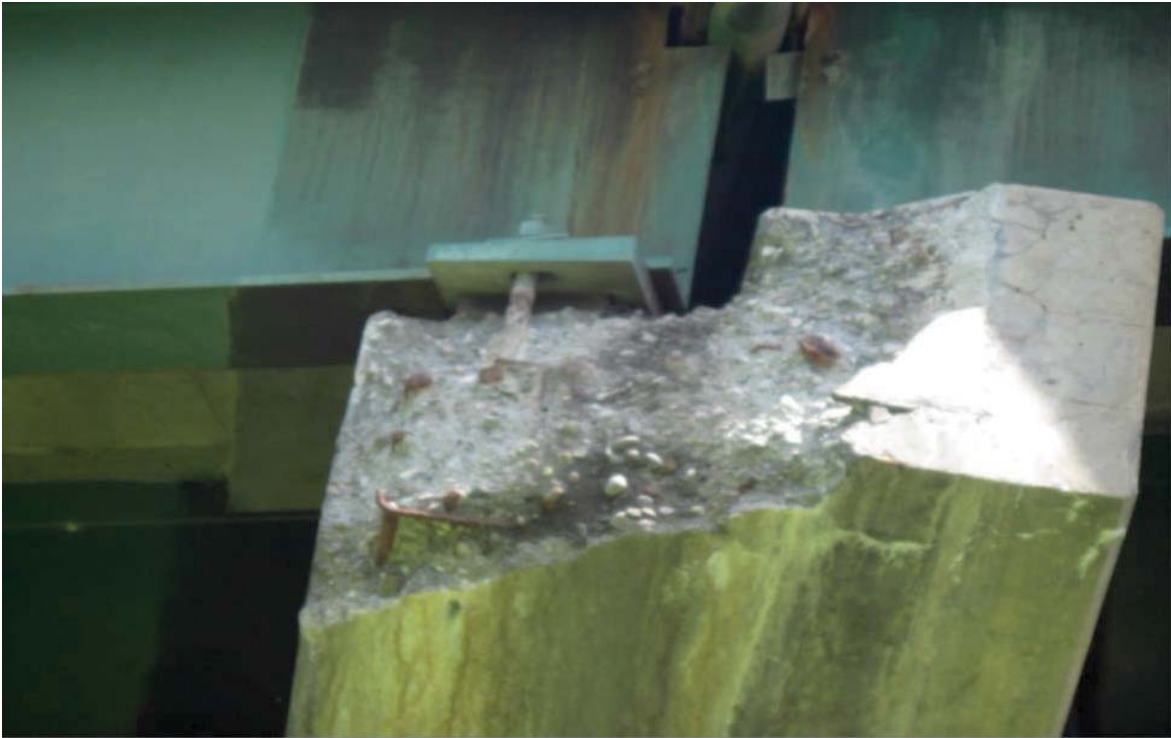
**Figure 4.18 River Street Rutland City Br. #27 – REPAIRED**

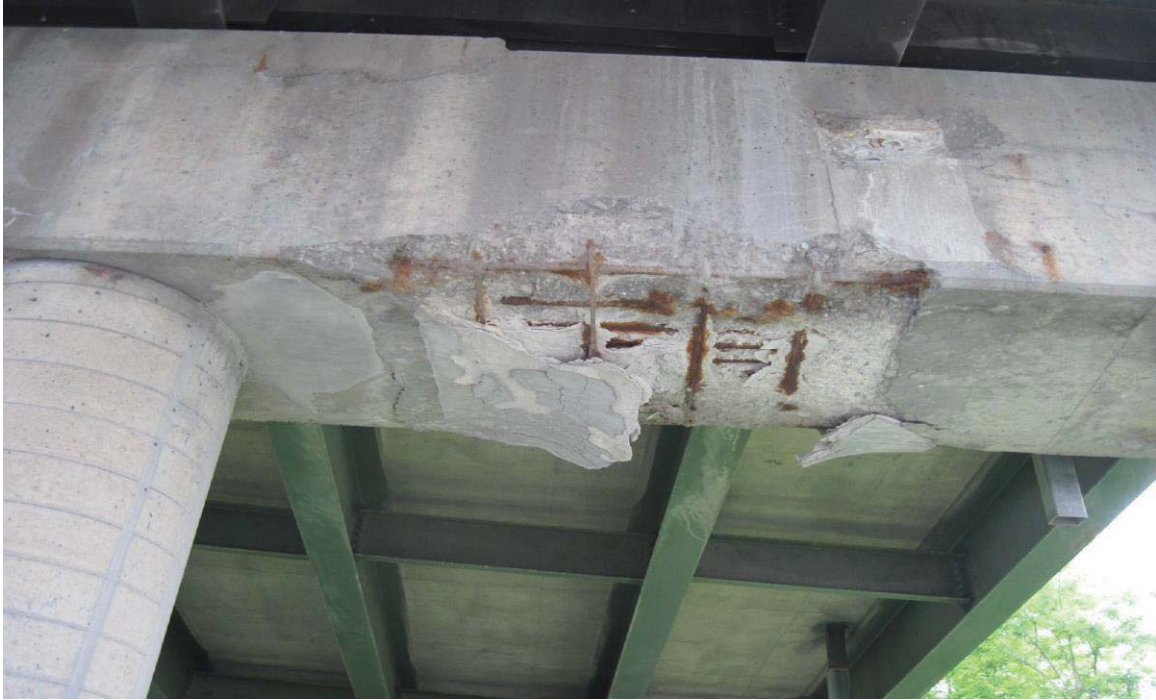
**Figure 4.20 | 89 Williston Br. #60 – REPAIRED Pier Repairs, \$150,000**

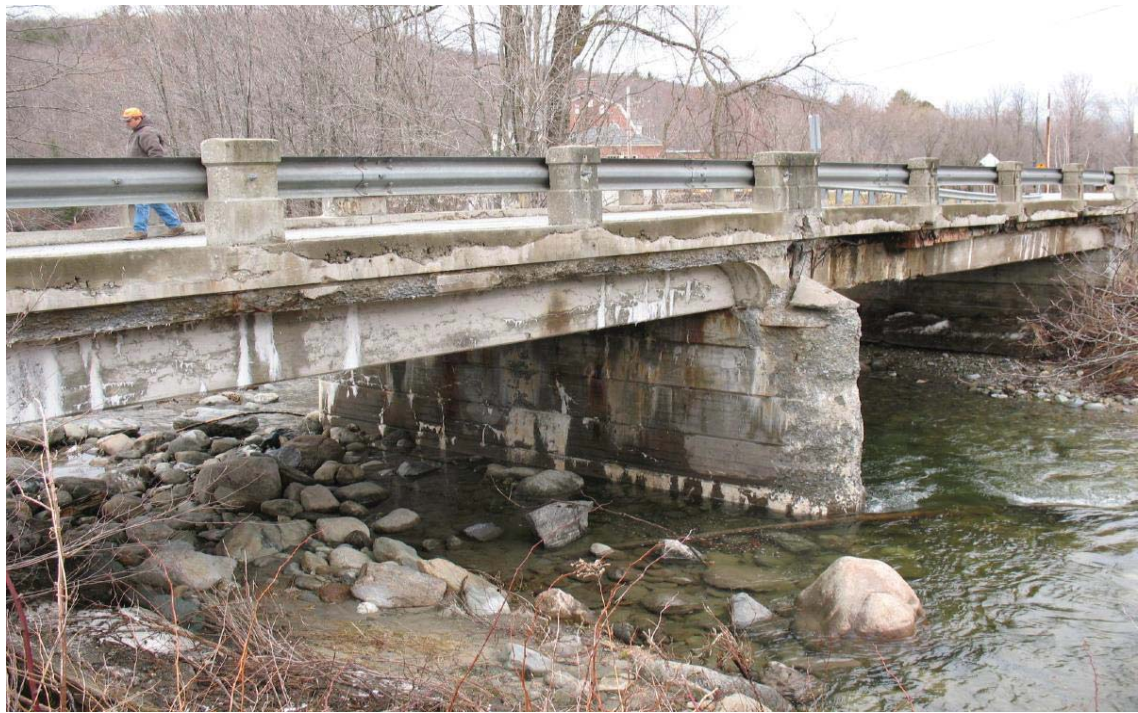
Many short span bridges in Vermont use combinations of integrated concrete beams and decks, with T-beam/deck combinations as common variants. The integration of concrete beams and decks produces an efficient structural form, but can result in combined damage to both the deck and beams, which leads to combined repairs. Figure 4.23 shows damage to both the deck and beams in Vt. Rte. 105A Richford Br. #2. Figure 4.24 shows a reconstruction repair. Figure 4.25 shows Vt. Rte. 12 Woodstock Br. #19 with considerable spalling from both the deck and the beam. Figure 4.26 shows the repaired bridge.

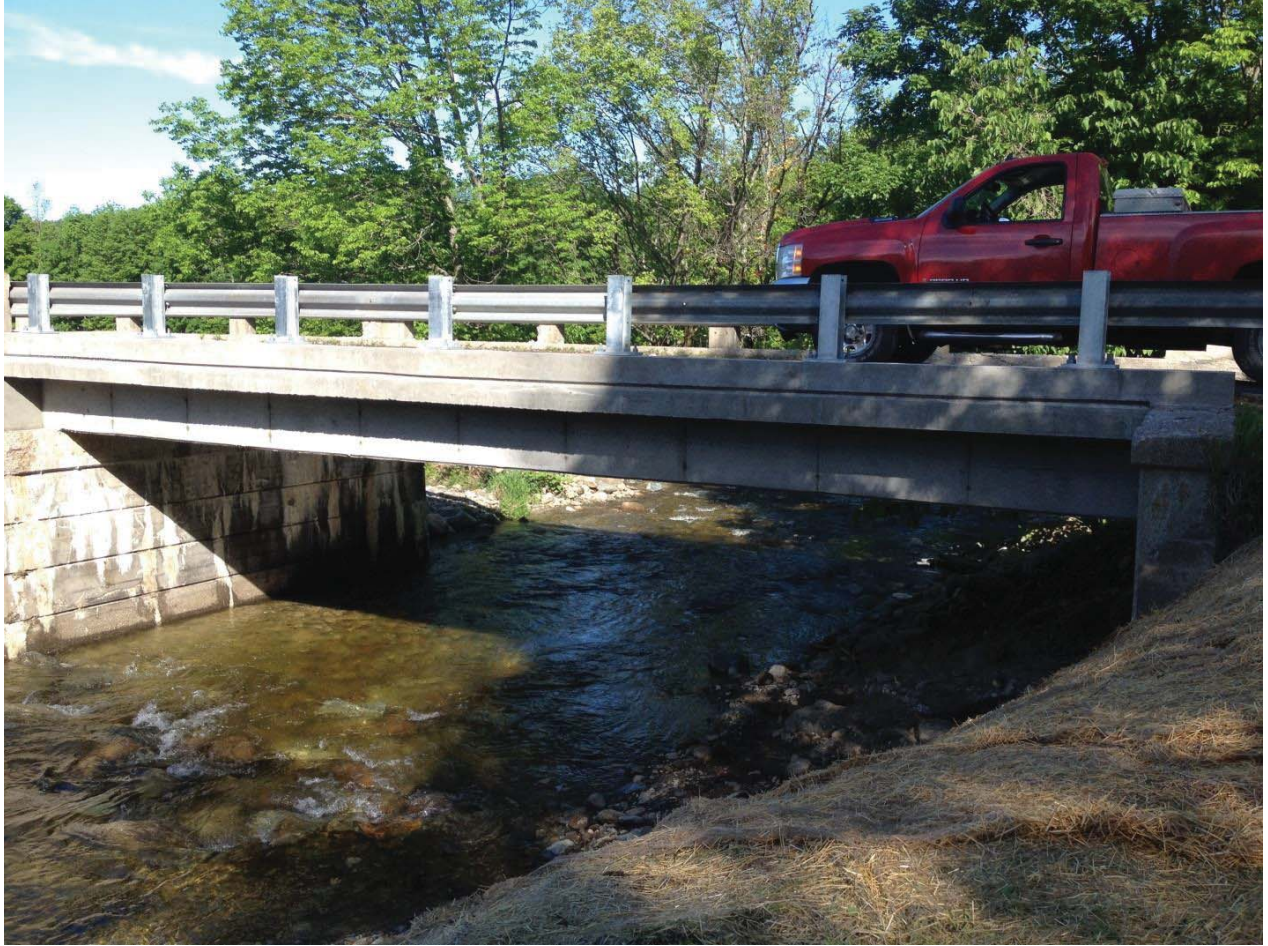
**Figure 4.24 Vt. Rte. 105A Richford Br. #2 –REPAIRED T Beam/Deck Reconstruction \$150,000**

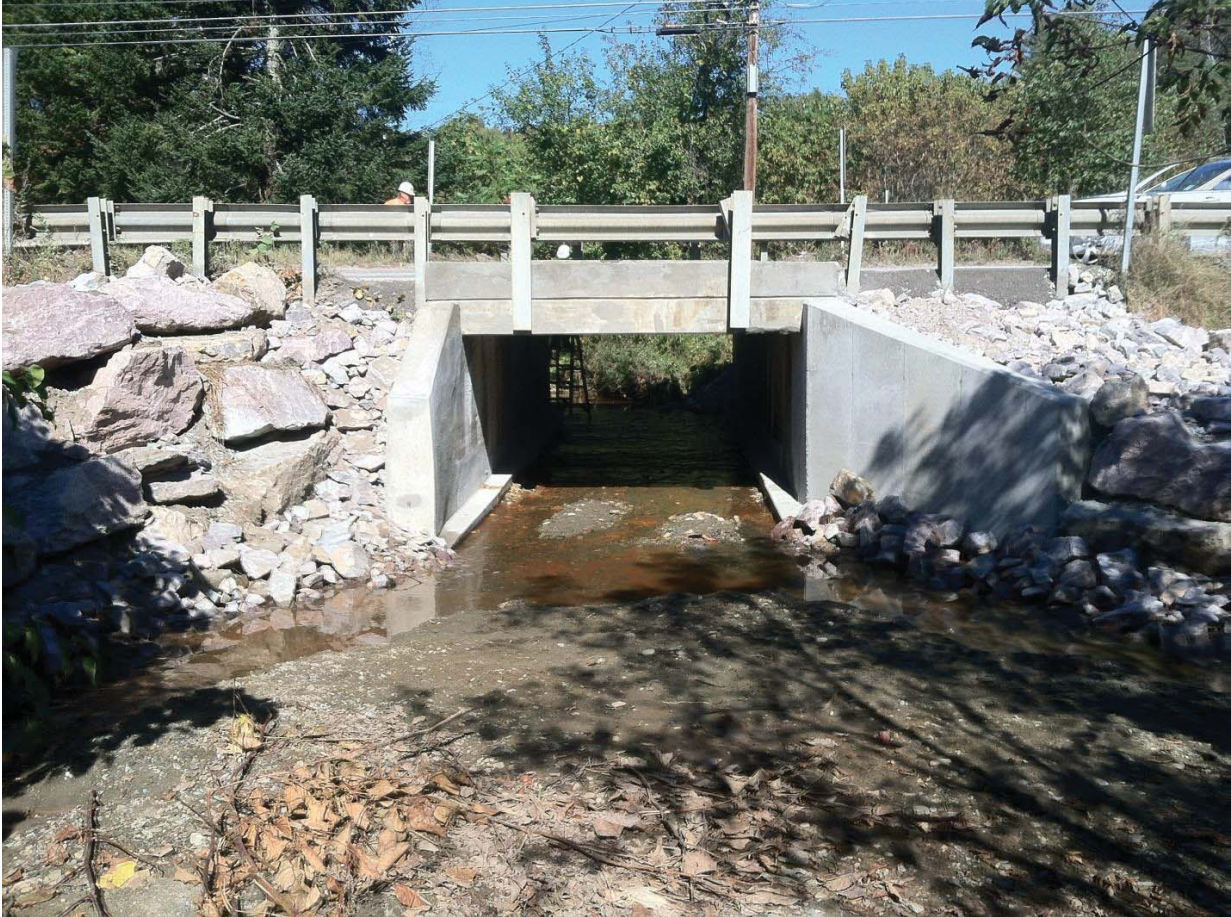
**Figure 4.28 Vt. Rte. 12 Berlin Br. #70 - REPAIRED Head Wall/Wing Wall Reconstruction, \$150,000**

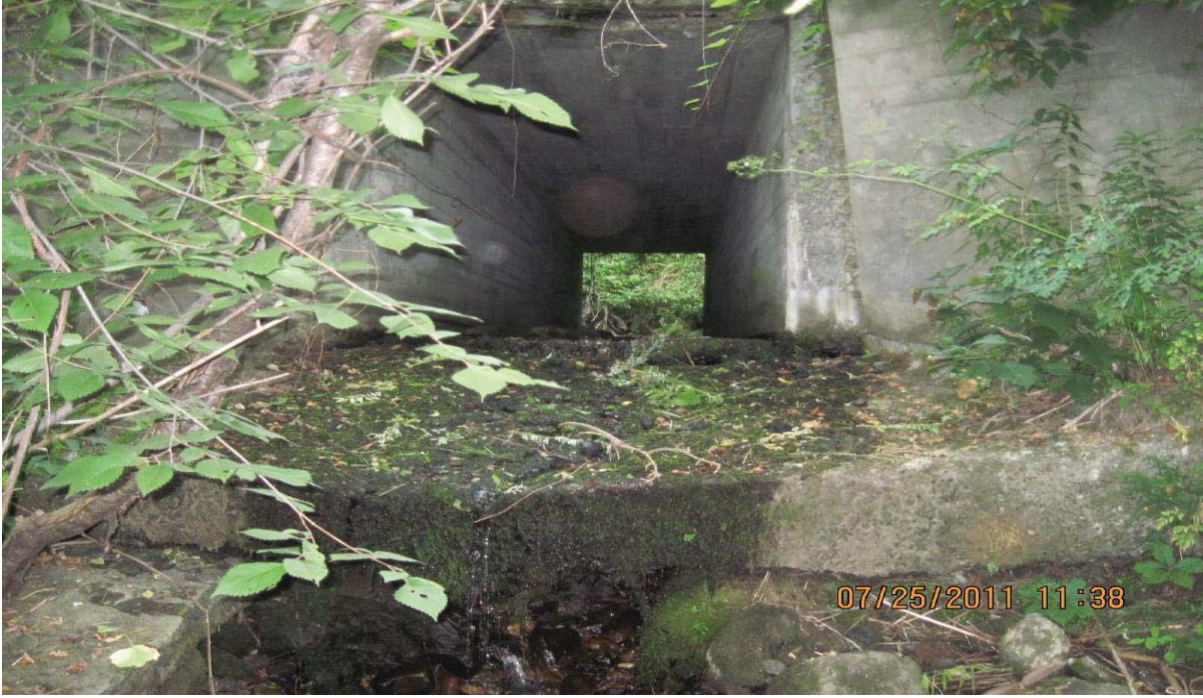
**Figure 4.30 Vt. Rte. 12 Elmore Br. #95 - REPAIRED Wing Wall Encasement, \$100,000**

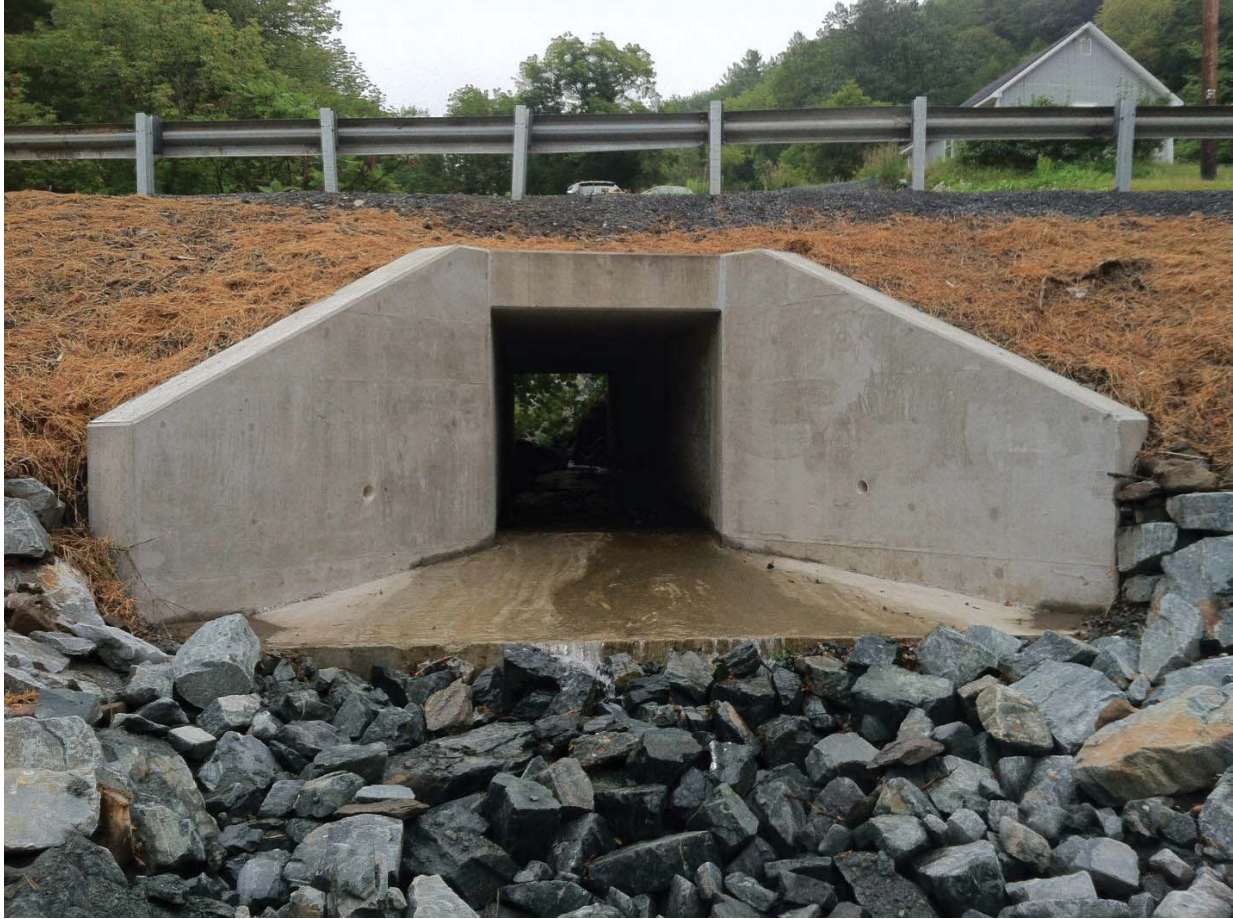
**Figure 4.32 Vt.Rte.14 Hartford Br.#7 - REPAIRED Wing Wall/ Cut-off Wall Reconstruction \$180,000**

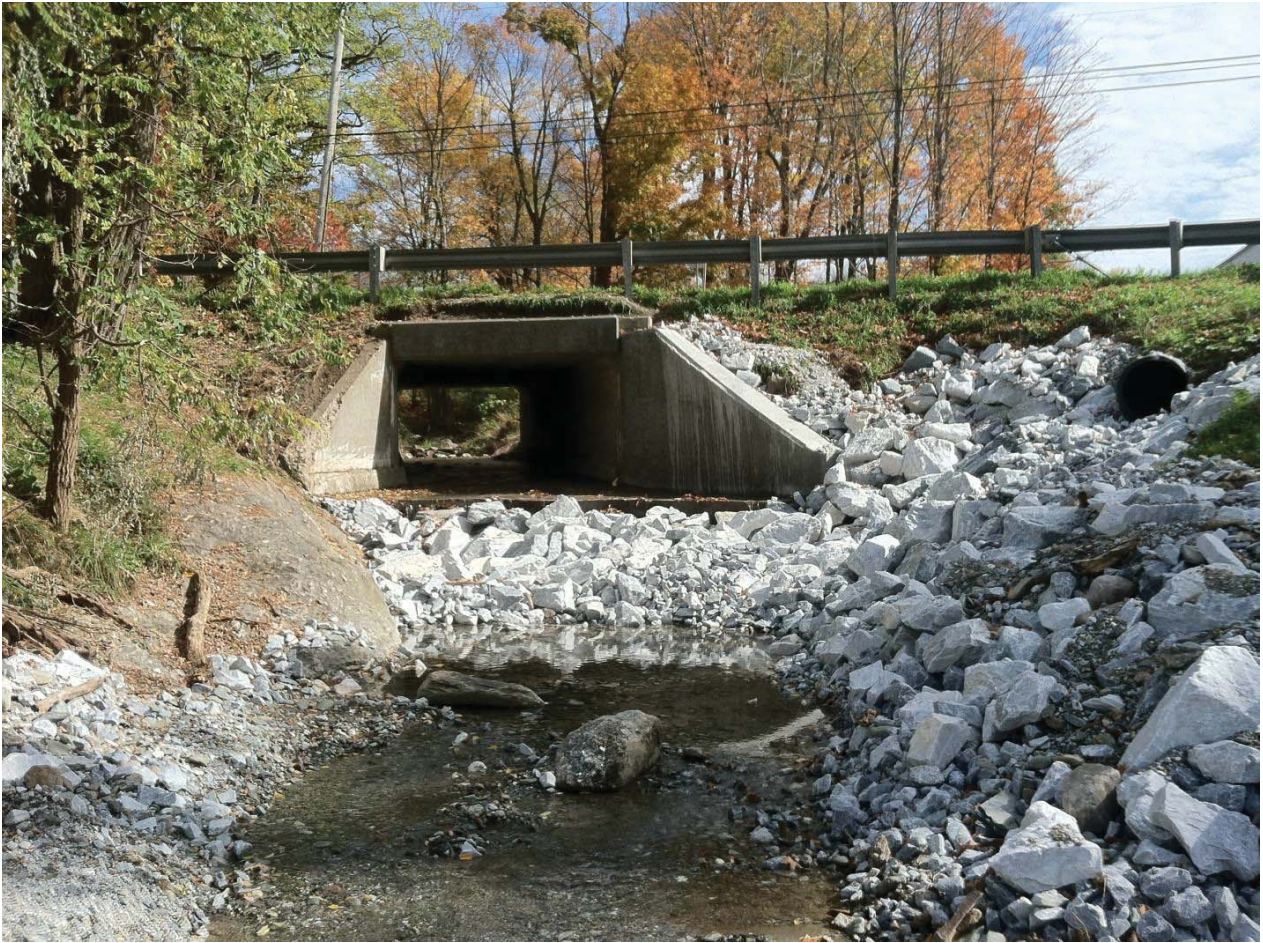
**Figure 4.34 Vt. Rte. 30 Pawlet Br. #78 - REPAIRED Wing Wall reconstruction, \$80,000**

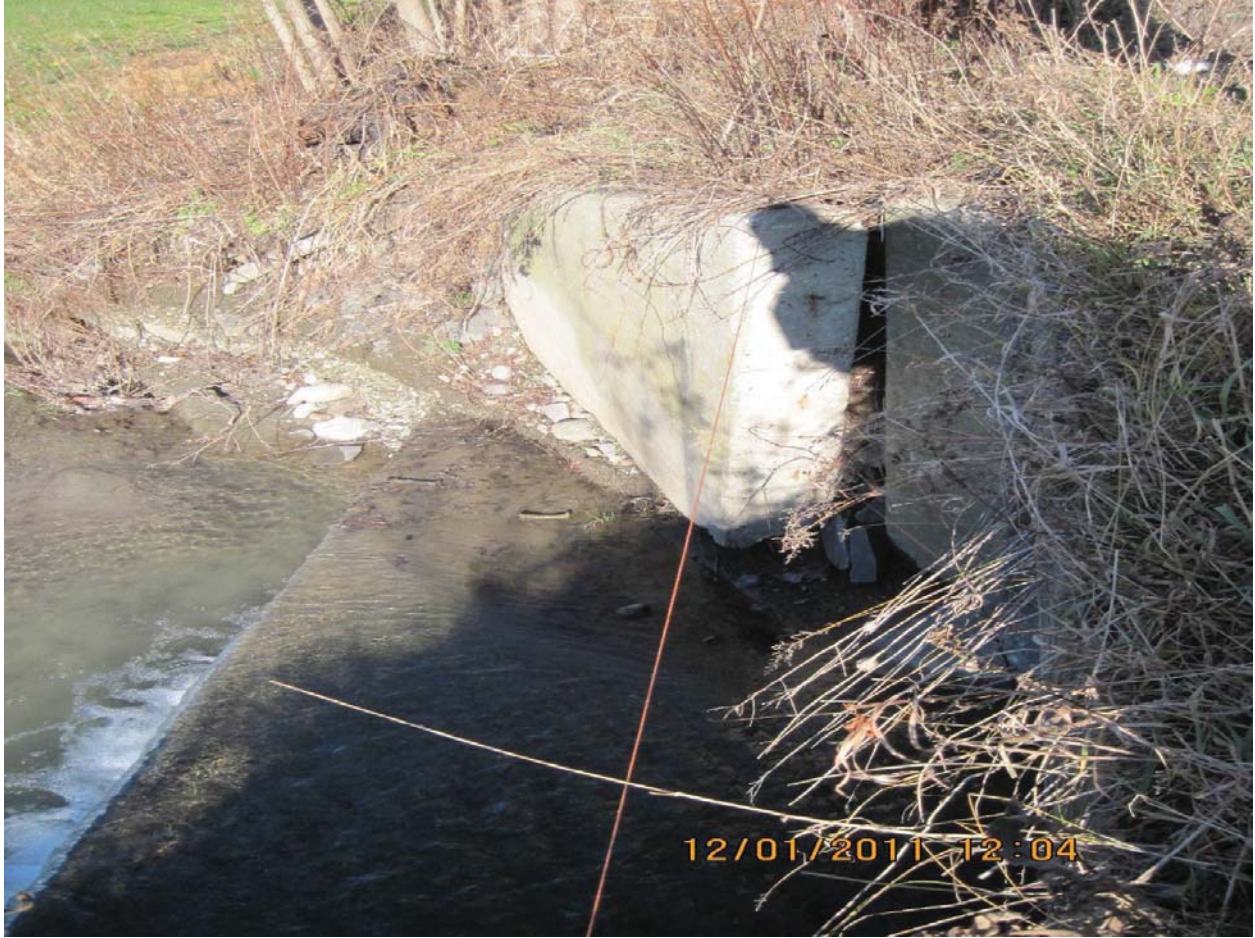
Figure 4.35 Vt. Rte. 30 Pawlet Br. #77

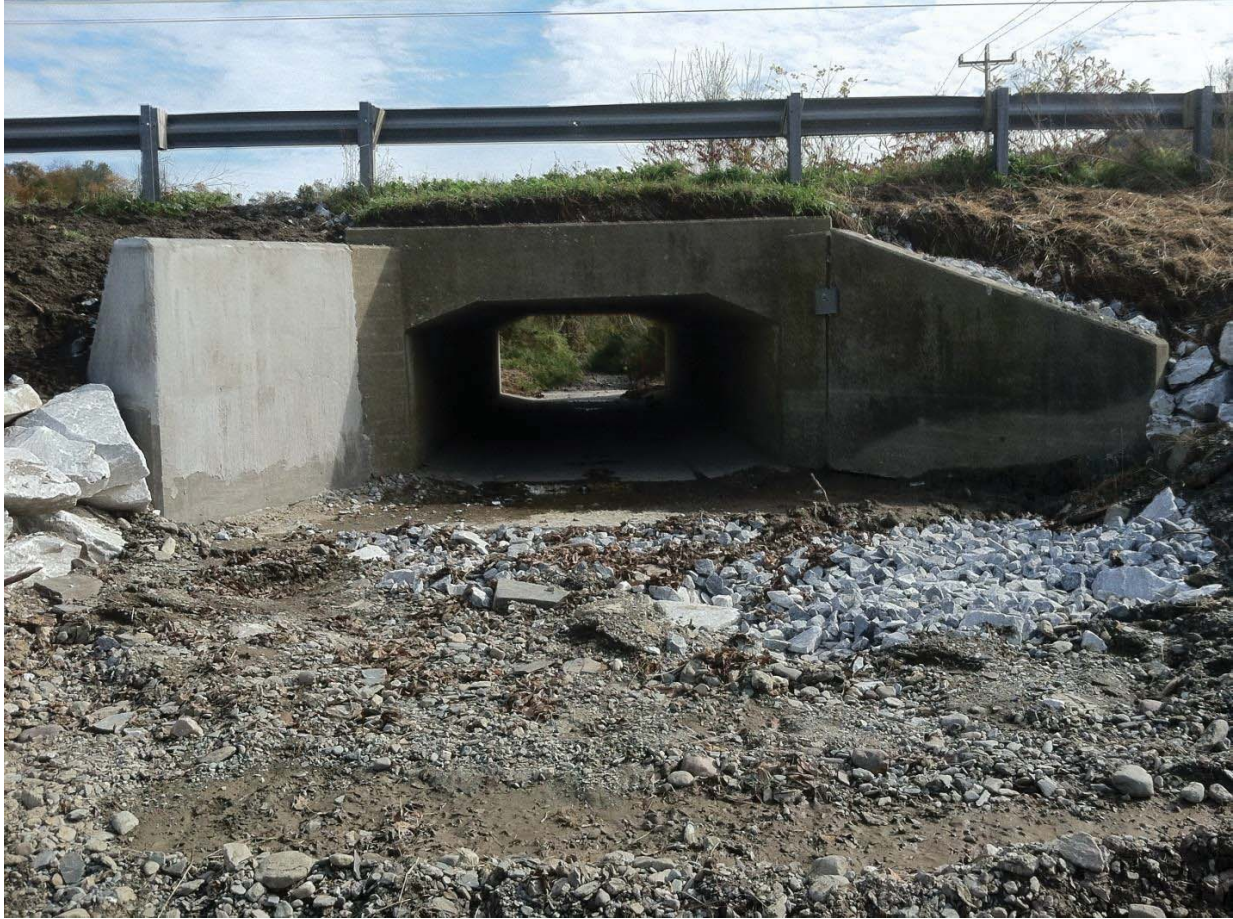
**Figure 4.36 Vt. Rte. 30 Pawlet Br.#77 - REPAIRED Wing Wall/ Cut-off Wall Reconstruction \$100,000**

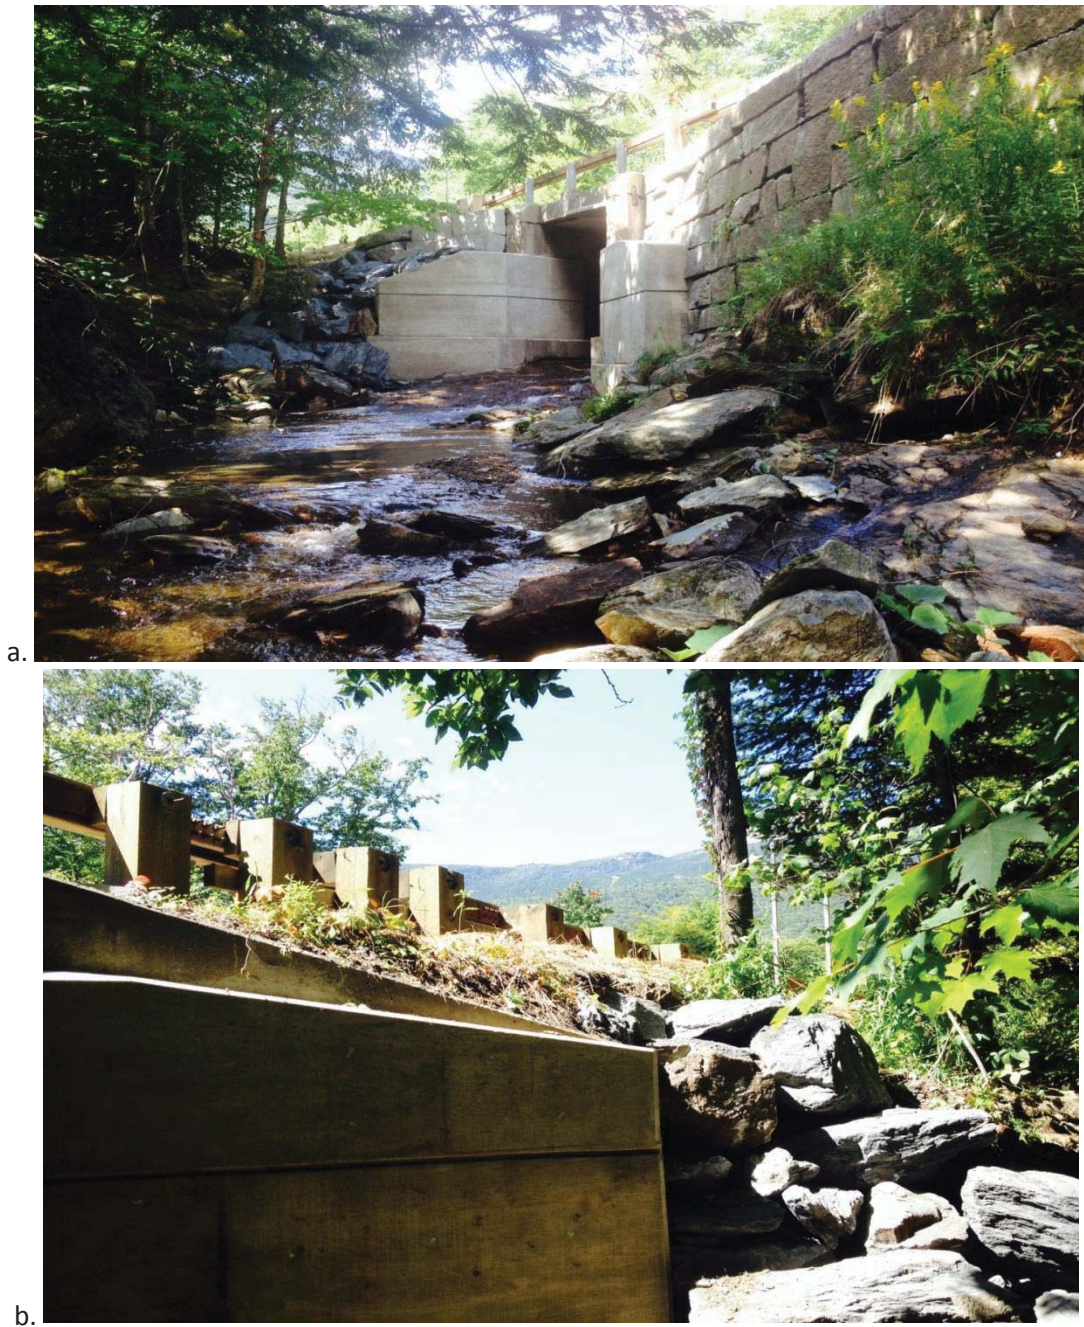
**Figure 4.38 Vt. Rte. 108 Stowe Br. #10 – Repaired Wing Wall Encasement/ Other Repairs, \$200,000**

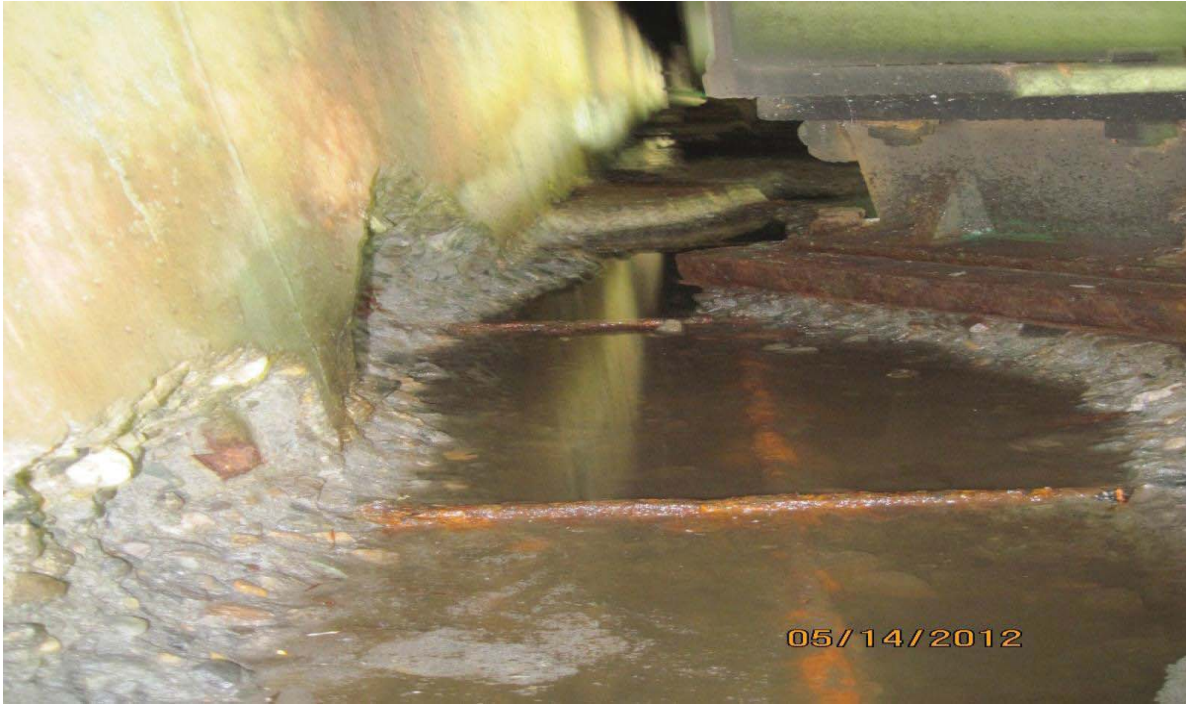
Some bridges suffer more than one type of damage. In these cases, it can be expeditious to perform multiple component repairs in one setting. Figure 4.39 I 91 Hartford Br. #42 N/S had damage to the abutments, piers and drainage system. Figure 4.40 shows the repairs. Figure 4.41 Vt. Rte. 113 Vershire Br. #11 had severe damage to both the deck and wingwalls. The repairs appear in Figure 4.42.
