1. Report No.	2. Government Accession No.	3. Recipient's Catalog No.
4. Title and Subtitle Cost-Effective and Rapid Concrete Repair Techniques		5. Report Date February 8, 2016

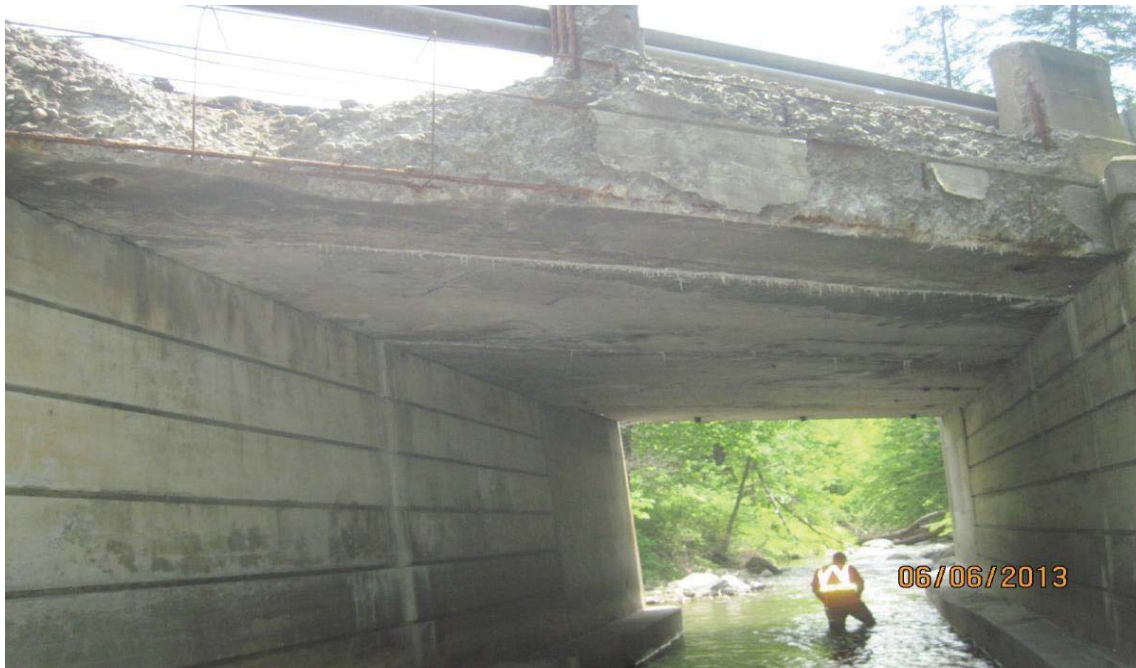
**Figure 4.40 | 91 Hartford Br. #42-REPAIRED Abutment/Pier Repairs/Drain System \$125,000**

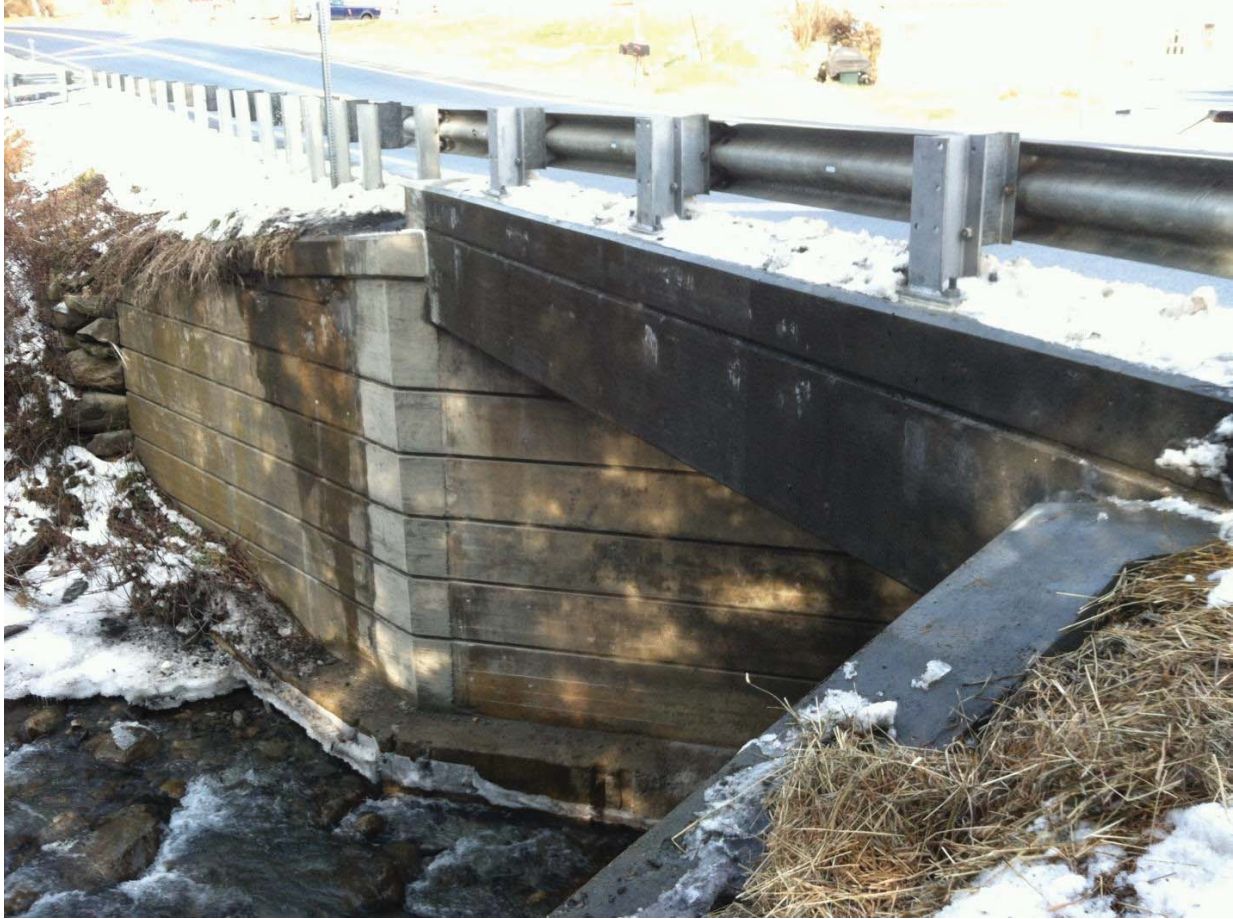
**Figure 4.42 Vt. Rte. 113 Vershire Br. #11 - REPAIRED Deck/Wing Wall Repairs, \$150,000**

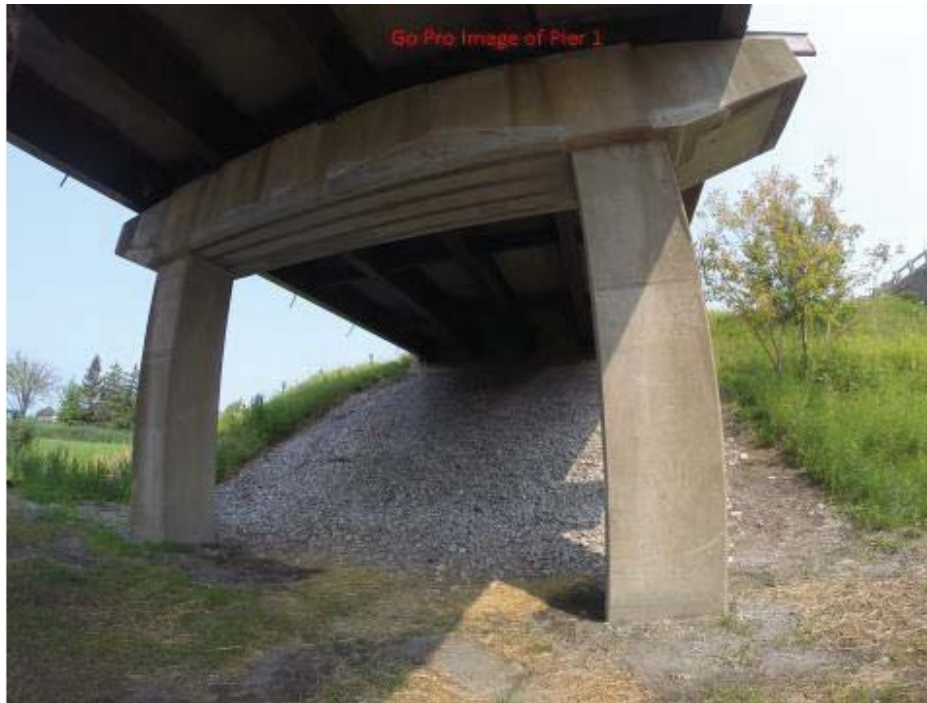
**Figure 5.1 Swanton I 89 overpass bridge with FRP strengthening strips bonded to the piercap**

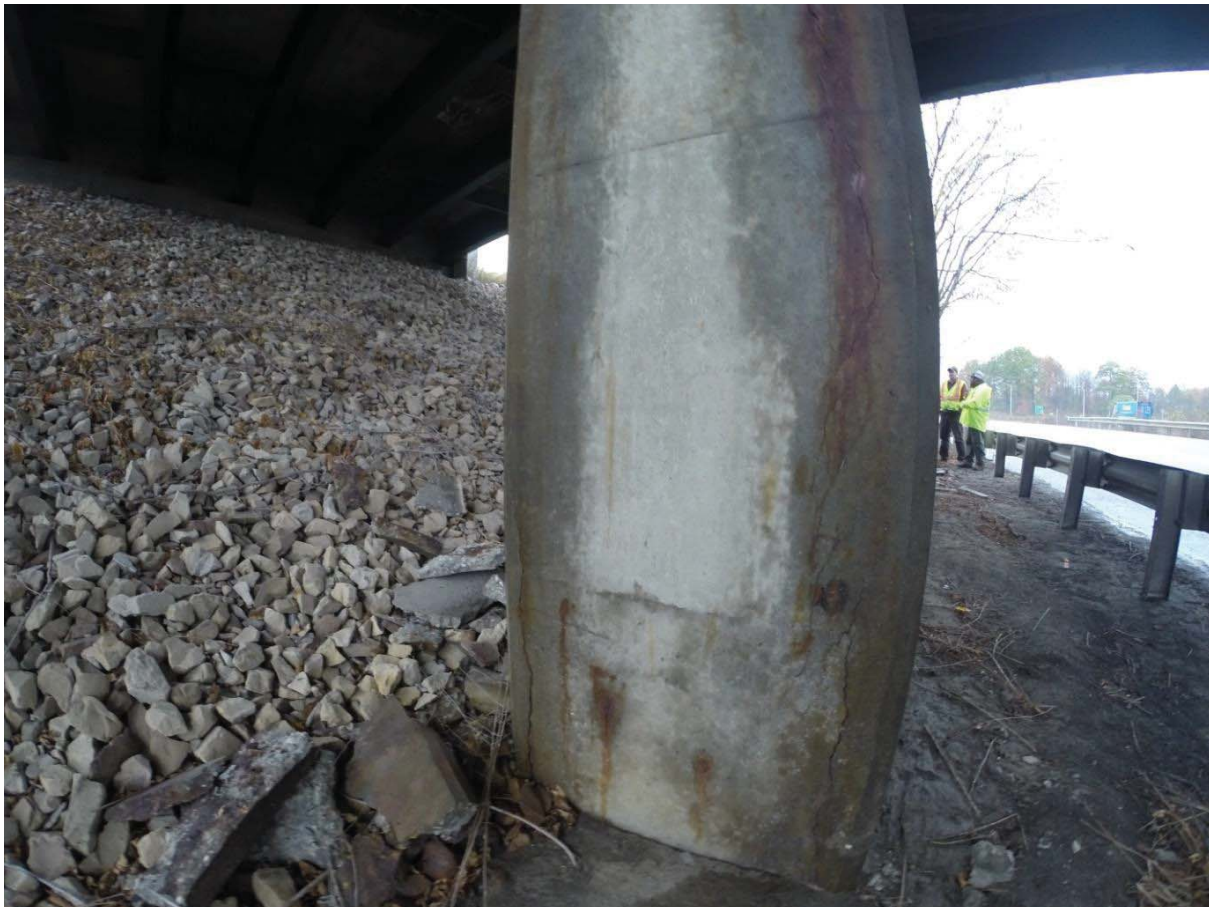
**Figure 5.9 Column on Colchester/Milton I-89 Bridge showing cracking, likely due to swelling corroded reinforcing bars**

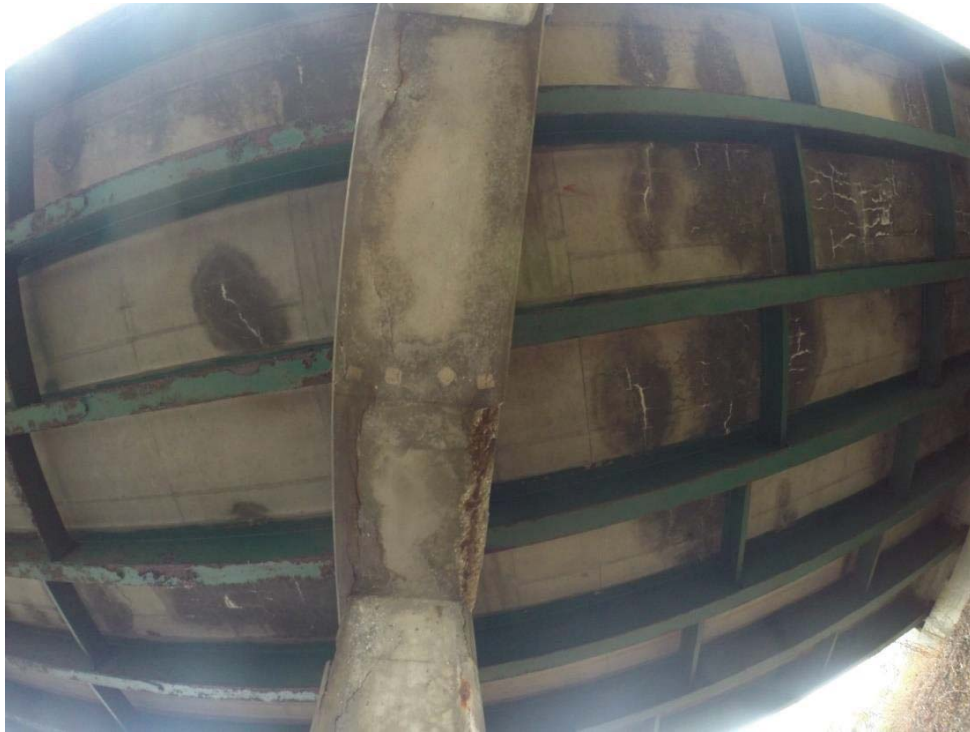
Figure 5.10 Spalling on underside of pier on Colchester/Milton I-95 Bridge. The deck is also showing some distress.

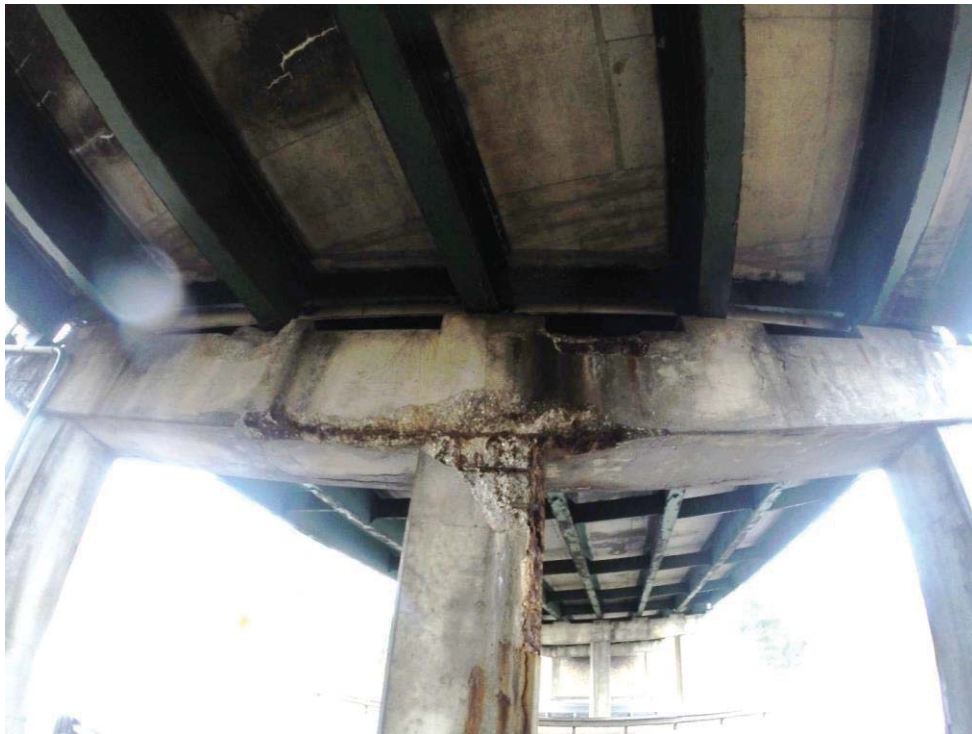
Figure 5.11 Spalling on pier cap of Colchester/Milton I-89 Bridge

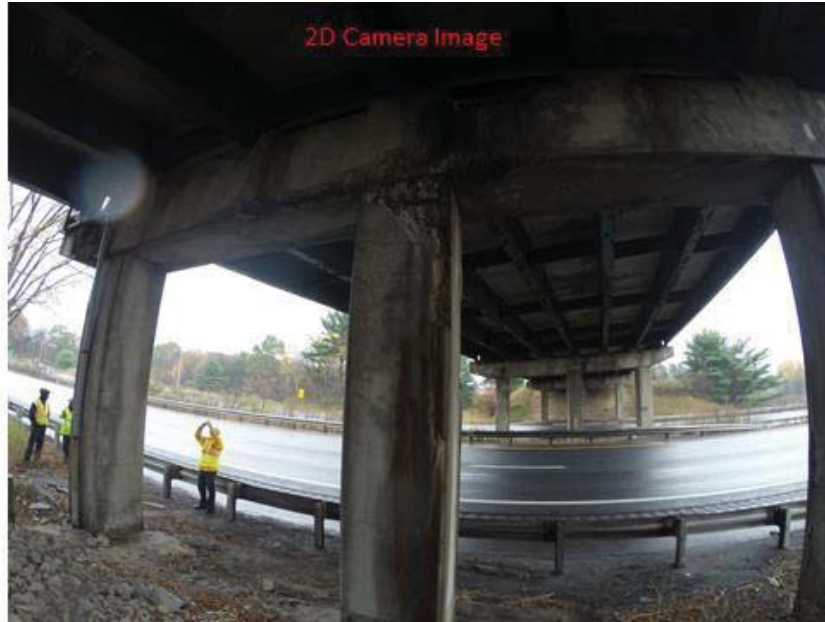
Figure 5.12 Spalling on column of Colchester/Milton I-89 Bridge

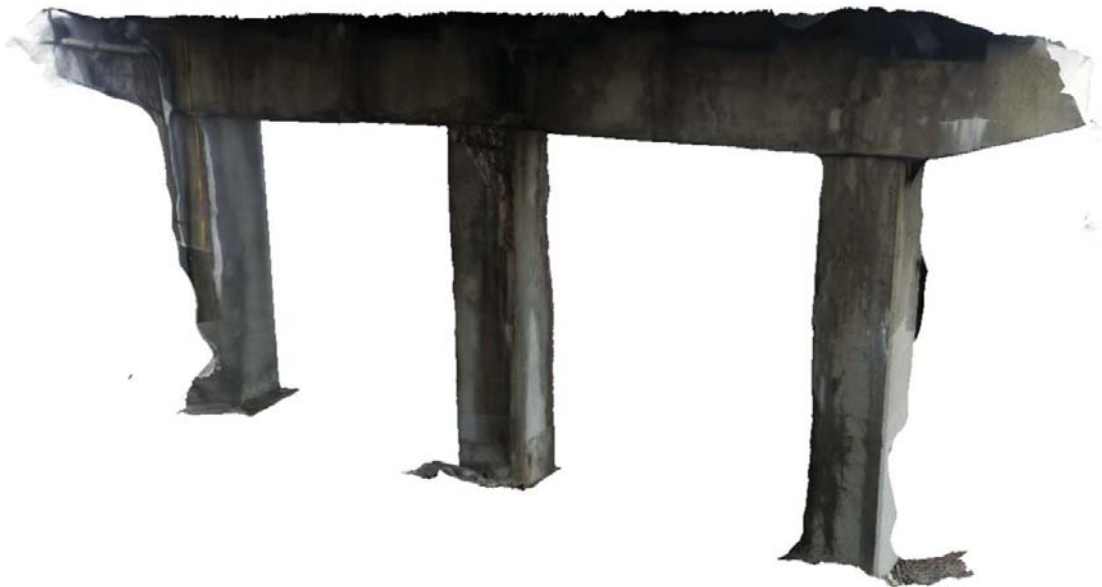
Figure 5.13 3-D photogrammetric point cloud rendering of Colchester/Milton I-89 Bridge

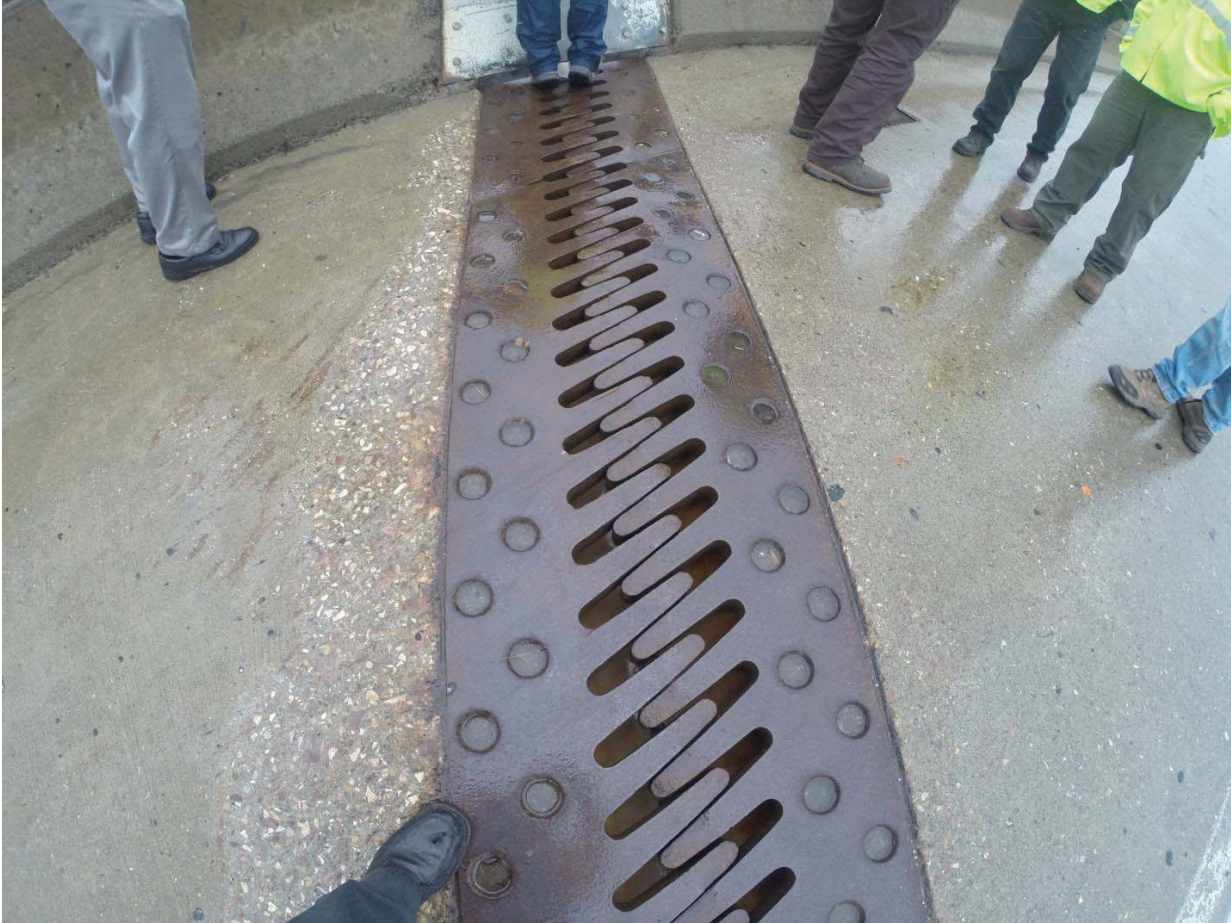
**Figure 5.17 Finger expansion joint on US 2 Lamoille River Crossing Bridge**

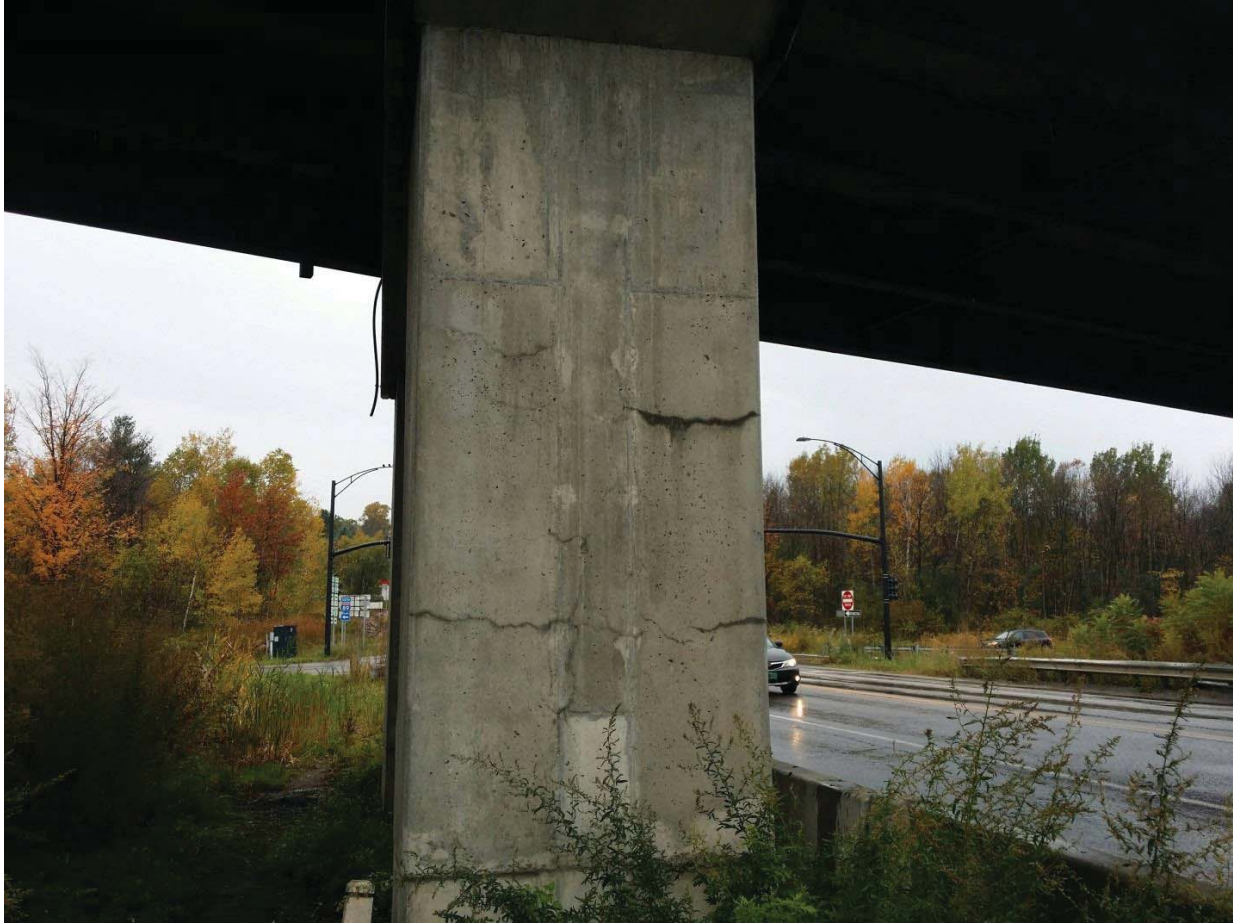
Figure 5.19 Encasement repaired column on Williston I-89 Overpass Tafts Corner, with visible cracking

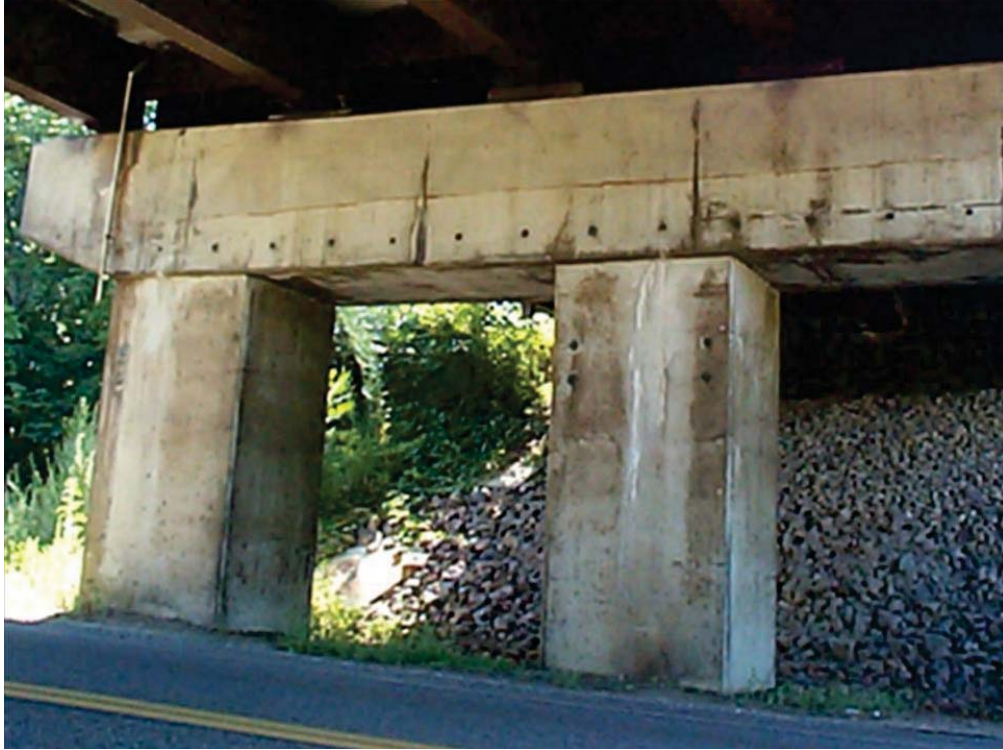
Figure 5.20 Spear St. I 189 Overpass Bridge pier in 2000 recently encased, with cracks

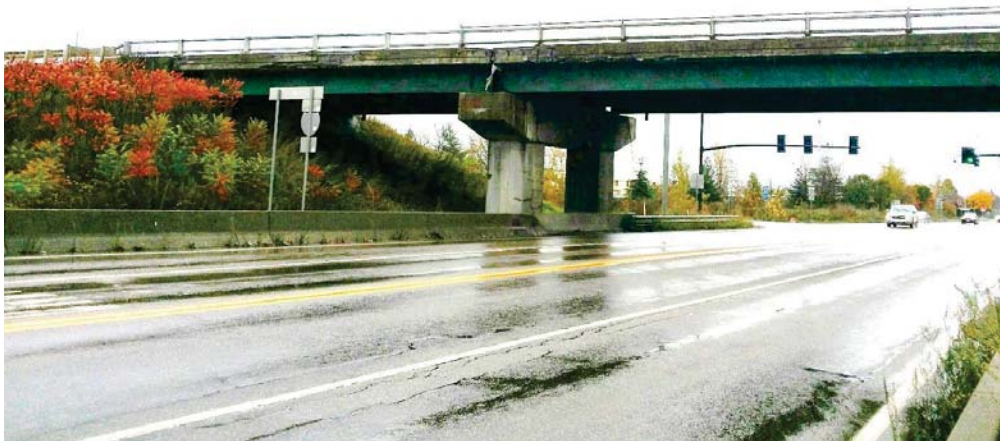
Figure 5.21 Williston I-89 Overpass Tafts Corner with encasement repair of the pier, failed expansion joint gutter and distressed fascia

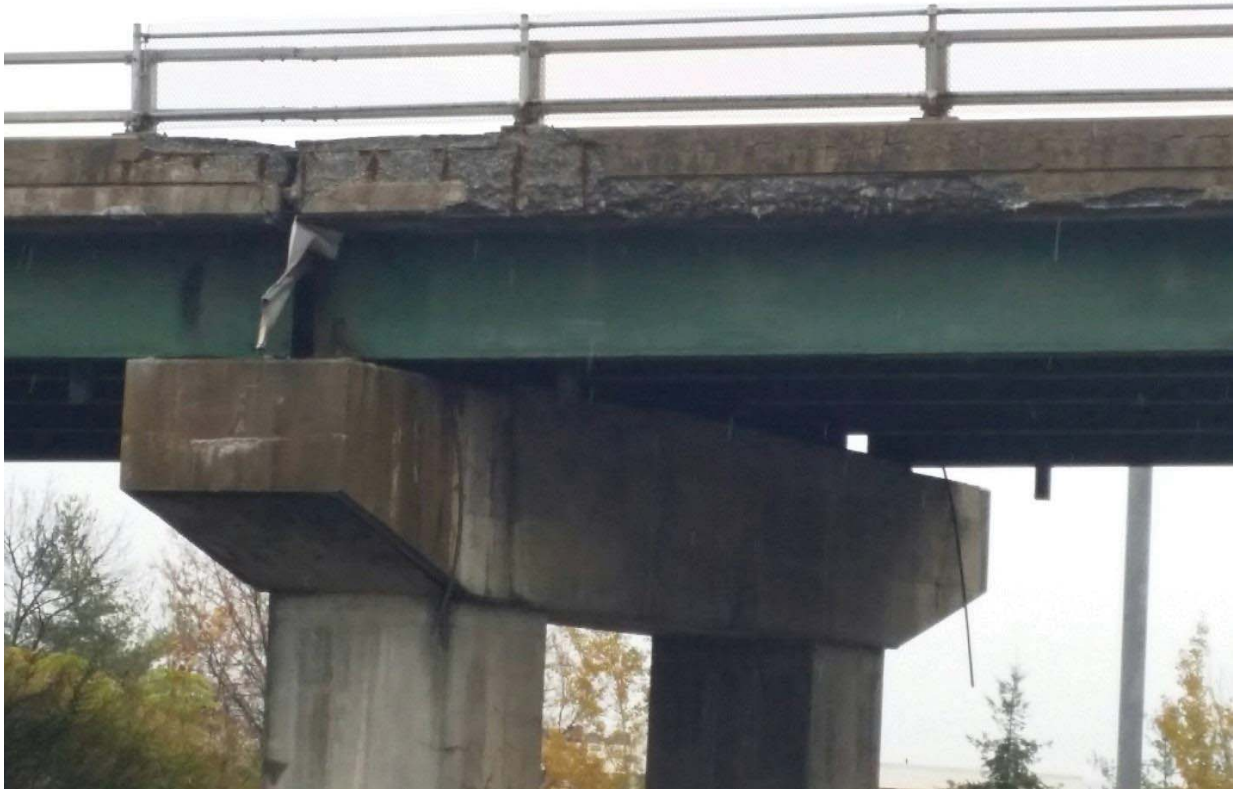
**Figure 5.22 Closeup of Williston I-89 Overpass Tafts Corner with encasement repair of the pier, failed expansion joint gutter and distressed fascia**

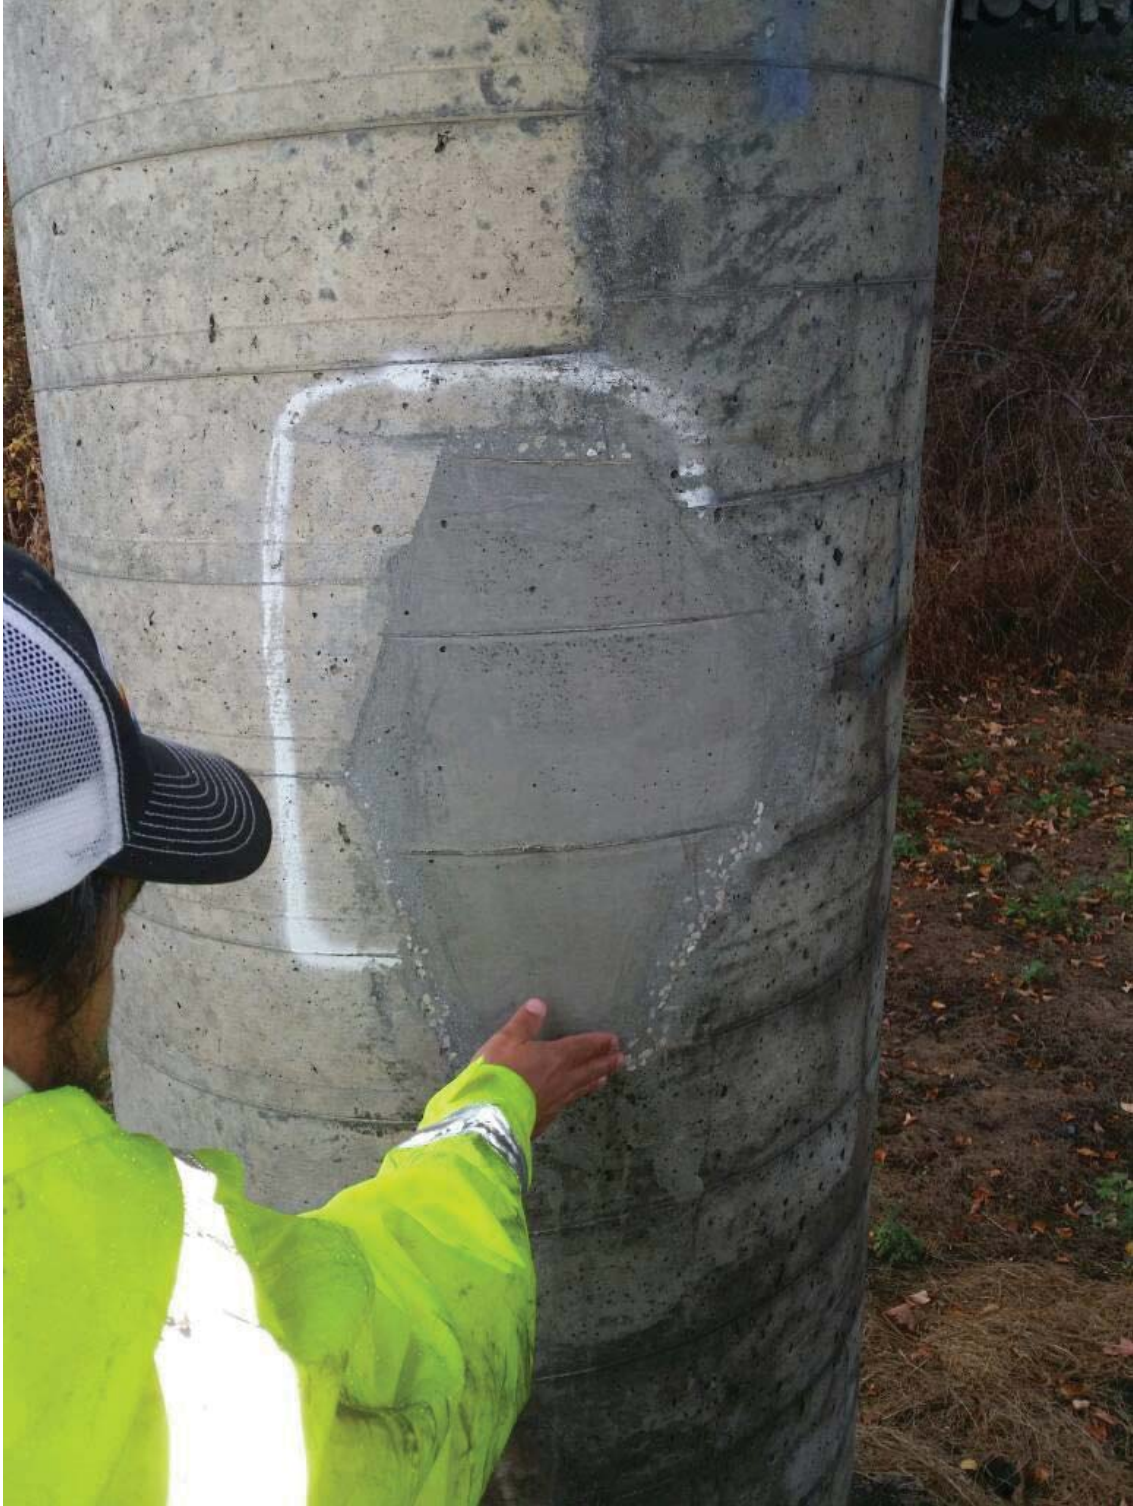
**Figure 5.23 Small column patch repair #1 on Williston I-89 Oak Hill Rd Underpass Bridge**

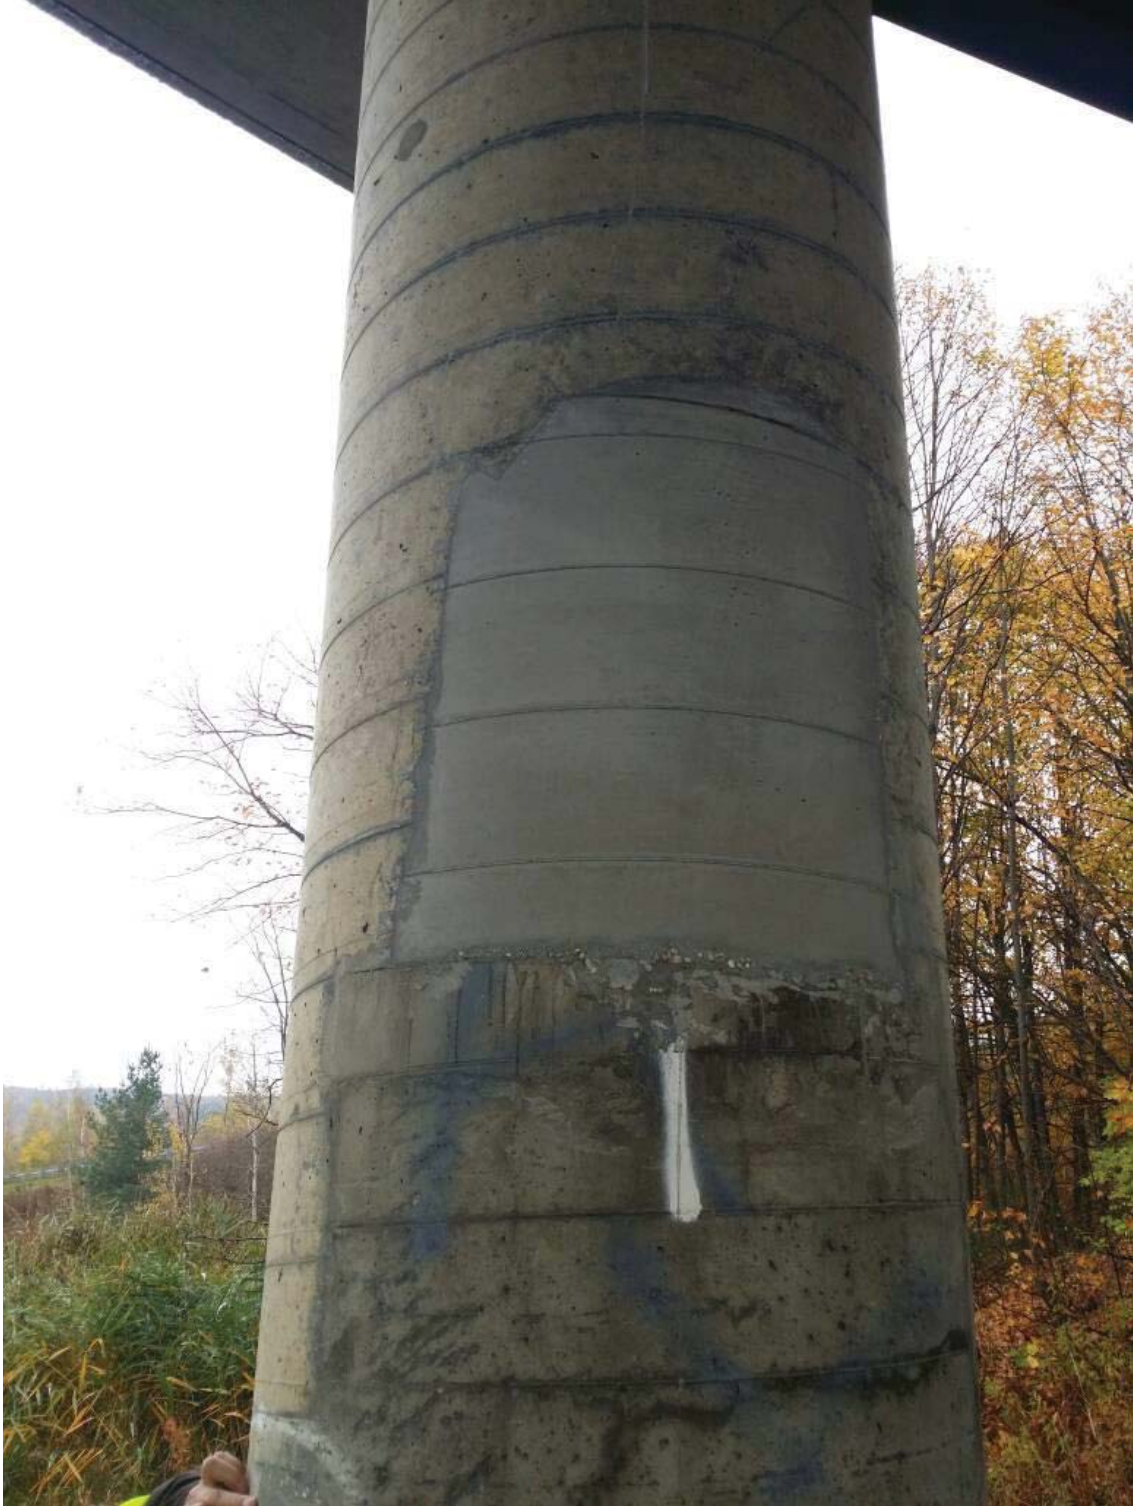
**Figure 5.24 Small column patch repair #2 on Williston I-89 Oak Hill Rd Underpass Bridge**

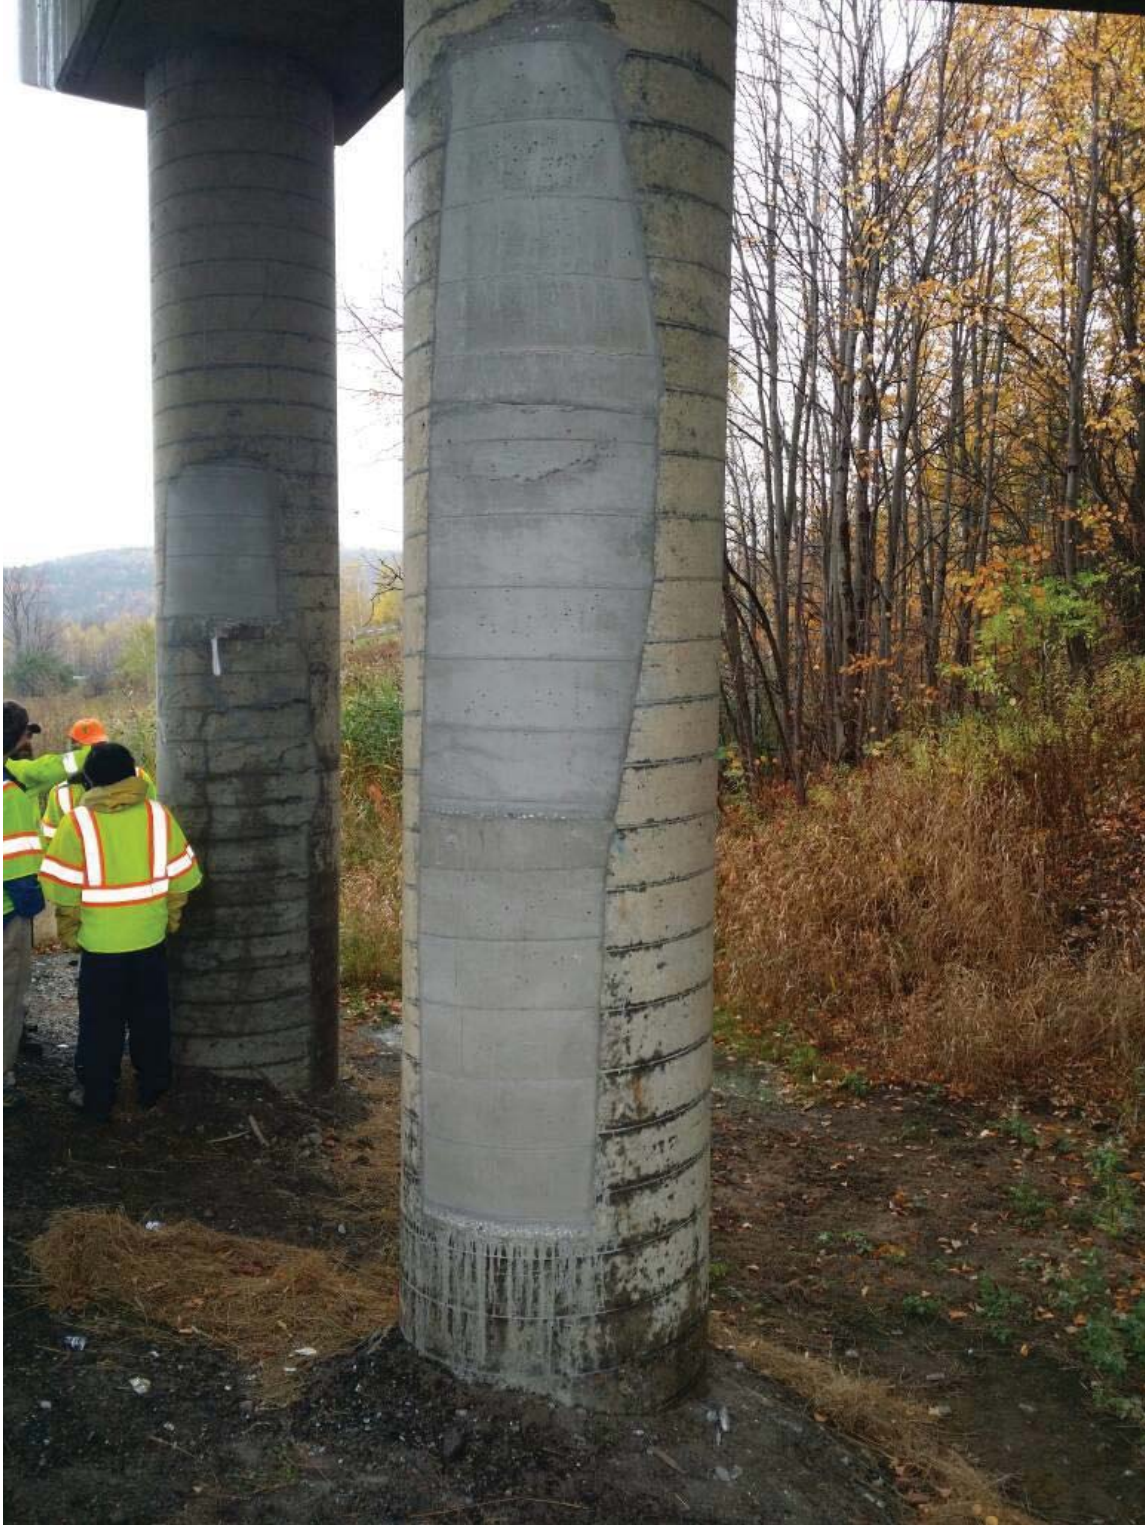
**Figure 5.25 Large column patch repair #1 on Williston I-89 Oak Hill Rd Underpass Bridge**

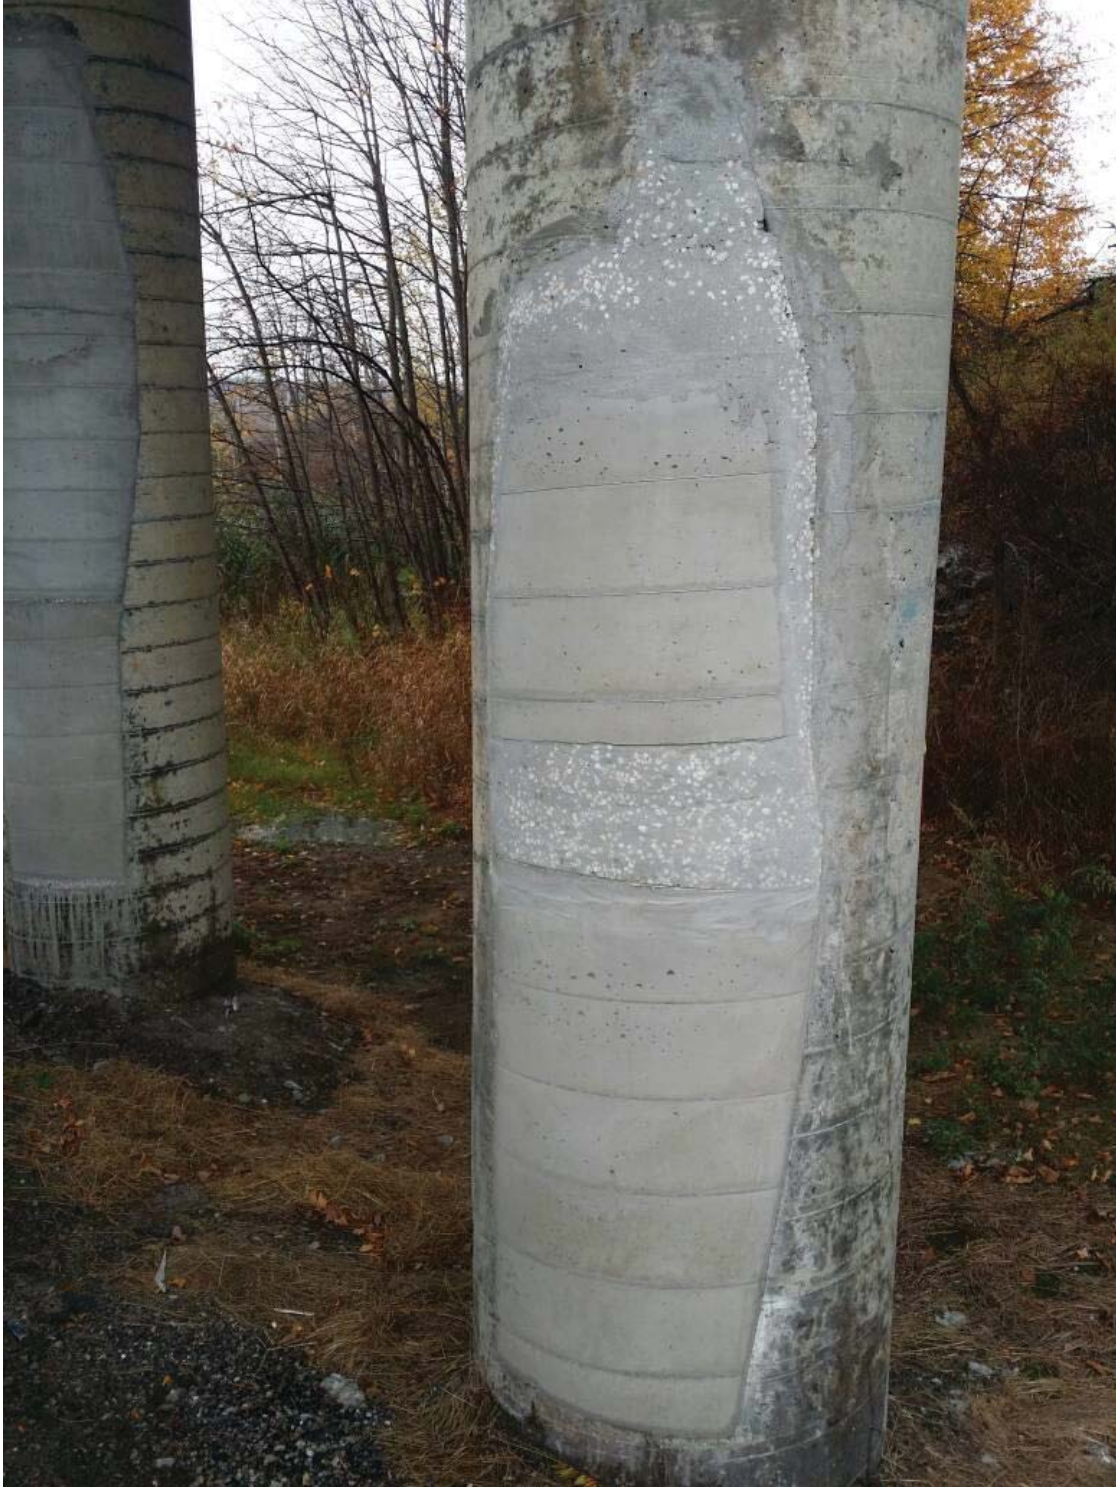
**Figure 5.26 Large column patch repair #2 on Williston I-89 Oak Hill Rd Underpass Bridge**

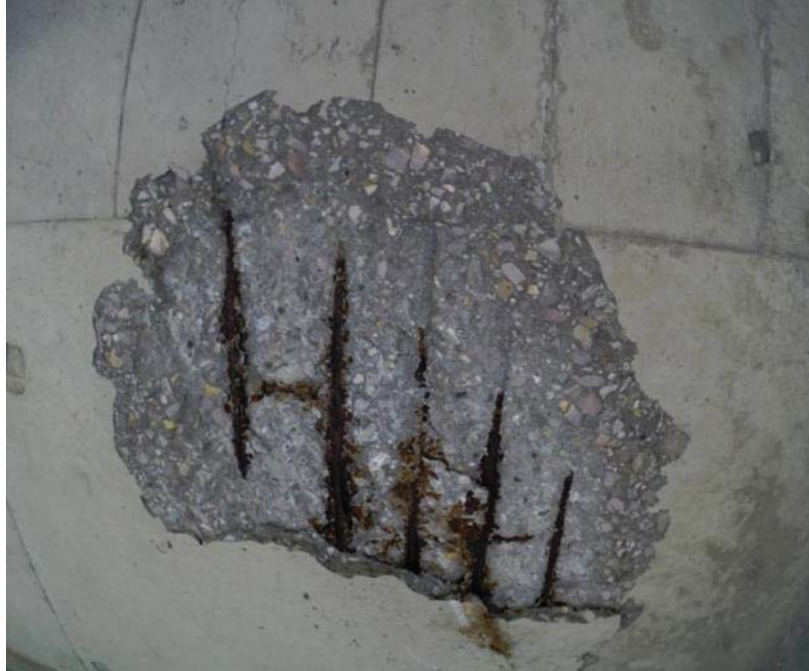
**Figure 5.27 Underside Deck Spalling on Williston I-89 Oak Hill Rd Underpass Bridge**

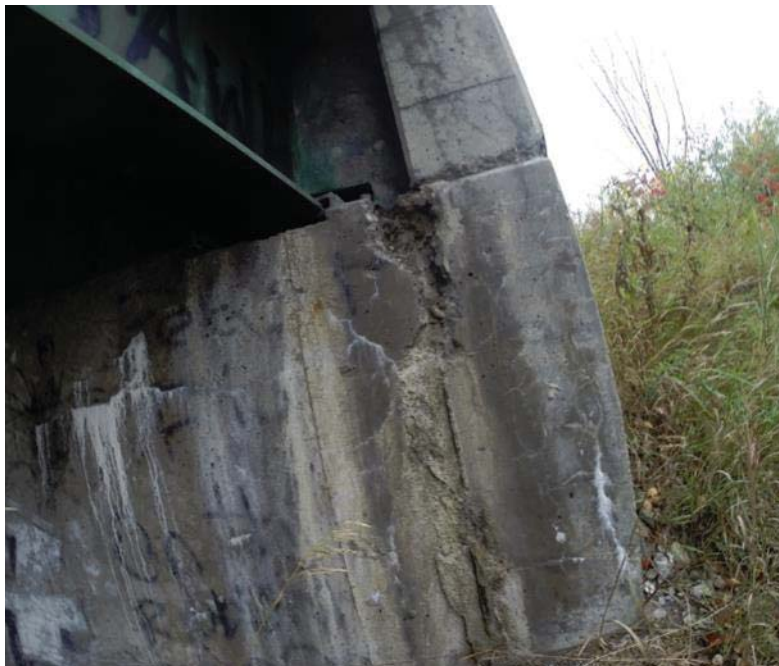
**Figure 5.28 Scaling on Abutment and Beam on Williston I-89 Oak Hill Rd Underpass Bridge**

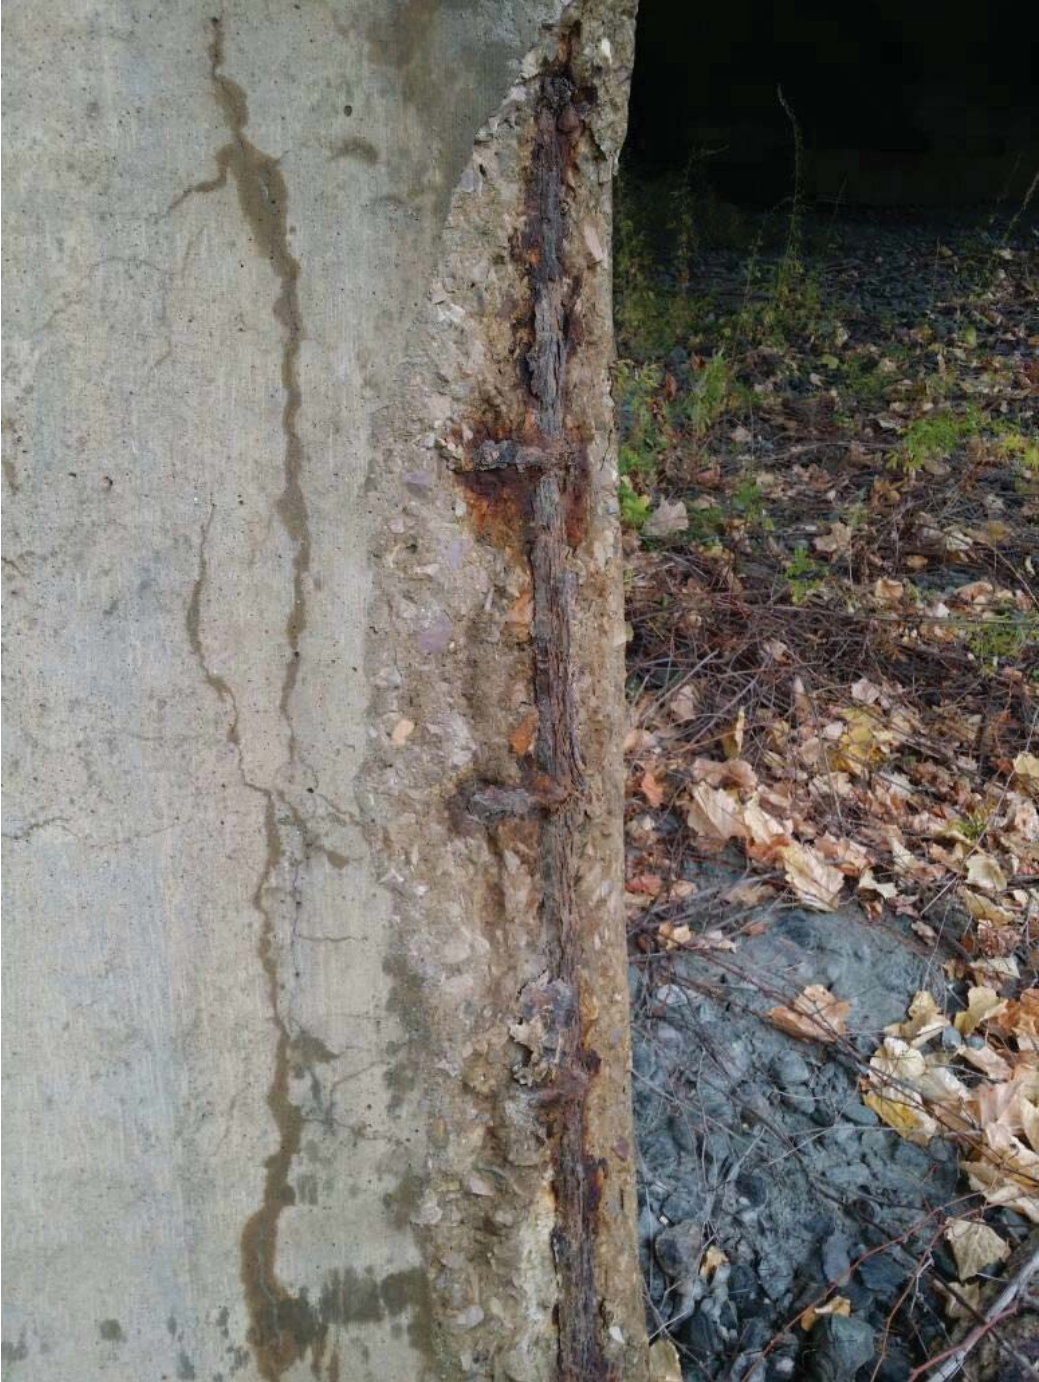
**Figure 5.29 Distressed column on Richmond I-89 US 2 Underpass Bridge**

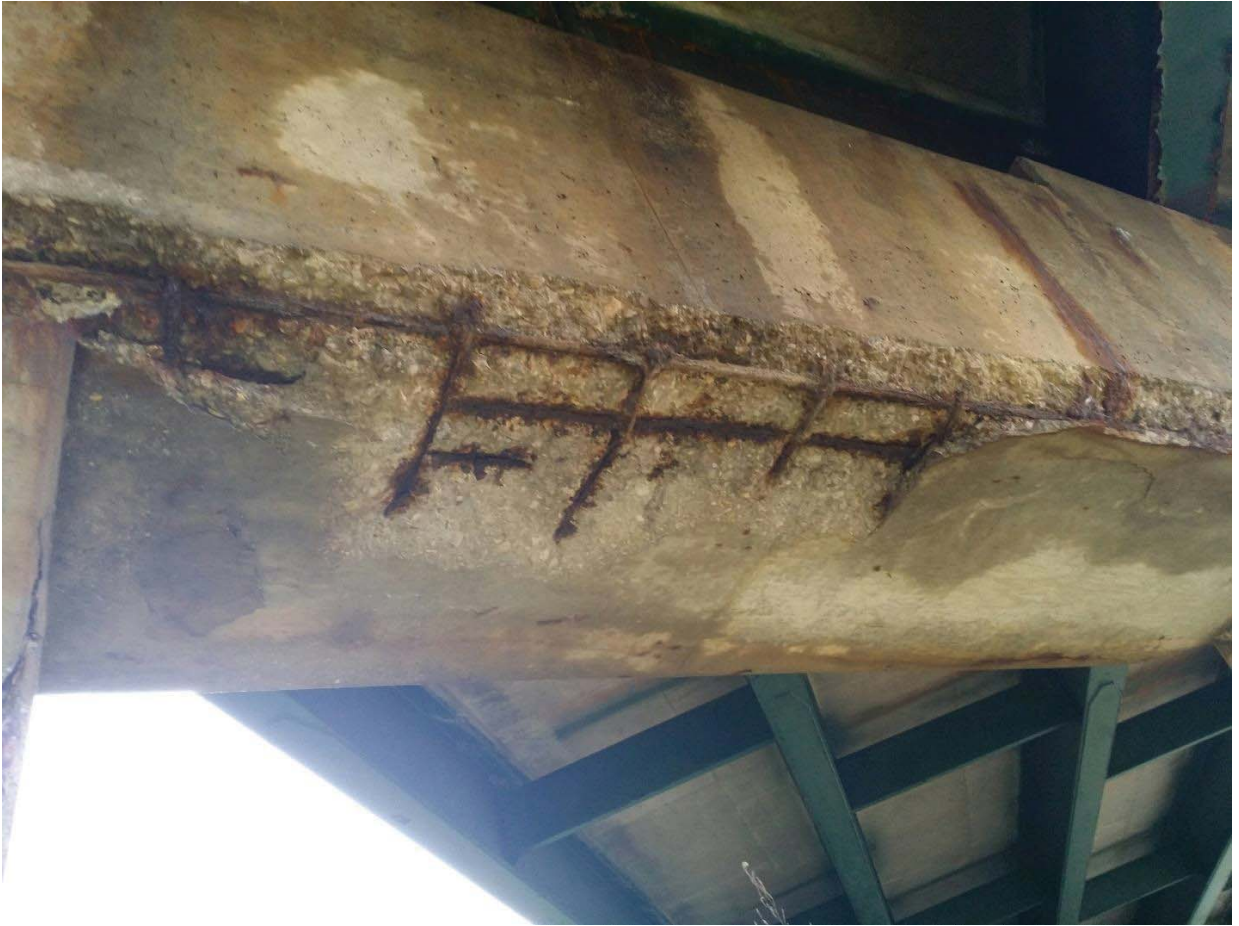
**Figure 5.32 Pier cap with spalling on Richmond I 89 US 2 Underpass Bridge**
