1. Report No.	2. Government Accession No.	3. Recipient's Catalog No.
4. Title and Subtitle Cost-Effective and Rapid Concrete Repair Techniques		5. Report Date February 8, 2016

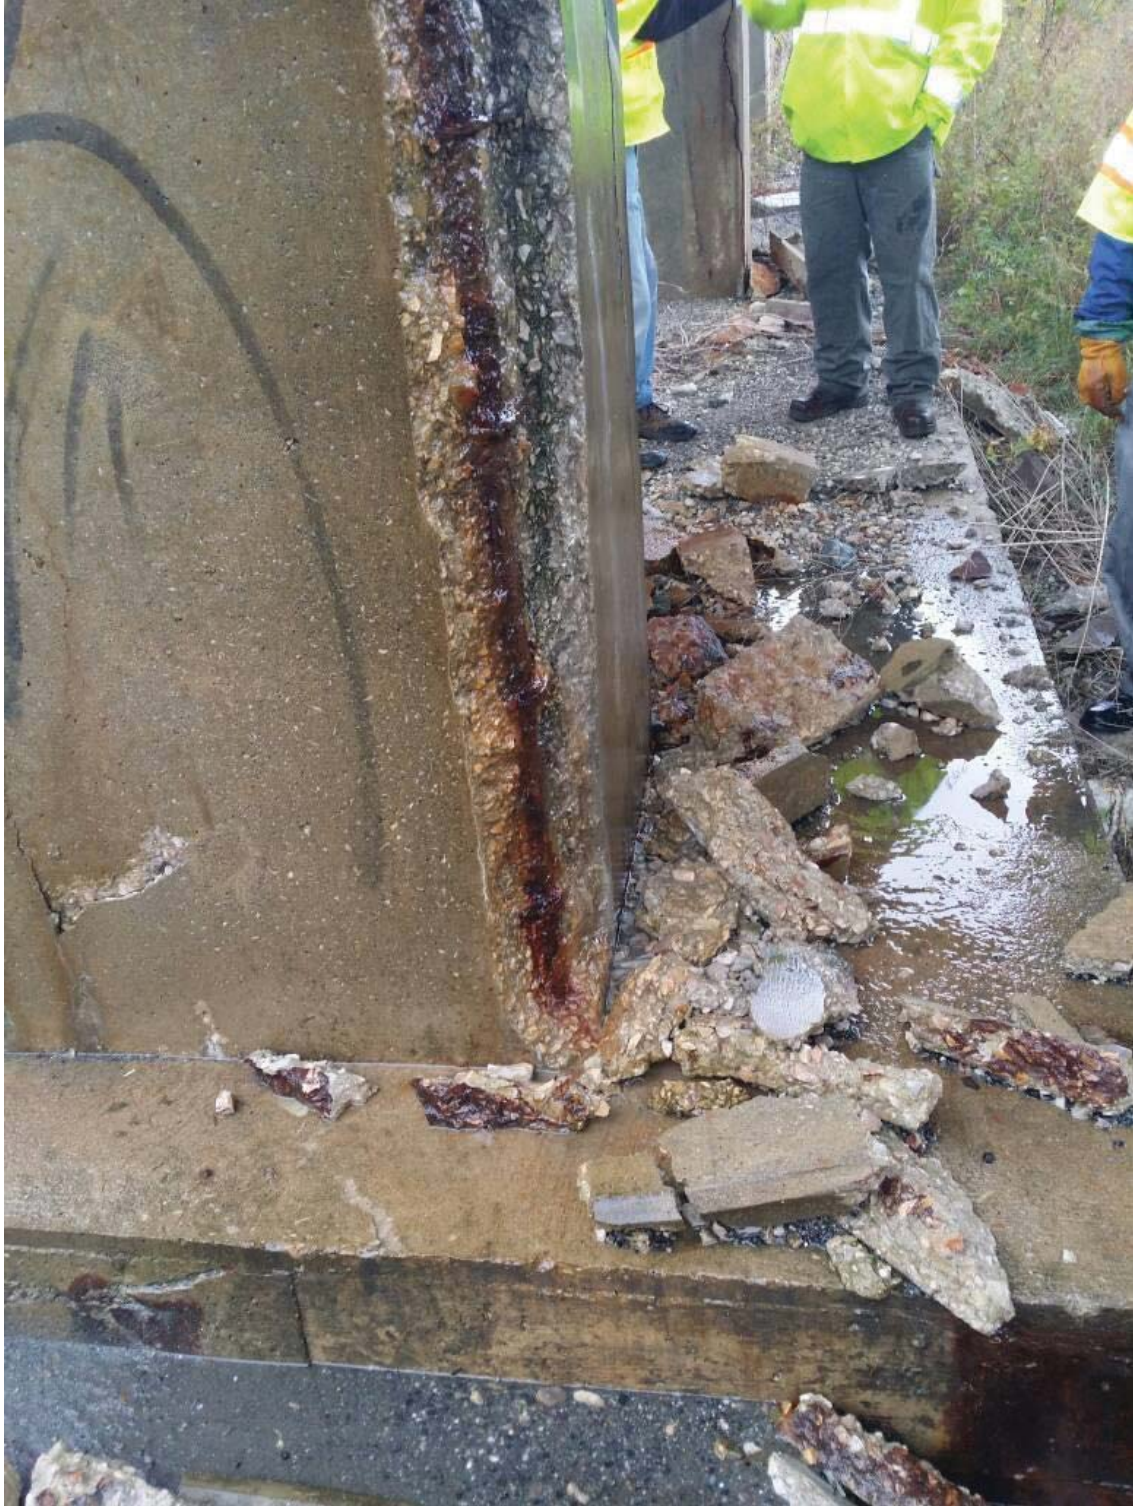
Figure 5.33 Square column with spalling at the corners on Richmond I-89 US 2 Underpass Bridge

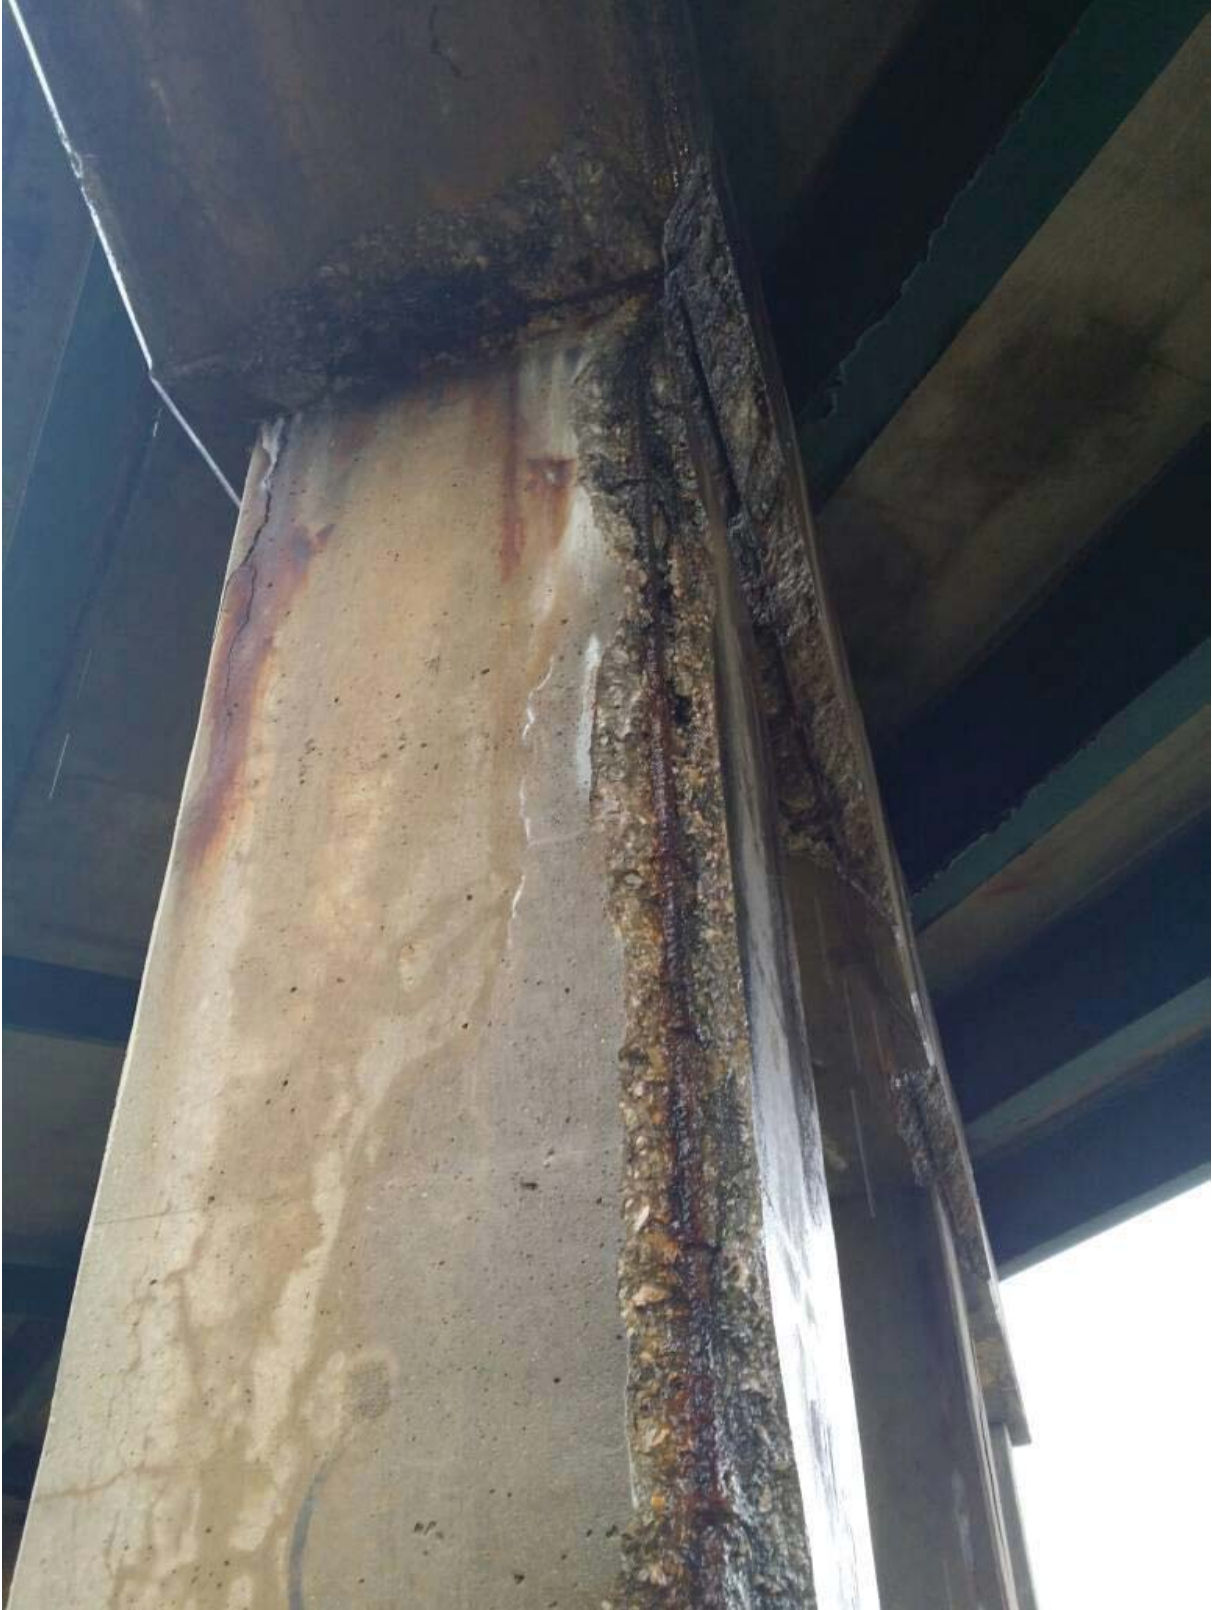
**Figure 5.34 Square column with spalling at the corners and pier cap on Richmond I-89 US 2 Underpass Bridge**

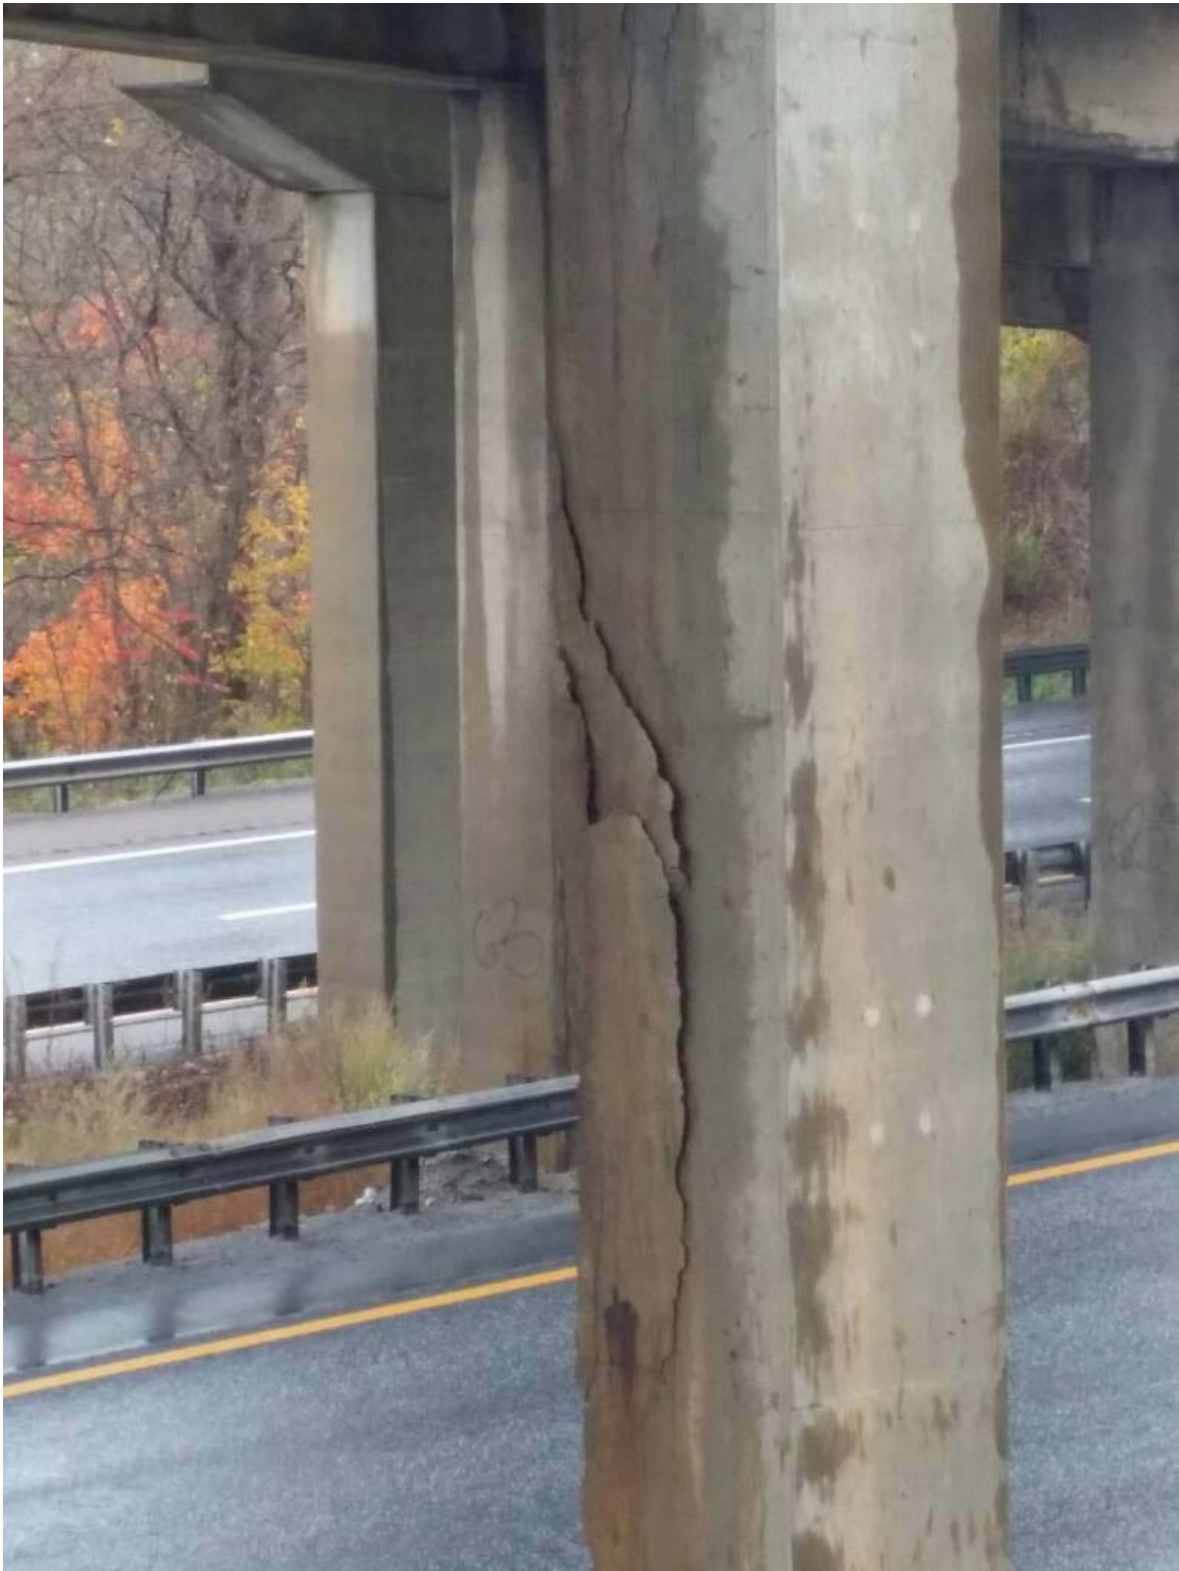
Figure 5.35 Column with spalling at the corners on Richmond I 89 US 2 Underpass Bridge

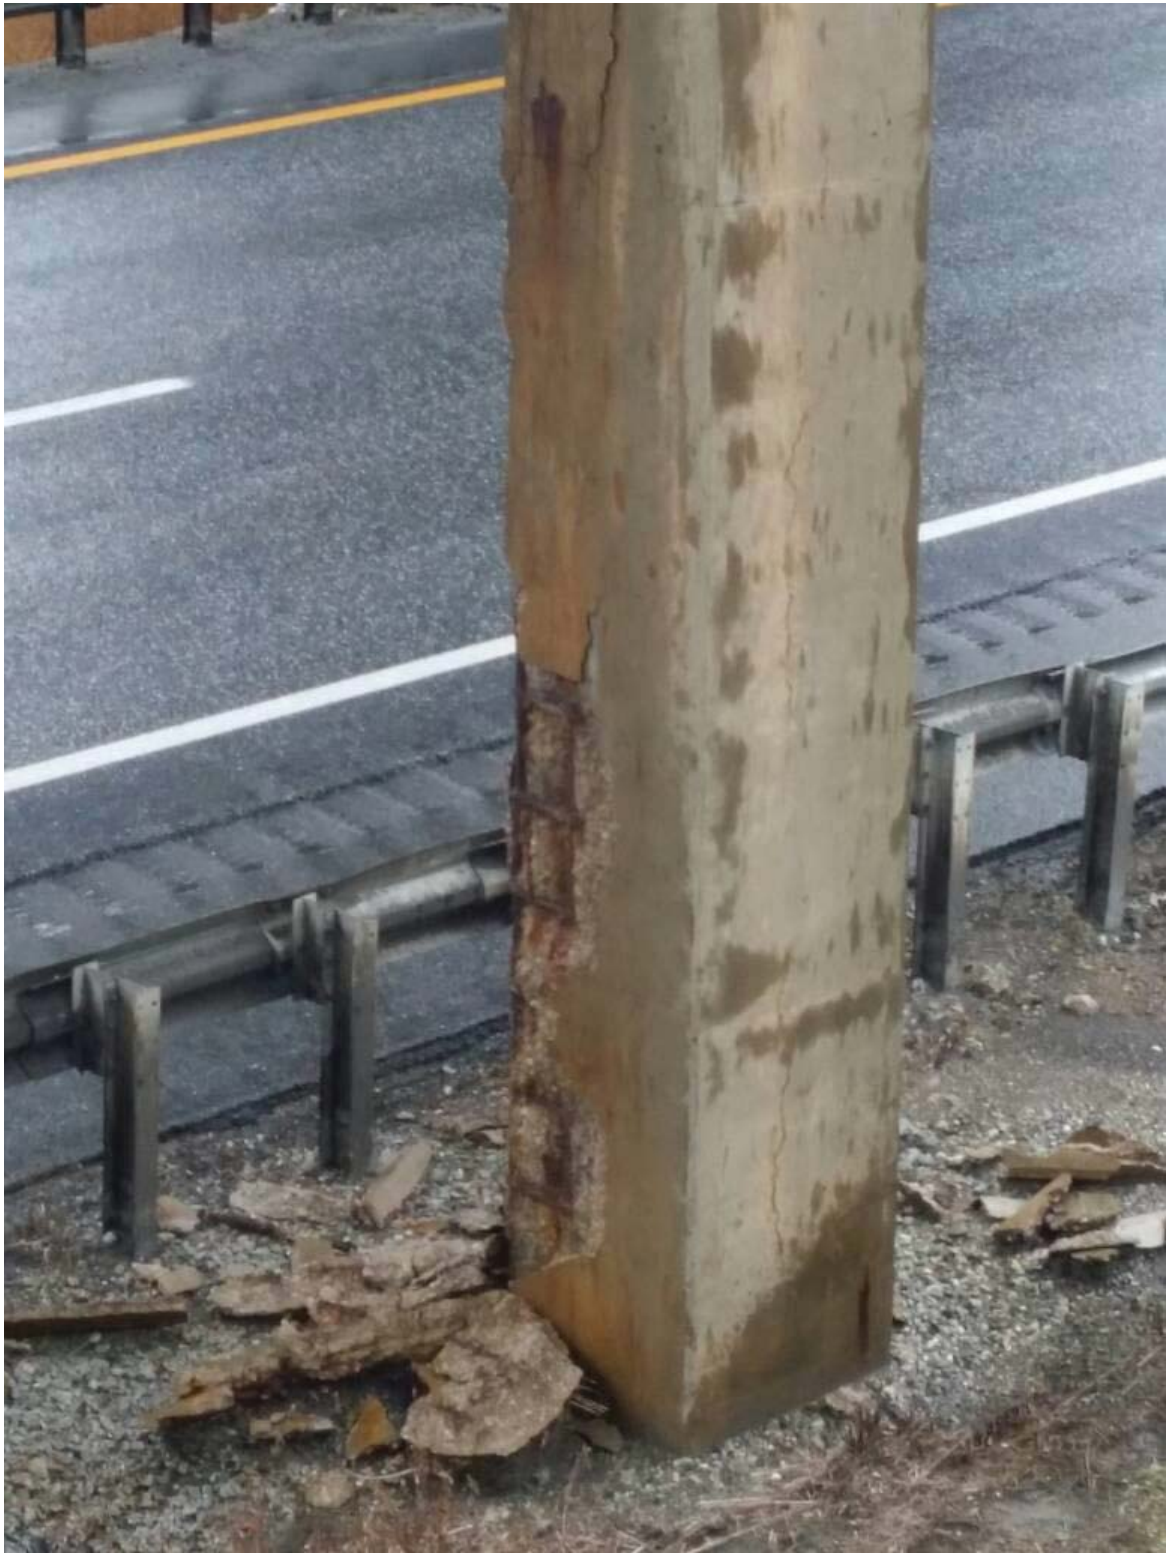
Figure 5.36 Column with spalling at the corners and side on Richmond I 89 US 2 Underpass Bridge

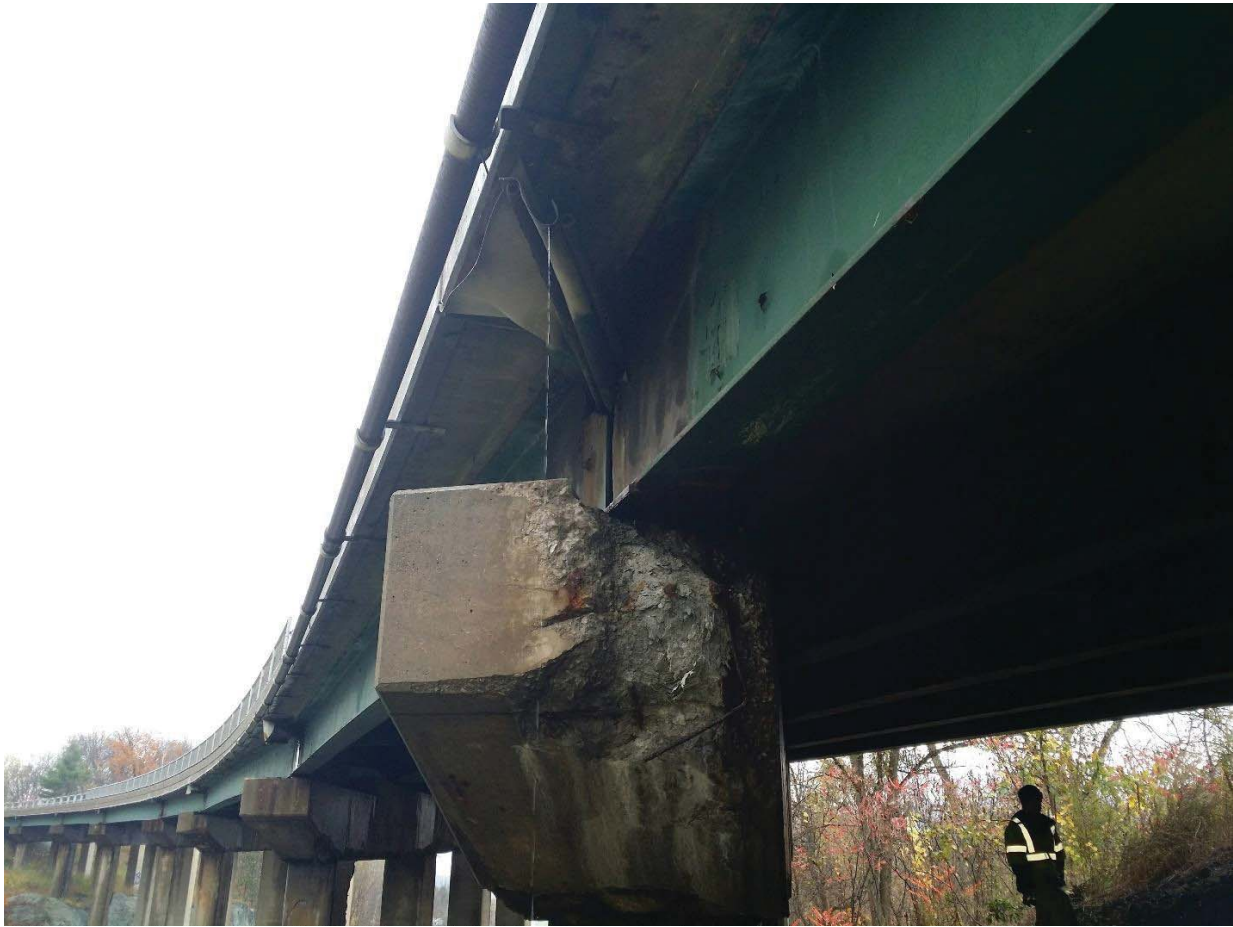
**Figure 5.37 Pier cap with lost corner section leading to subsided bearing on Richmond I 89 US 2 Underpass Bridge**

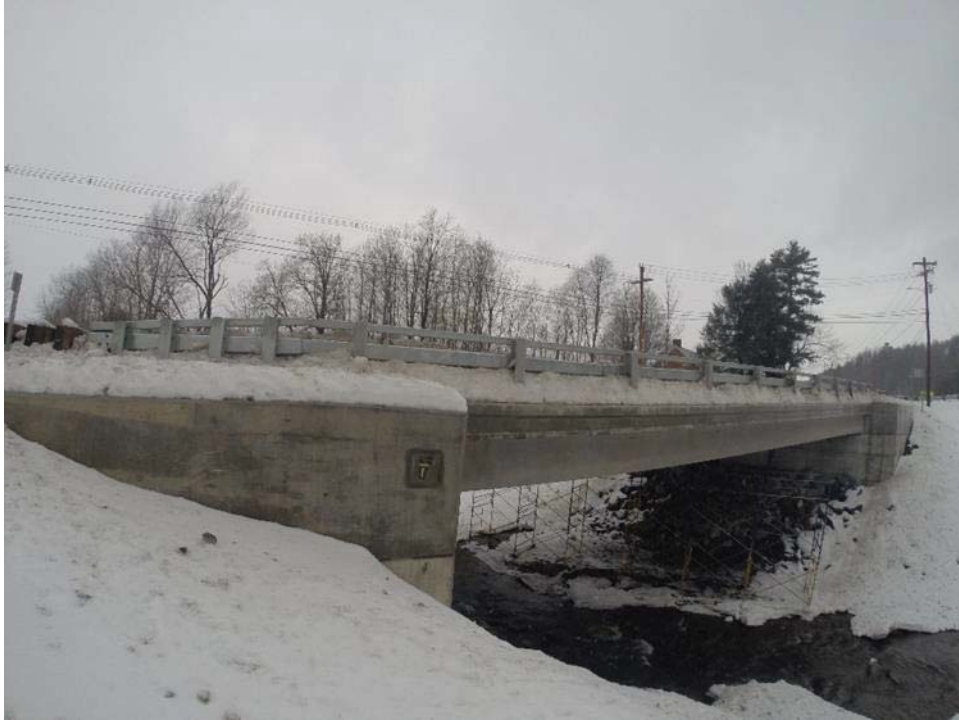
**Figure 5.41 Stowe Rte 100 Gold Brook Crossing Bridge**

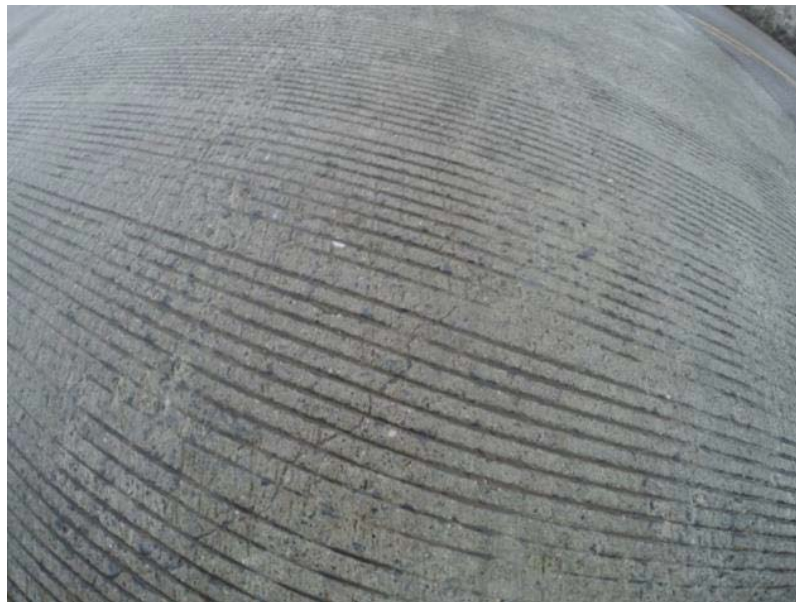
**Figure 5.42 Deck patterned with cross-span cracks, approximately every 200 mm on Stowe Rte 100 Gold Brook Crossing Bridge**

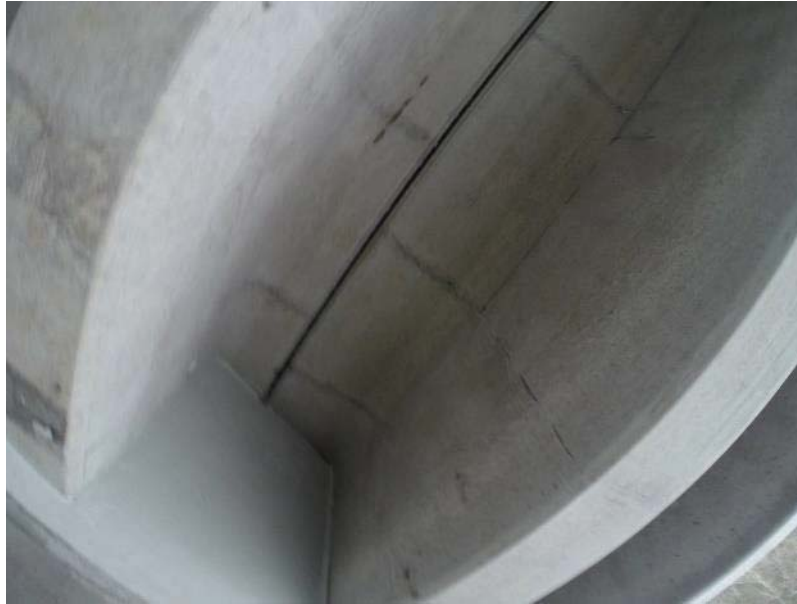
**Figure 5.43 Girders have multiple cracks in top flanges, Stowe Rte 100 Gold Brook Crossing Bridge**

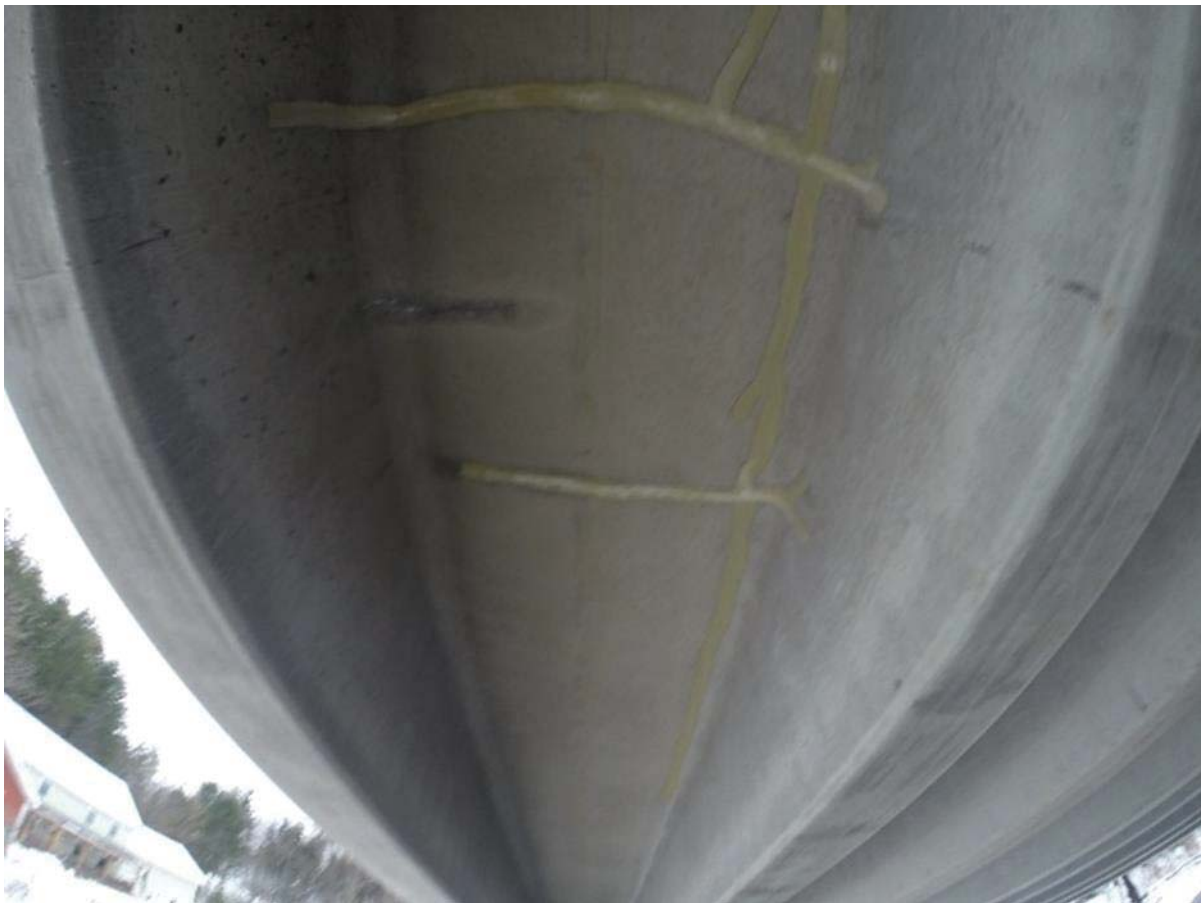
**Figure 5.44 Girder cracks sealed Stowe Rte 100 Gold Brook Crossing Bridge**

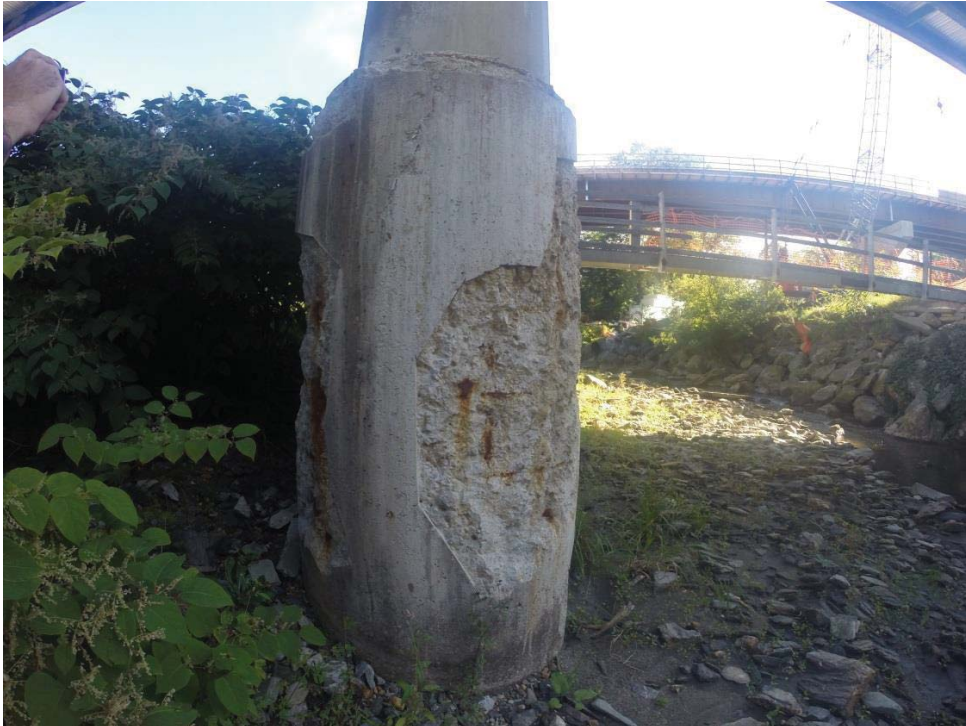
**Figure 5.45 End view of pier base with damaged concrete removed on I-89 Waterbury Overpass Bridge**

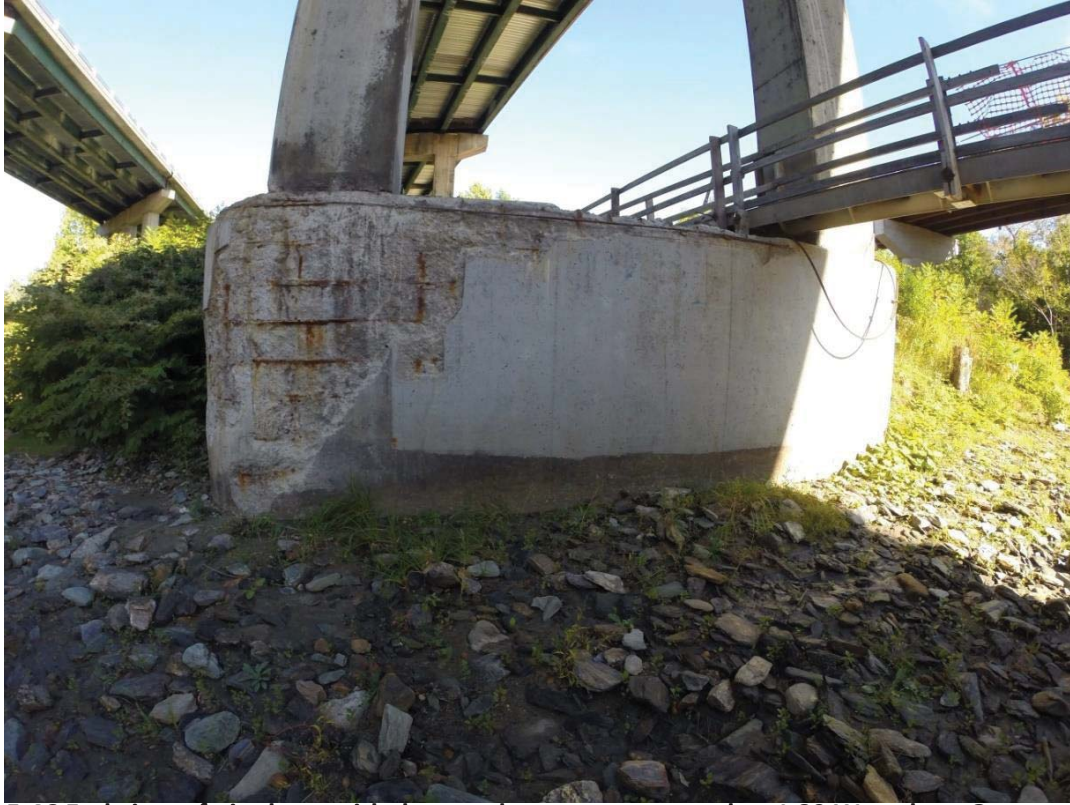
Figure 5.46 End view of pier base with damaged concrete removed on I-89 Waterbury Overpass Bridge

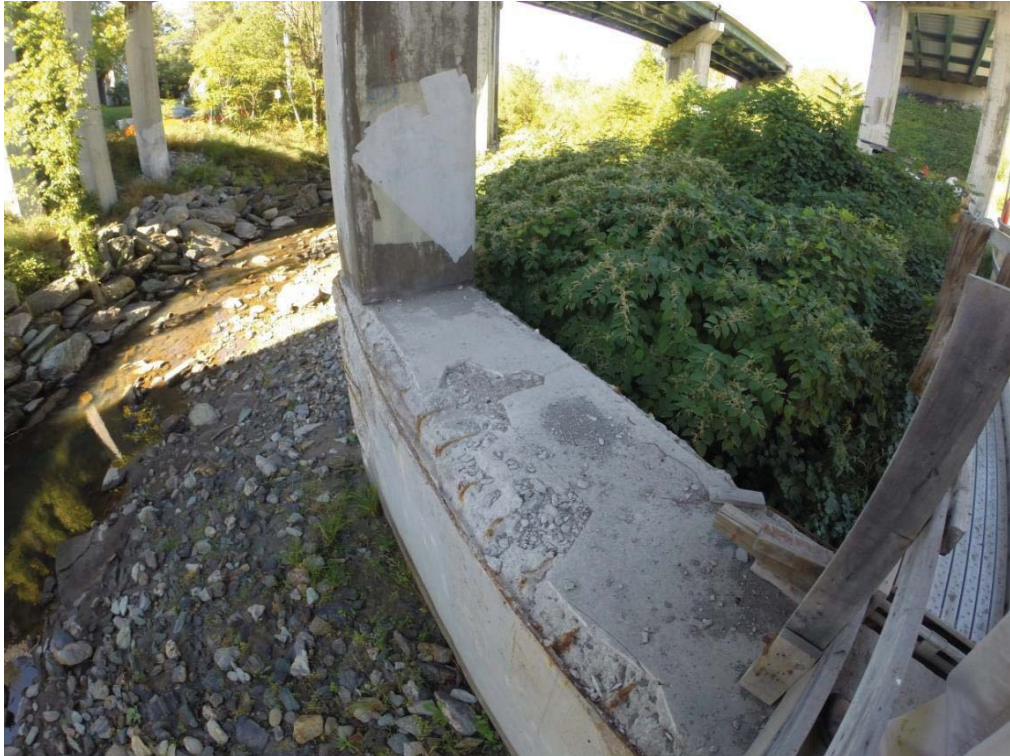
Figure 5.47 Top view of pier base with damaged concrete removed on I-89 Waterbury Overpass Bridge

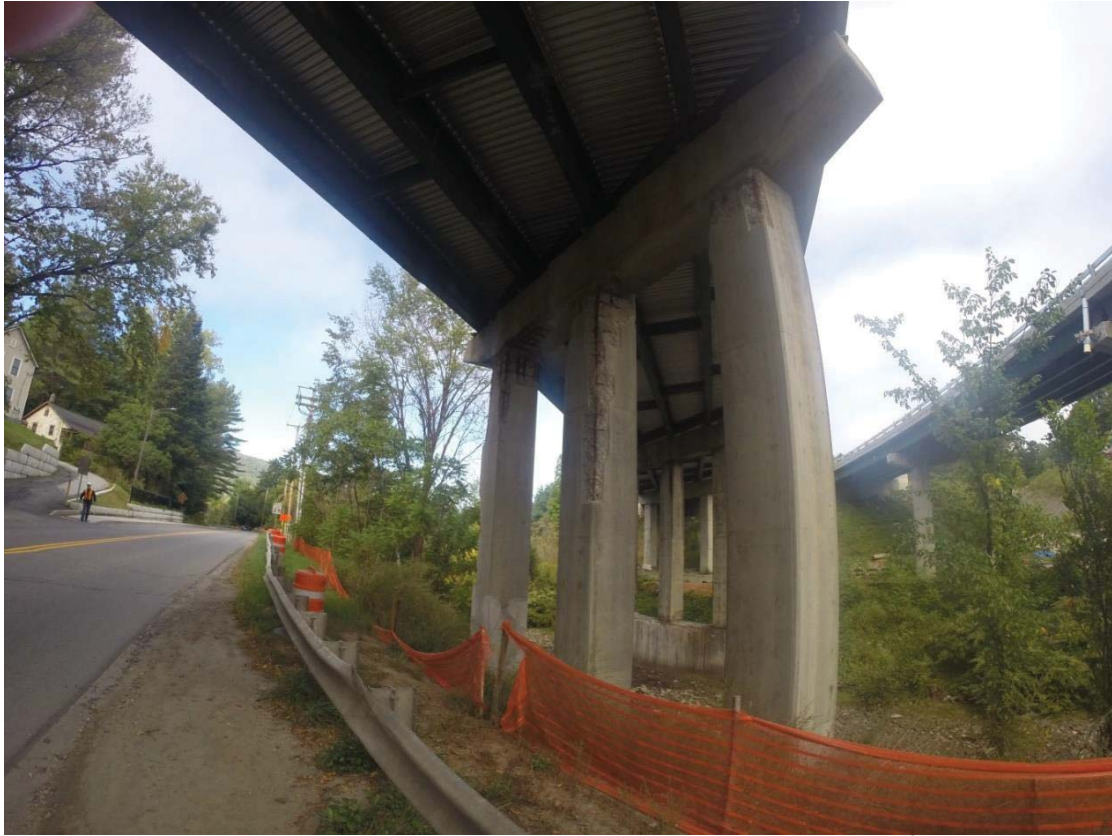
**Figure 5.48 Pier on I-89 Waterbury Overpass Bridge with corners prepared for patch repairs**

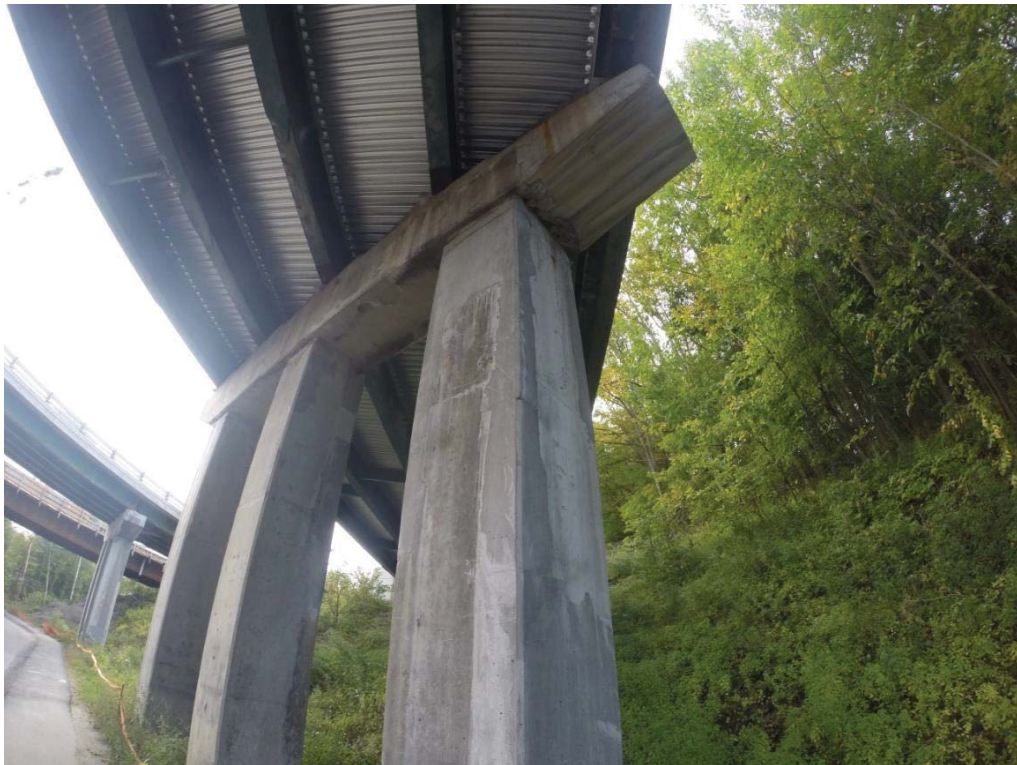
**Figure 5.49 Pier on I-89 Waterbury Overpass Bridge with patch repairs**

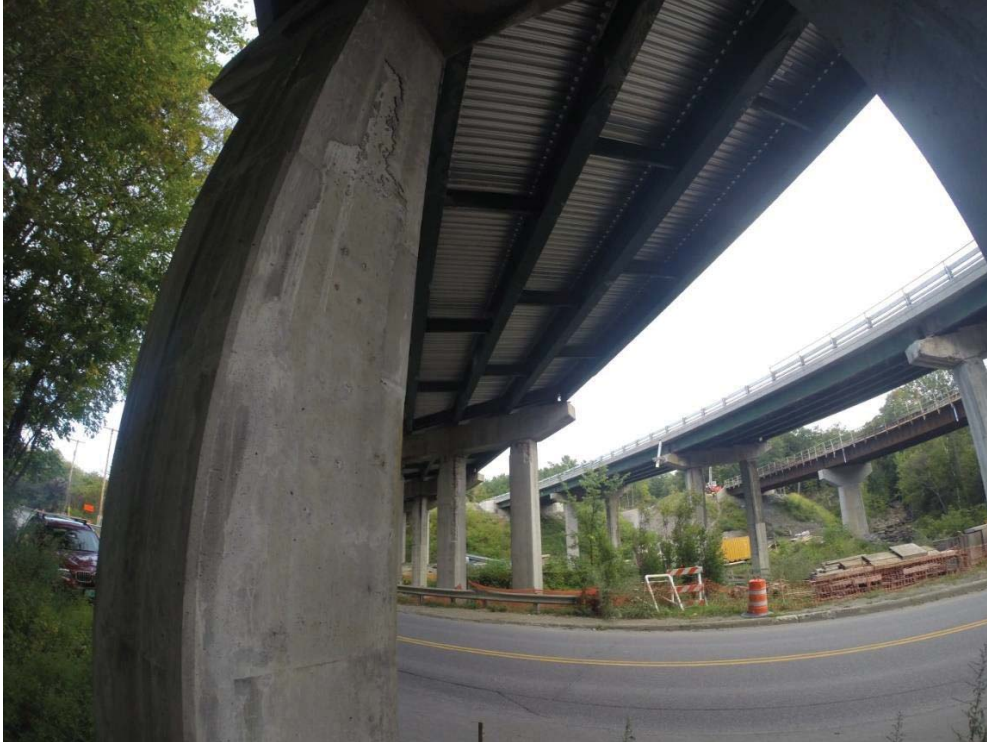
**Figure 5.50 Pier on I-89 Waterbury Overpass Bridge with patch repairs, note the extended gutters on span in background**

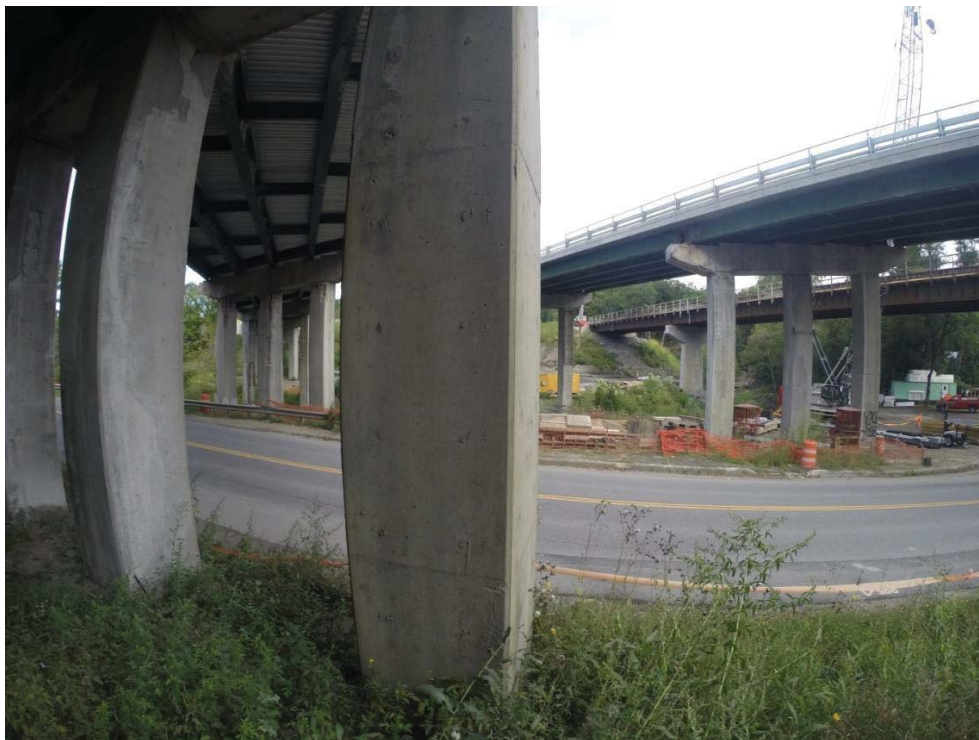
**Figure 5.51 Pier on I-89 Waterbury Overpass Bridge with patch repairs**

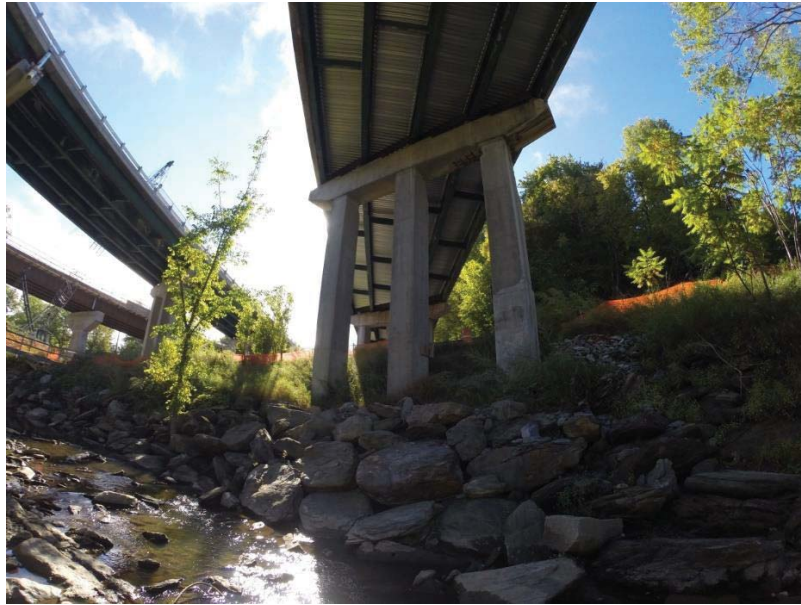
**Figure 5.52 Repaired pier on I-89 Waterbury Overpass Bridge with patch repairs, note the use of integrated corrugated panels on new concrete deck.**

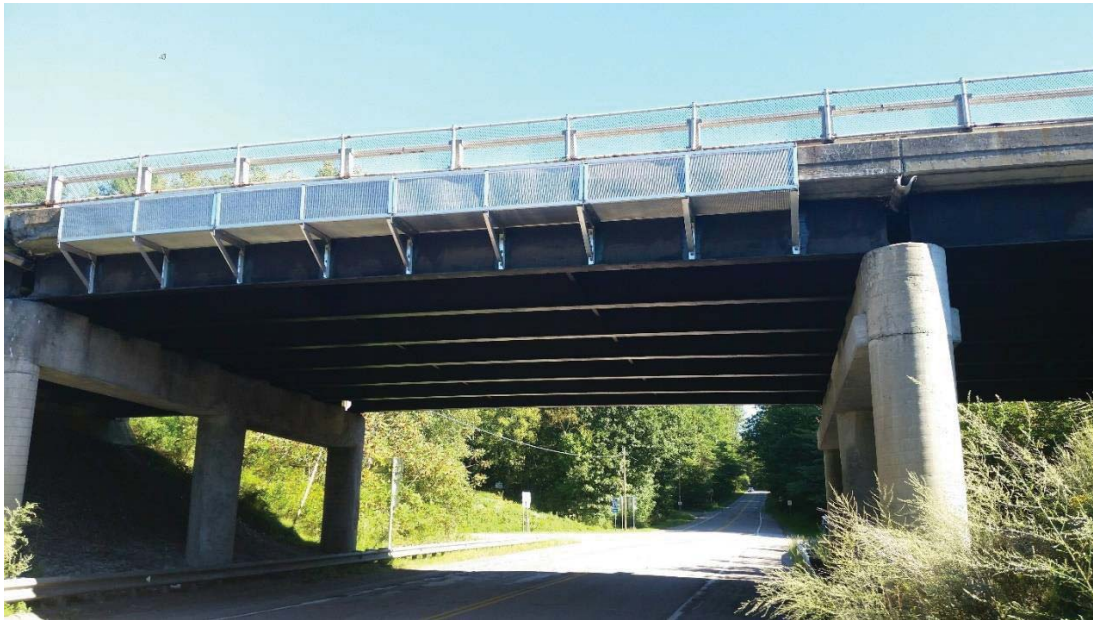
**Figure 5.53 I 89 Middlesex Overpass Bridge with supplemental rack to protect vehicles passing under by catching pieces of concrete that spall and fall from the fascia**

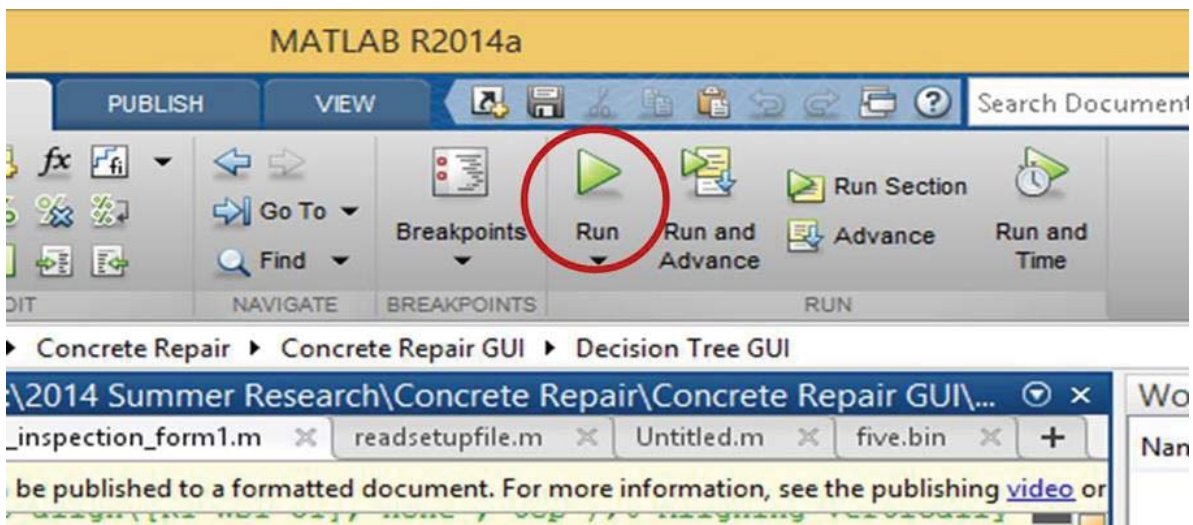
Figure 6.1 Bridge Inspection Form GUI with link to Field Inspection Coding Guide, coded in MATLAB, with executable file, exports Inspection Form to an Excel spreadsheet

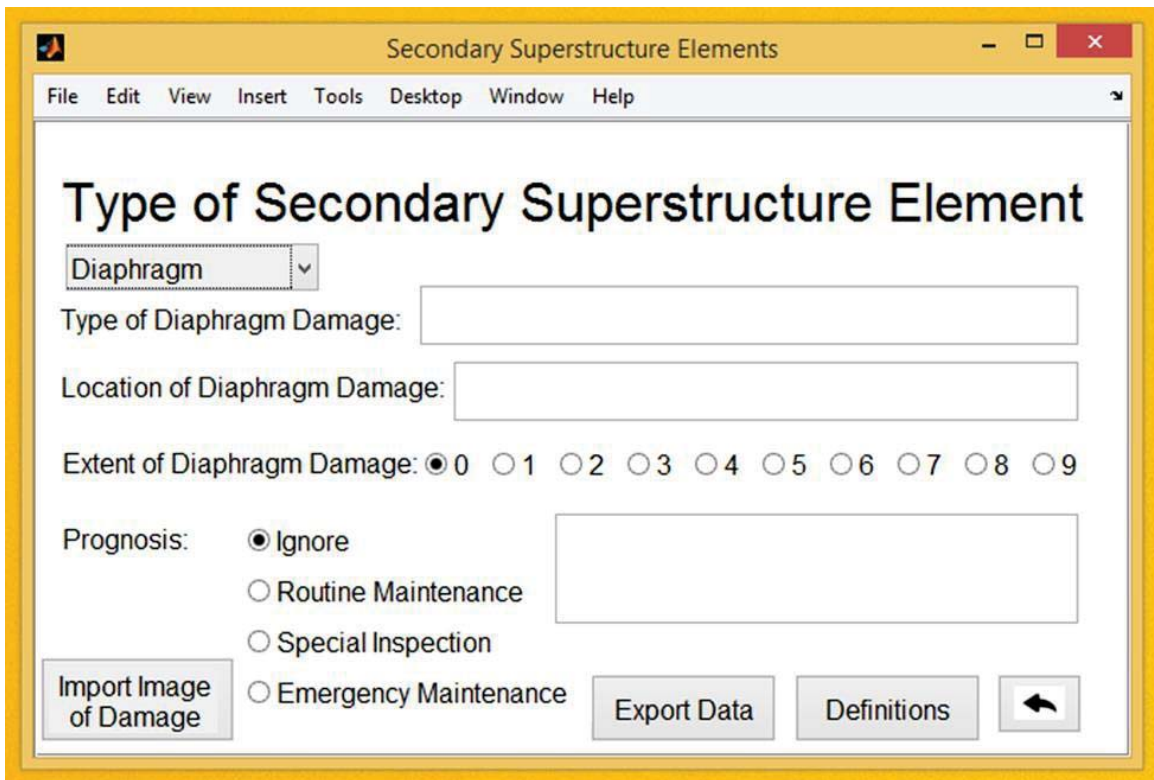
Figure 6.5 Assessment of bridge structure GUI, assessment of damage and prognosis, exports data to an excel spreadsheet. An image of structural damage can be uploaded.

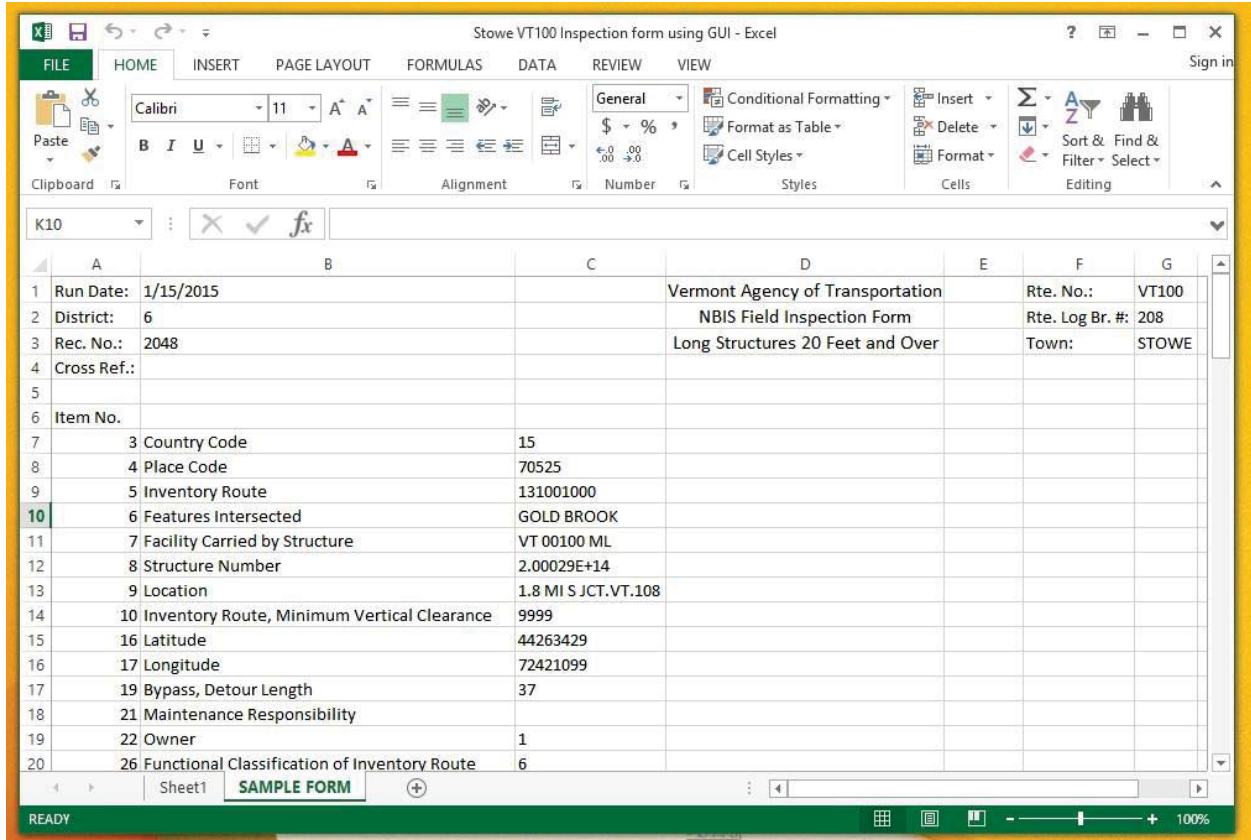
Figure 6.7 Bridge Inspection Form outputting data into an Excel spreadsheet

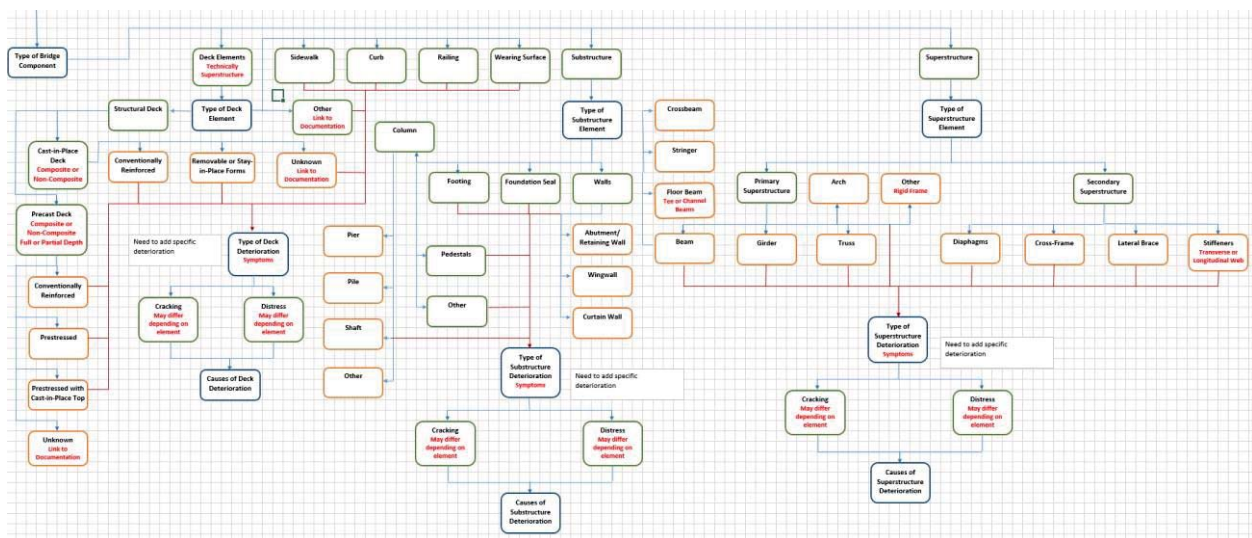
Figure 6.9 Bridge concrete repair decision tree, Adapted from ACI Concrete Repair Process Flow Chart (ACI Concrete Repair Manual 2013).

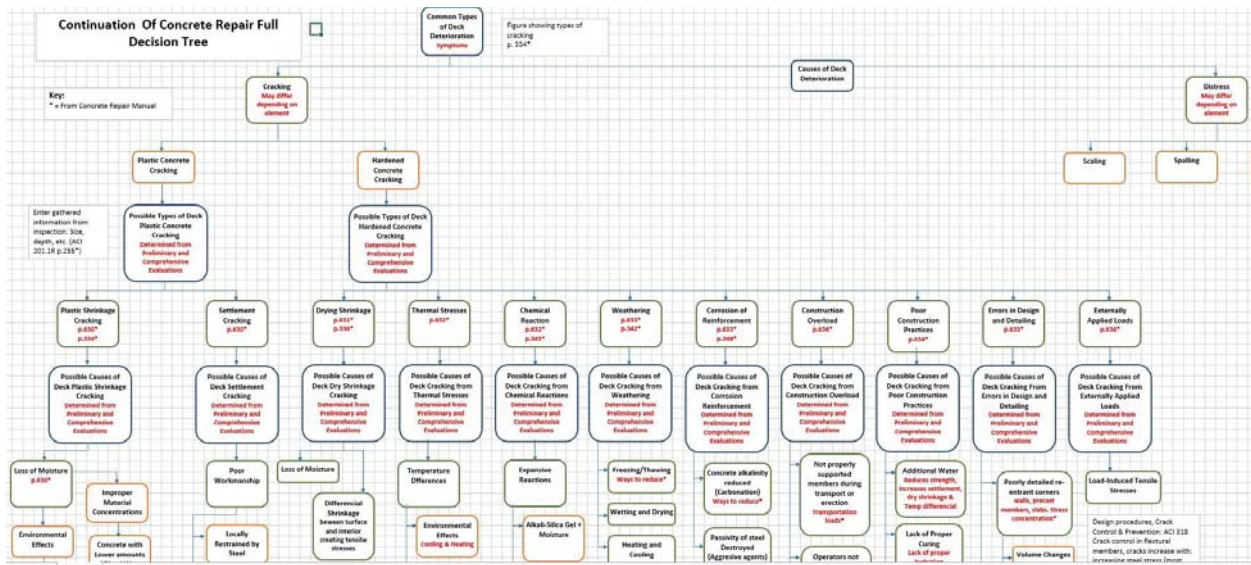
Figure 6.10 Deck branch of concrete repair decision tree, adapted from ACI Concrete Repair Process Flow Chart (ACI Concrete Repair Manual 2013)
