1. Report No.	2. Government Accession No.	3. Recipient's Catalog No.
4. Title and Subtitle Cost-Effective and Rapid Concrete Repair Techniques		5. Report Date February 8, 2016

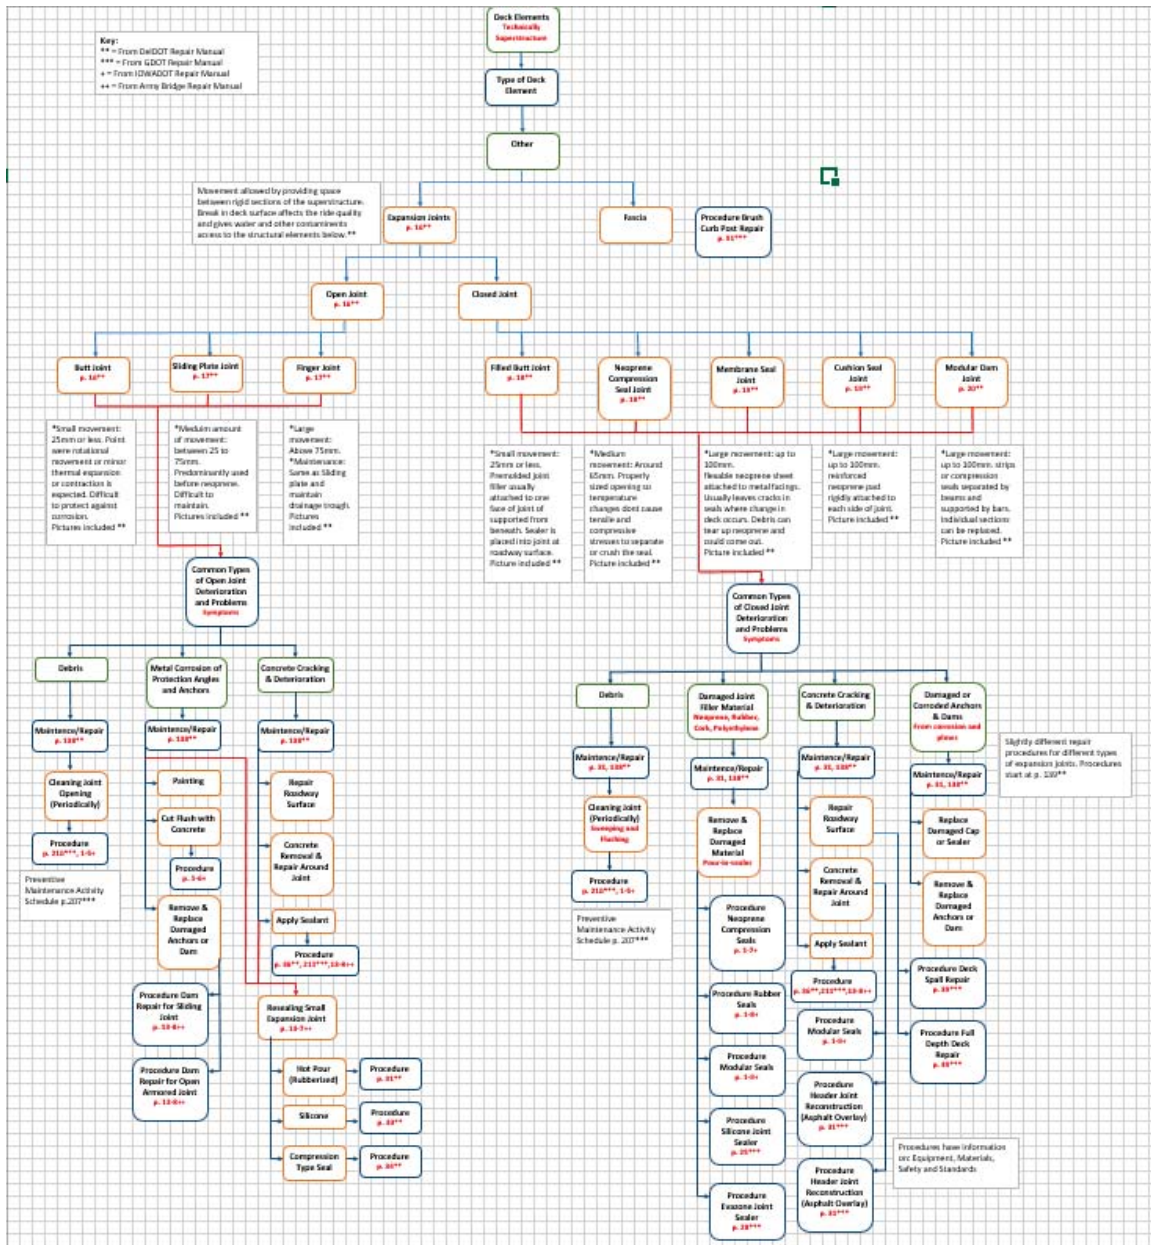
Figure 6.11 Expansion joint and fascia decision tree

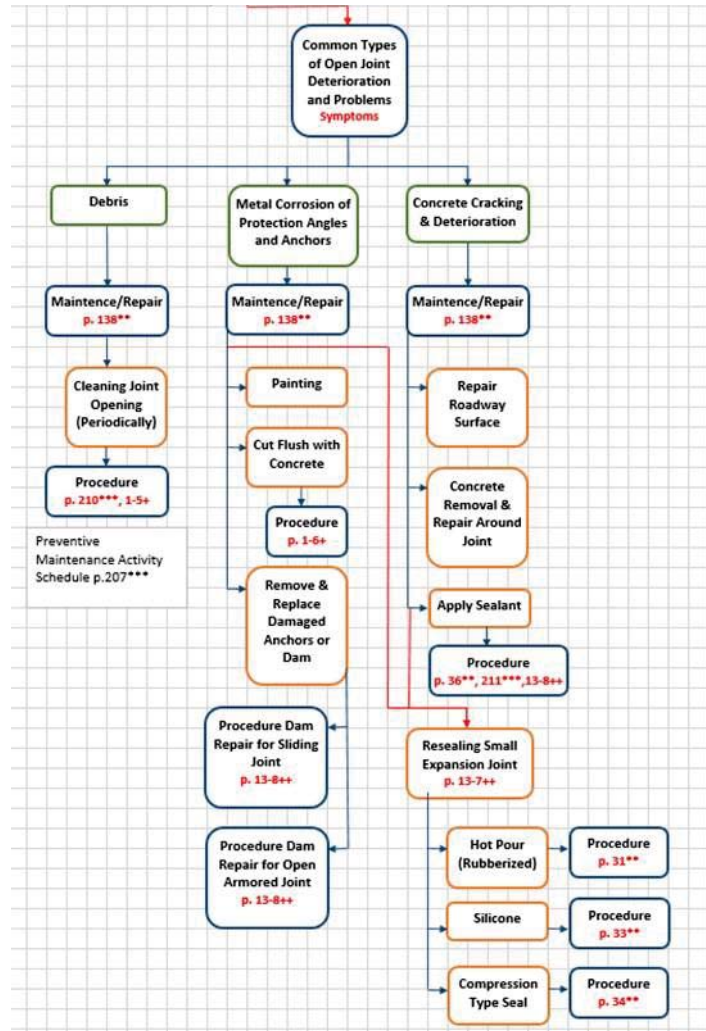
Figure 6.12 Bridge concrete repair decision tree – close-up of open expansion joint branch, adapted from ACI Concrete Repair Process Flow Chart (ACI Concrete Repair Manual 2013)

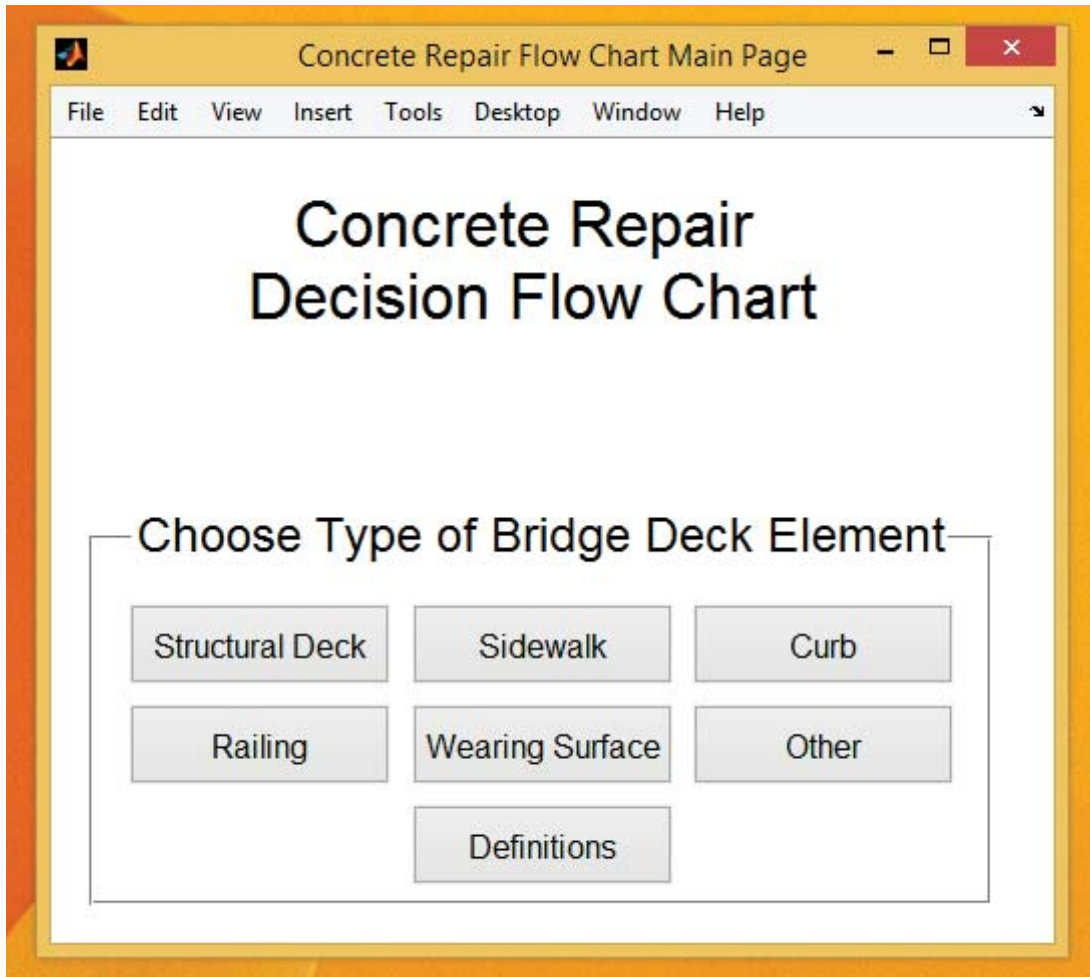
Figure 6.13 Screen shot of Concrete Repair Decision Flow Chart GUI main page, with user friendly features including definitions of terms in current GUI page

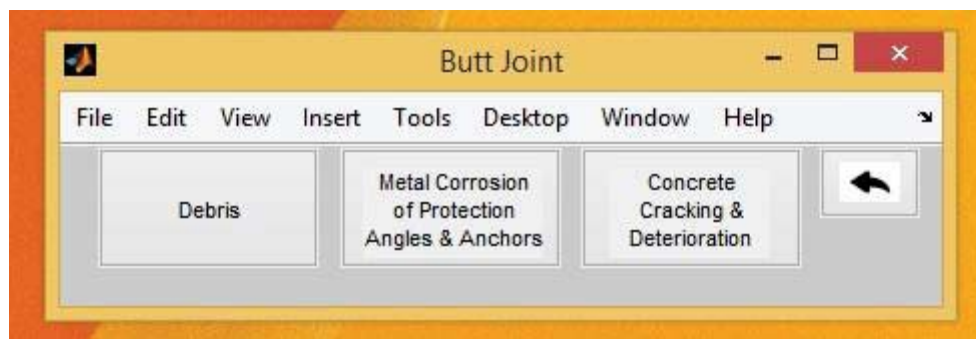
Figure 6.14 Screen shot of particular bridge deck element GUI (going through flowchart), enables picking type of damage to element to select proper repair procedure

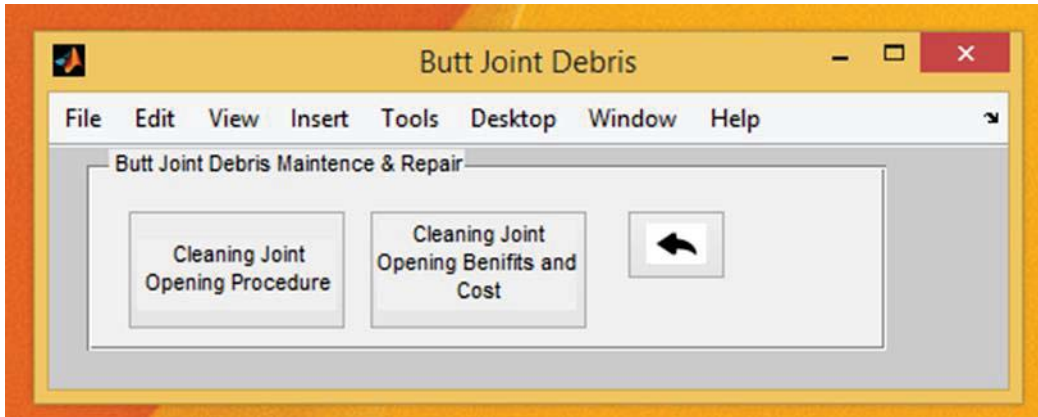
**Figure 6.15** Screen shot of particular bridge deck element GUI (going through flowchart) with particular damage, user can pick correct repair procedure (links to repair procedures from list of data files) and determine benefits associated to repair and estimated cost of repair.

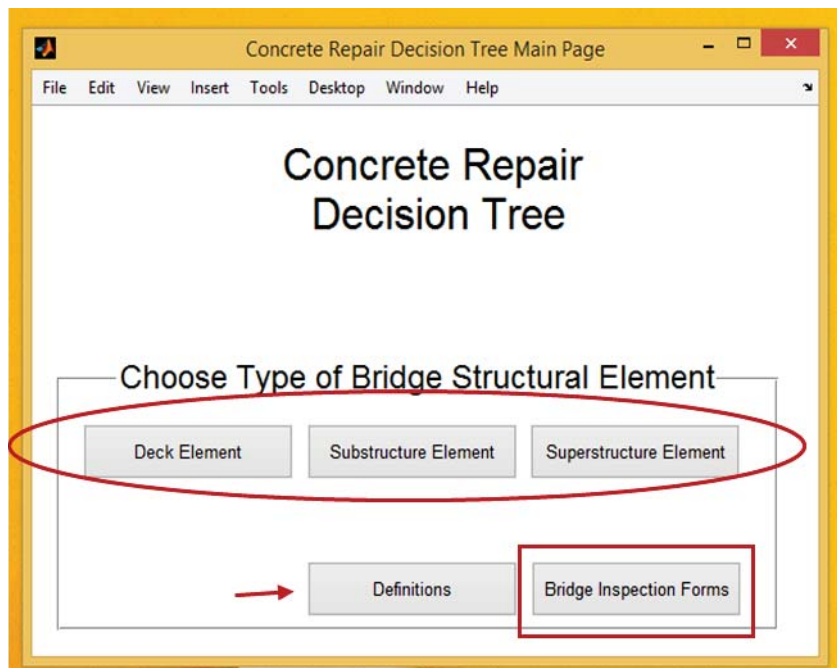
**Figure 6.16** Concrete Repair Decision Tree Main Page

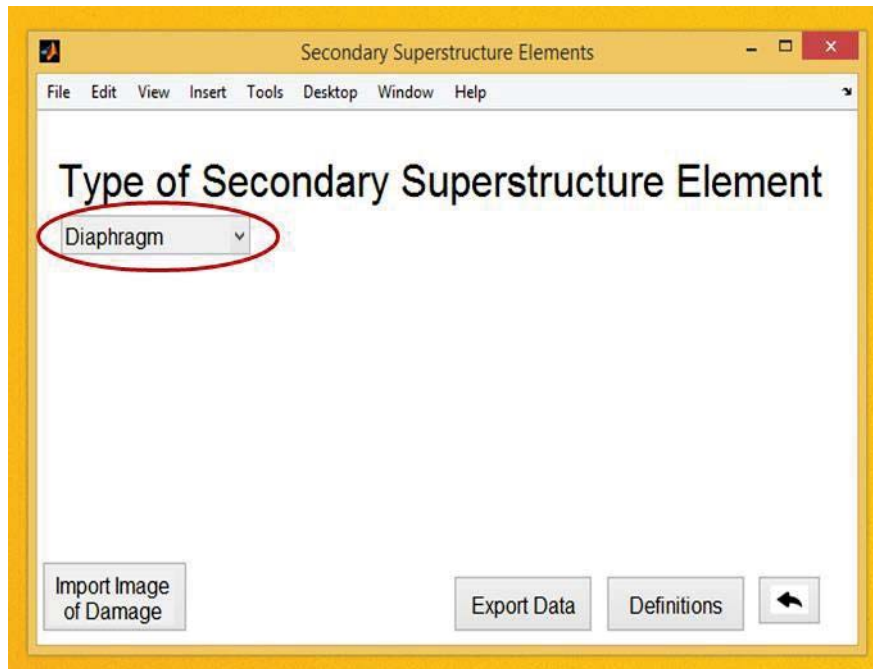
Figure 6.17 Damage and Prognosis Pop-up Window

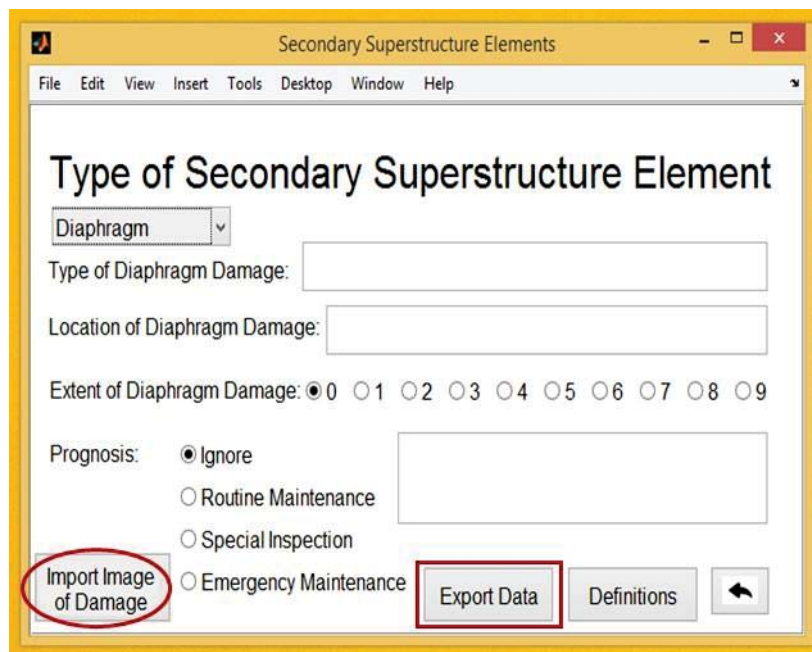
Figure 6.18 Damage and Prognosis Pop-up Window with Full Options

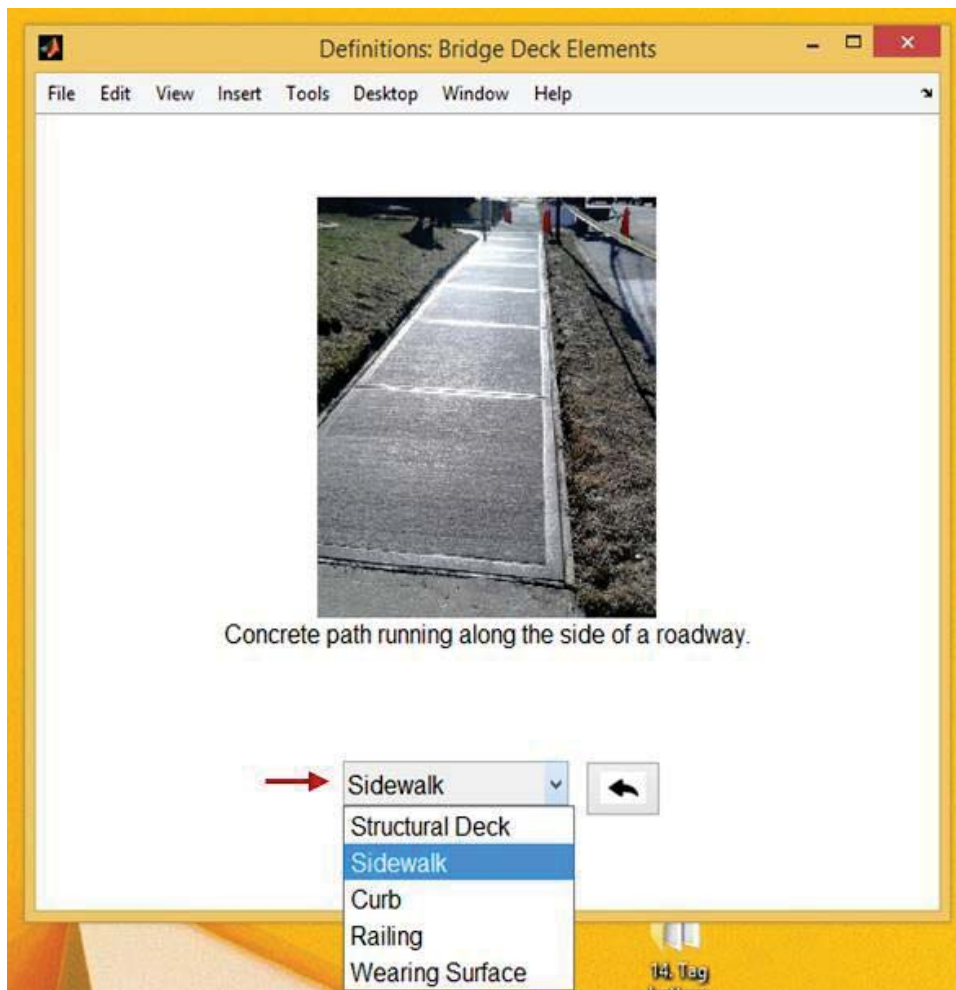
Figure 6.19 Clickable link to definitions

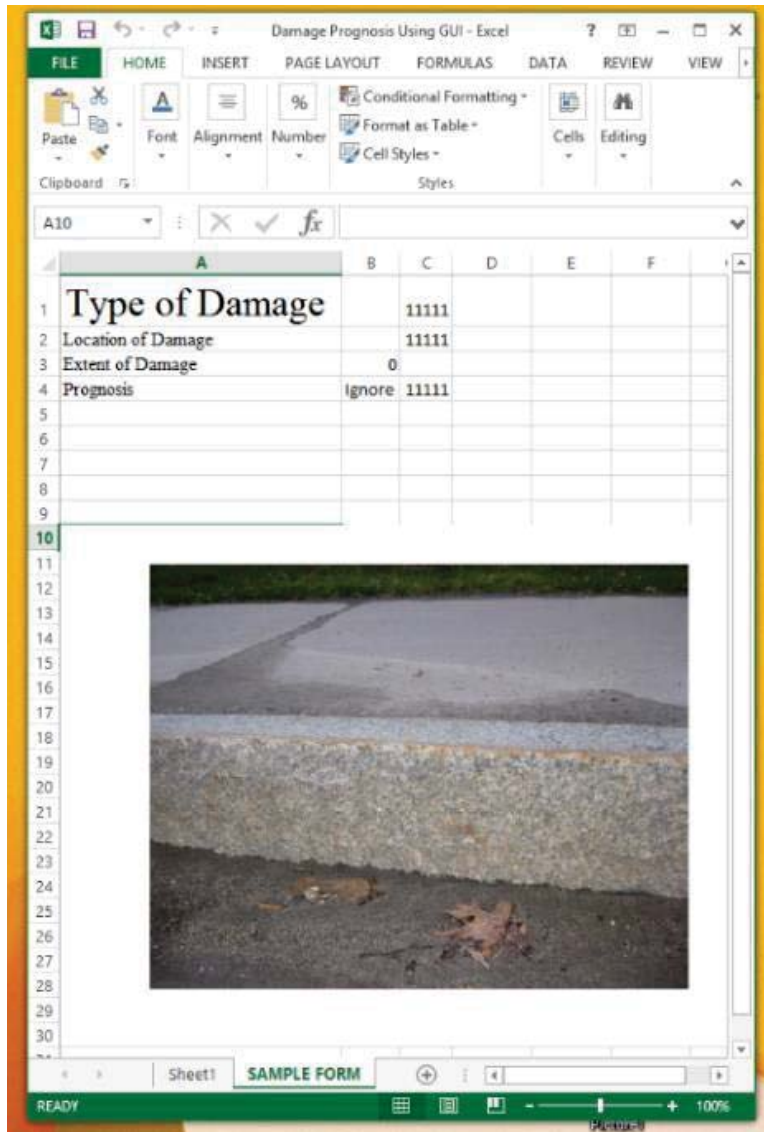
Figure 6.21 Exported Data from Decision Tree GUI

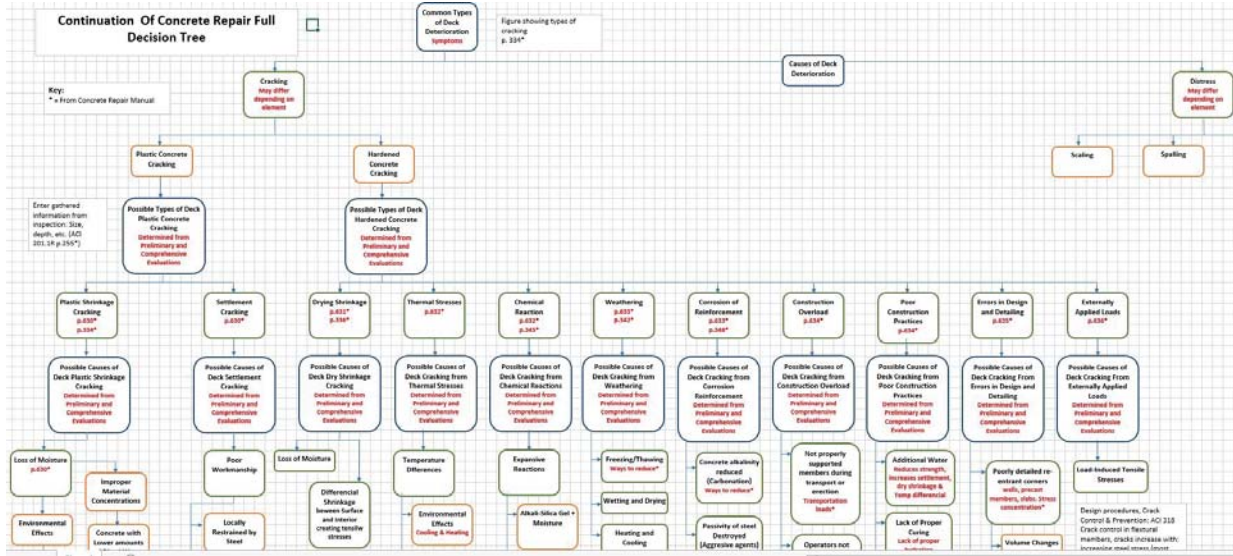
Figure 2: The Full Decision Tree can be accessed as the Excel File: (Deck Deterioration Repair Decision Tree)

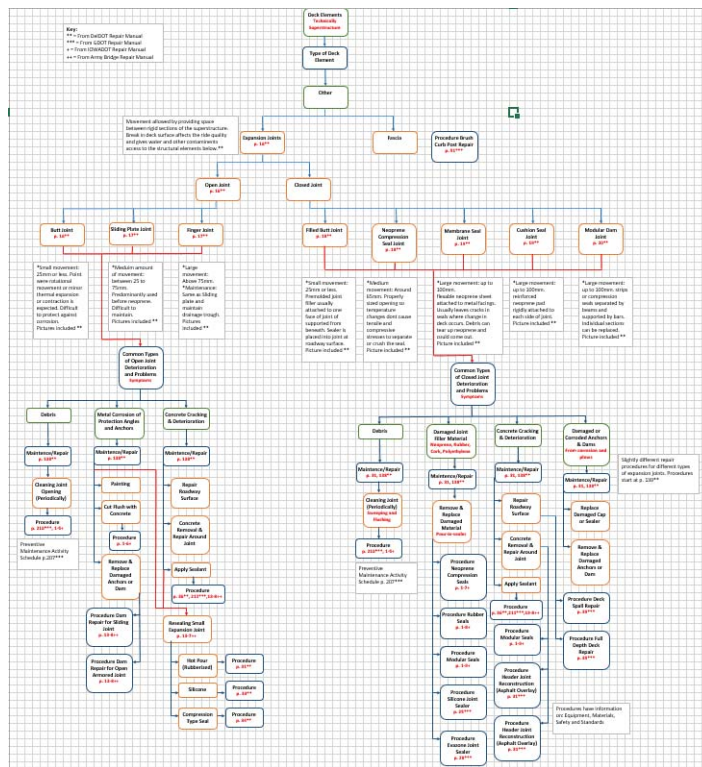
Figure 3: The Full Decision Tree can be accessed as the Excel File: (Expansion Joint and Fascia Deterioration Repair Decision Tree)

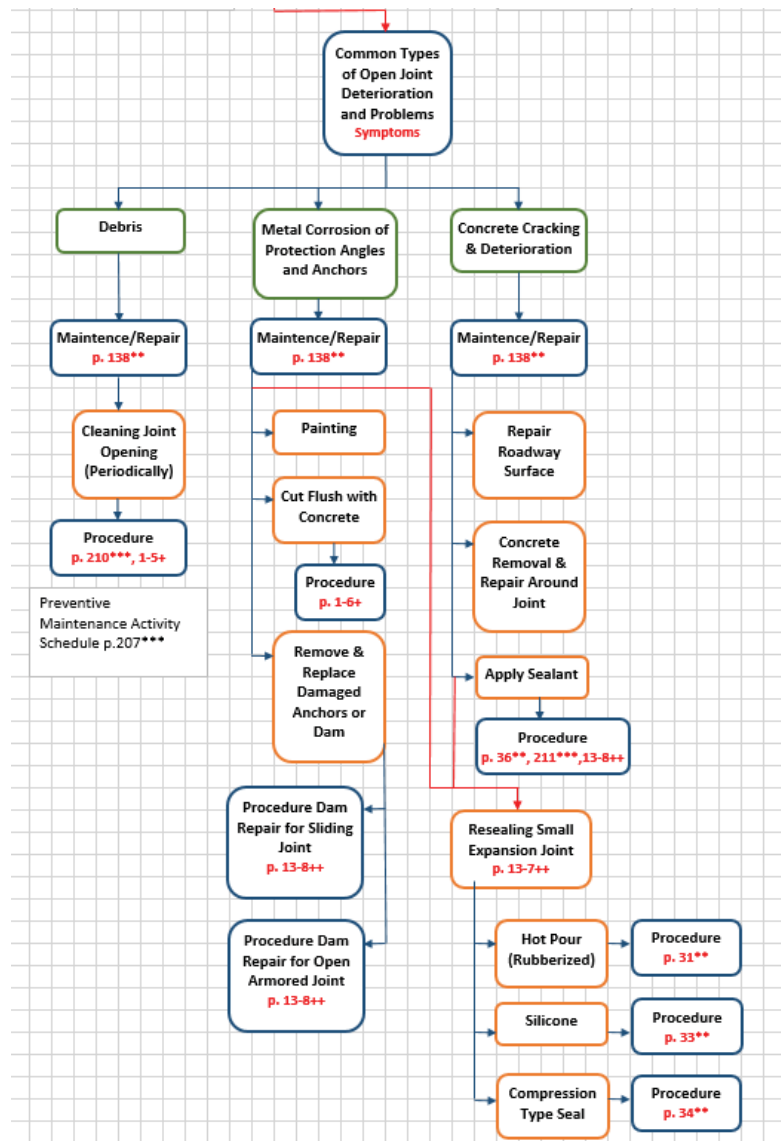
Figure 4: Figure 3: The Full Decision Tree can be accessed as the Excel File: (Expansion Joint and Fascia Deterioration Repair Decision Tree)

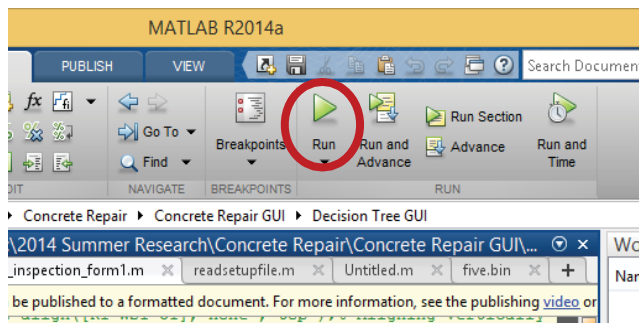
3. The **Bridge Inspection Form** window should pop-up, depicted in Figure (Figure 5). The window gives the user the option of clicking between two buttons:
  - a. The **Field Inspection Form** button, which directs the user to the electronic form
  - b. The **Field Inspection Coding Guide** button, which directs the user to a PDF version of the guide.

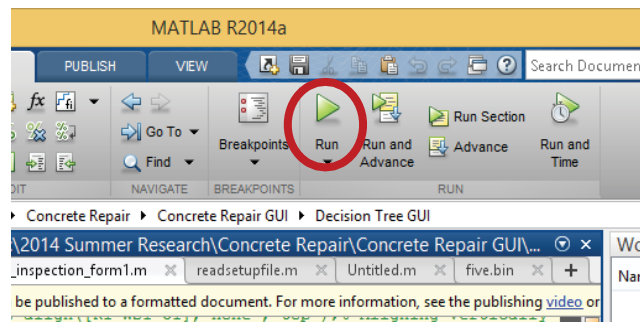
3. The **Concrete Repair Decision Tree** window should pop-up, depicted in Figure (Figure 10). The window gives the user the option of clicking between multiple buttons:
  - a. Choose from three structural element categories: **Deck Element**, **Substructure Element** or **Superstructure Element** (shown by red oval)
  - b. The **Field Inspection Form** button (shown by red rectangle), which directs the user to the electronic form
  - c. The **Definitions** button (to the right of the red arrow), which directs the user to a Definitions pop-up window that defines the bridge terminology of the previous window.

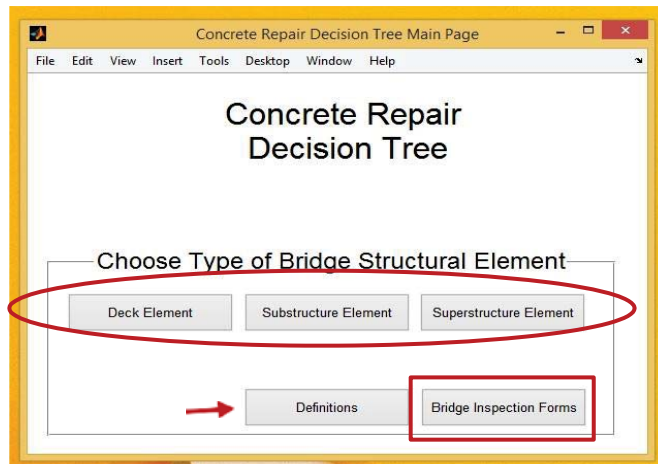
Figure 10: Concrete Repair Decision Tree Main Page

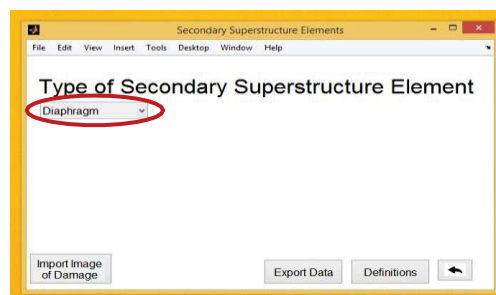
Figure 11: Damage and Prognosis Pop-up Window

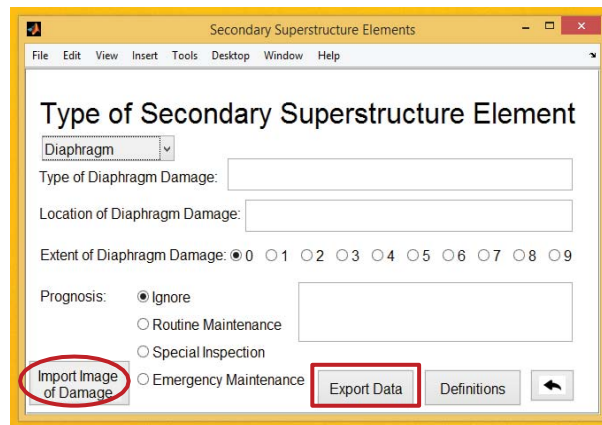
**Figure 12: Damage and Prognosis Pop-up Window with Full Options**

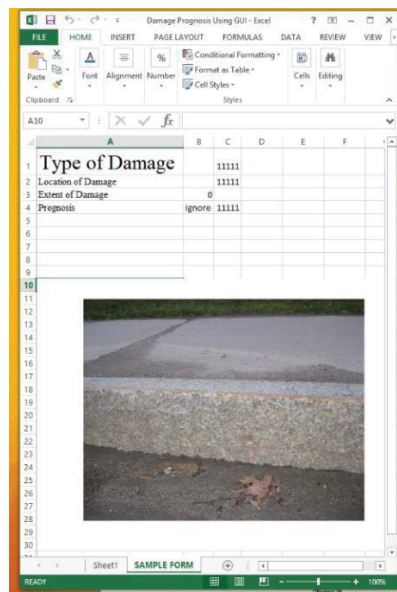
**Figure 13: Exported Data from Decision Tree GUI**

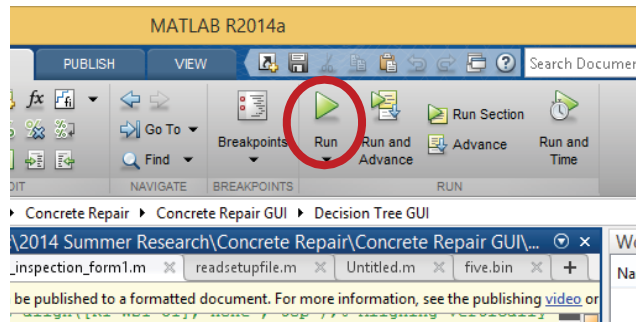
3. The **Concrete Repair Flow Chart** window should pop-up, depicted in Figure (Figure 15). The window gives the user the option of clicking between multiple buttons:
  - a. Choose from six deck elements: **Structural Deck, Sidewalk, Curb, Railing, Wearing Surface** or **Other** (shown by red oval) \*Only **Other** is currently active\*
  - b. The **Definitions** button (to the right of the red arrow), which directs the user to a Definitions pop-up window that defines the bridge terminology of the previous window. \*For Further Information on the **Definitions** window, reference **Step 11** in **1.2. Decision Tree GUI.**\*

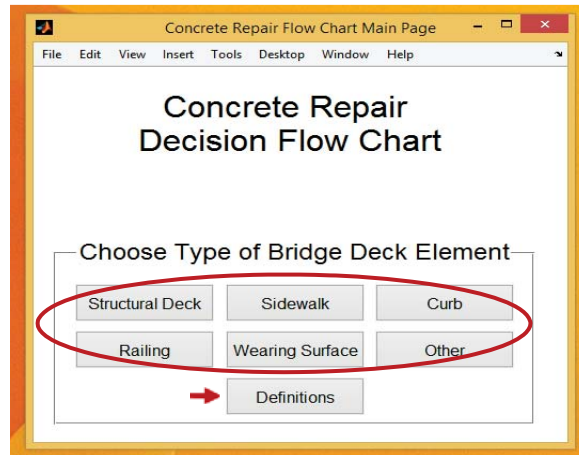
Figure 15: Concrete Repair Flow Chart Main Page

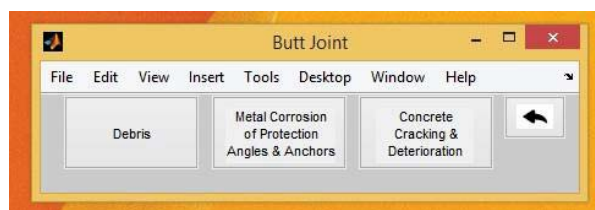
Figure 16: Butt Joint Pop-up Window

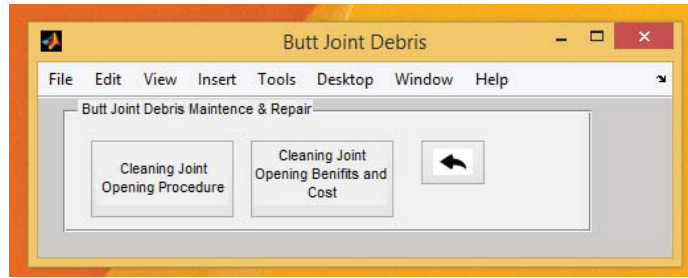
Figure 17: Butt Joint Debris Pop-up Window

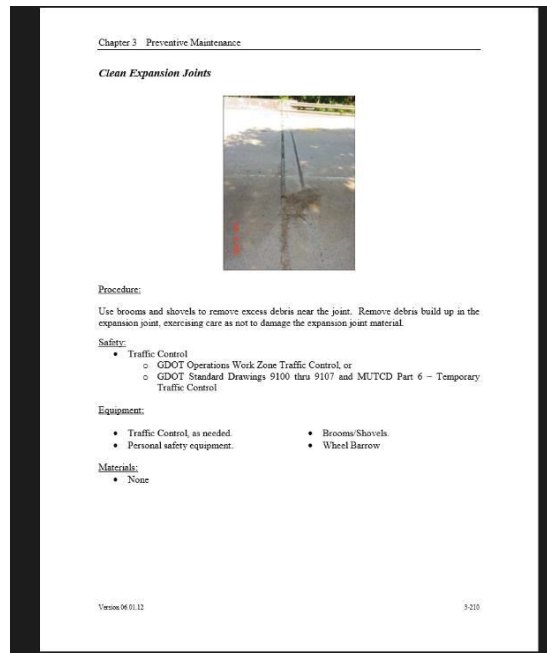
Figure 18: PDF Version of a Procedure from a Database

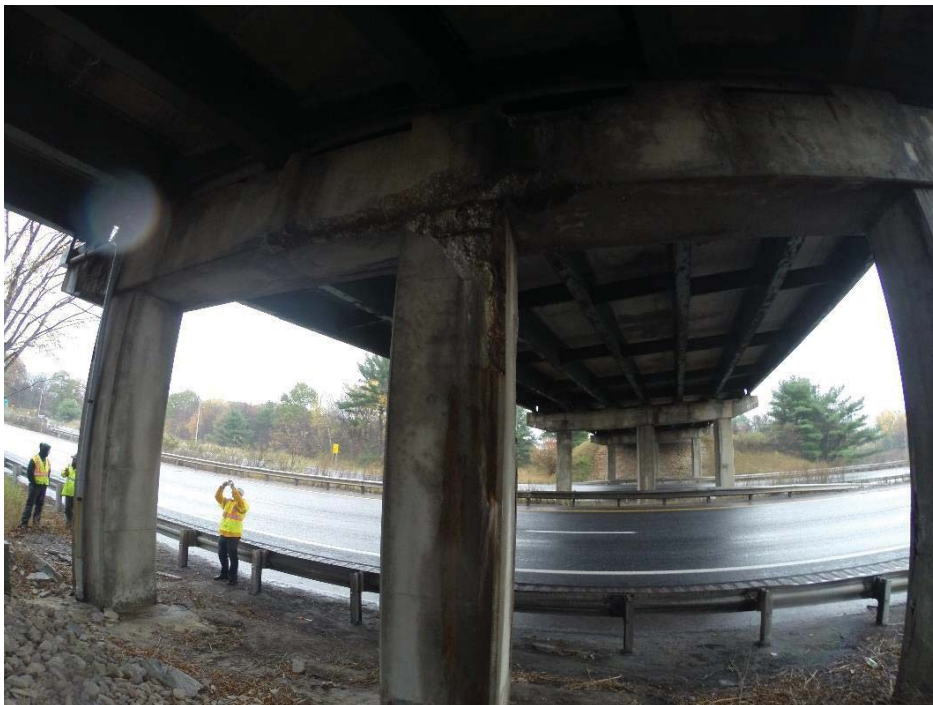
**Figure 19: Column and cap Spalling and steel corrosion**

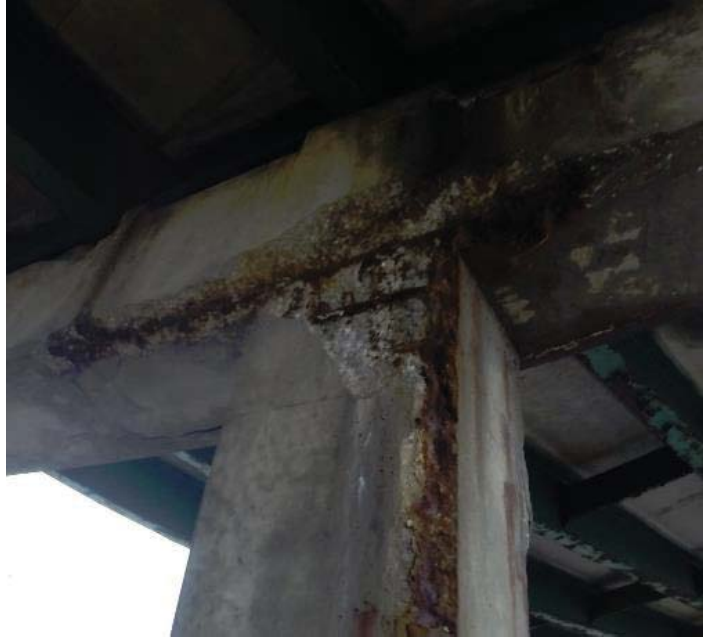
**Figure 20: Close-up of concrete spalling and steel corrosion on middle column and cap**

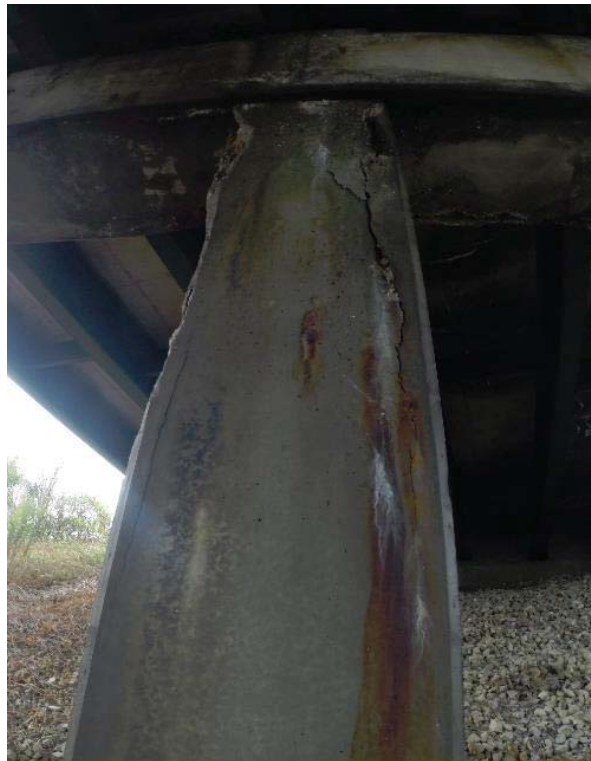
**Figure 21: Other side of middle column. Notice Spalling, cracks and corrosion stains.**

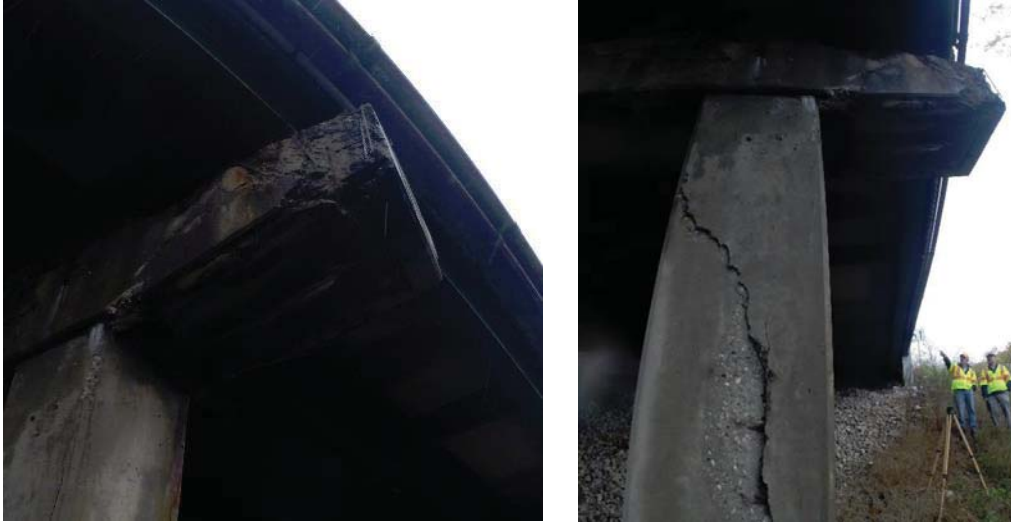
**Figure 22: Spalling on end cap and a large crack on end column**

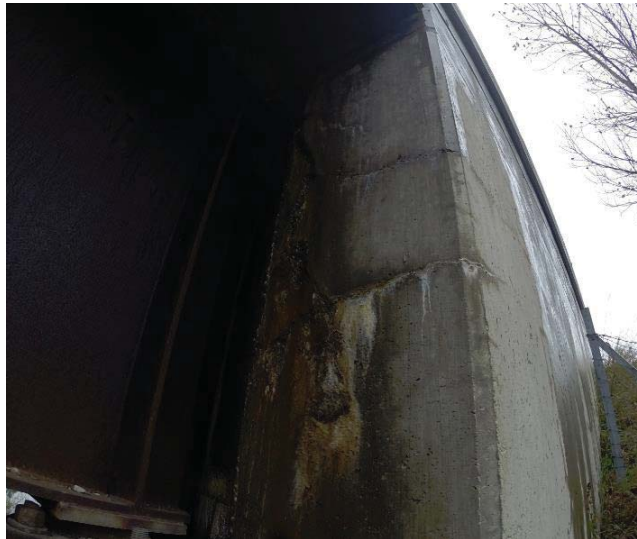
**Figure 25: Scaling and cracking on abutment. Corrosion stains from steel beams**

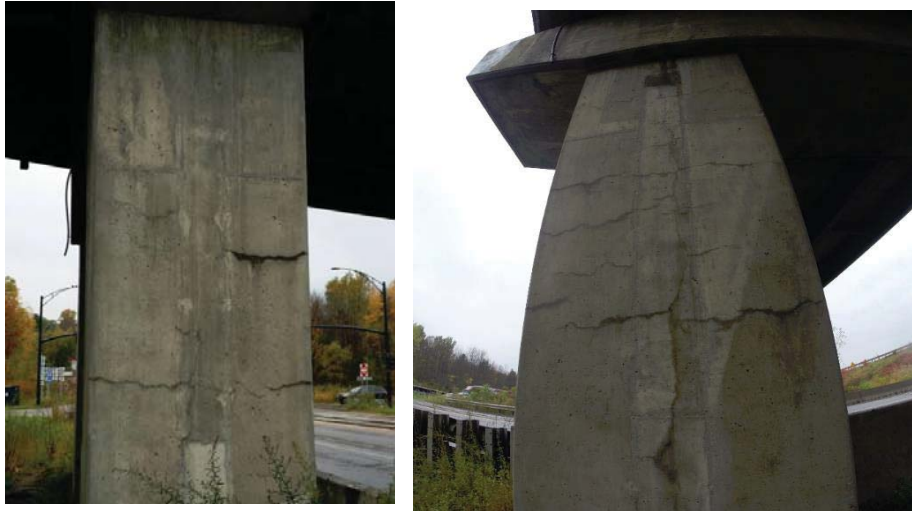
**Figure 26: Possible dry shrinkage cracks on concrete column that has had a 6" thick concrete jacket around column.**

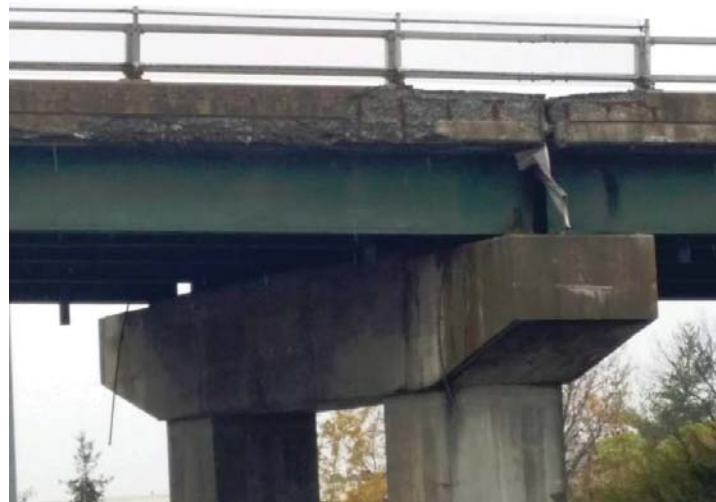
**Figure 27: Spalling and steel corrosion on concrete fascia.**

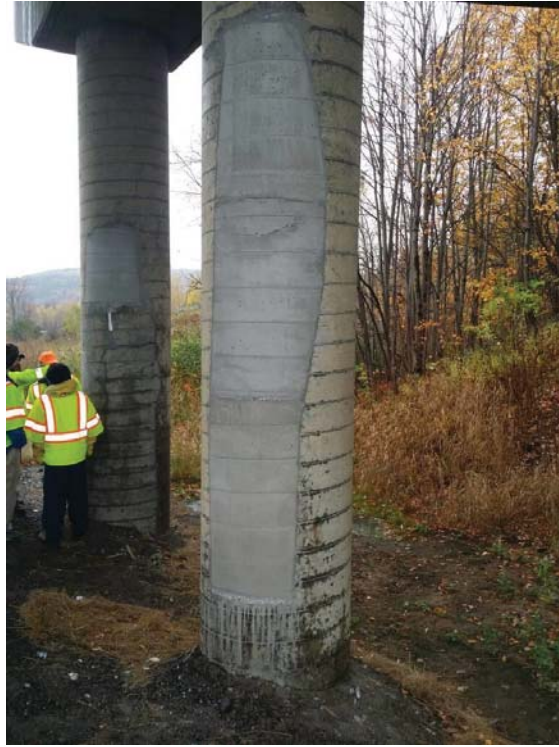
**Figure 28: Patches on columns to fix spalling and cracking.**

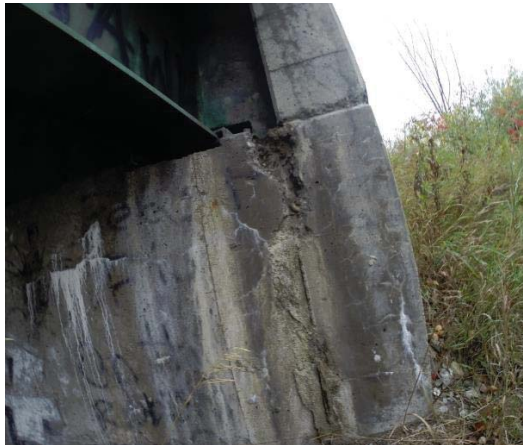
**Figure 29: Scaling on abutment around bearing and beam**

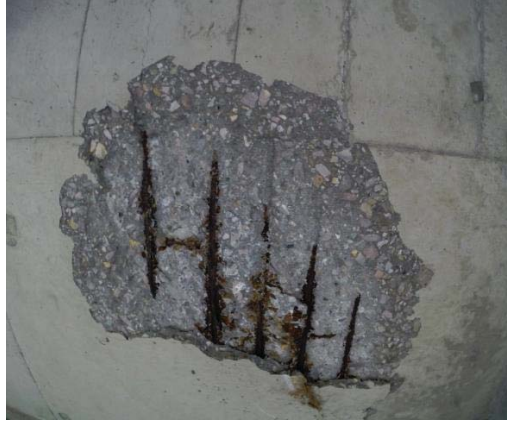
**Figure 30: Spalling and slight steel reinforcement corrosion on underneath portion of concrete deck**

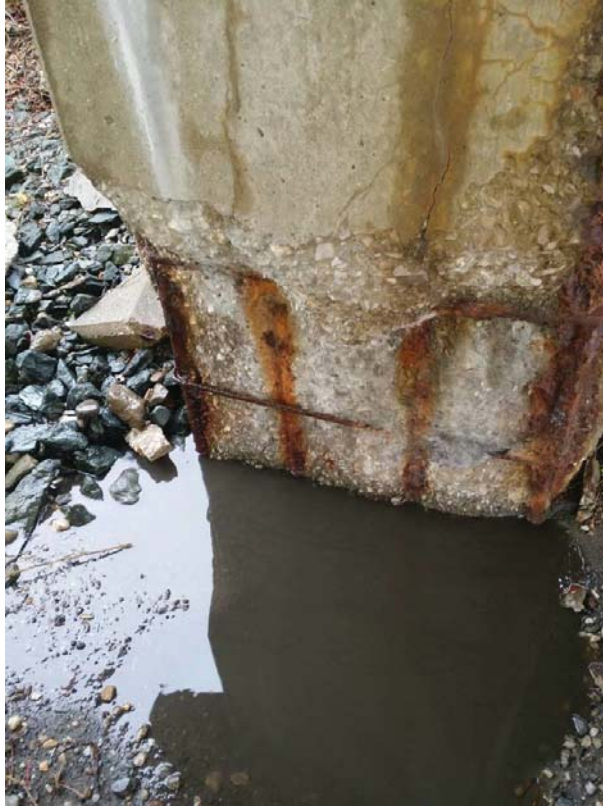
**Figure 31: Severe spalling and steel corrosion on column and footing. Notice that some of the steel reinforcement is non-existing.**

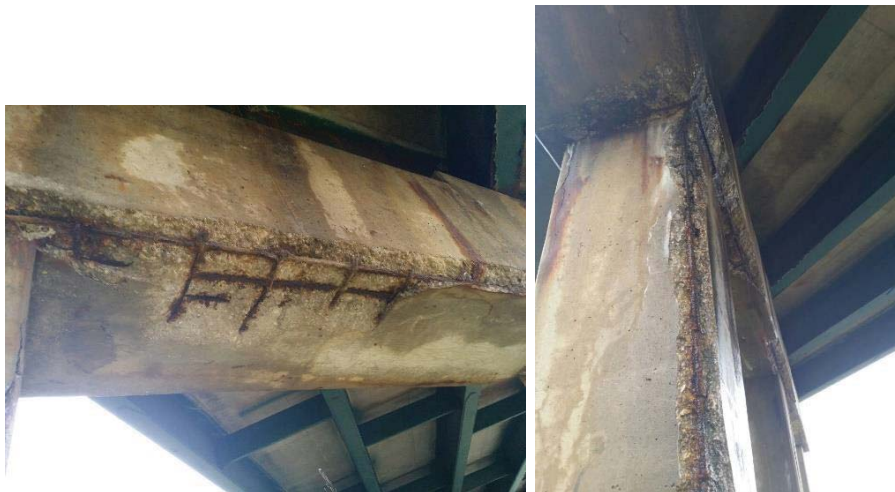
**Figure 32: Spalling and steel corrosion on columns and caps**

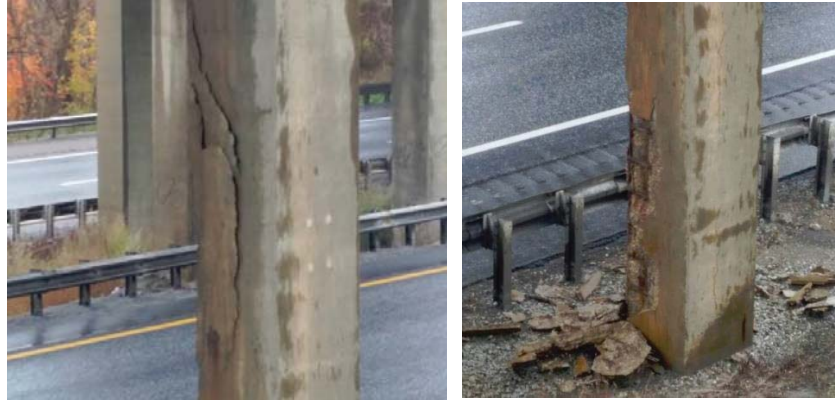
**Figure 33: Spalling and steel corrosion on concrete column. Notice concrete fragments falling near road.**

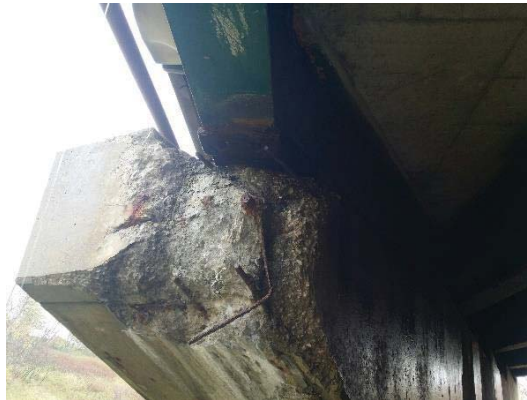
**Figure 34: End cap spalling and steel corrosion with non-existing bearing.**

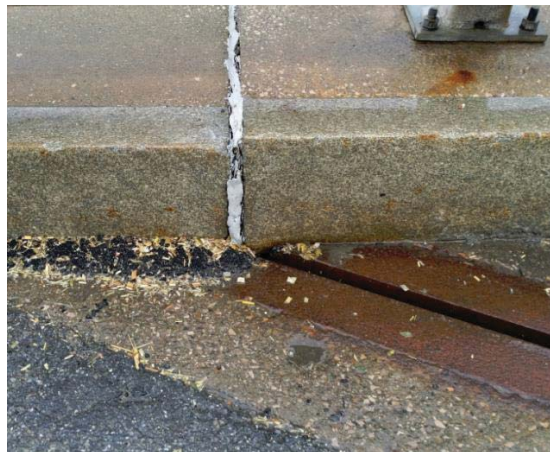
**Figure 35: Bridge deck and expansion joint. Because of non-existing bearing bridge deck has settled down about 1.5”.**

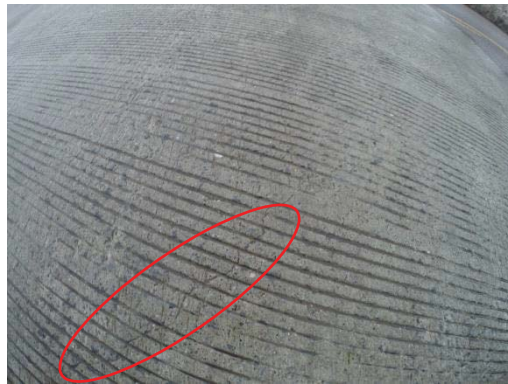
**Figure 37: Crack on Deck Surface. Highlighted by Red Oval**

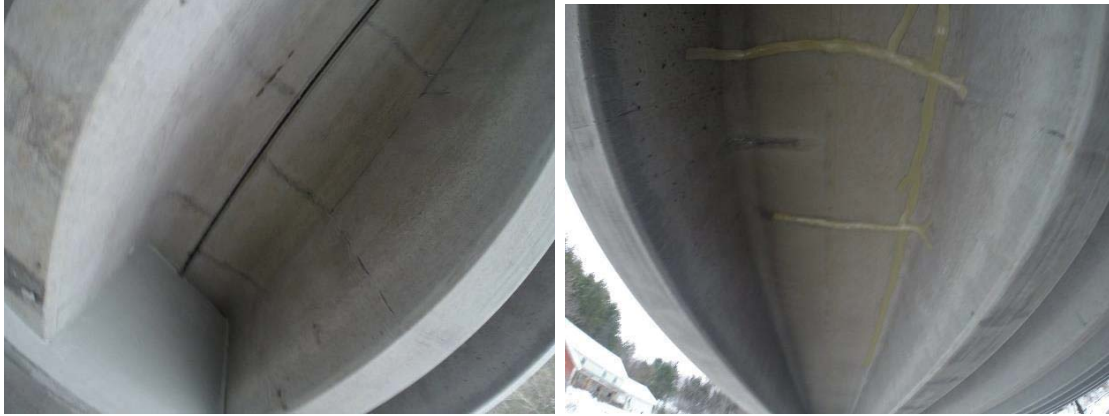
**Figure 38: Underside of Concrete Deck. Left Image: chows cracks going at the way through concrete deck. Cracks are highlighted by red ovals. Right Image: sealant used to seal large cracks.**
