# State Highway 9 Wildlife Crossings Monitoring – Annual Report Year 1

Report No. CDOT-2017-04  
Feb 2017

*Phase 1 Pre-completion Monitoring*

Study Number 115.01

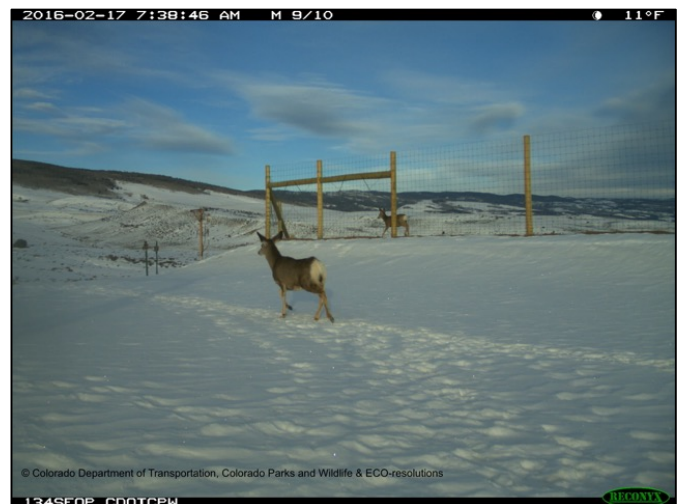
On several occasions mule deer were documented crossing over the North Overpass outside of the wildlife exclusion fence, along the structure edge. A gap in the wildlife fence between the fence and the edge of the structure was blocked with four-strand barbed wire fencing; however, camera monitoring documented that deer trapped in the right-of-way breached the barbed wire and crossed the overpass outside of the fence (Fig. 9).

**Figure 9.** Mule deer crossing over the North Overpass outside of the wildlife exclusion fence.

- **Fence gap on North Overpass.** To prevent mule deer from crossing the overpass outside of the wildlife fence, as documented by camera monitoring, the researchers recommended that the gap between the fence and the structure edge be closed with wildlife fencing. These fence gaps was closed during Phase 2 construction.

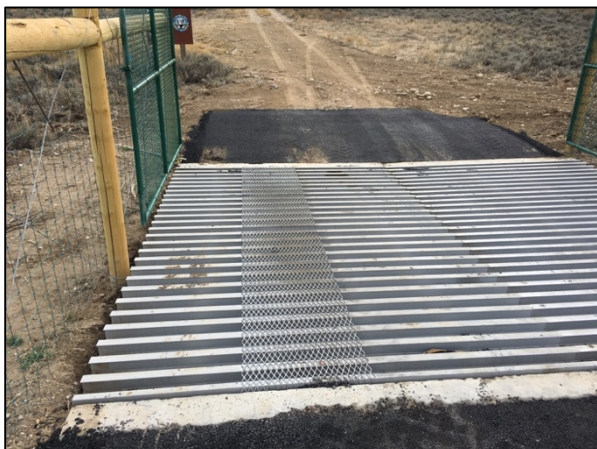
**Figure 10.** Example of a pedestrian grate across a deer guard.

the deer guards in Phase 1. Of these, 68 movements resulted in repels, while 38 times deer were recorded breaching the guard. Most breach movements were made by deer moving from the habitat side of the fence into the fenced right-of-way; however, breach movements were also documented of deer returning to the habitat side from the fenced right-of-way. Five such mule deer movements were captured at the County Road 33 deer guard; one at the Culbreath deer guard, and six at the Trough Road deer guard. Two guards had deer breach rates over 60% (County Rd 33 and Rusty Spur). Only one elk movement was recorded at the Thompson Deer Guard during this timeframe, and that movement resulted in a repel from the guard. Other species documented at the deer guards include badger, domestic cat, hare, raccoon and unknown. Most breach movements by all species were made by walking on top of the bars. On six occasions deer were recorded jumping across the guards. At Trough Road, deer breached the guards on seven occasions by walking across snow that was packed into the guard.

- **Deer guards.** Deer breaches observed in Phase 1 were hypothesized to be the result of 1) deer being able to easily walk on the flat bars, and 2) snow getting trapped between the flat bars and creating a packed surface for deer to walk across. As a result of these observations, CDOT developed a round-bar guard design that was installed at three locations in Phase 2 and was used to replace the flat-bar guards at two locations in Phase 1. This will enable the research team to study the relative effectiveness of the two designs in preventing incursions into the fenced right-of-way by deer and other wildlife

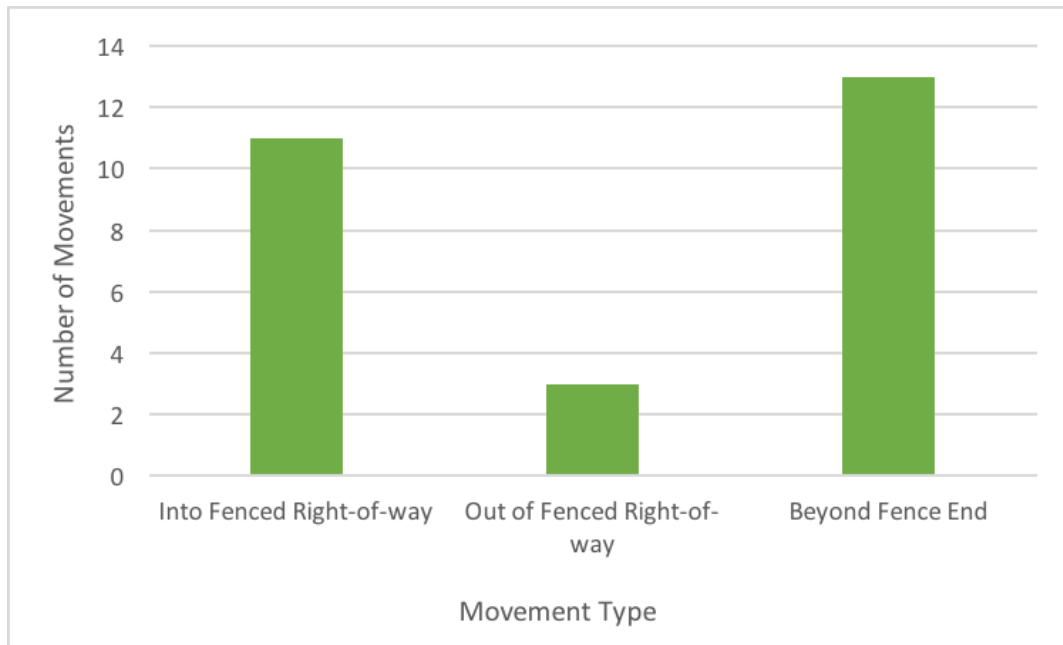
A total of 35 wildlife movements were recorded at the fence end, including 27 movements by mule deer and eight movements by red fox. The majority of mule deer movements occurred beyond the fence end (n=13), but 11 deer movements were documented moving from the habitat side of the fence into the fenced right-of-way (Fig. 12). Movements into the fenced right-of-way occurred when deer moved from the habitat side of the fence and either walked around the fence into the right-of-way or crossed the road and entered the right-of-way on the opposite side. Movements out of the fenced right-of way occurred when animals already inside the wildlife fence moved out to the habitat side of the fence. Movements beyond the fence includes movements where animals crossed the road beyond the fence end as well as those where the animal did not cross the road, but repelled from the road and remained beyond the fence end.

*Figure 12.* Mule deer movements at the temporary south fence end.
