ENHANCED CULVERT INSPECTIONS BEST PRACTICES

Guidebook

Author: Doug Youngblood, CDM Smith
Report Number: 2017-16
Date Published: June 2017

1. Report No. MN/RC 2017-16		2.		3. Recipients Accession No.	
4. Title and Subtitle Enhanced Culvert Inspections – Best Practices Guidebook				5. Report Date June 2017

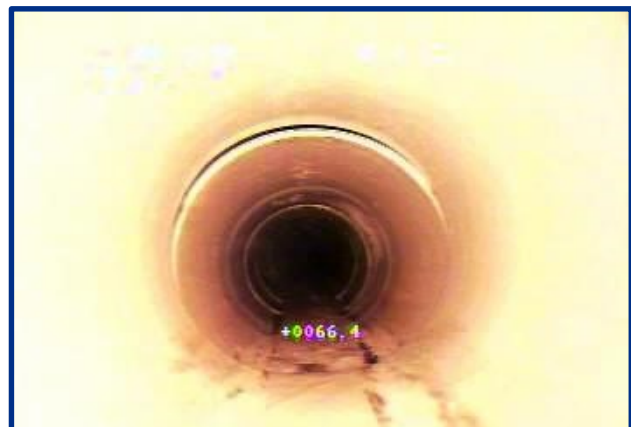
Figure 5.5 – CCTV Image with Too Much Light

crown condition. Over-lighting will wash out small damage on the culvert walls (**Figure 5.5**). Under lighting will prevent an inspector from identifying all damage.

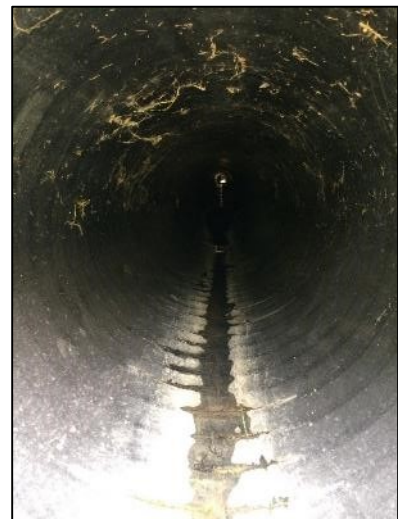
Figure 3 – Visual Inspection of Culvert ID 410672 indicates no major deformations impacting the culvert cross section.

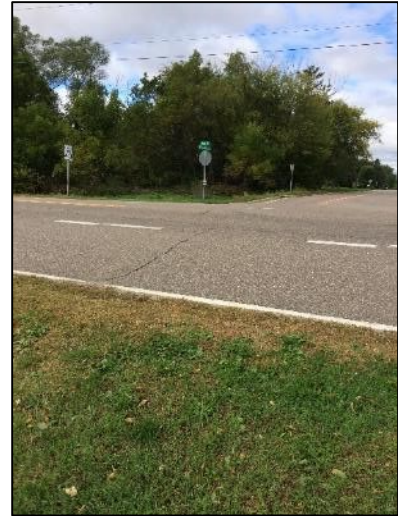
Figure 4 – A crack was observed in the road above Culvert ID 206853. This crack correlates with the culvert alignment.

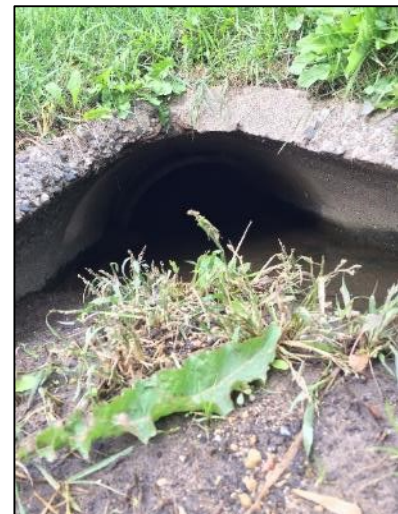
Figure 5 –Culvert ID 206853 was full of sediment. The CCTV camera could not inspect this culvert.

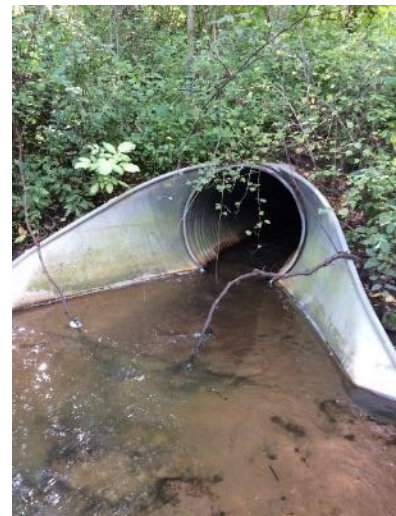
Figure 7 – Culvert ID 651309 had a severely corroded invert. The inspection camera could not travel through the culvert.

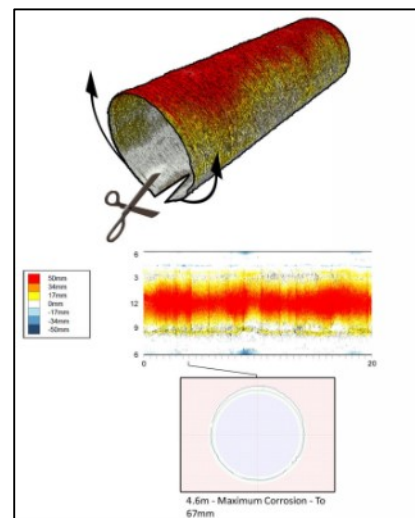
Figure 11 – Example topographic map showing culvert corrosion
