FINAL REPORT

Evaluation and Validation of Aboveground Techniques for Coating Condition Assessment

CC TECHNOLOGIES, INC GREGORY RUSCHAU, PH.D. ANGEL KOWALSKI

FEBRUARY 28, 2006

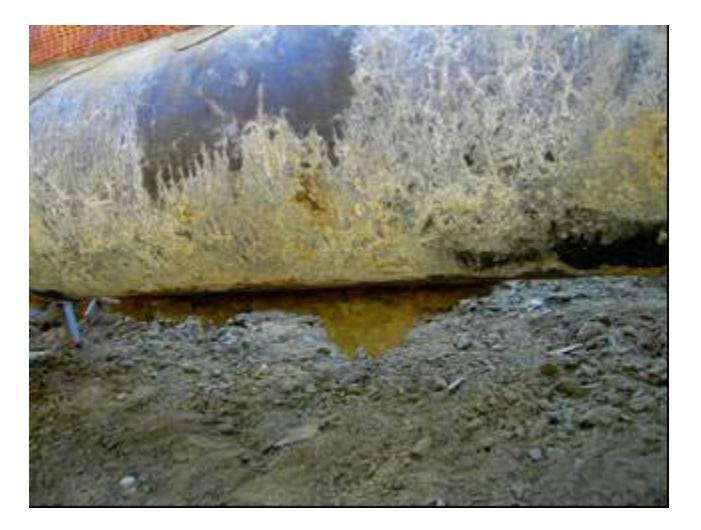
Figure 14: Indications 1 & 2: From dig stake distances 36' to 46', coating was entirely disbonded on the underside of the pipe.

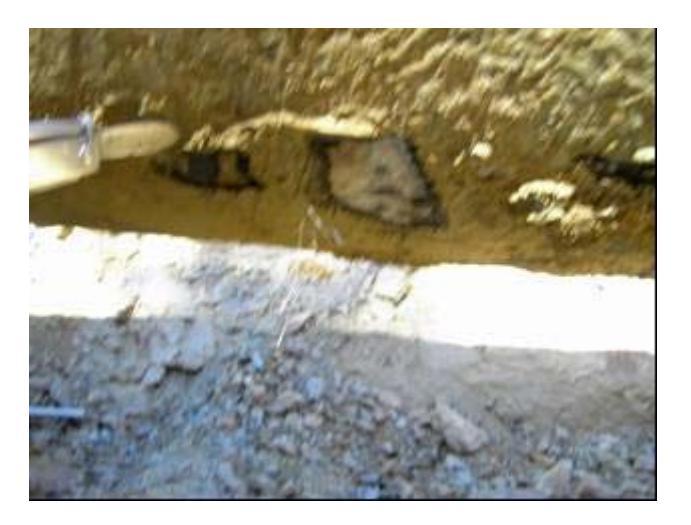
Figure 15: Indication #3: There were 3 small (~3" diameter) disbonded patches just above the 6 o'clock position on the pipe

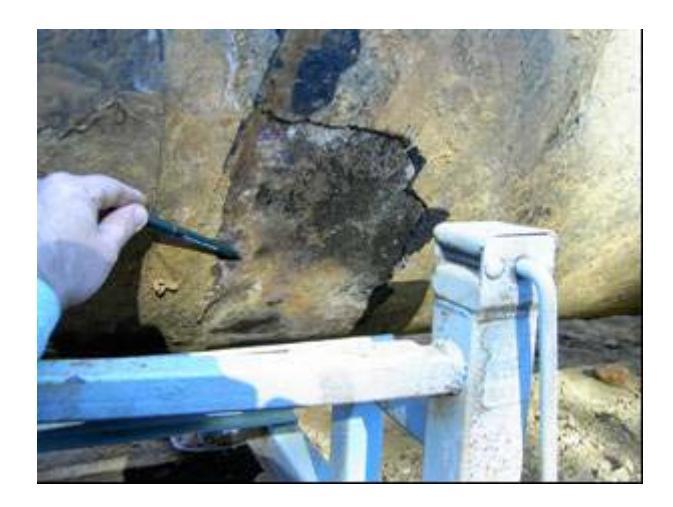
Figure 16: Indication #4: A large disbonded area about 1 square foot total, from 6 o'clock to 9 o'clock on the pipe.

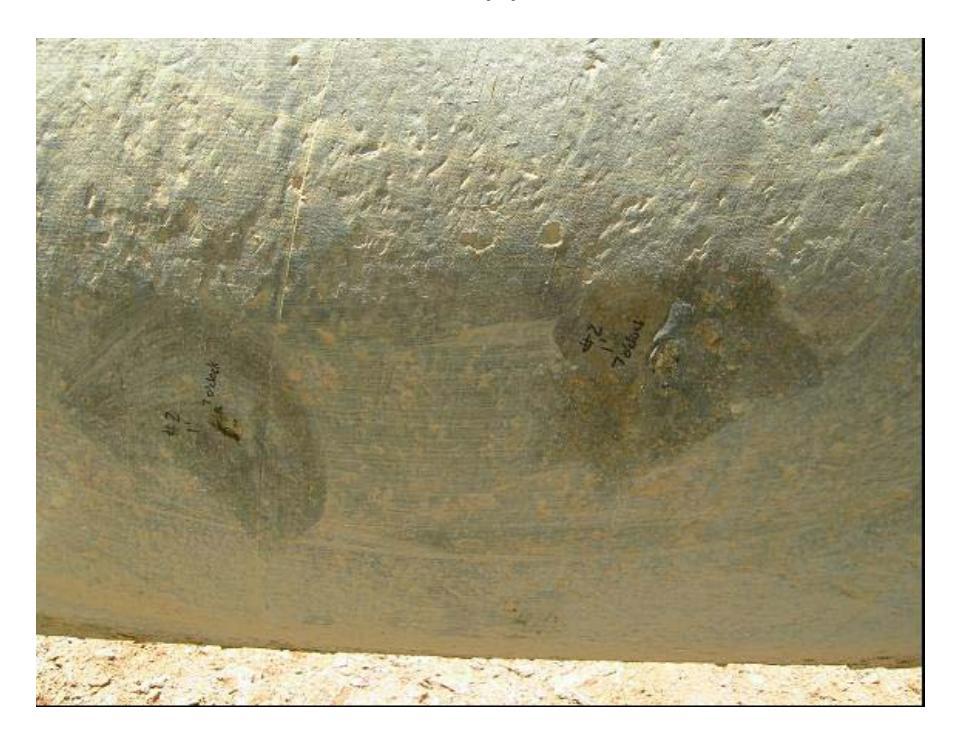
Figure 17: Indication 2A-1: 2 small gash marks at the 7 o'clock position

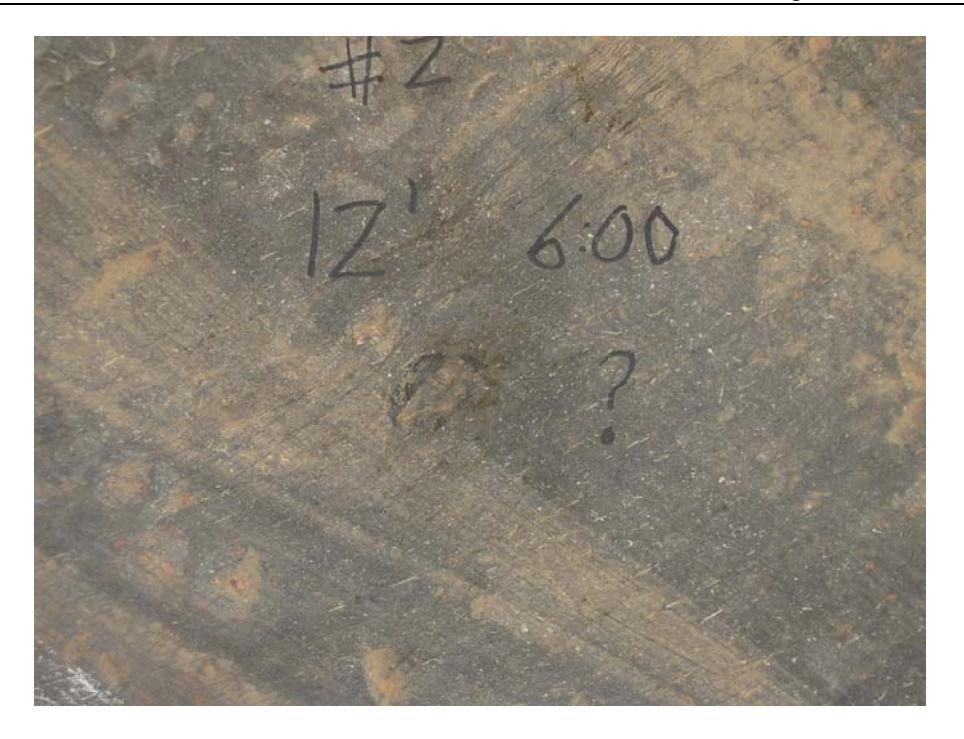
Figure 18: Indication 2A-2: One mark at 6 o'clock position

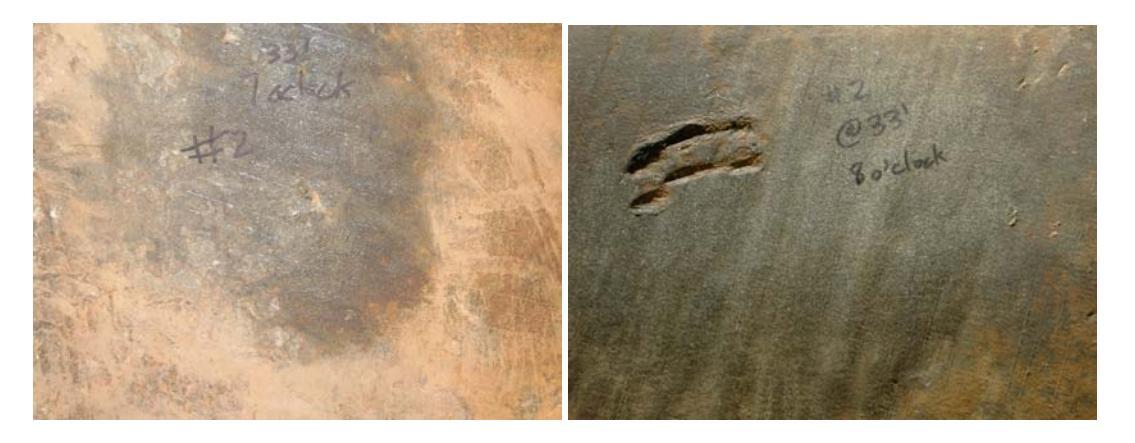
Figure 19: Indication 2A-4: Two marks at the 7 and 8 o'clock positions

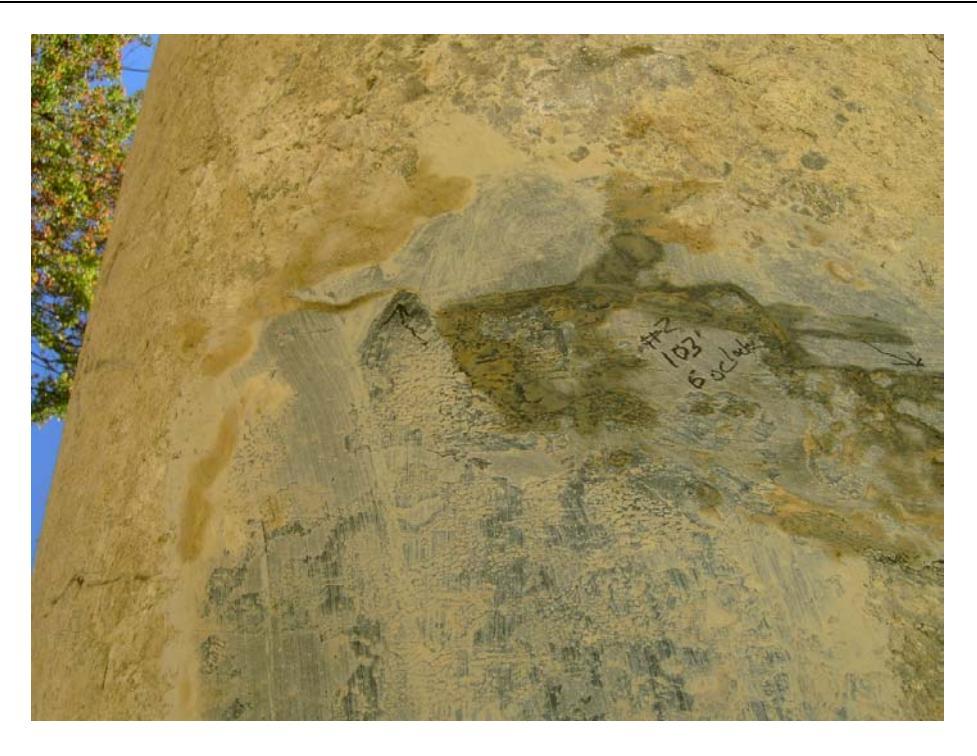
Figure 20: Indication 2A-5: A seam was noticed at 6 o'clock, but no obvious holiday

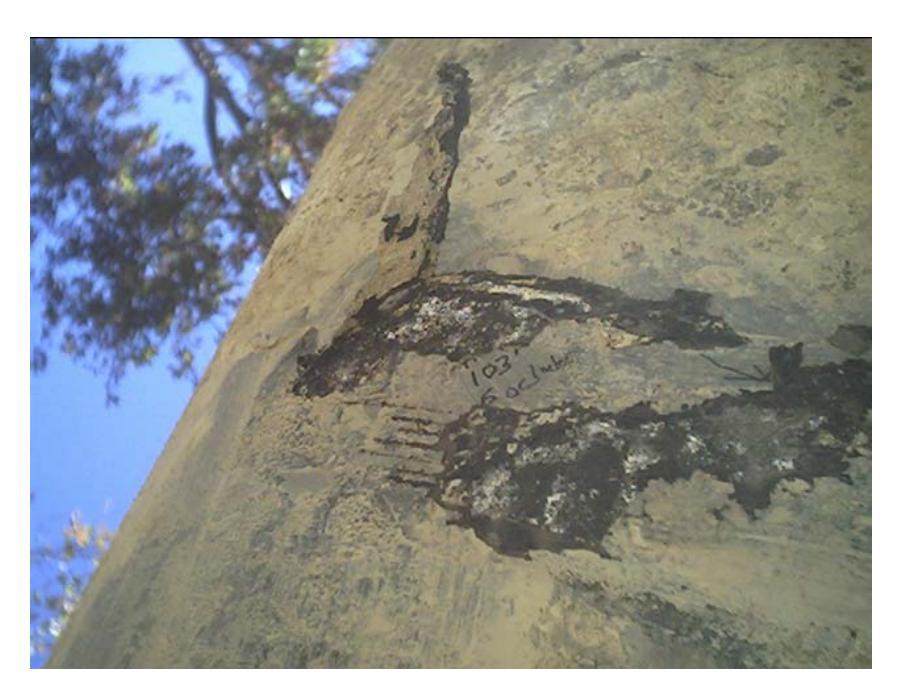
Figure 21: Indication 2A-5, after the coating was removed by a pocket knife.

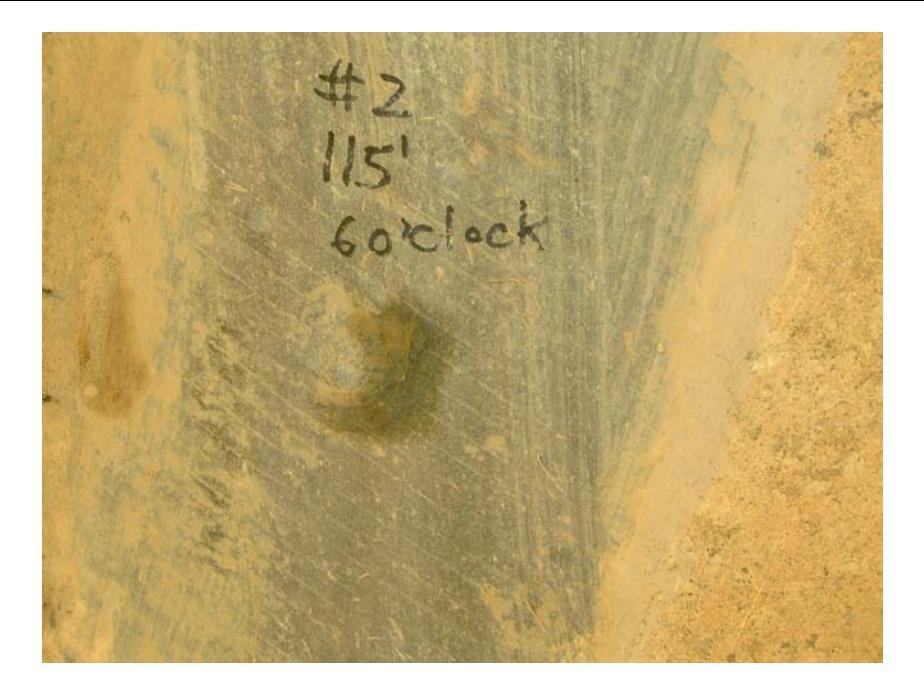
Figure 22: Indication 2A-6: small "ding" at 6 o'clock

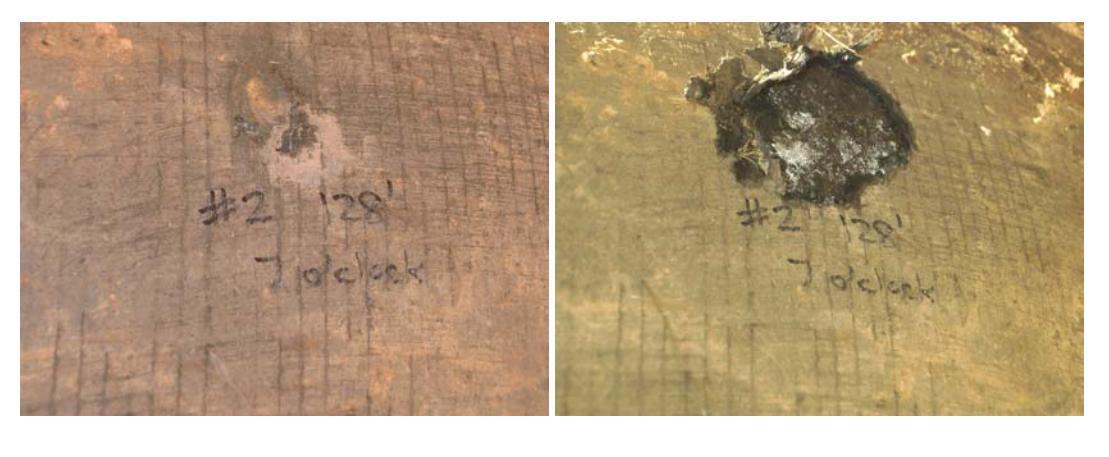
Figure 23: Indication 2A-7 (a) as-noted, and (b) calcareous deposits noted after coating removal

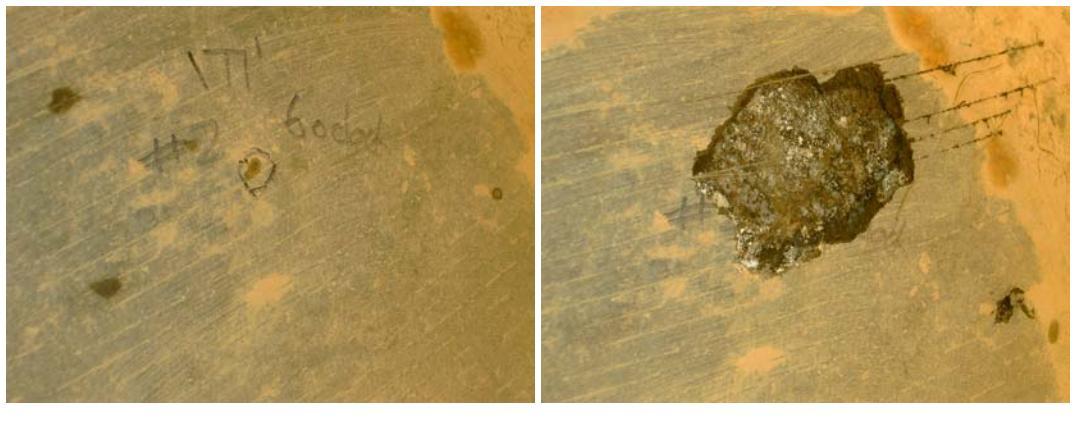
Figure 24: Indication 2A-9 (a) as-noted, and (b) calcareous deposits noted after coating removal

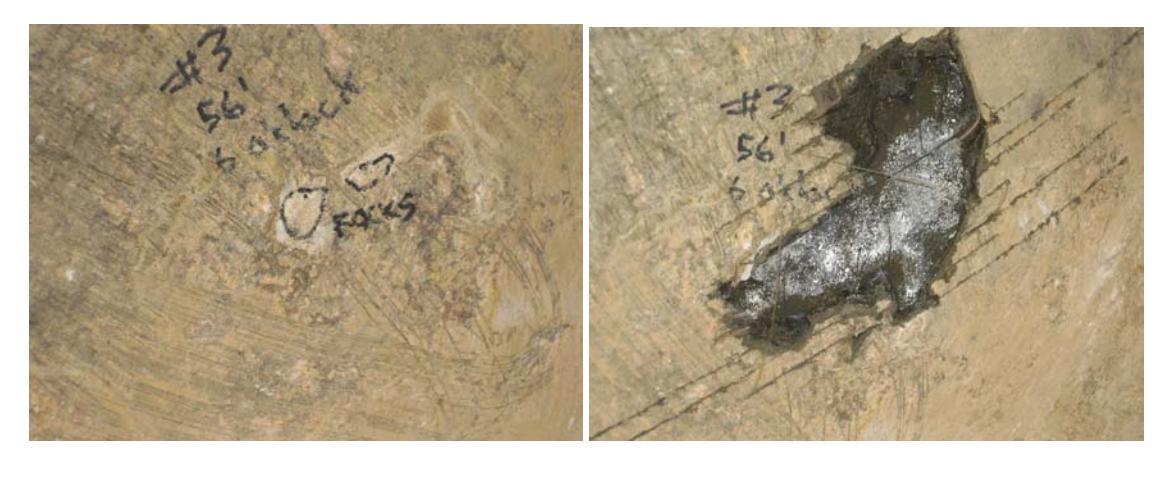
Figure 25: Indication 2B-1 (a) as-noted, and (b) calcareous deposits noted after coating removal

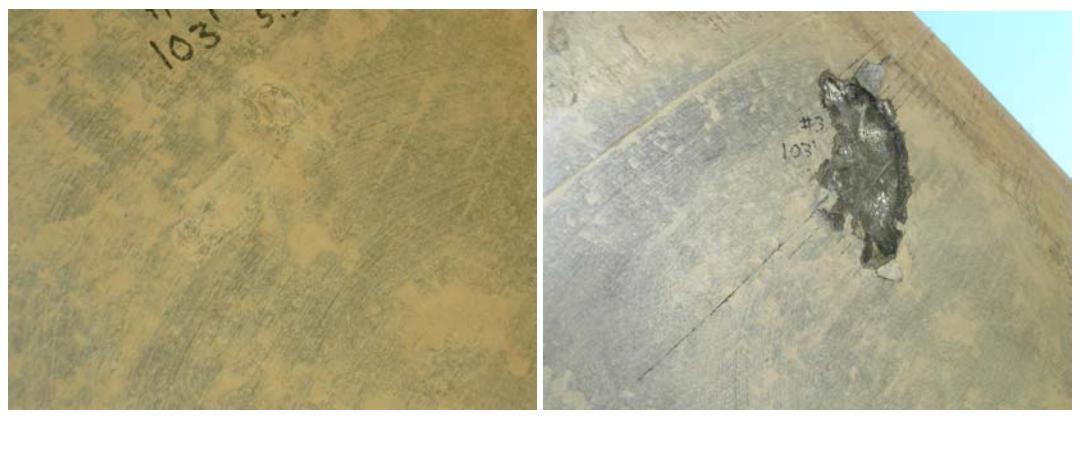
- (b)
- Figure 26: Indication 2B-3 (a) as-noted, and (b) calcareous deposits noted after coating removal

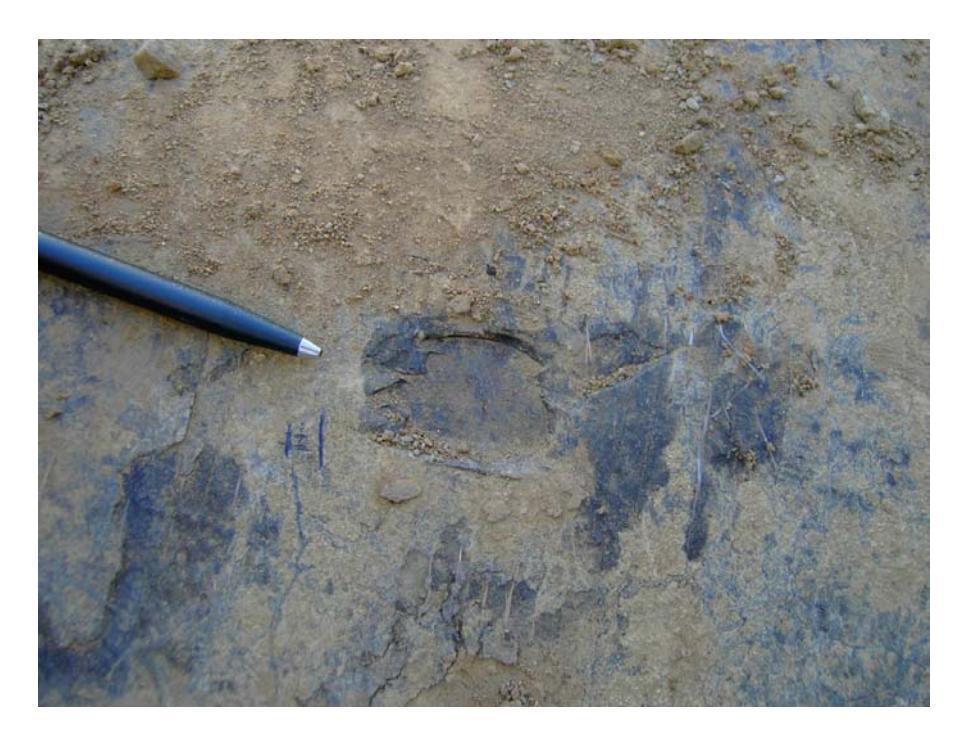
Figure 27: Site 1, undetected holiday, 1" diameter hole at 1 o'clock, 125'

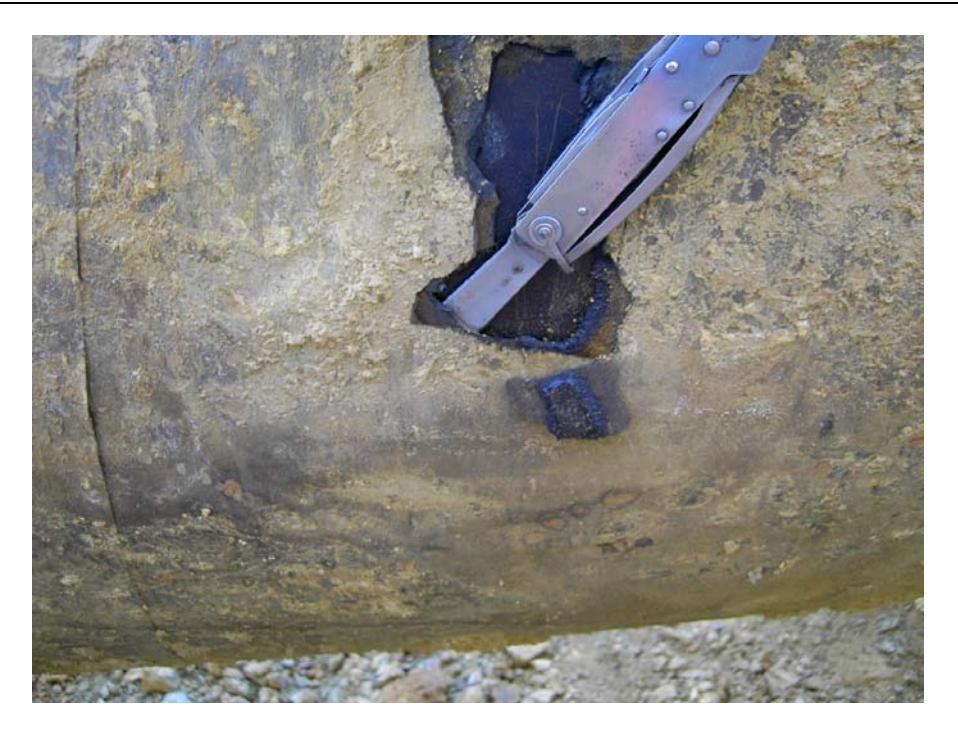
Figure 28: Site 1, undetected holiday, 2 o'clock position, 72' from dig stake

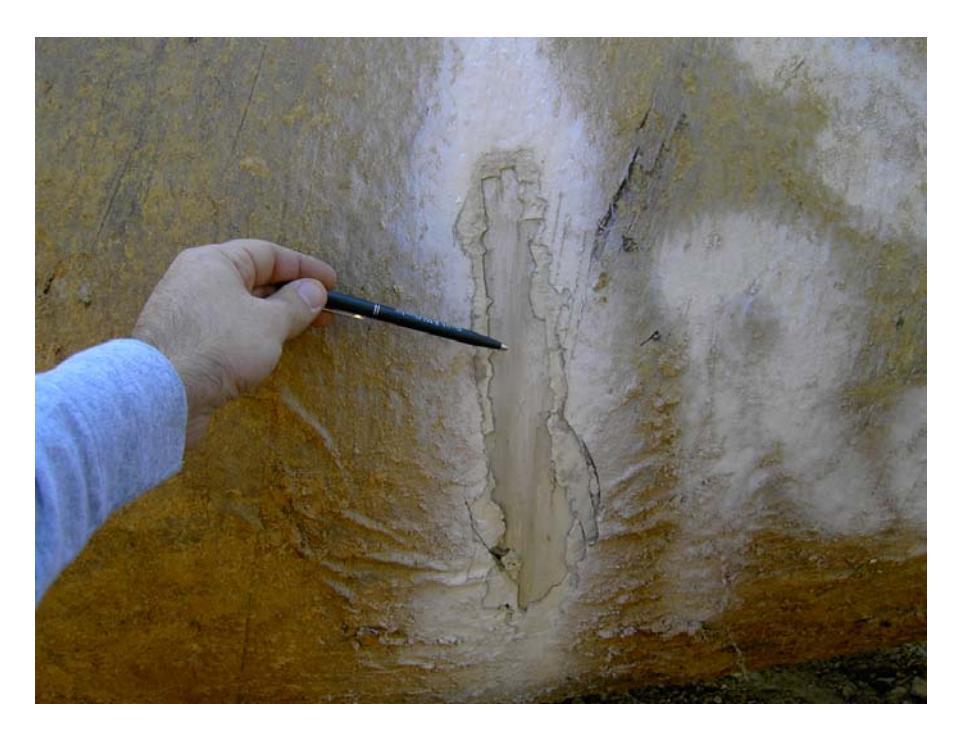
Figure 29: Site 1, undetected holiday, 3 o'clock position at 50'

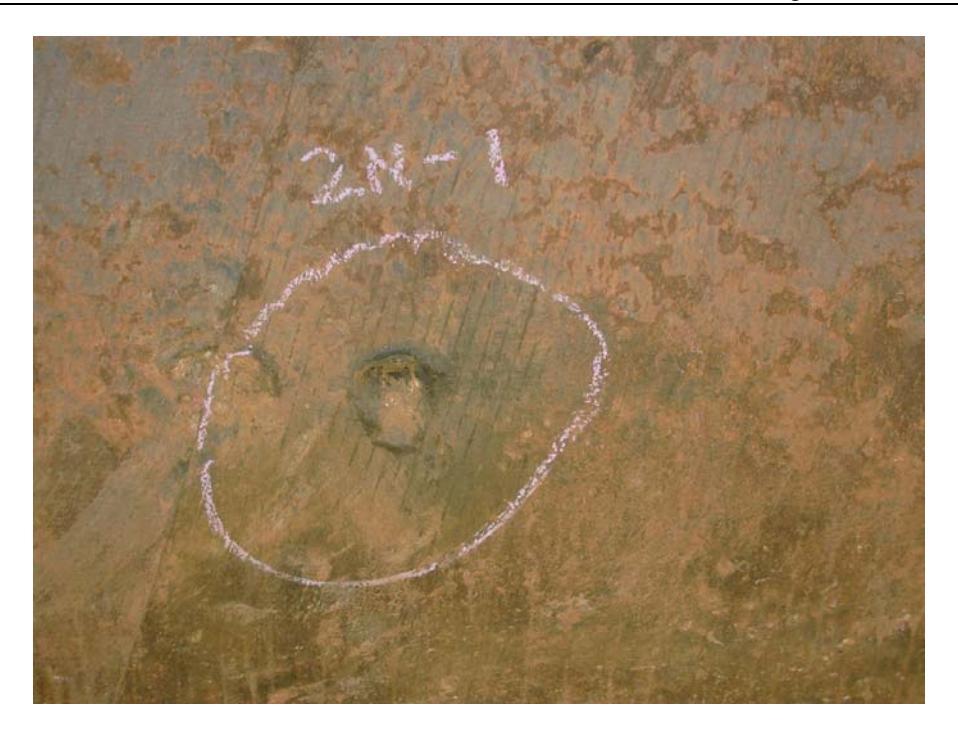
Figure 30: Site 2a, undetected holiday, 10 o'clock position, ¼" diameter holiday @ 3'

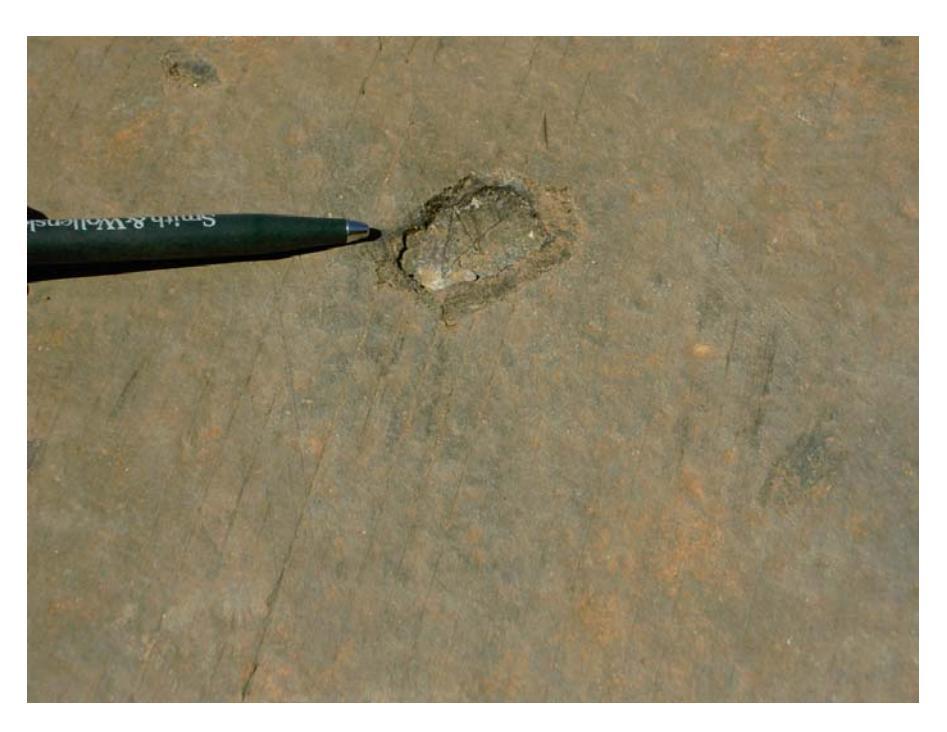
Figure 31: Site 2a, undetected holiday, 11 o'clock position, 1" diameter at 8' from dig

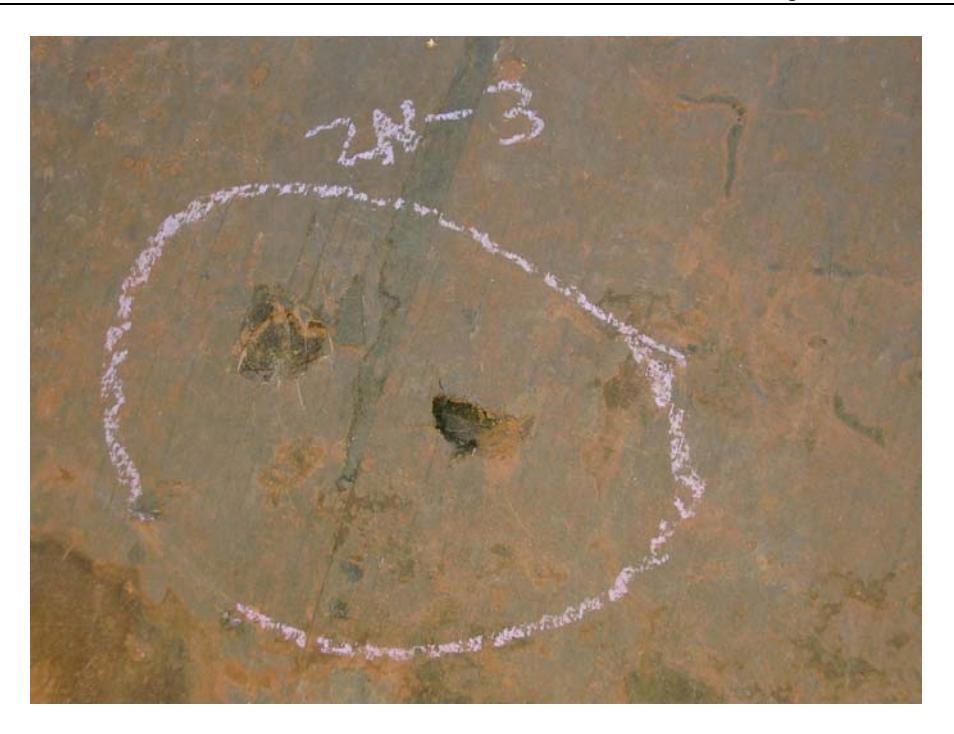
Figure 32: Site 2a, undetected holiday, 1" diameter hole at 7 o'clock, 44' from dig stake

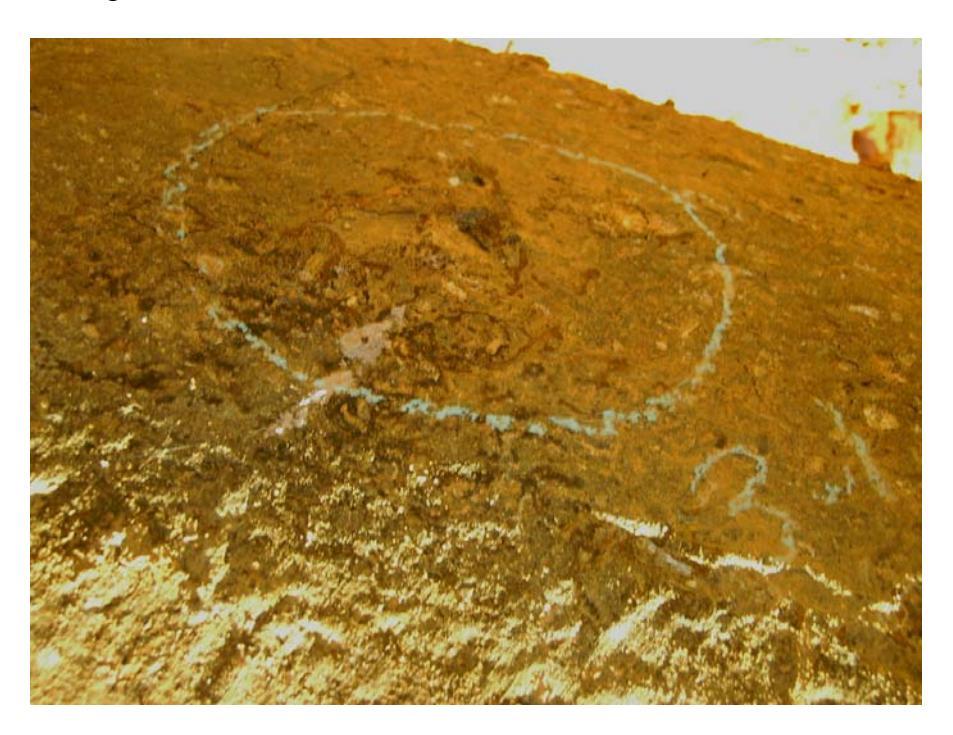
Figure 33: Site 2b, undetected holiday, 7 o'clock position, ¼" gouge at 9'6" from dig stake

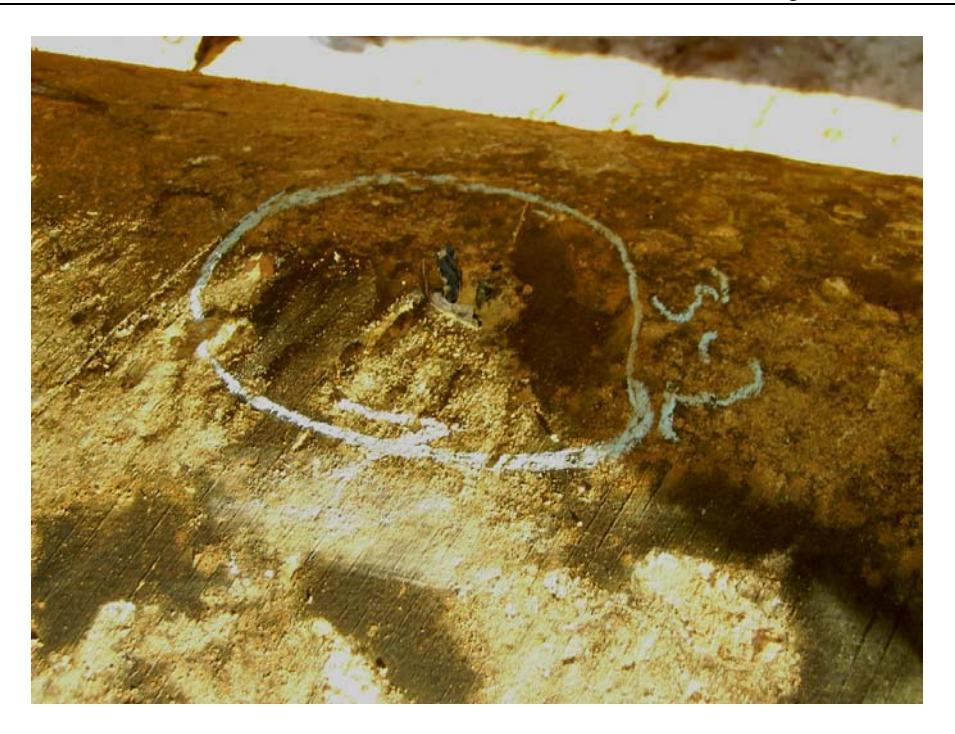
Figure 34: Site 2b, undetected holiday, 7 o'clock position , ¹/₄" gouge, 17' from dig stake

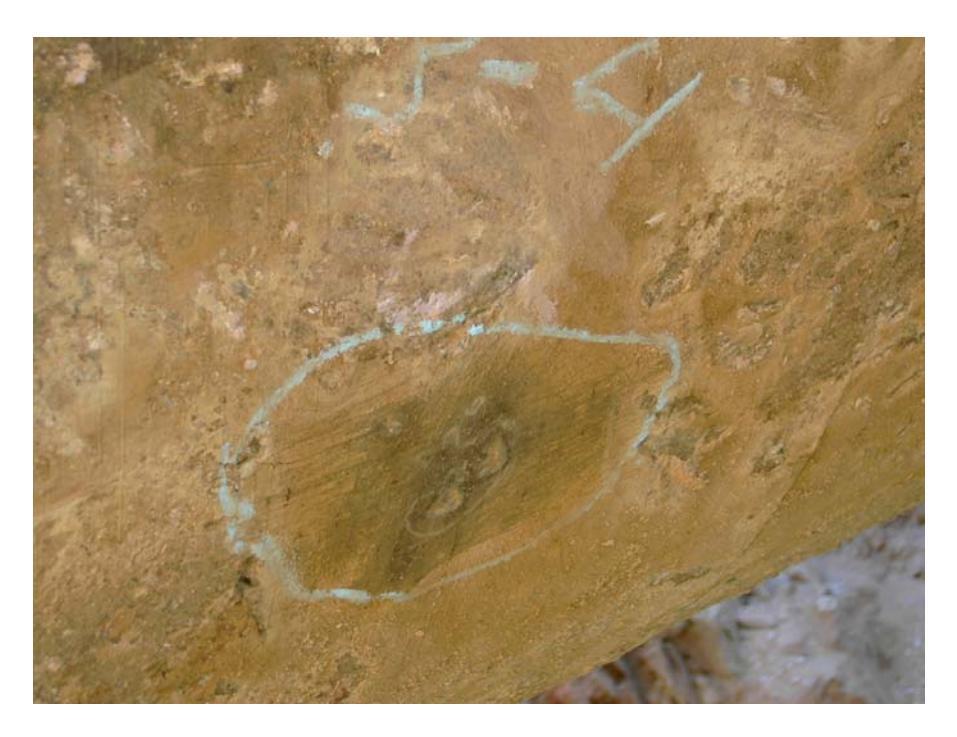
Figure 35: Site 2b, undetected holiday, 5 o'clock position, 2 parallel gouges at 47' from dig stake

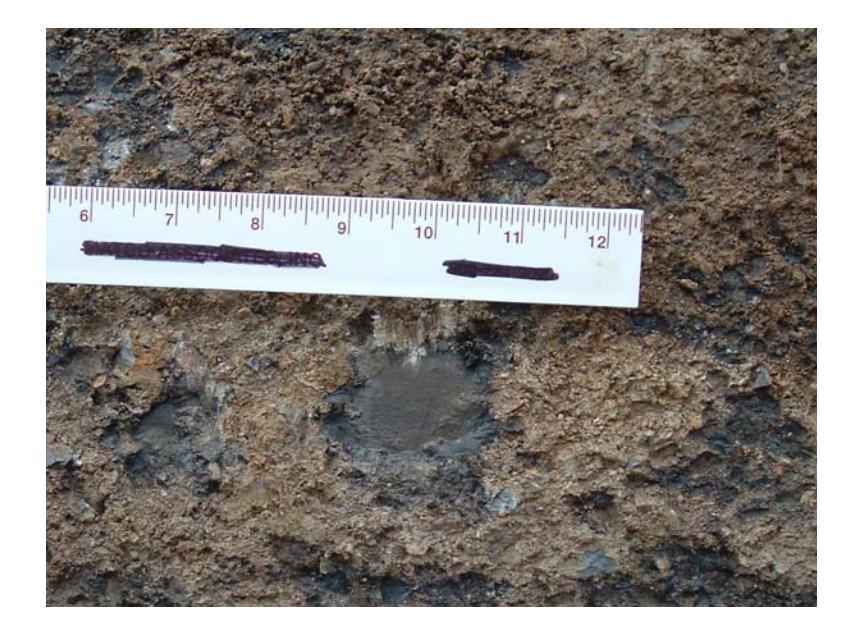
Figure 36: Holiday indication 3a-1 (indicated by DCVG, ACVG) at 10 o'clock position

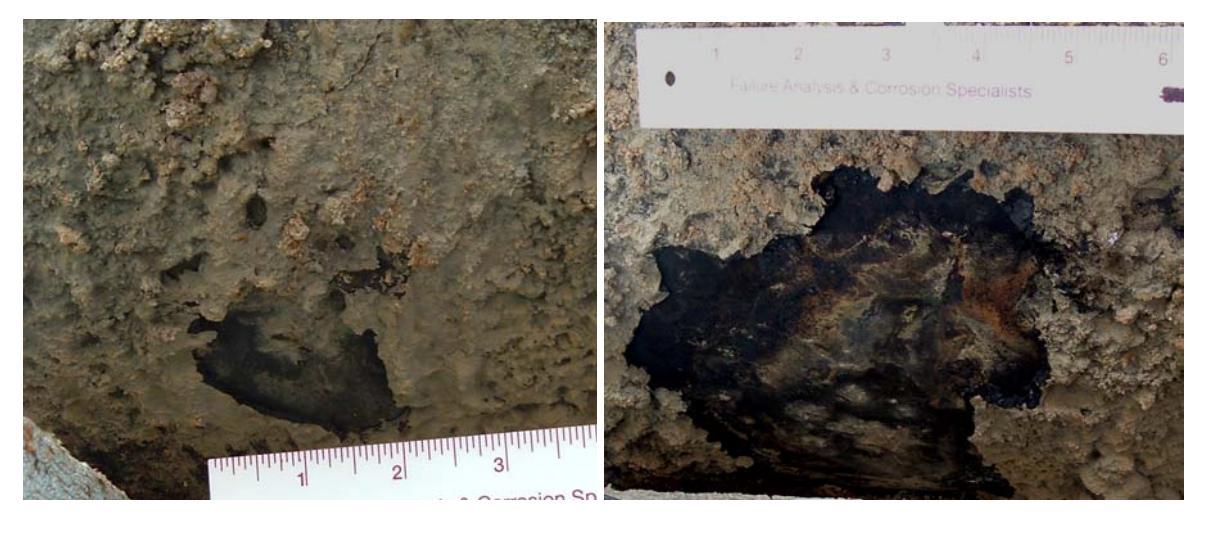
Figure 37: Holiday indication 3a-2 (indicated by DCVG, ACVG, Pearson) at 6 o'clock position (a) as-found after excavation, and (b) after removing unbonded coating

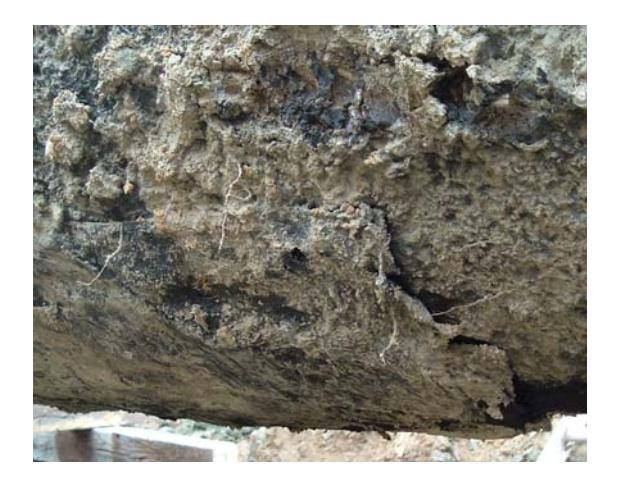
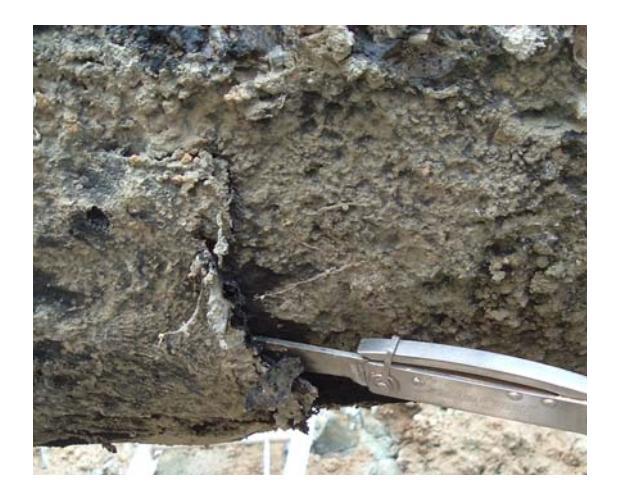
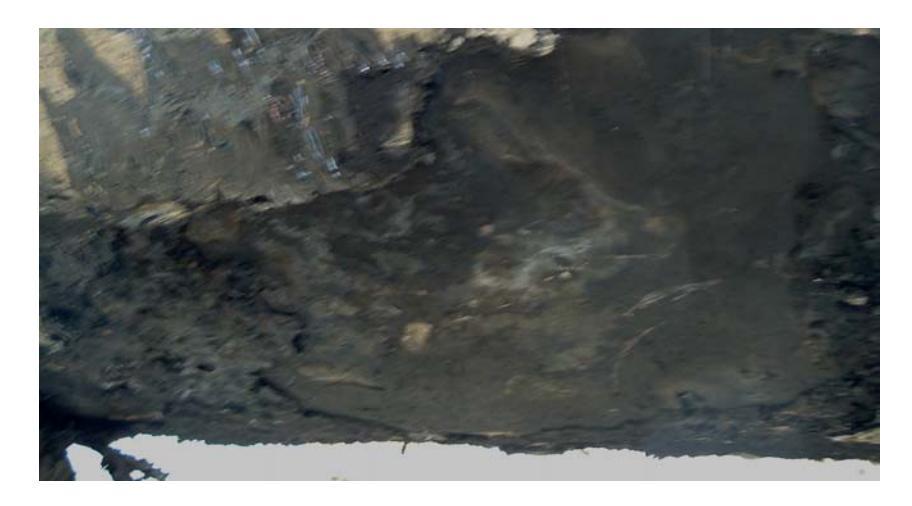
Figure 38: Indication 3a-3, a coating overpatch near the 6 o'clock position, (a) as uncovered, (b) after prodding, and (c) after patch was removed

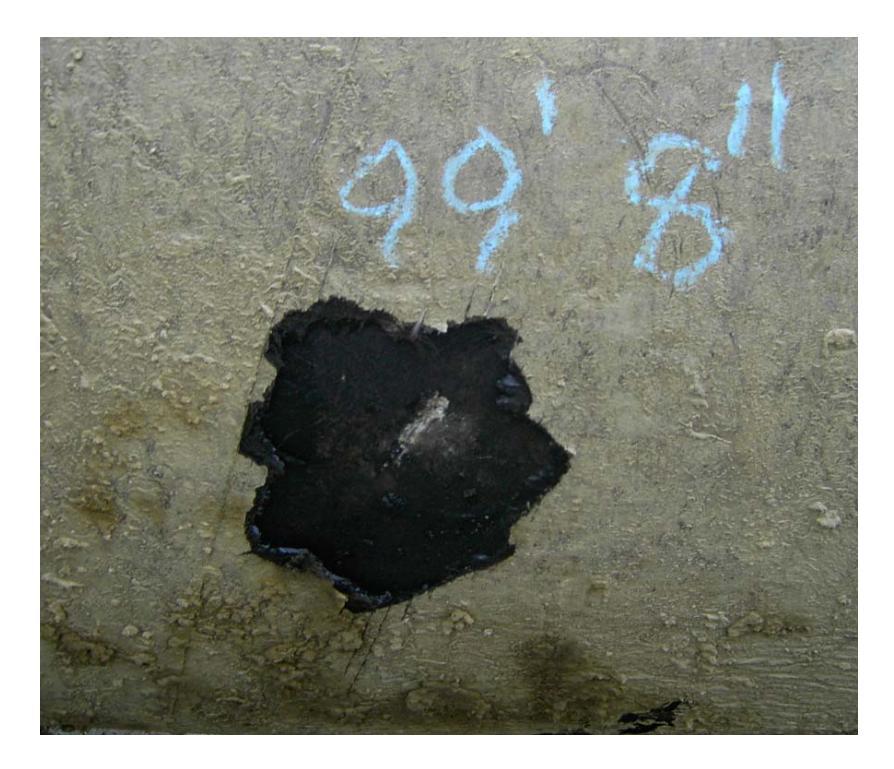
Figure 39: Holiday near 3b-1 found by DCVG, ACVG, 2 o'clock position

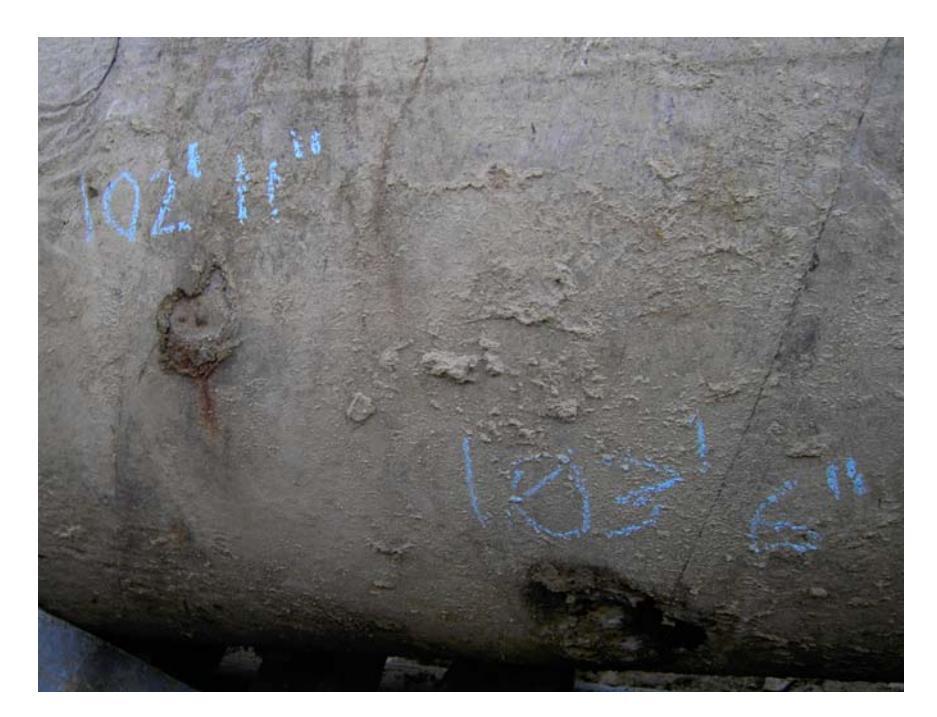
Figure 40: Defects found near 3b-1 indication, 8 o'clock position

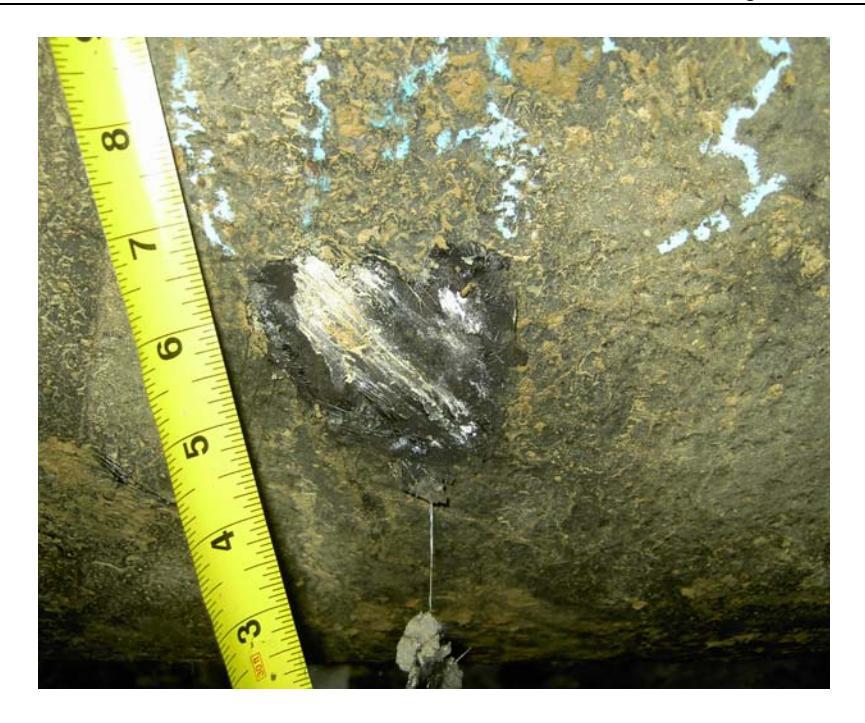
Figure 41: Indication 3b-2 at 114', 9 o'clock position

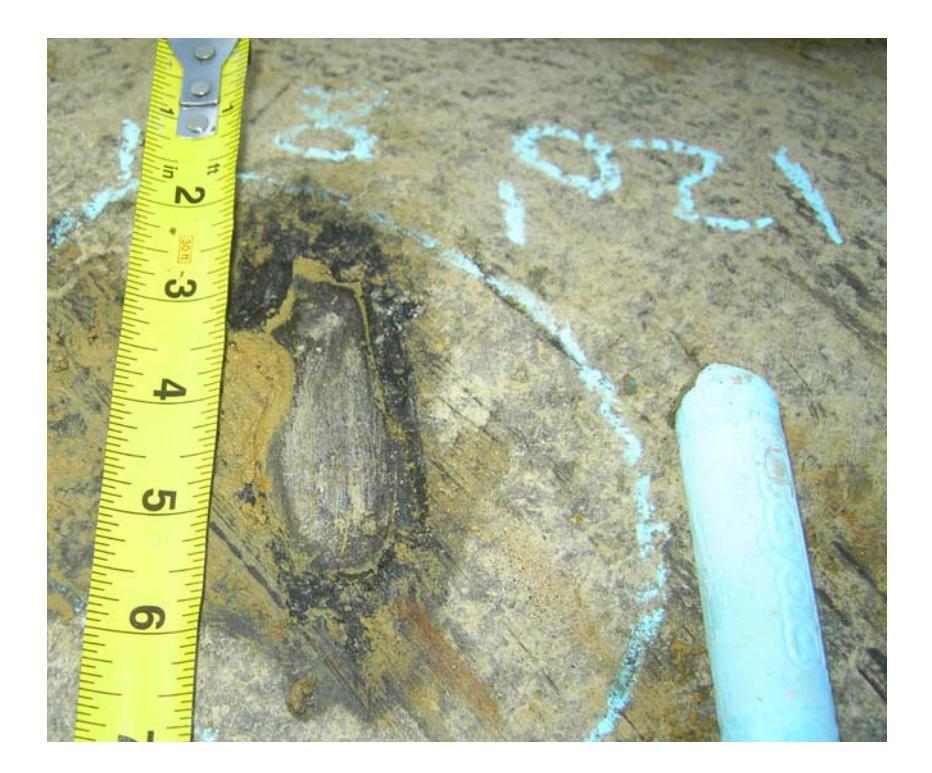
Figure 42: Indication 3b-3, 12 o'clock position

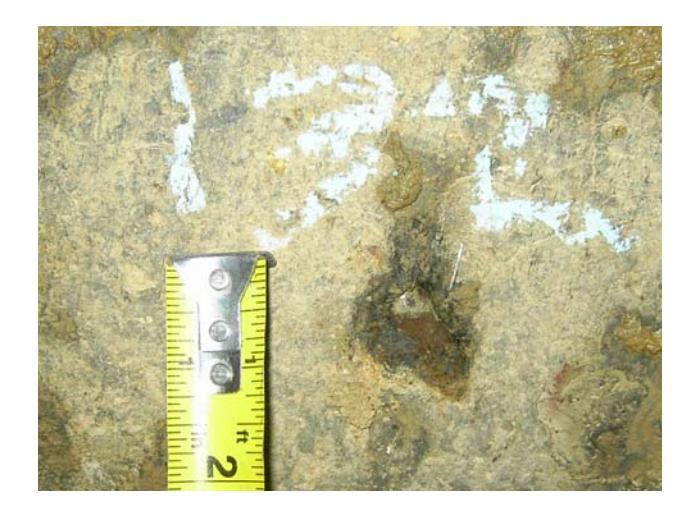
Figure 43: Indication 3b-4, 10 o'clock position

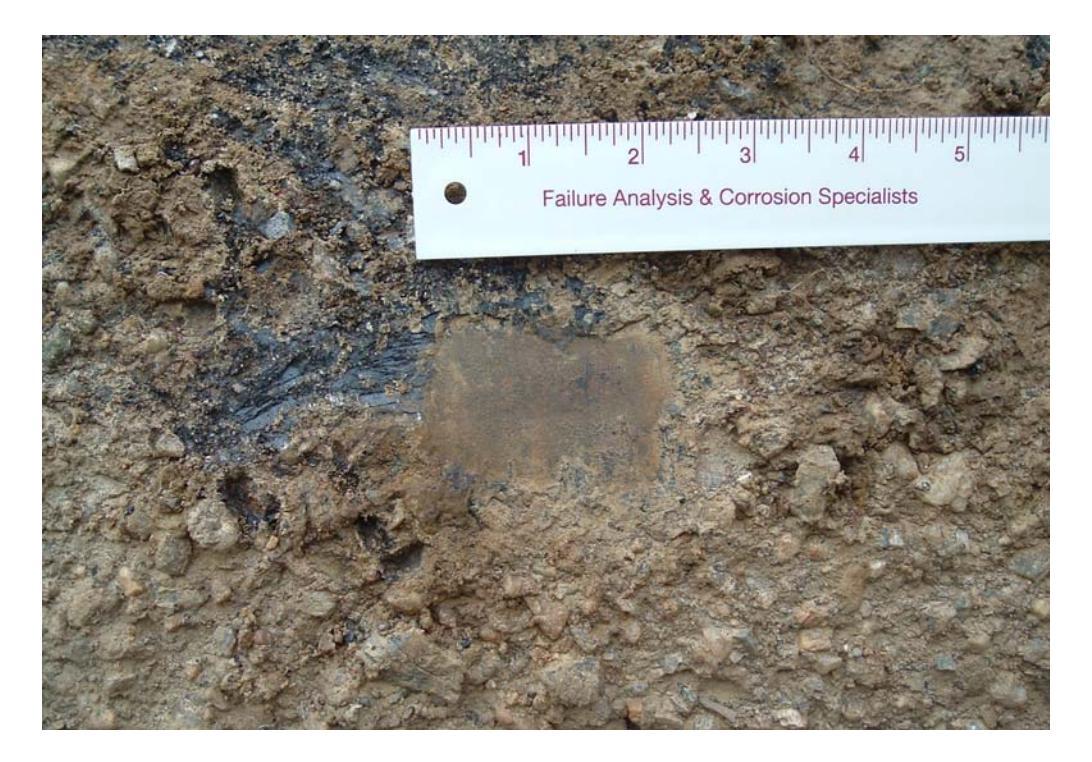
Figure 44: Holiday from site 3a not indicated during survey, 10 o'clock position (14')

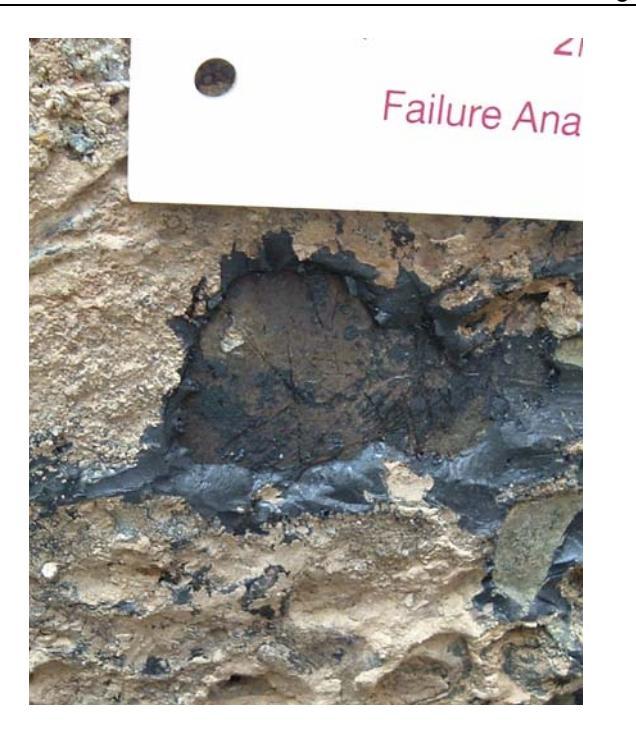
Figure 45: Site 3a undetected holiday at 28', 8 o'clock position

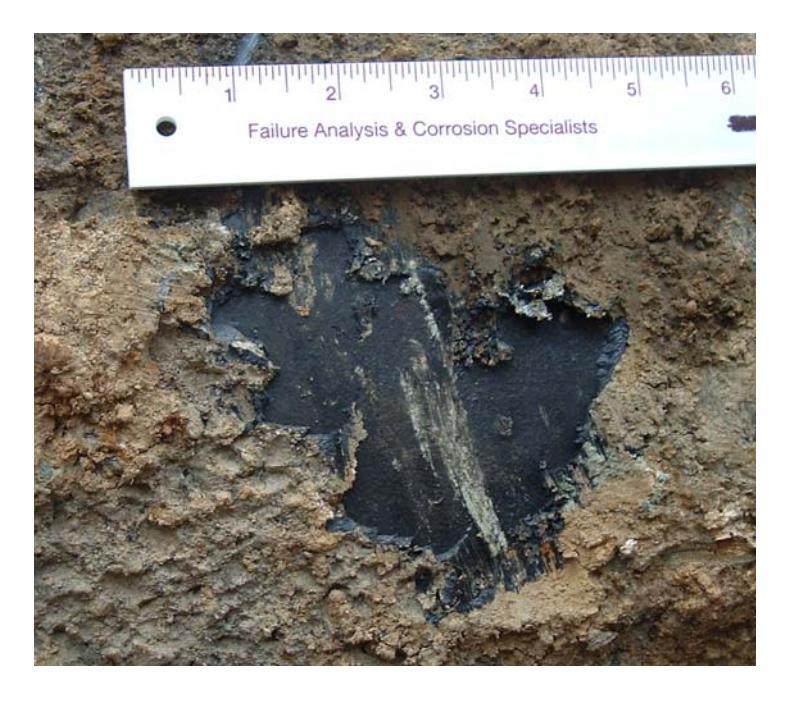
Figure 46: Site 3a undetected holiday at 52', 9 o'clock position

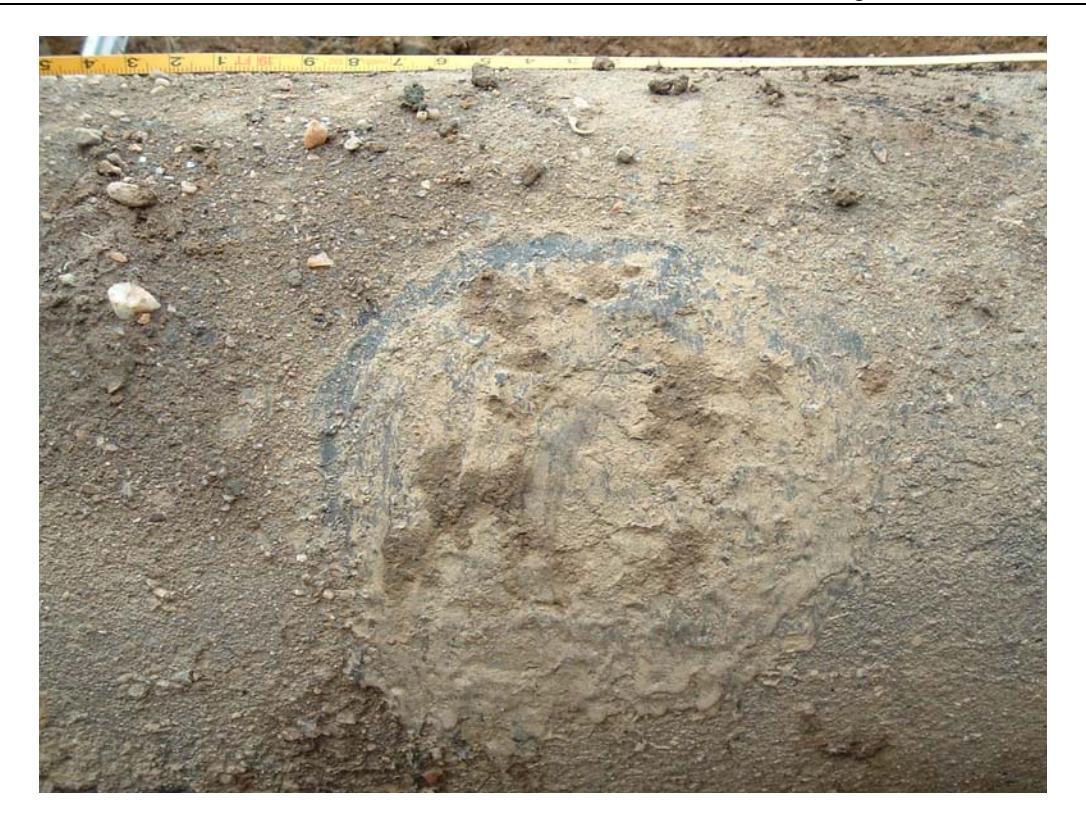
Figure 47: Site 3a large circular holiday not detected by survey, 9 o'clock position (possible patch?) at 18'

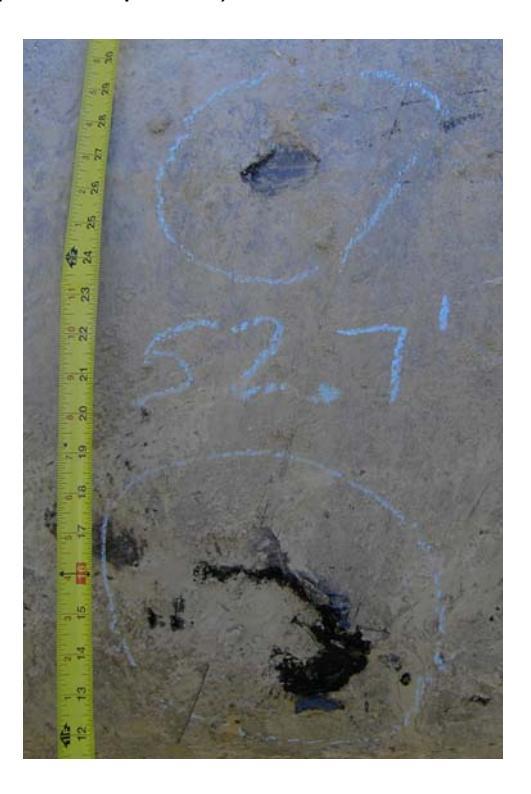
Figure 48: Site 3b undetected damage found at 53', 8 and 10 o'clock positions
