FINAL REPORT

Evaluation and Validation of Aboveground Techniques for Coating Condition Assessment

CC TECHNOLOGIES, INC GREGORY RUSCHAU, PH.D. ANGEL KOWALSKI

FEBRUARY 28, 2006

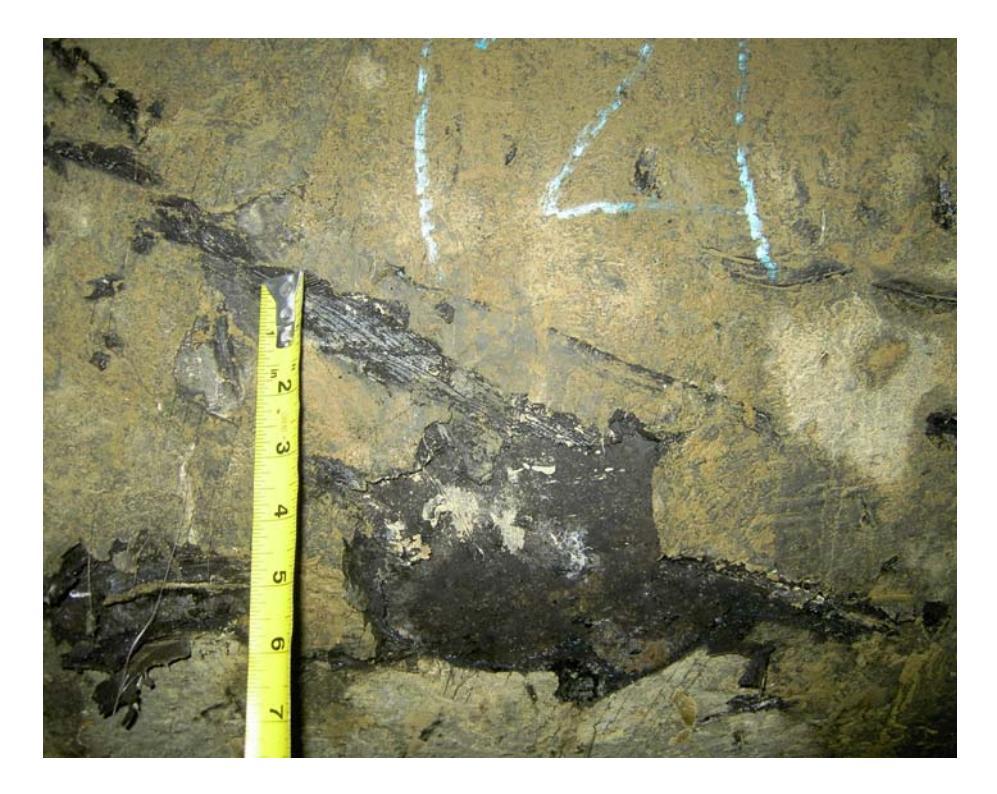
Figure 49: Site 3b undetected damage found at 140', 7 o'clock position
