NDOT Research Report

Report No: NV-RDT-10-001

# **NON-SACRIFICIAL, ANTI-GRAFFITI COATING 2009 EVALUATION**

**May 2010**

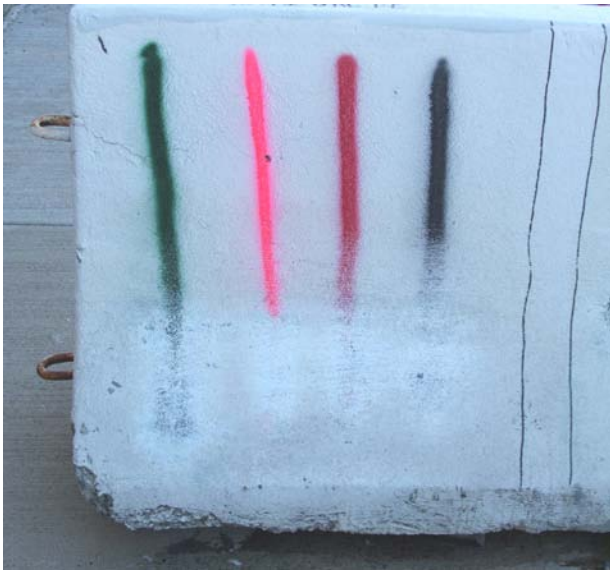
FIGURE 4.1A Removal – Painted Panel 1

There was difficulty with the graffiti removal and the representative was observed scraping off the graffiti with the metal/handle portion of a paint brush. This scraping action caused damage to the coating and some damage to the painted substrate. There was paint residue noted along with discoloration after the surface was dry (FIGURE 4.1A).

The recommendation was to not pursue further durability testing of this coating system because of difficulty of graffiti removal, damage to coating and substrate, discoloration, and paint residue during initial graffiti removal operations. Refer to Subsection 2.6 regarding additional durability testing for the panels. The representative is welcome to participate in the next scheduled evaluation if deficiencies are corrected.

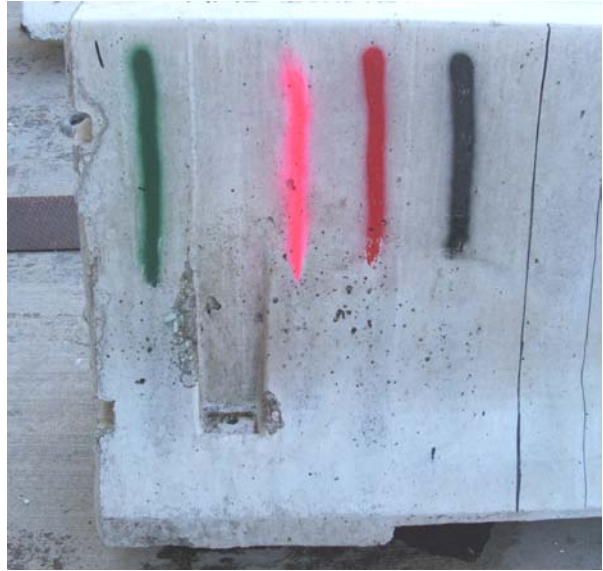
FIGURE 4.1B Removal – Unpainted Panel 1

There was difficulty with the graffiti removal and the representative was observed scraping off the graffiti with the metal/handle portion of a paint brush. This scraping action caused damage to the coating. There was only a trace amount of paint residue left on the substrate after removal effort (FIGURE 4.1B).

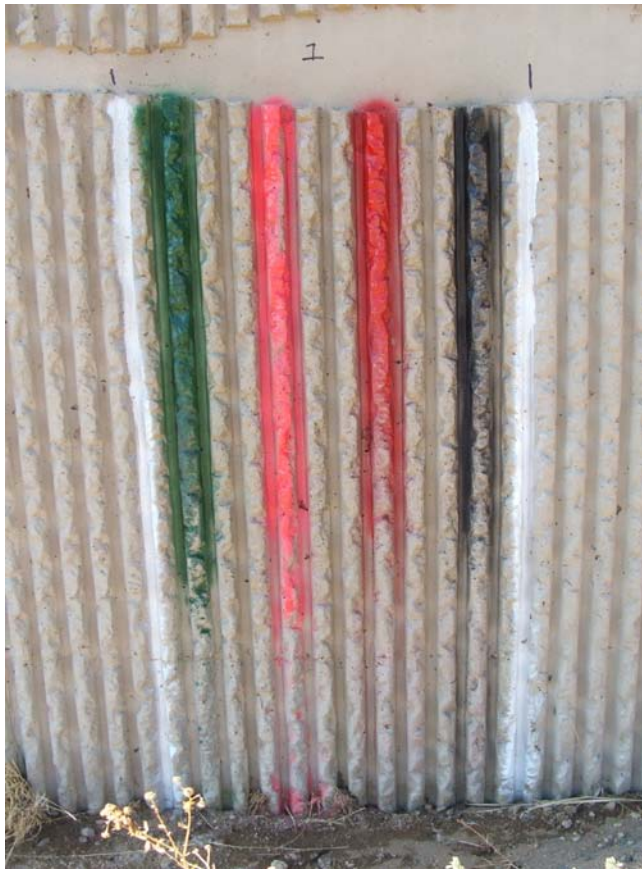
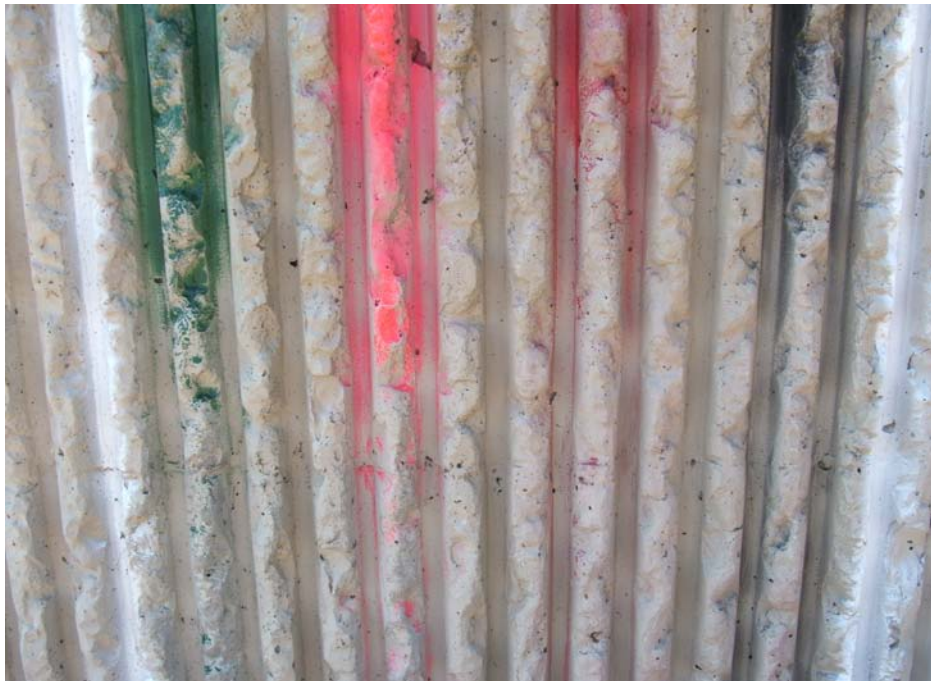
**FIGURE 4.1C Removal - Fractured Fin Facing Panel 1**

There was damage to the coating and substrate after the graffiti removal operations. Evidence of green and pink paint residue was reported. One evaluator mentioned that the coating became discolored (FIGURES 4.1C and 4.1D).

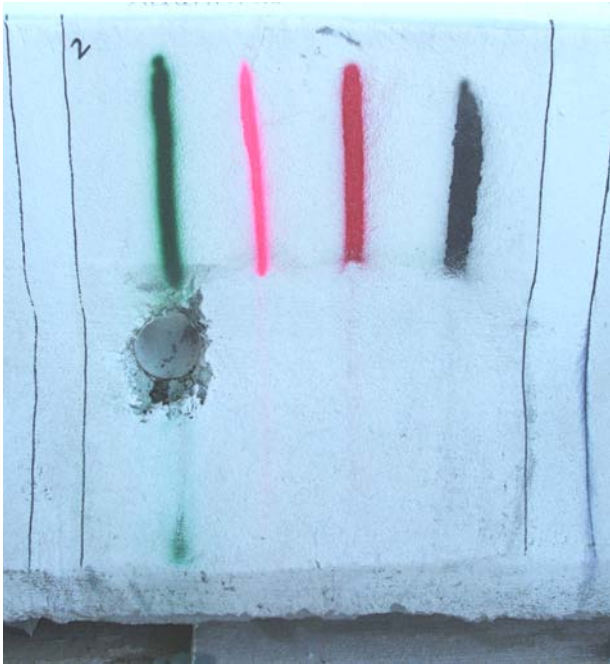
FIGURE 4.2A Removal – Painted Panel 2

There was difficulty with the graffiti removal when the representative used the manufacturer's removal agent and the representative borrowed a removal agent from another vendor. One evaluator documented the vigorous scrub action employed by the representative. There was paint residue observed as well as blistering (FIGURE 4.2A).

The recommendation was to not pursue further durability testing of this coating system because of difficulty of graffiti removal, paint residue, blistering, and damage and discoloration of the coating. Refer to Subsection 2.6 regarding additional durability testing for the panels. The representative is welcome to participate in the next scheduled evaluation if deficiencies are corrected.

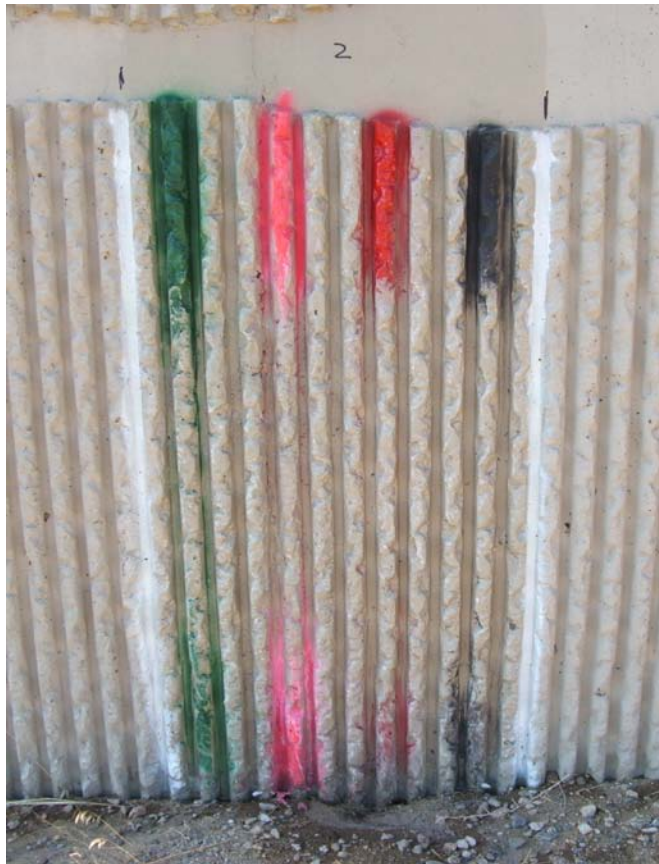
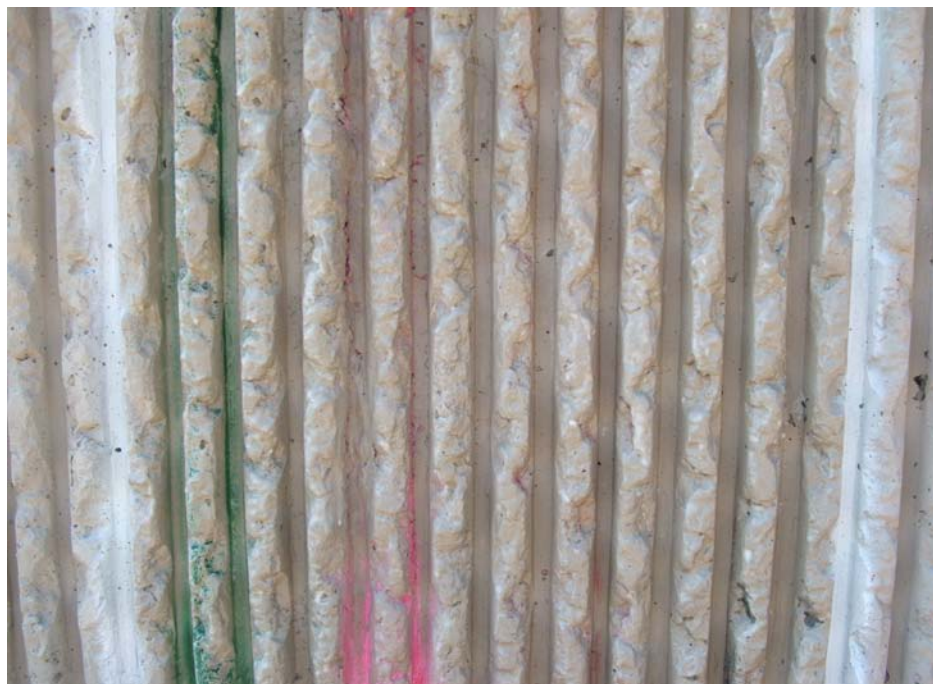
**FIGURE 4.2C Removal - Fractured Fin Facing Panel 2**

There was difficulty with the graffiti removal and the representative borrowed a removal agent from another vendor. There was damage to the coating, paint residue, and discoloration of the coating detected (FIGURES 4.2C and 4.2D).

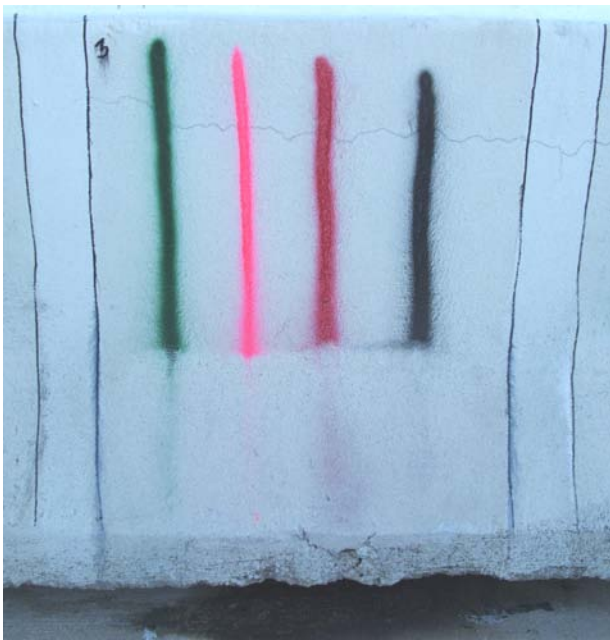
FIGURE 4.3A Removal – Painted Panel 3

Paint residue was observed (FIGURE 4.3A).

The recommendation was to not pursue further durability testing of this coating system because of paint residue, coating discoloration, and damage to the coating and substrate. Refer to Subsection 2.6 regarding additional durability testing for the panels. The representative is welcome to participate in the next scheduled evaluation if deficiencies are corrected.

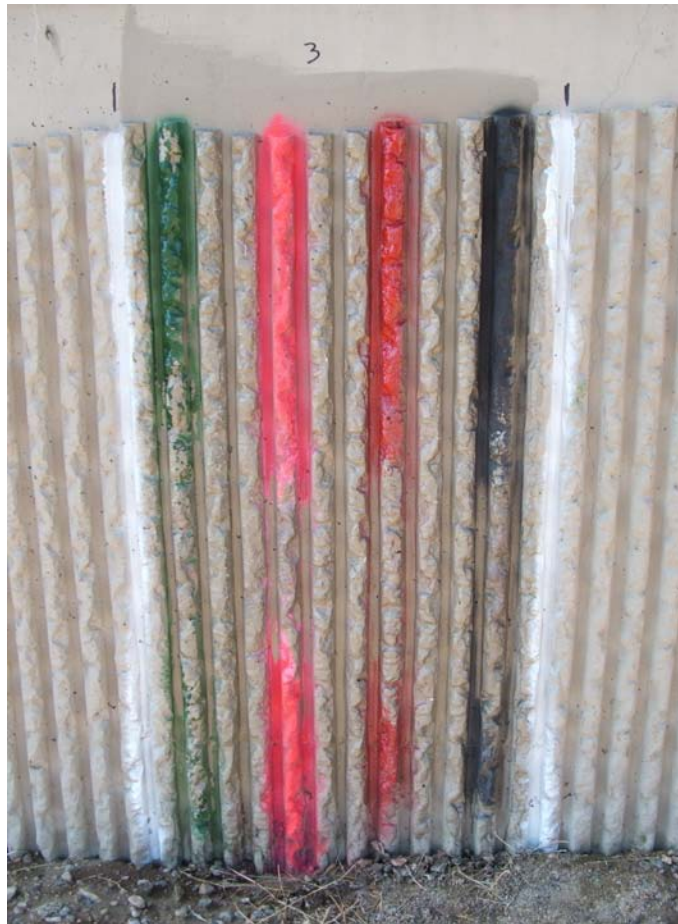
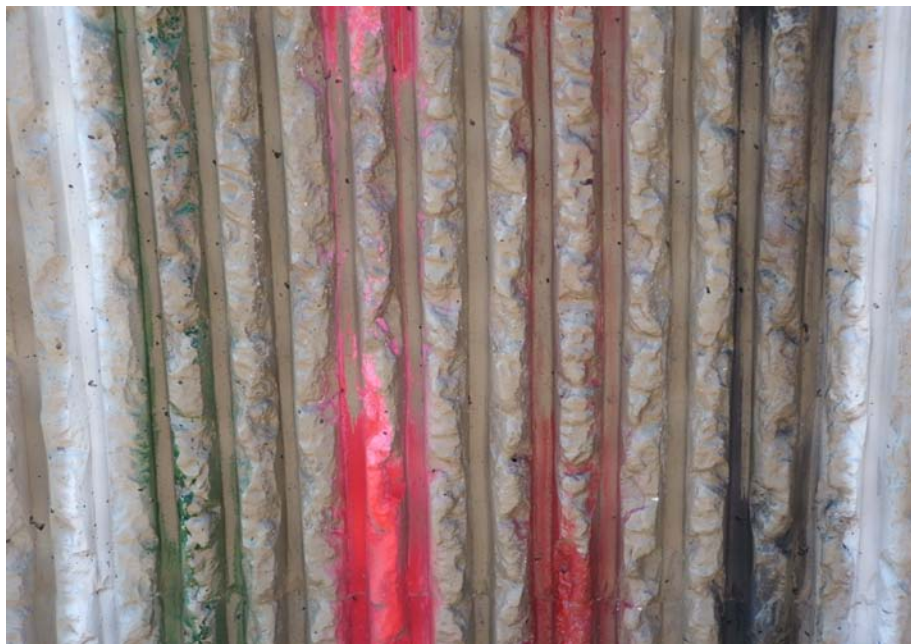
**FIGURE 4.3C Removal - Fractured Fin Facing Panel 3**

There was damage to the coating and substrate after graffiti removal operations. Evidence of paint residue and coating discoloration were recorded by all evaluators (FIGURES 4.3C and 4.3D).

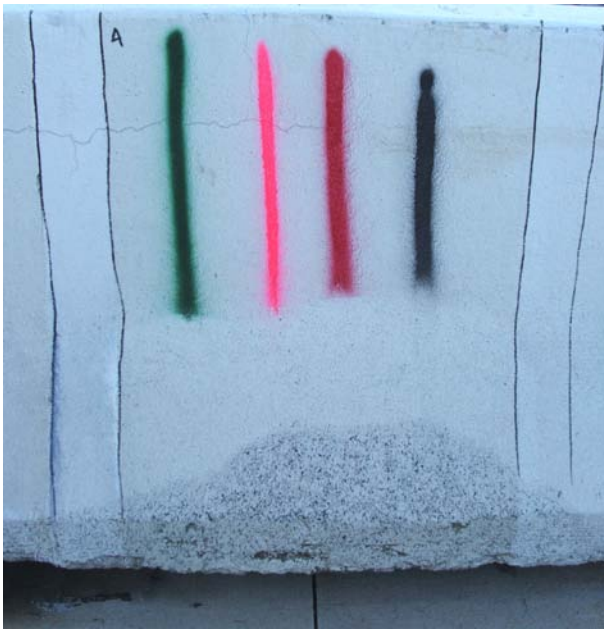
FIGURE 4.4A Removal - Painted Panel 4

There was difficulty with the graffiti removal and the representative was observed using various removal agents with unsatisfactory results. An additional removal agent was delivered to the representative during the last few minutes of the allowed removal time and the graffiti was removed to the satisfaction of the evaluators. There was no apparent paint residue and no damage to the coating or substrate (FIGURE 4.4A).

The recommendation was to pursue further durability testing of this coating system. Refer to Subsection 2.6 regarding additional durability testing. If further evaluation determines that the product can last through numerous graffiti removal cycles, the product will be identified for inclusion on the Qualified Product List.

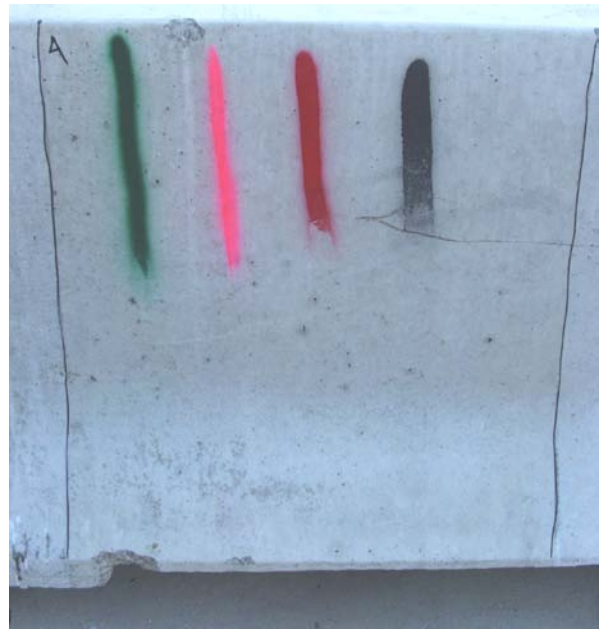
FIGURE 4.4B Removal – Unpainted Panel 4

There was difficulty with the graffiti removal and the representative was observed using various removal agents with unsatisfactory results. An additional removal agent was delivered to the representative during the last few minutes of the allowed removal time and the graffiti was removed to the satisfaction of the evaluators. There was no perceivable paint residue and no damage to the coating or substrate (FIGURE 4.4B).

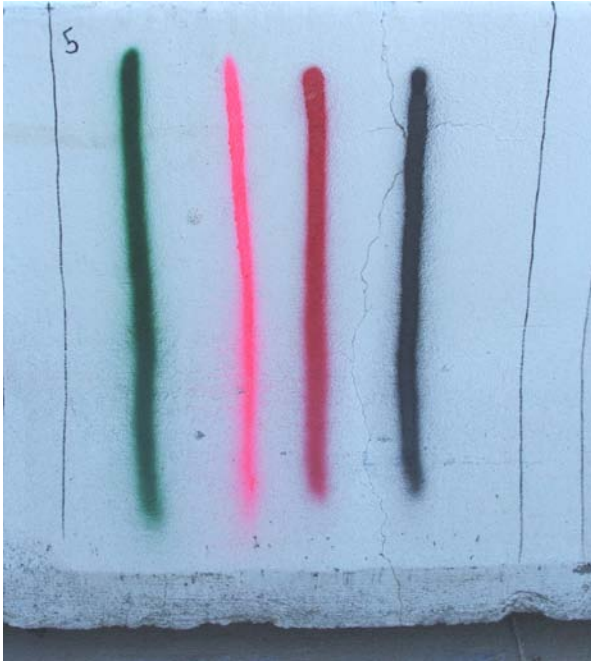
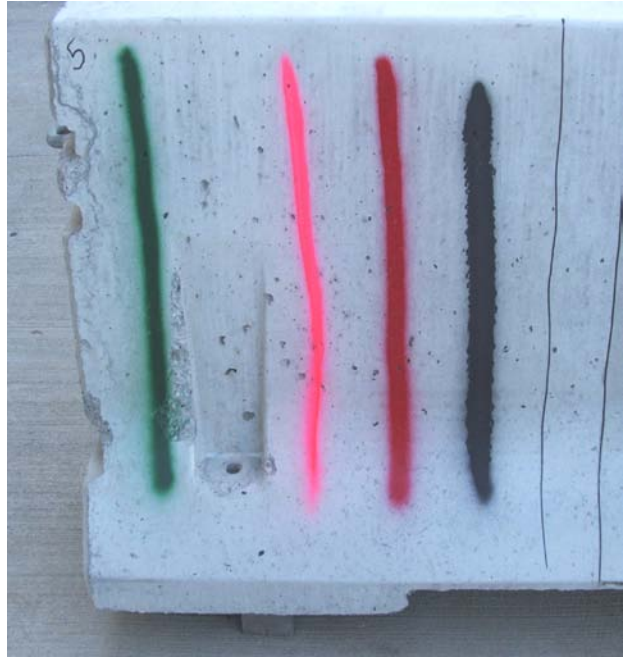
The coating system was disqualified because the representative did not return for the graffiti removal operations (FIGURES 4.5A and 4.5B).

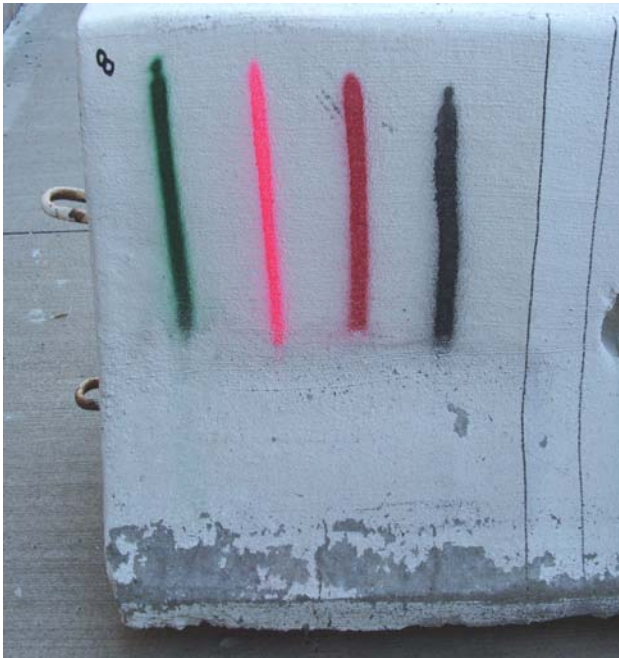
FIGURE 4.8A Removal – Painted Panel 8

There was green, pink, and red paint residue left on the substrate. The residue was especially noticeable with regards to the green color paint. The coating was slightly damaged due to the vigorous removal (FIGURE 4.8A).

The recommendation was to not pursue further durability testing of this coating system because of difficulty of graffiti removal, an unacceptable amount of green paint residue on the soundwall panel, and unacceptable gloss measurements. Refer to Subsection 2.6 regarding additional durability testing for the panels. The representative is welcome to participate in the next scheduled evaluation if deficiencies are corrected.

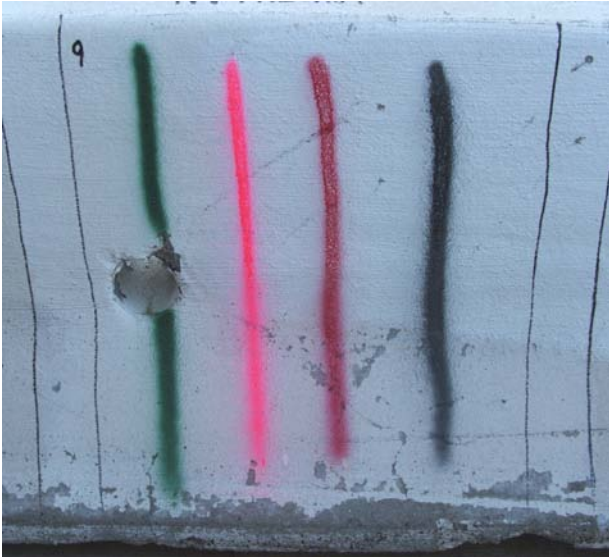
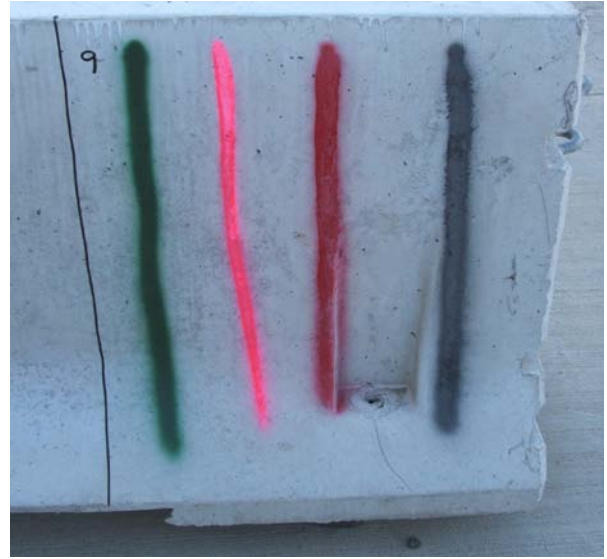
The coating system was disqualified because the representative did not return for the graffiti removal operations (FIGURES 4.9A and 4.9B).

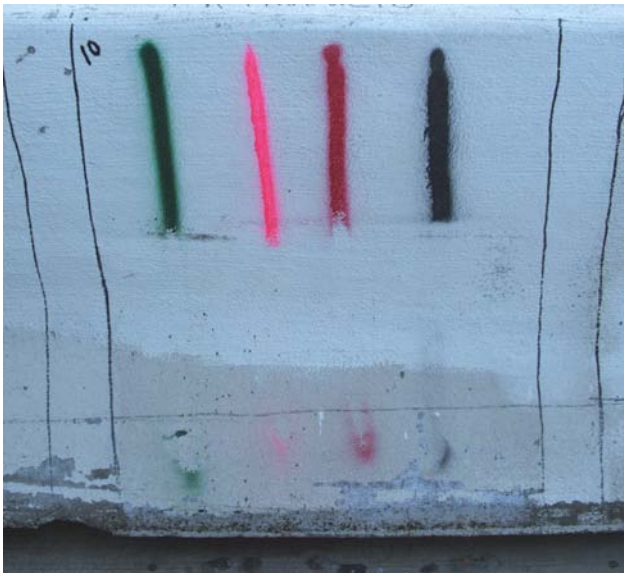
FIGURE 4.10A Removal – Painted Panel 10

There was noticeable paint residue with possible coating deterioration due to high pressure washing (FIGURE 4.10A).

The recommendation was to not pursue further durability testing of this coating system because of paint residue and damage to the coating and substrate. Refer to Subsection 2.6 regarding additional durability testing for the panels. The representative is welcome to participate in the next scheduled evaluation if deficiencies are corrected.

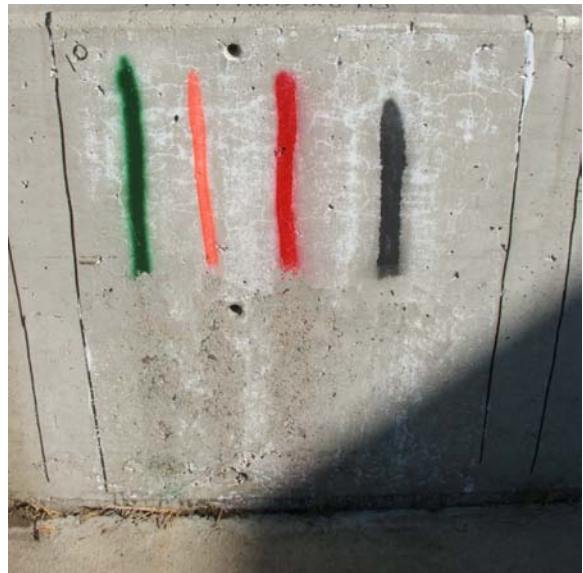
FIGURE 4.10B Removal – Unpainted Panel 10

Coating and substrate damage was noticeable due to high pressure washing. One evaluator mentioned that the surface looked blotchy with an efflorescence-type appearance (FIGURE 4.10B).

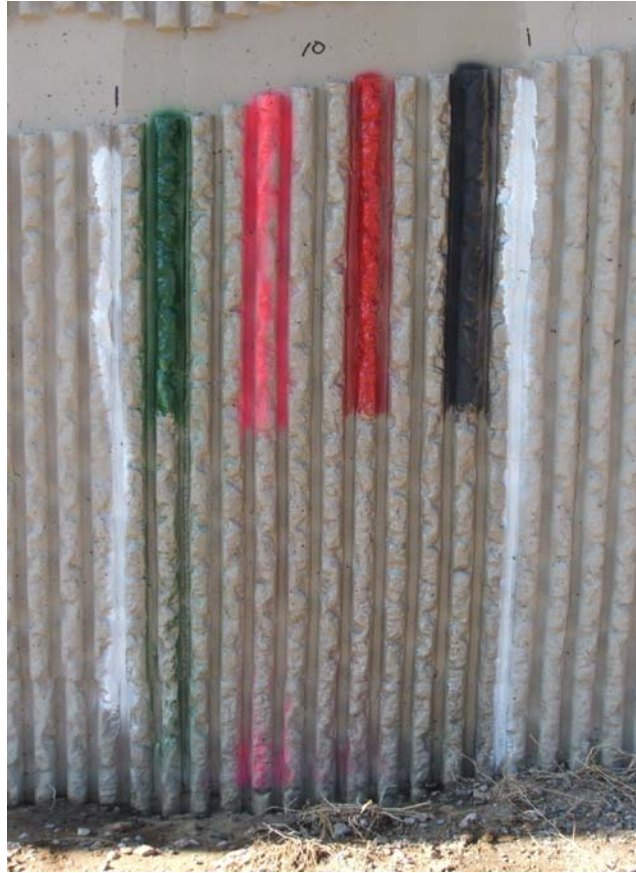
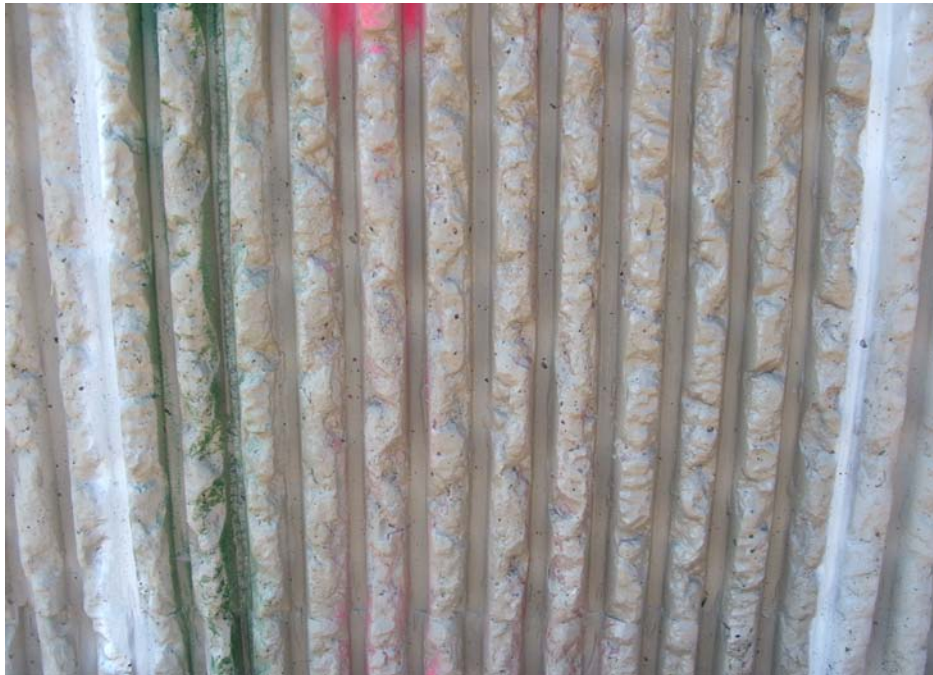
**FIGURE 4.10C Removal - Fractured Fin Facing Panel 10**

There was green paint residue and damage to the coating and substrate (FIGURES 4.10C and 4.10D).

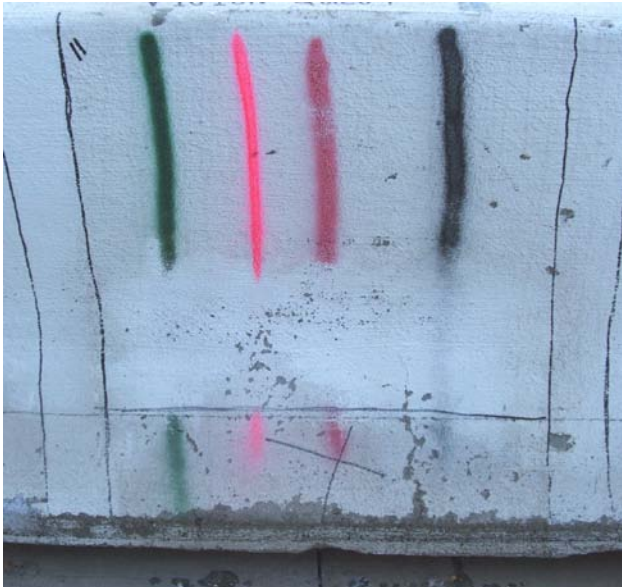
FIGURE 4.11A Removal – Painted Panel 11

Black and red paint residue was observed. Additionally, there was damage to the substrate and the coating discolored (FIGURE 4.11A).

The recommendation was to not pursue further durability testing of this coating system because of paint residue, coating discoloration, and damage to the coating and substrate. Refer to Subsection 2.6 regarding additional durability testing for the panels. The representative is welcome to participate in the next scheduled evaluation if deficiencies are corrected.

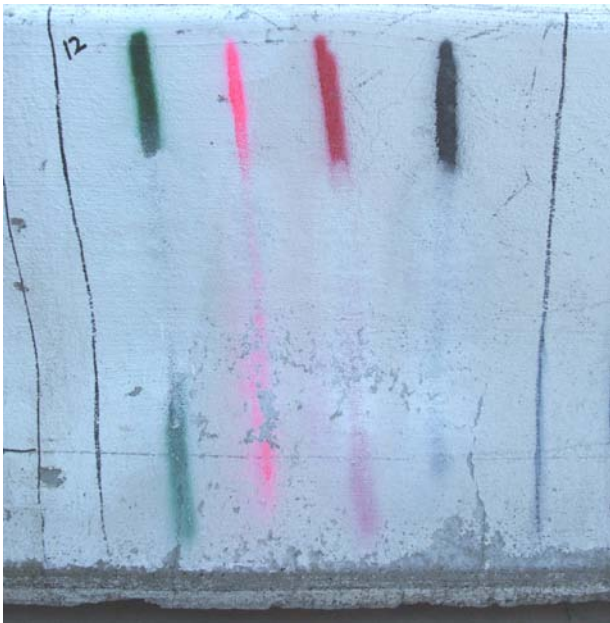
FIGURE 4.12A Removal – Painted Panel 12

Paint residue was conspicuous for all colors. One evaluator documented that there was damage to the coating along with coating discoloration (FIGURE 4.12A).

The recommendation was to not pursue further durability testing of this coating system because of paint residue, discoloration, and damage to the coating. Refer to Subsection 2.6 regarding additional durability testing for the panels. The representative is welcome to participate in the next scheduled evaluation if deficiencies are corrected.

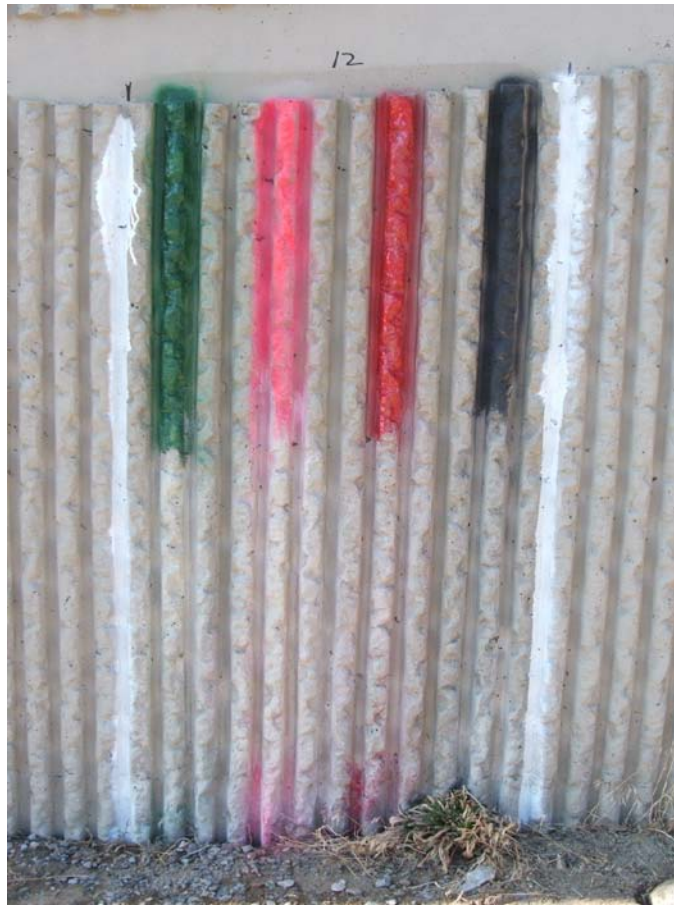
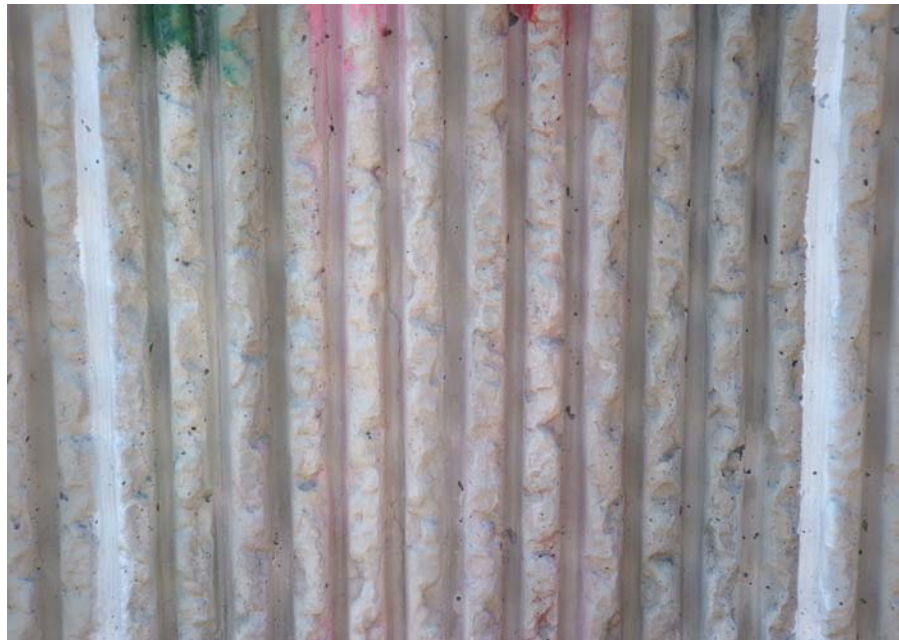
**FIGURE 4.12C Removal - Fractured Fin Facing Panel 12**

There was difficulty with the graffiti removal and the coating was damaged to a point where little evidence of coating remained (FIGURES 4.12C and 4.12D).

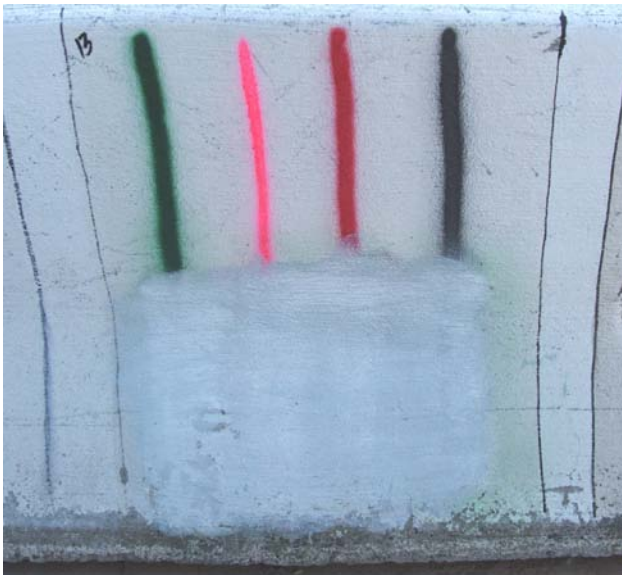
FIGURE 4.13A Removal – Painted Panel 13

There was damage to the coating and smeared paint residue (FIGURE 4.13A).

The recommendation was to not pursue further durability testing of this coating system because of paint residue, discoloration, and damage to the coating and substrate. Refer to Subsection 2.6 regarding additional durability testing for the panels. The representative is welcome to participate in the next scheduled evaluation if deficiencies are corrected.

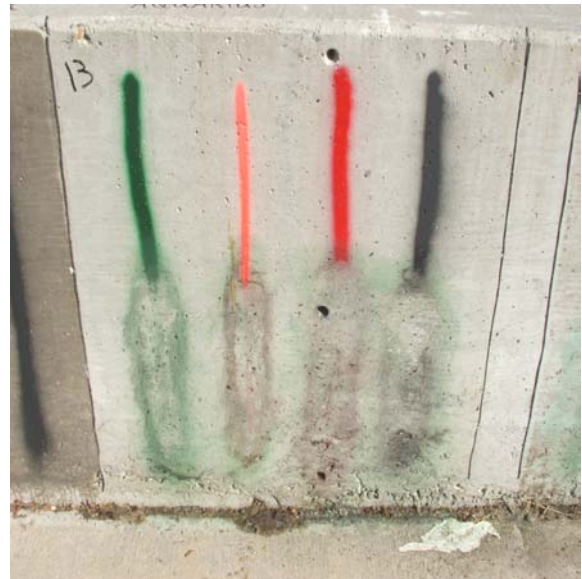
FIGURE 4.13B Removal – Unpainted Panel 13

There was distinct paint residue along with damage and discoloration of the coating (FIGURE 4.13B).

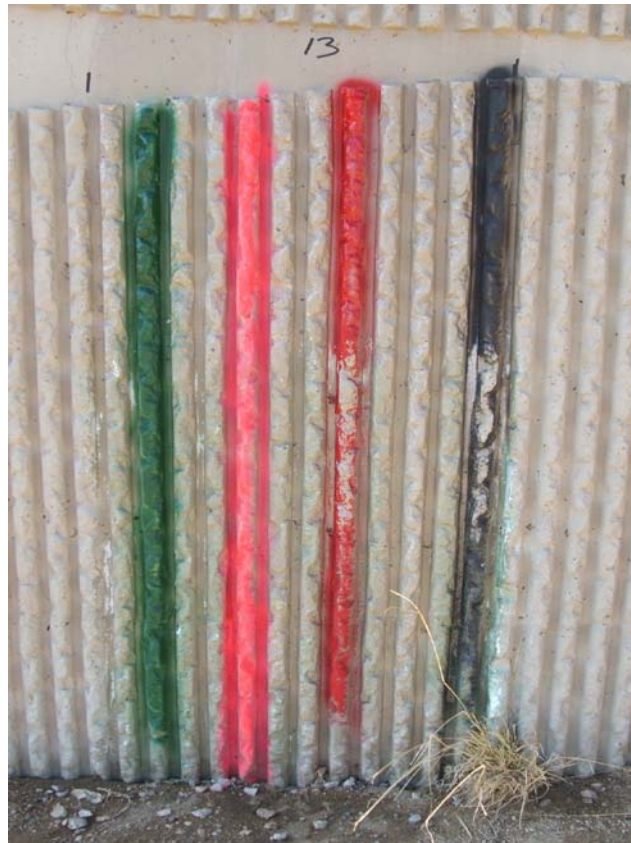
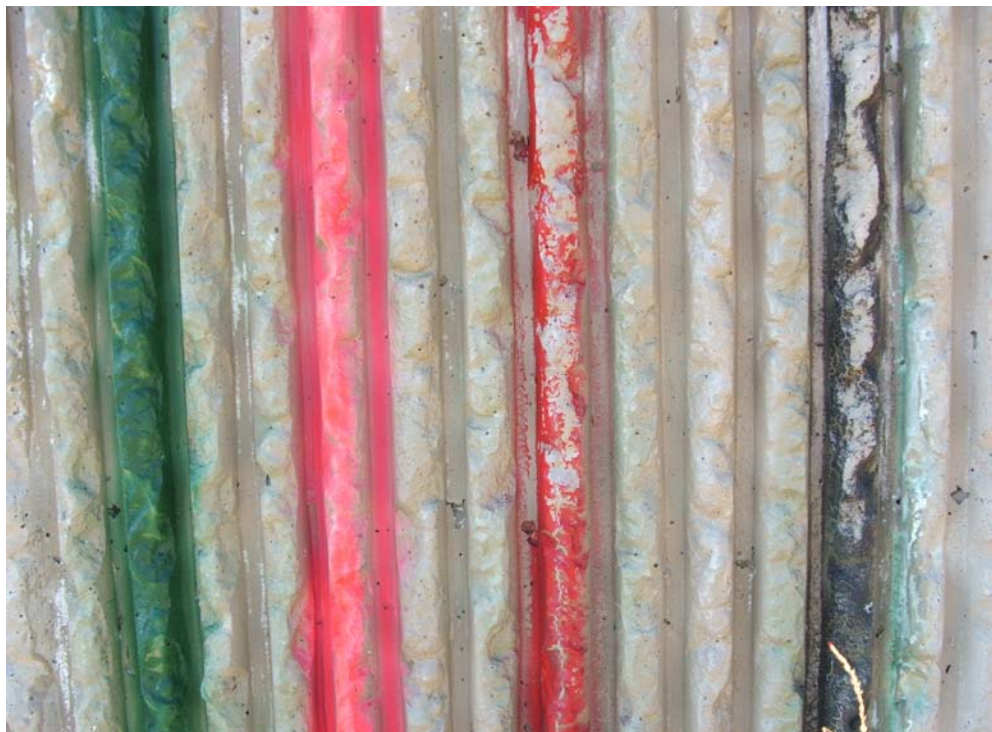
**FIGURE 4.13C Removal - Fractured Fin Facing Panel 13**

A substantial amount of paint residue was noted and the coating and substrate were damaged in the removal process (FIGURES 4.13C and 4.13D).
