Stabilization Procedures to Mitigate Edge Rutting for Granular Shoulders – Phase II

Final Report January 2011

Iowa Highway Research Board (IHRB Project TR-591) Iowa Department of Transportation (InTrans 08-319)

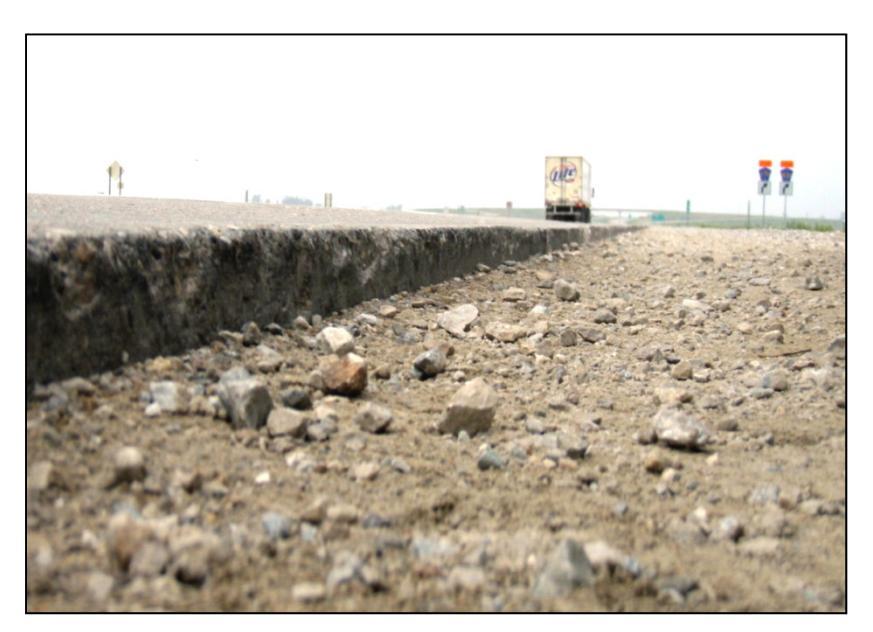
Figure 1. Shoulder drop-off near pavement edge Highway 18 milepost 195.95-196.2 westbound June 4, 2008

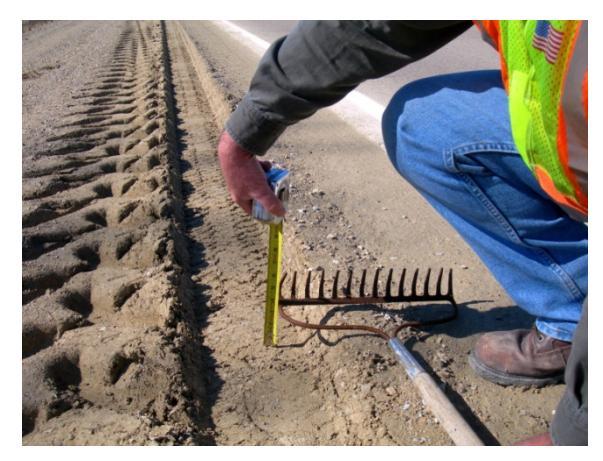
Immediately after construction, the full-depth reclaimed sections were sufficiently soft so that the rear tires of an unloaded 3/4-ton pickup truck sunk 3 to 4 in. into the shoulder surface (See Figure 16). The pull-behind compactor could not provide enough passes quickly enough, nor to the depth of compaction required, to stabilize the road surface. Because the truck could not back up with the compactor, it was necessary for the truck to take very long round trips from one exit to another on Highway 20 (with its controlled access design). Thus, few passes could be made in the available time.

Figure 16. Pickup truck tire rut that indicated the typically soft conditions one day after full-depth reclaiming

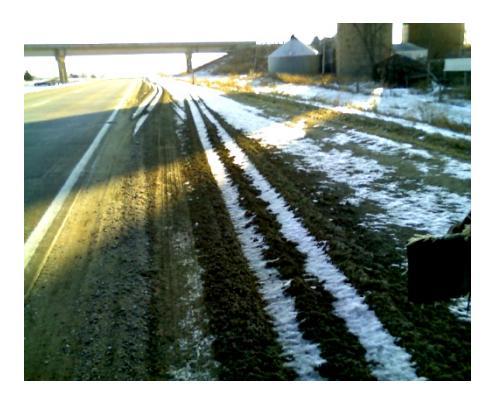
In February 2009 maintenance personnel notified the research team that some areas included in the test sections were experienceing heavy rutting during winter thaw periods. These areas were documented with photos. The locations were the full-depth reclamation areas for each of the stabilizing agents. In addition, Control Section 1 experienced some rutting (See Figure 20).

Figure 20. Rutting on Control Section 1 in February

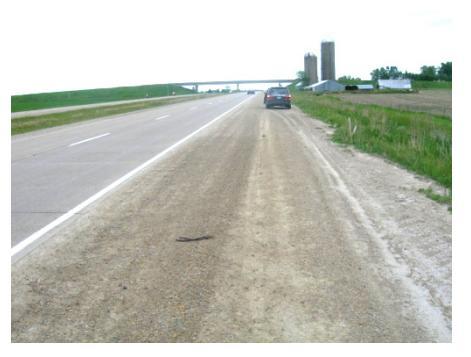
Figure 21. Mostly good calcium chloride full-depth 8 ft wide June 2009

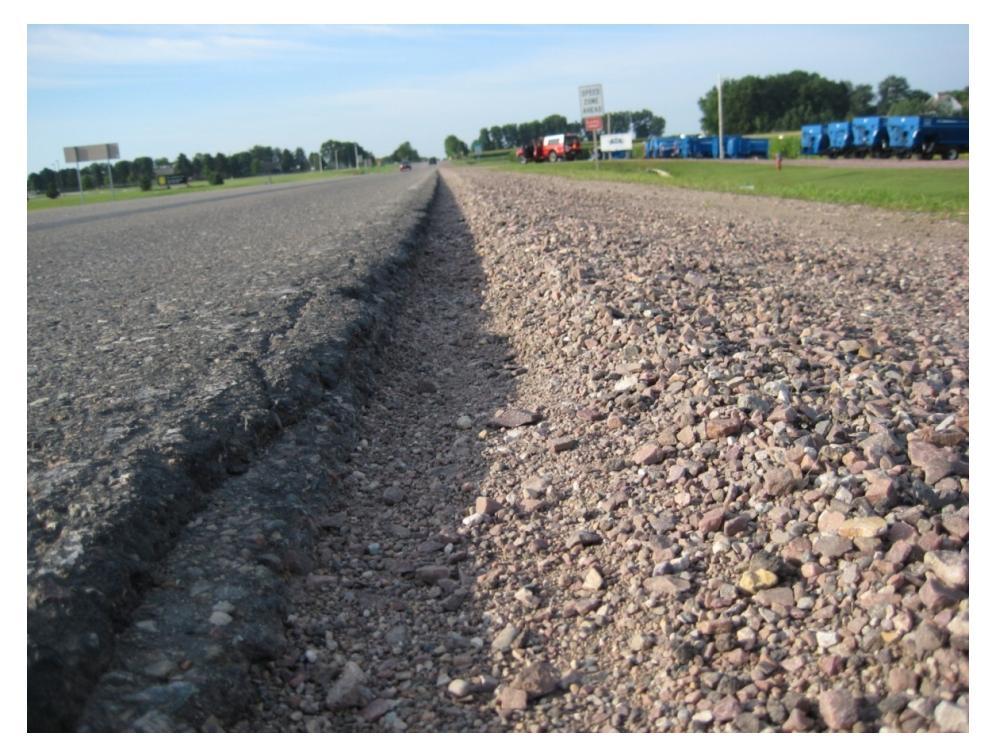
Figure 50. Shoulder rutting at Test Area I before stabilization July 28, 2009

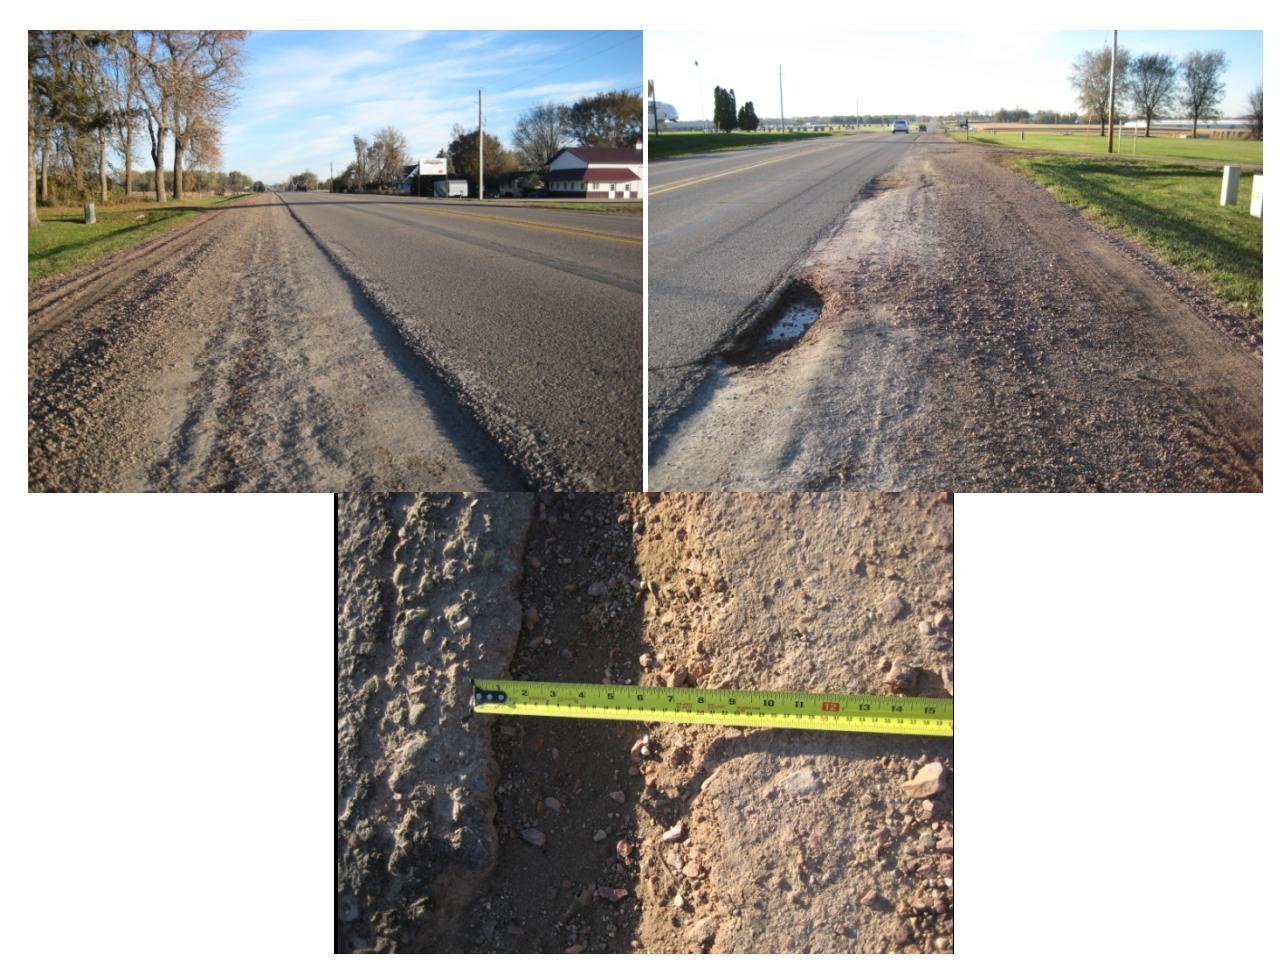
Figure 68. Shoulder condition of the Test Area III on the southbound shoulder of US 75 near Sioux Center, Iowa October 27, 2009

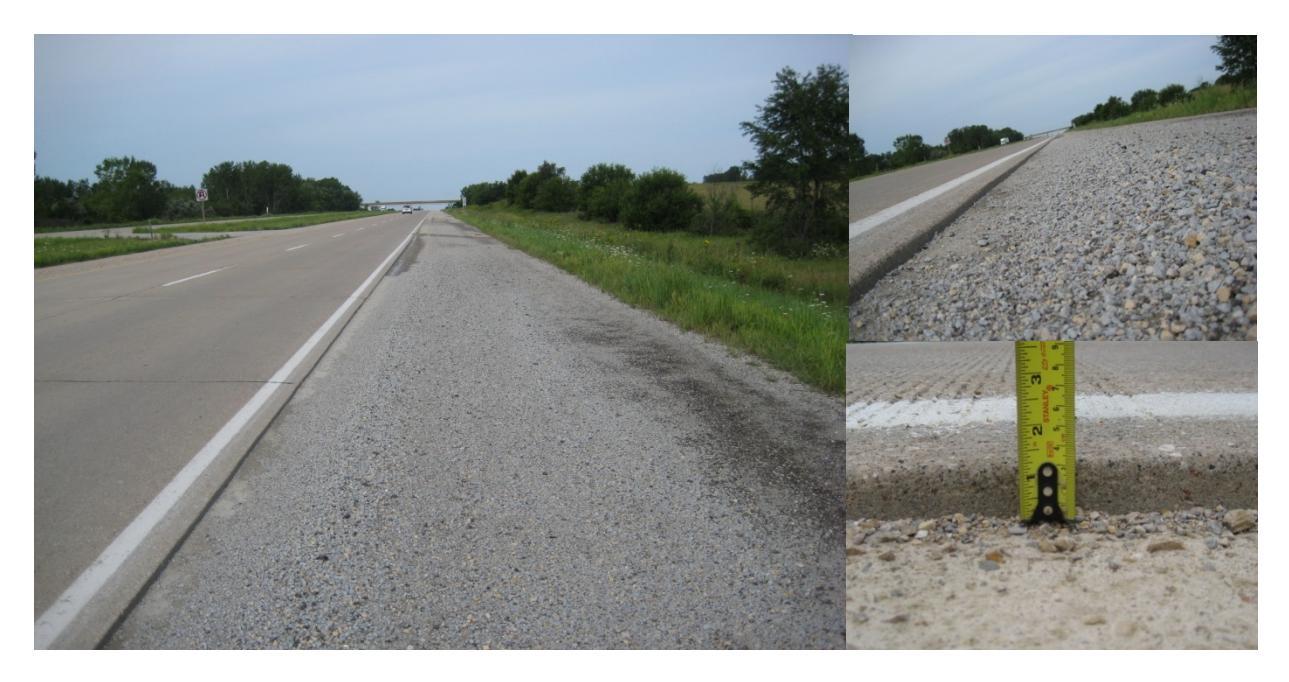
Figure 72. Shoulder conditions and edge ruts along the pavement slabs August 17, 2009

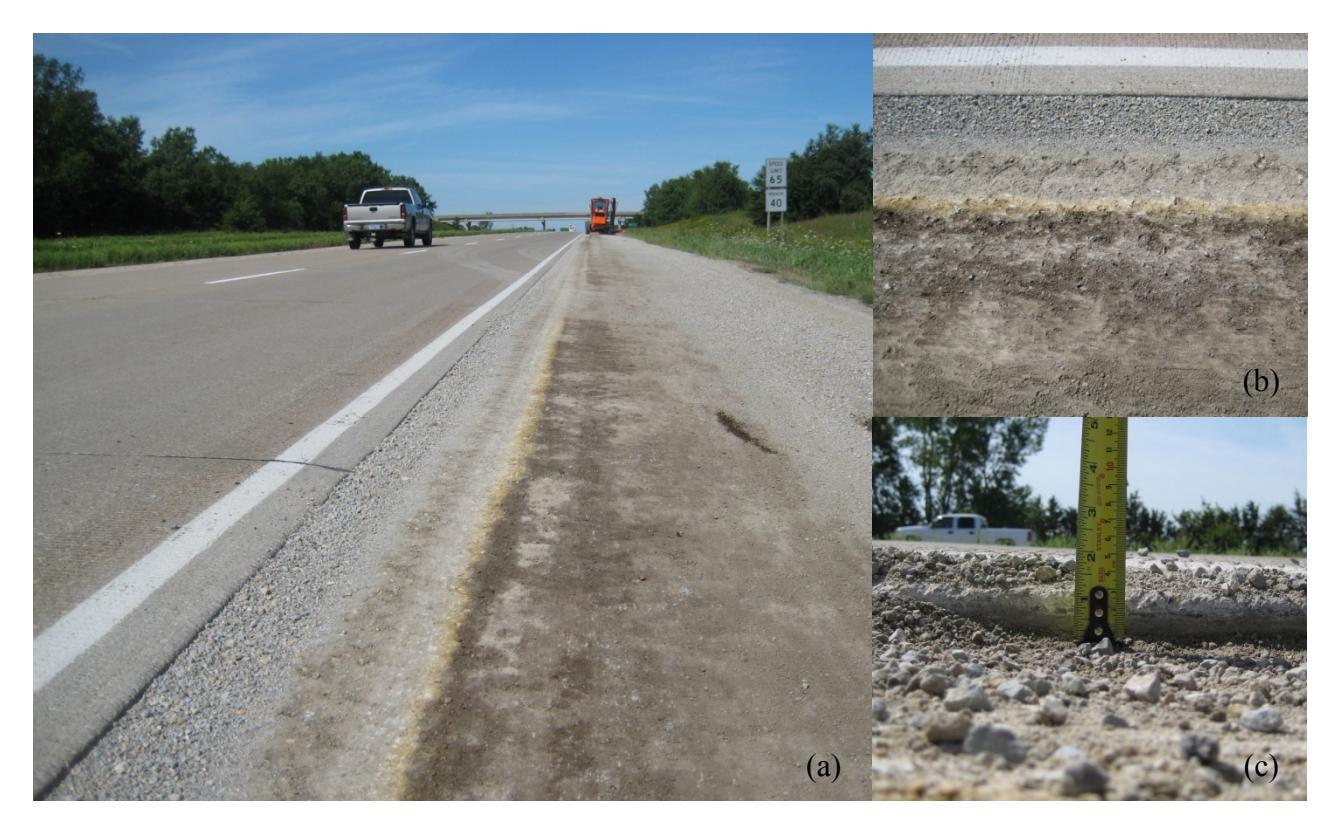
Figure 82. Section III: a) graded surface, b) side view of graded surface, and c) pavement edge drop off August 18, 2009

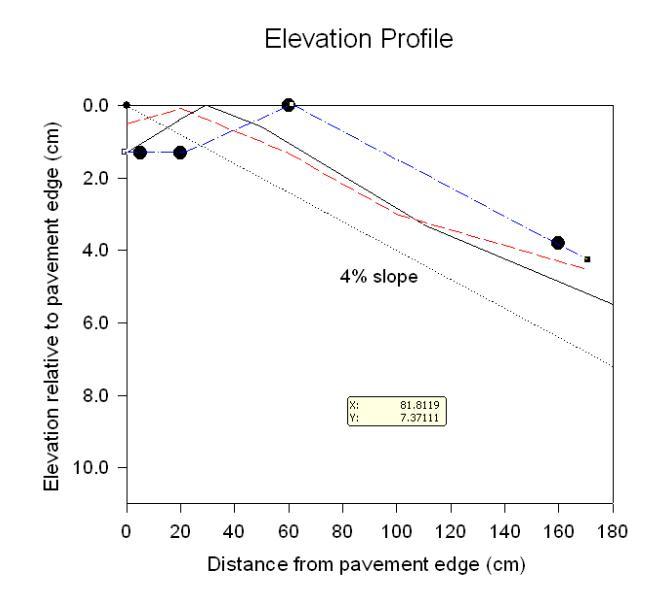
Figure 88. Elevation Profile of Section I Point 6 showing removal of DUSTLOCK from edge-rut area

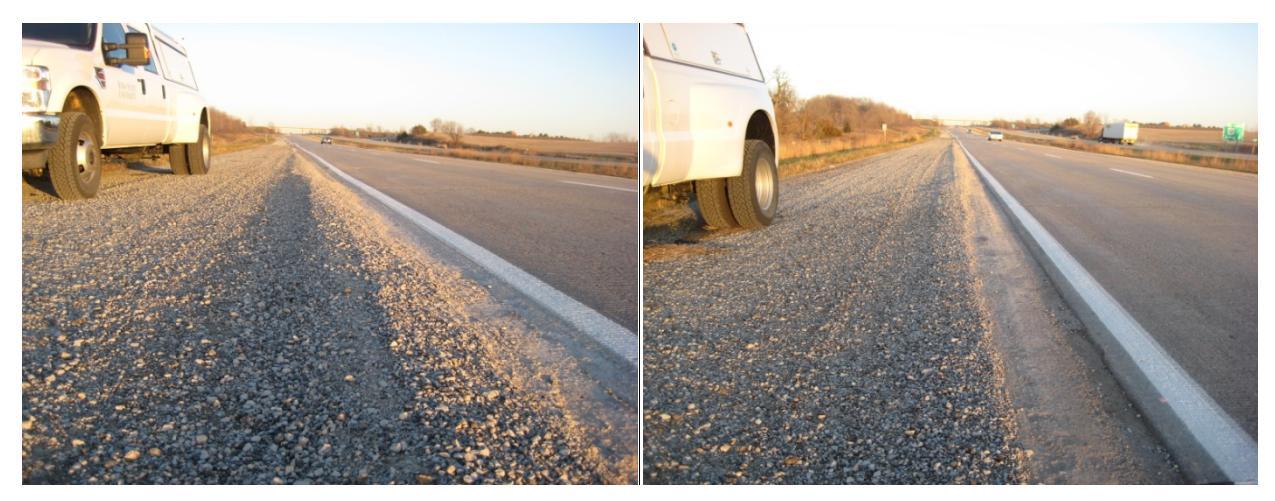
Figure 89. Stabilized shoulder using DUSTLOCK on US 20 westbound covered with course aggregate beyond edge-rut area November 7, 2009

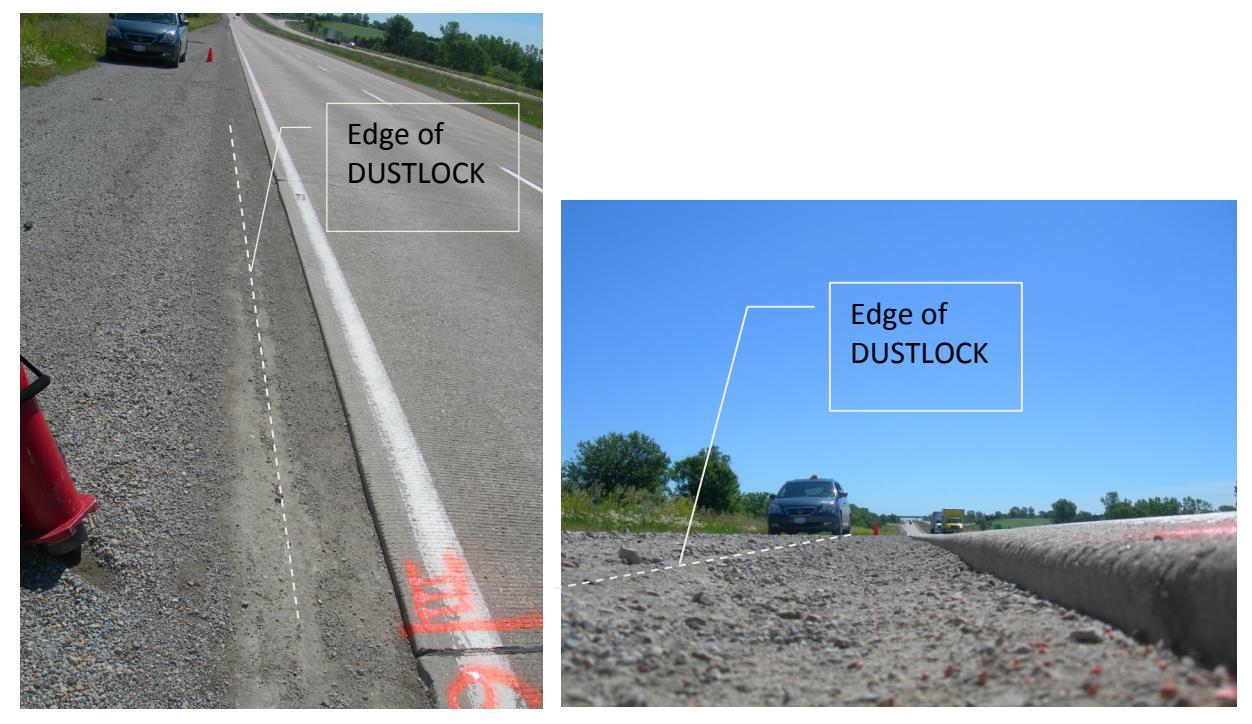
Figure 91. Removal of DUSTLOCK from edge rut area
