# High Tension Cable Median Barrier: A Scanning Tour Report

By Juan C. Medina Rahim F. Benekohal

A report prepared by **Traffic Operations Laboratory** Department of Civil and Environmental Engineering University of Illinois at Urbana-Champaign

January 2006

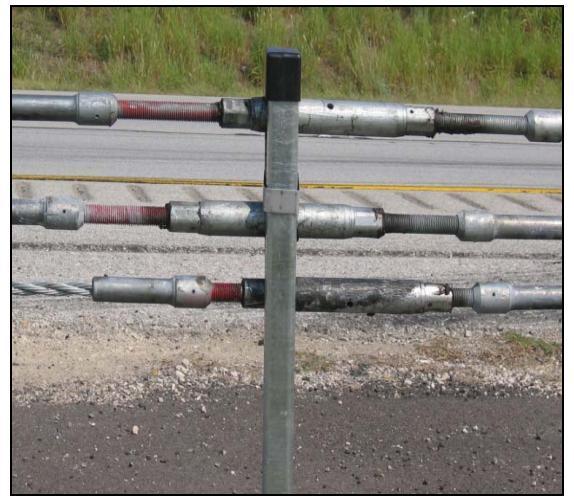
8. Inappropriate turnbuckle placement
