2007 RAILROAD EMPLOYEE FATALITIES:

CASE STUDIES AND ANALYSIS

Office of Safety Washington, DC 20590

March 2009

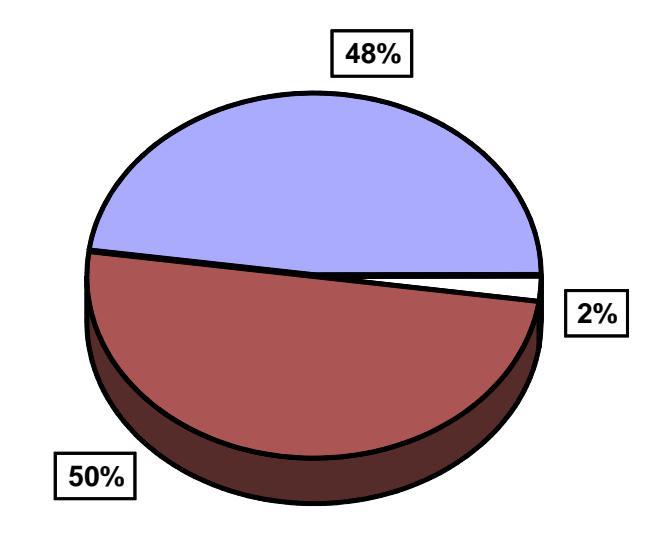
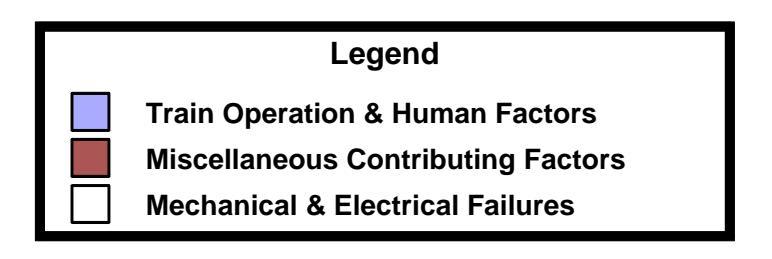
APPENDIX G

- In 2007, 50 percent of all PCFs to the year's fatalities were Miscellaneous Contributing Factors, followed closely by 48 percent which were Train Operation and Human Factors³.
- In 2007, the remaining 2 percent of all PCFs were Mechanical and Electrical Failures (a defective knuckle that prevented coupling).

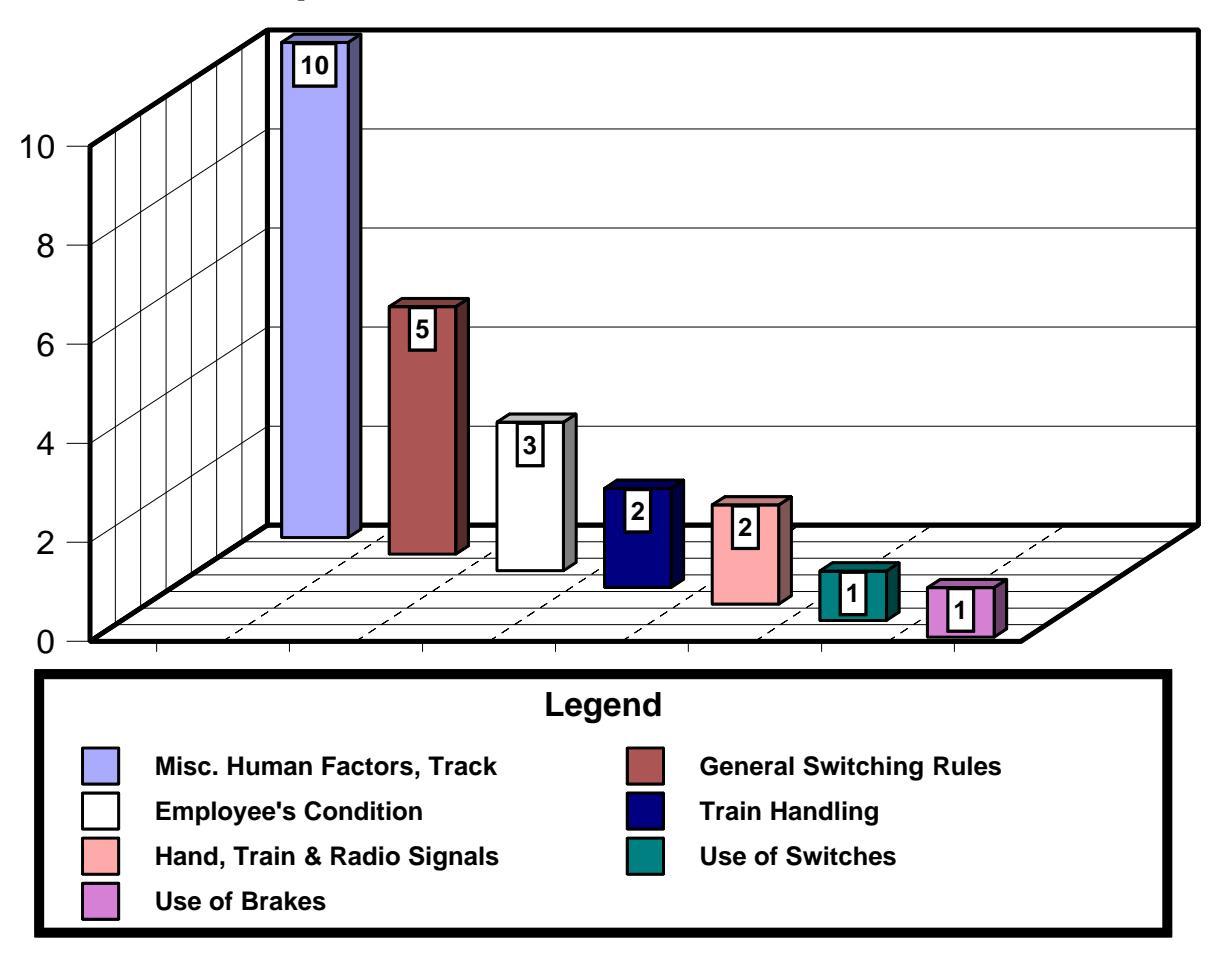
Train Operation & Human Factors Involved

This sub-category included lack of communication between the Conductor and Locomotive Engineer regarding how the movement was being protected; fouling the track between standing equipment to make an adjustment, without making sure another crew member was in control of the equipment; failure to move standing cars clear of the crossover; failure to verify whether equipment had coupled; and failure to couple.

- Ranking third, the sub-category Employee's Condition comprised approximately 13 percent of all Train Operation/Human Factors. The condition in each case was fatigue.
- The sub-categories, Train Handling, and Hand, Train & Radio Signals each comprised approximately 8 percent of all Train Operation/Human Factors.

Train Handling included riding on the platform improperly, and failure to stop a shoving movement within one half the specified distance. Hand, Train & Radio Signals included improper radio communication and failure to carry a radio to monitor train transmissions.

• Improper Use of Switches and Improper Use of Brakes each comprised approximately 4 percent. They included switches improperly aligned and failure to secure hand brakes.

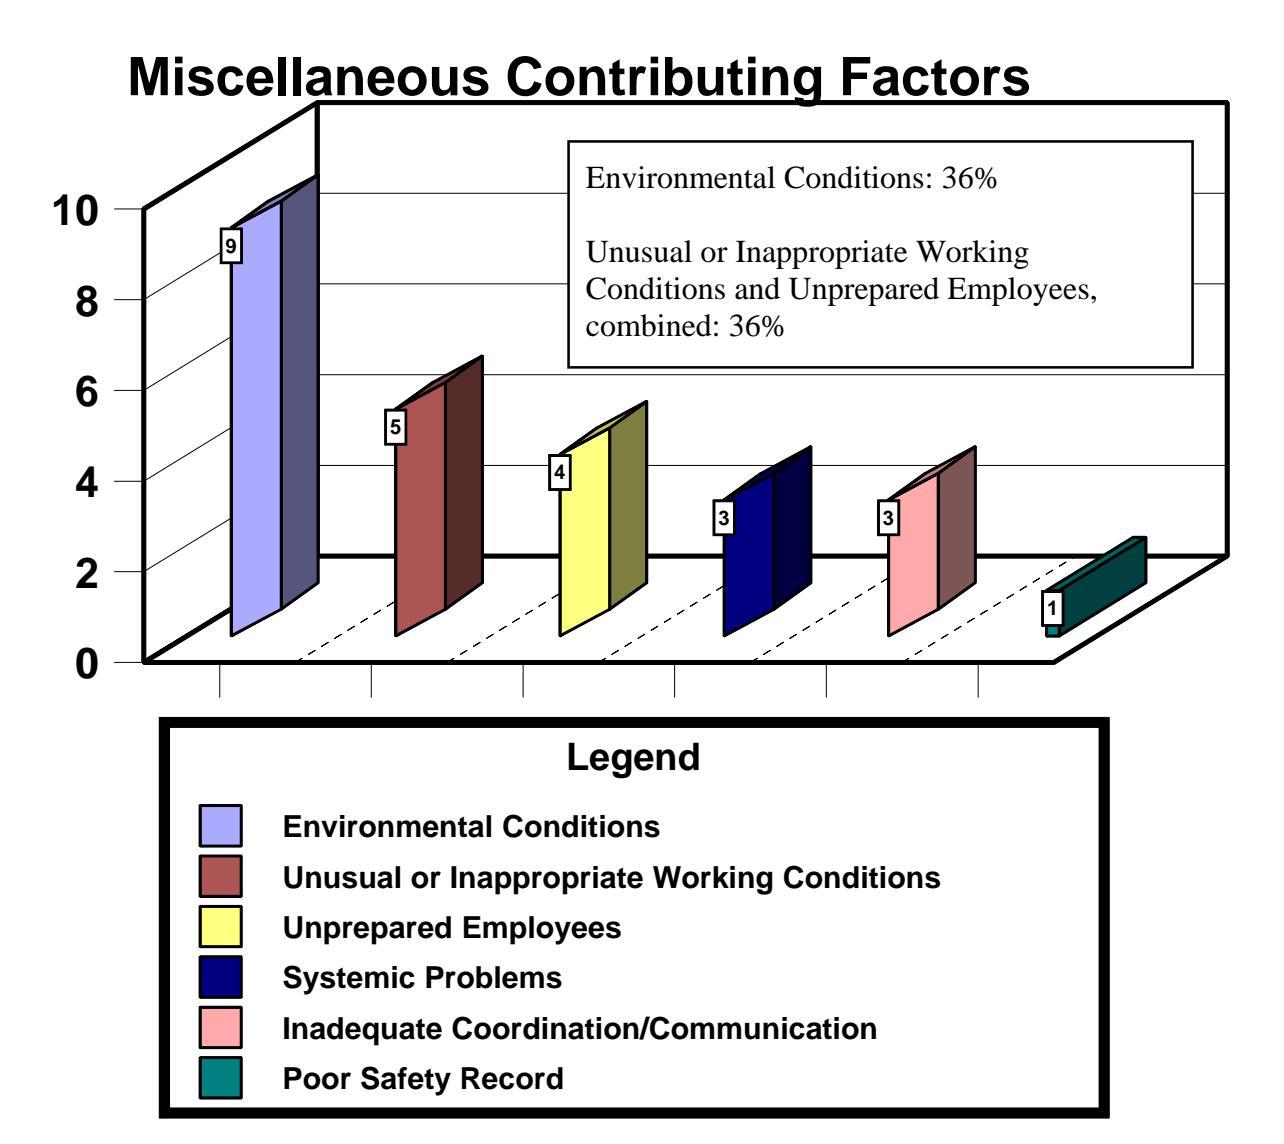
• Of all the Miscellaneous Contributing Factors in 2007, two sub-categories predominated: Environmental Conditions at 36 percent, and Unusual or Inappropriate Working Conditions at 20 percent.

Environmental Conditions included poor visibility due to sun in the eyes; poor visibility due to inadequate artificial lighting; poor visibility due to the curvature of tracks; poor visibility due to heavy rain; poor visibility due to the combination of the right-hand curve of the track, glare from the sun, and shadows from surrounding structures; ambient noise from construction and the overhead freeway interfering with the ability to hear the horn; tamper machine too loud to hear the locomotive horn; and ground wet with accumulated snow, causing slippery footing.

Unusual or Inappropriate Working Conditions included the supervision of too many inexperienced employees; employee functioning as a Watchman while performing other duties; the employee's physical position, while manipulating a shadow board, which restricted the ability to see or hear approaching trains; the atypical location of a switch stand and target, forcing the employee to work between two tracks; and an inexperienced employee supervising a less experienced employee.

Ranking third, Unprepared Employees represented 16 percent of all Miscellaneous Contributing Factors. Systemic Problems and Inadequate Coordination/Communication followed with 12 percent each, and Poor Safety Record represented 4 percent of all Miscellaneous Contributing Factors.
