# Predicting Erosion Impact on Highway and Railway Bridge Substructures

by  
Charles Swann<sup>1</sup>  
Chris Mullen<sup>2</sup>

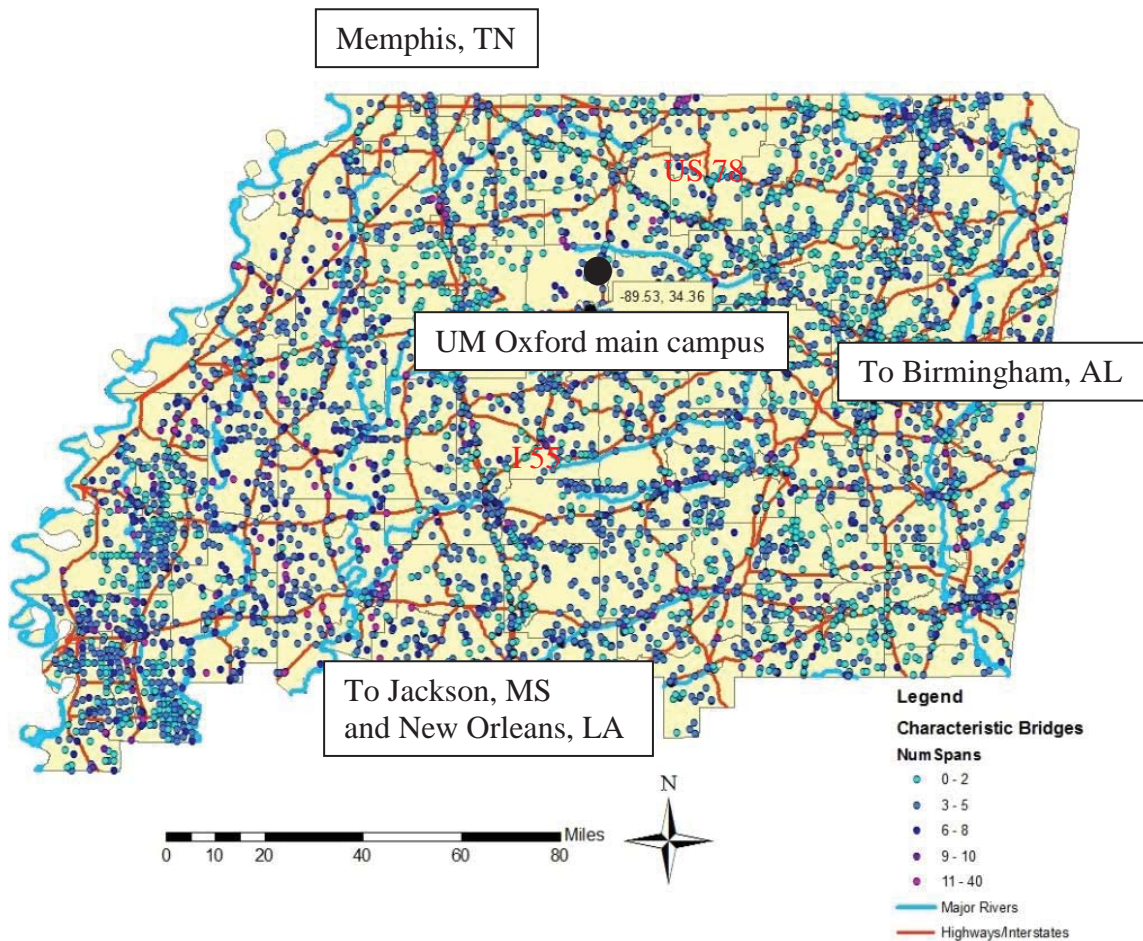
Figure 1. Locations of highway bridges in north Mississippi

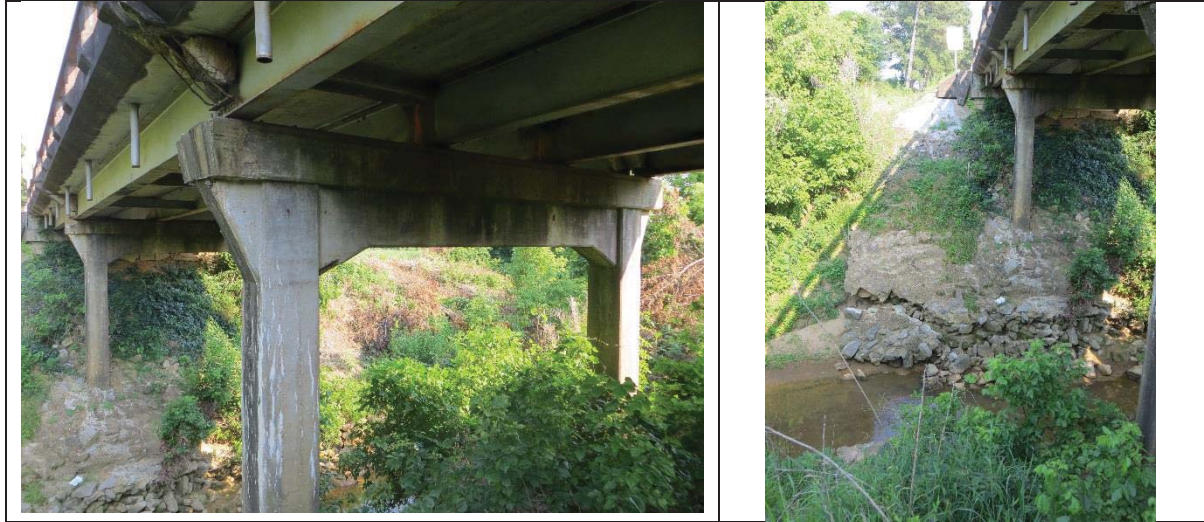
Figure 3. US 178 bridge with deep foundation- embankment eroded by scour (B-002)

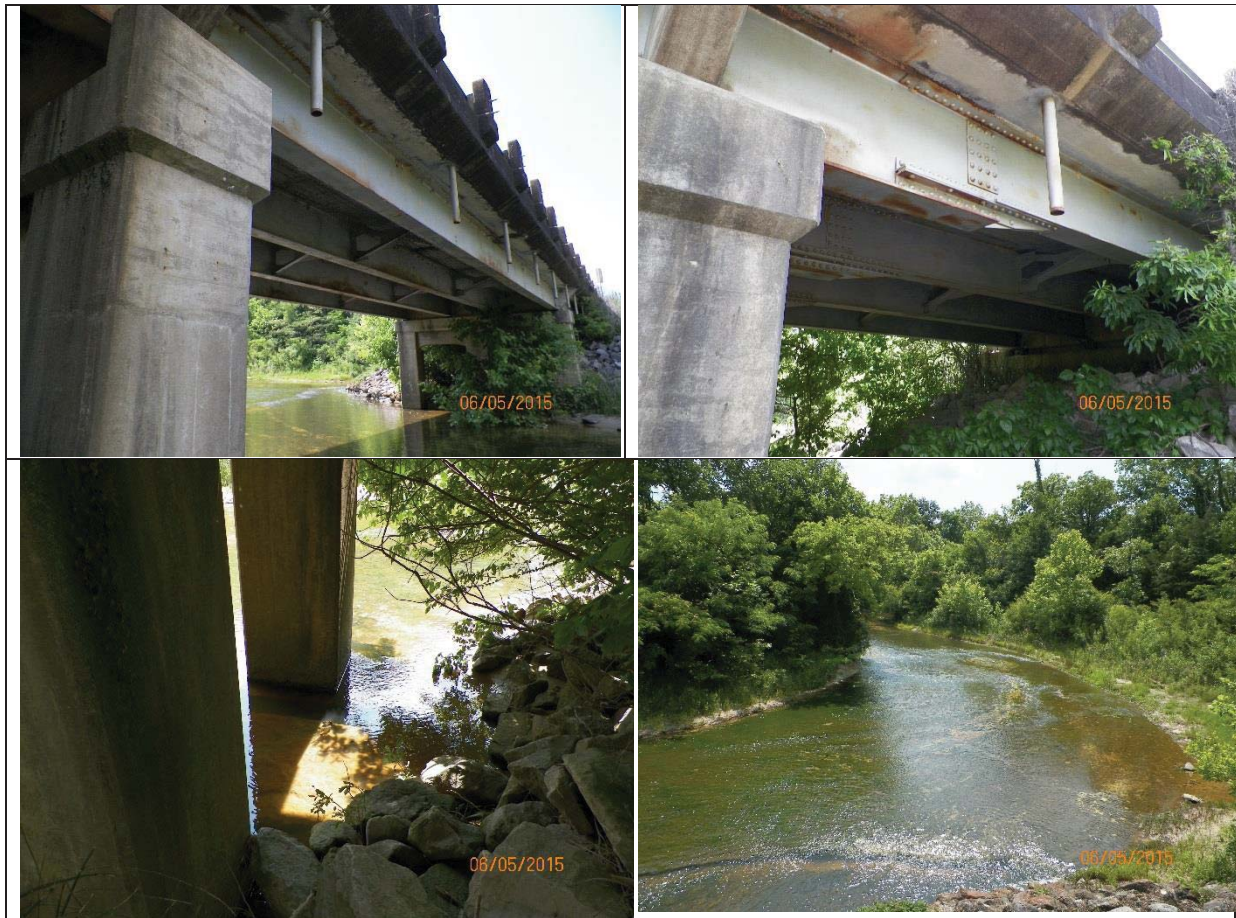
Figure 4. US 178 bridge with shallow foundation- footing exposed by scour (B-005)

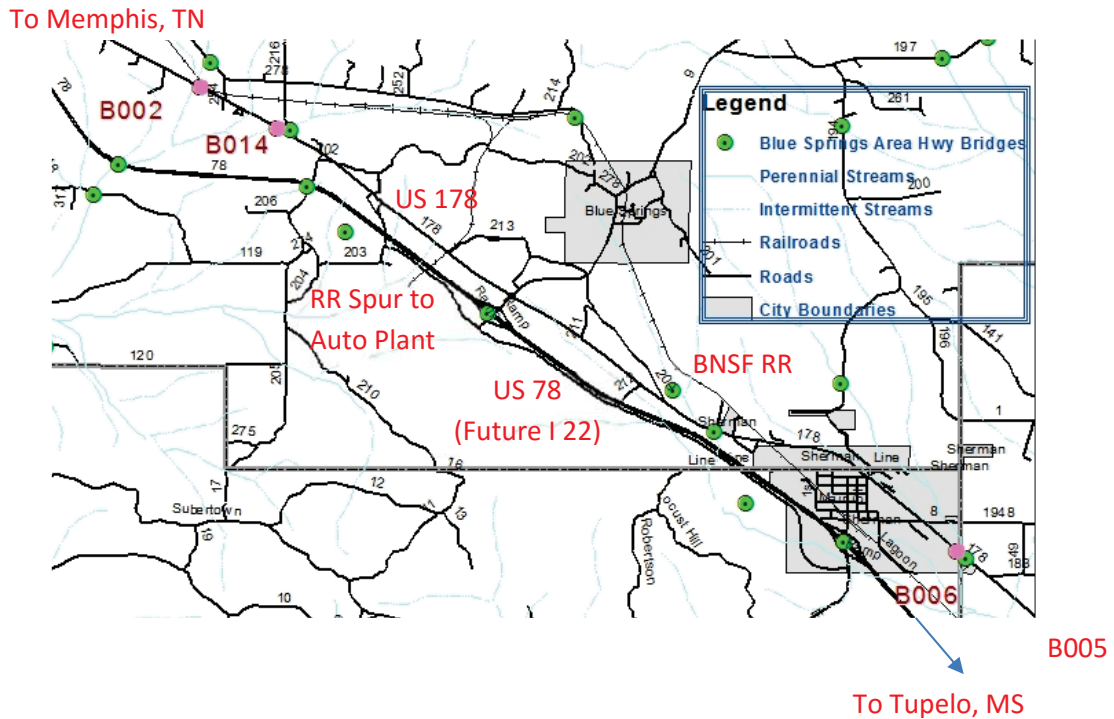
Figure 5. Highway bridges along major corridor in northeast MS

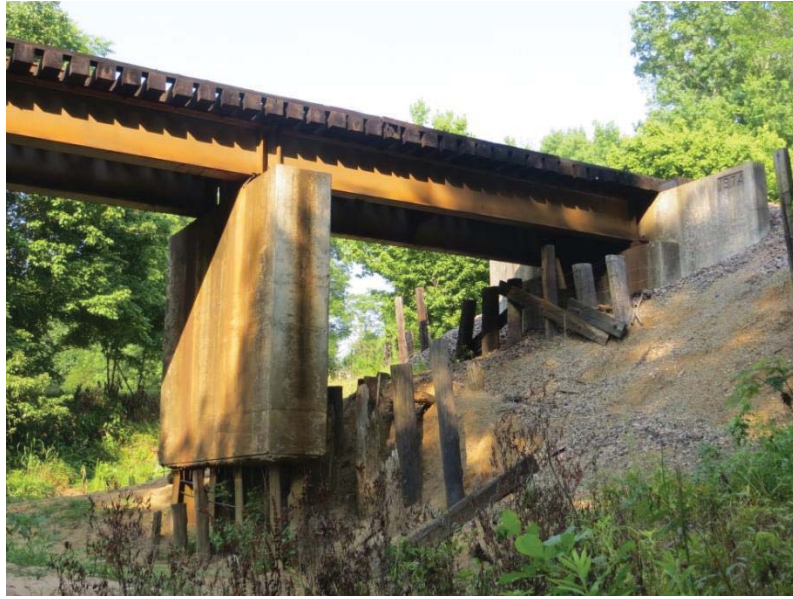
Figure 6. Railway bridge on deep foundation with piles exposed by scour.

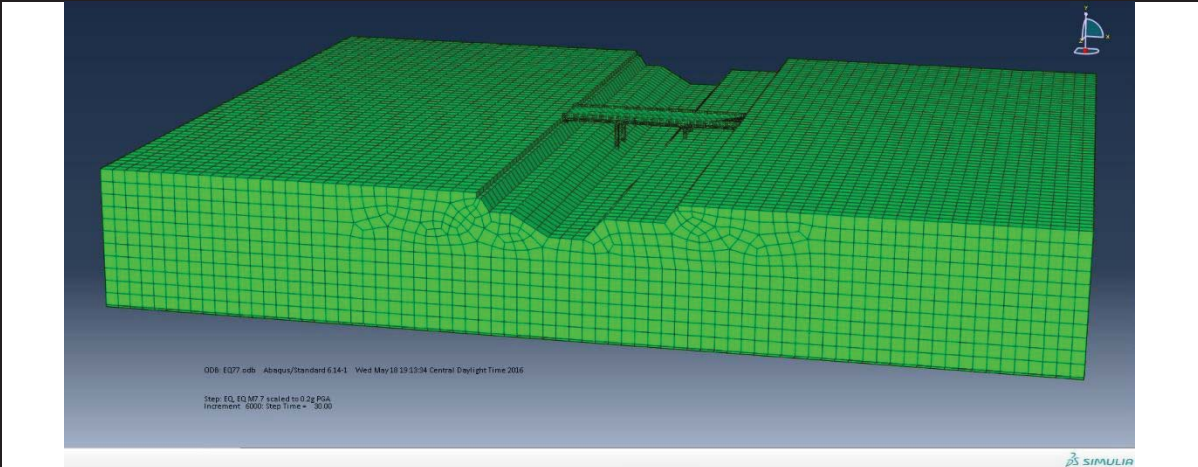
Soil-Foundation-Structure System

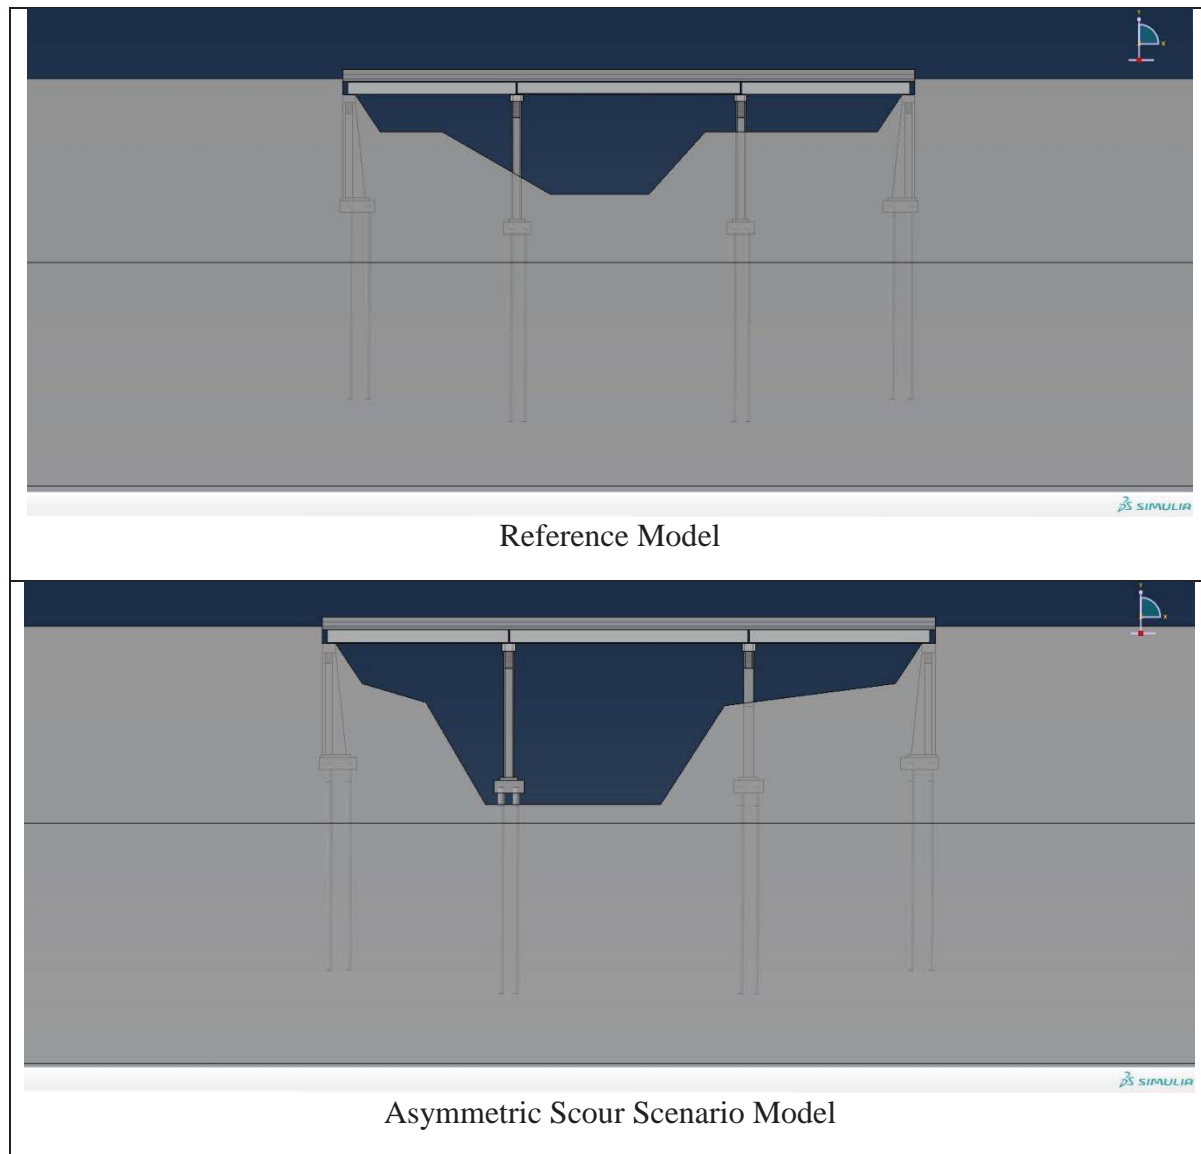
Figure 8. Flexible System Part Definition

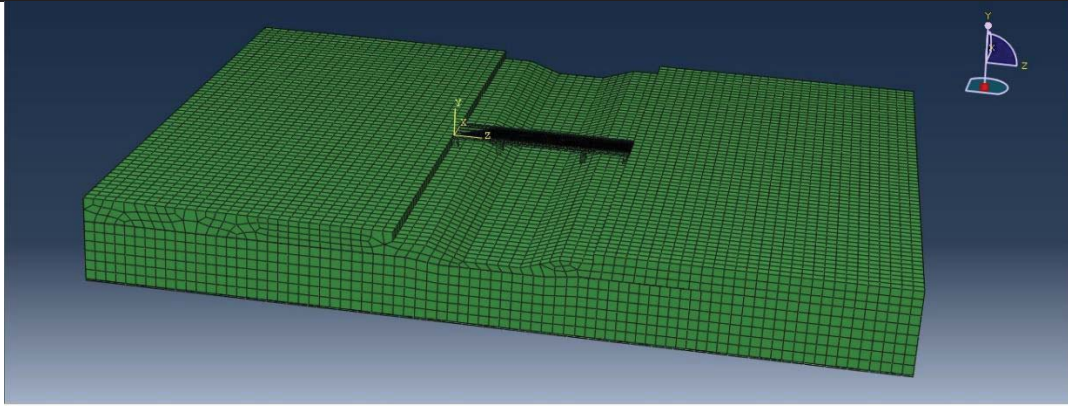
Soil-Foundation-Structure System

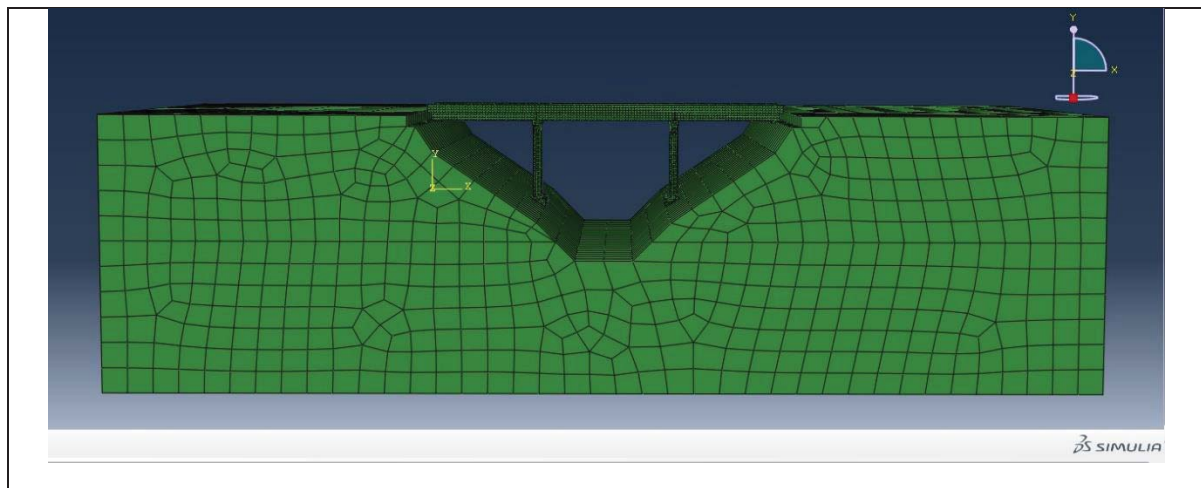
Figure 10. Flexible System Symmetric Scour Model Mesh

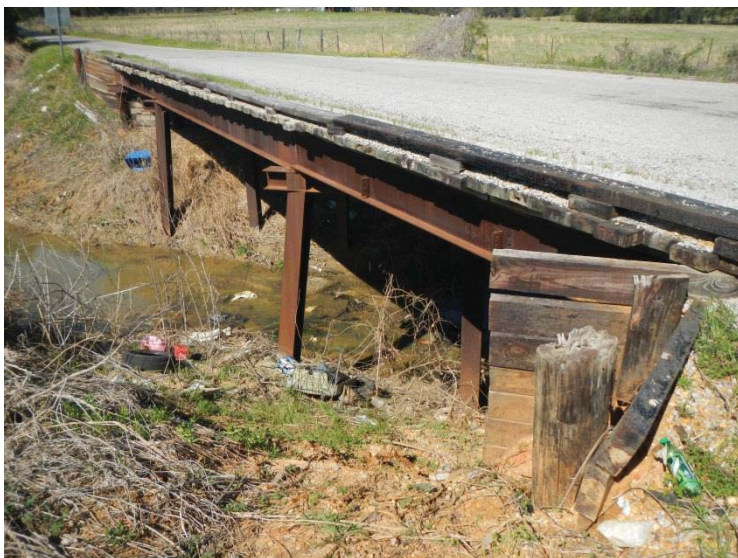
Figure 12. Bridge B-038 located on Union County road, CR 194, approximately 1.25 miles north of Sherman, Miss. (lat. 34.37675, long. -88.84149). Bridges of this type are not uncommon, but are being systematically replaced with box culverts.

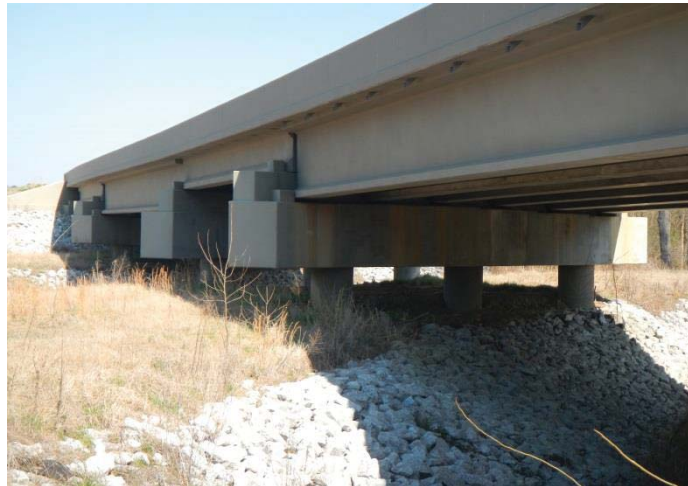
Figure 13. Bridge B-019 is a recent bridge on Mississippi Highway 9S in Pontotoc County. These new bridges are the least vulnerable within the study area. This bridge is approximately 0.8 mile from Endville, Miss. (lat. 34.311967, long.-88.888418). Neither this bridge nor any of the other bridges on the new portion of Highway 9 appear on the NBD.

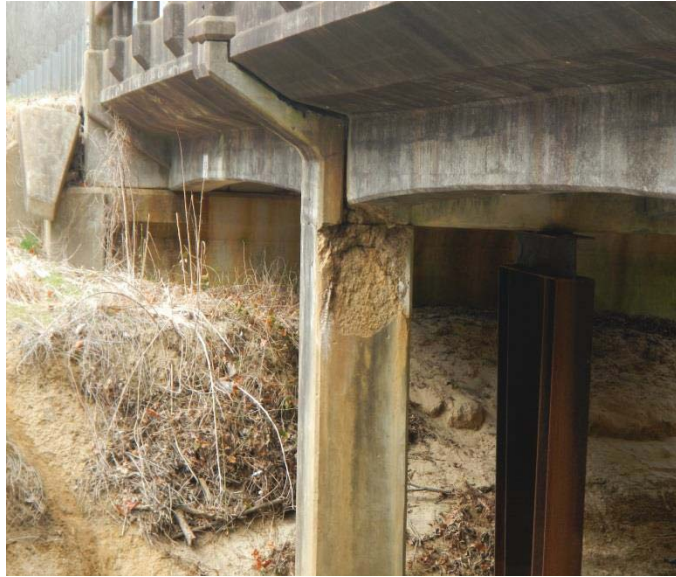
Figure 14. Bridge B-007 is located on the western edge of Sherman, Mississippi (lat. 34.451122, long. -88.760082) on Highway 178. Extensive damage to this bridge has required the insertion of an I-beam frame beneath the deck to assist in supporting the bridge. This bridge is considered a vulnerable to natural hazards such as earthquakes.

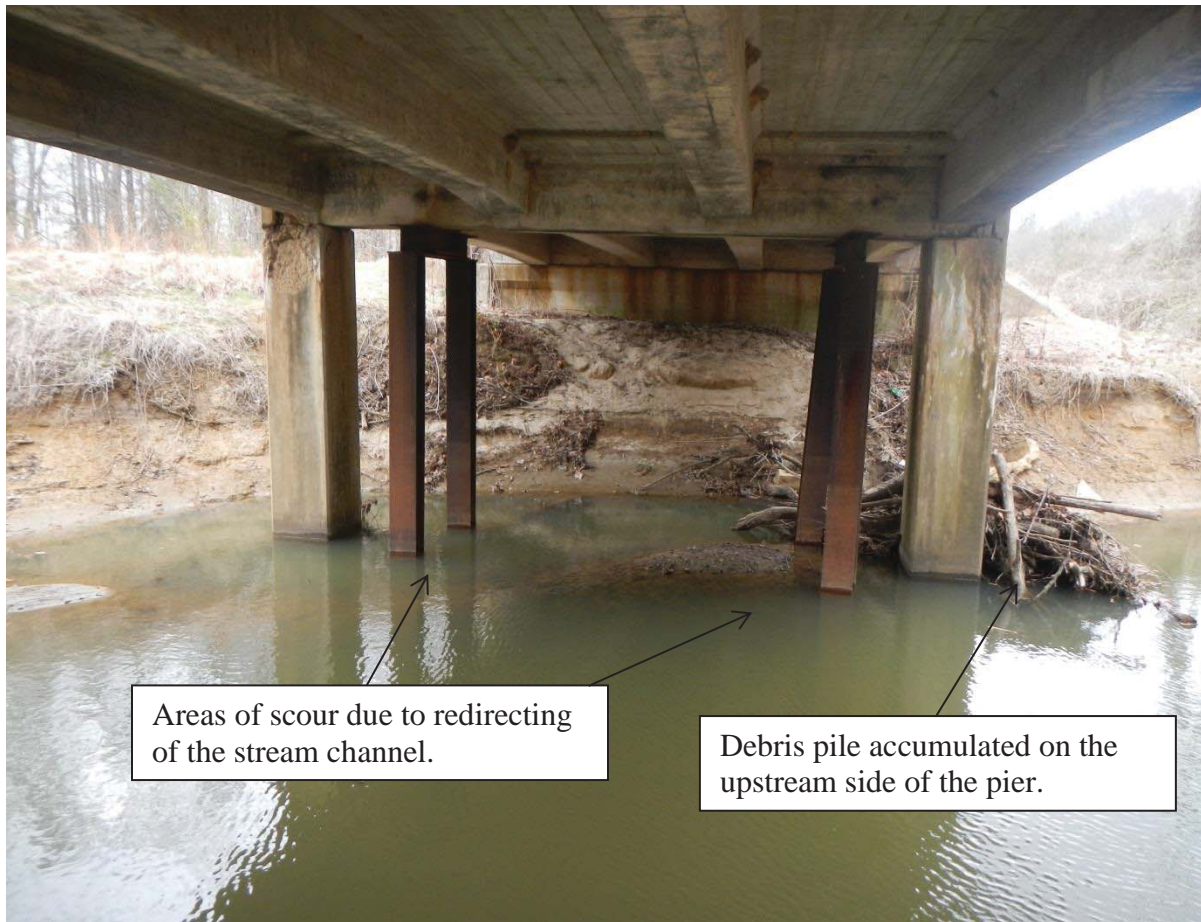
Figure 15. View beneath bridge B-007 (lat. 34.451122, long. -88.760082) showing a debris pile that is redirecting stream flow against the west bank causing additional lateral erosion not directly associated with the stream channel. The lateral erosion (and perhaps the in stream scour) here may be accelerated by flood conditions. Note there is no erosion mitigation such as rip rap.

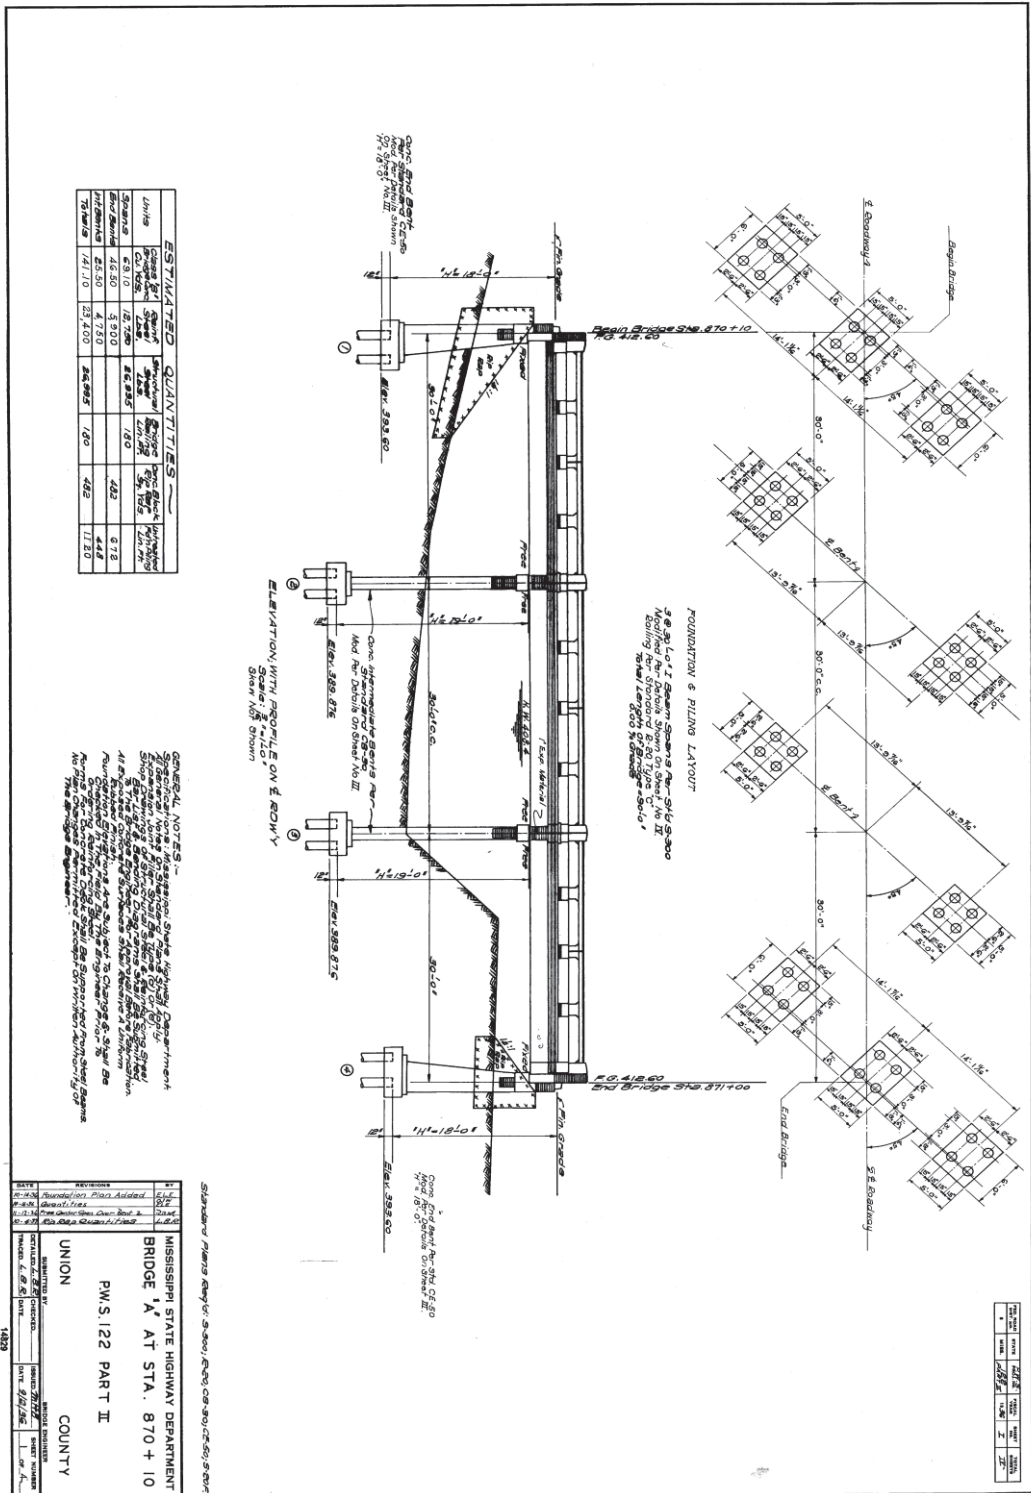
Figure 16. Cross section of bridge B-002 as it was in designed in 1936. Note that the location of the stream or stream characteristics below the structure is not indicated.

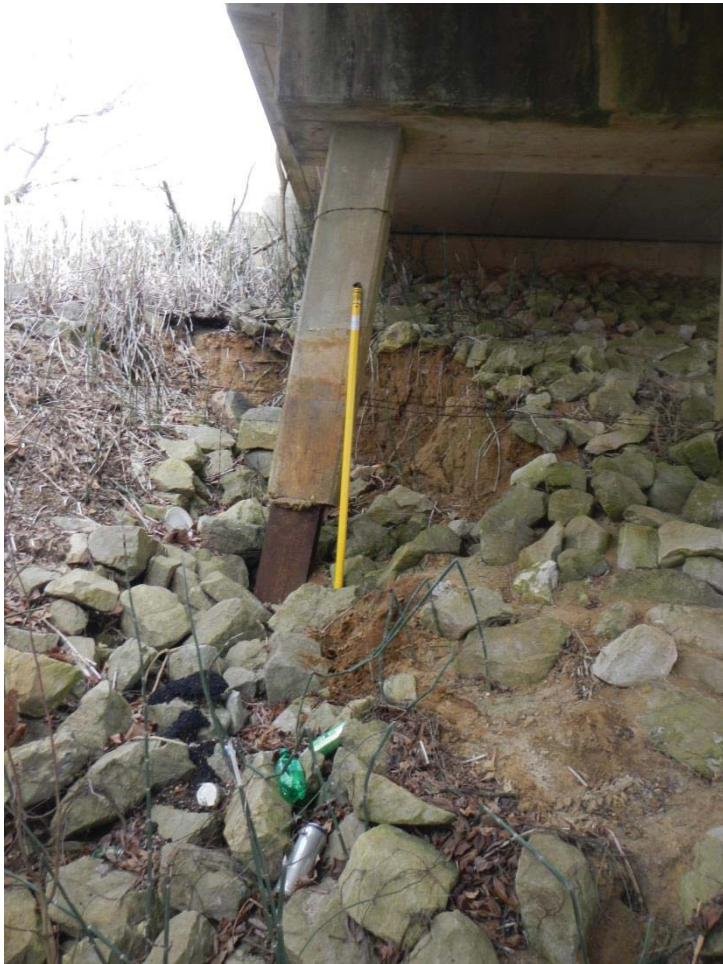
Figure 17. Above is an example of erosion originating from sources other than the stream channel. Downspouts direct the deck water downward forming linear gullying which expands to include the piers. Here (B-0013, lat. 34.44944, long. -88.83196 ) the gullying has exposed the piling to surface oxidation and erosion.

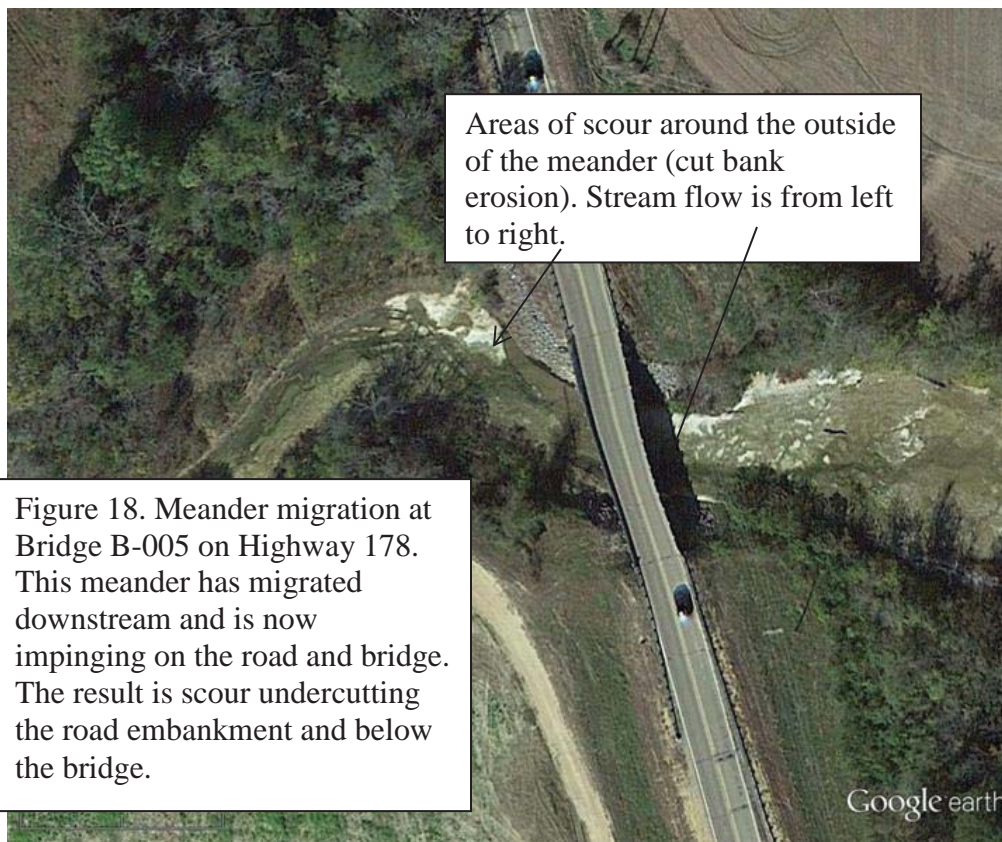
concentrated on the outside of the meander in what is referred to as the cut bank. In the case of B-005, the cut bank has intersected the embankment and scour has required MDOT to place rip rap for protection and then to bind the rip rap with concrete to form a cohesive “blanket” of rip rap. When the field inspections were conducted, scour in the cut bank of the

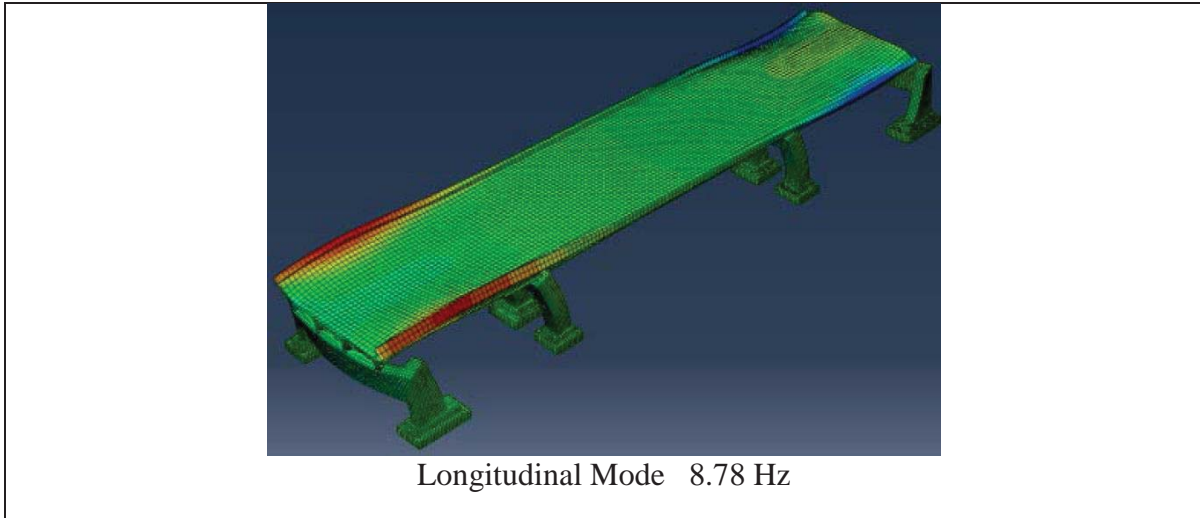
Figure 20. Fixed base modes for the stiff system

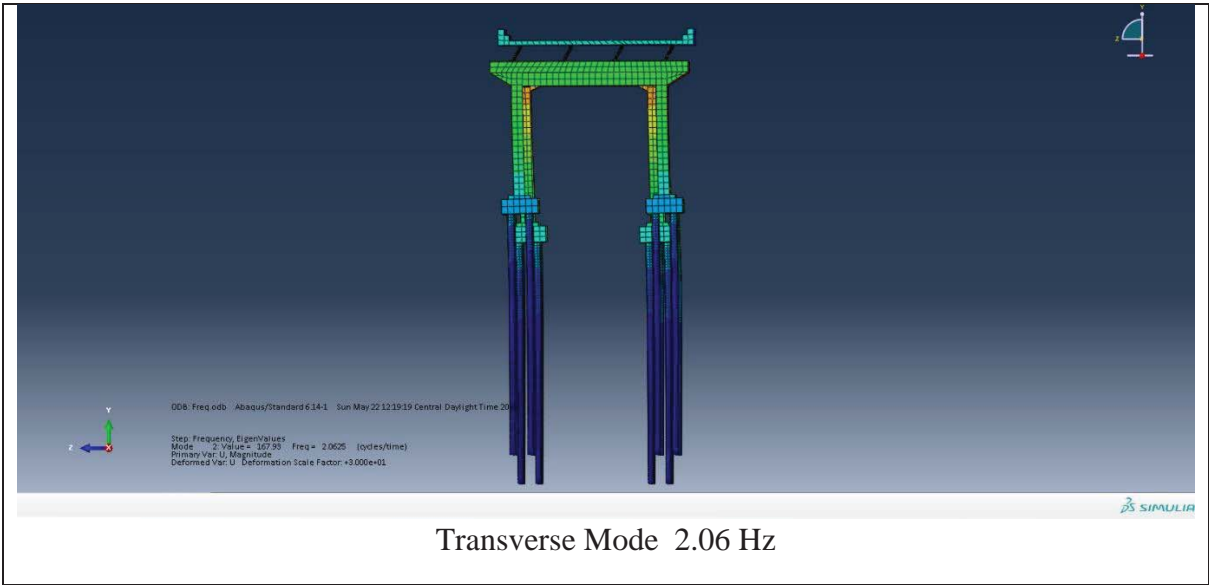
Figure 21 shows how each of the four characteristic modes identified in Figure 19 is altered by SSI. In the first three modes shown, the soil has been removed for clarity. In the fourth mode, it is included and illustrates the faceted appearance of the relatively coarse soil mesh when amplified 30 times to highlight the bending action in the stiffer structural elements.

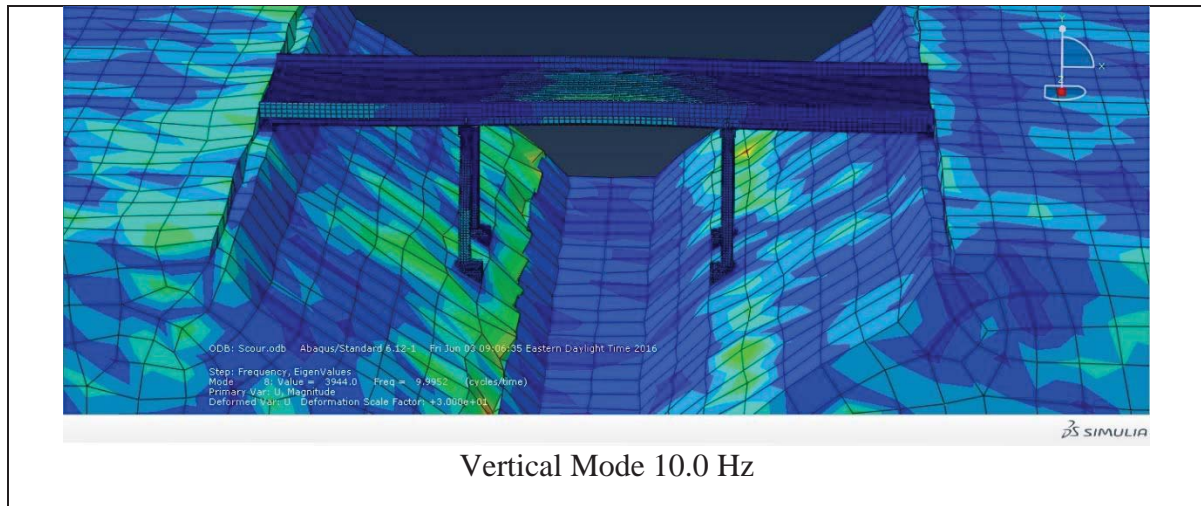
Figure 22. SSI mode for flexible system with symmetric scour scenario

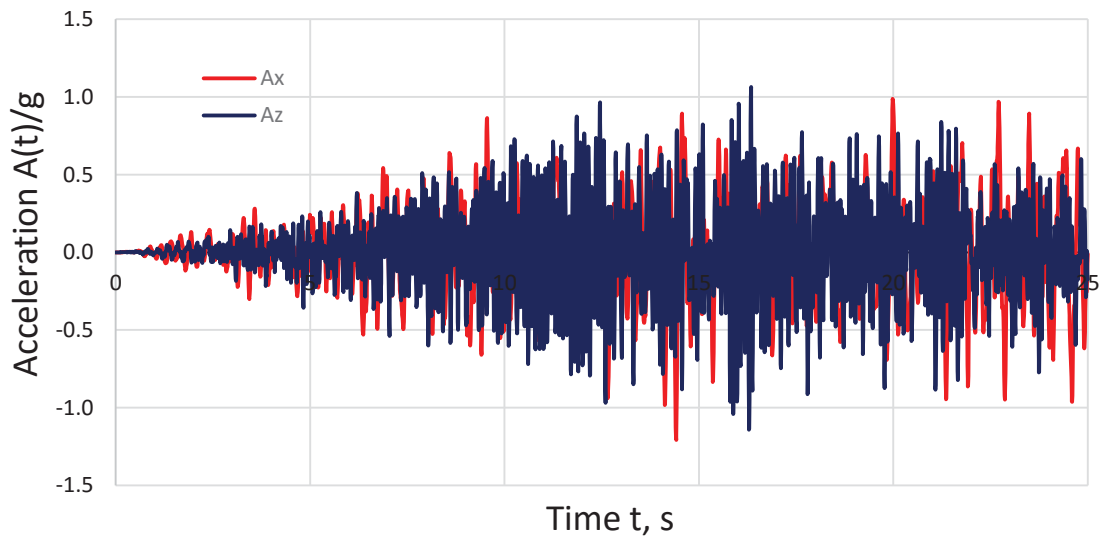
Figure 24. Asymmetric scour model response time history for simulated earthquake event
