TWO APPROACH GUARDRAIL TRANSITIONS FOR

CONCRETE SAFETY SHAPE BARRIERS

MIDWEST ROADSIDE SAFETY FACILITY

MwRSF Research Report No. TRP-03-69-98

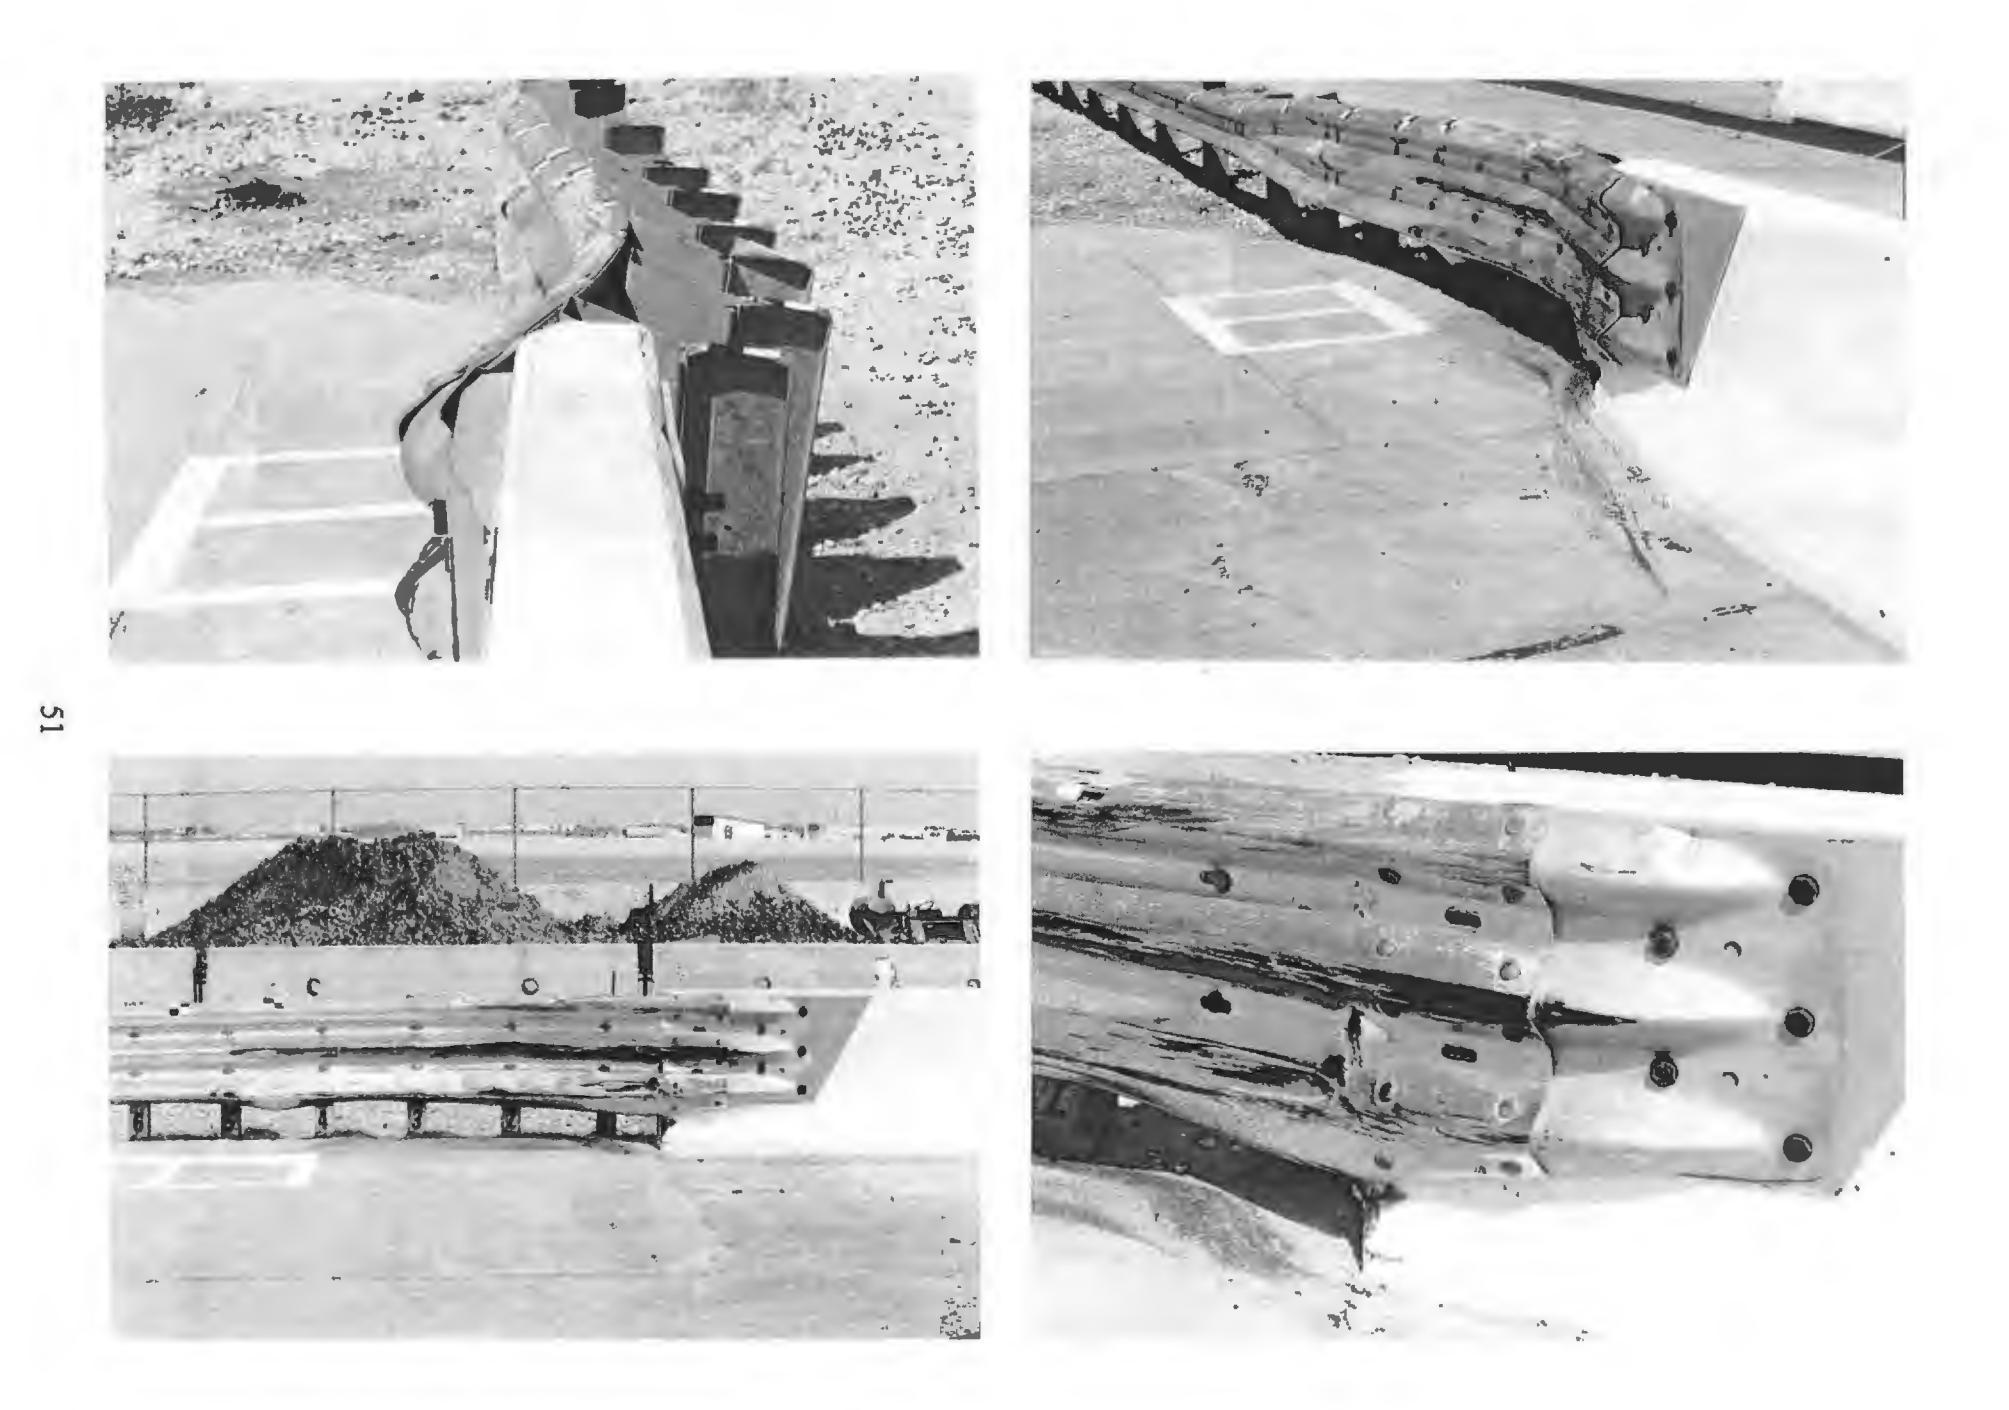
Figure 30. Barrier Damage, Test ITNJ-1 (Design No. 1)

Damage to the barrier was moderate, as shown in Figures 30 through 33. Barrier damage consisted mostly of deformed three beam, tire marks on the lower upstream face of the concrete end section, and cracking in the concrete end section. Concrete cracking and minor spalling was observed on the upstream end of the concrete end section, as shown in Figure 31. The permanent set of the guardrail and posts is shown in Figures 30 and 32 through 33. The maximum lateral permanent set deflection was approximately 241 mm at post no. 3, as measured in the field. The maximum lateral dynamic deflection was 349 mm at post no. 3, as determined from the high-speed film analysis.

modifications were made to the approach guardrail transition system. The embedment depth of post nos. 1 through 7 were increased by 152 mm, resulting in a total embedment depth of 1,245 mm. The relatively poorly-graded aggregate material used in Design No. 1 was replaced with a crushed limestone material more consistent with the AASHTO specification. In addition, a 25-mm chamfer was placed on the front vertical edge of the concrete safety shape's upstream end. These modifications, incorporated in Design No. 2, are shown in Figure 36.

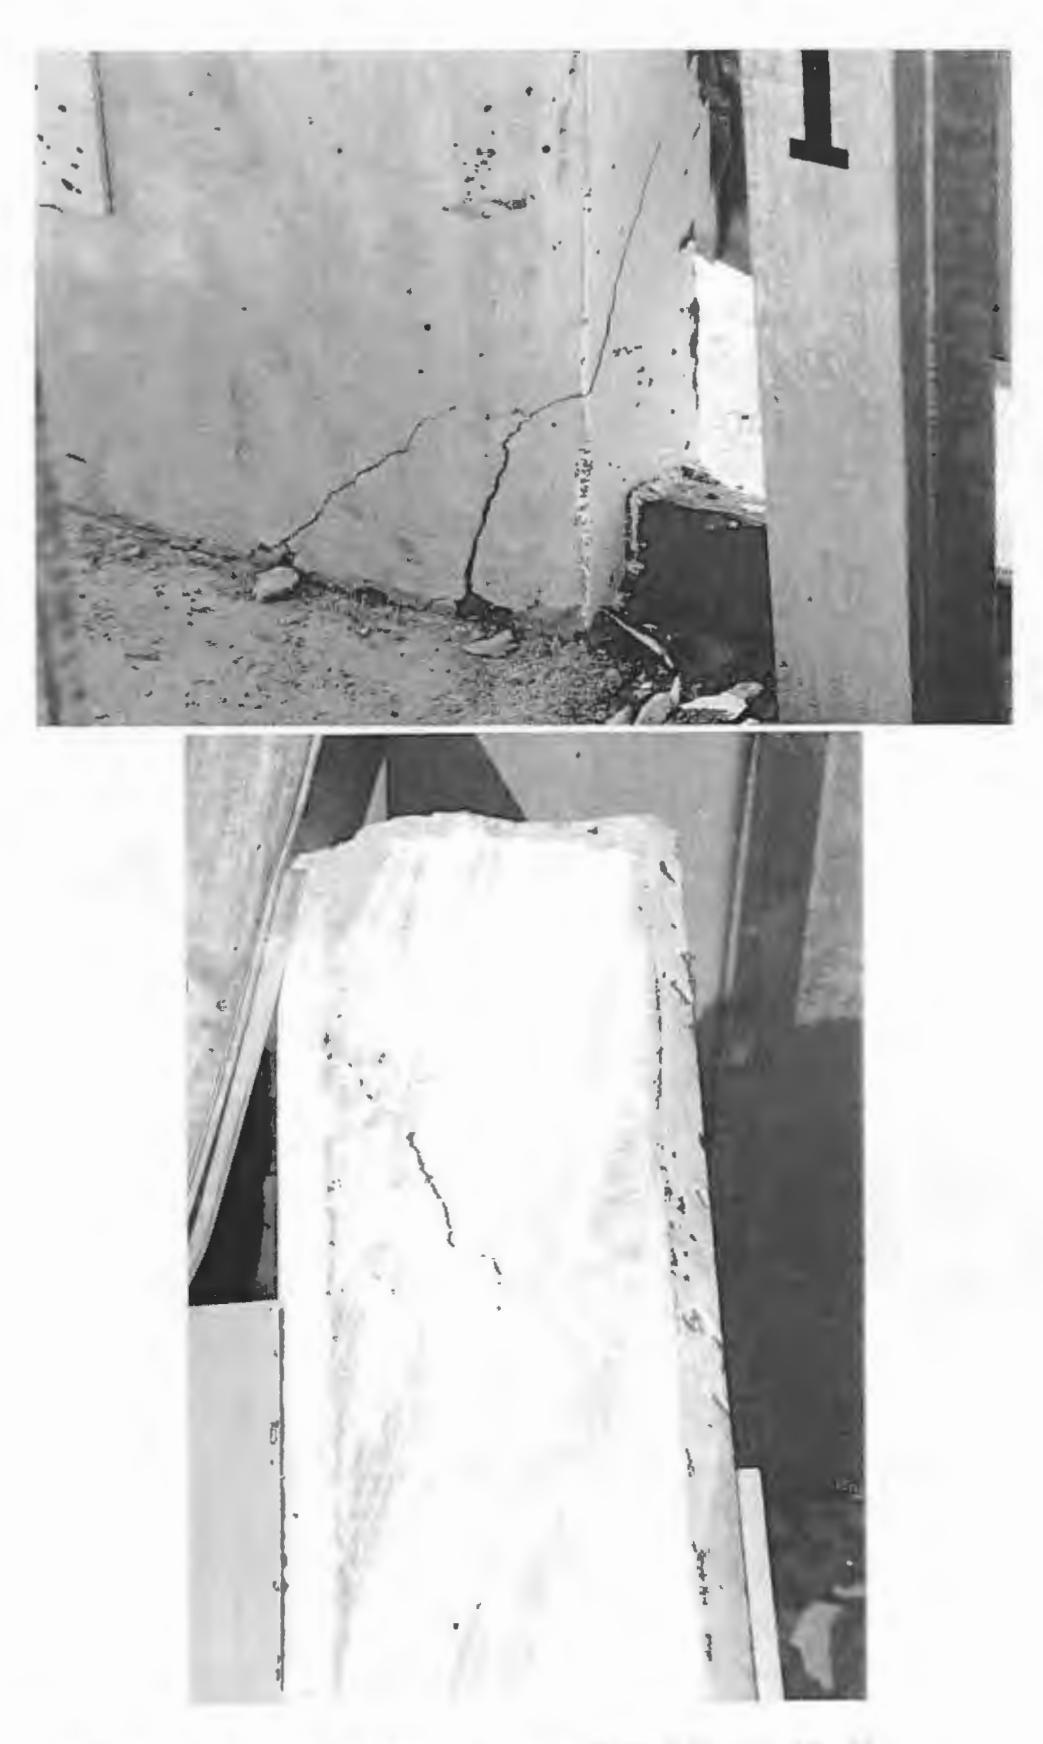
Figure 31. Cracking in Concrete End Section, Test ITNJ-1 (Design No. 1)

As a result of the extensive vehicle penetration into the barrier system, the pickup truck was redirected out of the barrier system at a higher than normal exit angle. Significant roll, pitch, and yaw angular motions were also produced, resulting in vehicle rollover. In addition, the increased vehicle penetration and minor pocketing led to higher than expected impact forces being applied to the concrete end section, resulting in cracking of the safety shape barrier.

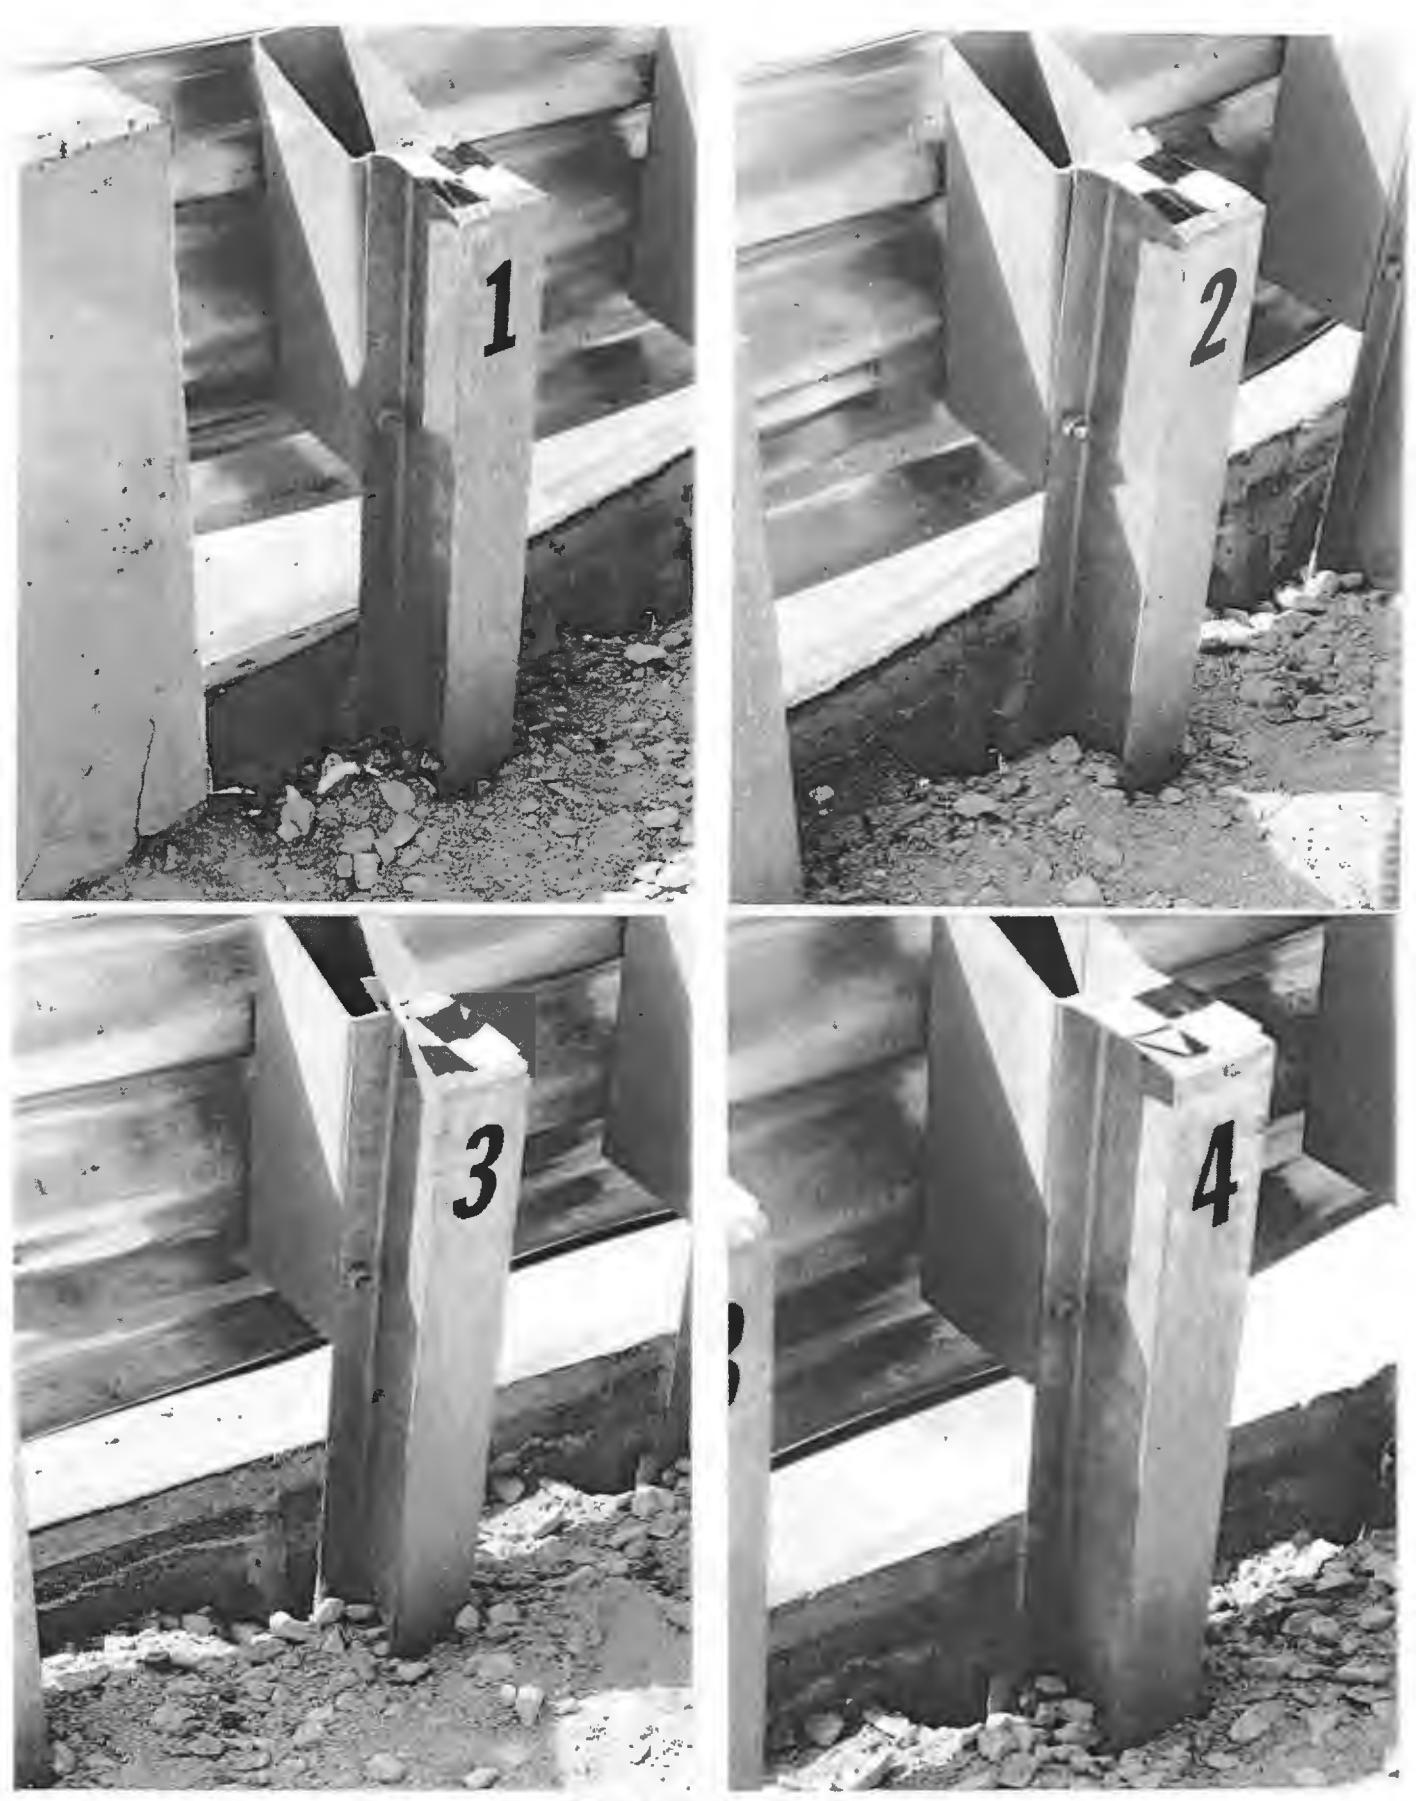
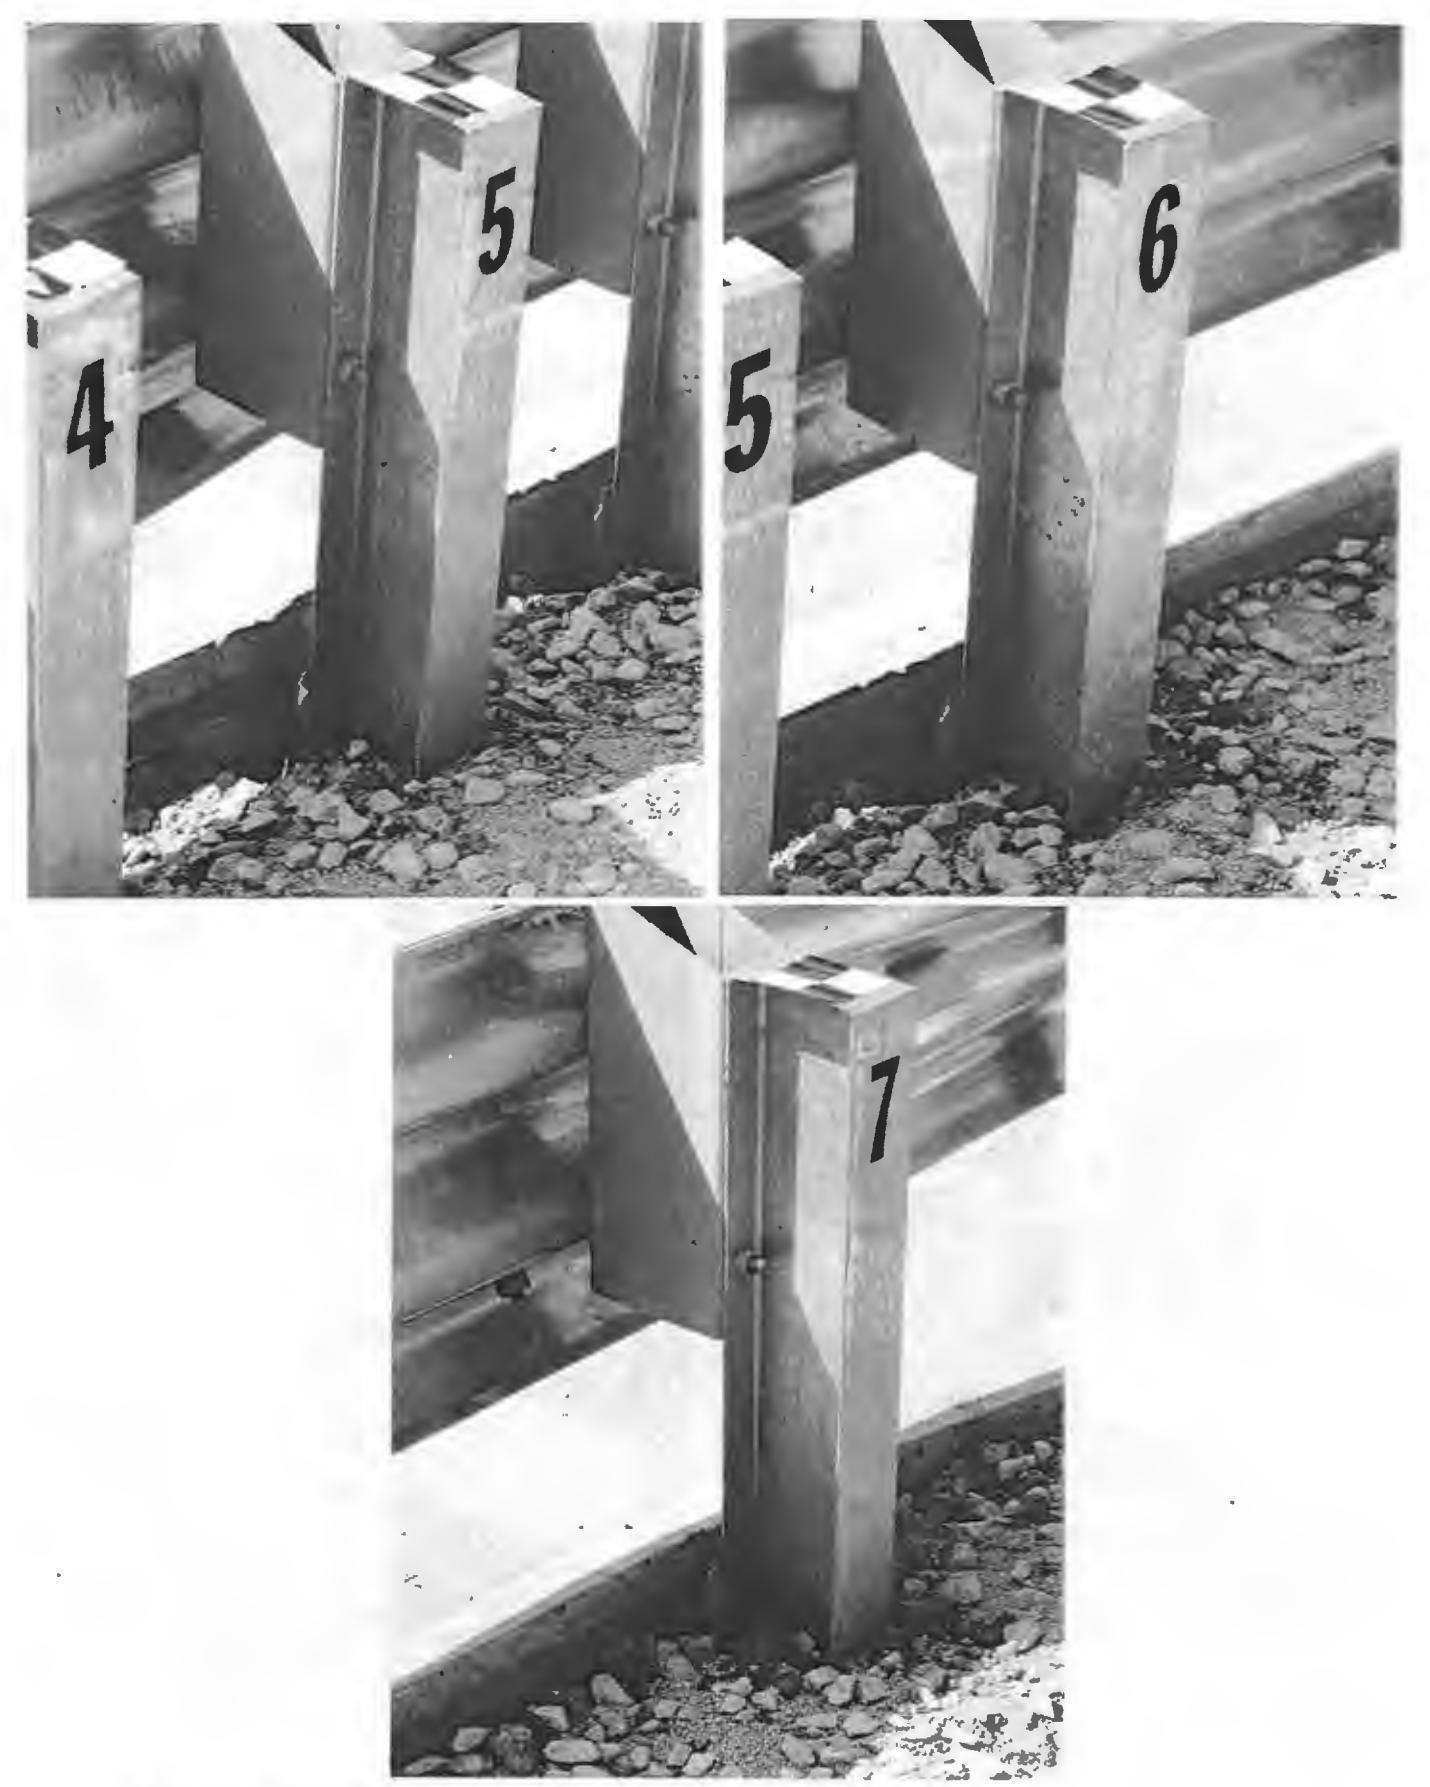
Following the unsuccessful crash test of Design No. 1, it was necessary to determine the cause of the poor barrier performance and subsequent vehicle rollover so that design modifications could be made to the system. A careful examination of the damaged barrier system and an analysis of the test results revealed that the dynamic and permanent set barrier deflections were greater than those predicted. It is believed that these excessive barrier deflections occurred due to post-soil forces being significantly lower than expected. These lower post-soil forces may be attributed to the use of a relatively poorly-graded, coarse crushed limestone material meeting NCHRP Report 350 specifications.

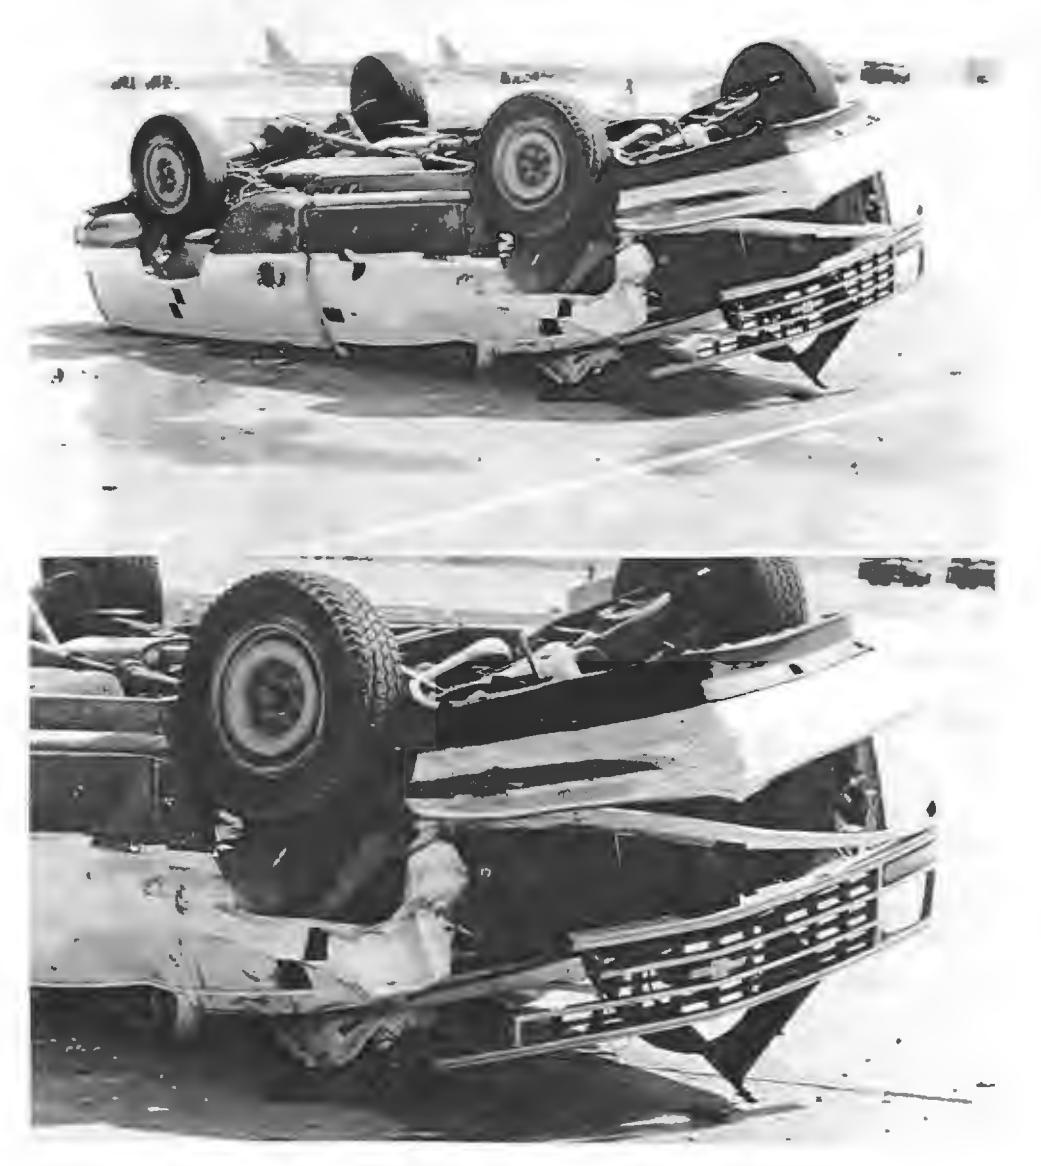
Figure 34. Vehicle Damage, Test ITNJ-1 (Design No. 1)

Exterior and interior vehicle damage was extensive and occurred at several body locations, as shown in Figures 34 and 35. The left-front quarter panel was crushed inward, and the left-side of the front bumper was bent back toward the engine compartment. The engine hood, roof, truck cab, and window glass were severely crushed during the vehicle rollovers. The floorboard of the occupant compartment also sustained significant plastic deformations due to the severe impact with the barrier as well as from vehicle rollover.

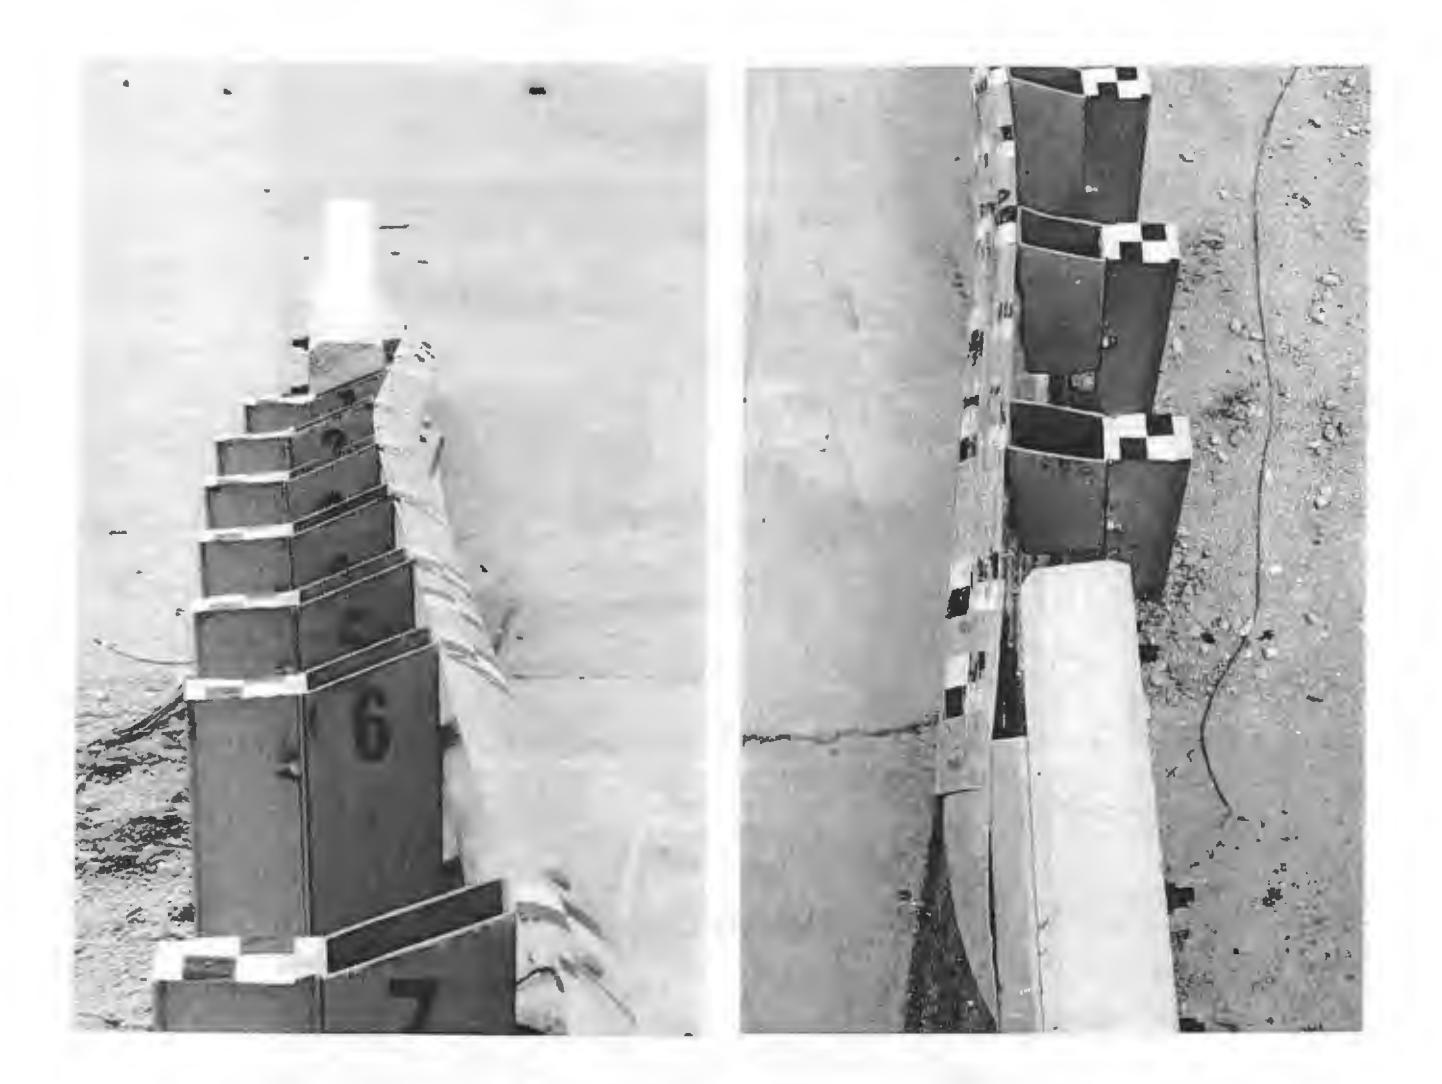
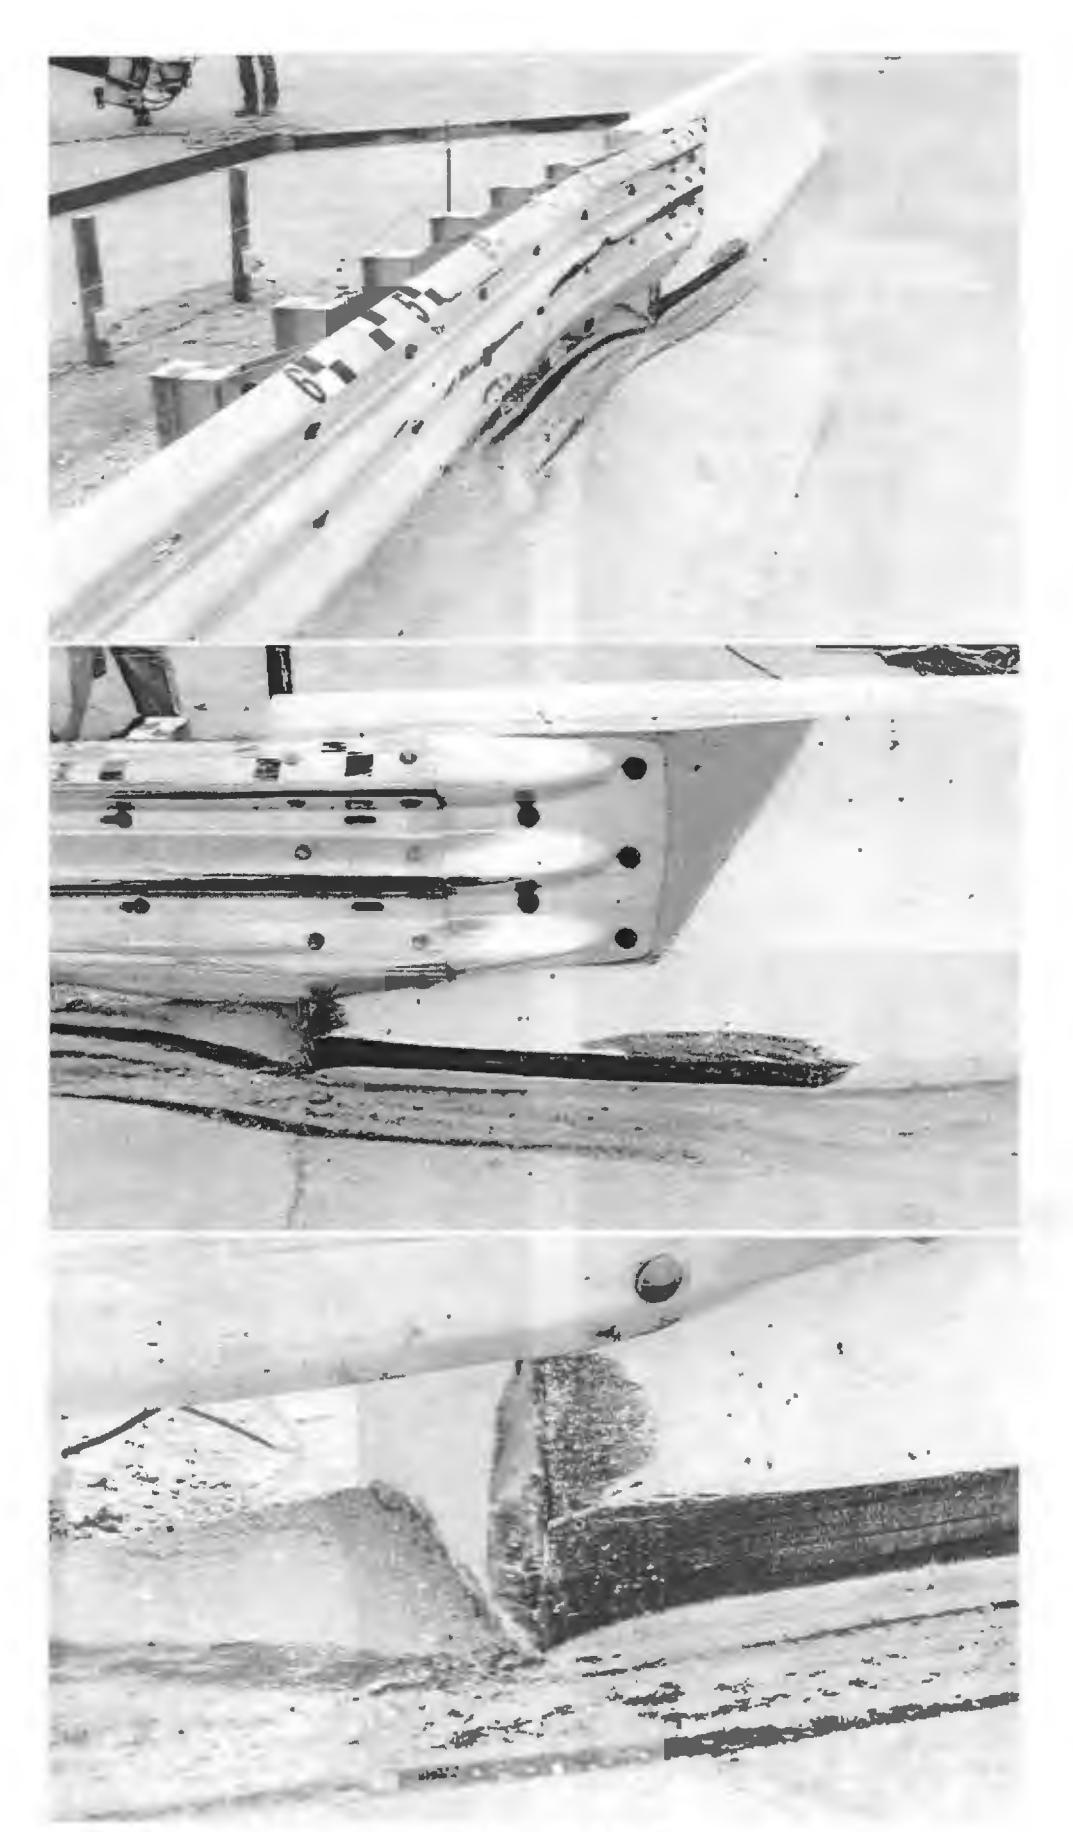
Damage to the barrier was moderate, as shown in Figures 42 through 45. Barrier damage consisted mostly of deformed thrie beam and tire marks on the lower upstream face of the concrete end section. No cracking was observed in the concrete end section. The permanent set of the guardrail and posts is shown in Figures 42 and 44 through 45. The maximum lateral permanent set deflection was approximately 92 mm at post no. 2 and the midspan between post nos. 2 and 3, as measured in the field. The maximum lateral dynamic deflection was 133 mm at post no. 3, as determined from the high-speed film analysis. It is noted that some dynamic deflection measurements were not available for viewing from the overhead camera due to the vehicle extending over the barrier.

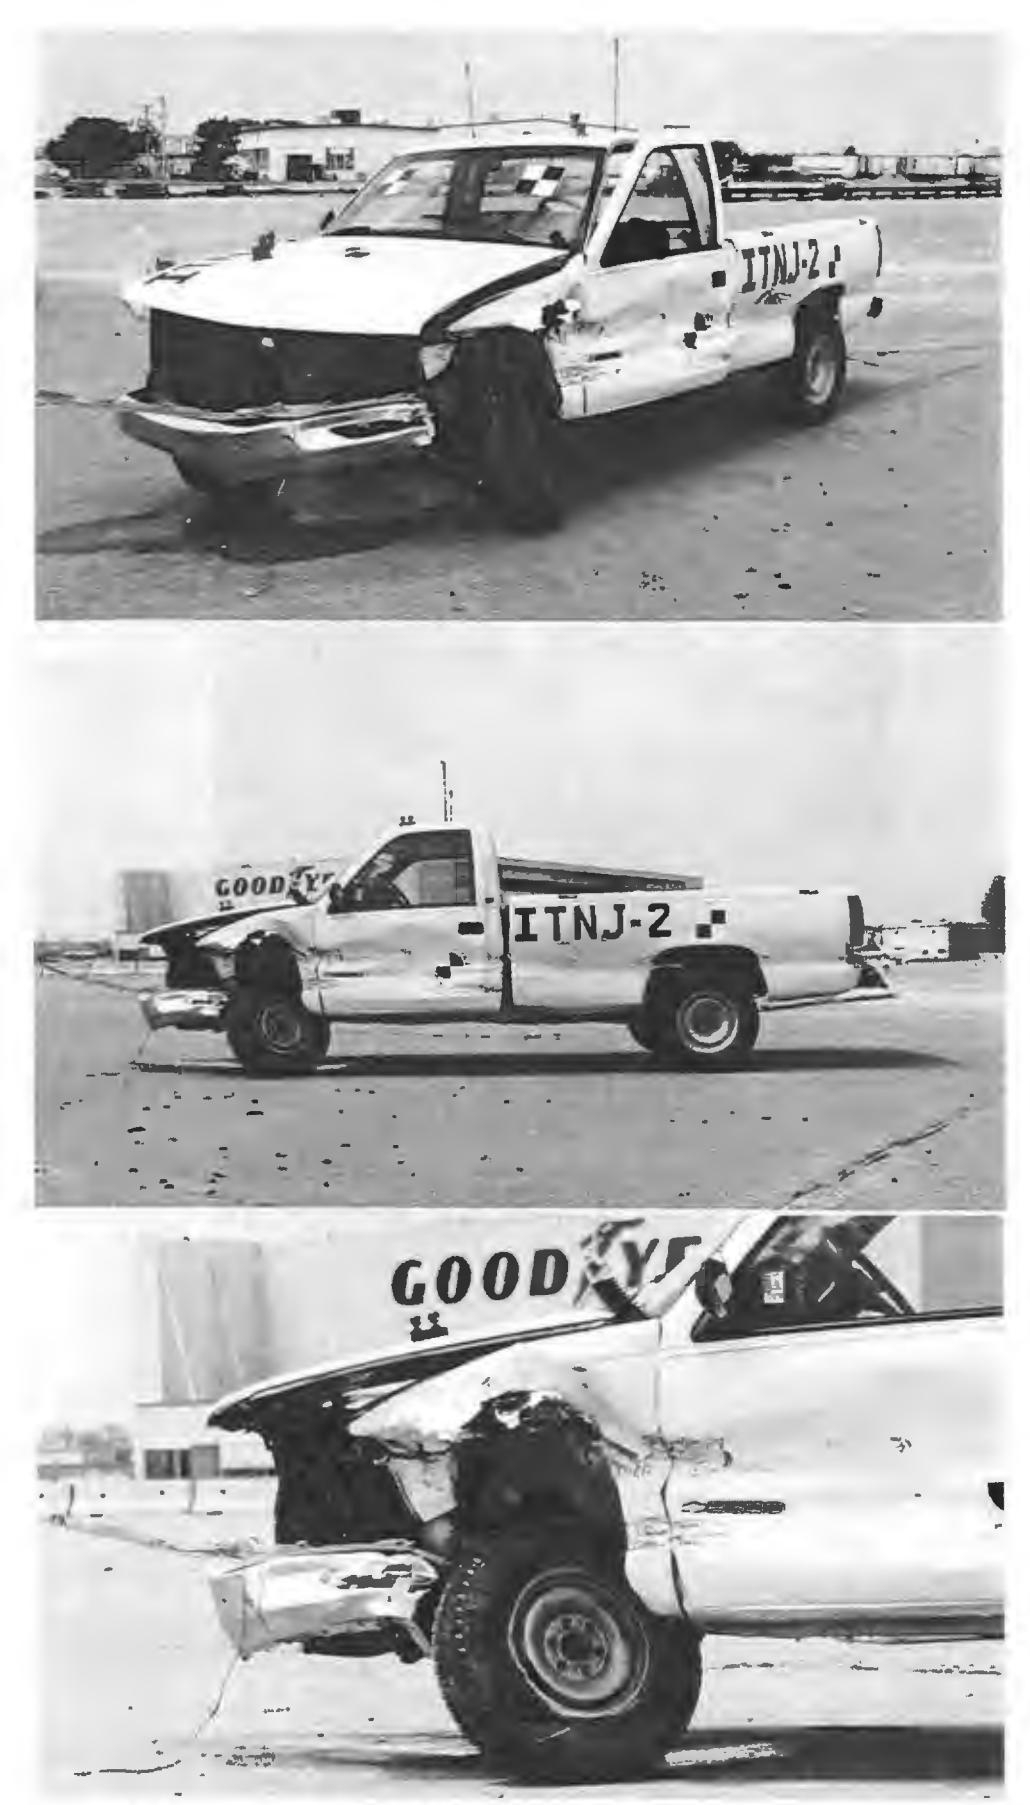
Figure 46. Vehicle Damage, Test ITNJ-2 (Design No. 2)

Vehicle damage was moderate, as shown in Figure 46. The left-front quarter panel was crushed inward, and the left-side of the front bumper was also bent back toward the engine compartment. The left-front wheel assembly was deformed and pushed backward into the firewall. Longitudinal deformations, due to vehicle-rail interlock, were observed along the entire left-side of the vehicle. Maximum occupant compartment deformations to the floorboard and/or firewall in the lateral, longitudinal, and vertical directions were 95 mm, 83 mm, and 83 mm, respectively, as shown in Figure 47.
