1. Report No.	2. Government Accession No.		3. Recipient's Catalog No.	
FHWA-RD-93-058				
4. Title and Subbide			5. Report Date	
TESTING OF NEW BRIDGE RAIL AN VOLUME I: TECHNICAL REPORT	ND TRANSITION D	DESIGNS	6. Performing Organization Code

10. ADSTACT				
The objectives of this study were to develop safer bridge rail and transition designs and to improve design guidelines. Ten bridge railings and two transitions were designed, tested, and evaluated in accordance with American Association of State Highway and Transportation Officials (AASHTO) requirements. The railings were designed using ultimate strength procedures and collision forces from earlier research. Design procedures, railing designs, and test results are presented. All designs demonstrated acceptable collision performance.			nes. Ten of State th ented. All

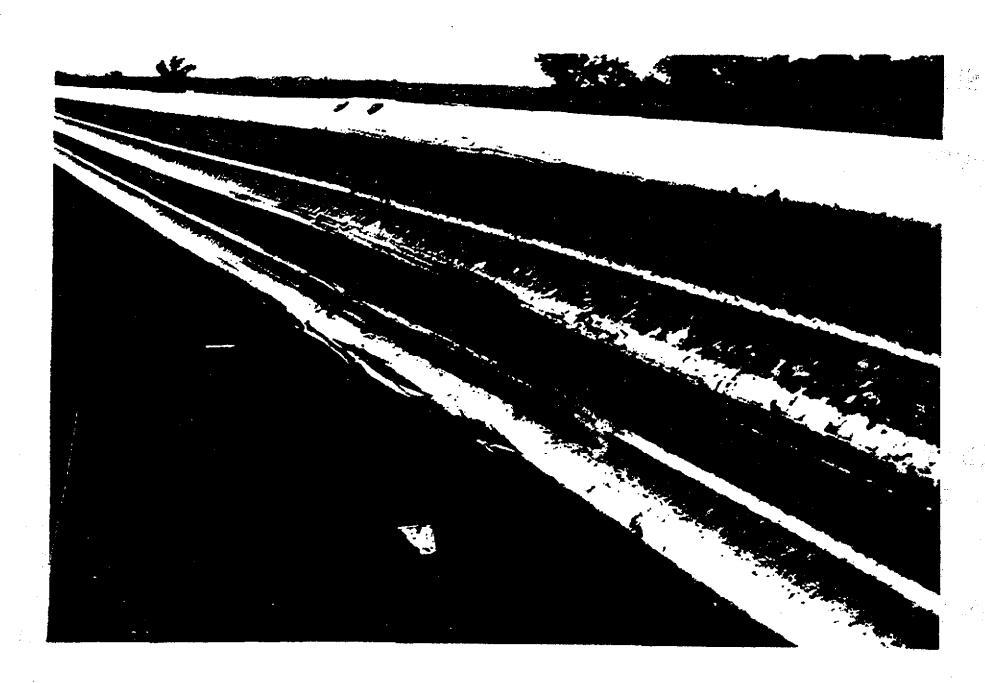
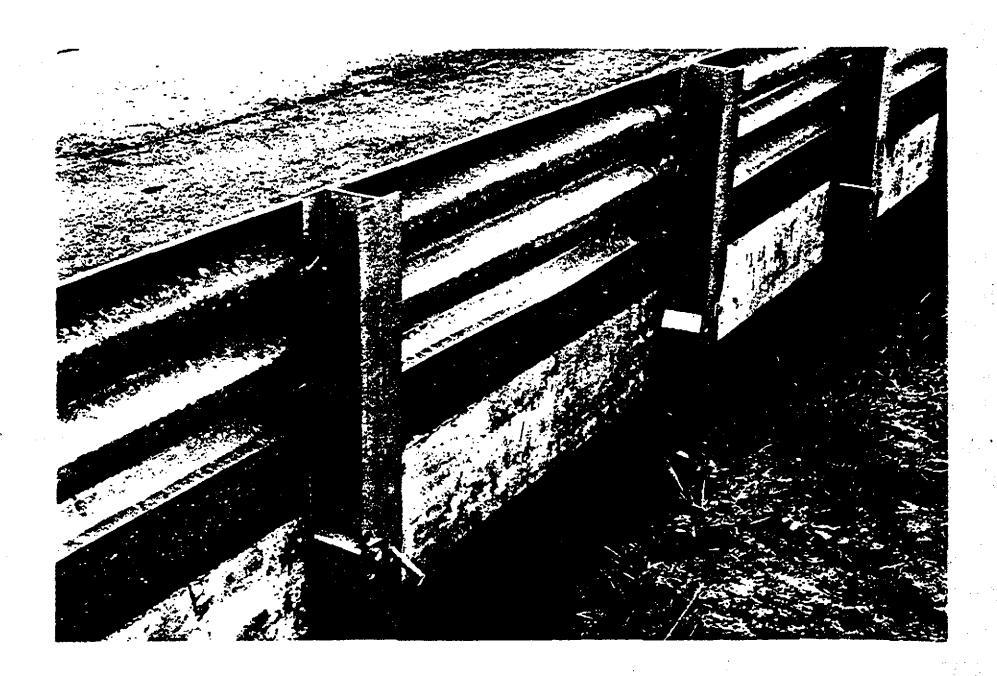
Figure 20. Damage to railing system in test 7069-17.

The railing received moderated damage (figure 20). Maximum lateral deflection was 0.5 in (13 mm) at the top of post 5. At post 4, the top anchor bolts connecting the post to the bridge deck showed structural distress. One bolt was pulled from the anchor insert in the concrete. Post 5 was bent outward about 0.5 in (13 mm) at the top and the top anchor bolts showed structural distress. One of the bolts in this post was also pulled from the anchor insert.

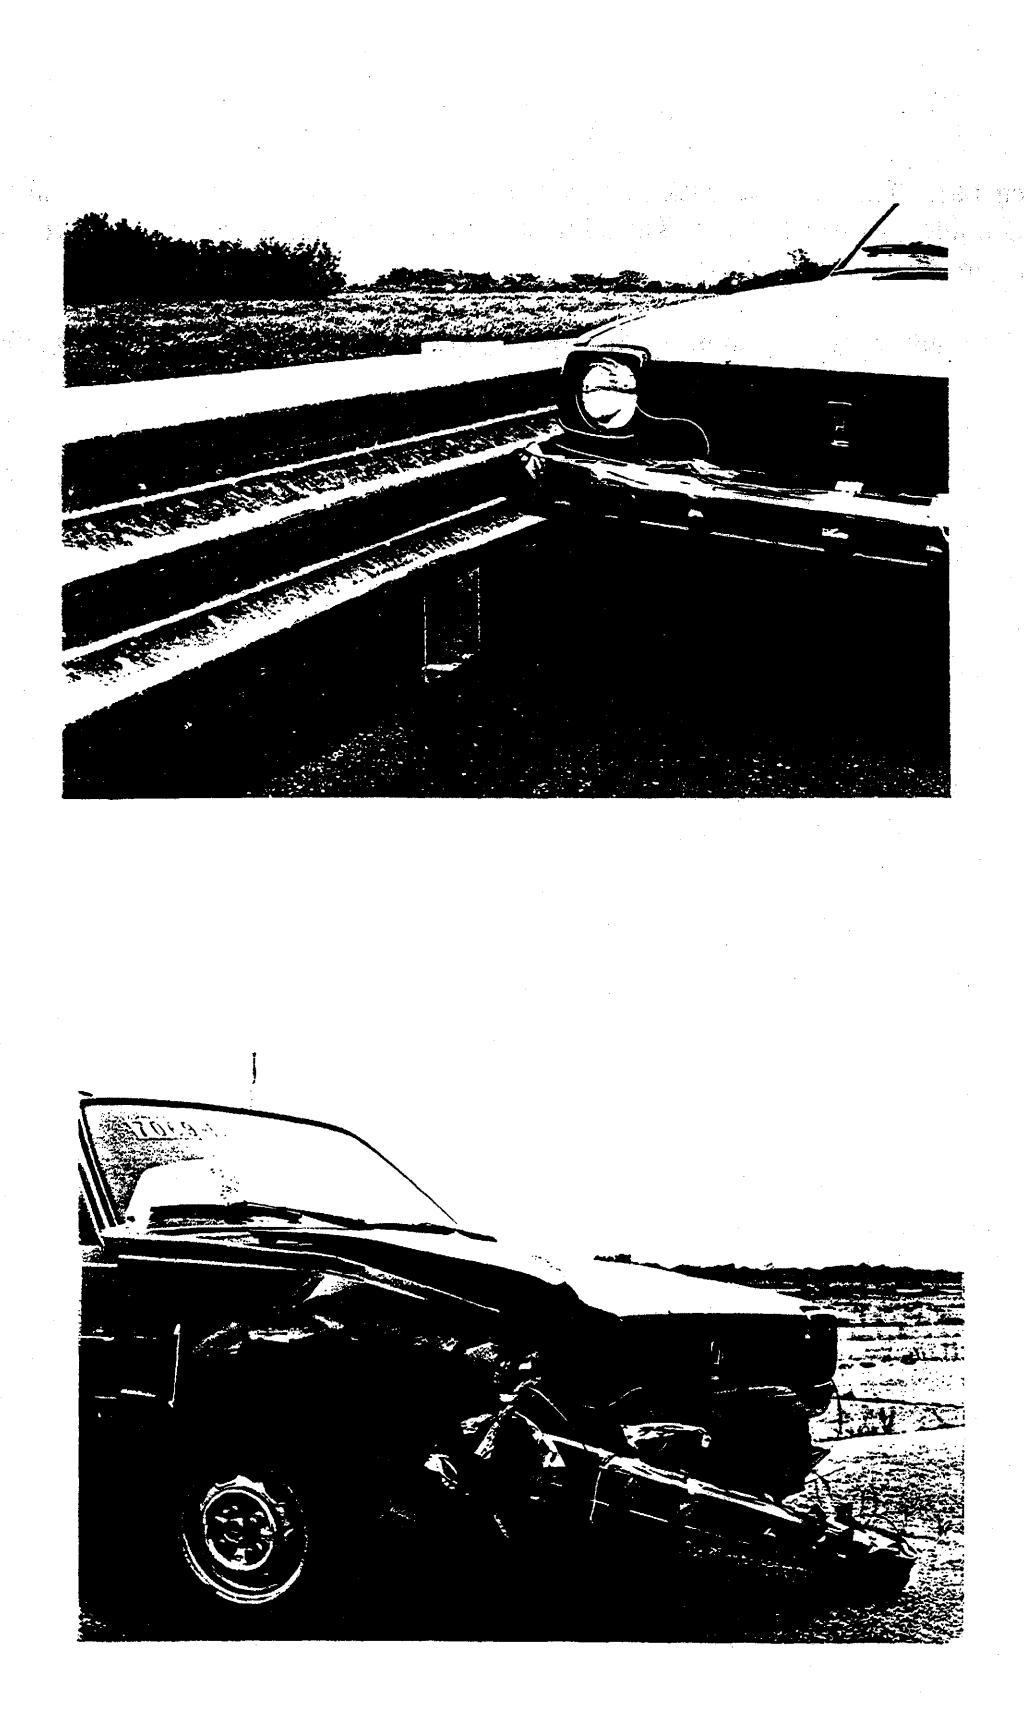
Figure 21. Vehicle and railing for test 7069-17.

The vehicle sustained damage to the right side (figure 21). Maximum crush at the right front corner at bumper height was 9.0 in (229 mm). The strut and constant velocity joint on the impact side were damaged. The right front wheel was canted inward at the bottom and pushed back into the fender well. The right side window was broken out by the dummy's head. Also, damage was done to the front bumper, hood, grill, radiator and fan, right front quarter panel, and right door.

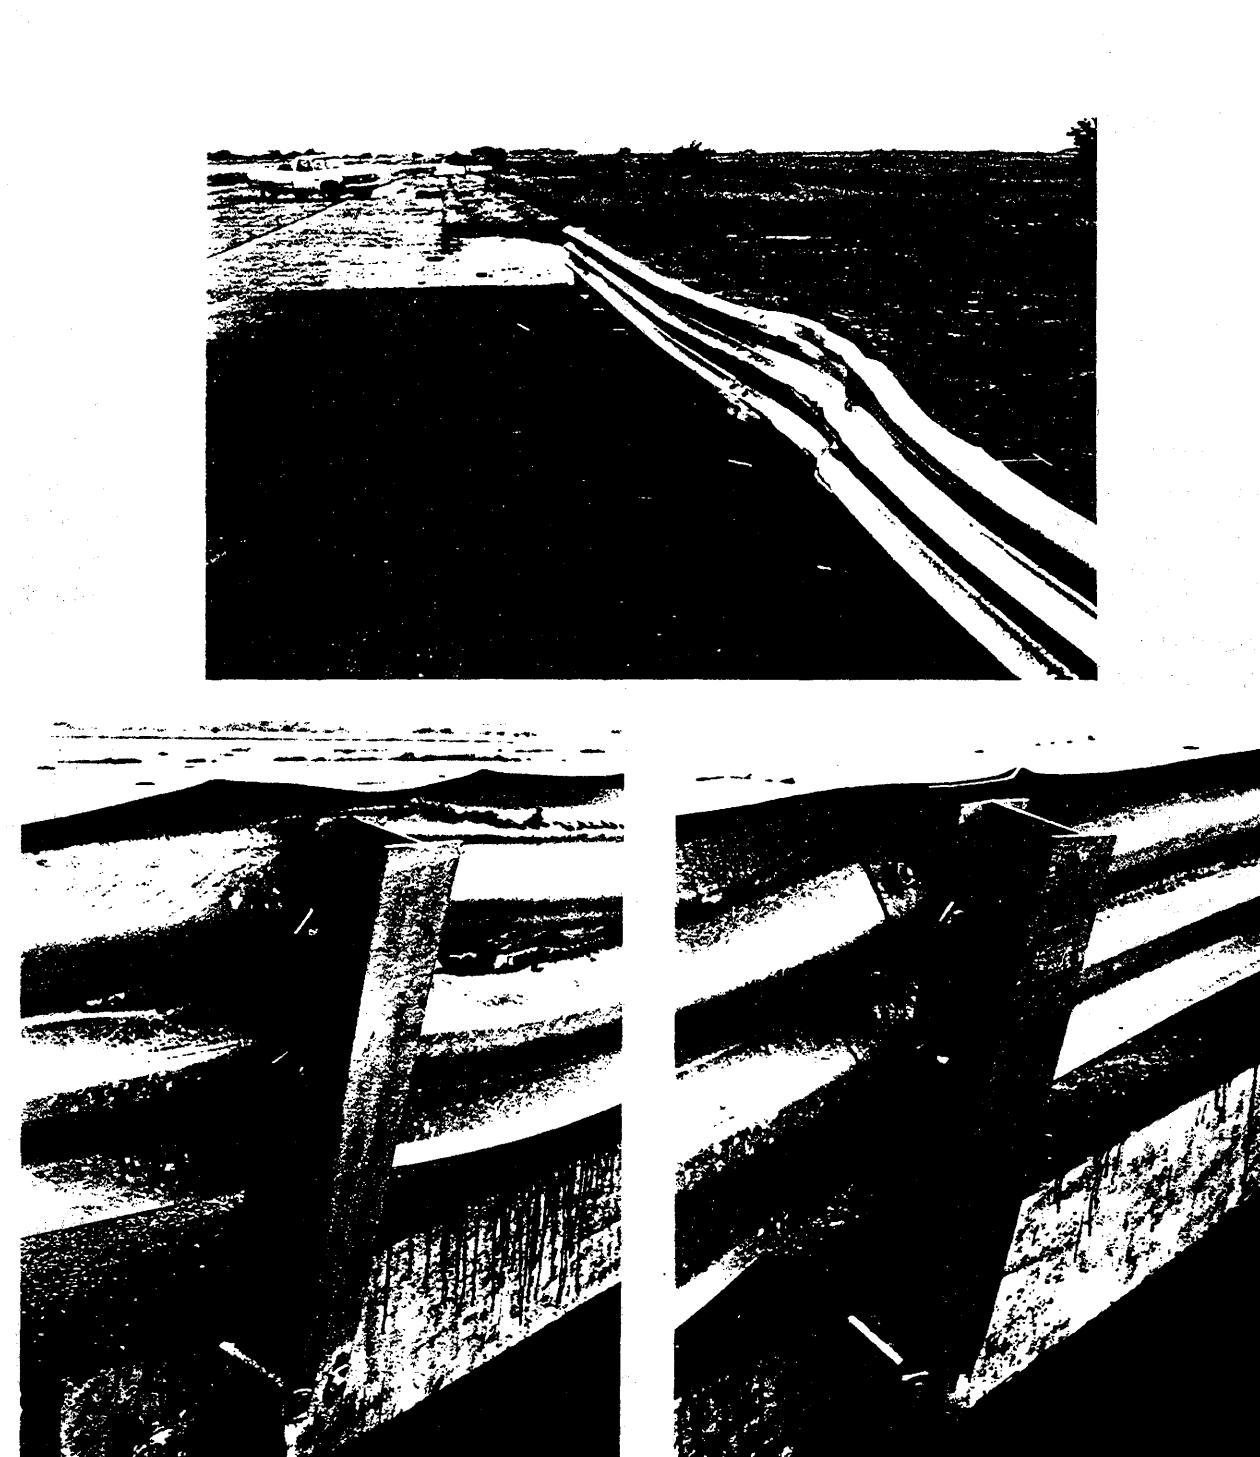
Figure 23. Damage to railing in test 7069-18.

The railing received moderate damage (figure 23). At post 8 the upper deck bolts connecting the post to the bridge deck were bent and the post was bent back 1.5 in (38 mm) at the bridge deck surface. Post 9 was bent 2.5 in (64 mm), the upper deck bolt on the right side was bent, and the upper deck bolt on the left side pulled through the outer flange. Post 10 was slightly twisted. Maximum lateral deflection was 13.0 in (330 mm) at the top of the thrie-beam between posts 8 and 9.

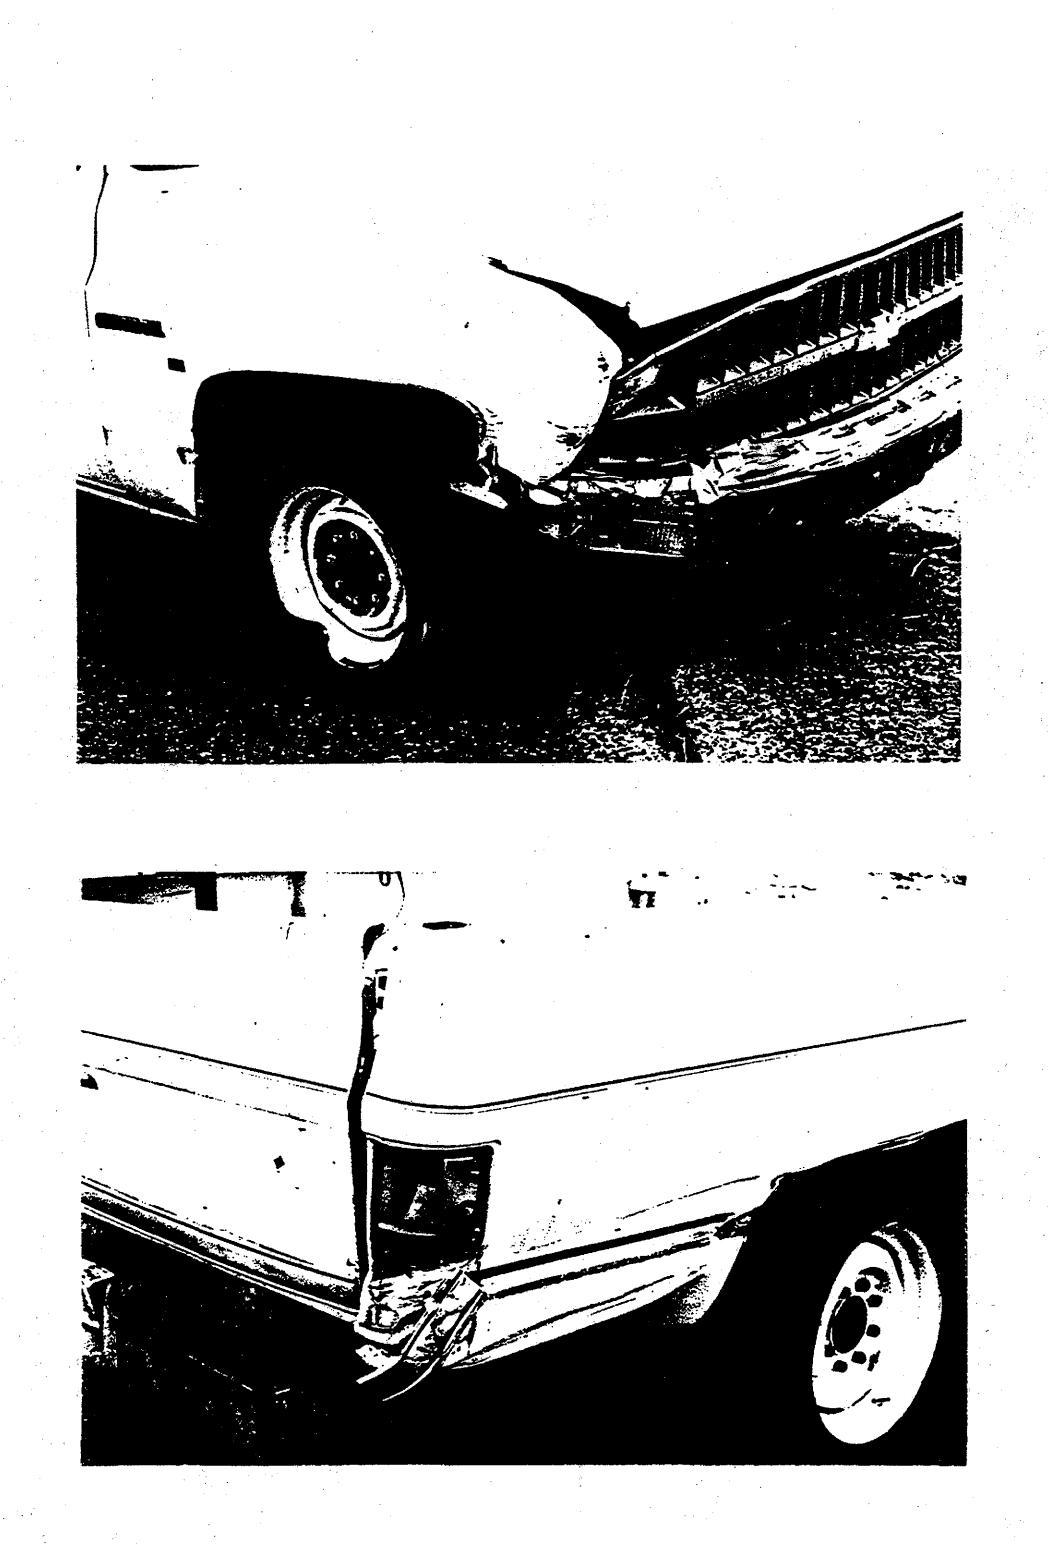
Figure 24. Damage to vehicle in test 7069-18.

The vehicle sustained damage to the right side as shown in figure 24. Maximum crush at the right front corner at bumper height was 6.5 in (165 mm). The right front tire deflated, and the rim was bent. The right side window was broken out by the dummy's head. Also, damage was done to the front bumper, hood, grill, right front and rear quarter panels, and right door.

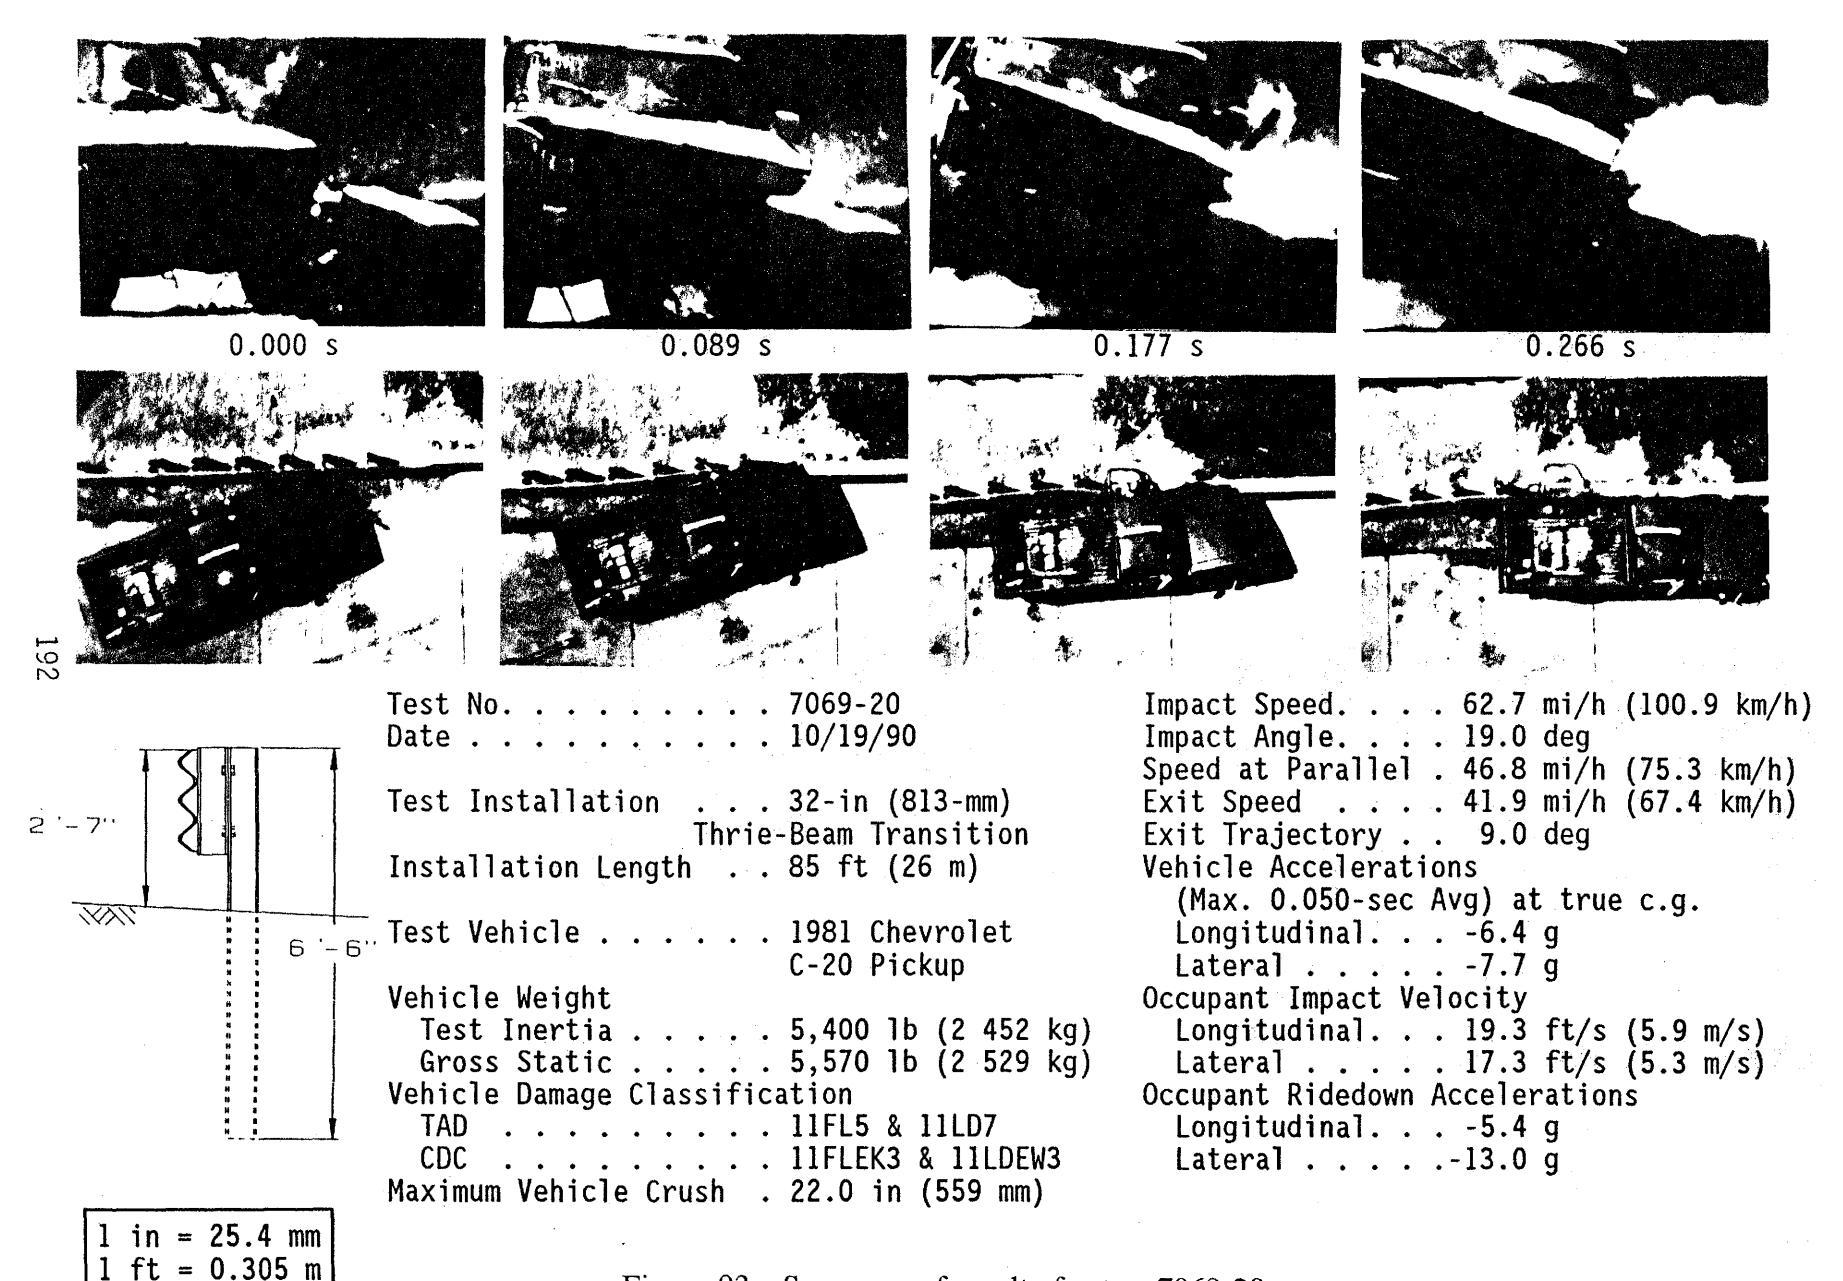
Figure 93. Summary of results for test 7069-20.

Performance of the transition in this test is judged unacceptable, as indicated in figure 93 and table 40.
