EVALUATION OF WORK ZONE BARRICADES AND TEMPORARY SIGN SUPPORTS

Report No. 5388-1F Research Study No. 585xxA3014 Research Study Title: Development of New Designs for Barricades and Sign Supports in Work Zones

> Sponsored by the Texas Department of Transportation

> > February 1996

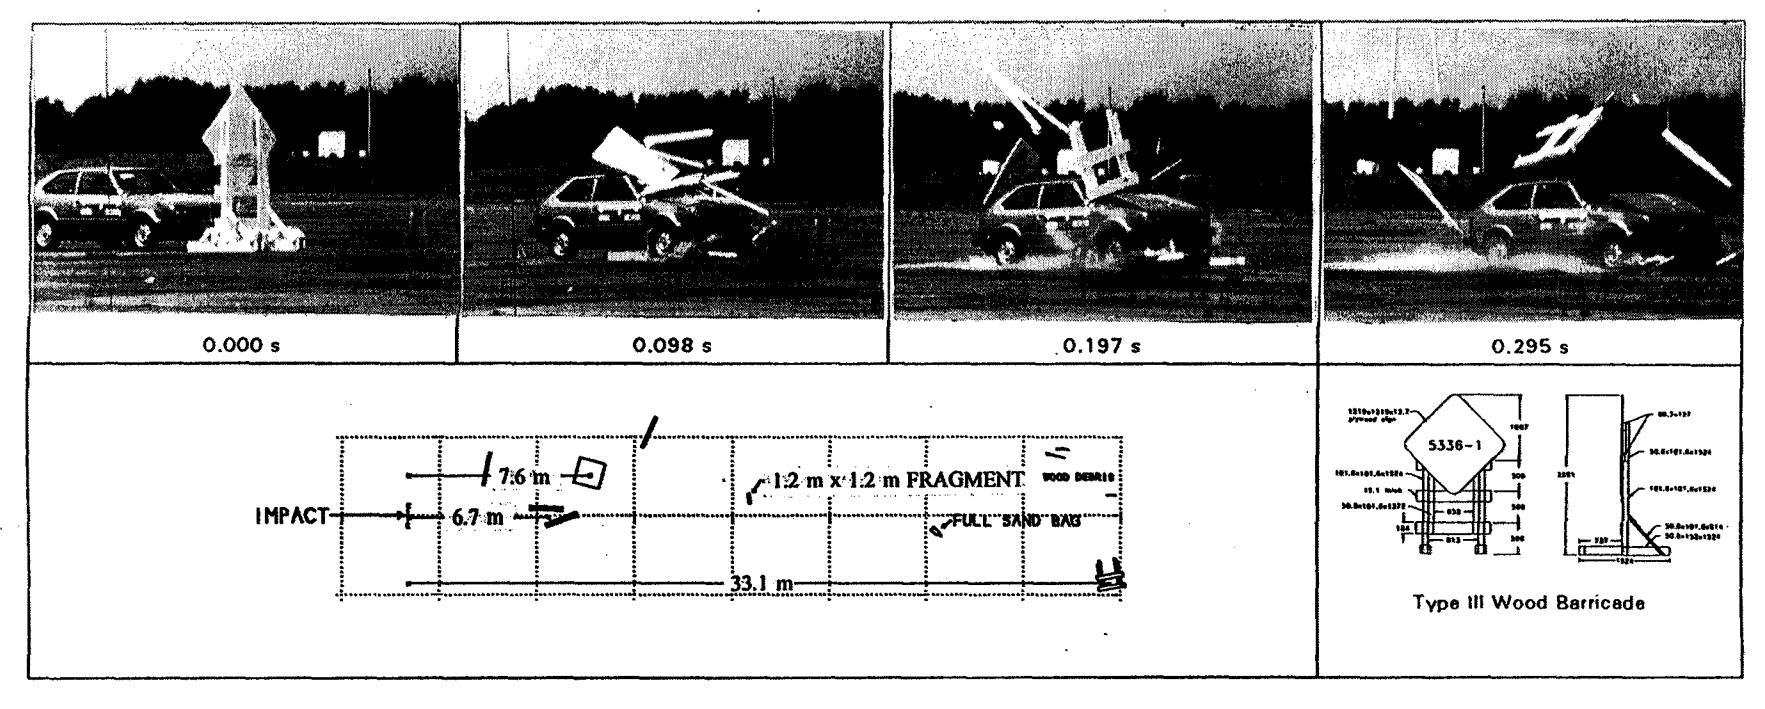
Figure 4. Summary of Results for Test No. 453360-1

Figure 4 presents a brief summary of the results of this test. The barricade shattered upon impact. The vertical supports broke from the bases and impacted and penetrated the windshield, resulting in broken glass entering the occupant compartment. The sign panel was detached from the barricade and impacted the roof of the vehicle. Debris from the barricade was thrown along an area 11 m wide by 37 m long. Some fragments were fairly large, which could pose potential hazard to oncoming traffic in adjacent lanes and to workers in the area. Sand was also scattered on the pavement, which could lead to loss of control of other vehicles. The vehicle sustained damage to the front bumper, hood, windshield and roof. There was no occupant contact during the test period. The maximum 50-msec average accelerations were -5.9 g in the longitudinal direction and 1.1 g in the lateral direction. The vehicle exited the immediate test site in a relatively smooth, stable manner and showed no potential for intrusion into adjacent traffic lanes.

In summary, the performance of the barricade was judged to be unsatisfactory due to penetration of the windshield and the occupant compartment by the fractured vertical supports of the barricade.

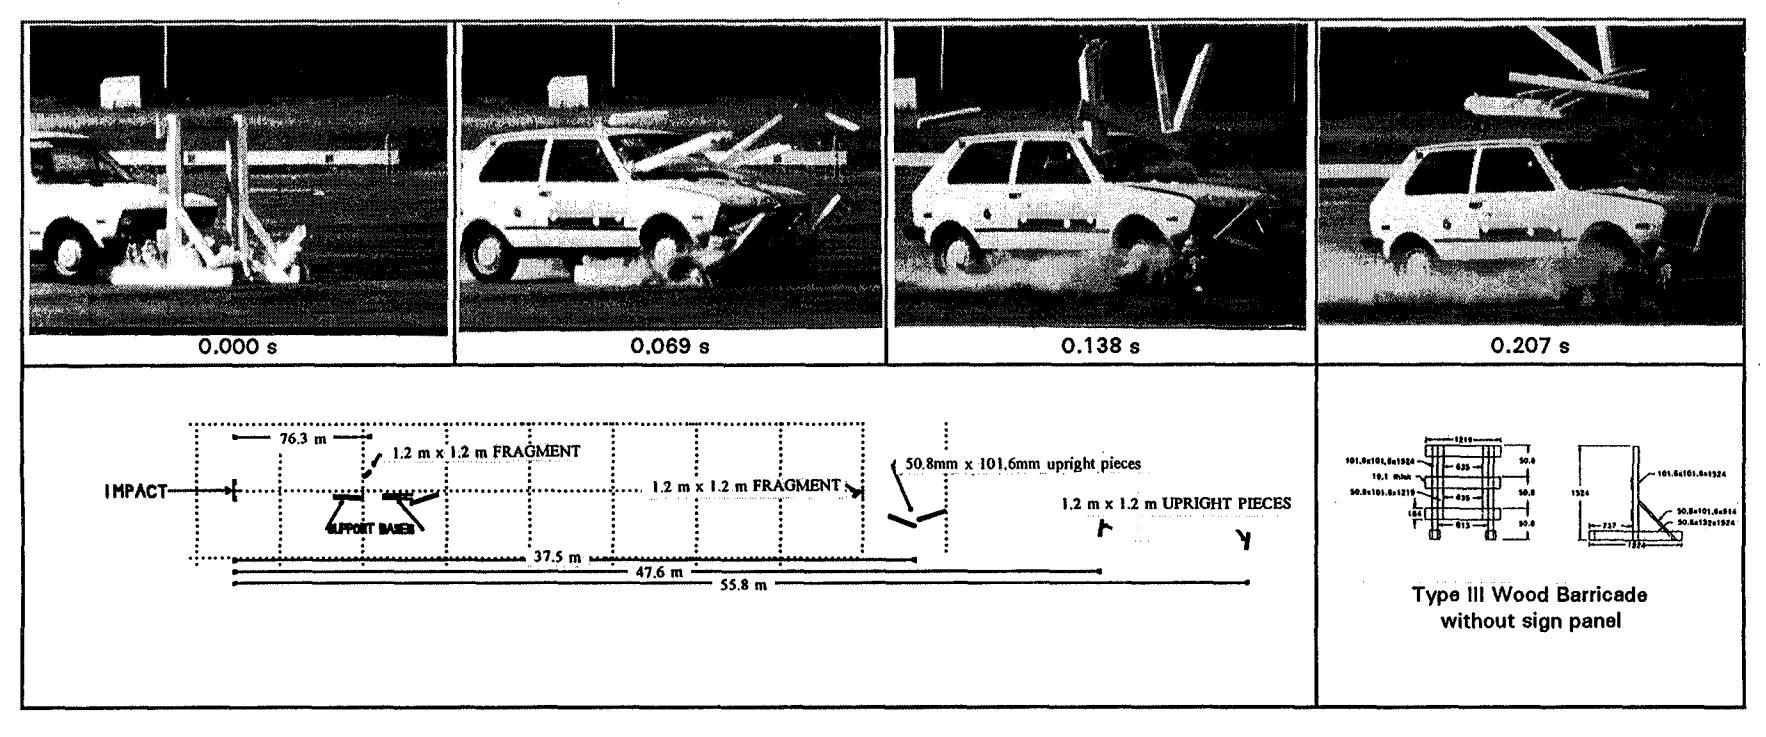
Figure 8. Summary of Results for Test No. 453360-4

Figure 8 presents a brief summary of the results of this test. The barricade shattered upon impact, and a segment of the barricade impacted the windshield, penetrated and intruded into the occupant compartment. The 533 mm long fragment was found in the rear section of the occupant compartment, showing potential risk to occupants in the vehicle. Sand and many fragments of the barricade were scattered along an area 18 m wide by 56 m long. Some fragments were fairly large, which could pose potential hazard to oncoming traffic in adjacent lanes and to workers in the area. Sand was also scattered on the pavement, which could lead to loss of control of other vehicles. The vehicle sustained damage to the front bumper, hood, windshield and roof. The longitudinal occupant impact velocity was 2.8 m/s and the highest 10-msec average ridedown acceleration was -0.9 g. There was no lateral occupant contact during the test period. The 50-msec average accelerations were -4.8 g in the longitudinal direction and 0.7 g in the lateral direction. The vehicle exited the immediate test site in a relatively smooth, stable manner and showed no potential for intrusion into adjacent traffic lanes.

In summary, the performance of the barricade was judged to be unsatisfactory due to penetration of the windshield and the occupant compartment by the fractured vertical supports of the barricade.

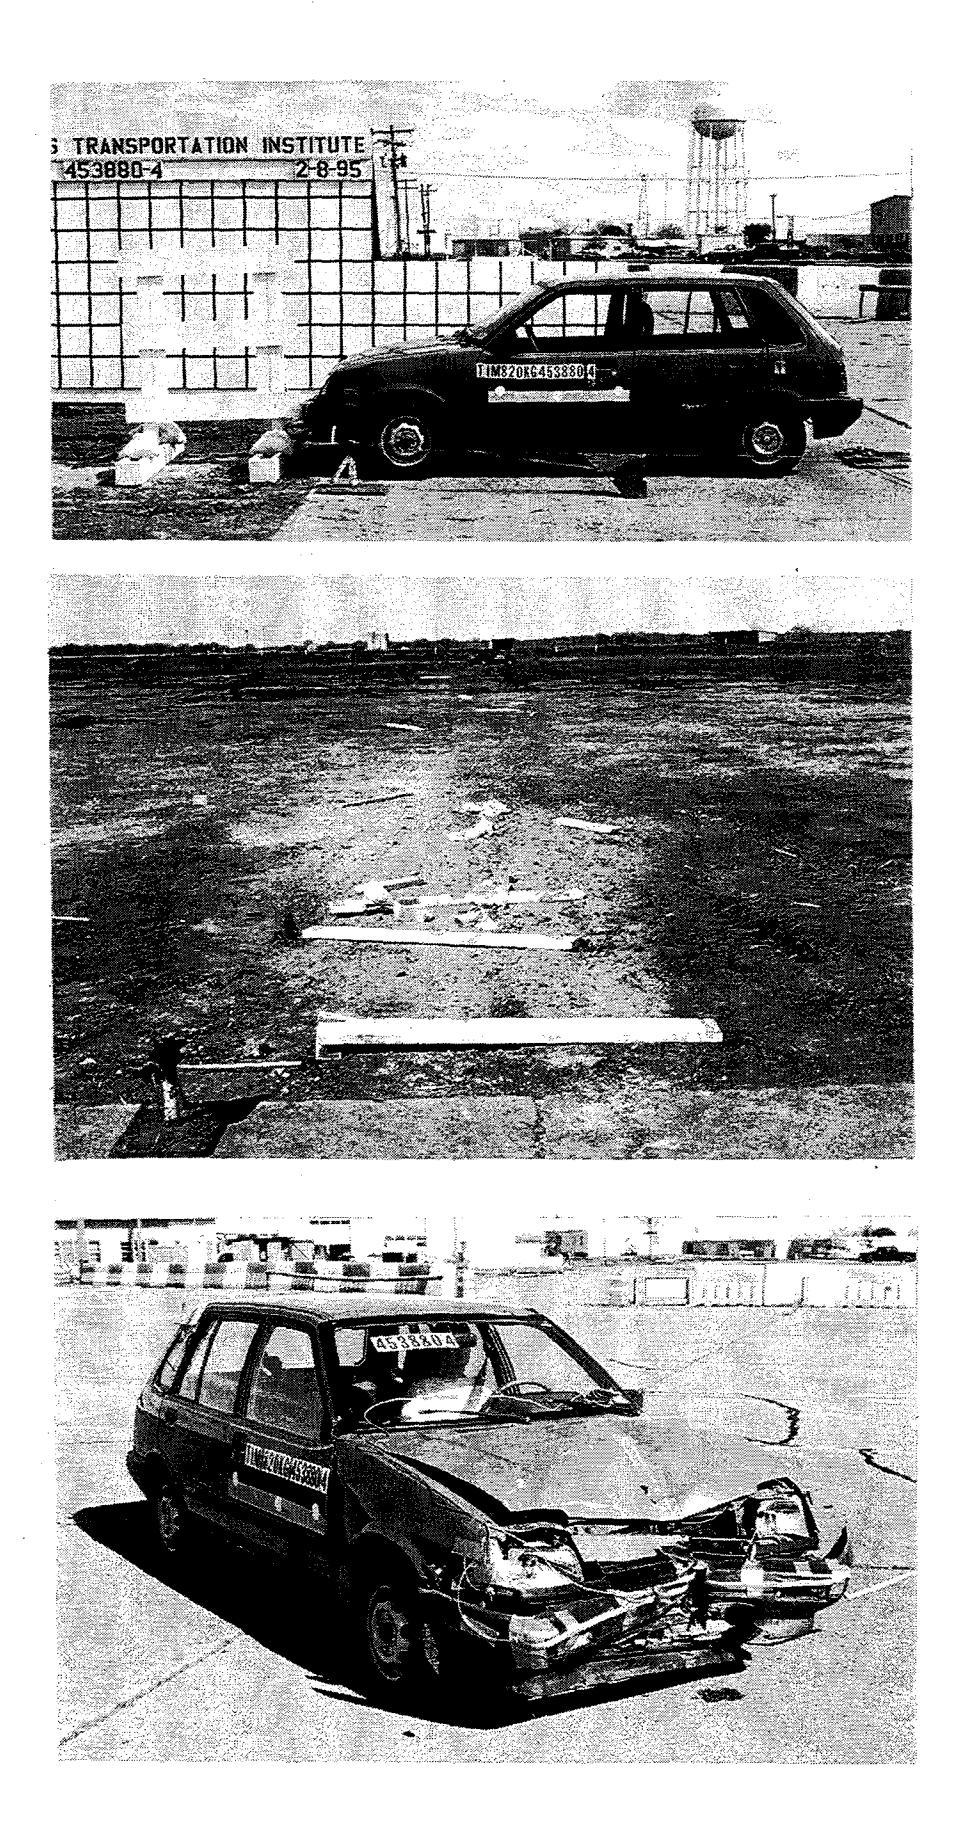
Figure 10. Vehicle and Barricade for Test No. 453880-4

The barricade separated from the base upon impact, as can be seen in Figure 10. Debris and sand were strewn along the path of the vehicle in an area 4.3 m wide by 58.8 m long. Figure 10 shows damage to the vehicle. Maximum crush to the exterior of the vehicle was 190 mm to the center front bumper. The right front door was jammed, and there was damage to the bumper, grill, and hood. The right front tire was flat.

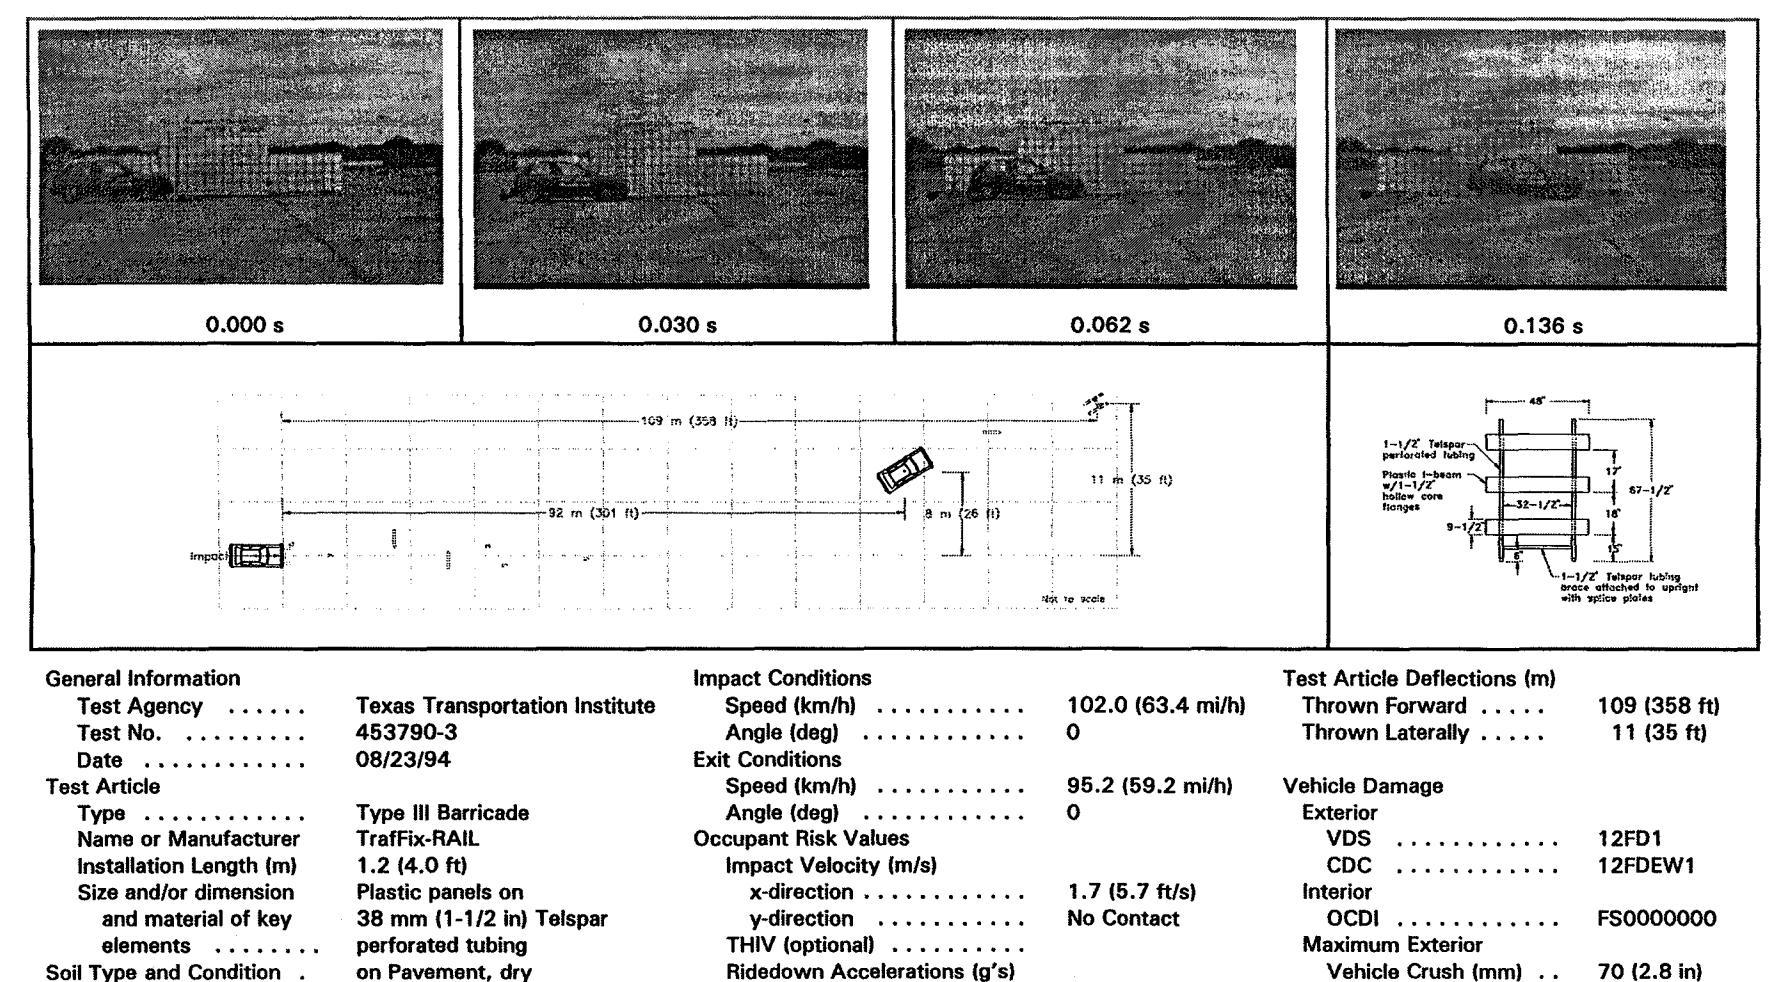
Figure 48. Summary of Results for Test No. 453790-3

Upon impact, the middle and top rail elements separated from the vertical supports while the vertical support uprights deformed and wrapped around the front of the vehicle. At 7 msec, the middle rail element contacted the hood of the vehicle. The vehicle lost contact with the left vertical support at 37 msec. The top rail element contacted the windshield at 47 msec, and the middle rail element contacted the windshield at 49 msec. However, the windshield remained intact. The vehicle lost contact with the right vertical support, which then rode underneath the vehicle, and the lower rail element rode along on the bumper. At 142 msec, the vehicle cleared

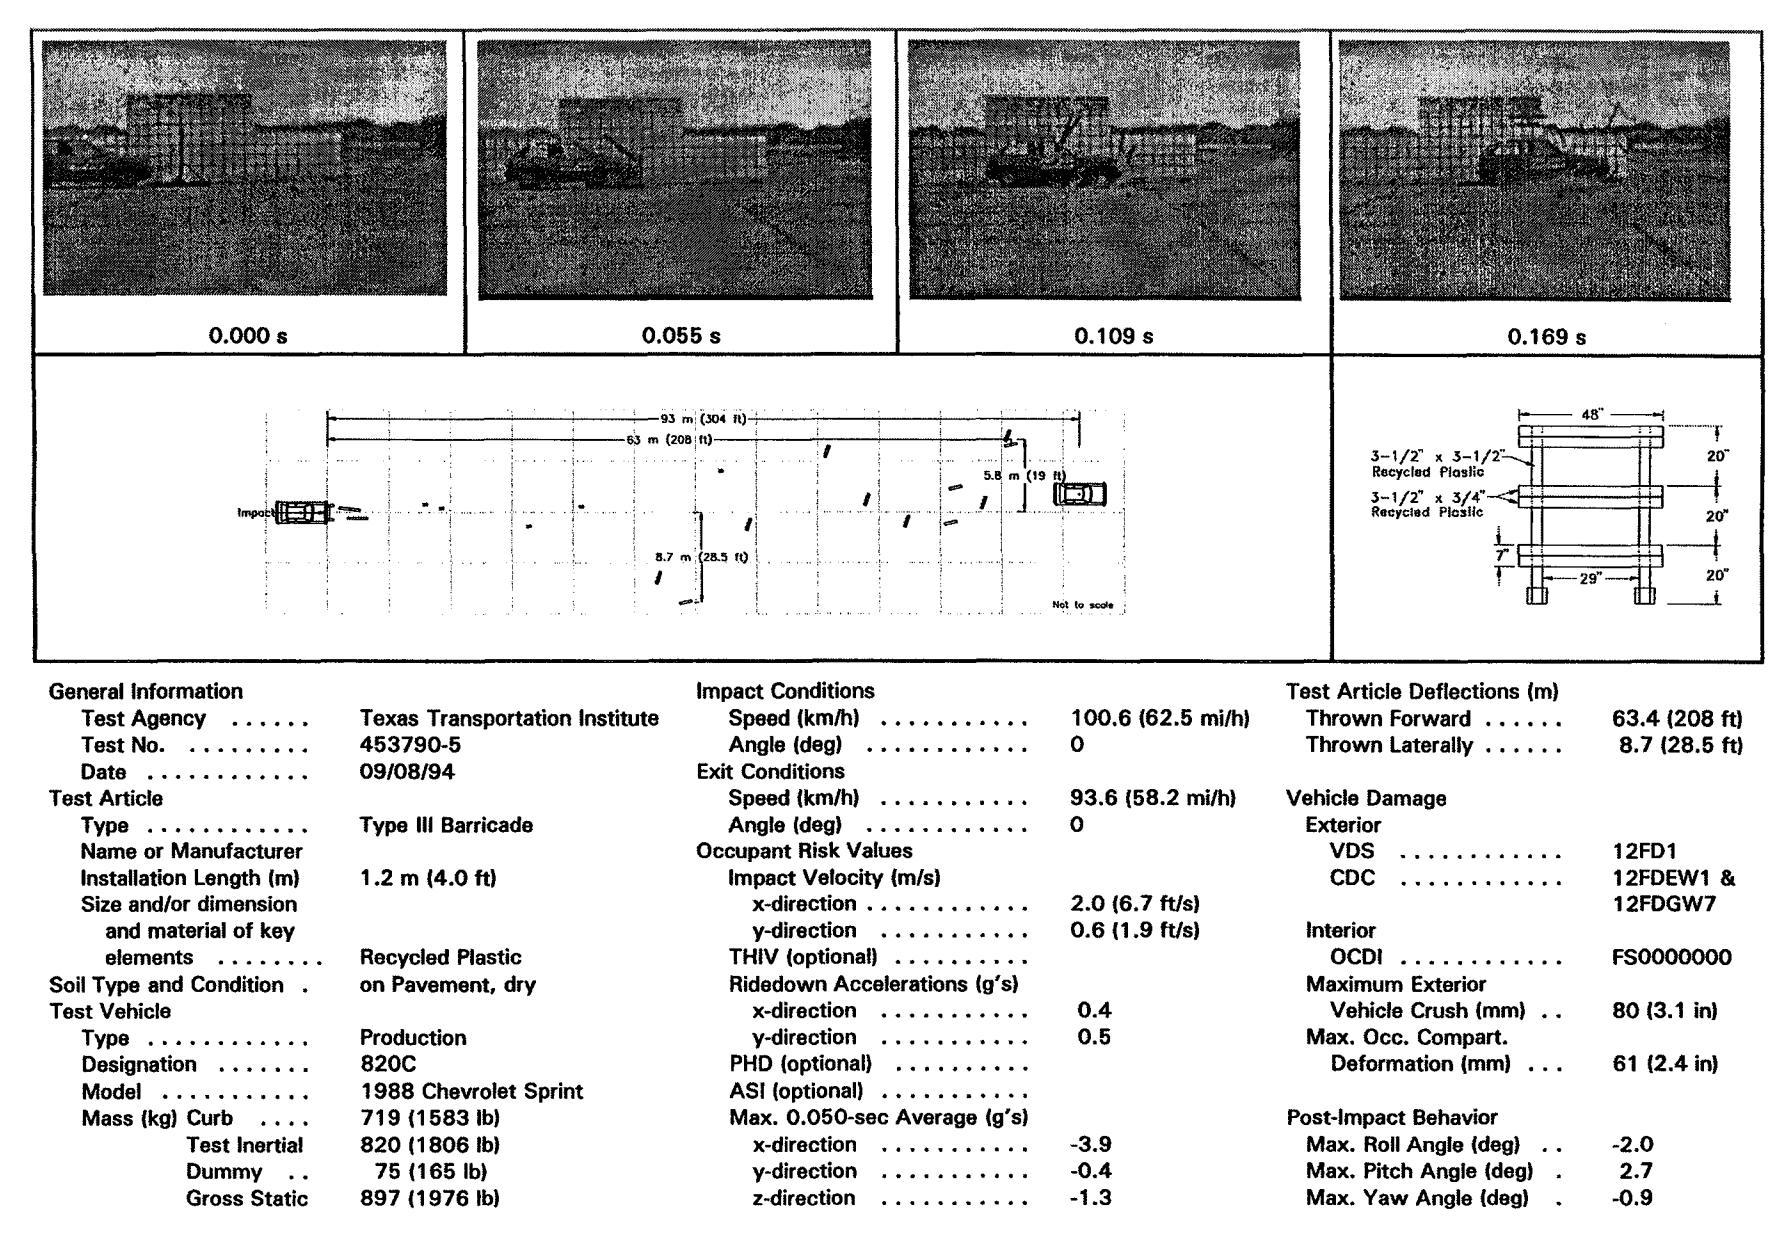
Figure 72. Summary of Results for Test No. 453790-5

As Figure 70 shows, the solid recycled plastic barricade shattered upon impact. Debris and sand were strewn along the path of the vehicle in an area 14.5 m wide by 63 m long. Figure 70 also shows damage to the vehicle. The bumper, grill, and hood of the vehicle were dented and scratched. The left side A-post was dented, the windshield was broken, and the roof was dented. Maximum exterior crush to the front of the vehicle at bumper height was 80 mm. Maximum intrusion into the occupant compartment (measured from high-speed film) was 259 mm near the head area of the driver. The maximum residual deformation into the occupant compartment was 61 mm.

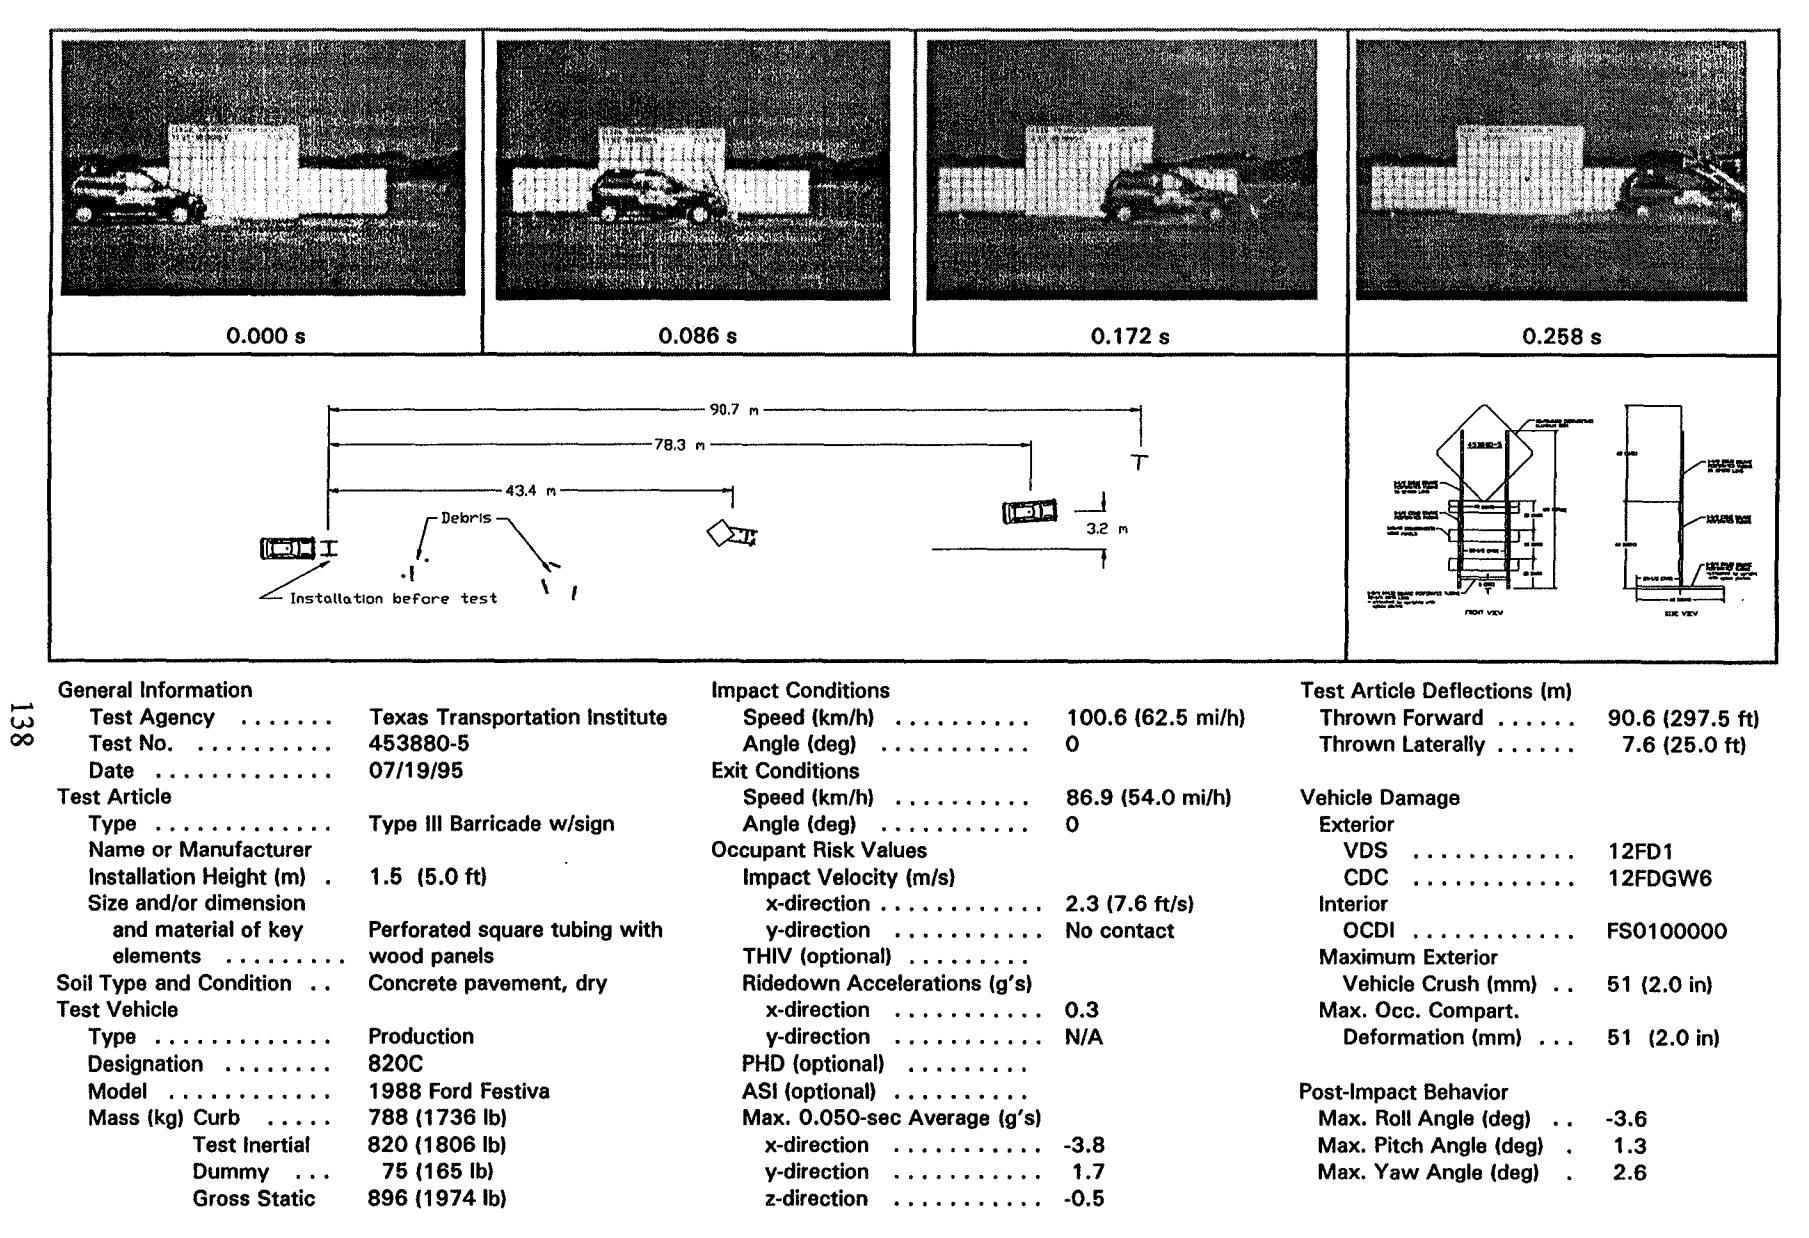
Figure 79. Summary of Results for Test No. 453880-5

Figure 79 presents a brief summary of the results of this test. The barricade and sign panel attachment mechanism shattered upon impact. The bottom corner of the sign panel contacted and shattered the windshield and deformed the windshield into the occupant compartment by 51 mm,
