# **RAILROAD ACCIDENT REPORT**

HEAD-ON COLLISION AND DERAILMENT OF BURLINGTON NORTHERN FREIGHT TRAIN WITH UNION PACIFIC FREIGHT TRAIN KELSO, WASHINGTON NOVEMBER 11, 1993

Adopted: November 15, 1994 Notation 6247A

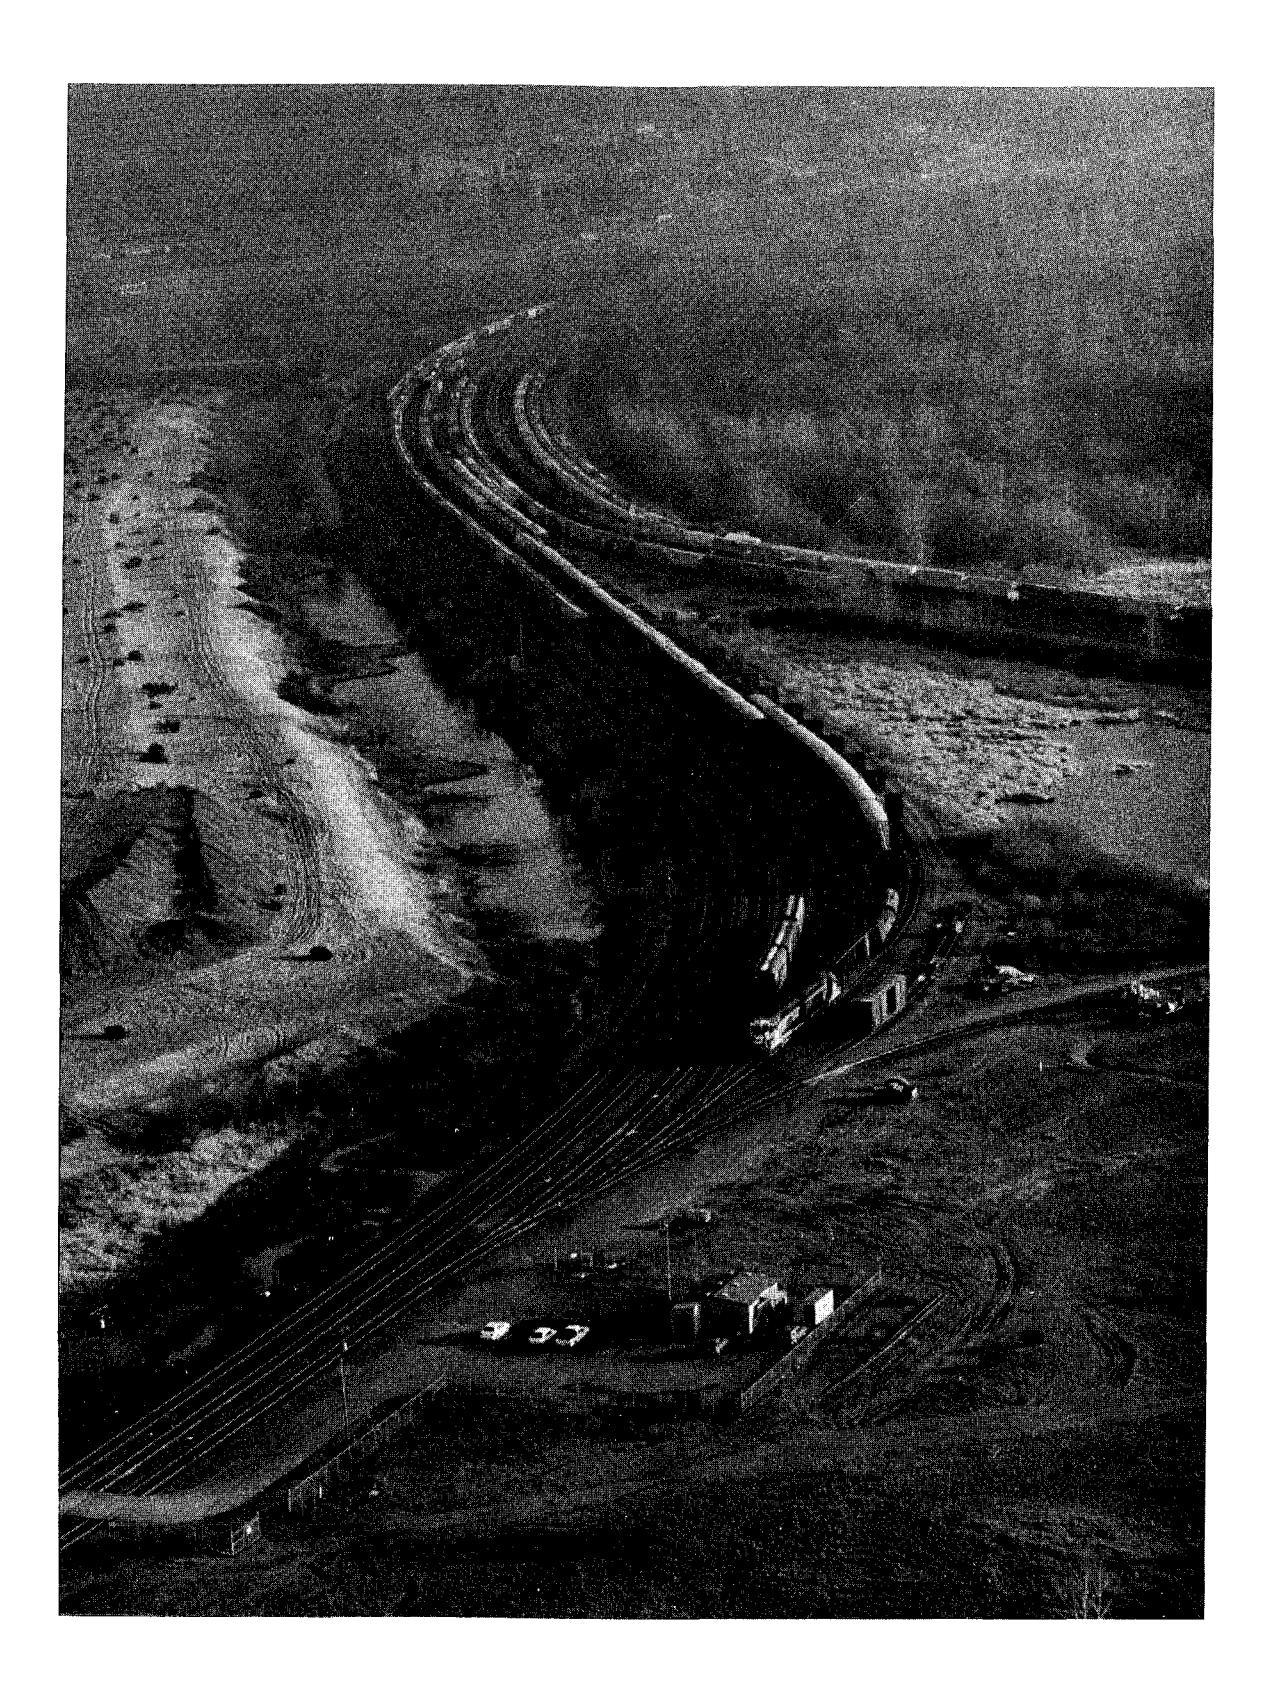
Figure 3.--Longview yard and office and intermediate signal, looking south. (Photo courtesy of *The Daily News*, Longview, Washington.)

The yard clerk stated that he was engaged in a telephone conversation when train 111 passed the yard office. The clerk further stated that although visibility was "maybe a couple of hundred feet" due to fog, he could discern the locomotives He added that he could not see the positions of the crewmembers but he waved to the train because he waves to all the trains that go by. He said there had been instructions on his turnover when he arrived at work that evening saying that train 111 would not stop to work at the yard He stated that on most of the trips, the train was on main track 1 and stopped to work in the yard The pick-up was cancelled because the train had reached its tonnage capacity He said that the instructions were from the trainmaster He did not talk to the train crew about the instructions because he assumed that the crewmembers had already received them

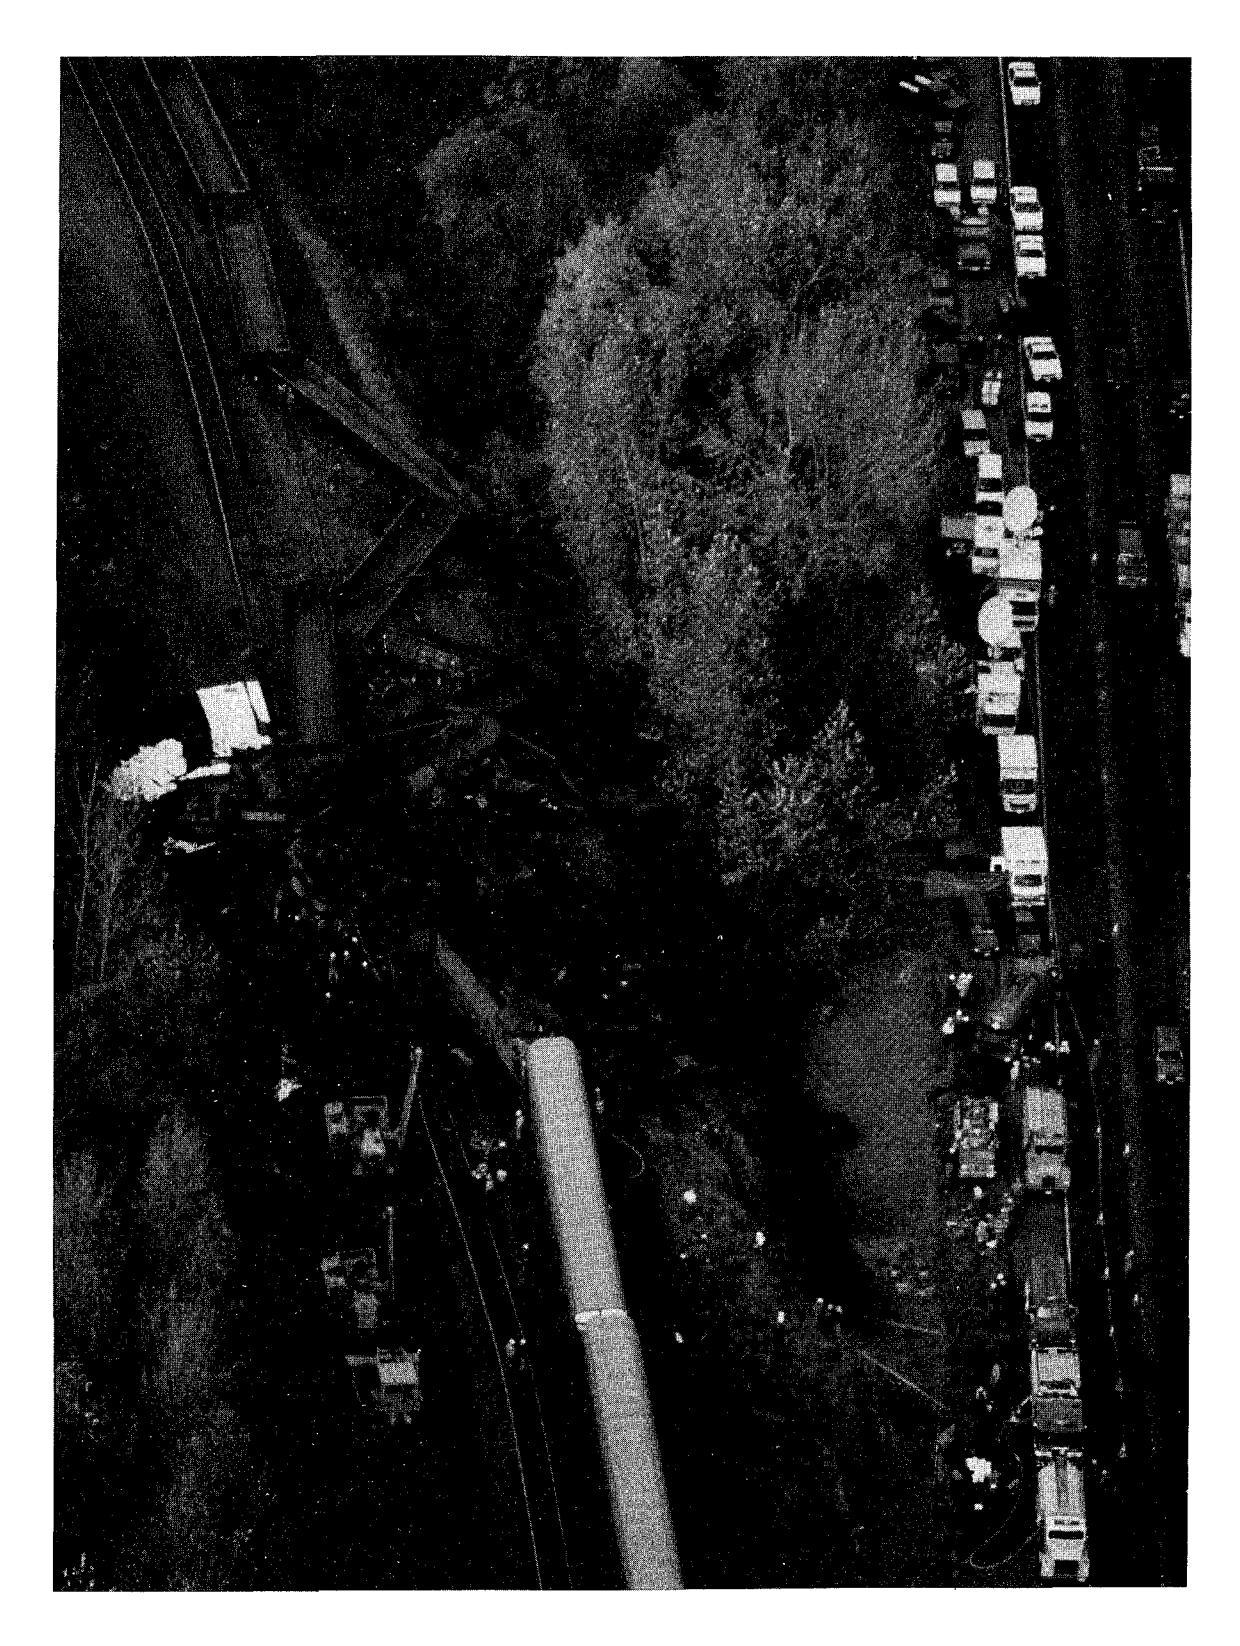
The collision occurred at BN MP 1028, south of the Longview Junction South interlocking (MP 1026) All locomotives were either destroyed or severely damaged Following the collision, a fire from punctured fuel tanks engulfed the derailed locomotives In total, 8 cars were destroyed and 16 were damaged (See figure 4)

Figure 4.--Wreckage. (Photo courtesy of *The Daily News*, Longview, Washington.)

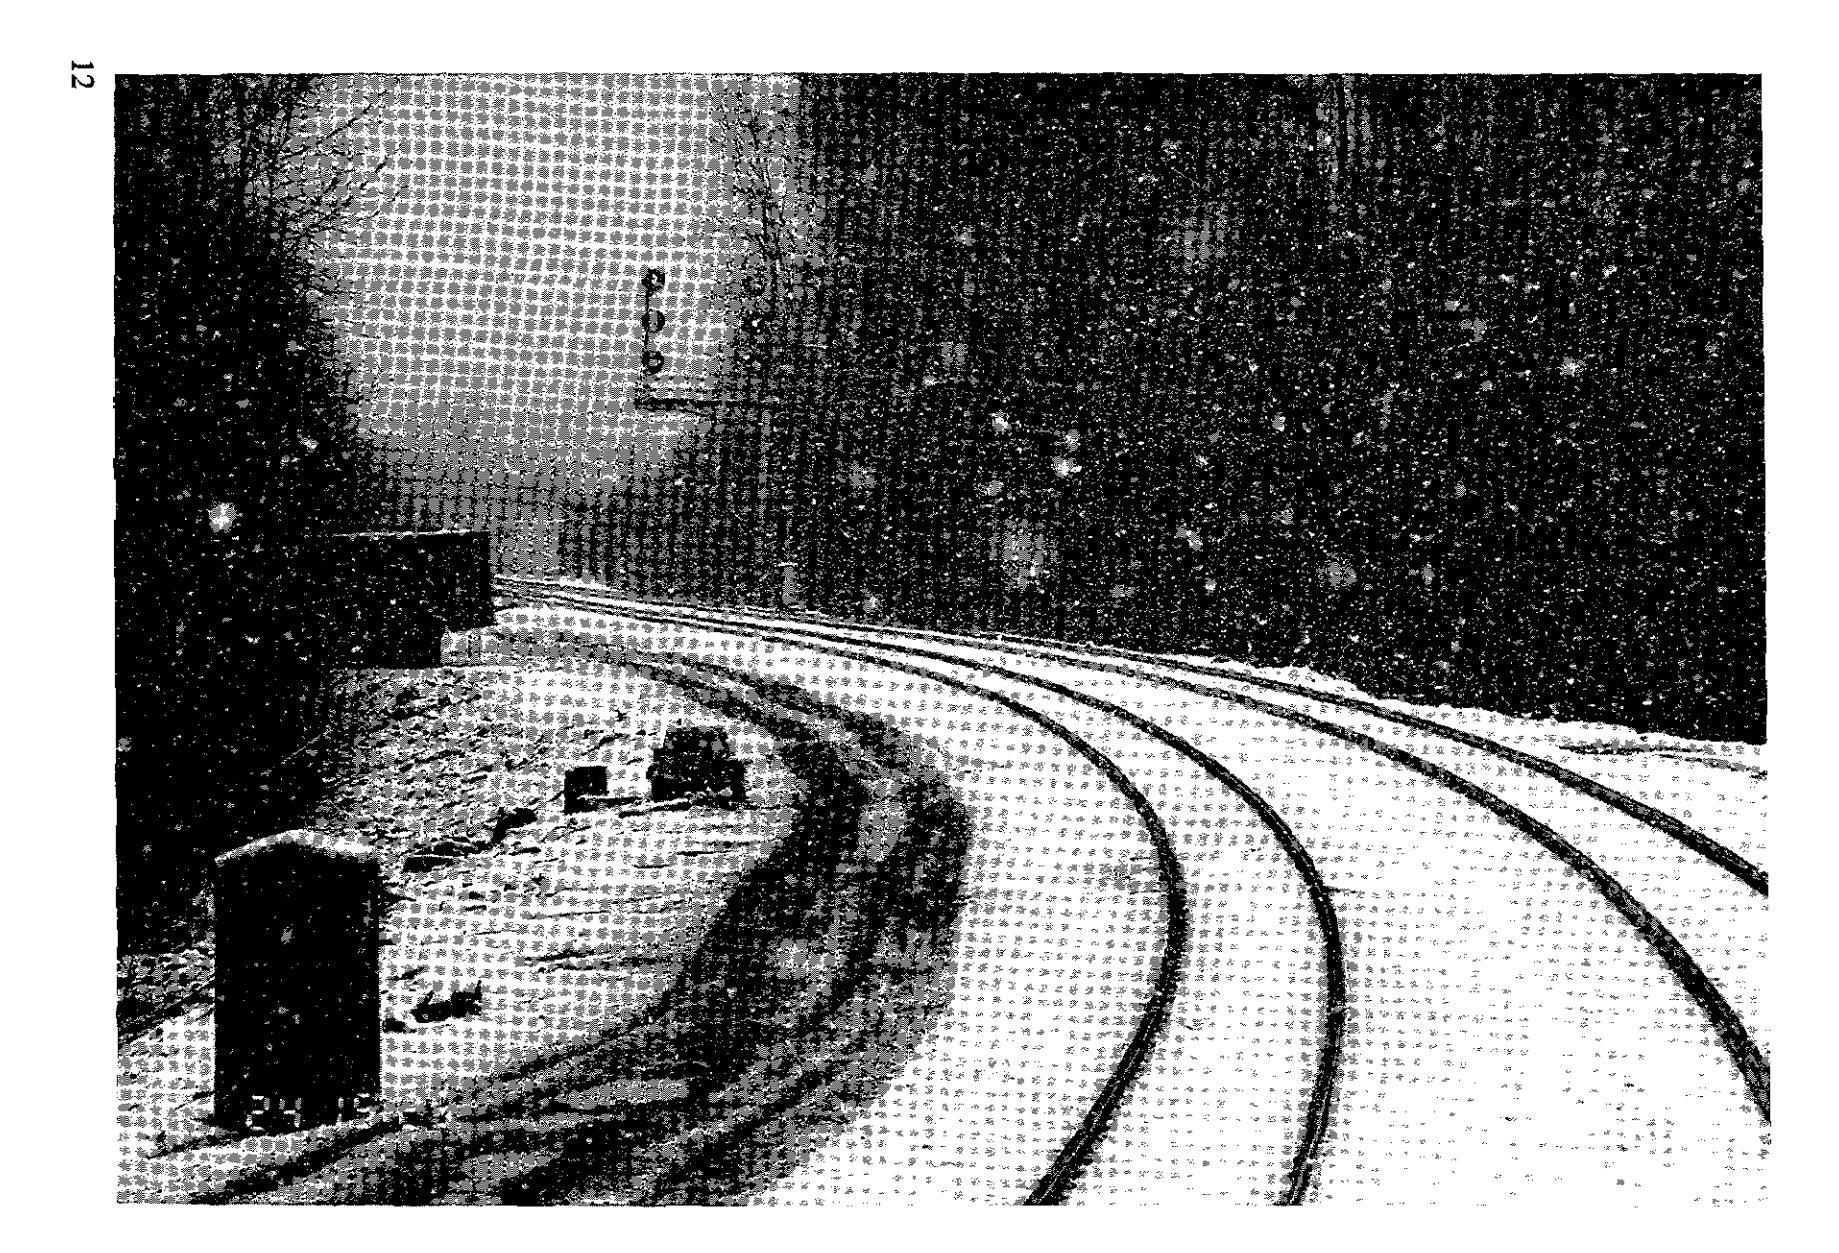
The collision occurred on main track 2 in a curve that is, for a northbound train, a 1degree 45-minute curve to the left (See figure 6) The track gradient is 0.06 percent ascending from south to north

Figure 6 -- Longview Junction South interlocking, looking north.

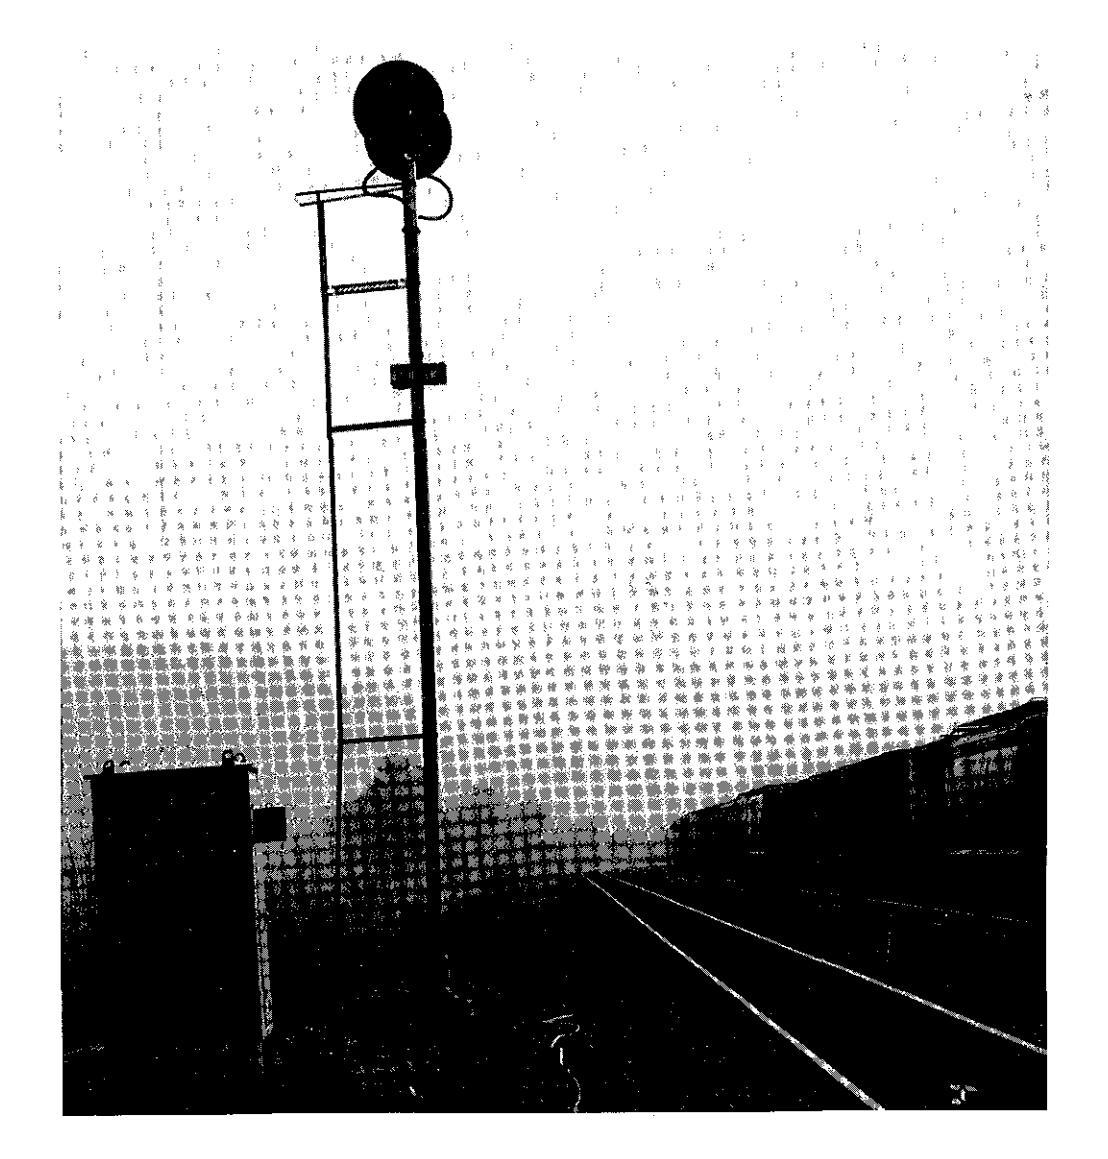
Figure 9 ---Intermediate signal, looking south

The conductor of train 59 testified that 3 months after the accident he was traveling south on main track 2 in conditions similar to those on the night of the accident He stated that the intermediate signal "being high in the fog and looking out in the fog with the headlights shining, your visibility is greatly decreased. The block [signal] is visible for just a few brief moments."

After the accident, the conductor of train 59 traveled down main track 2 in conditions which he described as being similar to those on the night of the accident He stated that the intermediate signal "being high in the fog and looking out in the fog with the headlights shining, your visibility is greatly decreased The block is visible for just a few brief moments."
