HE 1780 ,F133 MO, NTISB-RAR DEPARTMENT OF TRANSPORTATION 12-1 0.3 APR 18 1972 LINRARY SS-R-13 RAILROAD ACCIDENT REPORT. PENN CENTRAL TRANSPORTATION COMPANY FREIGHT TRAIN DERAILMENT PASSENGER TRAIN COLLISION WITH HAZARDOUS MATERIAL CAR SOUND VIEW, CONNECTICUT **OCTOBER 8, 1970** ADOPTED: DECEMBER 22, 1971 NATIONAL TRANSPORTATION SAFETY BOARD Washington, D. C. 20591 **REPORT NUMBER: NTSB-RAR-72-1**,

Adopted: December 22, 1971

PENN CENTRAL TRANSPORTATION COMPANY FREIGHT TRAIN DERAILMENT, PASSENGER TRAIN COLLISION WITH HAZARDOUS MATERIAL CAR SOUND VIEW, CONNECTICUT, OCTOBER 8, 1970

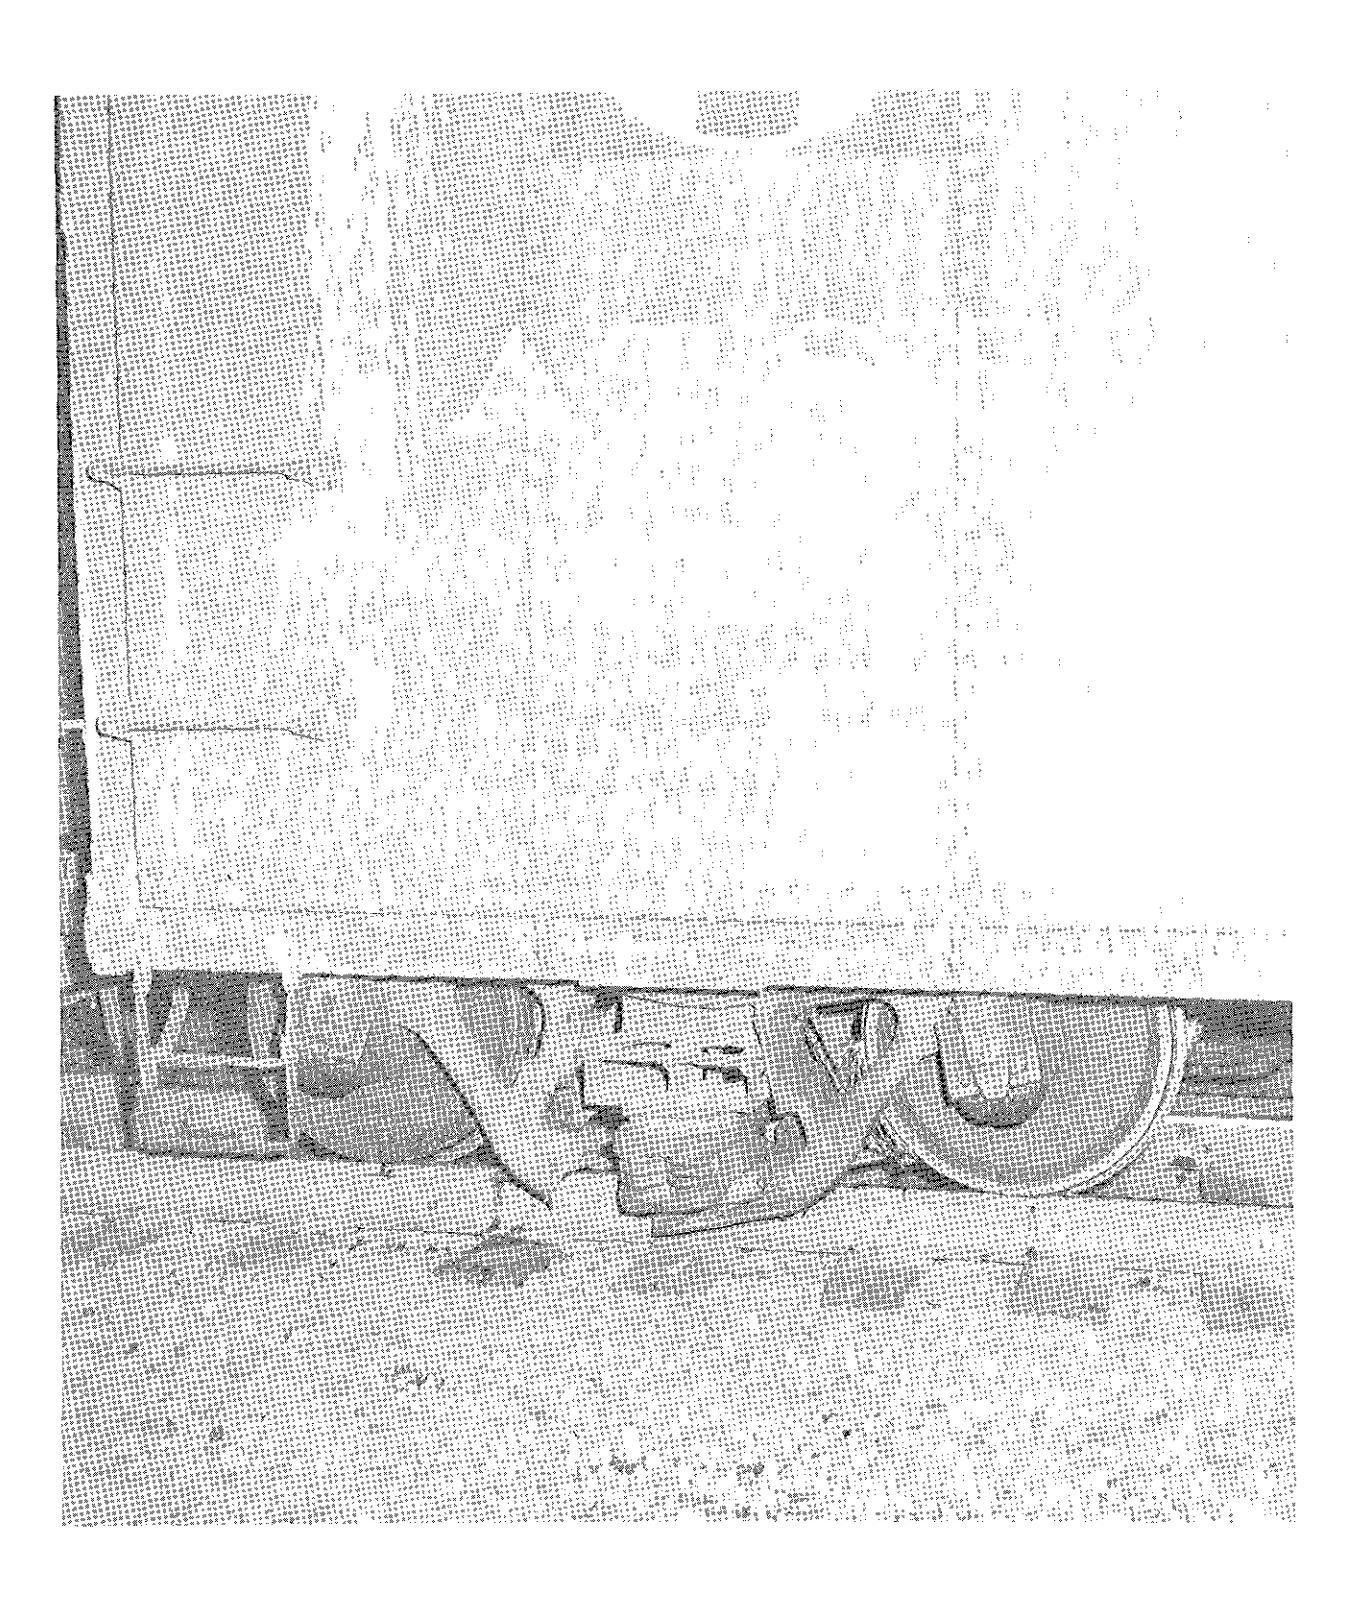
Figure 2.--Broken truck side frame of ATSF 19334 with spring package No 402

"ASF does not recommend the use of spring package no. 402 for this truck design The 402 package is rated for 40-ton (5 inch \times 9 inch journals), and this cat's trucks are 50-ton (5¹/₂ inch \times 10 inch). ASF furnished the 402 spring package only to the AT & SF, and on May 25, 1955 furnished them a copy ot our application drawing 2-7510 which refers to their car series: 31656-32655, 32656-33155, 33156-33655. These cars used ASF side frame patterns 21267-L, 21362-F or 21456."

"Since spring capacity was too little for the 50-ton car, doubtless the springs went solid many times and the resultant shock loading may have contributed to failure of the side frame."

There is little doubt that the use of the No. 402 spring package in a truck designed for a 50-ton car contributed to the failure of the truck side. The No. 402 spring package would have been deflected 20 percent more than the 50-ton spring when fully loaded, and therefore there was less space before the coils closed up. This allowed the spring to go solid with much greater frequency, thus imparting shocks to the side frame and contributing to its failure. Although the use of the incorrect spring package produced much more frequent shock loads on the truck side, there is no direct evidence to indicate when the fatigue crack was initiated.

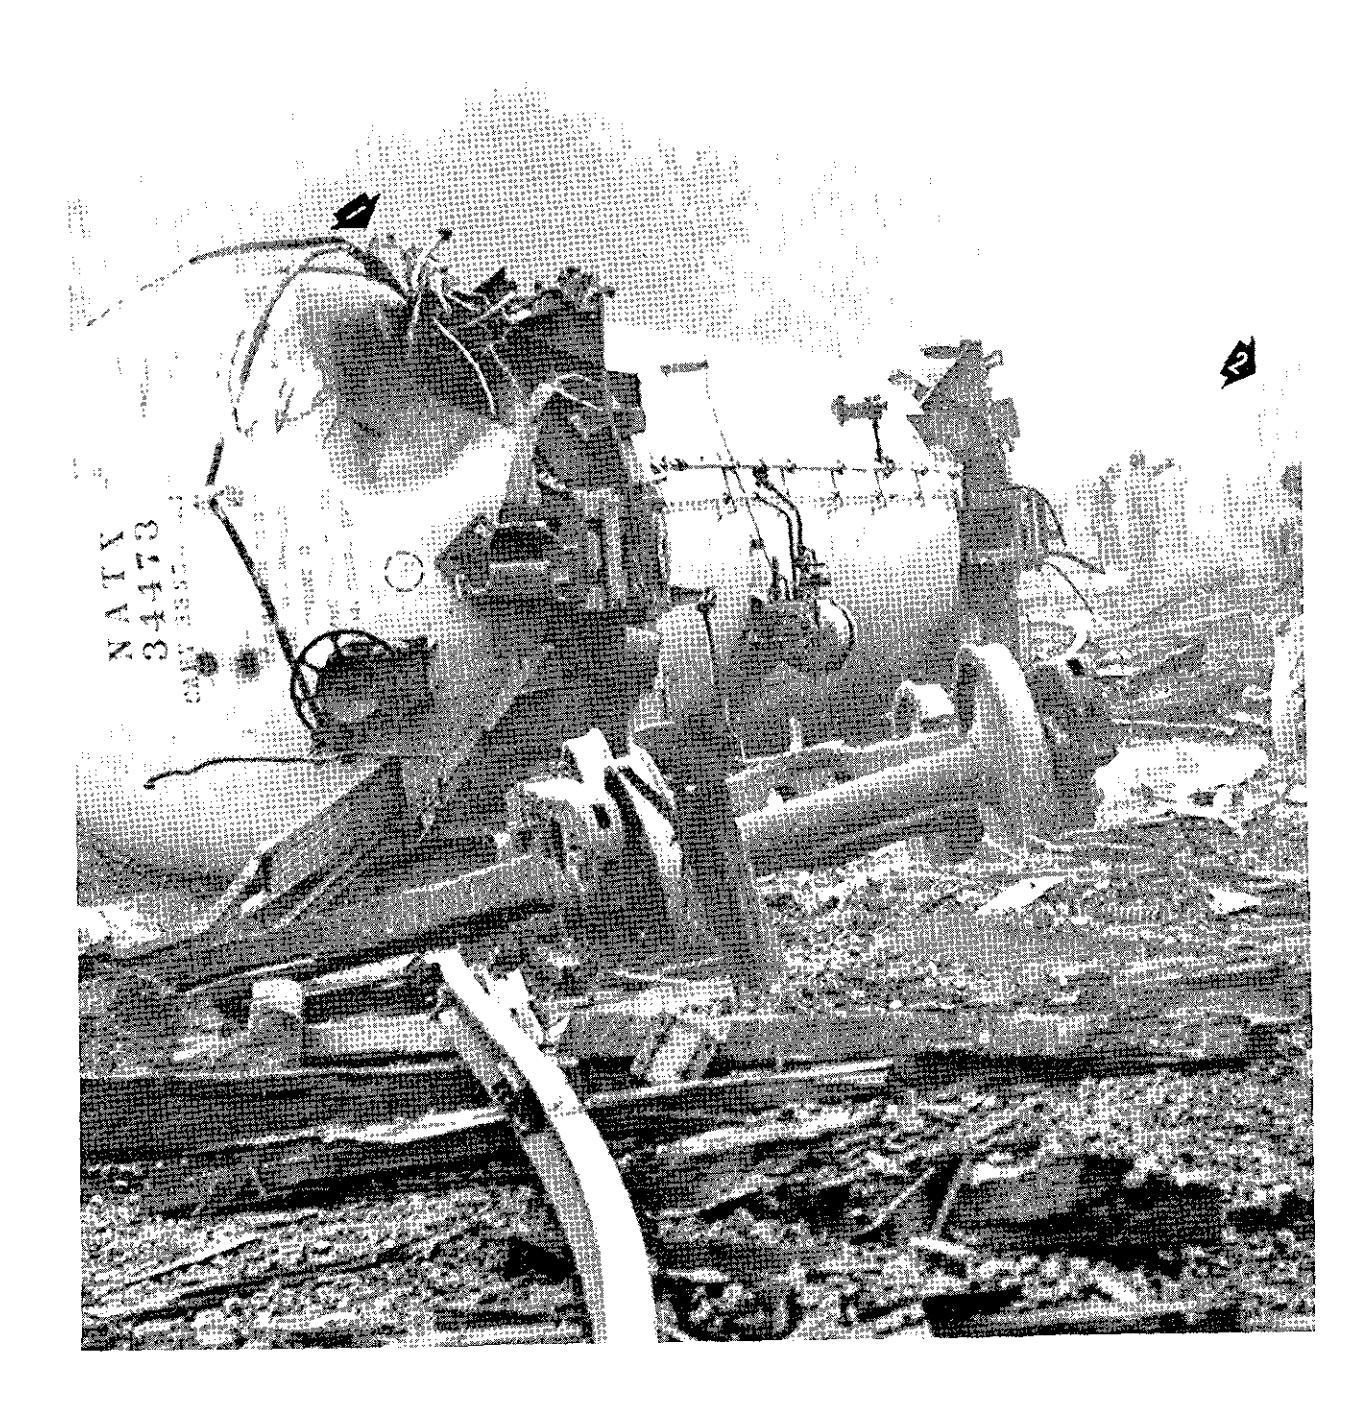
As train No. 174 rounded the curve at Sound View, the headlight illuminated a boxcar fouling track No. 2. This boxcar was probably the 48th car of Adv. CB-1, CGW 5040. The force of the impact of No. 174 on the car drove the 48th car into the 49th car of Adv. CB-1. MSTL 50428. The 49th car of Adv. CB-1 was driven back. Parts of boxcars clung to the locomotive of the passenger train. When the locomotive struck the tank car, NATX 34473, on the west end, the pilot of the locomotive was severed, the front truck was struck, and the entire passenger train was derailed. A cylinder was imbedded in the tank car, and the tank car was punctured (see Figure 11).

Figure 11.-Tank car NATX 34473, showing point of puncture (1) and last car of the passenger train (2)

The tank car was punctured with subsequent ignition and fire following escape of the liquefied petroleum gas. The locomotive and the passenger cars of No. 174, while derailed, continued through the derailment area, and passed through the flaming gas escaping from the punctured LPG tank car These flames were observed on both sides of the passenger train by crewmembers and passengers in the cars. The fire burned about 2½ hours before being extinguished.

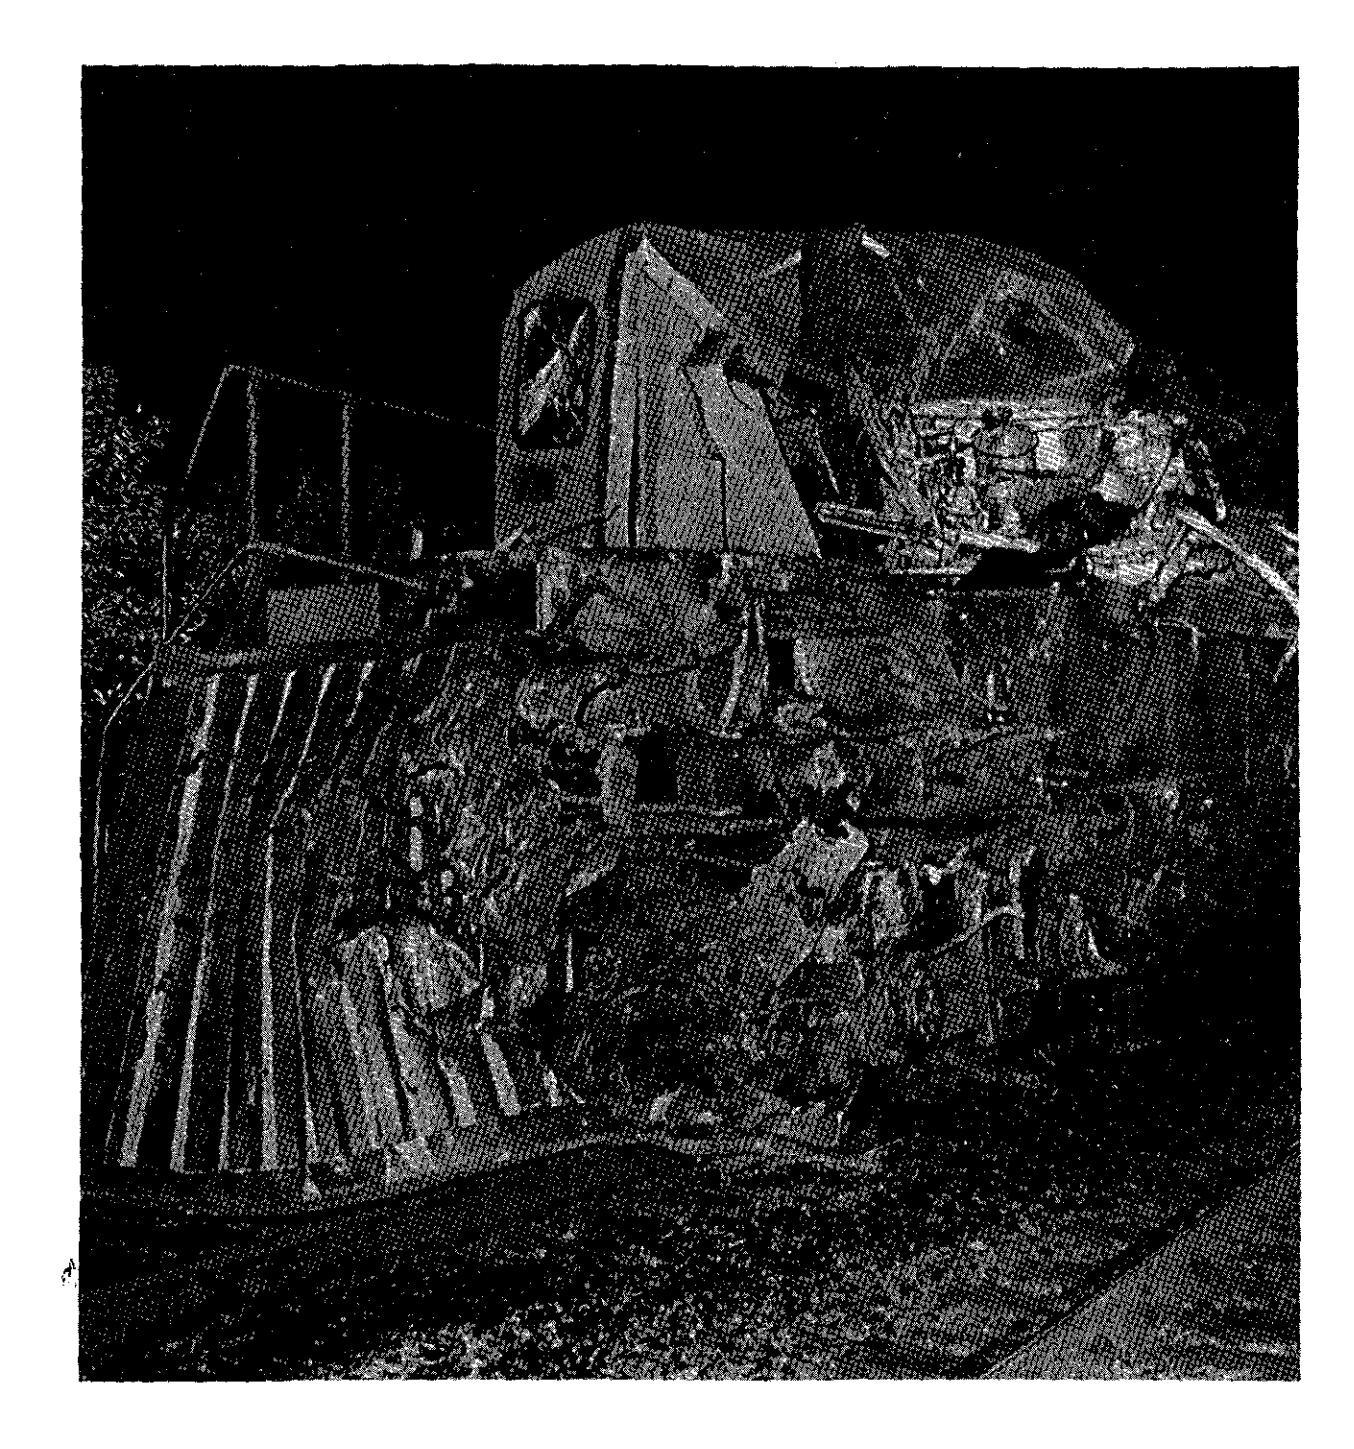
The steps of the lead locomotive unit of train No. 174 were torn loose and caught on the tank car. The locomotive nose section was severed, and most of the cab section was destroyed. The steam generator, which is housed in the short hood, broke loose from its mountings and was imbedded in the rear wall of the locomotive cab section, behind the seat of the fireman (see figure 12). The engineer and fireman were injured. The fuel tank of the locomotive was punctured, and a fire started from the diesel fuel that leaked out of the tank.

Figure 12.-Lead locomotive of passenger train No. 174, parts of boxcar on front of locomotive; front steps, pilot and entire nose section severed; steam generator shown imbedded in rear wall of cab compartment.

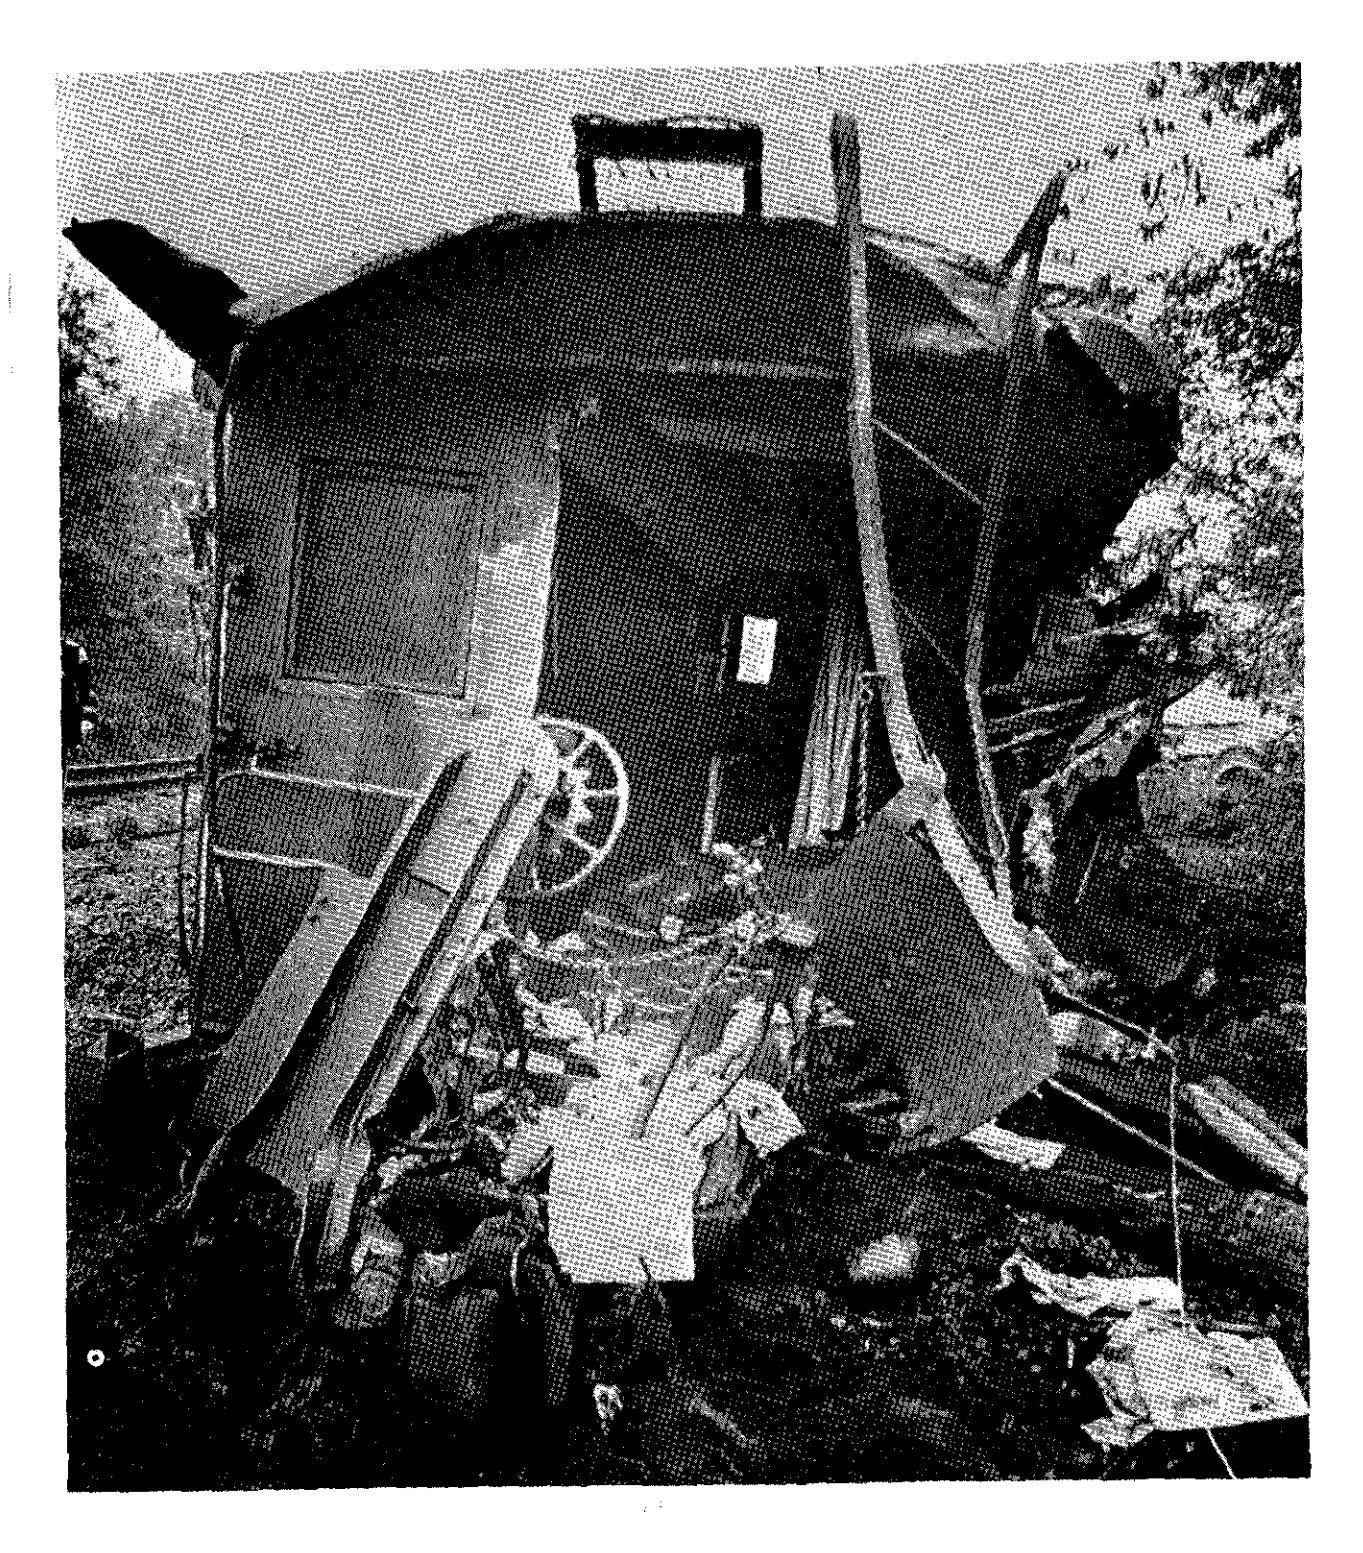
The tank car or the engine of No. 174, or both, struck the caboose of Adv. CB-1, injuring the flagman, who fell from the cupola, and the conductor. An entire section of the caboose was destroyed. The wood-lined interior of the caboose was shattered. The platform and a corner section were severed. The superstructure crumbled and separated from the frame (see Figure 13)

Figure 13.---Damaged caboose No. 586
