TECHNICA	L REPORT DOCUMENTATION PAGE
I. Report No. NTSB/RAR-85/08	2.Government Accession No. PB85-916308	3.Recipient's Catalog No.
+. Title and Subtitle Ra	5.Report Date	
Vinyl Chloride Monomer 1 Tank Can and Fine Forme	Release from a Railroad	May 14, 1985
Plant, Baton Rouge, Louis	Code Code

At 3:45 a.m., on July 30, 1983, vinyl chloride monomer (VCM) under pressure escaped from a railroad tank car at the loading facility within the Formosa Plastics Corporation chemical manufacturing plant at Baton Rouge, Louisiana. The released VCM was ignited by an undetermined source, and a large billowing fire ensued. An adjacent tank car containing VCM was involved in the fire but did not rupture violently. Two persons were injured seriously, two tank cars were destroyed, three tank cars were damaged moderately, and the loading facility was damaged extensively. Damage was estimated to be \$1 million.

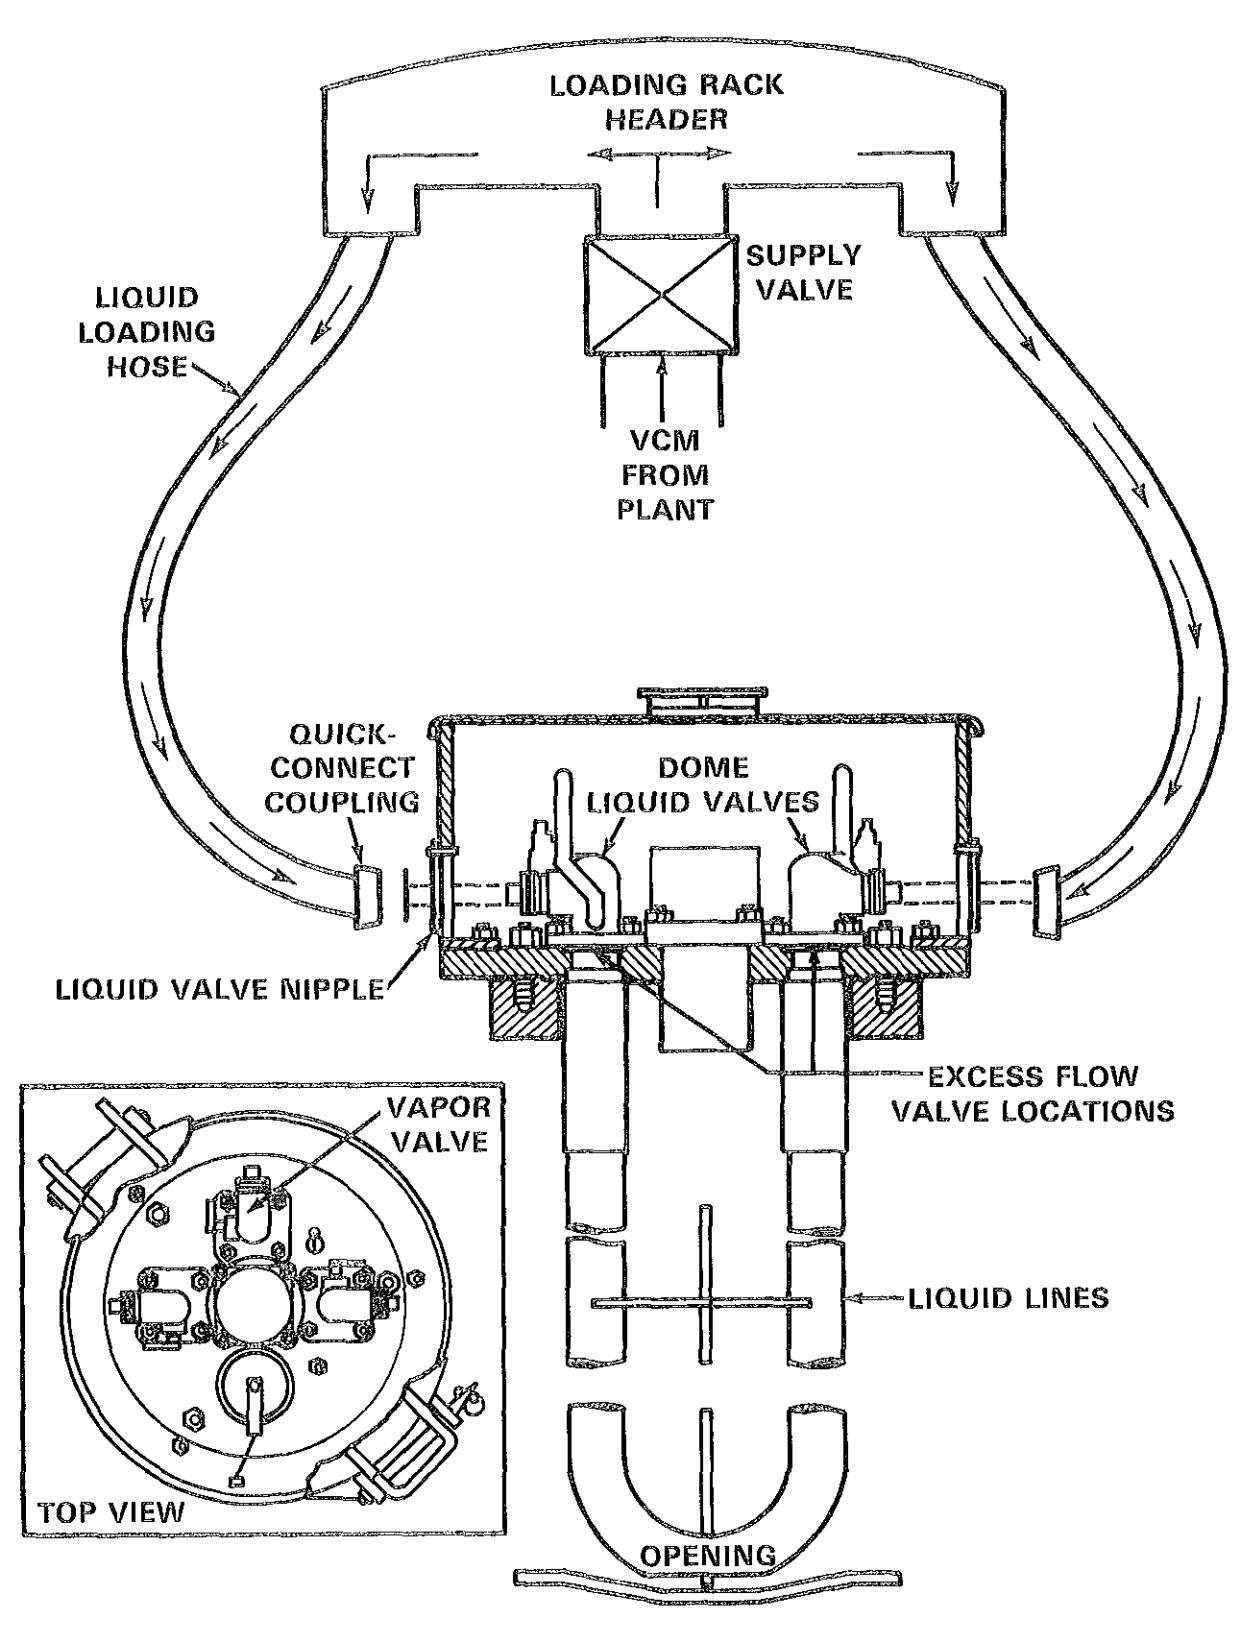
Figure 1.—Side view of tank car with liquid loading hoses attached for loading, and top view (inset) of tank car shown without manway bonnet cover.

Following the accident, investigators found that the safety value 4/ (see figure 1) on the tank car at station No. 6-2 did not activate during the fire. Loader-1 had laid the seal used to secure the manway bonnet cover on top of the safety value before the accident, and the seal was not blown away as it would have been if the safety value had released. Investigators also found that the liquid loading and vapor hoses had been removed from the tank cars at station Nos. 5-1 and 6-1 and that all of the values and manway covers on these tank cars had been closed before the accident.

Both tank cars had two internal liquid lines through which chemicals could be loaded. The liquid lines extended into the tank from the manway entrance at the car dome. (See figure 1.) Each liquid line was fitted at the manway entrance with a 2-inch-diameter, ball-type, steel-body angle valve containing a stainless steel ball. Directly under each liquid valve was a 3-inch-diameter excess flow valve. Each tank car also contained a vapor line through which chemical vapors could be vented during loading. The vapor line extended into the tank from the manway entrance. The vapor line was fitted at the manway entrance with a 2-inch-diameter, steel-body angle valve containing a stainless steel ball. Directly under the vapor valve was a 2-inch-diameter excess flow valve. Both cars were equipped with a safety valve and were stenciled to indicate that the valve was set at 247 psi. Both tank cars also were equipped with a sampling line, a gauging device, and a thermometer well at the manway entrance.

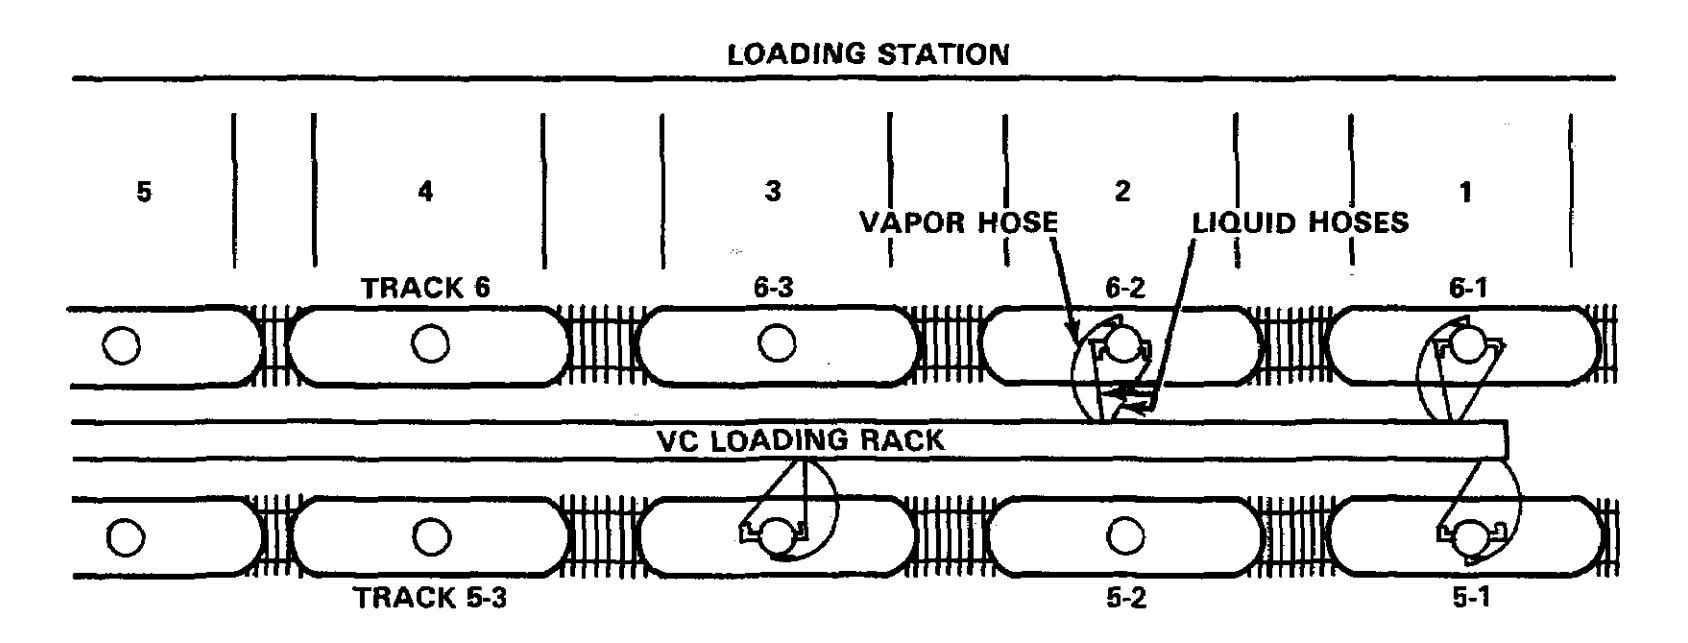
Loader-2 said that after loader-1 left, he crossed over the bridge from the loading rack onto the dome of the tank car located at station No. 6-2 (see figure 2) and stopped to look at the early morning sky. Loader-2 said that, as he did so, he was struck on the back by one of the VCM liquid loading hoses, which had come loose from its attachment to the tank car. (See figure 1.) Seeing pressurized VCM pouring from the liquid valve nipple and knowing that VCM is combustible, is carcinogenic, and freezes the skin on contact, he ran to the end of the tank car and slid down the side of the car to the ground below. He did not use the bridge from the tank dome to the loading rack to escape because the loose hose was between his position on the tank car and the bridge. The sudden outward flow of VCM was not stopped by the tank car's excess flow valve. 3/ (See figure 1.) VCM accumulated on the ground below and between the tank cars at station Nos. 6-2 and 5-2 and was ignited by an undetermined source; a large billowing fire ensued. VCM spraying from the liquid valve nipple of the tank car at station No. 6-2 was ignited and, because of the angle of the valve nipple, burning VCM sprayed like a torch onto the tank car at station No. 5-2. When the other liquid loading hose on the tank car at station No. 6-2 was burned off, burning VCM also began spraying onto the tank car at station No. 5-2 from the car's other liquid valve nipple.

Figure 2.—Tank car locations and hose attachments when loader-1 stopped working at the loading rack.
