INTERSTATE COMMERCE COMMISSION

REPORT OF THE DIRECTOR OF THE BUREAU OF SAFETY IN RE INVESTIGATION OF AN ACCIDENT WHICH OCCURRED ON THE ST LOUIS-SAN FRANCISCO RAILWAY NEAR VICTORIA, MISS, ON OCTOBER 27, 1925¹

JUNE 16 1927

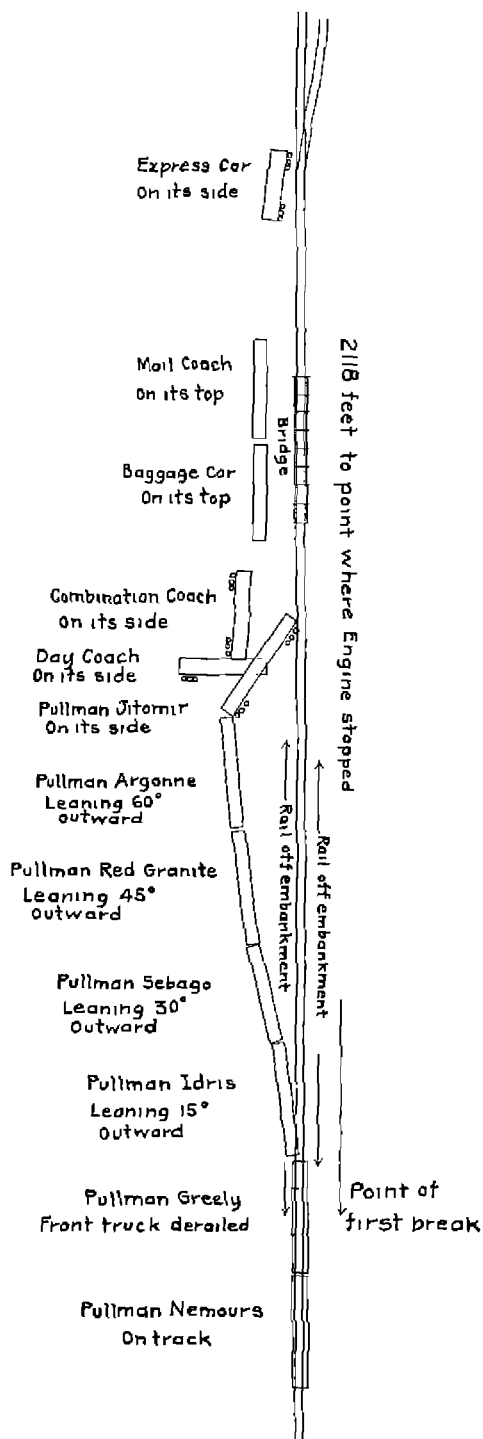
The 1—Plan of the track showing positions occupied by the railed cars.

Figure No. 1 is a plan of the track taken from a blue print from the office of the division engineer of the railroad. It shows the first car of the train on its side, the second and third cars bottom side up, the fourth car on its side, the fifth and sixth cars, a day coach and a Pullman sleeper, jammed together. Four Pullman sleepers, next in order, leaned outward at different angles, while the last two Pullman sleepers remained in upright positions. The car next the last one of the train spanned the broken rail, its forward truck derailed its rear truck on the rails.

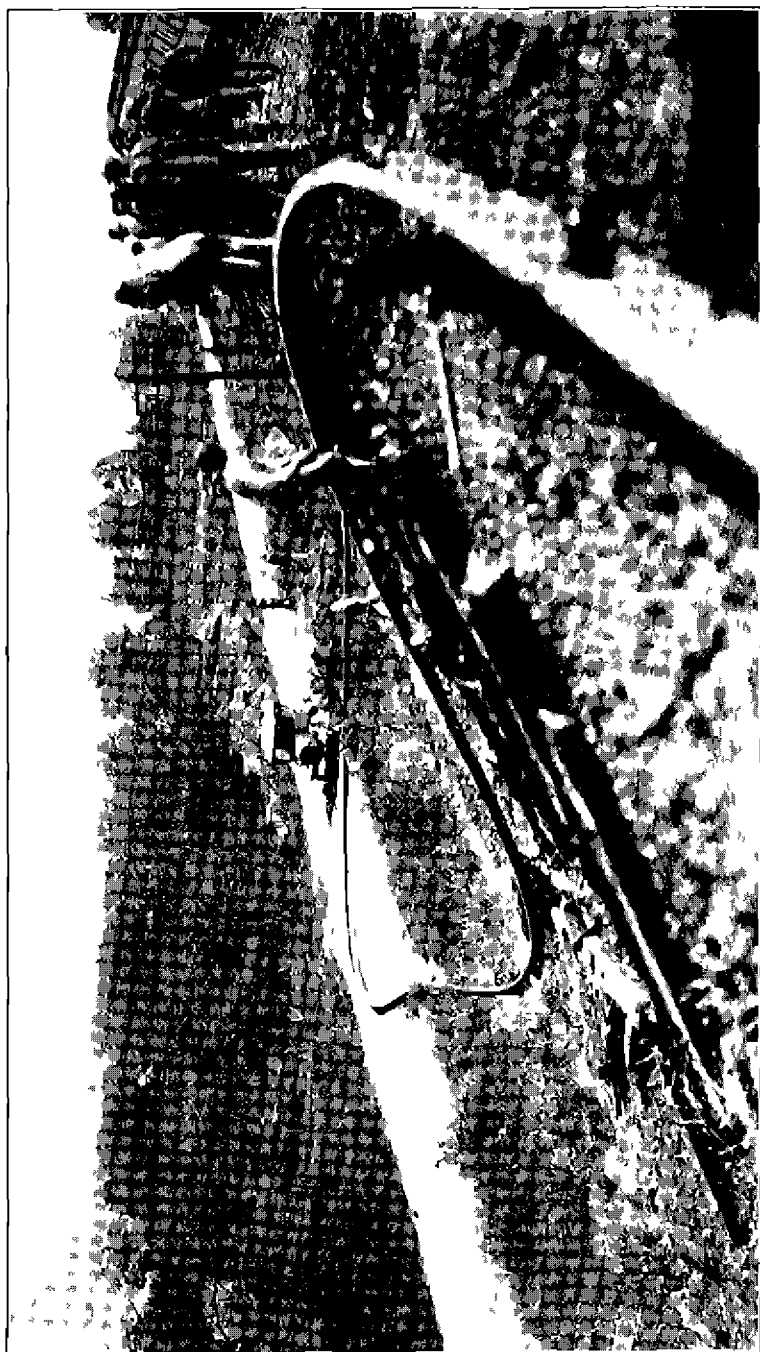
The rails from the west side of the track were broken or detached from each other. Nine rails of the east side of the track remained attached to each other, their splice bars unbroken. These nine rails were ploughed off the ties and thrown from the roadbed out on to the highway paralleling the track. They formed a large loop which extended at its farthest point 75 feet from their position in the track. They were bent sidewise, some convex on the gauge side, others concave. Figure No. 2 illustrates the positions occupied by these nine rails after the accident. They were thrown from the track with such force and suddenness that the loop was made in the air and fell almost vertically upon the highway.

FIG. 2.—Loop made by min. rails plowed off the easterly side of the track. Rail, bent splice bars unbroken

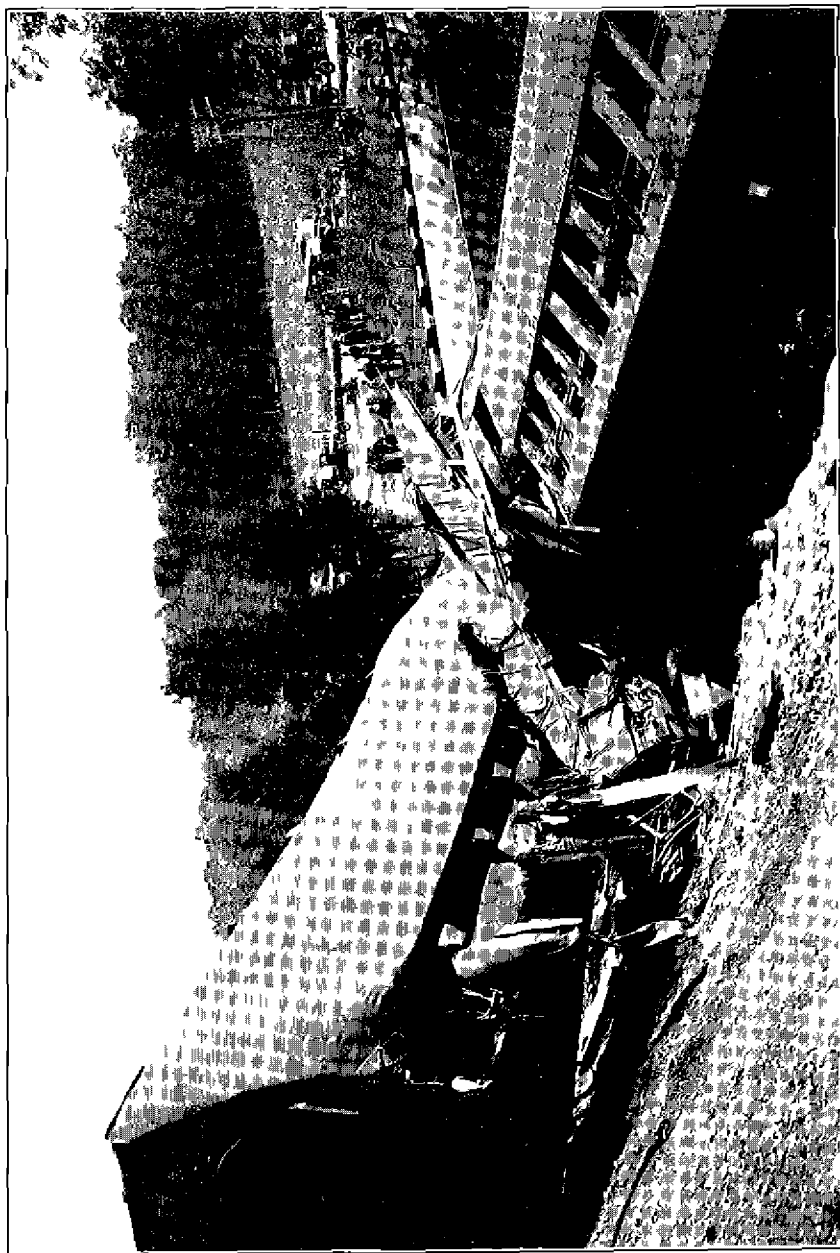
FIG 3—View of the Pullman sleeper the Jtomar and a day coach Middle of Pullman sleeper and end of day coach jammed together

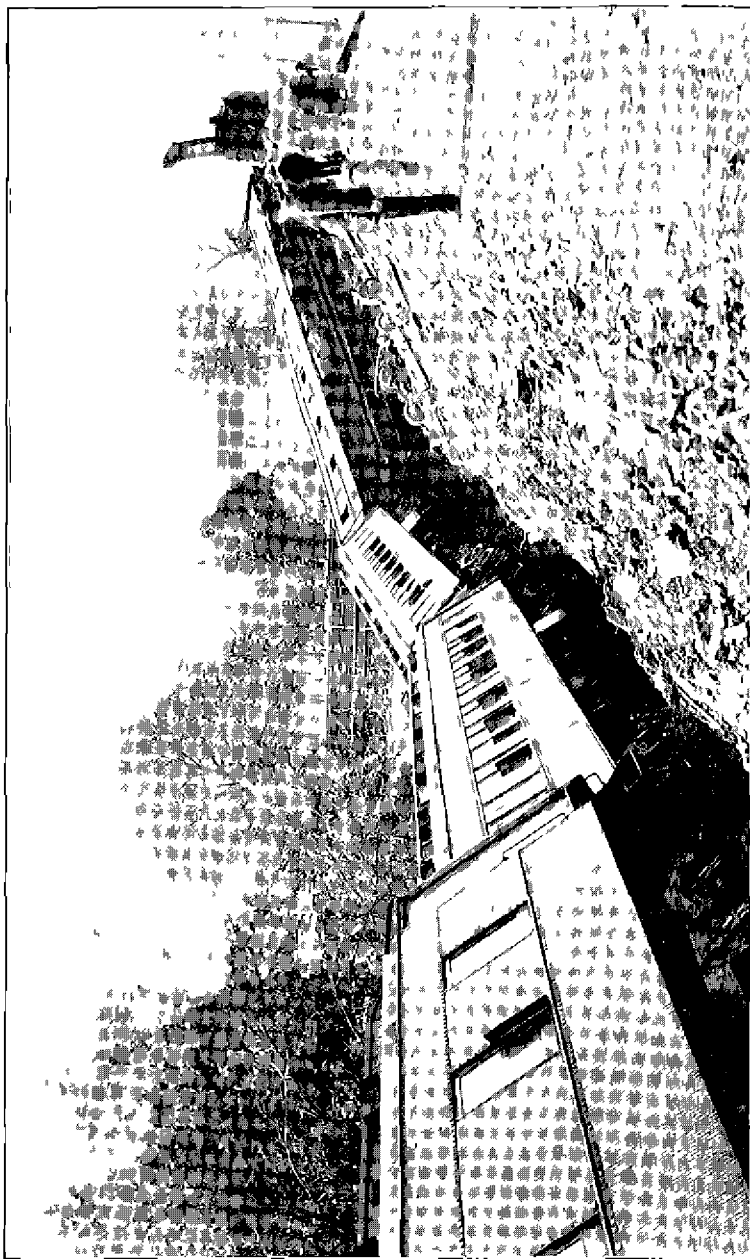
FIG. 4.—View of the derailed Pullman sleepers Schago and Argonne and Hiram, respectively.

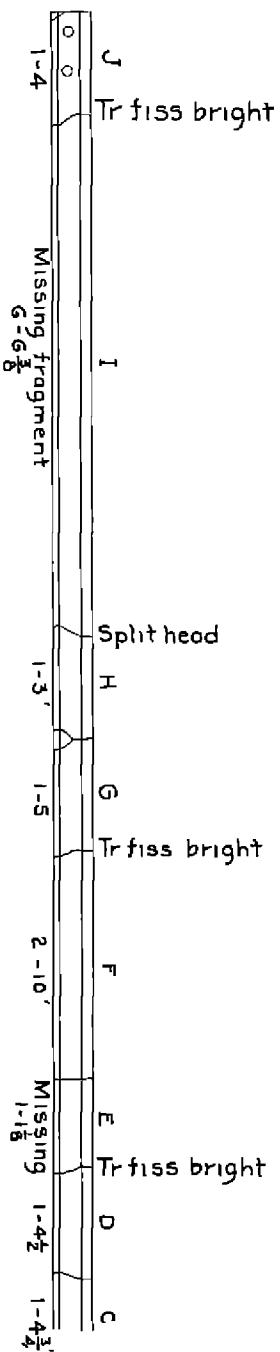
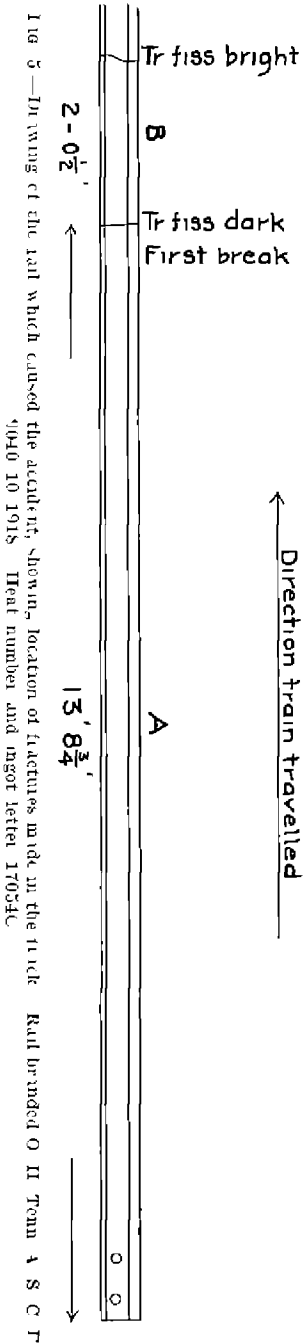
Figure No. 5 is a drawing of the rail which broke and caused the accident. It weighed 90 pounds per yard, was rolled by the Tennessee Coal, Iron & Railroad Company in the month of October, 1918, and was laid in the track in April, 1919. It had been in service, therefore 6 years and 6 months. It was branded O. H. Tennessee A. S. C. E. 9040 10 1918. Heat number 17054, ingot letter C.

There was a transverse fissure at the first break in the rail which measured $1 \frac{13}{16}$ by $1 \frac{7}{16}$ inches. The surfaces were darkened, indicating the fissure had reached the periphery of the head and an had been admitted prior to the accident.

For convenience of reference the fragments of this rail are designated by letters of the alphabet. The first break was between fragments A and B, which displayed the transverse fissure above described. Four additional transverse fissures were displayed at the time of the accident, the positions of which are indicated by Figure No. 5. Each of these showed bright surfaces with a silvery luster. None of these four had reached the surface of the head prior to the accident. Subsequently a hammer test of fragment A revealed two more transverse fissures, making in all seven in this rail.

Fig 3—Drawing of the rail which caused the accident, showing, location of fractures made in the truck. Rail branded O H Tenn A S C T 1040 10 1918 Heat number and mark letter 17034C

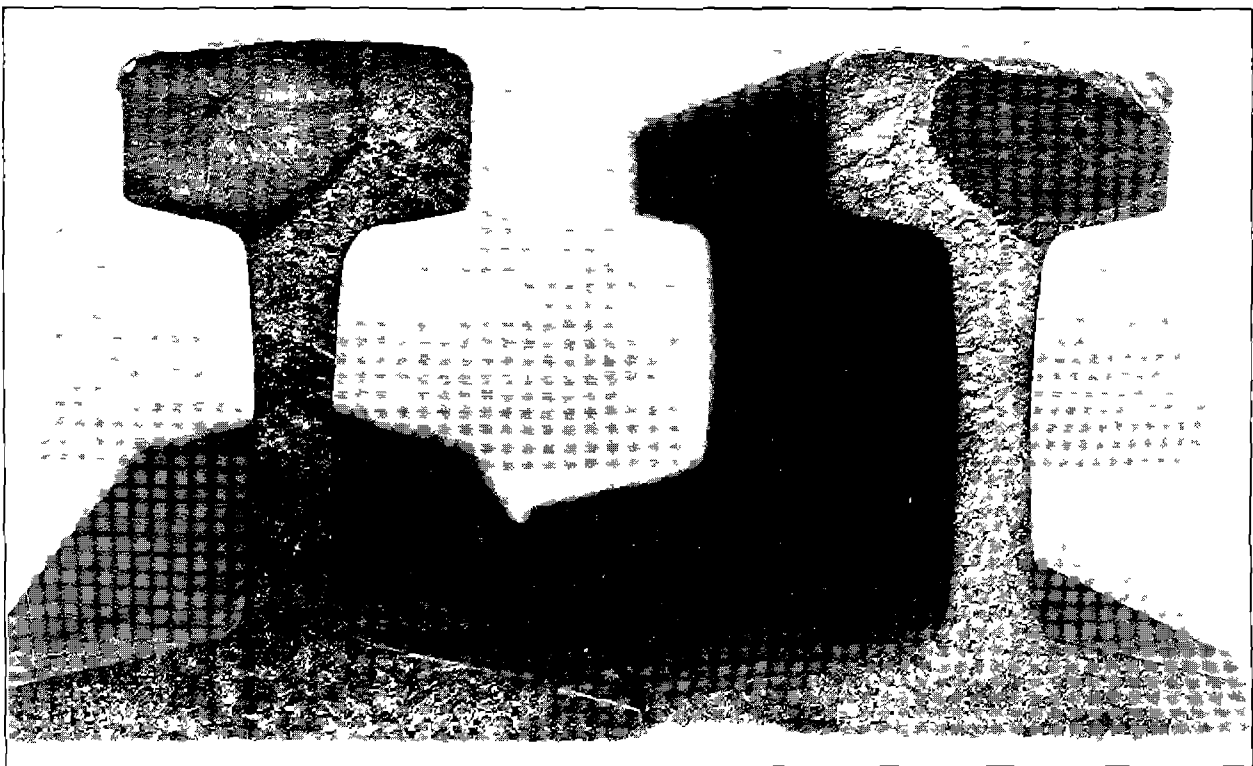
Figure No. 6 illustrates the appearance of the opposite faces of the transverse fissure at the first break in the rail. The section on the left of the cut represents the leaving end of fragment A, the section on the right, the receiving end of fragment B. This transverse fissure covered more than one-half the cross section of the area of the head. The nucleus of the fissure was located on the gauge side of the head, not quite half way down its depth.

FIG 6—Appearance of the opposite faces of the transverse fissure first to break Leaving and receiving ends respectively of fragments A and B

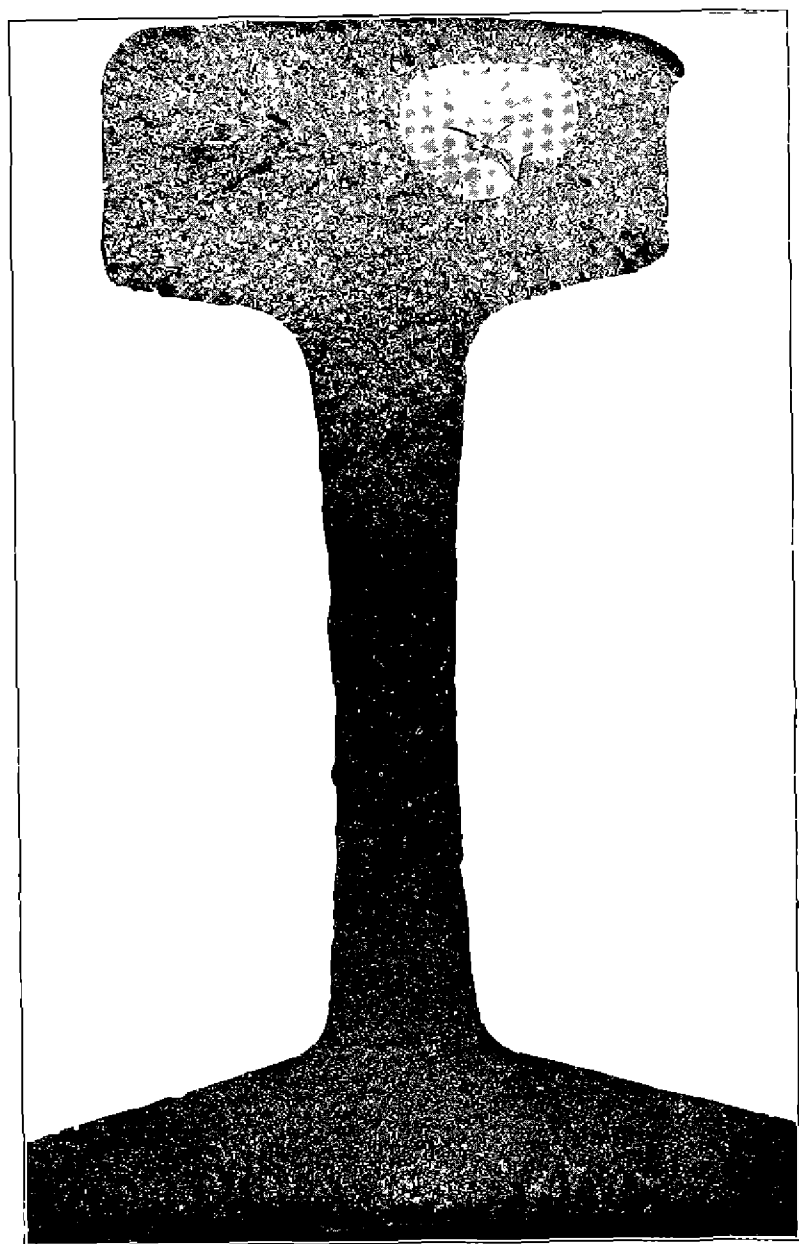
Figure No. 7 shows the appearance of one of the additional transverse fissures found in fragment A under the hammer test. Its bright silvery luster will be noted, a characteristic feature of transverse fissures before air is admitted to them. Its nucleus is on the gauge side of the head, in common with all others of this rail.

FIG. 7 —Pit fully formed in reverse fissure revealed by hammer test of fragment A

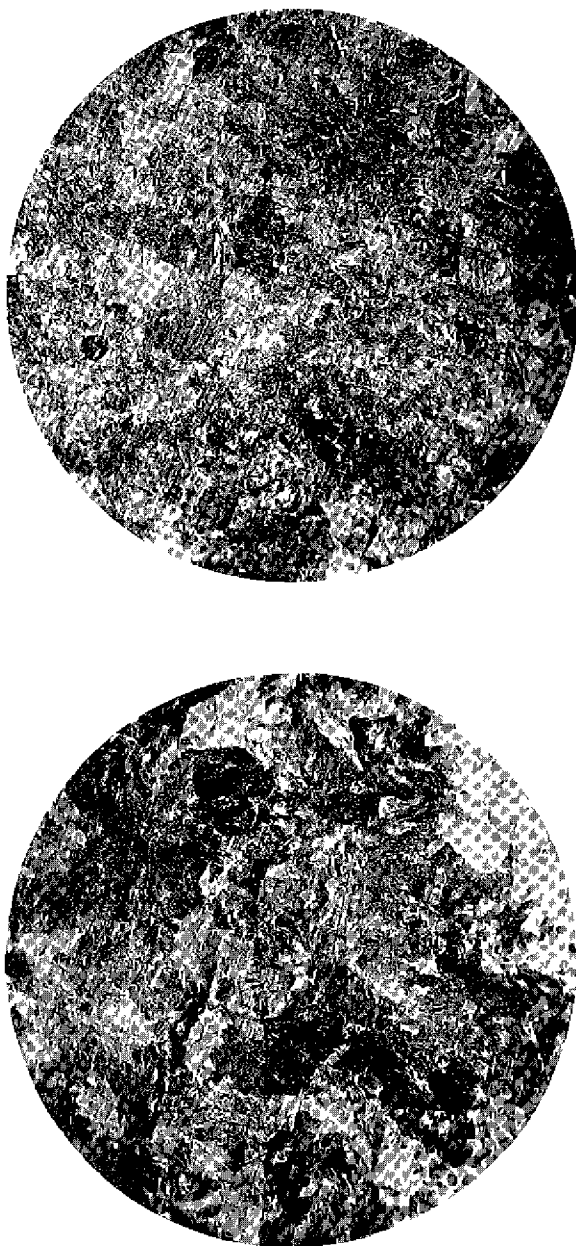
Prior to taking out chips for chemical analysis, the micro structure of rails 17054 C and F was developed by picric acid etching, the results being shown by Figures Nos. 8 and 9. Substantially the same structure was displayed by each, with no peculiar characteristic in the vicinity of the transverse fissures.

FIG 8—Micro-structure of rail 17034C. zone of transverse fissure and opposite side of head Magnification 100 diameters

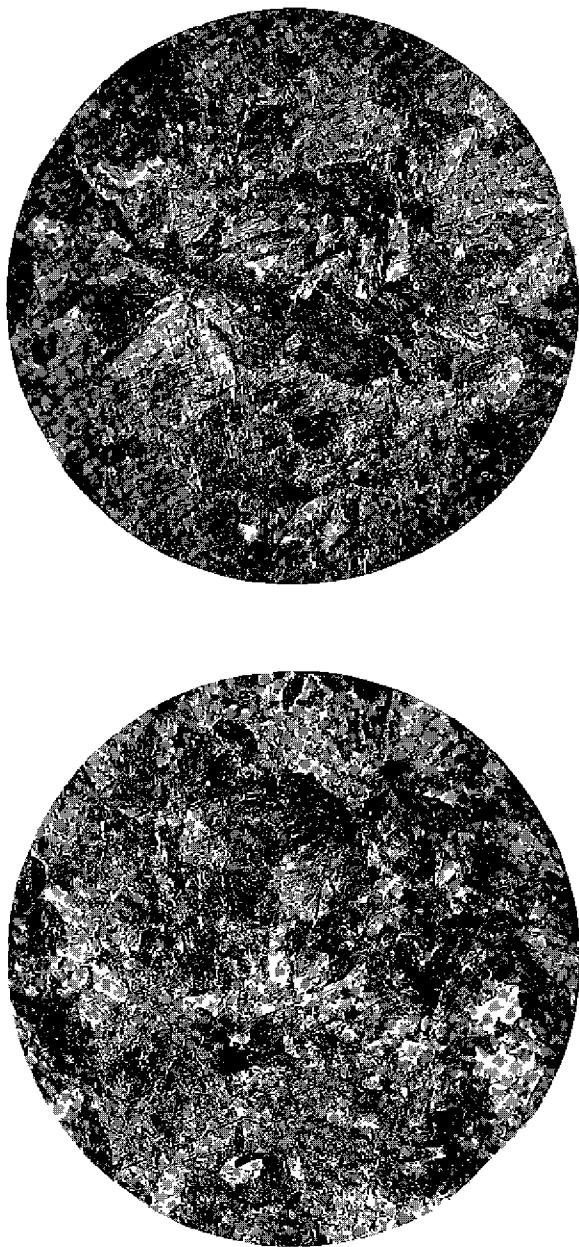
FIG. 9.—Microstructure of rail 37054T /one of transverse fissure and opposite side of head Magnification 100 diameters

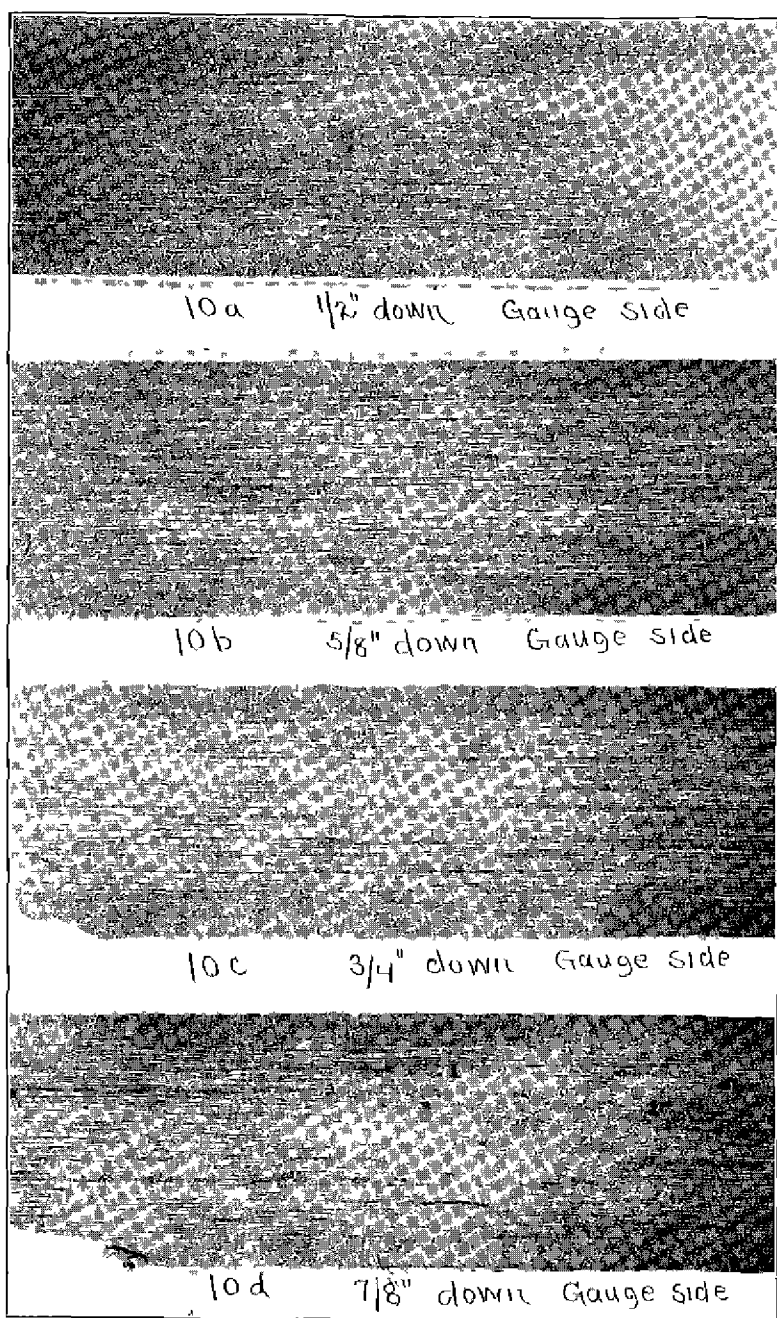
Fragment F of rail 17054 C, Figure No. 5, was used in an examination of the structural state of the steel at different depths below the running surface of the head. The metal was planed off in successive stages and the rail pickled in hot hydrochloric acid at each stage. Figure No. 10 a, b, c and d are photographic views of the pickled surfaces at depths of one-half, five-eighths, three-fourths, and seven-eighths inch, respectively. The surface was clear at a depth of one-half inch. A few crosswise cracks appeared at five-eighths-inch depth. Again the head was nearly clear at three-fourths-inch depth. At seven-eighths-inch depth numerous cracks appeared on the pickled surface. The nuclei of transverse fissures are seldom located so far down as the surface last pickled.

FIG. 10 —Head of rail 17054C fragment B planed off in successive stages surface pickled at each stage

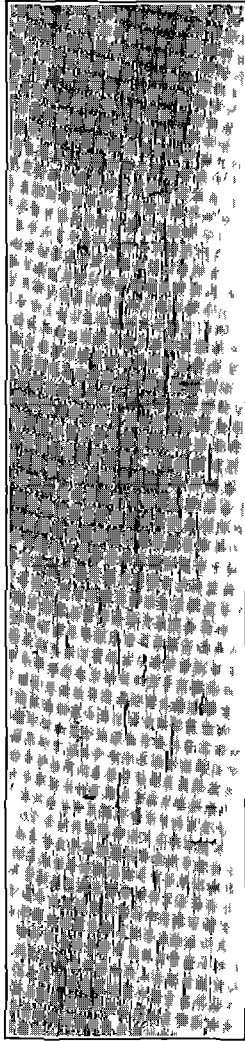
Figure No. 13 illustrates the pickled surface of a 130-pound rail from the Baltimore & Ohio Railroad, planed off to a depth of three-fourths inch. Incipient transverse fissures are displayed in echelon from the gauge side of the head in steps toward the middle of its width. The short longitudinal cracks shown are believed to represent acicular slag streaks.

FIG. 13.—Head of a 140 pound rail planed off $\frac{1}{8}$ inch and surface pickled. Incipient transverse fissures from surface stress would also longitudinal slag cracks.

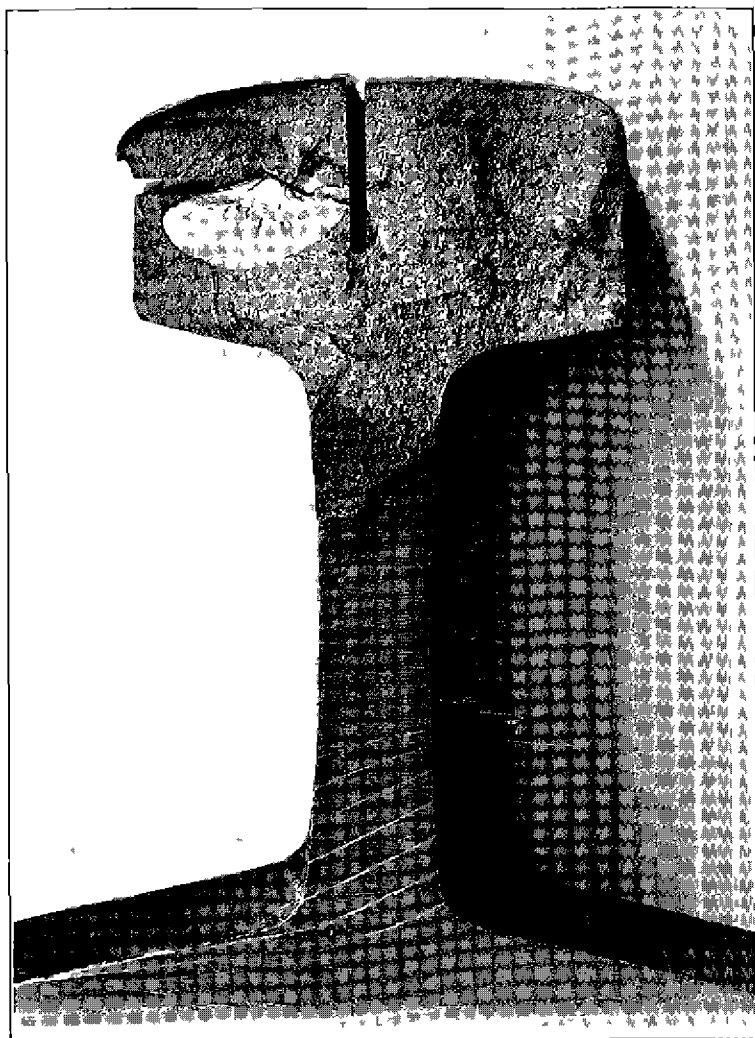
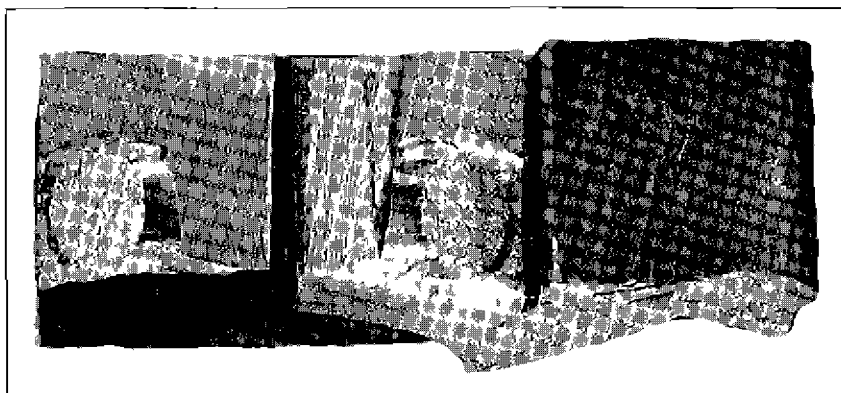
FIG 30a

Figs 30a and 30b—Compound transverse fissure originating at a small longitudinal seam. Vertical development shown by Figure 30a, horizontal oval fissure containing longitudinal seam shown by Figure 30b.

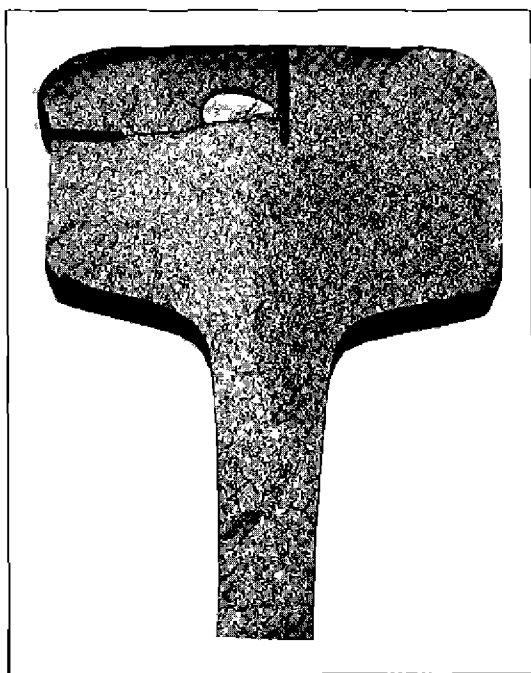
FIG 31a

FIGS 31a and 31b—Compound transverse fissure
Horizontal split head branching upward into a
transverse fissure Origin of split head at longitudinal seam

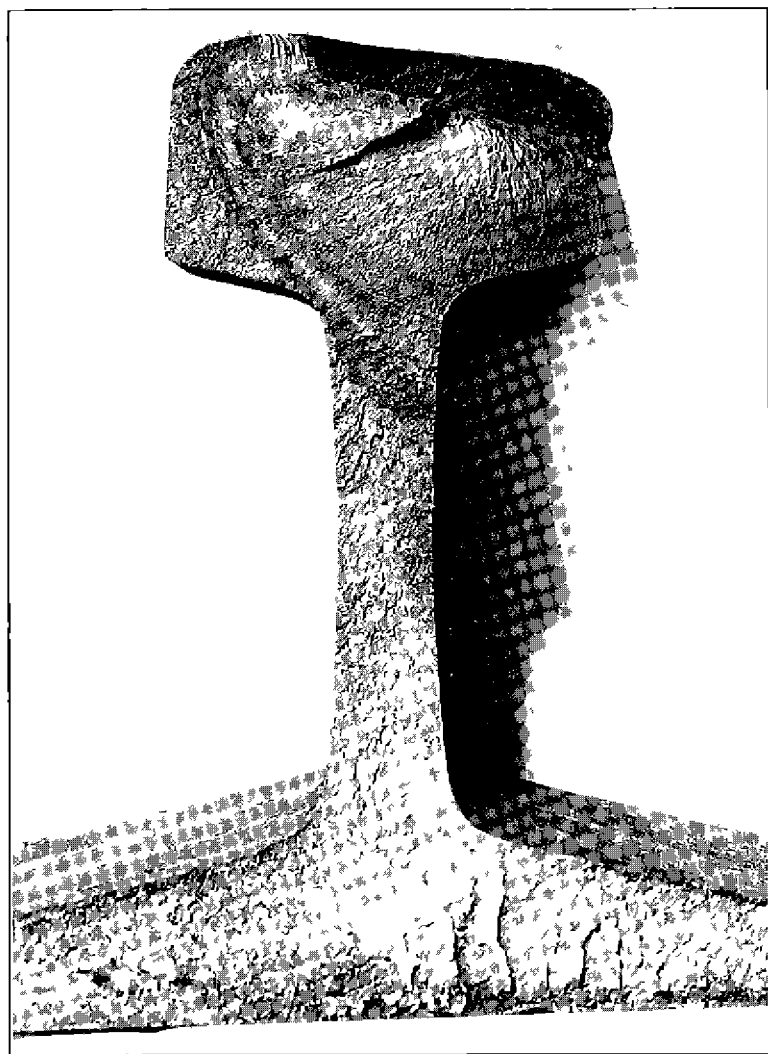
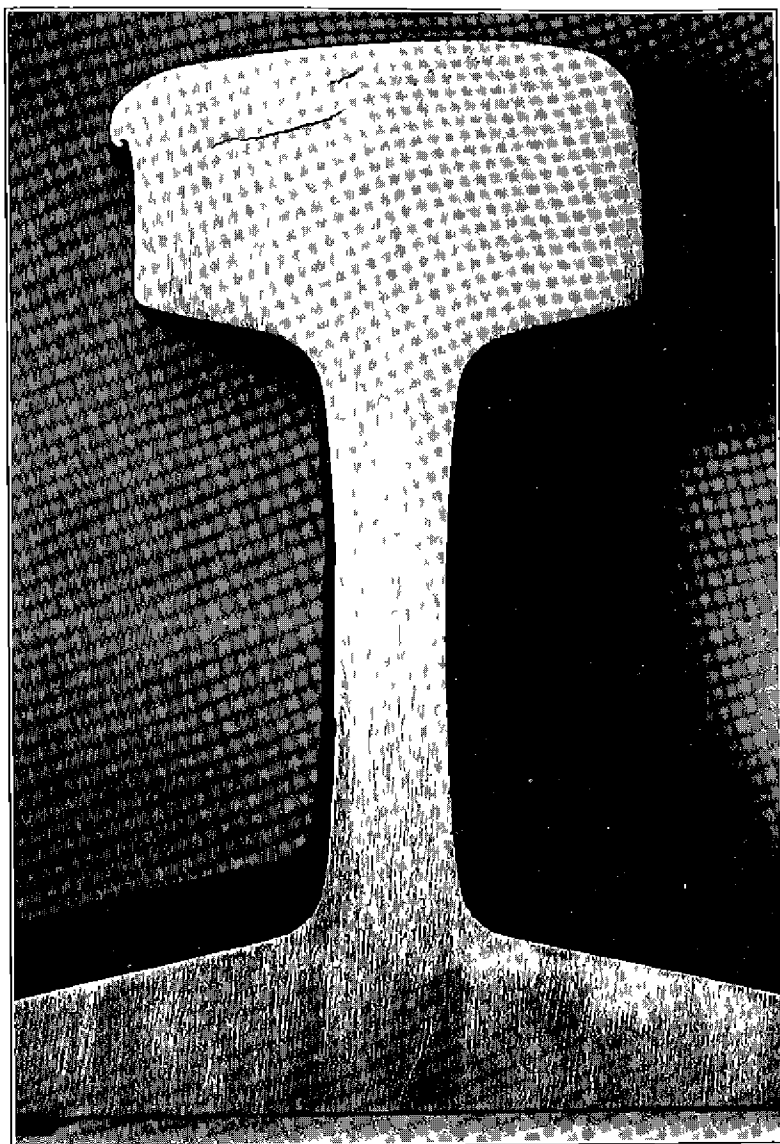
FIG. 32a

FIGS. 32a and 32b—Compound transverse fissure in a 100 pound rail originating at a horizontal split head. Figure 32a, transverse fissure branching downward from split head. Figure 32b, two horizontal split head cracks the longer of which led to the formation of the transverse fissure.

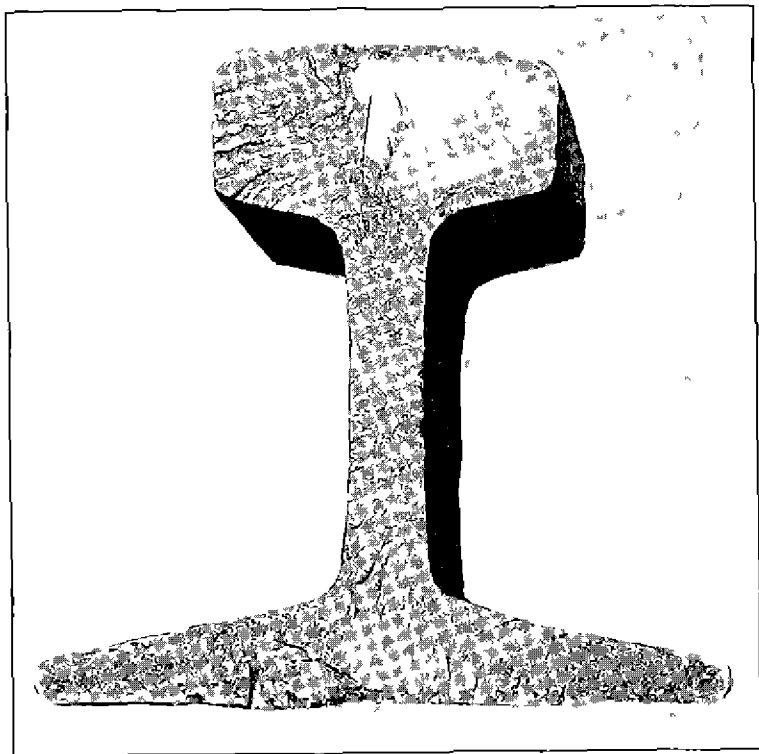
Figure No 33a illustrates a transverse fissure which, in its development, was arrested by the presence of a vertical split head fracture. Its growth, however, continued by extending over and beyond the upper edge of the vertical fracture. This rail furnishes an example of reverse action to preceding illustrations of compound fractures where horizontal split heads branched, upward or downward, into transverse fissures. In the present example the nucleus of the transverse fissure was on the gauge side of the head remote from the vertical crack. The transverse fissure was stopped at the vertical crack. This rare combination of fractures prompts the query: If a large seam or crack possesses the ability to stop a transverse fissure would it be expected that a small seam would possess the ability to start one? The matter resolves itself into the question of orientation, this example tending to eliminate from consideration the presence of longitudinal seams as essential precursors in the formation of transverse fissures. If they are not vital, anxiety would center solely upon those shrinkage cracks which are oriented in planes substantially normal to the axis of the rail.

FIG 33a—Transverse fissure in an 85 pound rail affected at a split head fracture

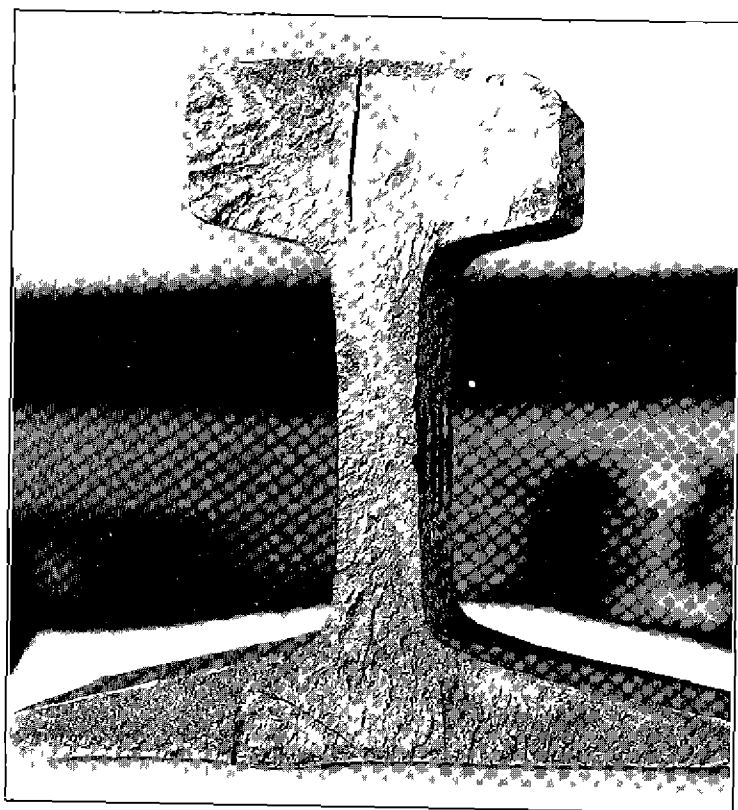
FIG 3**b**—Split head fracture of Figure 3**a** extended across transverse fissure
by peening to running surface of head
54235—27—5

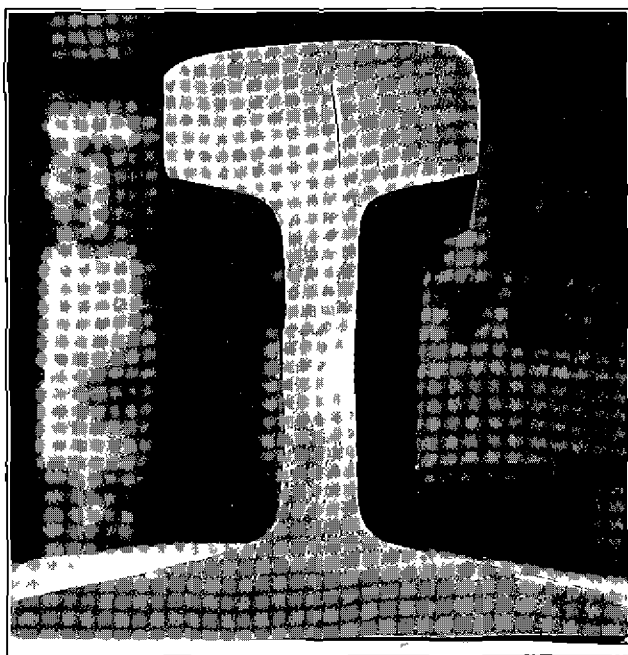
FIG 34a —Split head fracture in an 85 pound rail Opposite end
of short fragment Figures 33a and 33b

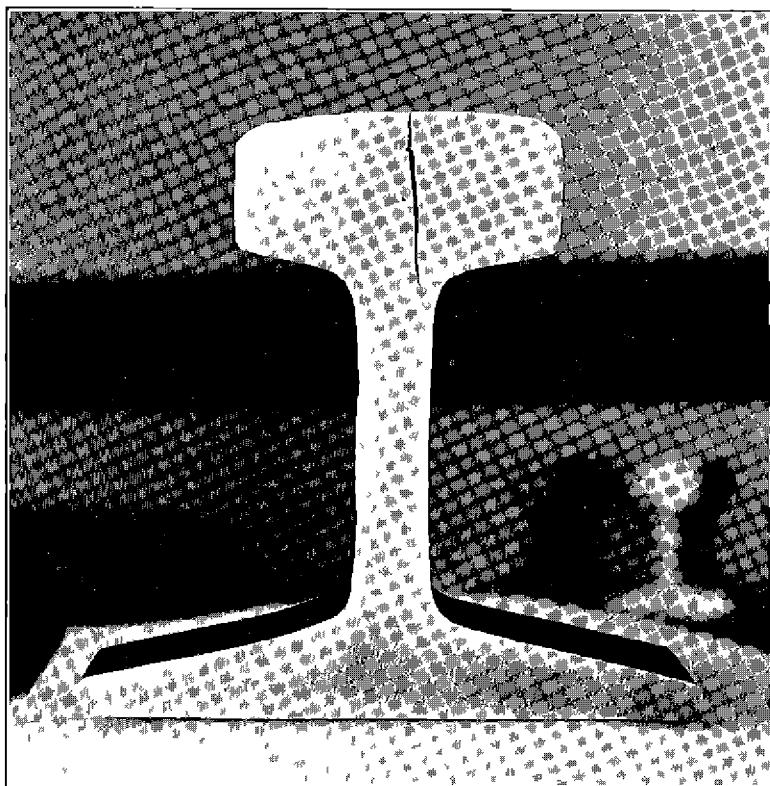
FIG. 34b -- Split head fracture of Figure 34a extended by peening to running surface of head

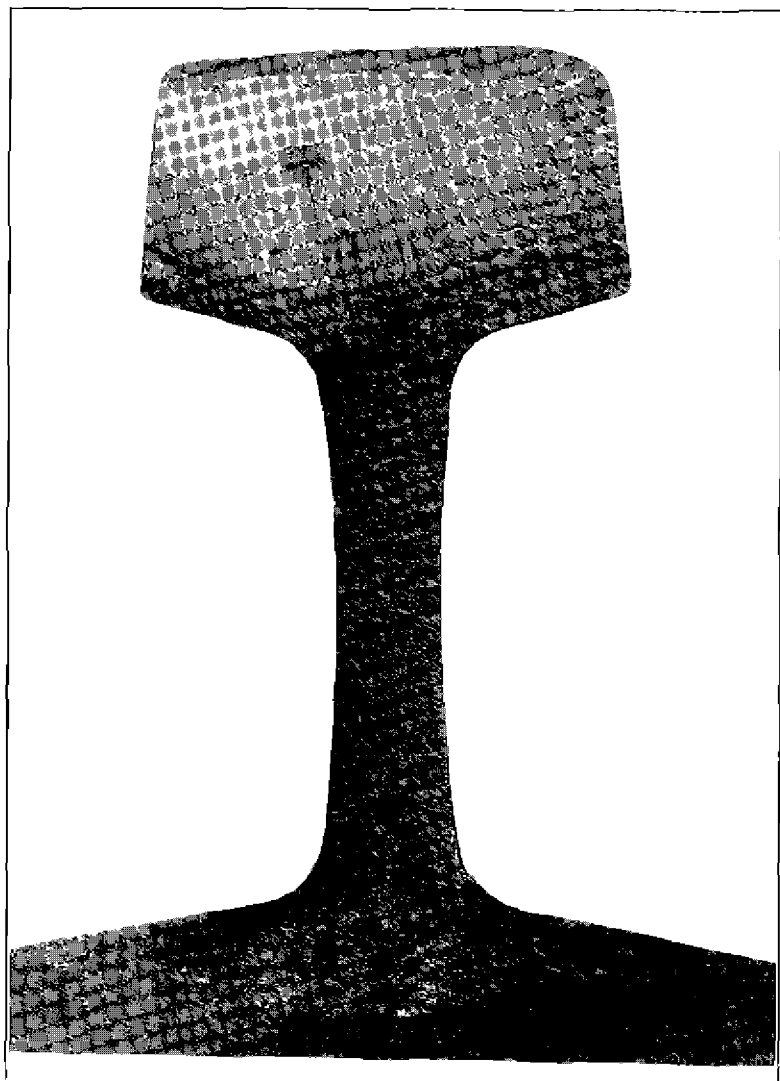
FIG. 35.—Transverse fissure in 100 pound O H Vanadium steel rail. Transverse fissure reached surface at side of head but not running surface.

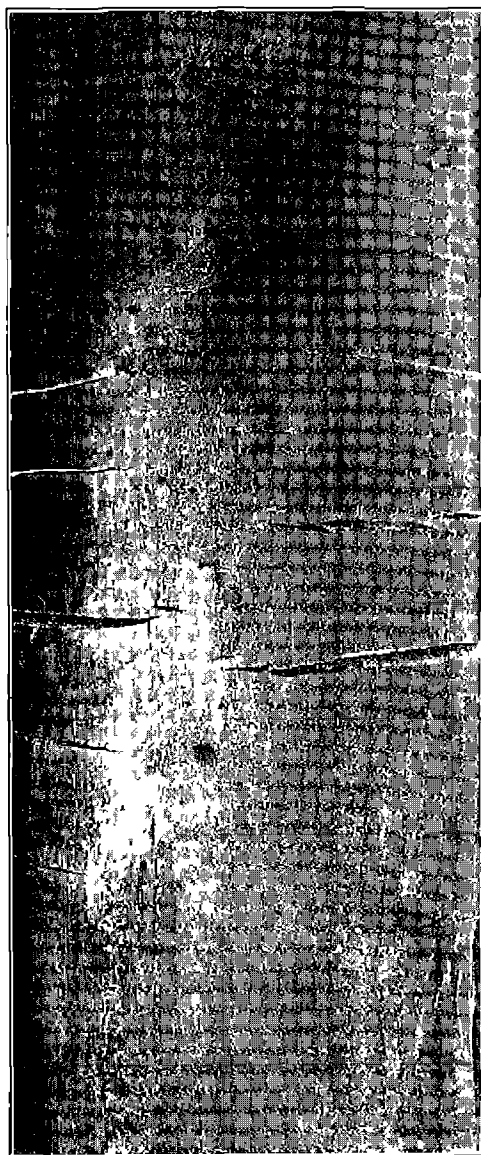
Figure No. 37 illustrates the gashes which were formed in the head of a high manganese steel rail in a bending test, with the head on the tension side. Fractures of this kind are not displayed by carbon-steel rails. The toughness of this remarkable material was destroyed by the cold rolling of the wheels at the immediate running surface.

FIG. 37.—Manganese steel rail 100 pounds weight per yard. Cracks in running surface developed in a bending test of the rail. Elastic limit approximately 54,000 pounds per square inch.

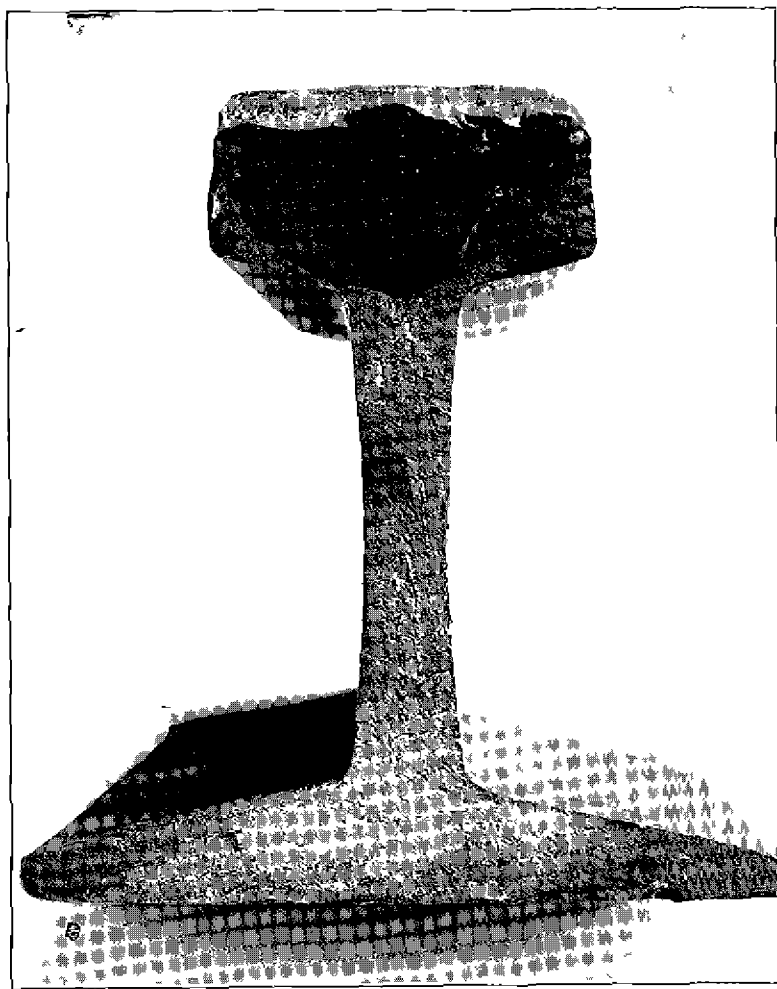
FIG. 38 — Transverse fissure displayed by a medium manganese steel rail Bessemer steel In service 13 years

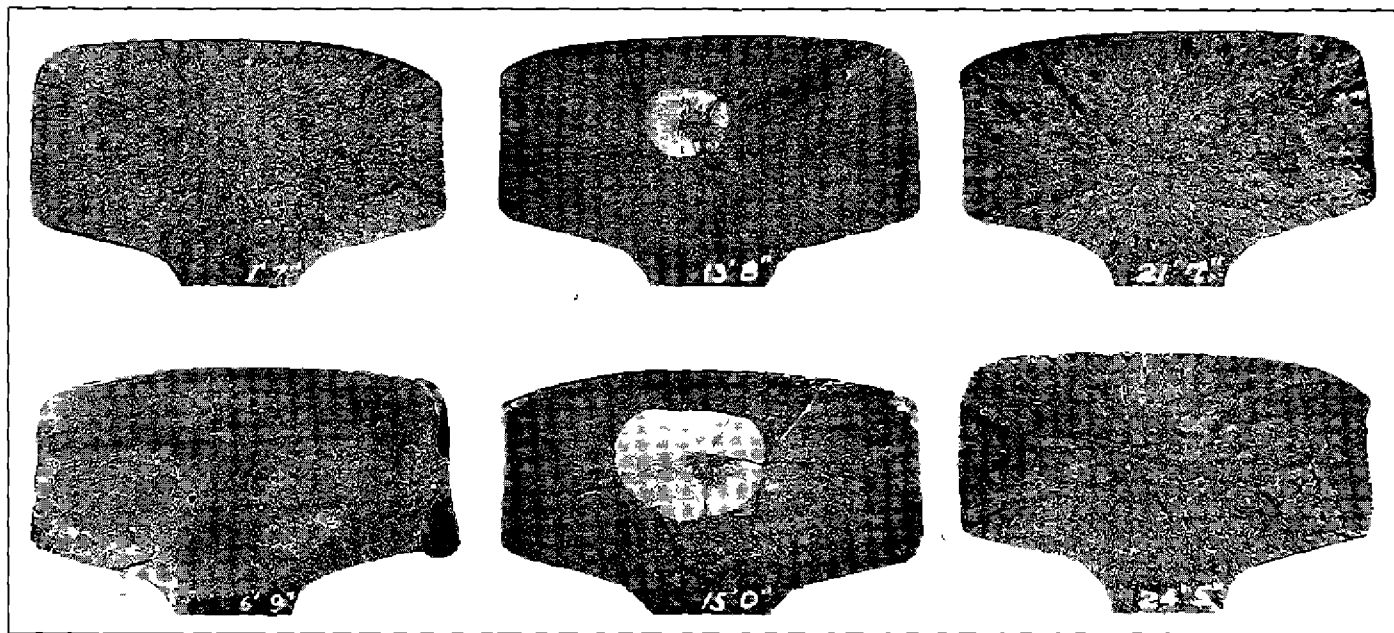
FIG. 39a.—Stalling effects and transverse fissures in different stages of development in a 90 pound rail. Fifteen fractured surfaces

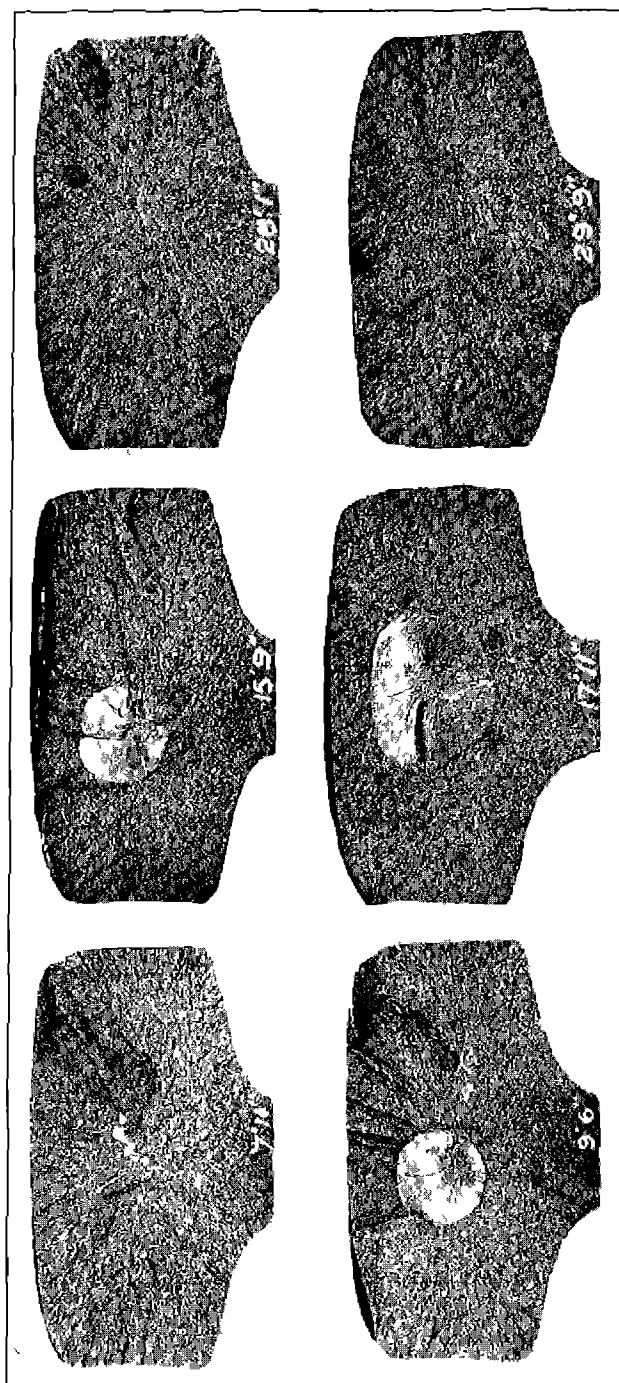
FIG. 390.—Stairing effects and transverse fissures in different stages of development in a 90 pound rail. Fifteen fractured surfaces

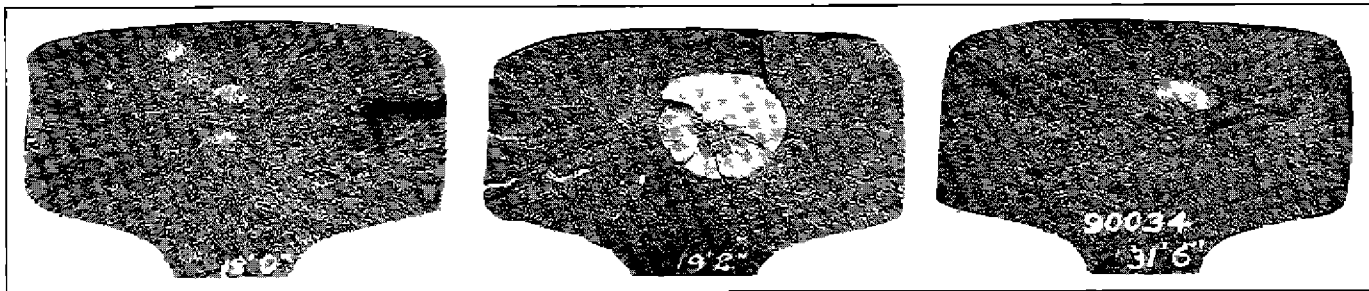
FIG 39c—Starring effects and transverse fissures in different stages of development in a 90 pound rail Fifteen fractured surfaces

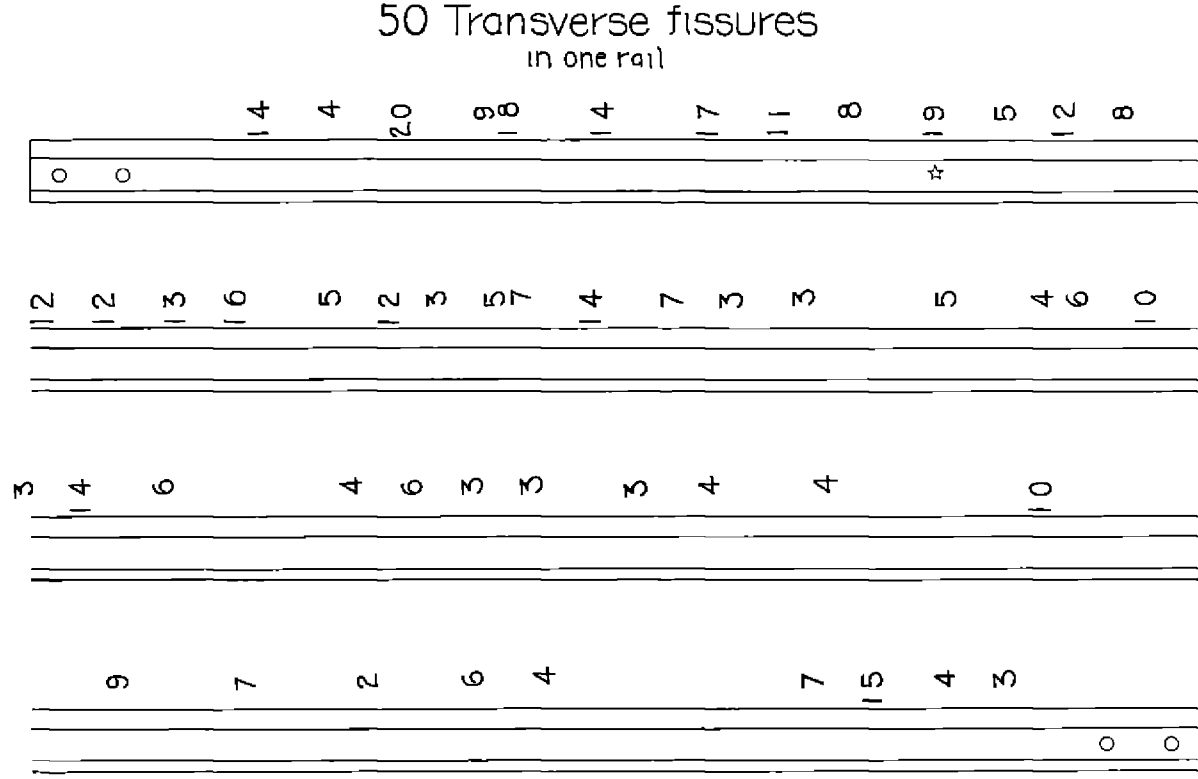
FIG. 40.—Fifty transverse fissures in the same rail. Ninety pound rail about 14 years in service
