# JOINT TRANSPORTATION RESEARCH PROGRAM

# Concrete Box Beam Risk Assessment and Mitigation: Volume 1 – Evolution and Performance

SPR-4009 • Report Number: FHWA/IN/JTRP-2020/06 • DOI: 10.5703/1288284317117

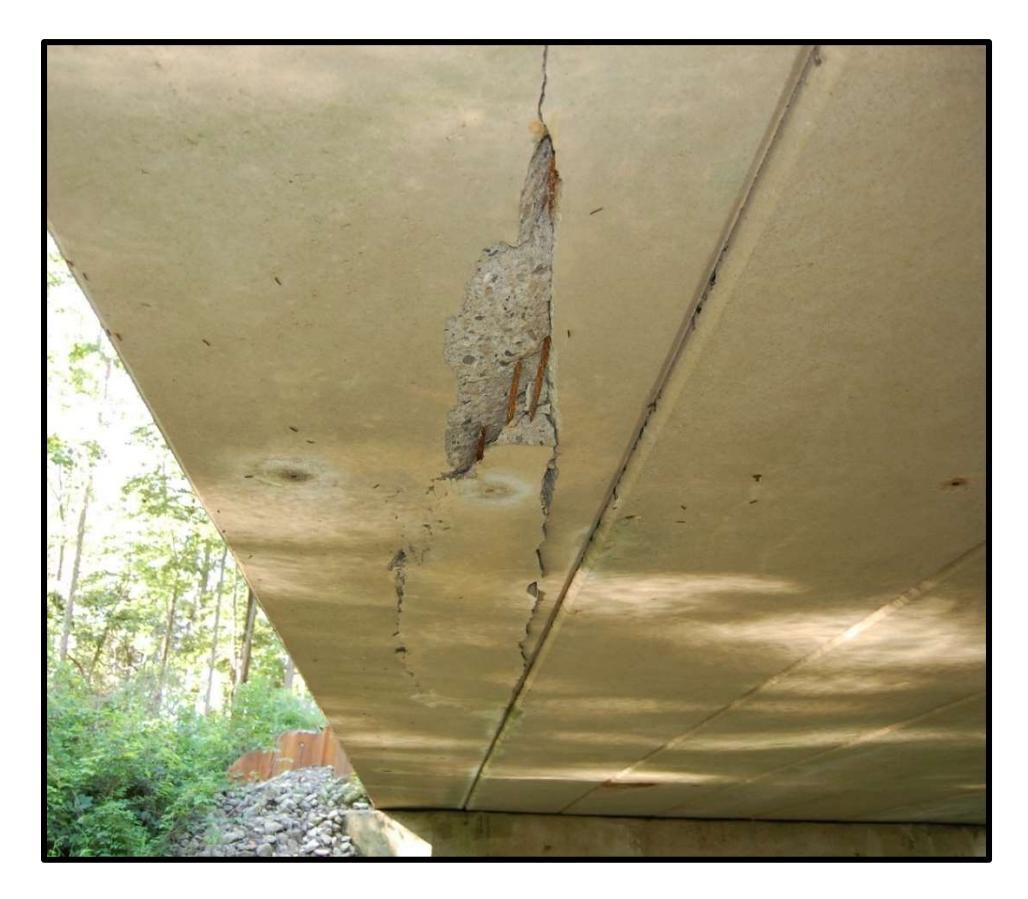
From visual observations made on July 27, 2016, the exterior beam on the east side of the bridge has cracking, spalling, and exposed strands toward midspan (Figure 4.3). Longitudinal cracking in the bottom flange was also noted in one of the middle beams and the first interior beam on the west side (Figure 4.4). Efflorescence covered a majority of the first interior beam on the
west side, which was due to a leaky, exterior shear key (Figure 4.5). The complete deterioration map for this bridge is provided in Figure 4.6.

Figure 4.4 Cracking, spalling, and exposed strands in exterior beam on east end.

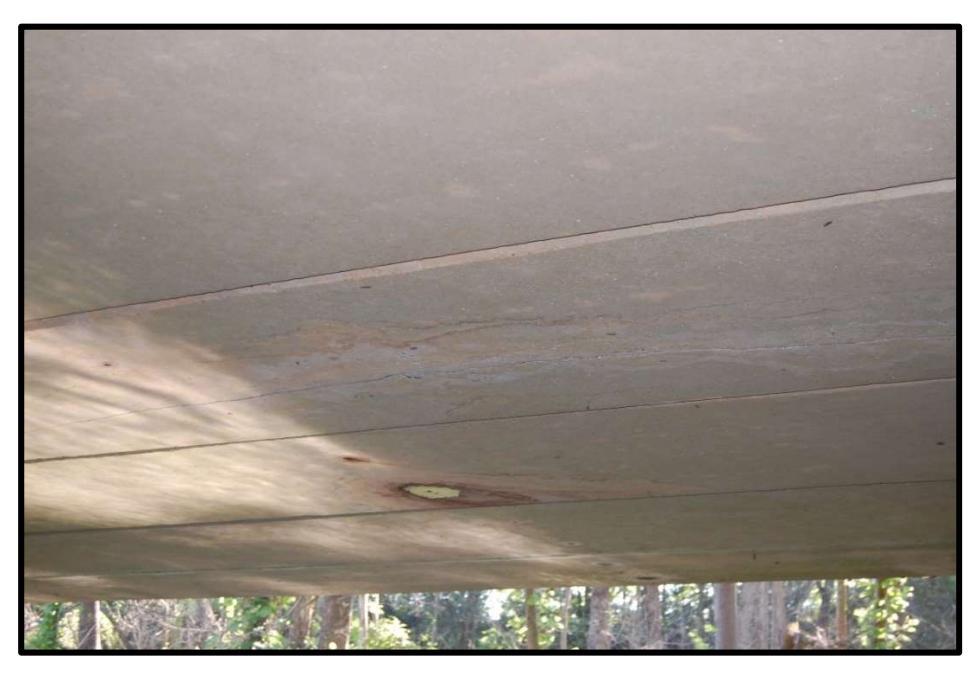
Figure 4.5 Longitudinal crack in middle beam.

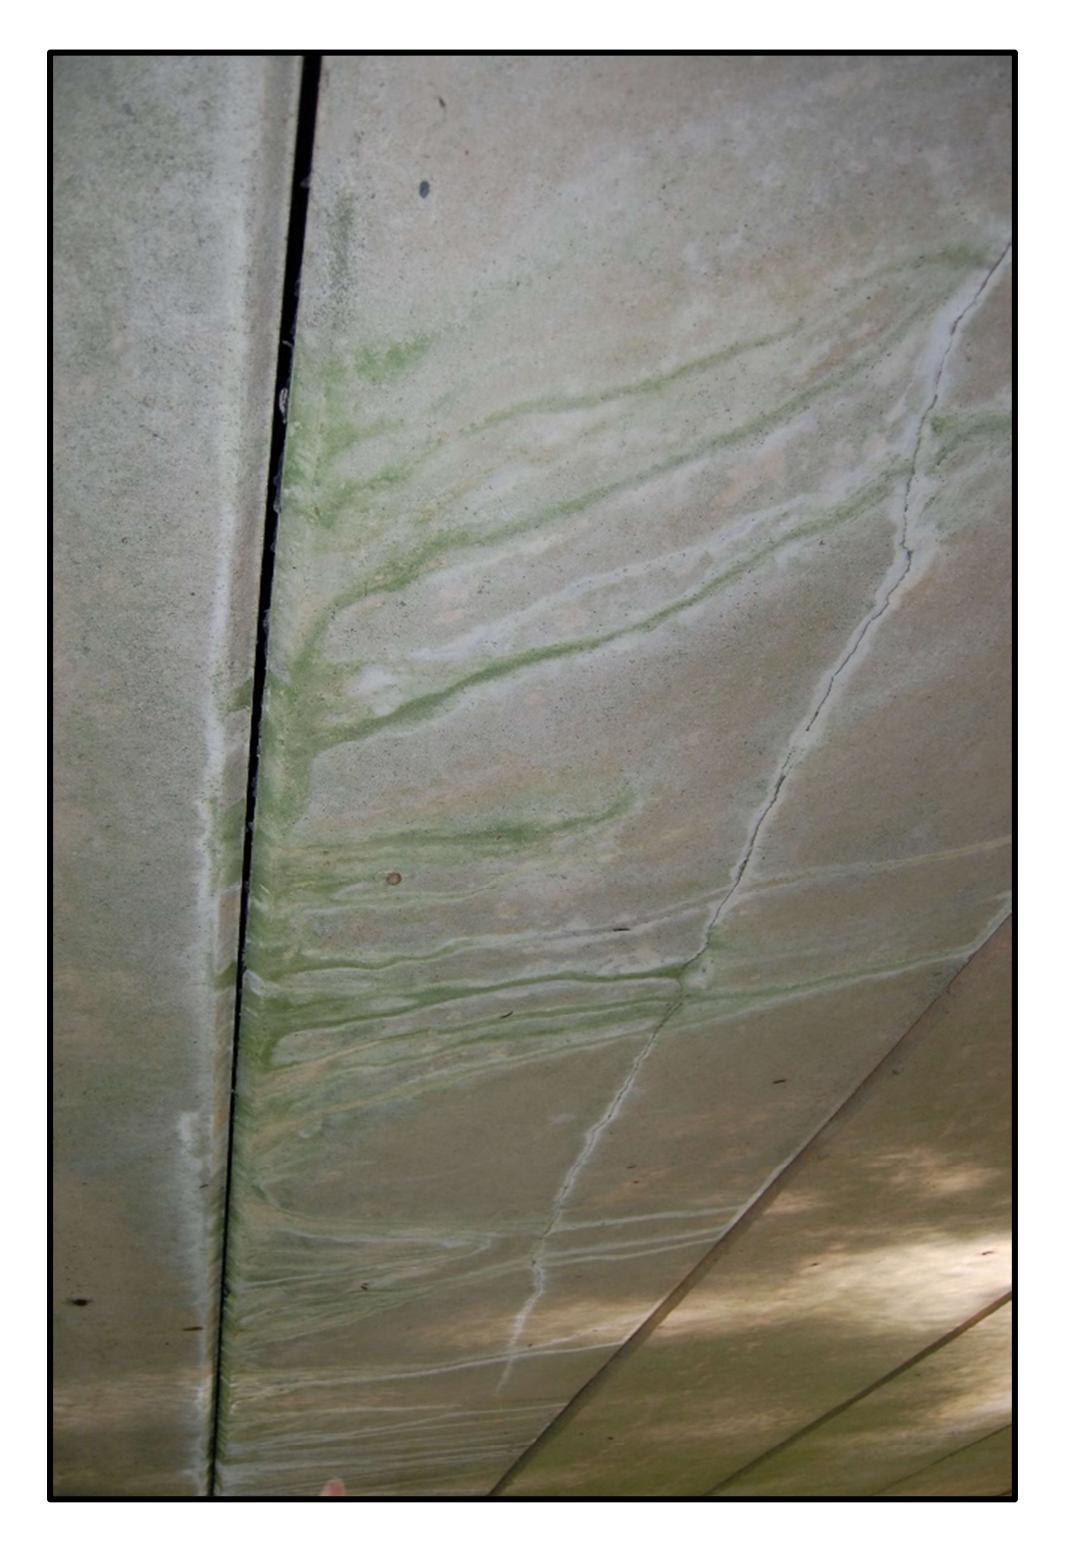
Figure 4.6 Longitudinal crack and staining at first interior beam.

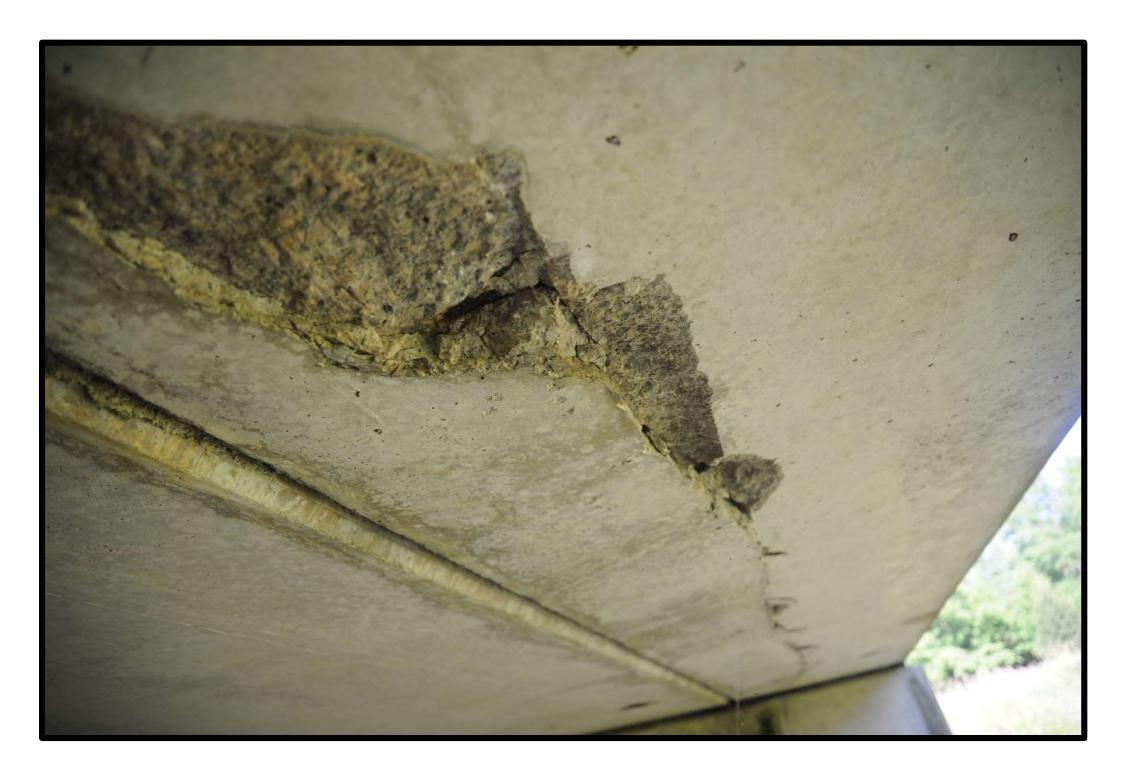
The most deteriorated span was on the east end of the bridge. One of the exterior beams has a large region of spalling with two exposed stirrups and signs of water leakage around the shear key (Figure 4.8). The other exterior beam has a longitudinal crack in the bottom flange and a hole in the top flange (Figure 4.9). The hole revealed standing water in the void of the box beam. The middle span has one beam with a longitudinal crack in the bottom flange and signs of water leakage at the shear key (Figure 4.10). The complete map is provided in Figure 4.11.

Figure 4.9 Exterior beam with spalling and exposed stirrups.

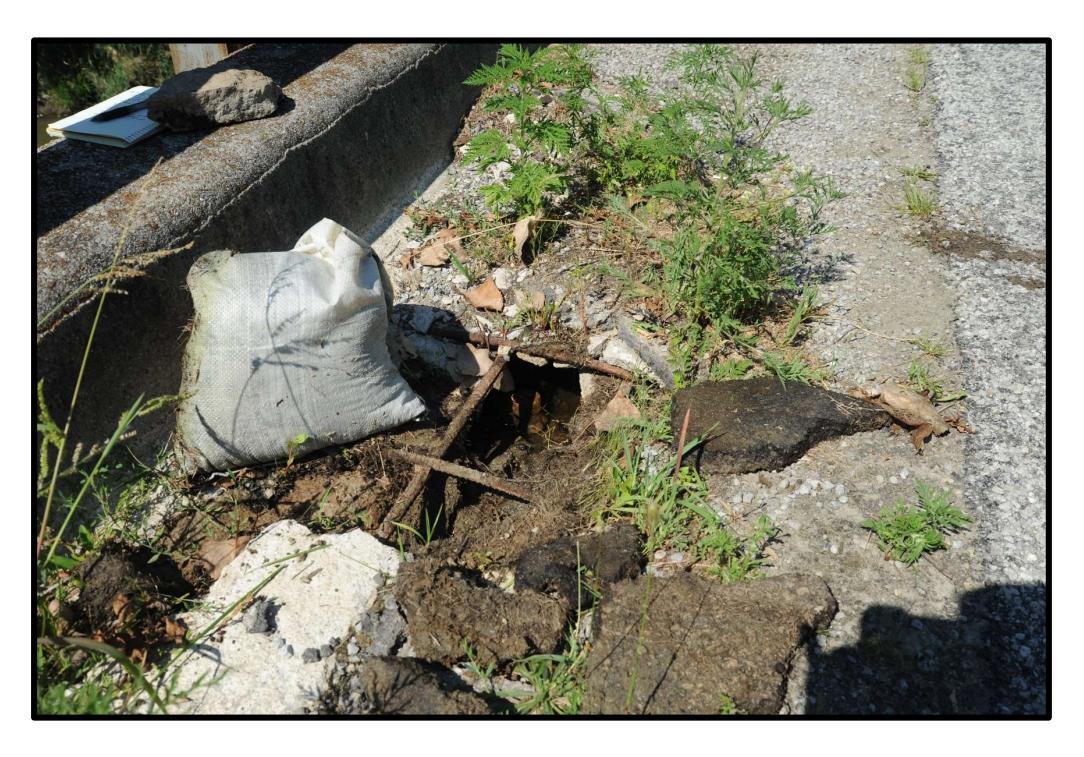
Figure 4.10 Hole in top flange of box beam.

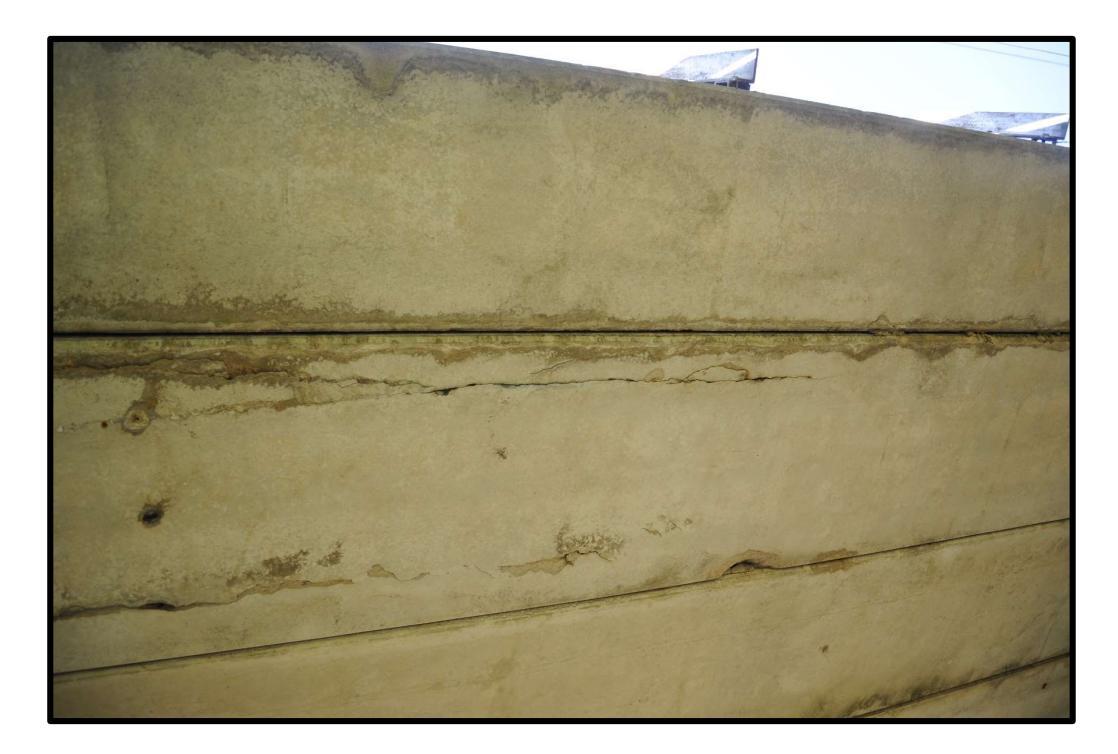
Figure 4.11 Longitudinal crack, spalling, and efflorescence in bottom flange in middle span.

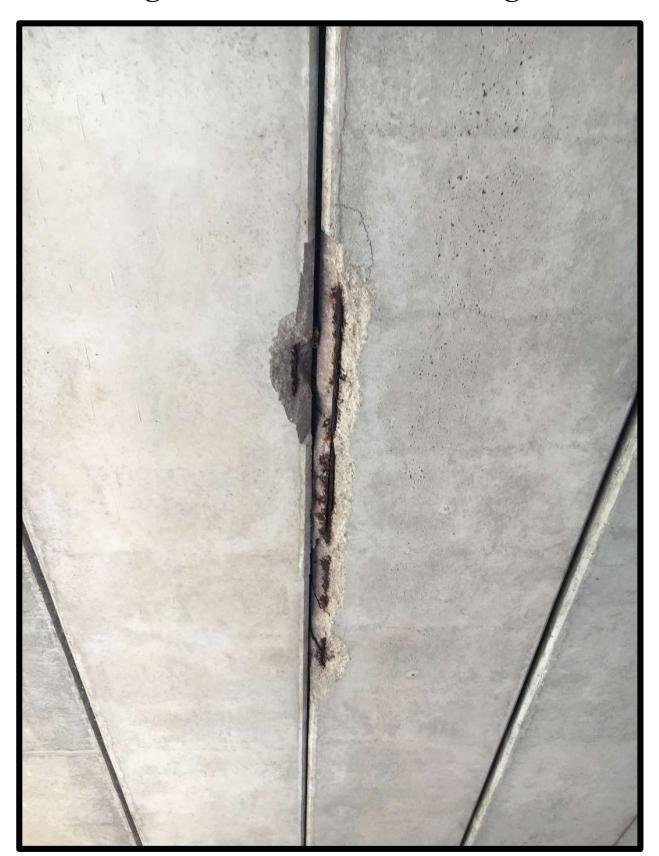
The bottom of the superstructure is in good condition compared to the Pond Creek and Rock Creek bridges. Spalling at the bottom corners of two adjacent beams with two exposed strands in the middle of the span was noted (Figure 4.13). Between Beam 3 and Beam 4, rust staining was observed towards midspan (Figure 4.14). Corrosion and two exposed stirrups were also observed at the southeast corner of the bridge (Figure 4.15). The complete deterioration map is provided in Figure 4.16.

Figure 4.14 Region of spalling with two exposed strands.

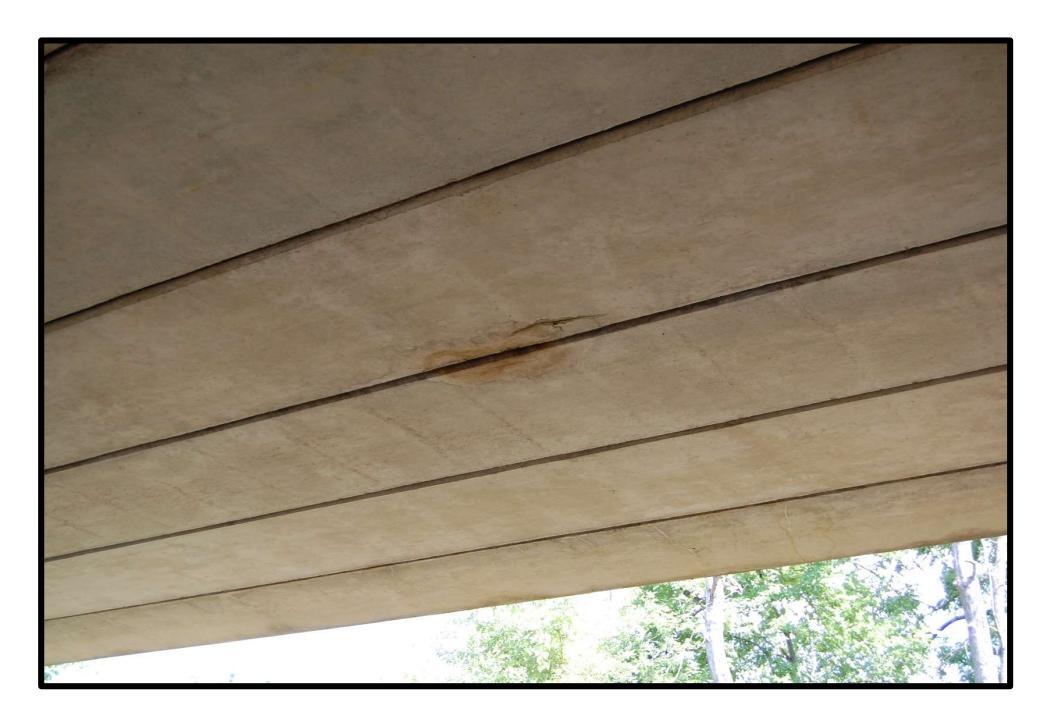
Figure 4.15 Staining near bottom of longitudinal joint.

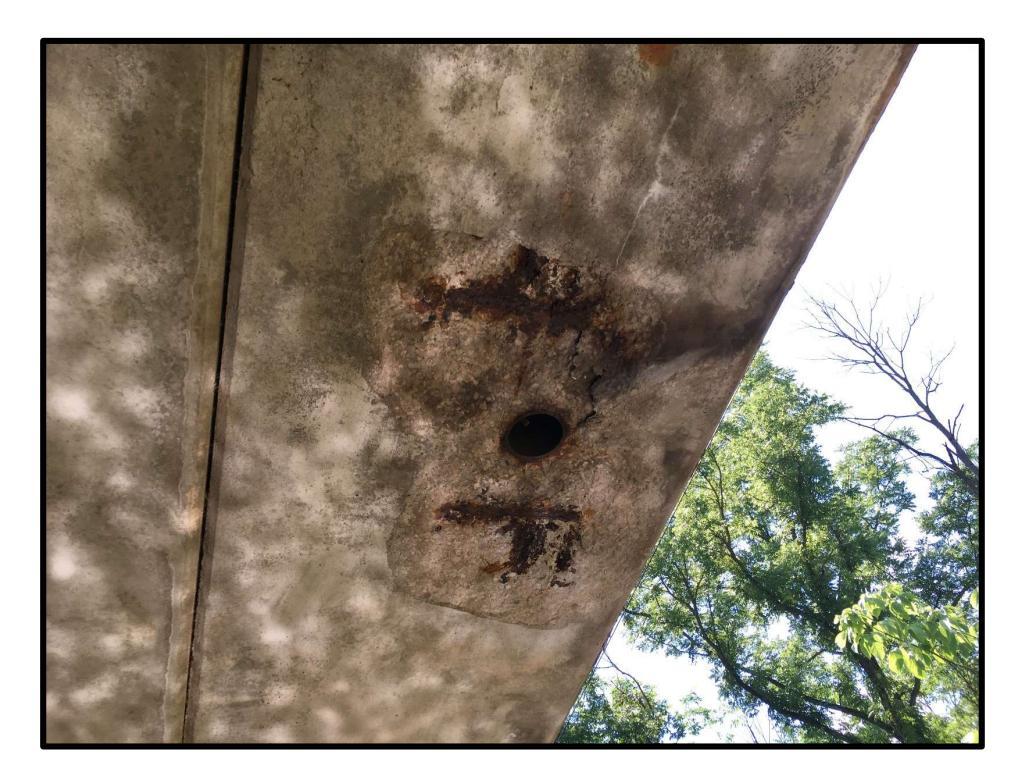
Figure 4.16 Corrosion and exposed stirrups around steel downpipe.

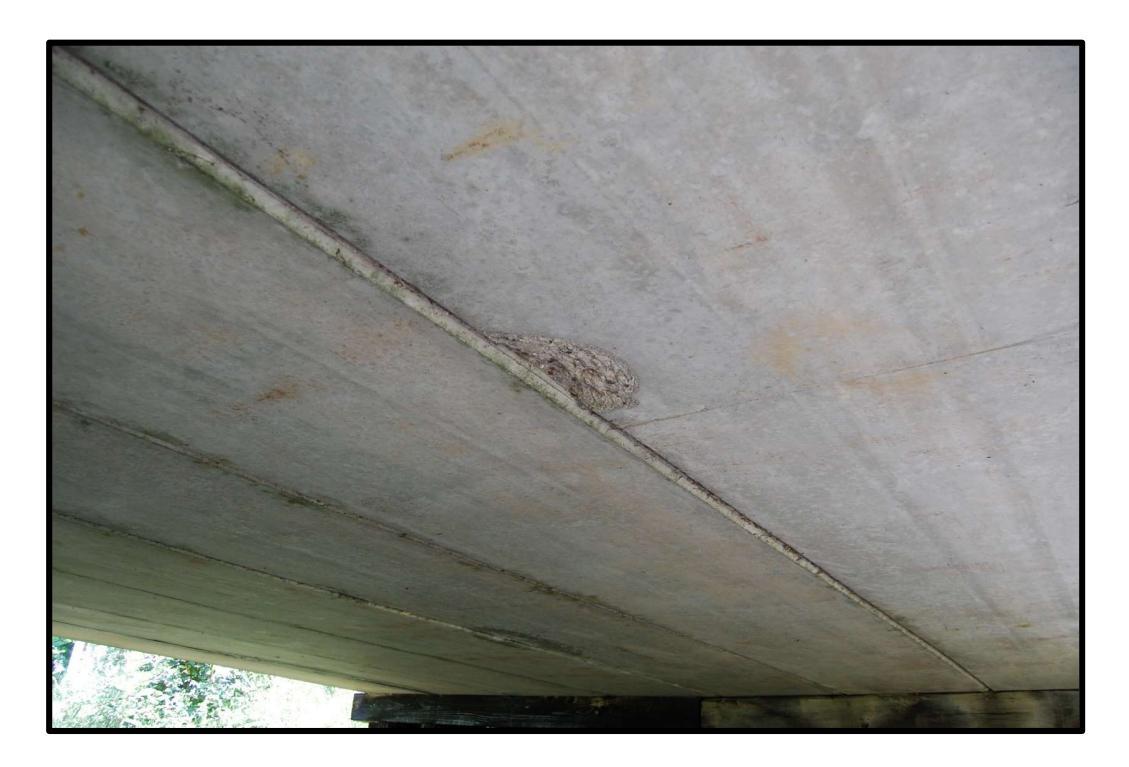
The underside of the Yellow Creek Bridge has small regions of spalling at the edges of the first interior beams along with an exposed strand (Figures 4.18 and 4.19). An exposed stirrup was observed on the exterior face of the exterior beam on the east side (Figure 4.20). Patched potholes were scattered across the concrete wearing surface and were filled with asphalt (Figure 4.21). A correlation was made between the location of the patches and the location of the longitudinal joints of the box beams. A complete map of the deterioration is provided in Figure 4.22.

Figure 4.19 Spalling along bottom of longitudinal joint.

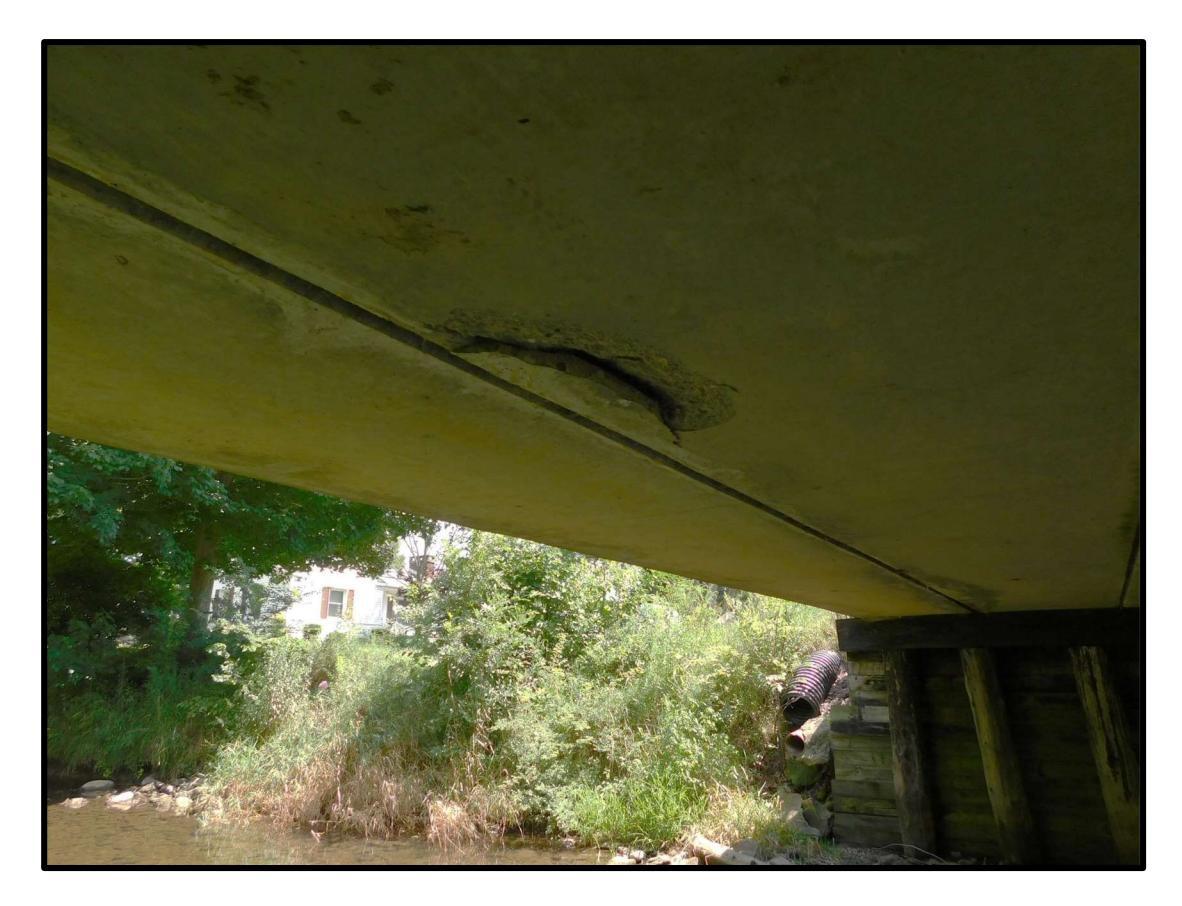
Figure 4.20 Spalling with exposed strand on Beam 7.

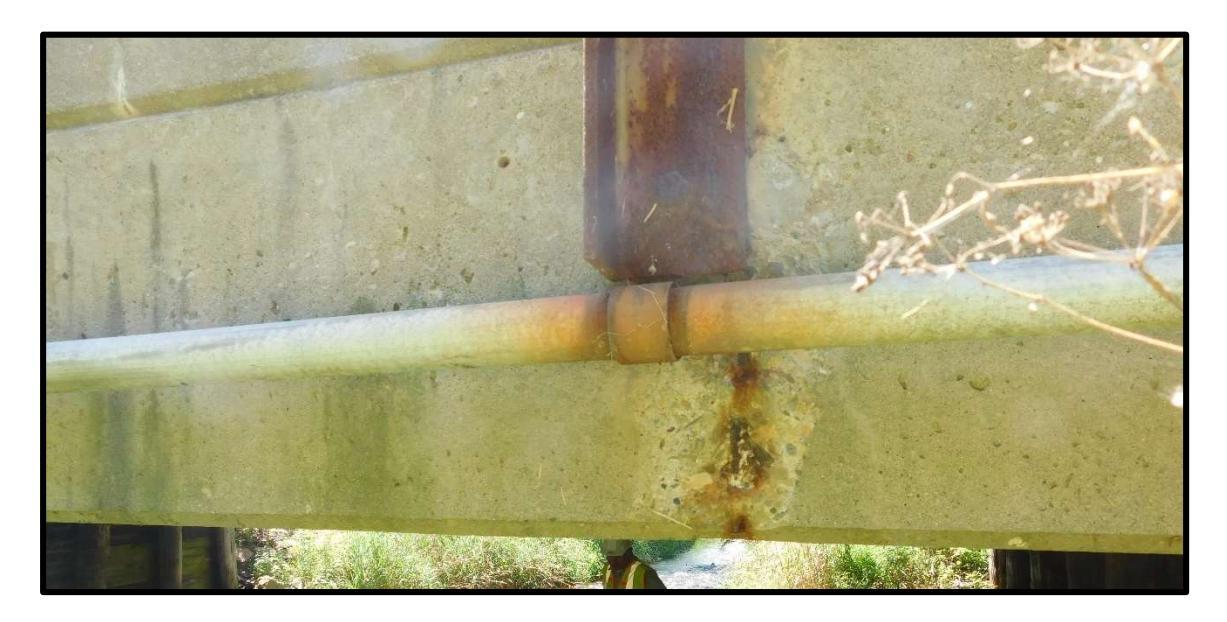
Figure 4.21 Spalling and exposed stirrup on the exterior face of Beam 8.

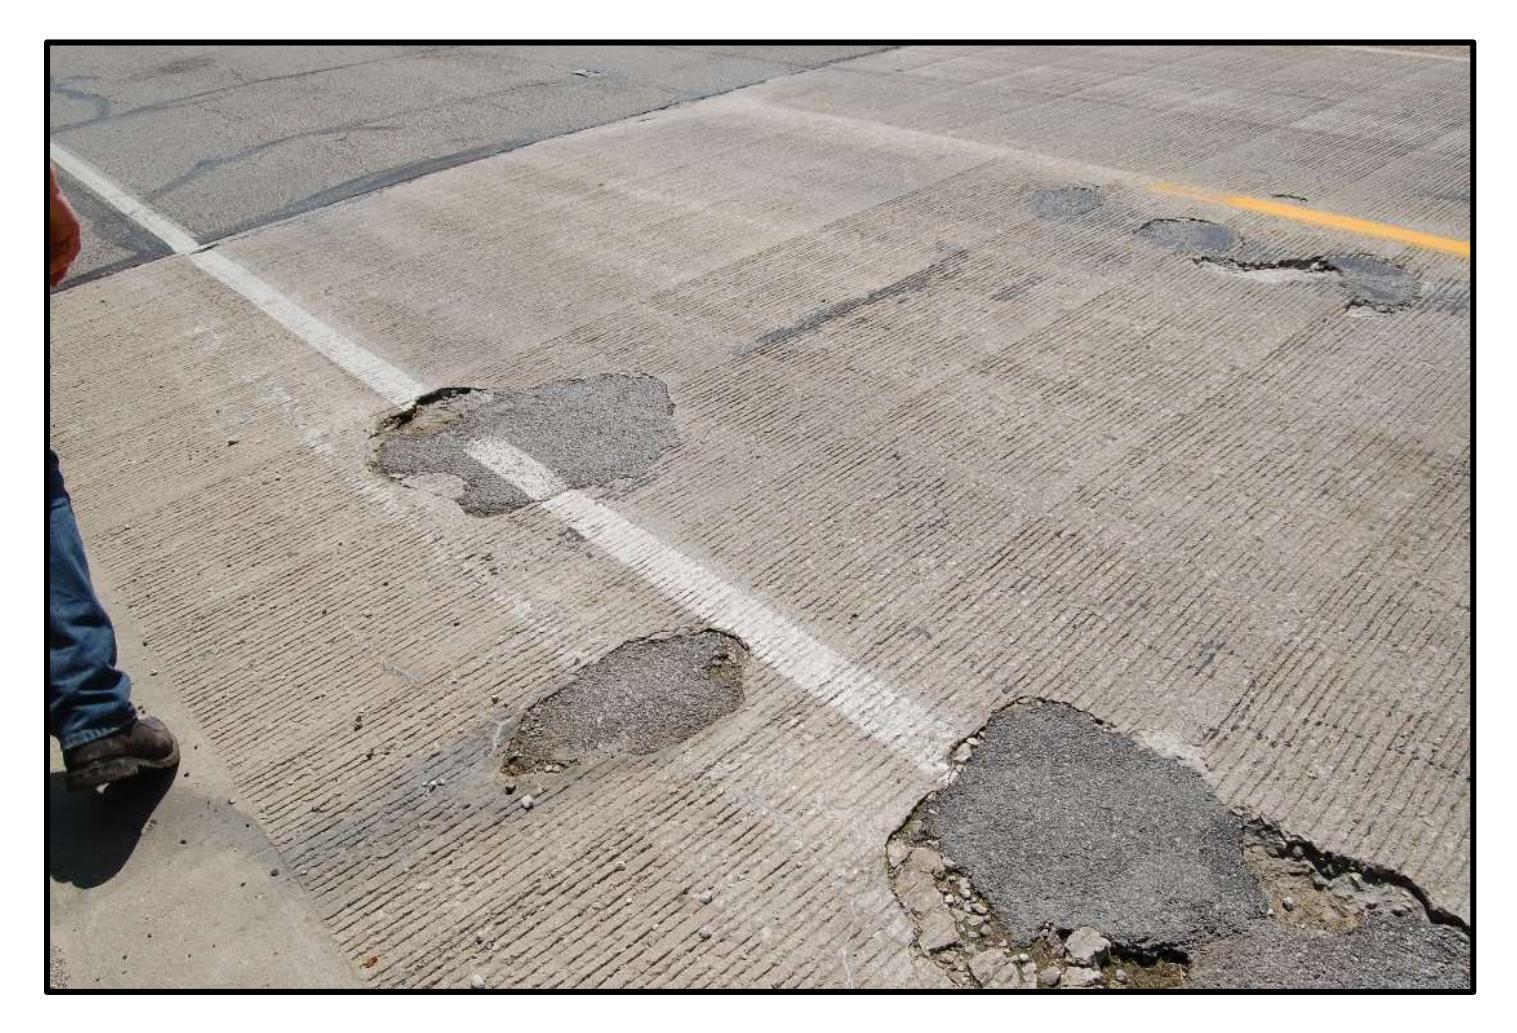
Figure 4.22 Potholes in wearing surface.

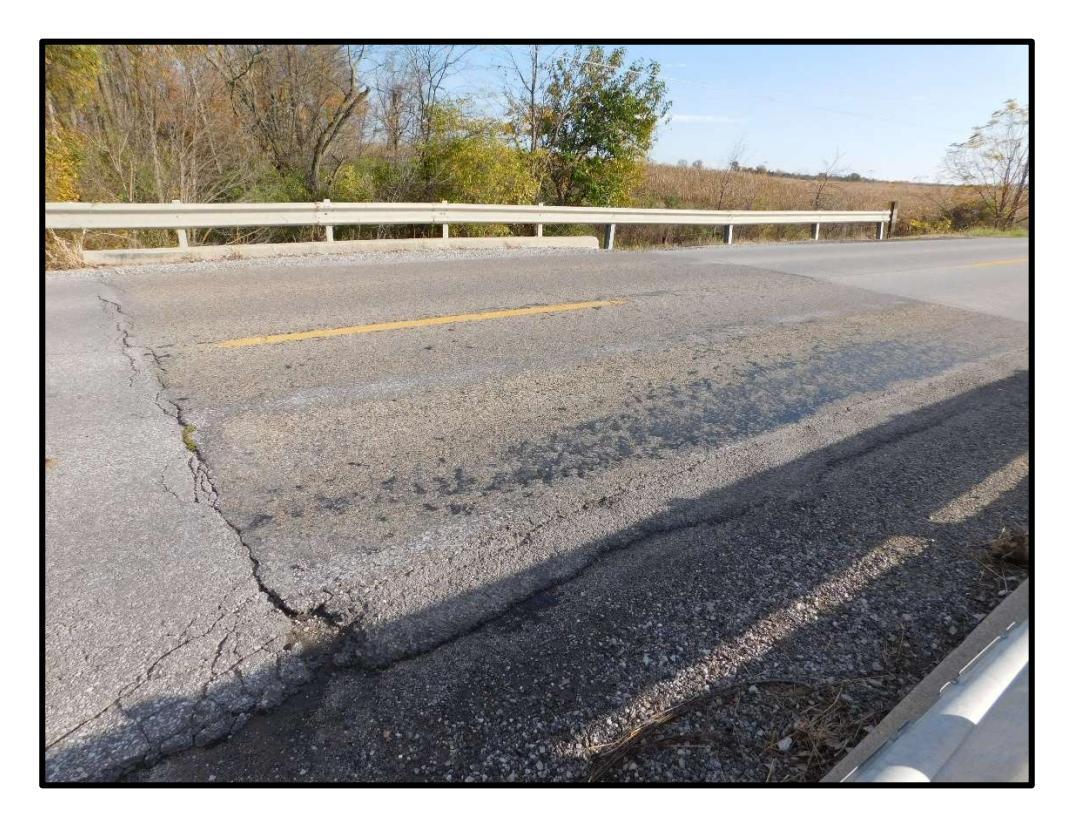
Figure 4.25 Bituminous wearing surface with gravel shoulders.

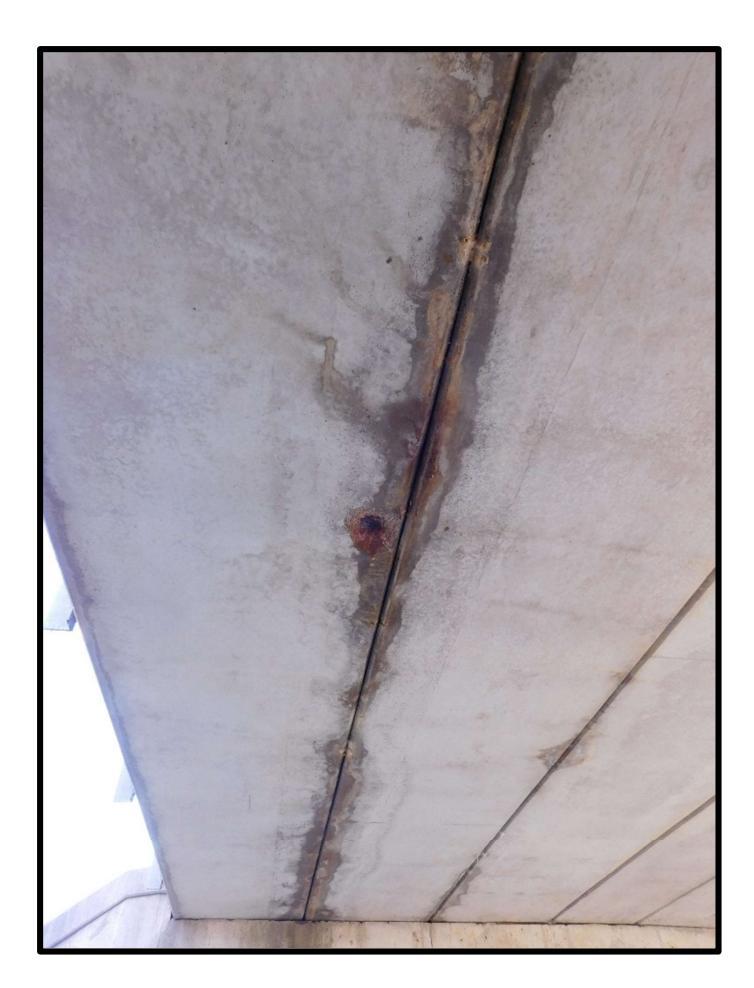
The only problems observed on this bridge were located at the longitudinal joints. On November 3, 2016, which was a relatively dry day, five of the seven longitudinal joints showed leakage. The most moisture along with efflorescence was observed at the exterior joints and extended the full length of the span. In addition, spalling and corrosion were observed at the exterior joint on the east side (Figure 4.25). Moisture was also observed at the interior joints, generally near midspan (Figure 4.26). Leakage was observed near the abutments between Beams 6 and 7. The complete deterioration map is provided in Figure 4.27.

Figure 4.26 Efflorescence, spalling, and corrosion along bottom of exterior joint.

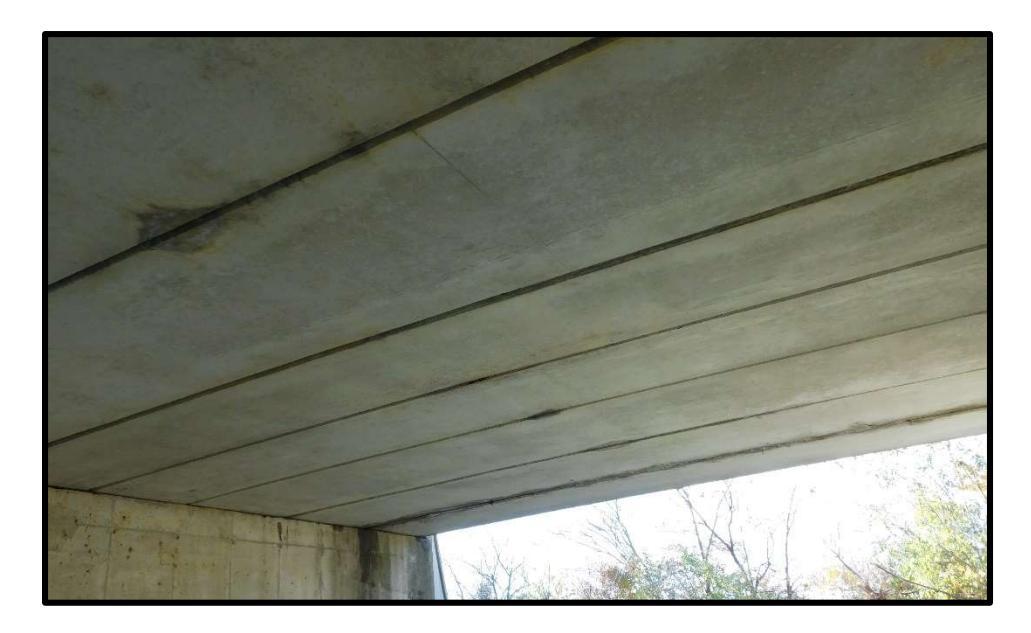
Figure 4.27 Efflorescence along bottom of interior joint.

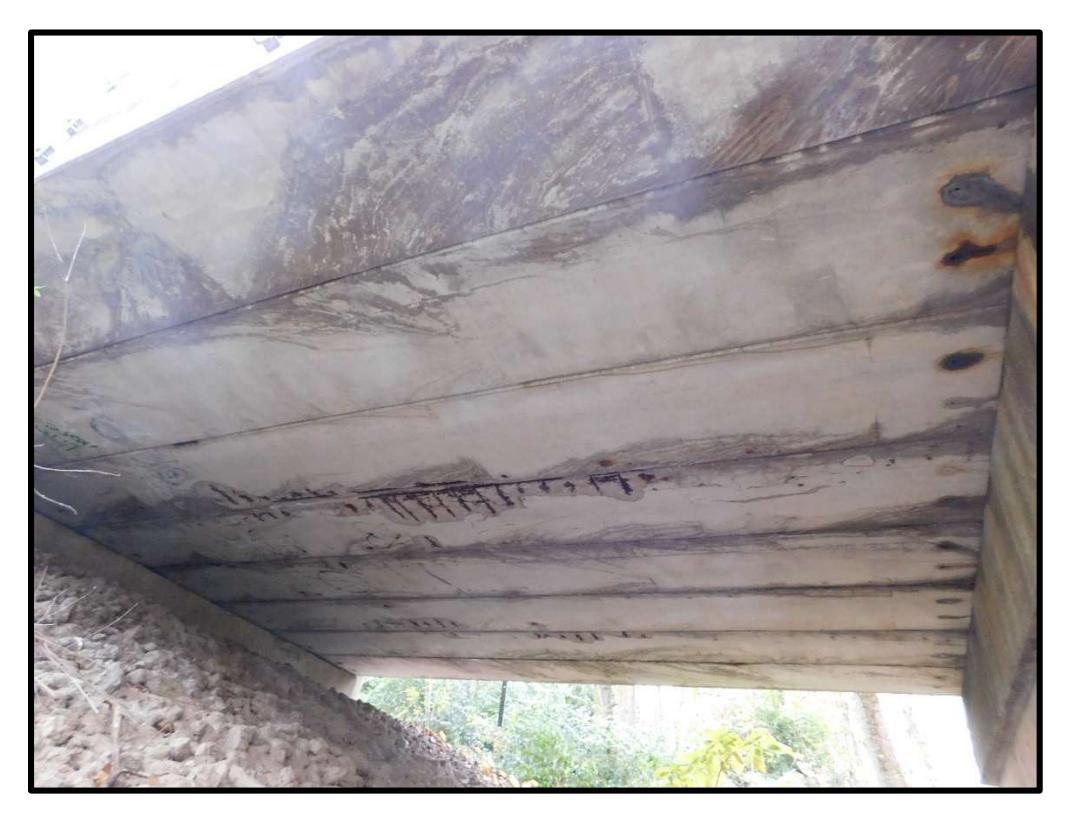
This bridge was noted to be in the worst condition compared to the other five bridges inspected. The end spans have multiple regions of spalling with exposed stirrups and strands (Figure 4.29). Corrosion on the west span was so severe that prestressing strands had fractured and debonded from the concrete (Figure 4.30). Strands were observed hanging from the underside of the superstructure. Spalling initiated near the longitudinal joints and, over time, moved closer to the center of the beams. For one particular beam, 24 exposed stirrups and four exposed prestressing strands were noted. The middle span appeared in better condition with only three locations of spalling, each region having three exposed stirrups (Figure 4.31). A complete deterioration map is provided in Figure 4.32.

Figure 4.30 Spalling and exposed stirrups on east span.

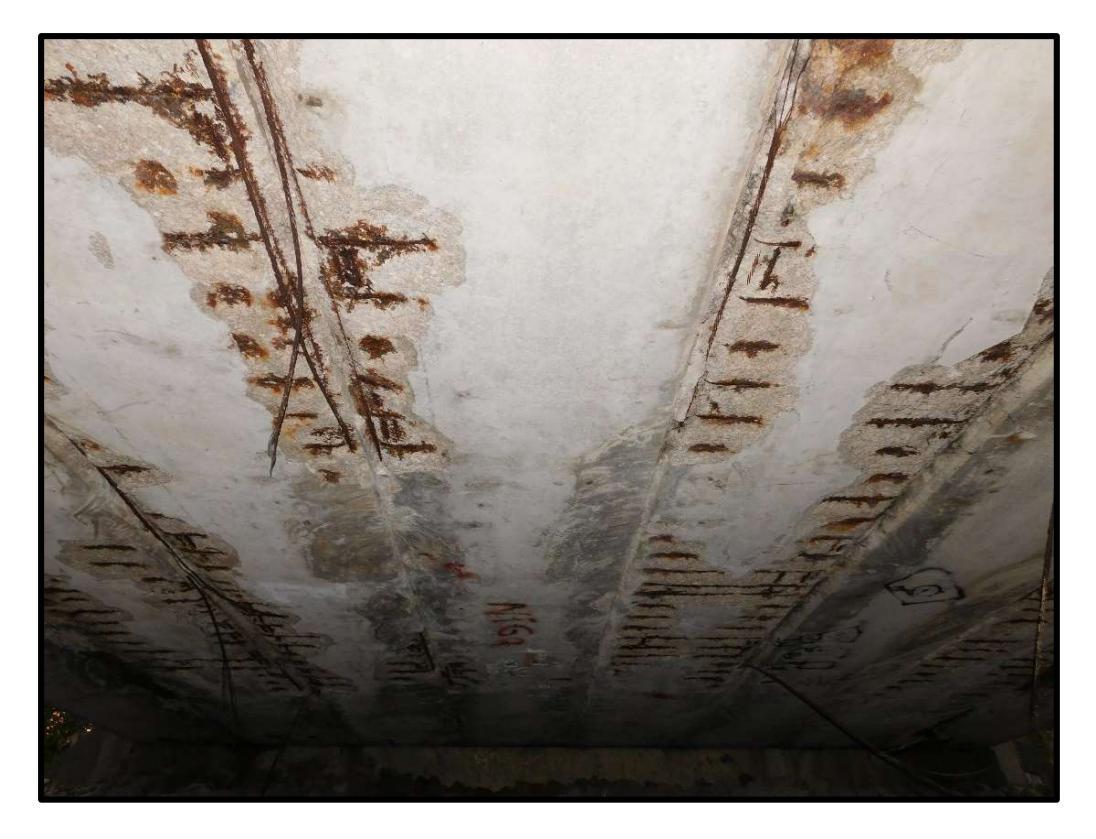
Figure 4.31 Spalling, corrosion, and fractured prestressed strand on west span.

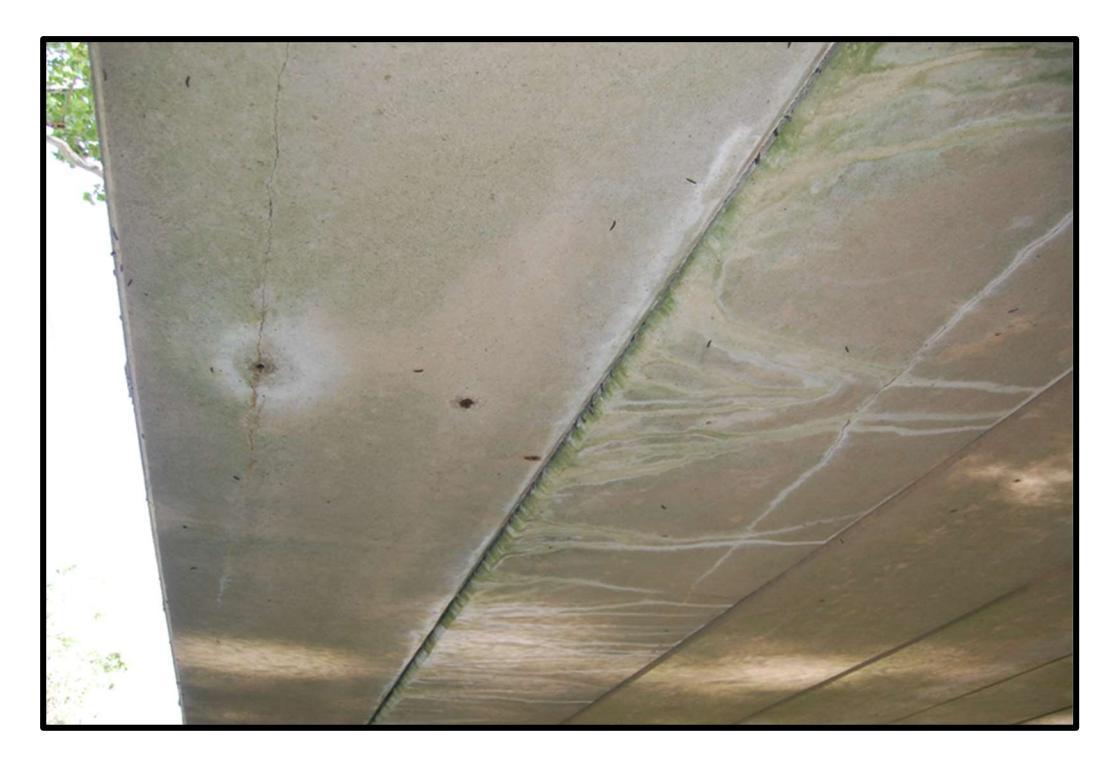
A combination of fractured shear keys and reflective cracking in the wearing surface leads to water seepage through the joints. Water staining on the bottom side of box beams near the longitudinal joint was frequently observed. The Pond Creek (35-00013) Bridge exhibited water staining and efflorescence at the exterior longitudinal joint. The staining revealed that the water was seeping through the joint and curling onto the bottom side of the first interior beam (Figure 4.33). The Main Street (02-00601) Bridge also had efflorescence and rust staining near the longitudinal joint (Figure 4.34). In both cases, staining occurred between the exterior and first interior beams. This leakage may be an indication that the exterior shear keys are not performing as well as the interior shear keys. Torsion of the exterior beam may be a contributing factor.

Figure 4.34 Water staining at the exterior longitudinal joint (Pond Creek).

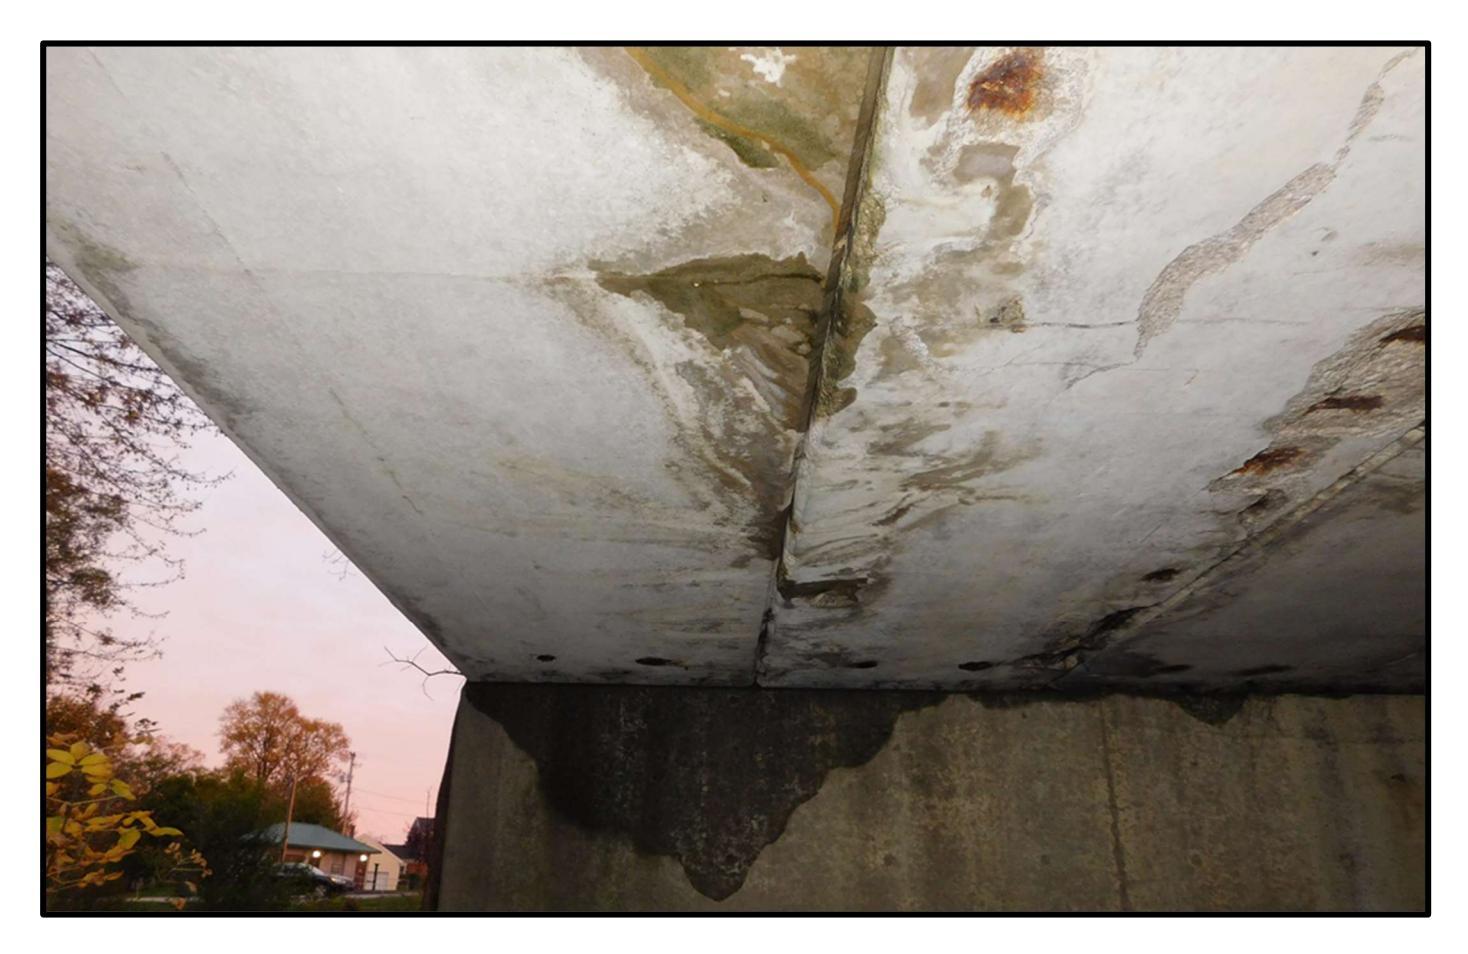
Figure 4.35 Water staining and effloresce at the exterior longitudinal joint (Main Street).

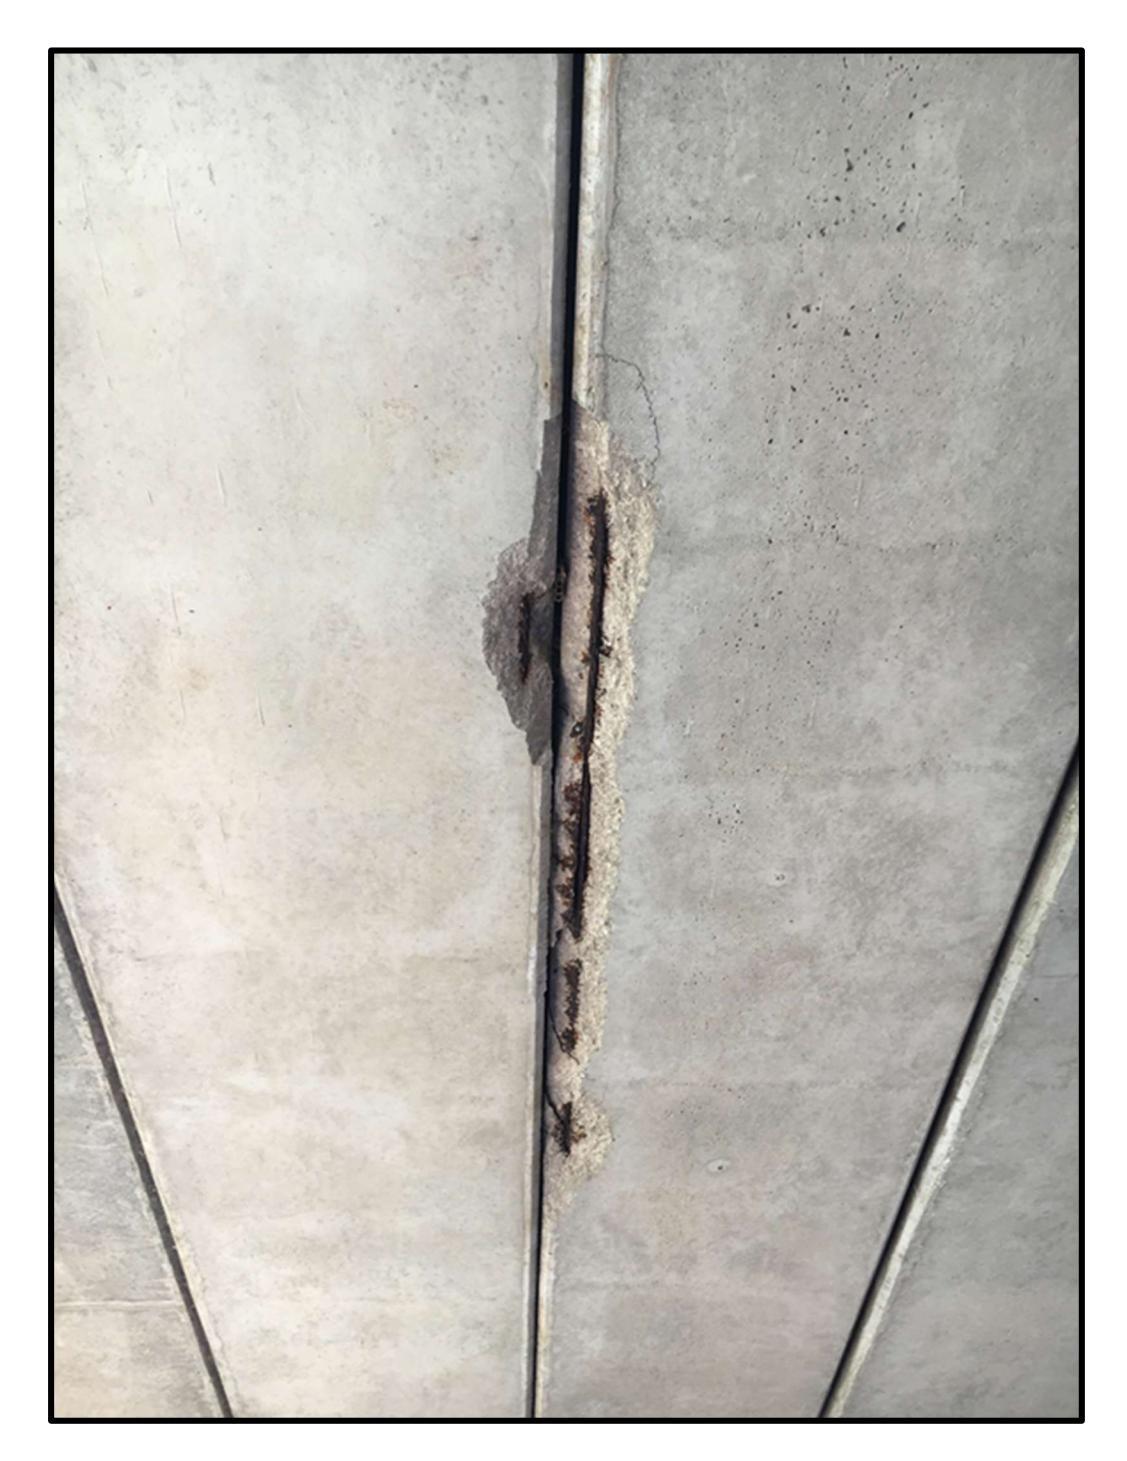
Figure 4.37 Spalling and exposed strand in the bottom corner of box beam (Clear Creek).

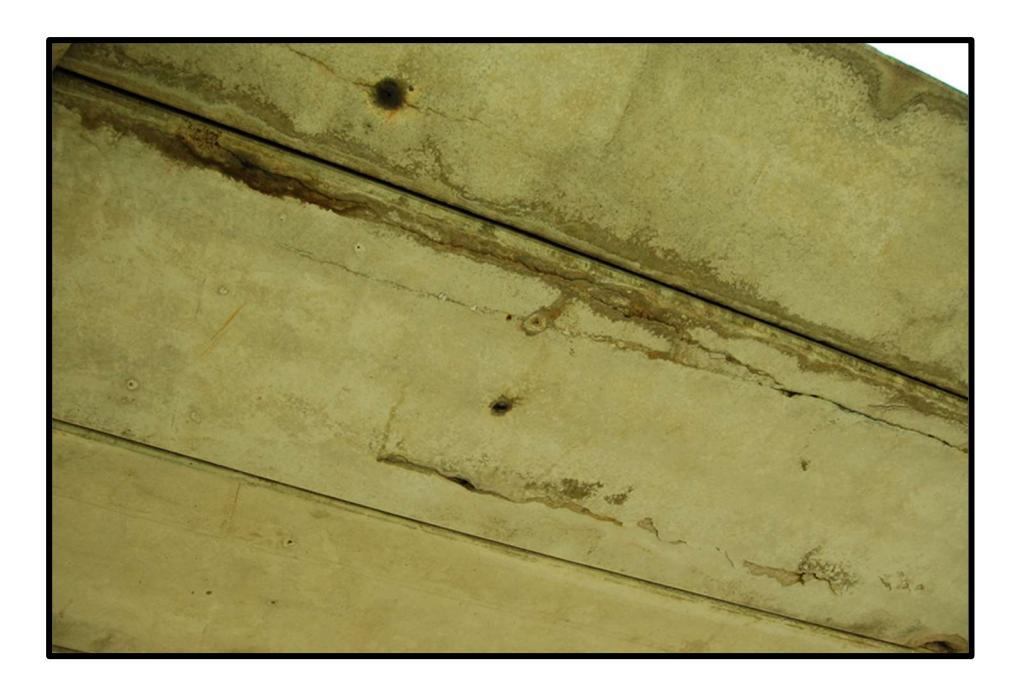
Longitudinal cracking was found on the bottom flanges of the adjacent box beams. Cracking usually occurred near midspan and was generally observed on or near the exterior beams. Rock Creek (90-00079) Bridge had two locations of longitudinal cracking. The first was in the middle span on the first interior box beam. Rather than being in the center for the flange, the longitudinal crack was closer to the joint with the exterior beam (Figure 4.37). This crack may be indicative of corrosion of the prestressing strand in the bottom corner of the beam. Longitudinal cracking was also observed on an exterior beam in the east span of the Rock Creek (90-00079) Bridge. This crack was closer to the center of the flange; however, the crack propagated toward the shear key closer to the abutment (Figure 4.38). A large region of spalling was observed in the center of the crack and exposed three prestressing strands. A group of drain holes was noted near the damaged location. Deterioration may have begun due to standing water in the void, causing corrosion of the prestressing strands, ultimately resulting in cracking and spalling.

Figure 4.38 Longitudinal cracking in bottom flange near shear key (Rock Creek).
