# JOINT TRANSPORTATION RESEARCH PROGRAM

# Concrete Box Beam Risk Assessment and Mitigation: Volume 1 – Evolution and Performance

SPR-4009 • Report Number: FHWA/IN/JTRP-2020/06 • DOI: 10.5703/1288284317117

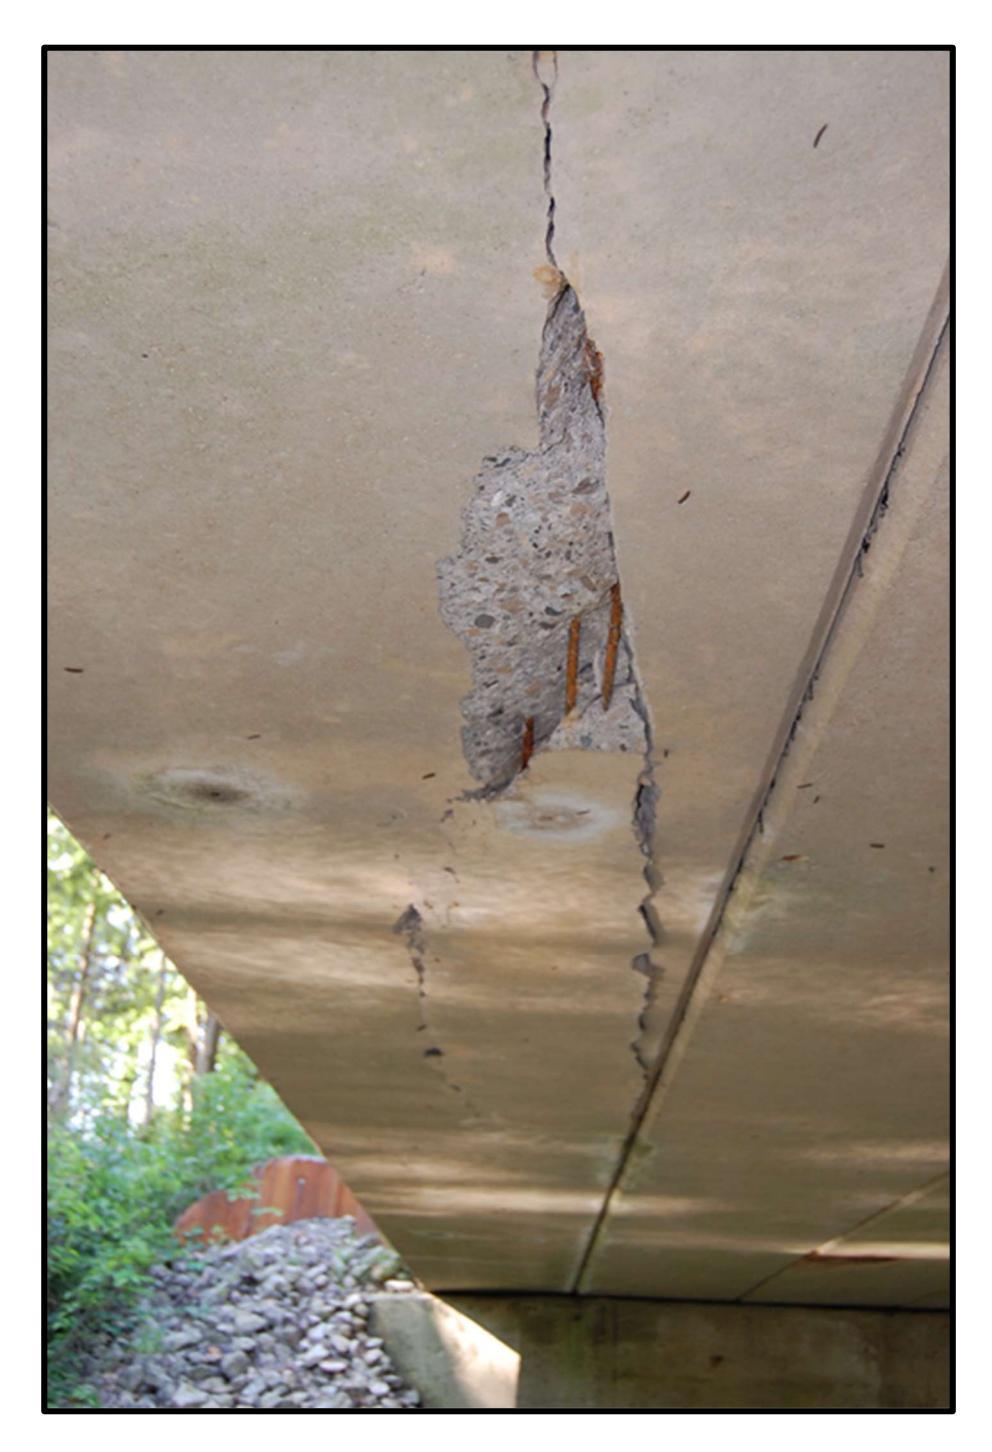
Figure 4.39 Spalling and exposed strands (Yellow Creek).

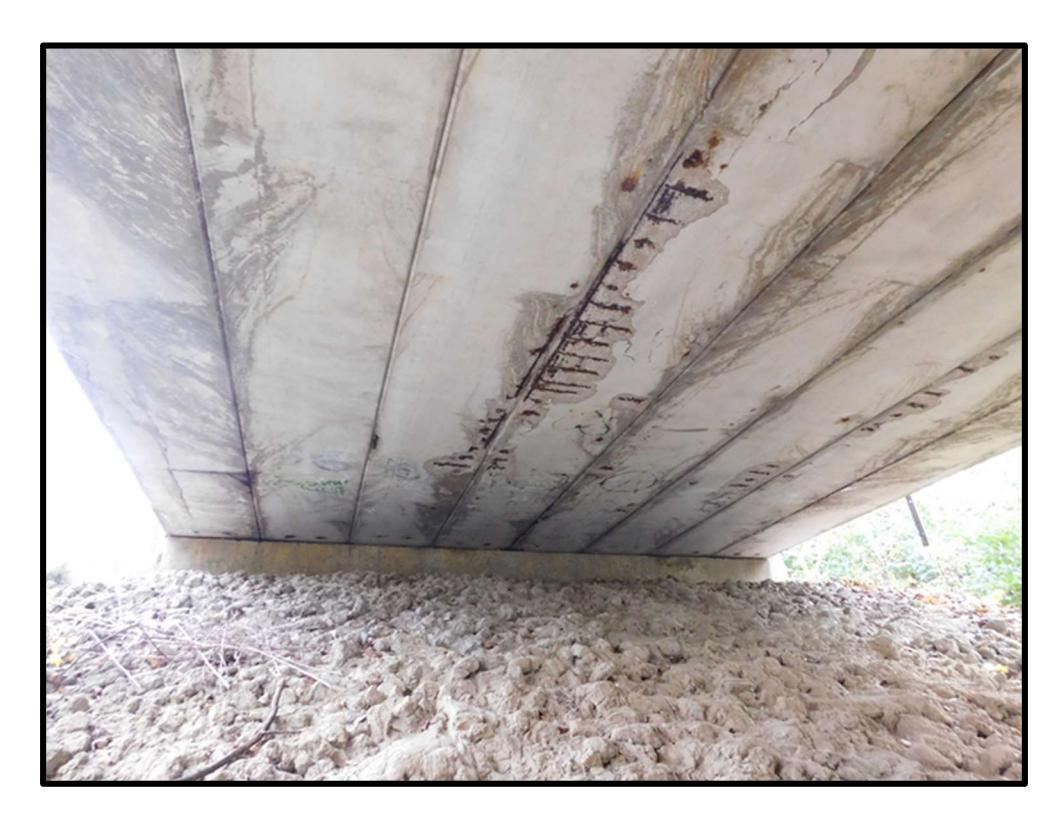
Corrosion of the reinforcement, both prestressing and stirrups, was frequently observed during the inspections. The worst case of corrosion was observed on the Main Street (02-00601) Bridge in Fort Wayne, IN. Spalling of concrete exposed a large number of stirrups and prestressing strands (Figure 4.39). In one span, the prestressing strands had fractured and debonded from the concrete, leaving them hanging from the underside of the beams (Figure 4.40).

Figure 4.40 Corrosion of shear reinforcement (Main Street).

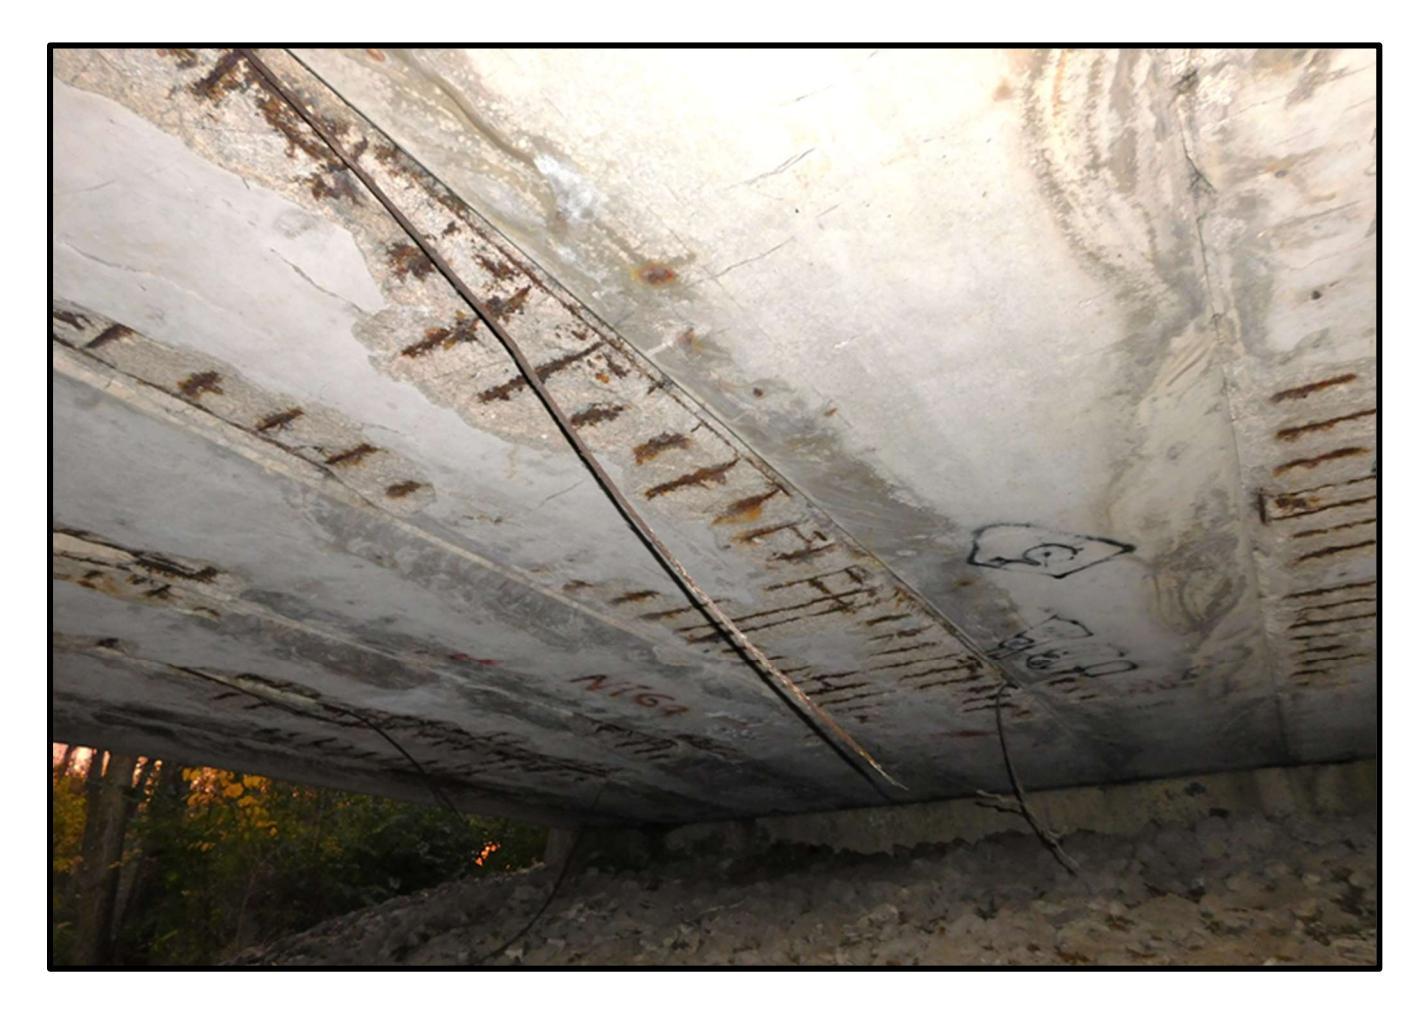
Figure 4.41 Fractured prestressing strands and corroding shear reinforcement (Main Street).
# 4.3.5 Clogged Drain Holes

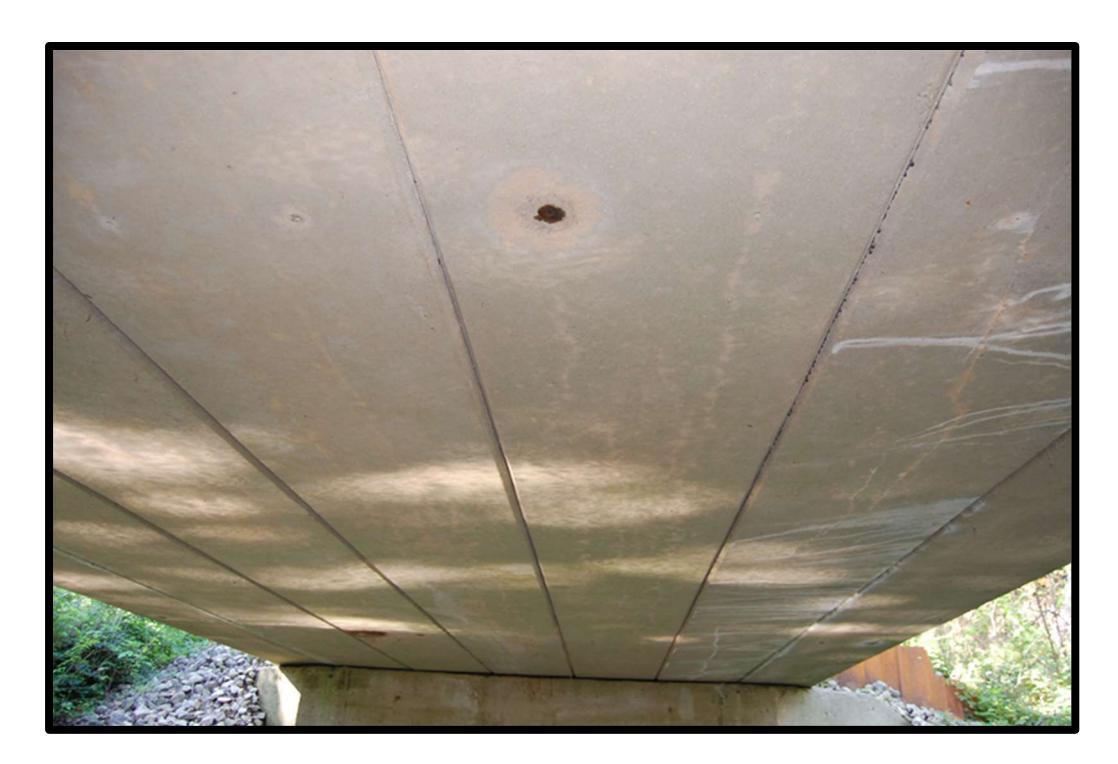
Cardboard that was used in the past to form the voids in prestressed box beams decomposes if exposed to moisture and can clog the drain holes. Therefore, standing water can accumulate in the box beams and accelerate deterioration. Furthermore, this added dead load reduces carrying capacity of the bridge. In many cases, rust staining and efflorescence were observed around the perimeter of drain holes. As an example, rust staining was observed around the drain holes of the Pond Creek (35-00013) Bridge (Figure 4.41). In contrast, the staining around the drain holes on the Main Street (02-00601) Bridge was black in color (Figure 4.42). For a number of the bridges, it was clear that water is being retained in the voids due to the clogged drain holes. In many cases, the clogged drain holes allow slow release of water while the drainage capacity of others is questionable.

Figure 4.42 Rust staining around drain holes (Pond Creek).

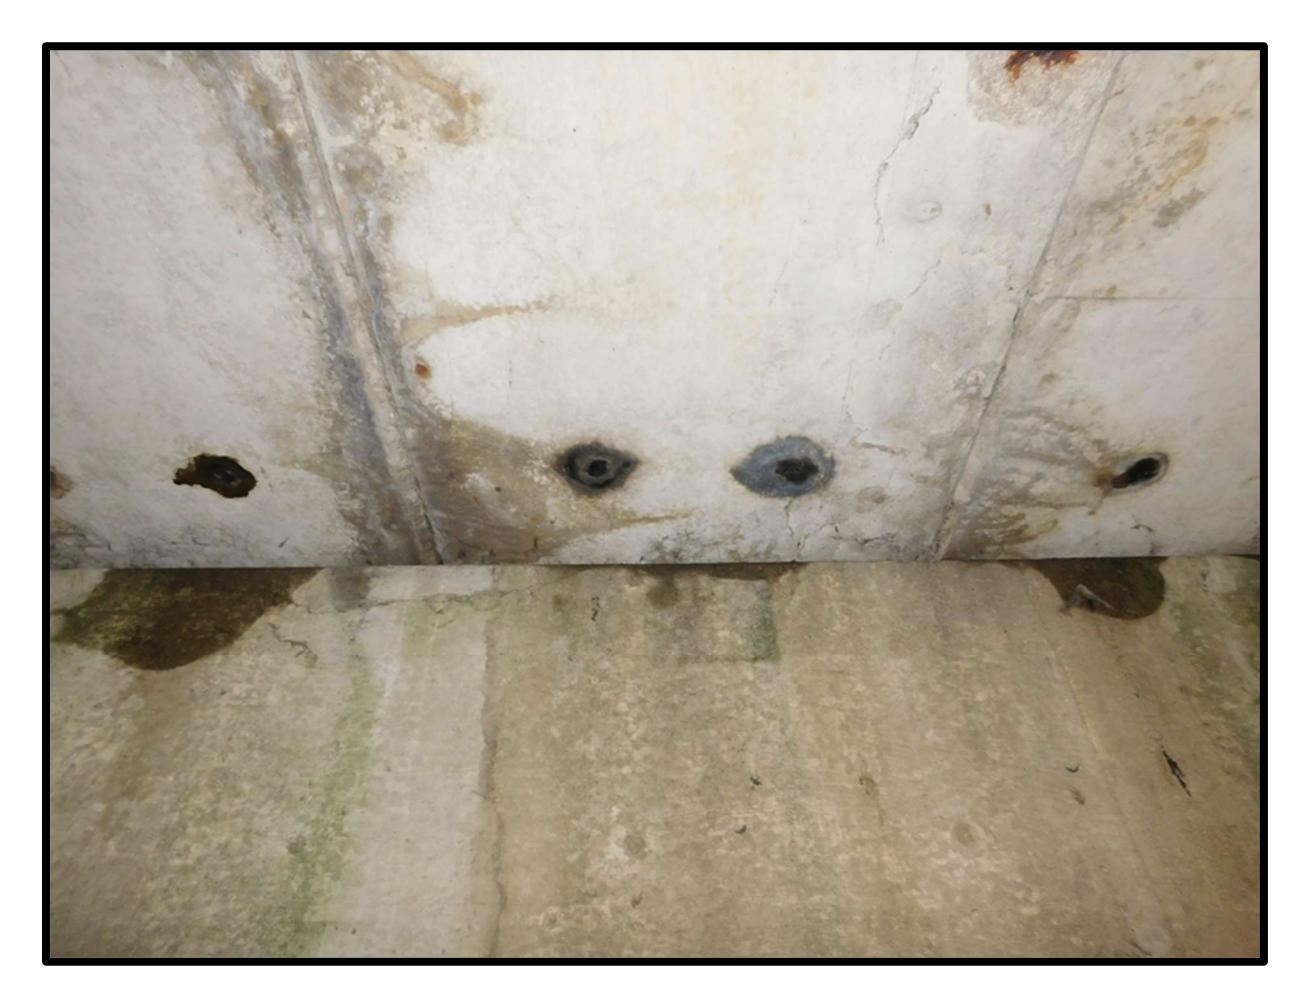
Figure 4.43 Black residue around drain holes (Main Street).

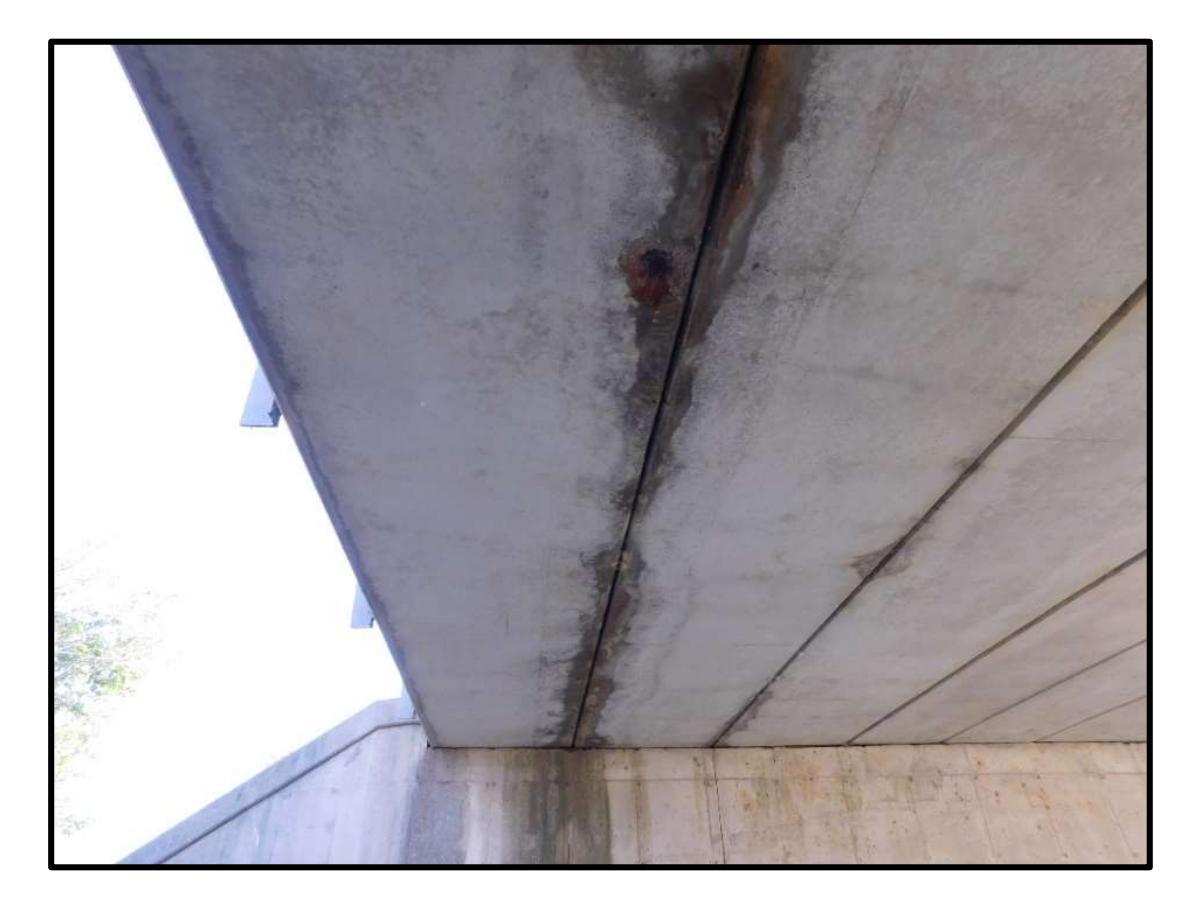
The eccentricity from the curb, railing, and/or barrier produces torsion which may cause rotation of the exterior beam, especially if there is failure of tie rods or no continuity from the wearing surface. This rotation can cause tension in the top region of the shear key, which may explain why the joint between the exterior and first interior beam is frequently observed to be leaking (Figure 4.43). Curb outlets also enable water to leak onto the side of exterior beams, leading to efflorescence, chloride penetration, and corrosion (Figure 4.44). Reduction of these exterior strands could lead to further section eccentricity.

Figure 4.44 Leaking exterior joint (Beal-Taylor Ditch).

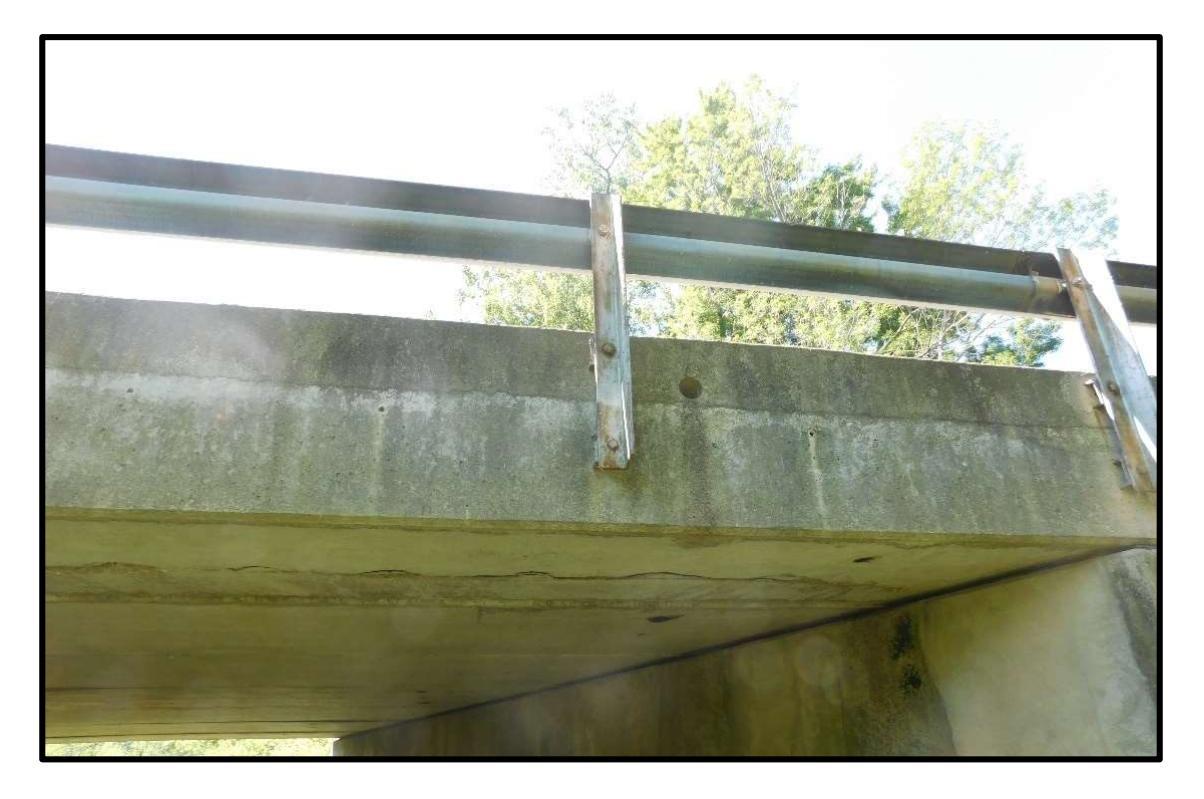
Figure 4.45 Curb cutout and efflorescence on exterior beam (Rock Creek).

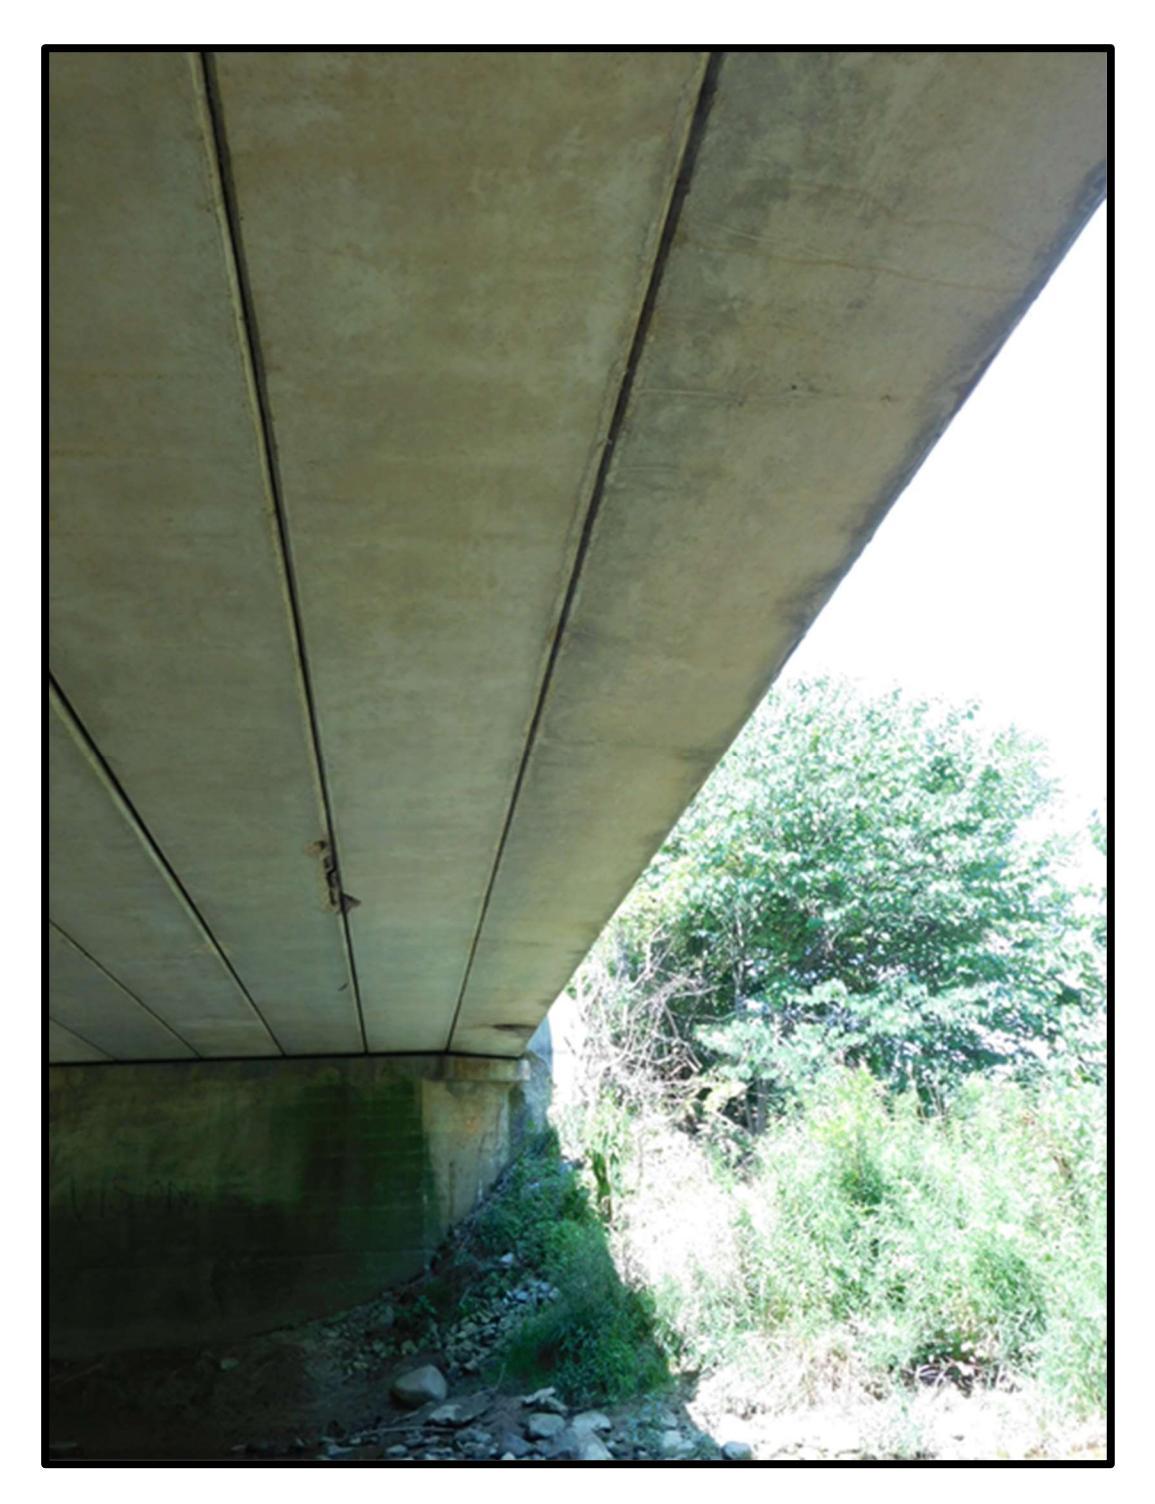
Figure 4.46 Rotation of exterior beam (Clear Creek).

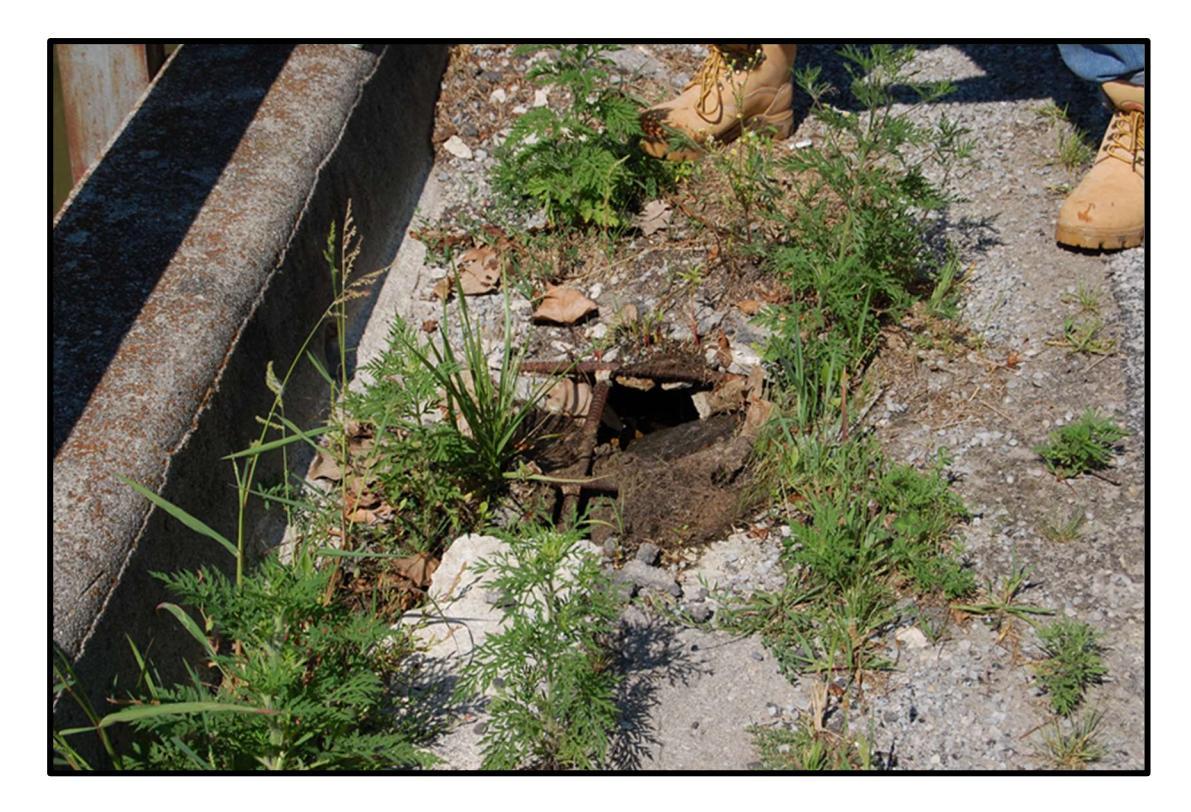
Figure 4.47 Opening in top flange of exterior beam (Rock Creek).

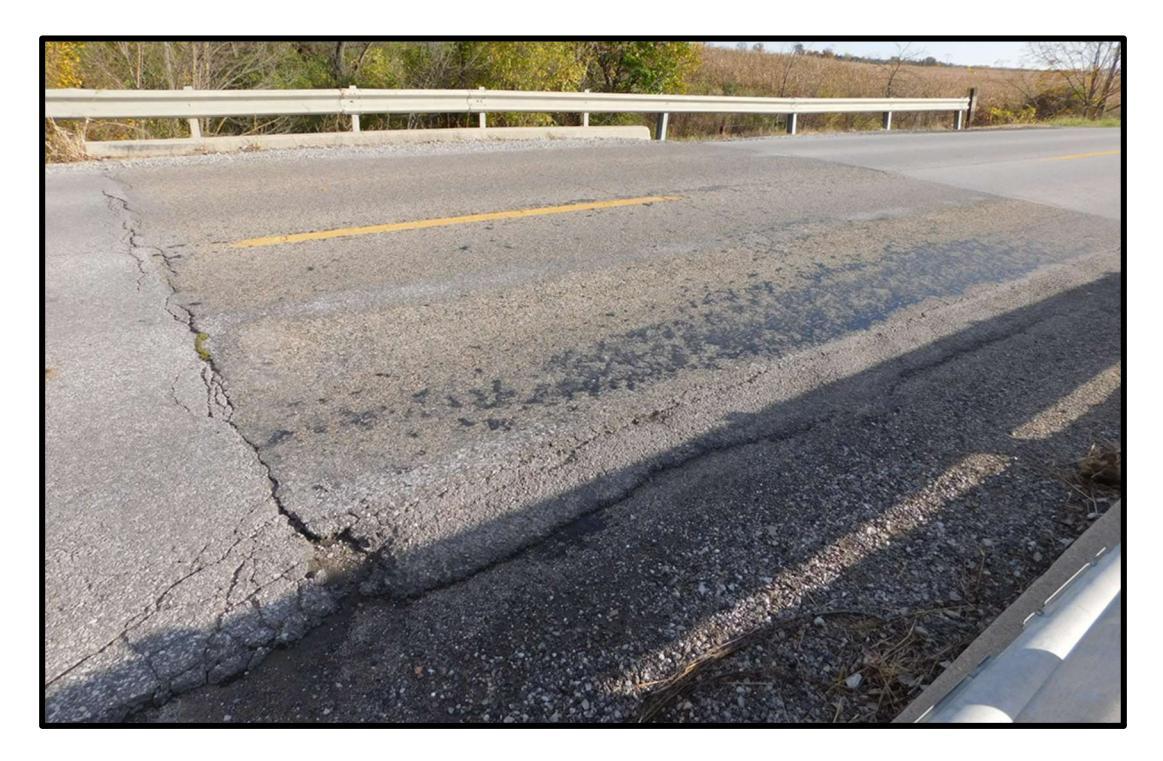
Figure 4.48 Reflective longitudinal cracking in bituminous wearing surface (Beal-Taylor Ditch).
